Assessment of Dam Safety Coal Combustion Surface Impoundments Draft Report

Duke Energy
Riverbend Steam Station
Mt. Holly, North Carolina

July 7, 2009

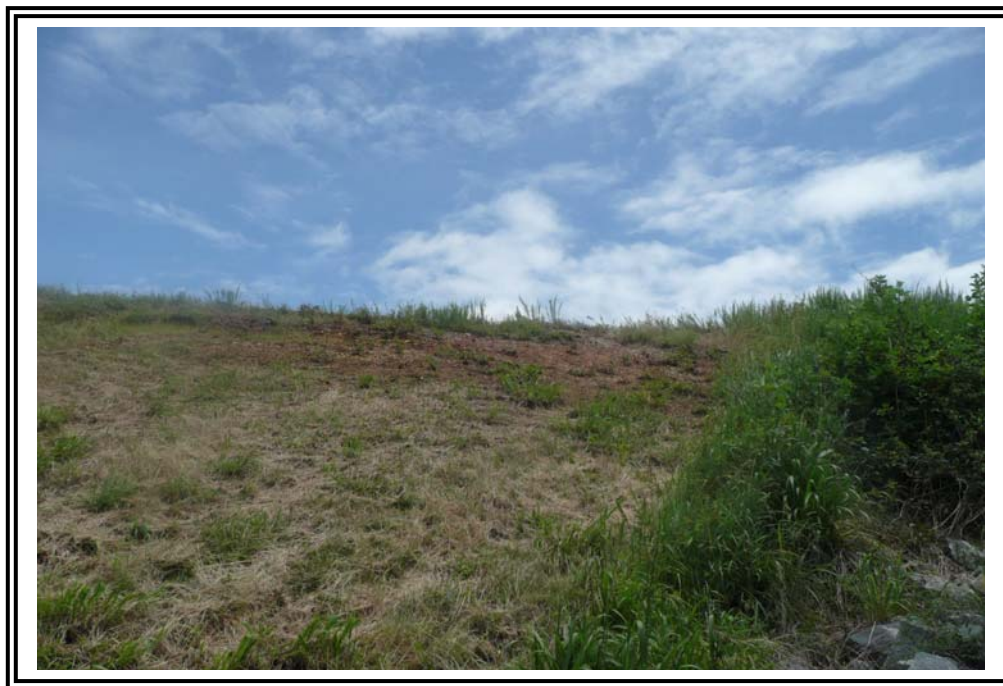
7

Close-up of slope at left (south) abutment with sparse vegetation.

Appropriate grass vegetated the dikes. However, there were areas of sparse vegetation where reseeding maintenance should be performed. There are also some areas where the grass cover appeared to be removed by sliding mower wheels. Duke Energy should perform reseeding as required yearly to maintain a good grass cover on the dikes. If mower damage routinely occurs in the same areas each time grass is re-established, consideration should be given to using alternative methods (such as weed-whacking) of cutting the grass in these areas.

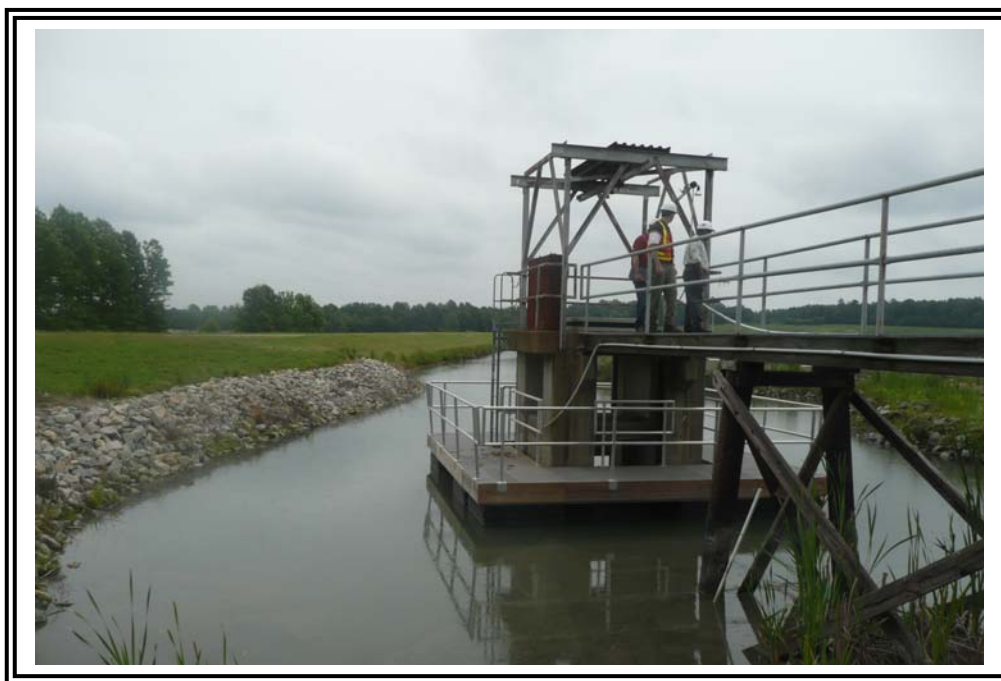
Primary pond outlet tower at north corner of the pond.

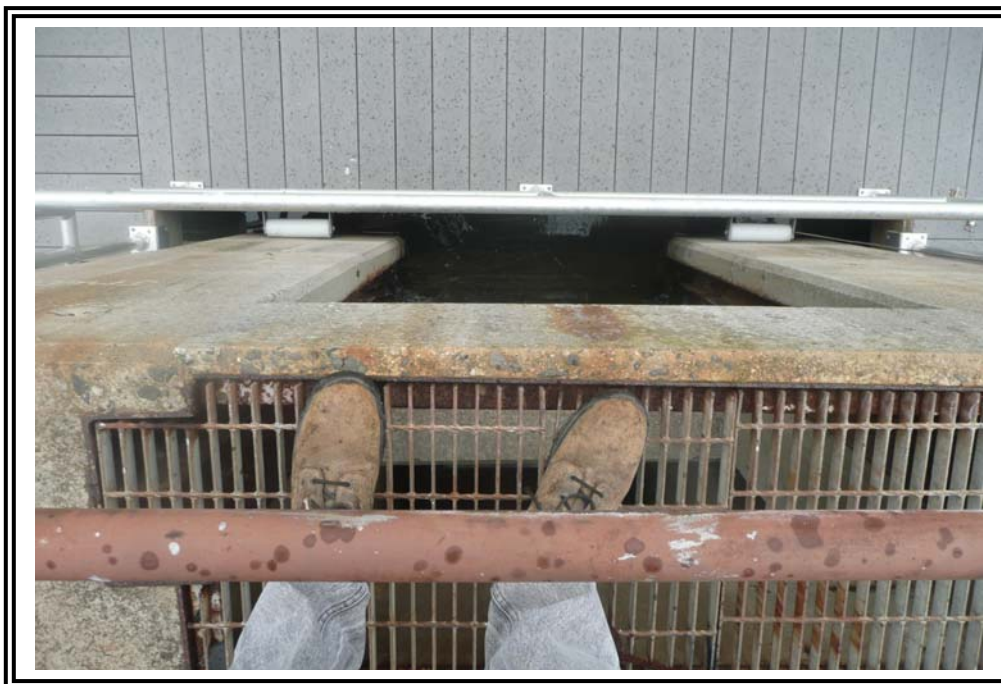
21

Open weir in primary cell outlet tower.

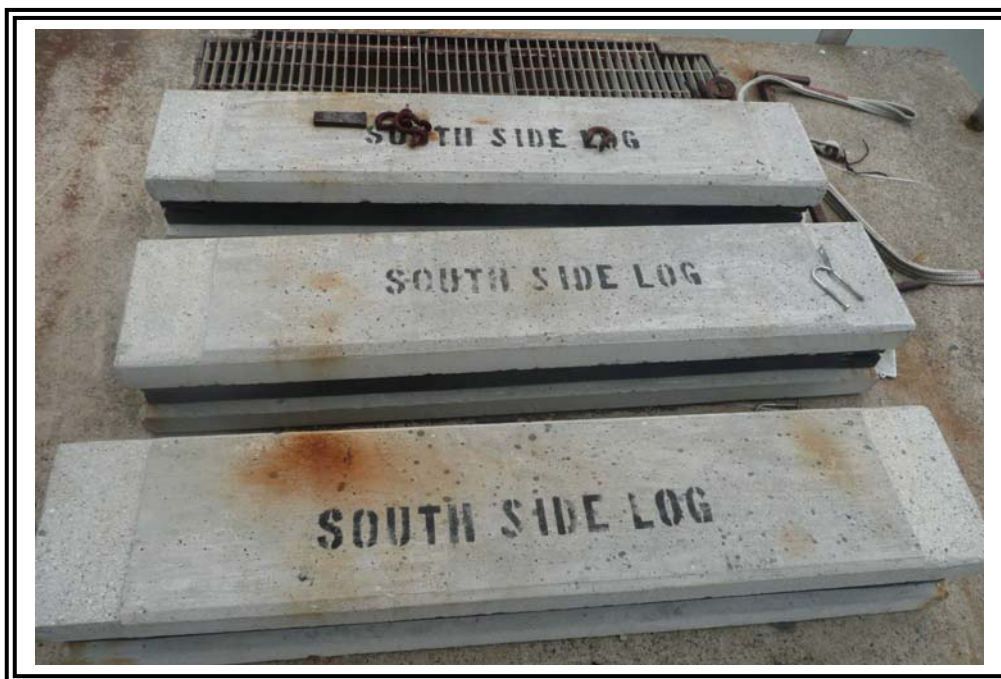
22

Concrete stop logs used to regulate water level in the primary pond.

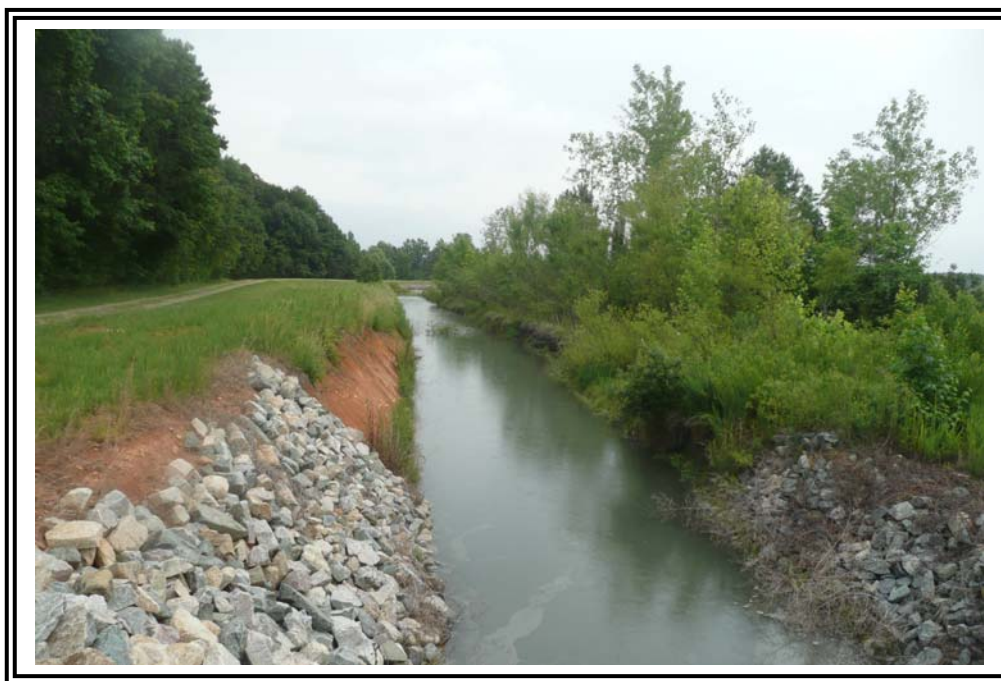
24

Outlet channel into secondary pond. Vegetated area on right side of channel is accumulated ash in secondary pond.

During our site visit the outlet pipe from the primary pond to the secondary pond was submerged. This concrete pipe was constructed beneath the intermediate dike on top of sluiced ash. We recommend a condition survey be performed on this pipe to check for condition degradation, leaking joints, joint settlement, etc. that could impact the performance of the overlying intermediate dike.

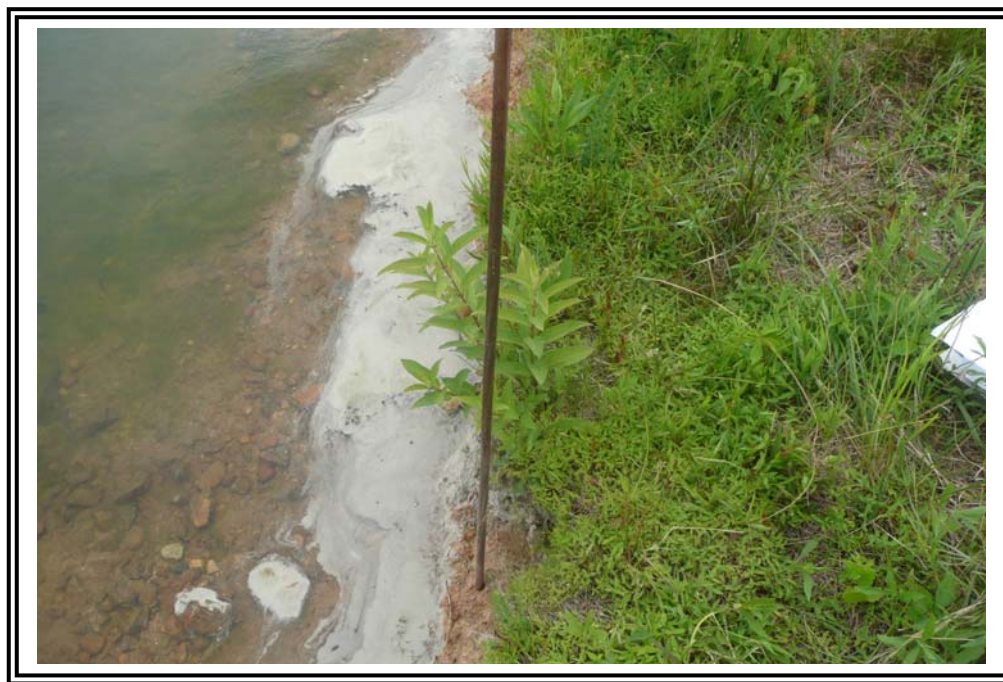
28

Along the upstream slope, an inboard ash diverter dike was constructed during previous dredging operations and left in place to create a dewatering channel for future dredging operations. Photos 25 through 27 show this dewatering channel. A breach in this diverter dike, as shown in Photo 31, is filled in during dredging operations, and then rebreached to allow normal operating flows to reach the outlet control structure for the primary ash pond. Slight beach erosion was noted at the water line of the upstream slope.

Slope intermediate dike beach erosion.

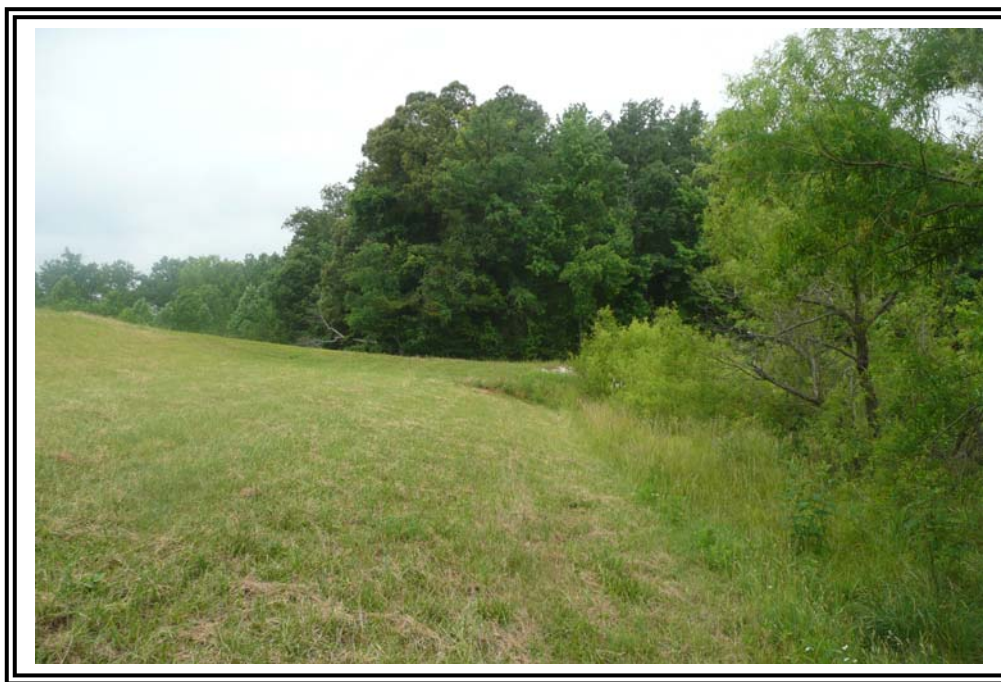
36

Downstream slope of intermediate dike near west abutment. Tree growth in right of photo is on deposited ash in secondary pond.

Similarly, trees have established themselves in ash sediment adjacent to or over the toe of the intermediate dike at the west end. CHA recommends these trees be removed under the direction of a professional engineer.

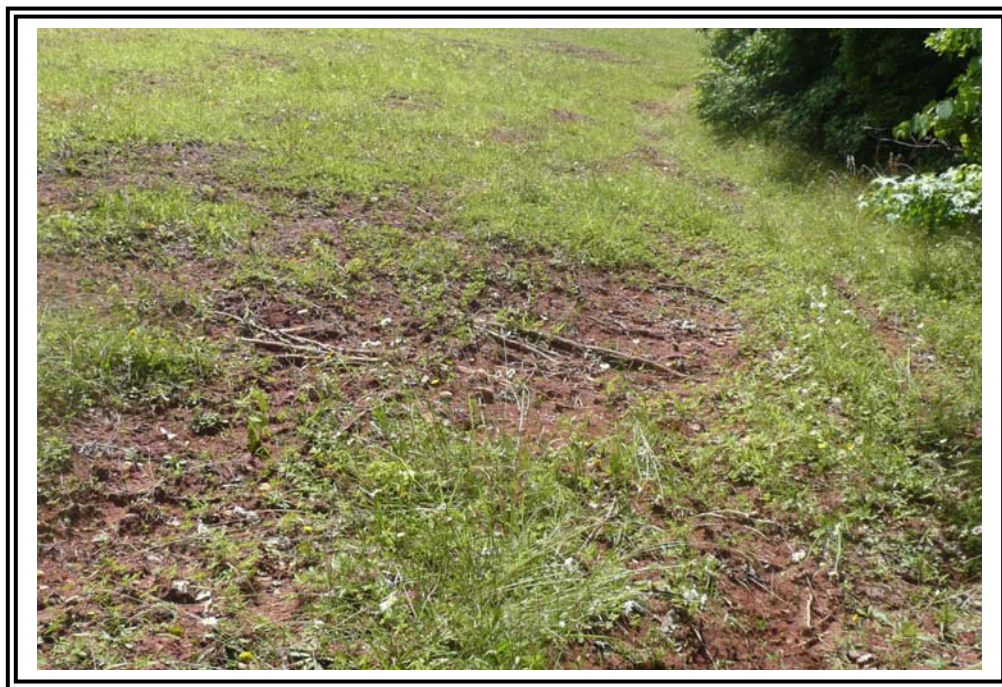
47

The downstream slope was reasonably uniform and predominantly covered with appropriate grass vegetation although areas of sparse grass were noted in isolated areas, some of which appeared related to mower wheels sliding on the slope. Photos 45 through 52 and 57 through 59 show the condition of the downstream slope. Near the tree line at the northwest edge of the high embankment, roots were noted on the ground surface. It appeared these roots were growing from trees located immediately beyond the toe.

Close up of root growth.

Tree roots were observed at the slope surface near the northwest end of the secondary dike. These tree roots appear to be from trees growing beyond the toe of the dam. CHA recommends that Duke Energy, under the direction of a professional engineer, remove trees from beyond the toe of the dam, and remove large root masses in the embankment toe.

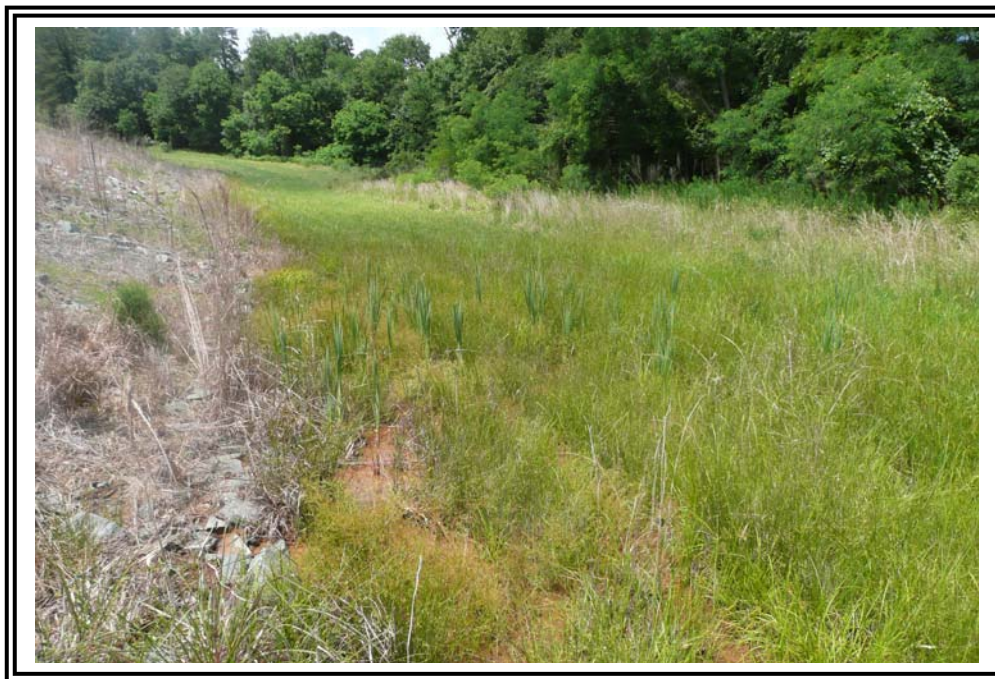
Seepage, as shown in Photos 54 and 55, was observed from the toe drain between about redacted redacted northwest of a rip rapped swale extending beyond the toe of the dam (see photo 56). Flowing water was observed in these seepage areas, and the type of vegetation at the toe was indicative of perennially wet conditions. The observed flow was clear.

Reeds growing in area of seepage at the toe.

As discussed in Section 2.3.1, flowing seepage was observed at the toe of the secondary dike. Duke Energy was aware of this seepage and makes observations of this area during their routine inspections. CHA recommends a collection trench or pipe and monitoring weir be installed in this area to facilitate quantifiable volume measurements and sample collection. Quantifiable measurements will allow Duke Energy and outside consultants to see changes if they occur which would need to be addressed, and allow for a sampling point so a sample can be observed for sediment transport on a routine basis, again to simplify observations of change in the condition.

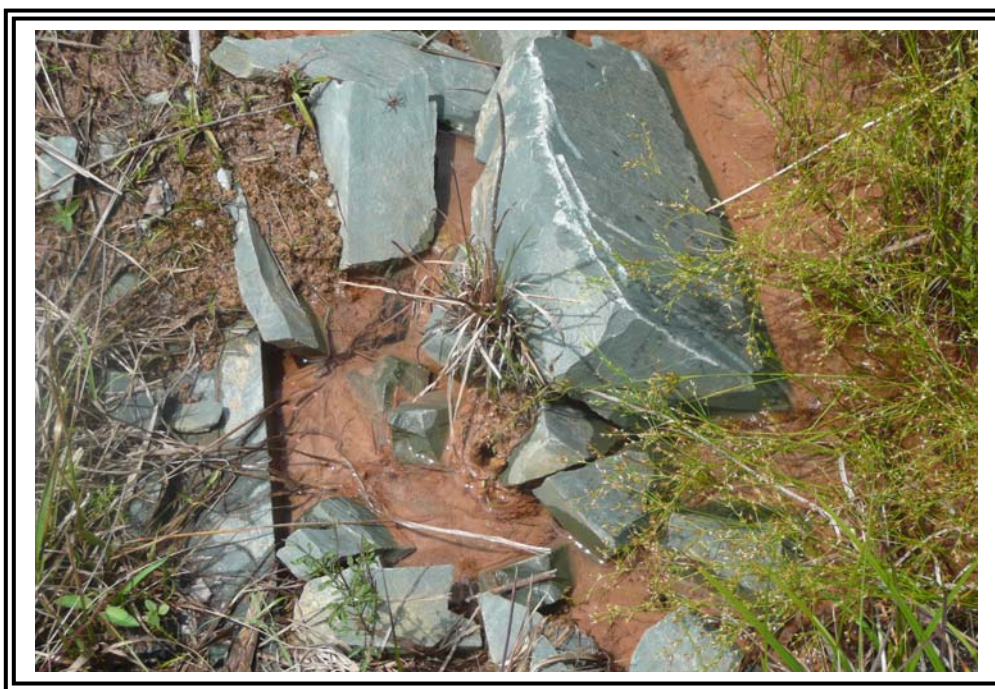
55

Seepage at the toe of the secondary dike about 300 feet from piezometer row. Water is clear.

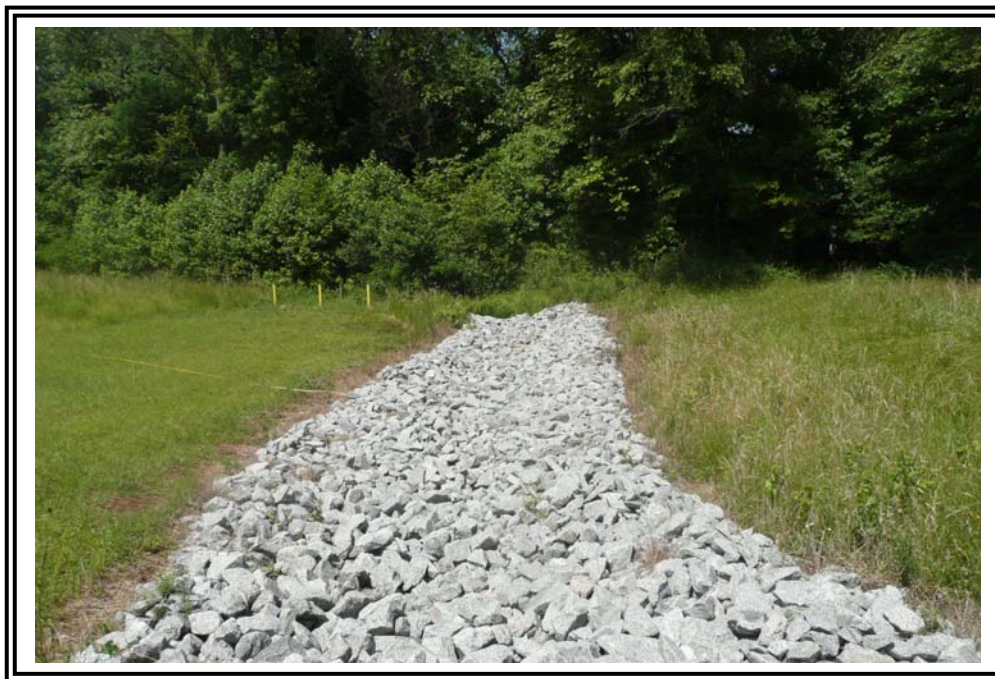
56

Rip rap placed in a wet area at the toe of the secondary dike. Based on field observations it appears the wet area was the result of surface drainage from the bench swale discharge and shallow groundwater levels in this area.

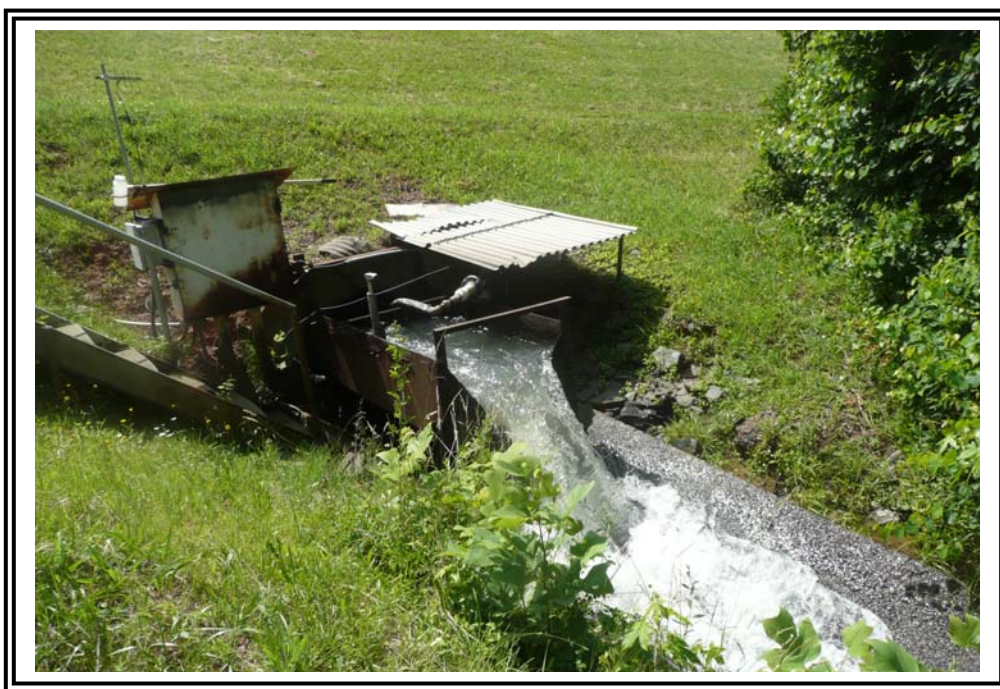
63

Outlet structure at toe of secondary dike, looking upstream.

The secondary pond outlet pipe was inspected in 2008 via video survey. This pipe is a corrugated metal pipe that was installed in 1958. Corrugated metal pipes are subject to corrosion and, although commonly used in the era when this dam was constructed, current industry practice recommends against using this type of pipe. CHA recommends Duke Energy considers replacing or slip-lining this pipe with a less corrosive material, or at a minimum, performs periodic video inspection of the pipe to observe for changes that will indicate when the pipe has reached the end of its useful life.

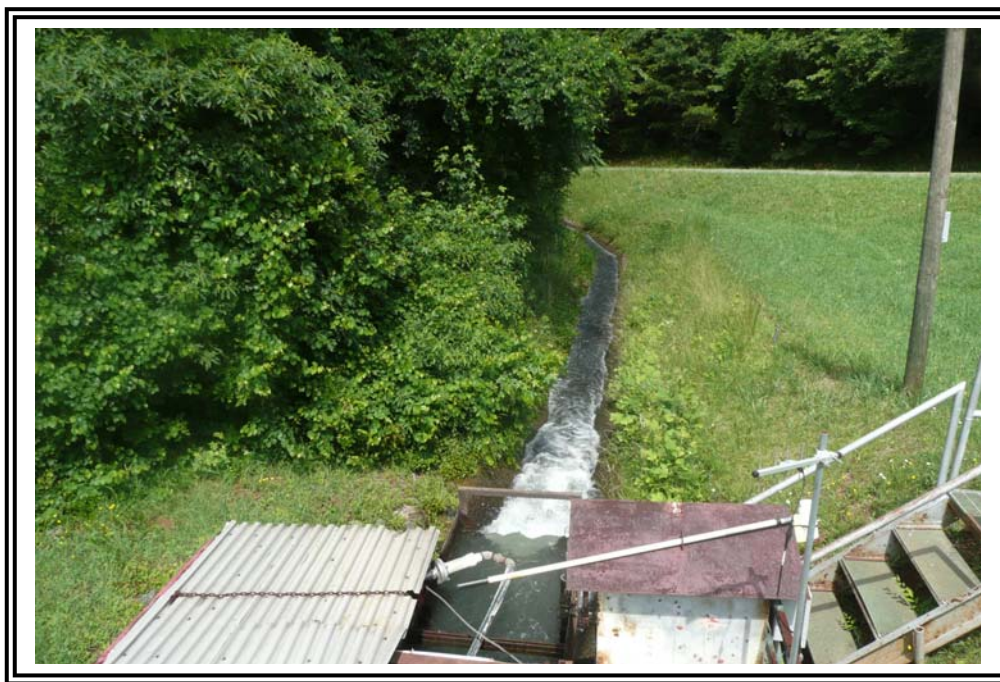
64

Outlet channel of secondary dike, looking downstream.
