Assessment of Dam Safety Coal Combustion Surface Impoundments (Task 3) Final Report

Duke Energy
Riverbend Steam Station
Mt. Holly, North Carolina

September 14, 2009

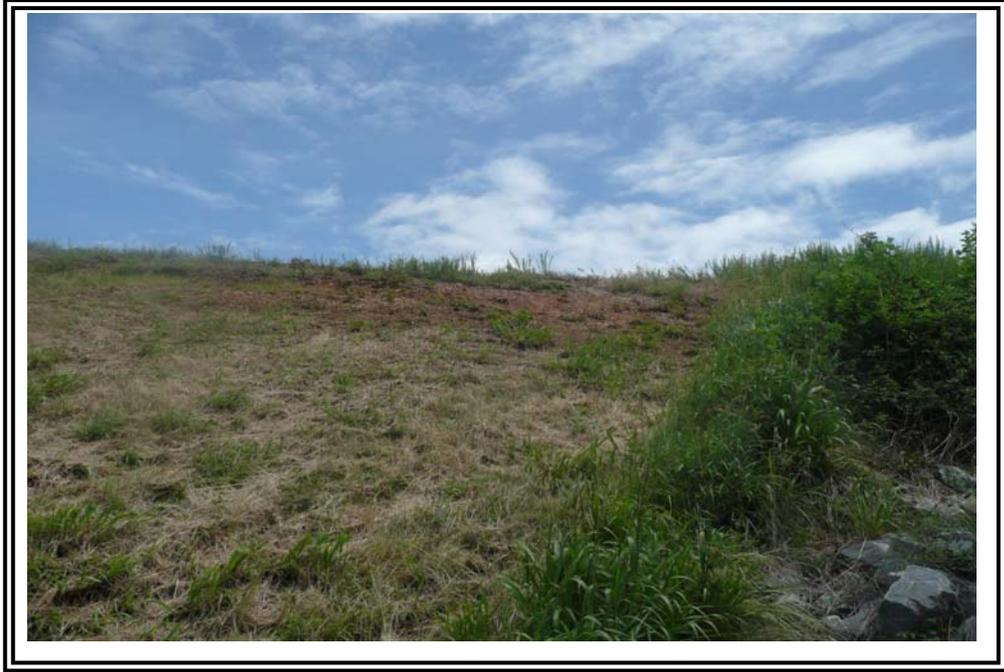
7

Close-up of slope at left (south) abutment with sparse vegetation.

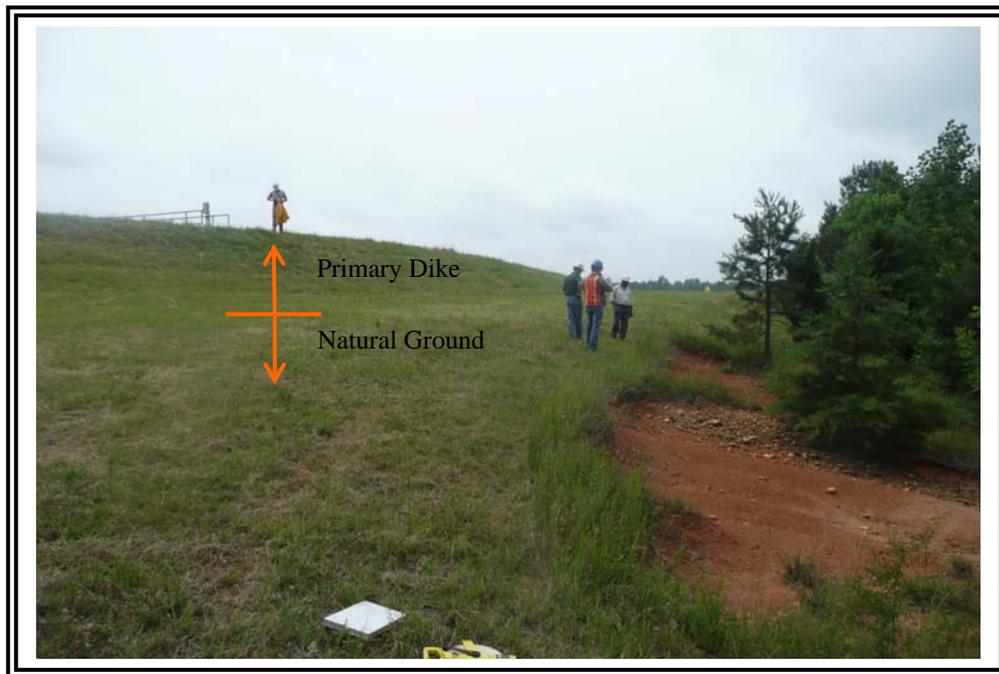
Photo 16 shows an area downstream of the toe at the north end of the primary dike where soil is exposed. Duke Energy personnel indicated this area had remained unchanged in many years, and CHA observed signs in this exposed soil that it was natural ground and not part of the embankment. The upstream embankment is shown in Photos 17 through 19.

Right end of primary dike downstream slope, looking south. Erosion area in right of photo appears to be in natural ground and is reportedly unchanged in many years.

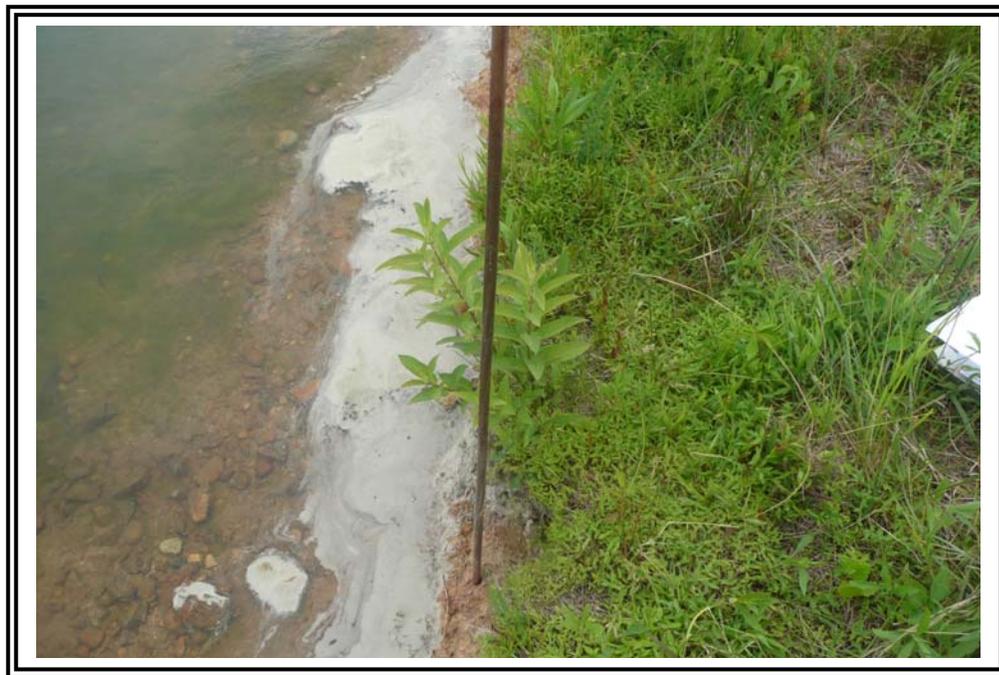
28

Upstream slope intermediate dike beach erosion. Floating material is composed of cenospheres.

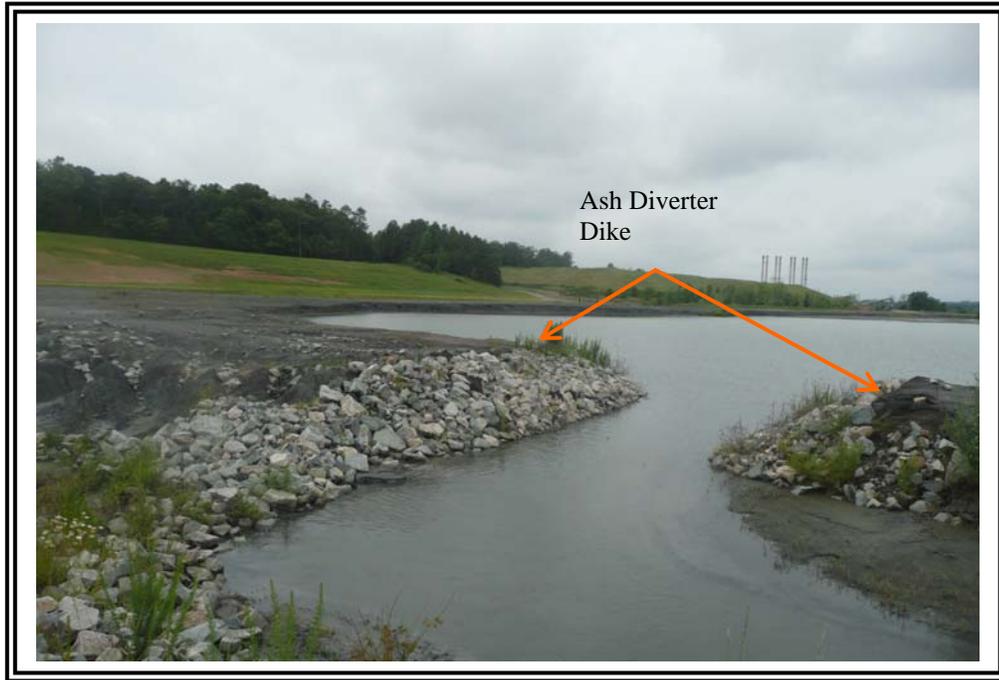
31

Breach in ash diverter dike filled during dredging operations to isolate primary pond from water draining to outlet tower.

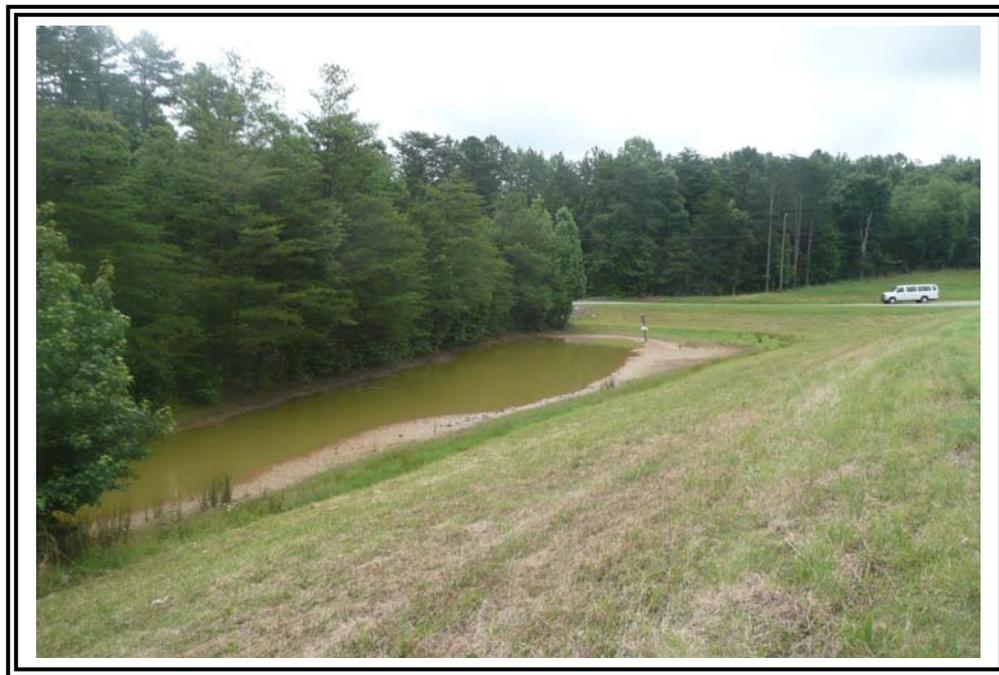
32

Intermediate dike downstream slope/right (east) abutment contact. Note water at the toe is partially from storm water runoff and partly a shallow portion of the secondary pond.

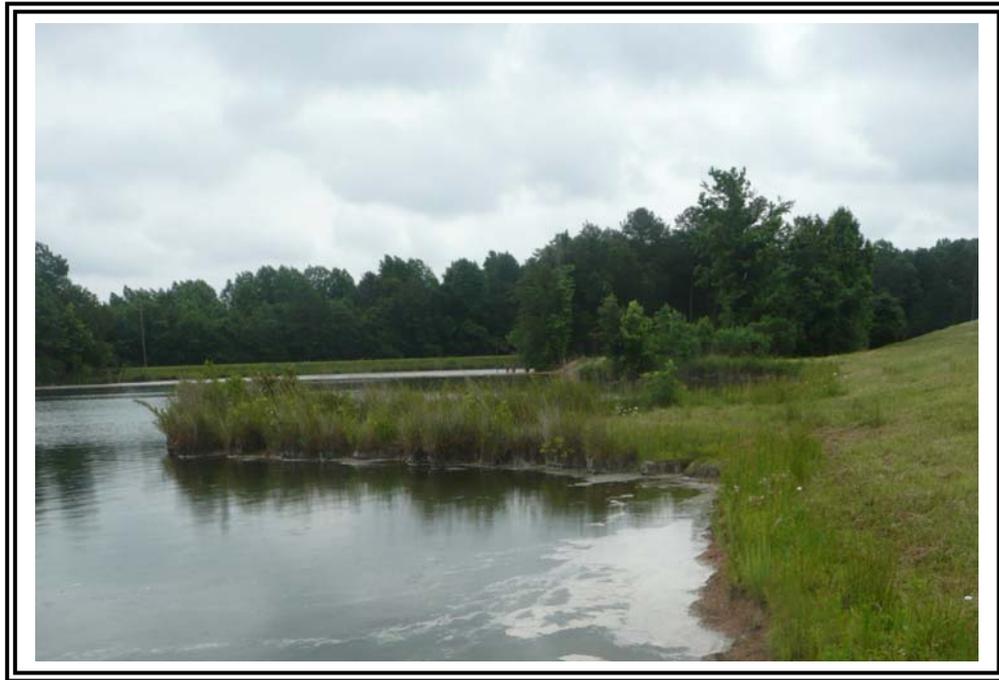
35

Downstream slope of intermediate dike beach erosion, looking east.

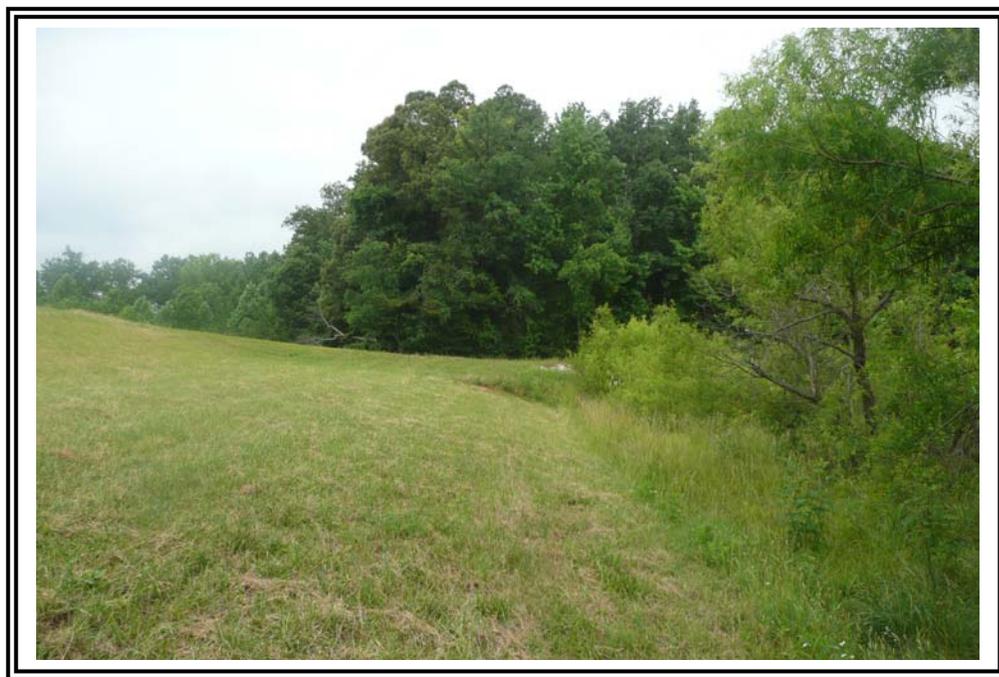
36

Downstream slope of intermediate dike near west abutment. Tree growth in right of photo is on deposited ash in secondary pond.

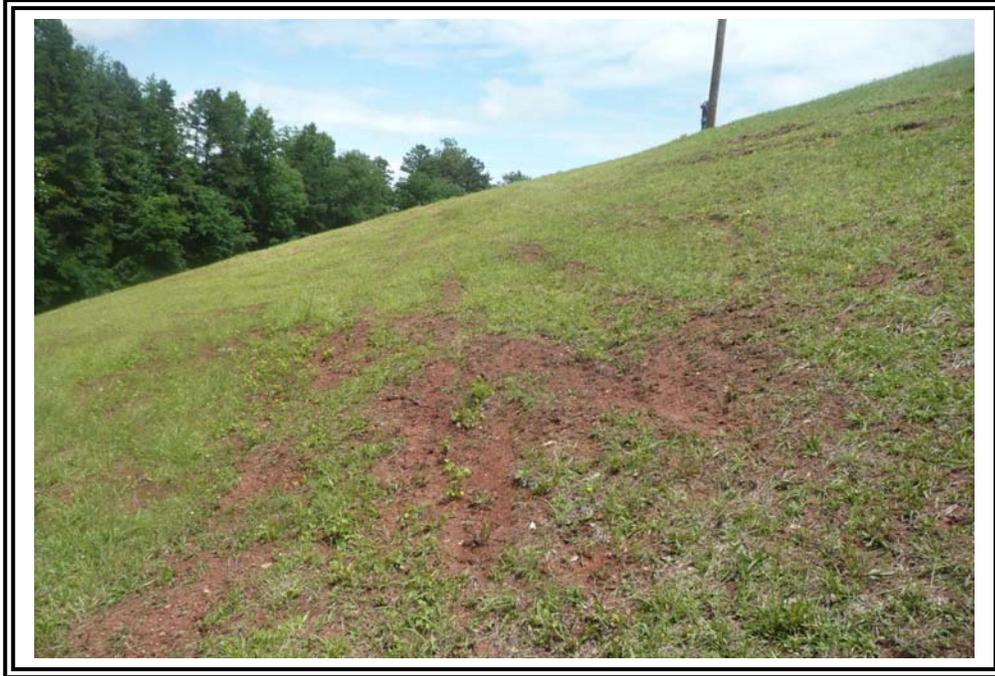
45

West end of secondary dike downstream slope, looking east. Note sparse grass cover.

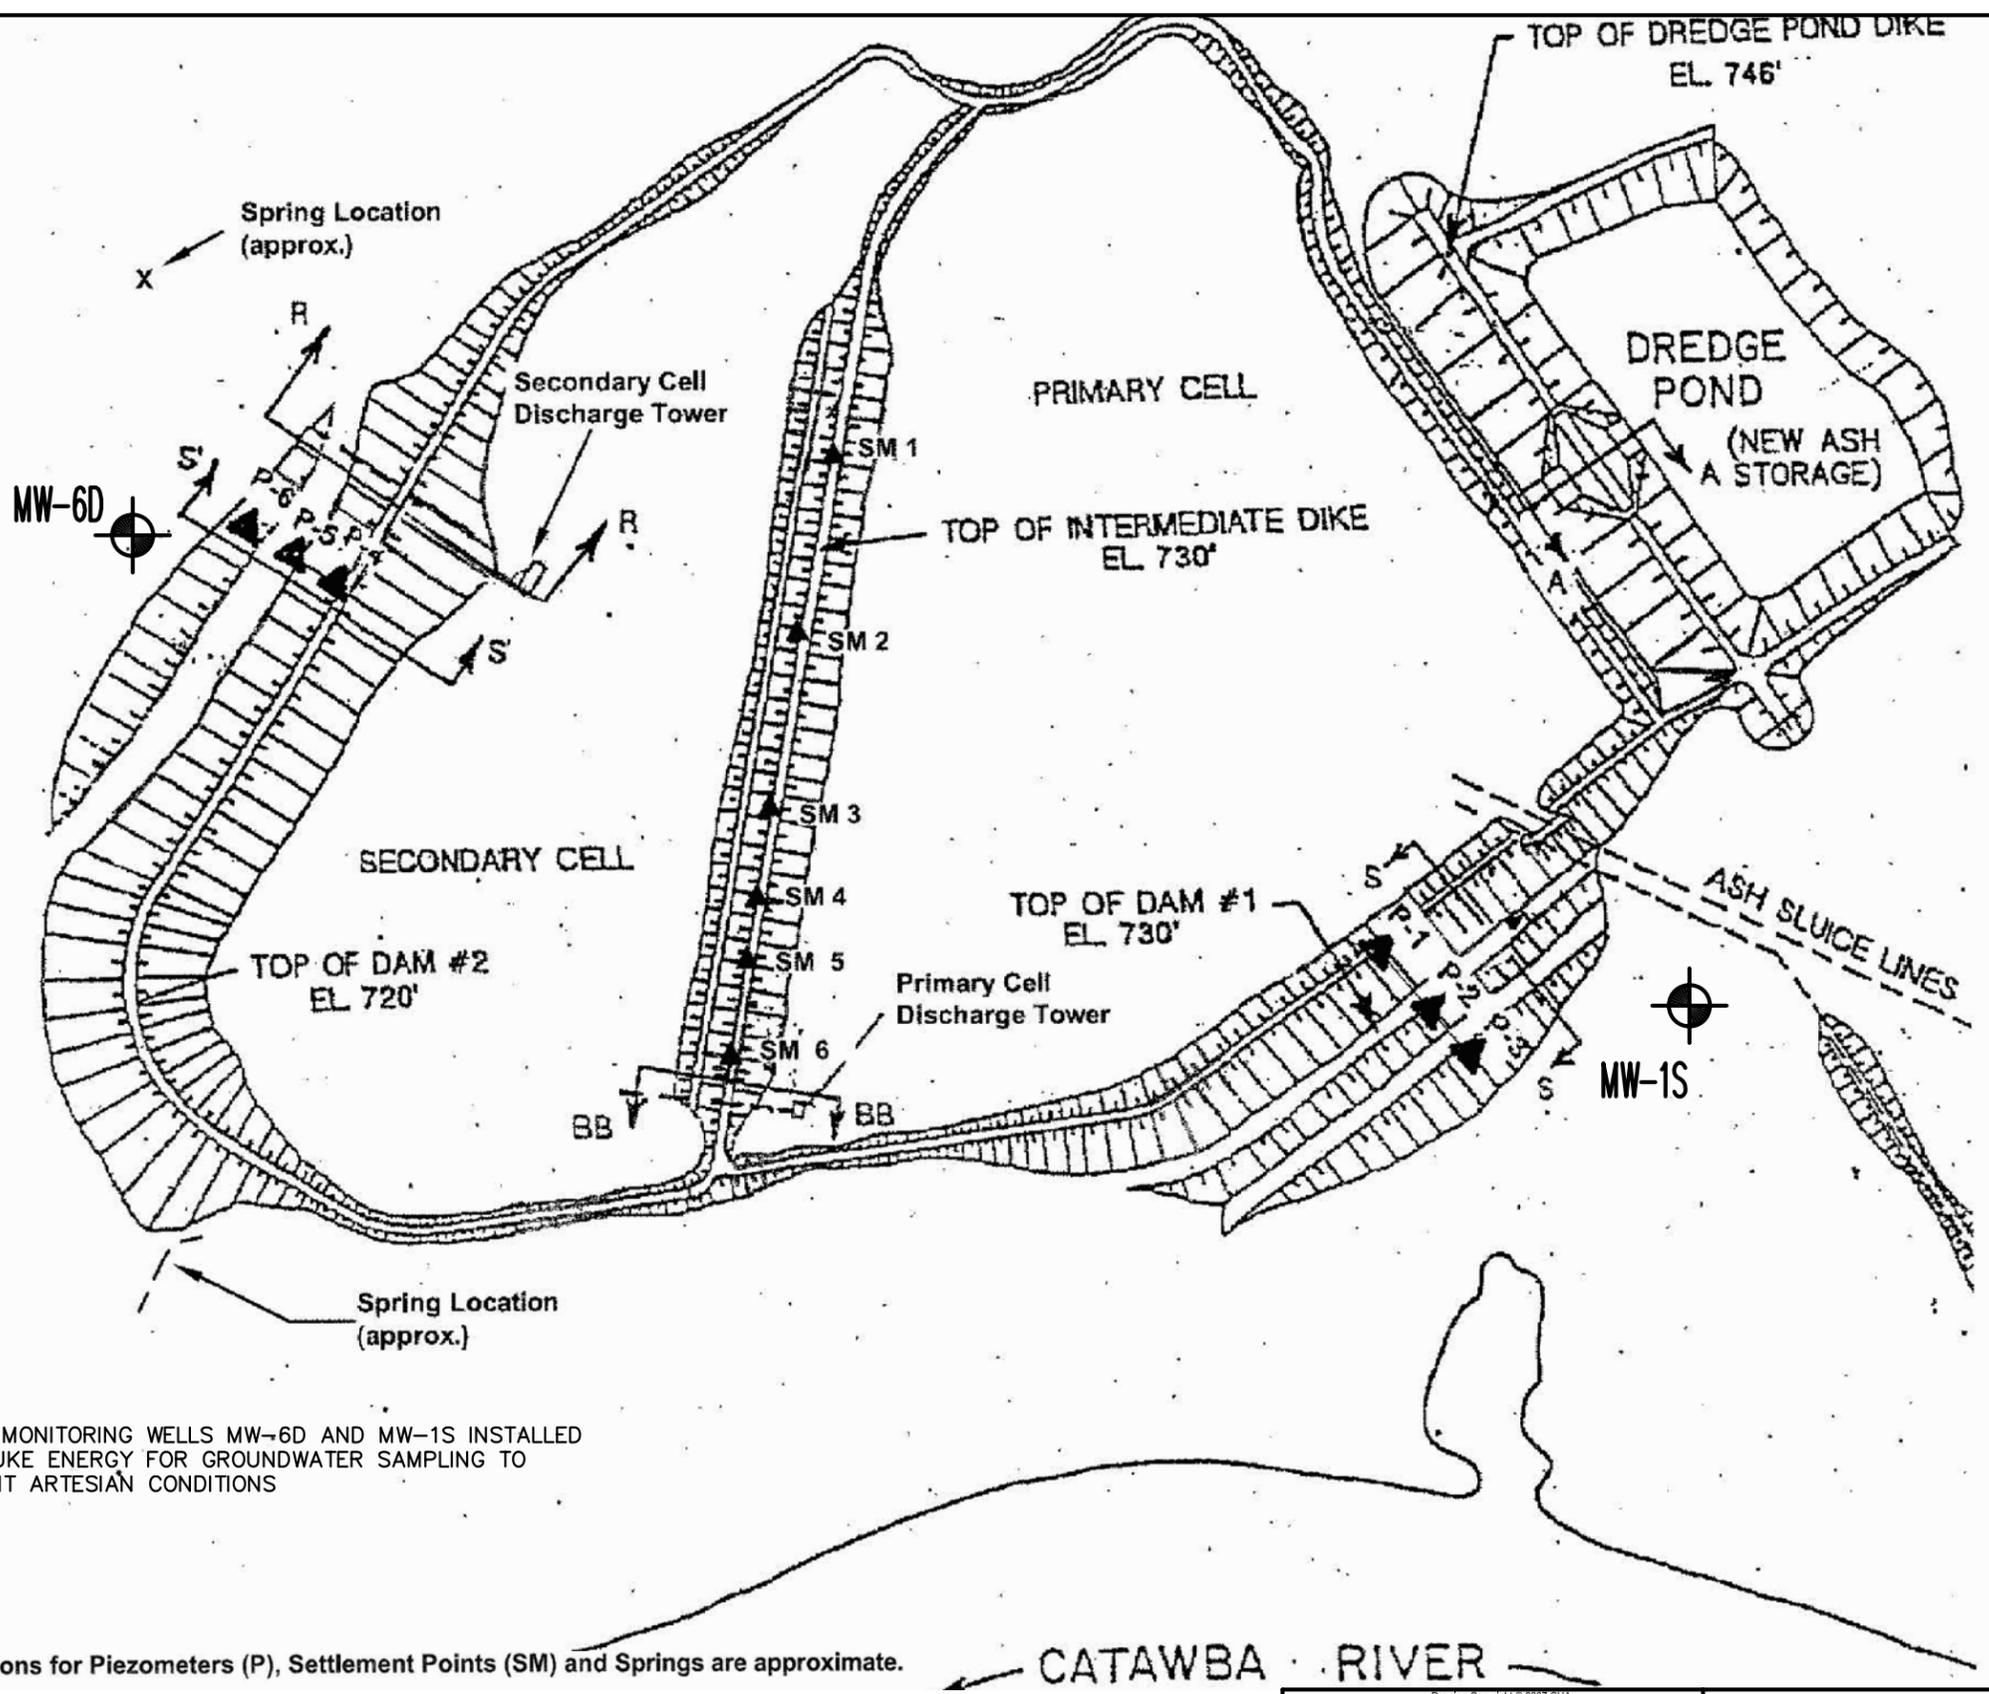
FIGURE 8

Two groundwater sampling wells are under apparent artesian conditions. These wells are identified as MW-1S and MW-6D and their approximately locations are shown on Figure 8.

NOTE: MONITORING WELLS MW-6D AND MW-1S INSTALLED BY DUKE ENERGY FOR GROUNDWATER SAMPLING TO EXHIBIT ARTESIAN CONDITIONS

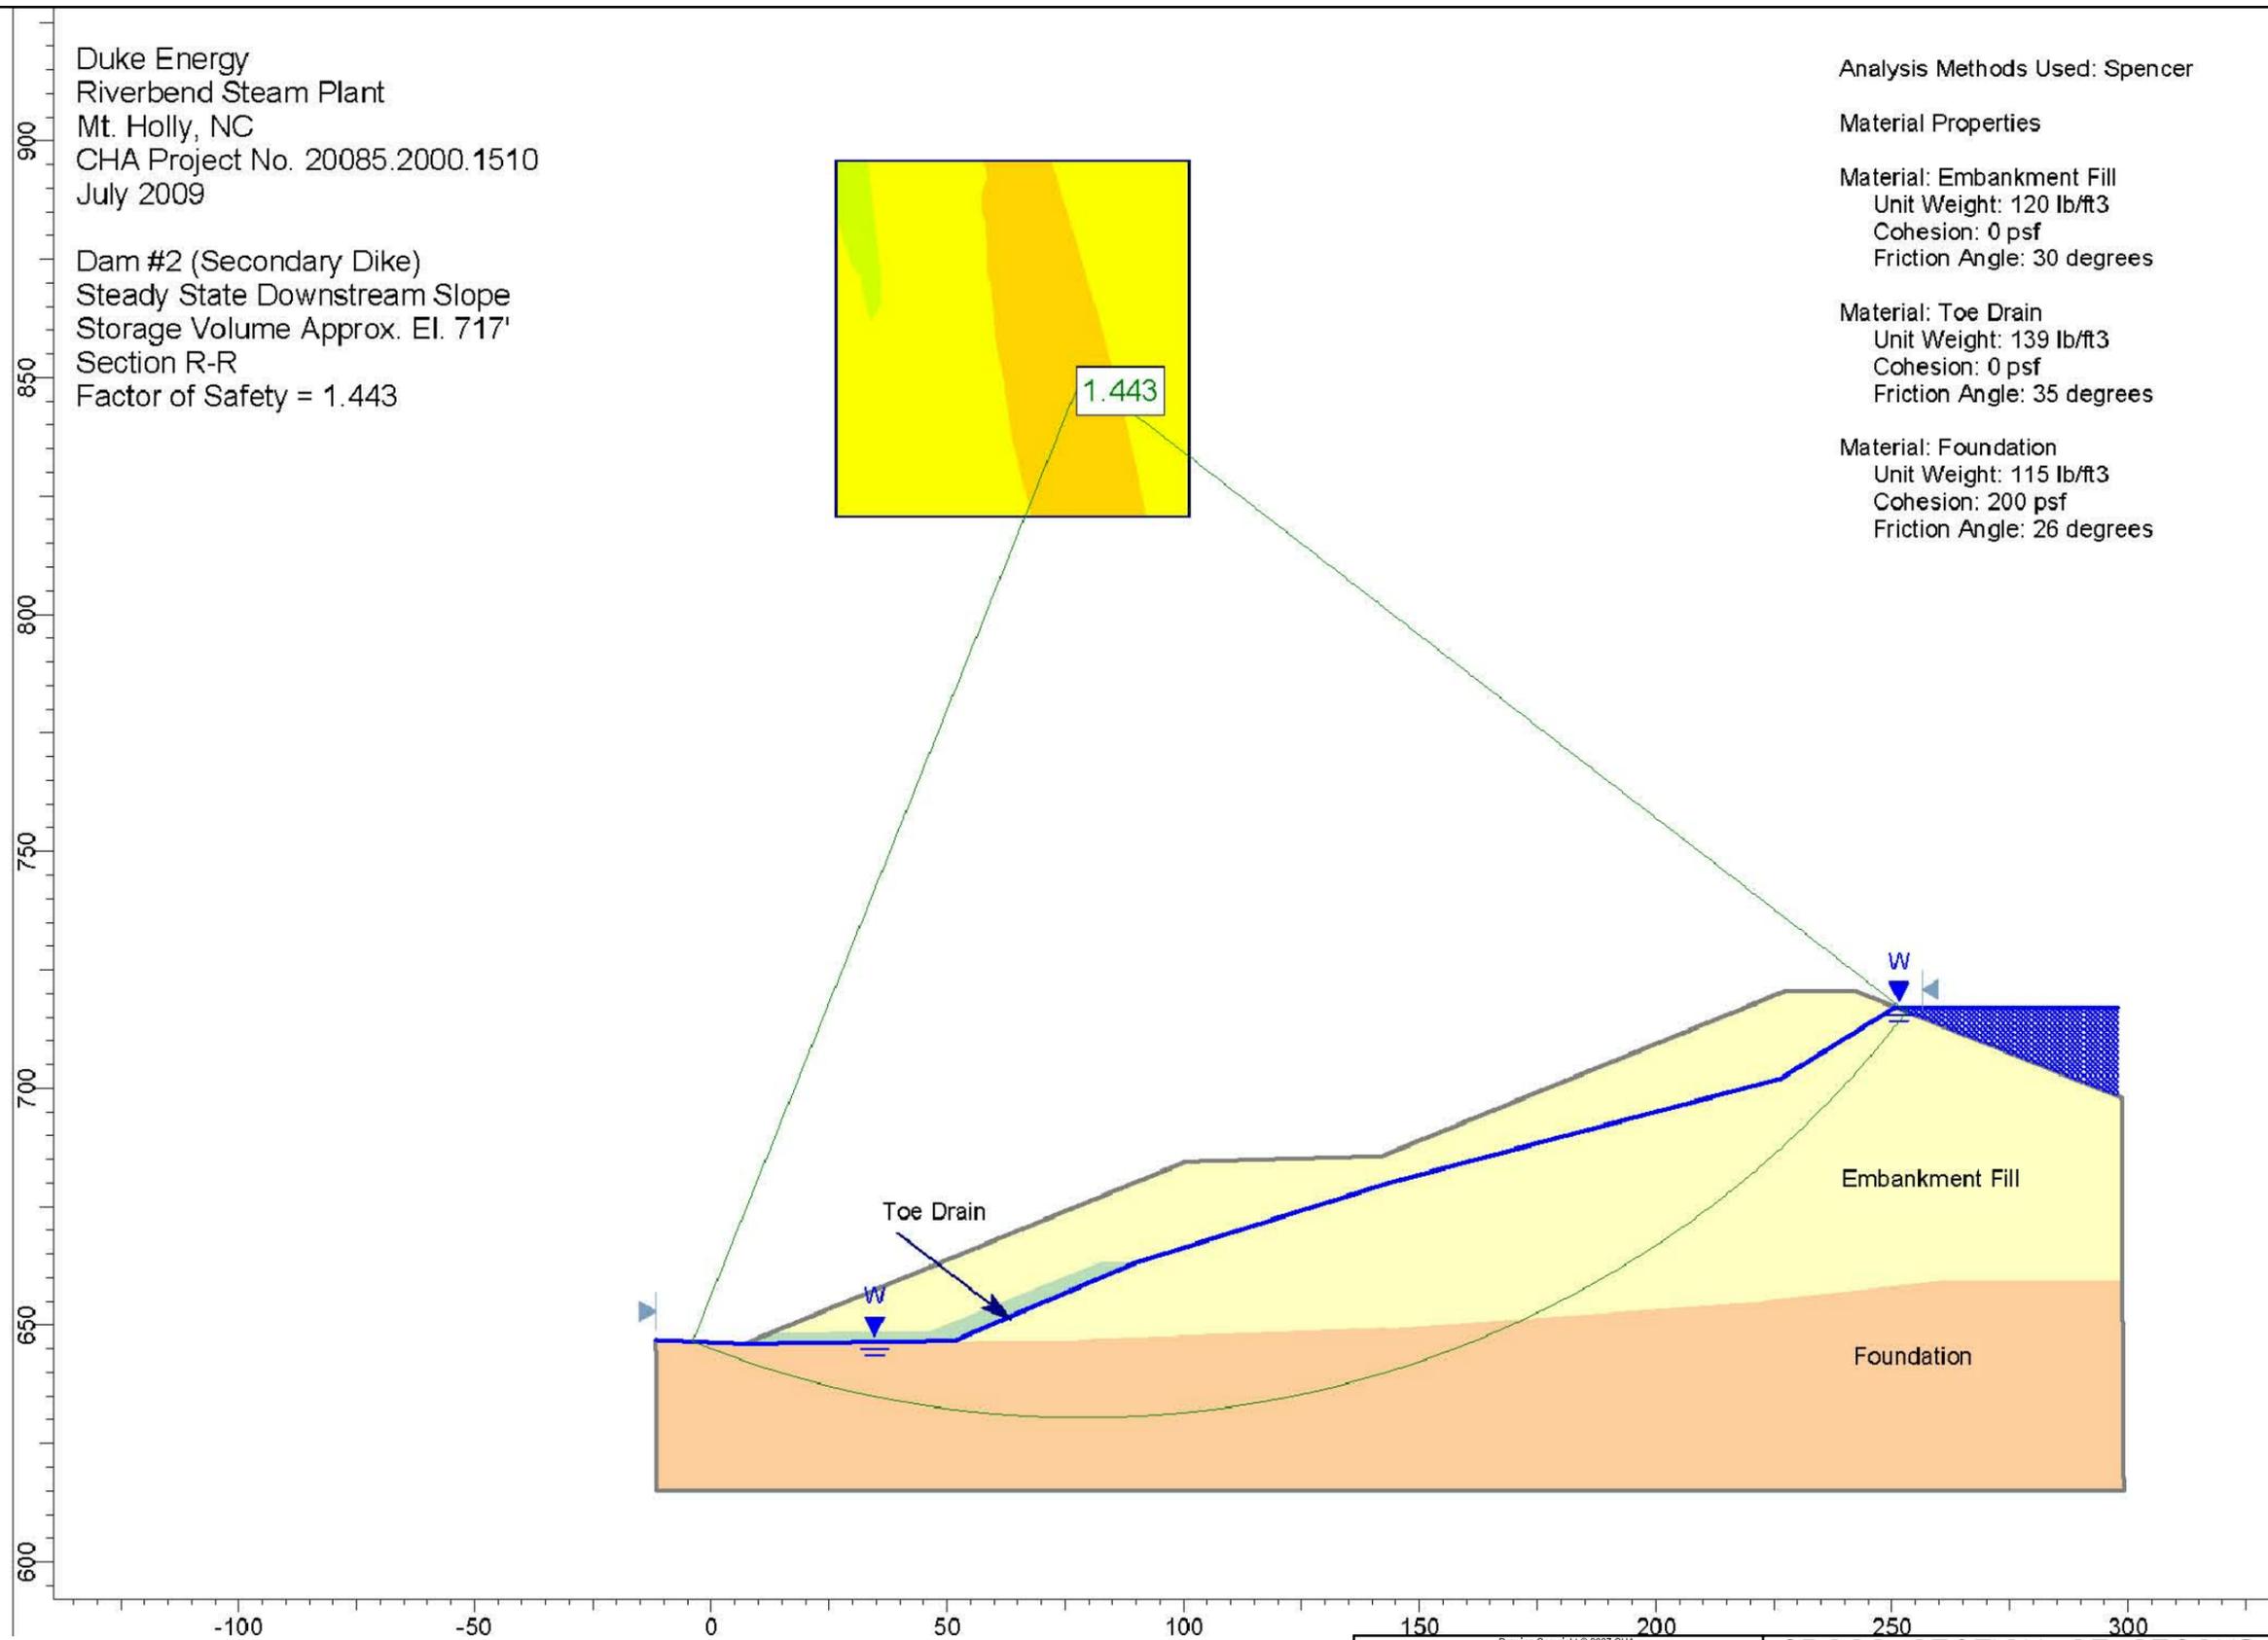
PROJECT NO. 20085.2000
DATE: JULY 2009
FIGURE 11A

Load Case	Required Minimum Factor of Safety	Calculated Minimum Factor of Safety
Steady State Conditions at Present Pool or Flood Elevation (Downstream Slope) - Figure 11A	1.5	1.4
Rapid Draw-Down Conditions from Present Pool Elevation	1.25	NP
Maximum Surcharge Pool (Flood) Condition - Figure 11B	1.4	1.4
Seismic Conditions from Present Pool Elevation – Figure 11C	1.0	1.0
