# **Dam Safety Assessment of CCW Impoundments**

## **Wabash River Generating Station**

**United States Environmental Protection Agency  
Washington, DC**

June 21, 2010

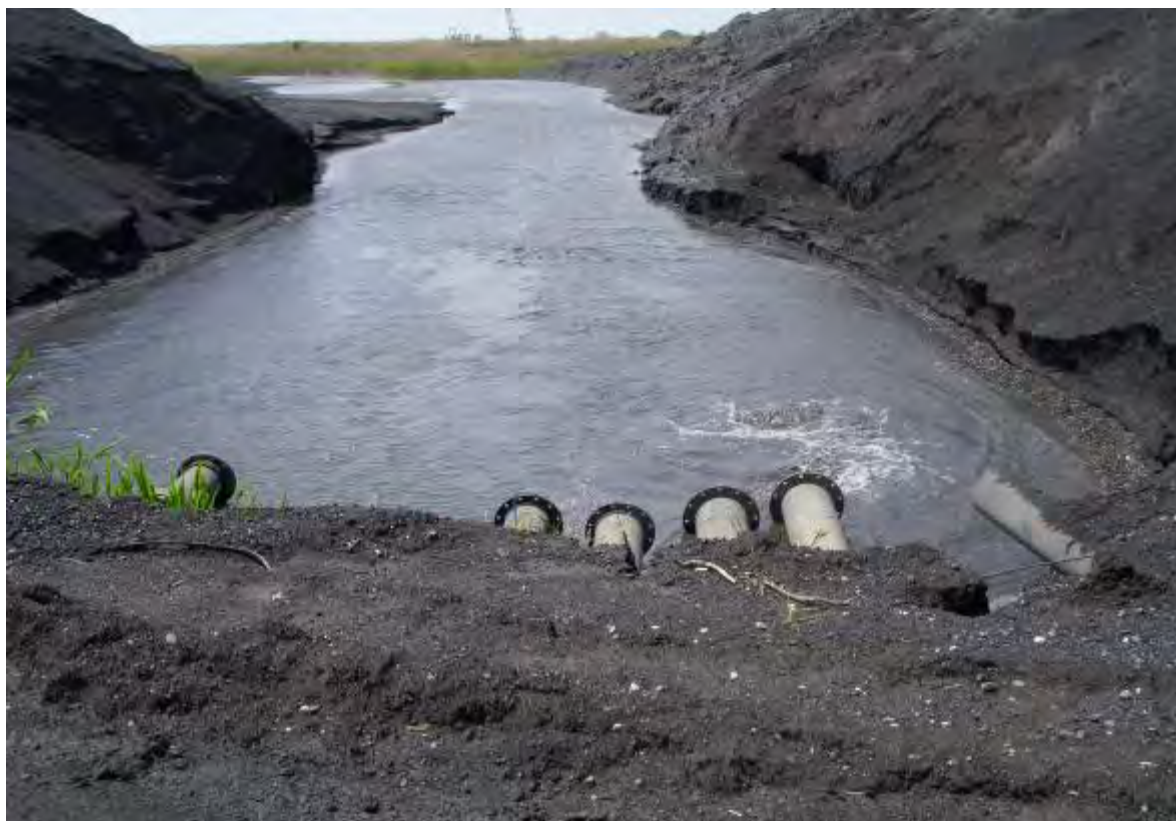
Photo Number:  
1

Description:  
CCW sluice  
discharge into  
Primary Ash  
Pond

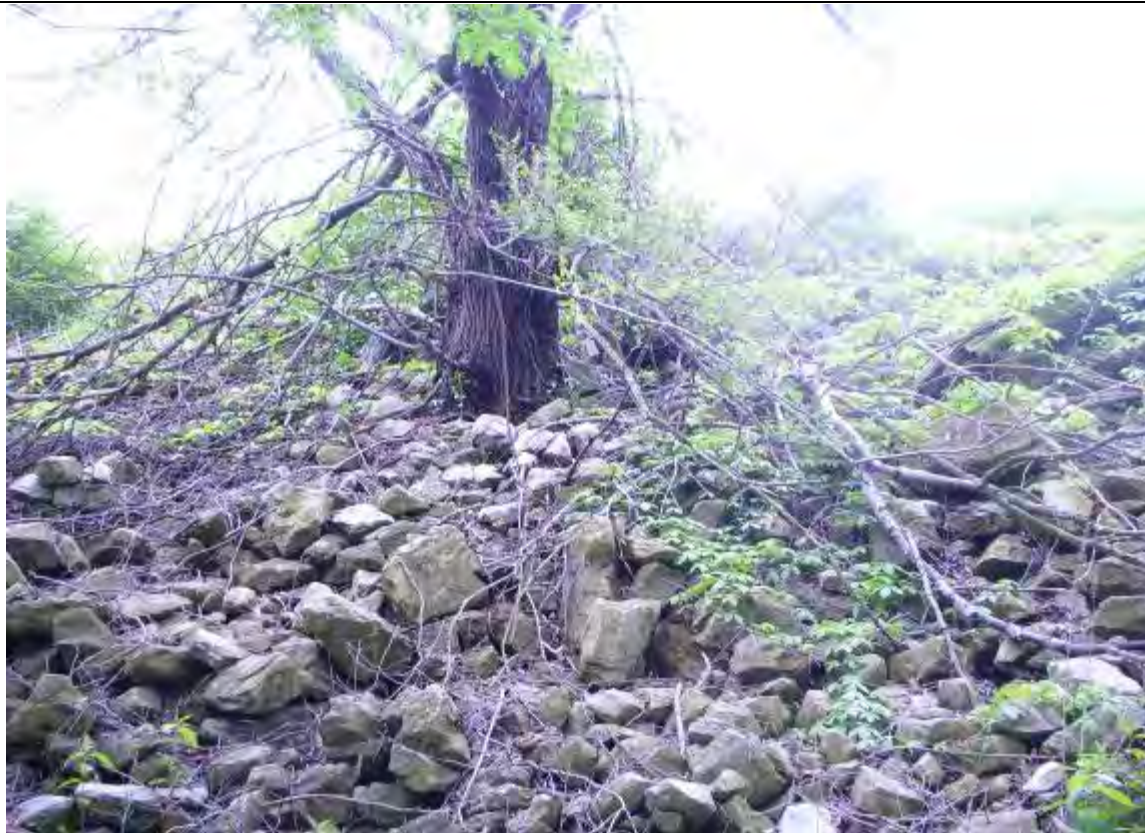
Photo Number:  
3

Description:  
Large tree in  
downstream  
slope of east  
dike. Riprap  
covered slope.

The trees growing along the outboard slope and within 5 feet of the toe of the Secondary Ash Pond dike should be removed. Additional maintenance recommendations are provided below:

- Remove trees/control heavy vegetation along freeboard of upstream slopes
- Place additional gravel road base in low areas on crest and regrade to maintain positive drainage
- Monitor outboard slopes for erosion and repair if conditions worsen

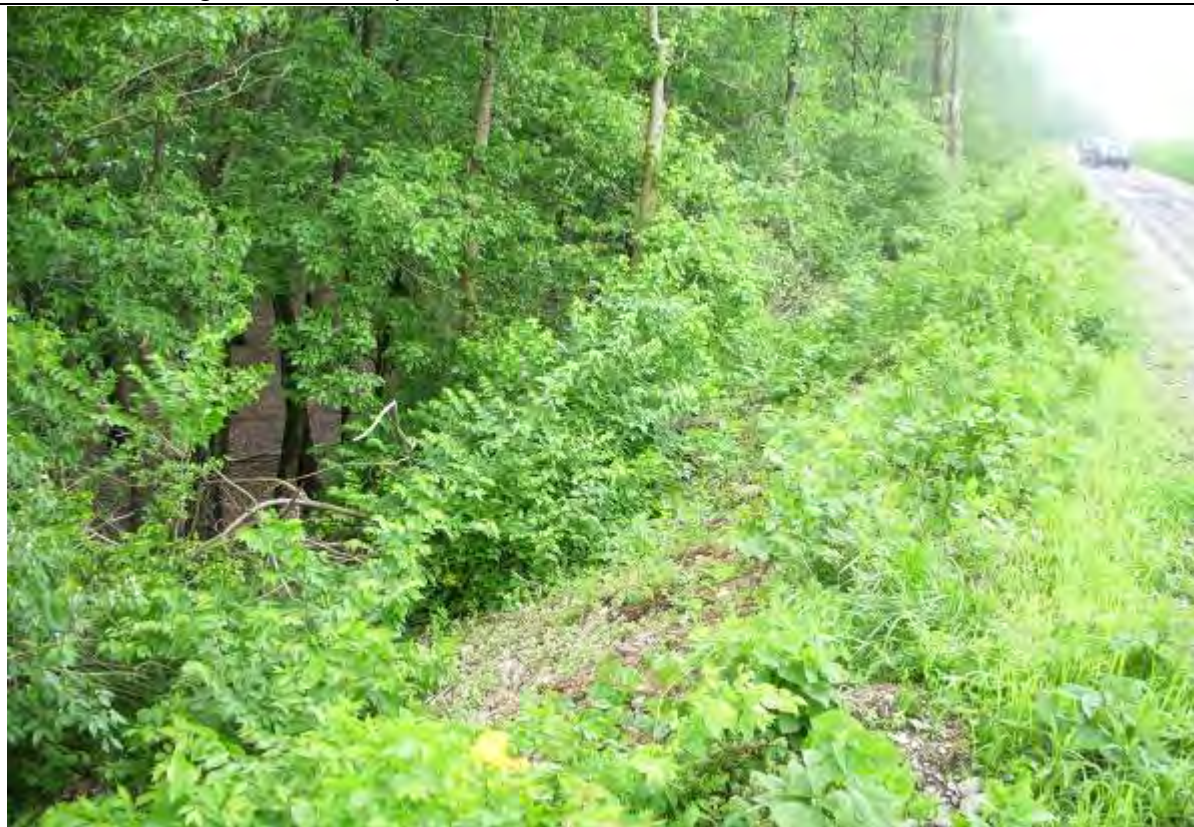
Photo Number:  
5

Description:  
Heavy  
vegetation  
slope  
downstream  
slope of east  
dike.

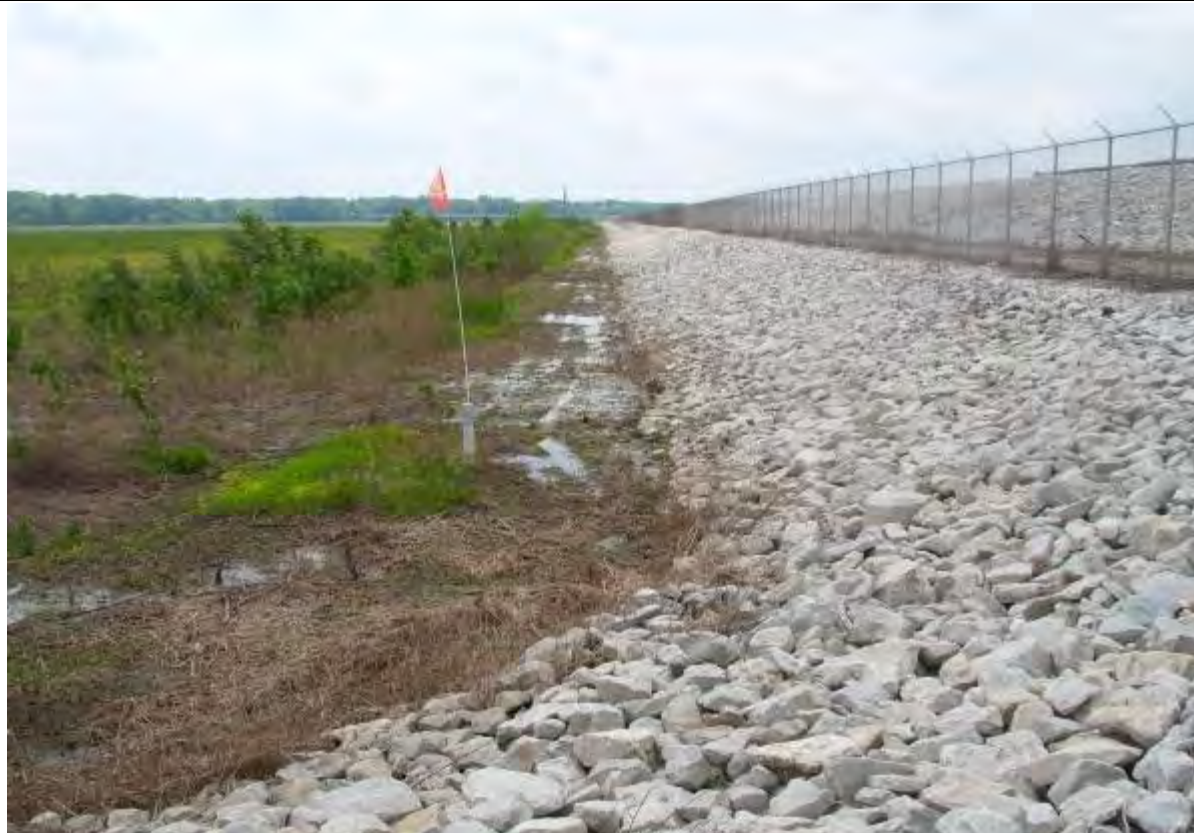
Photo Number:  
1

- Some ponding stormwater was observed beyond the toe of the east dike. This condition appears to be due to insufficient surface slope and rutting due to vehicle traffic. (Appendix C, Photo 1)

Description:  
Riprap armored  
downstream  
slope of east  
dike. Water at  
toe due to  
recent rainfall.

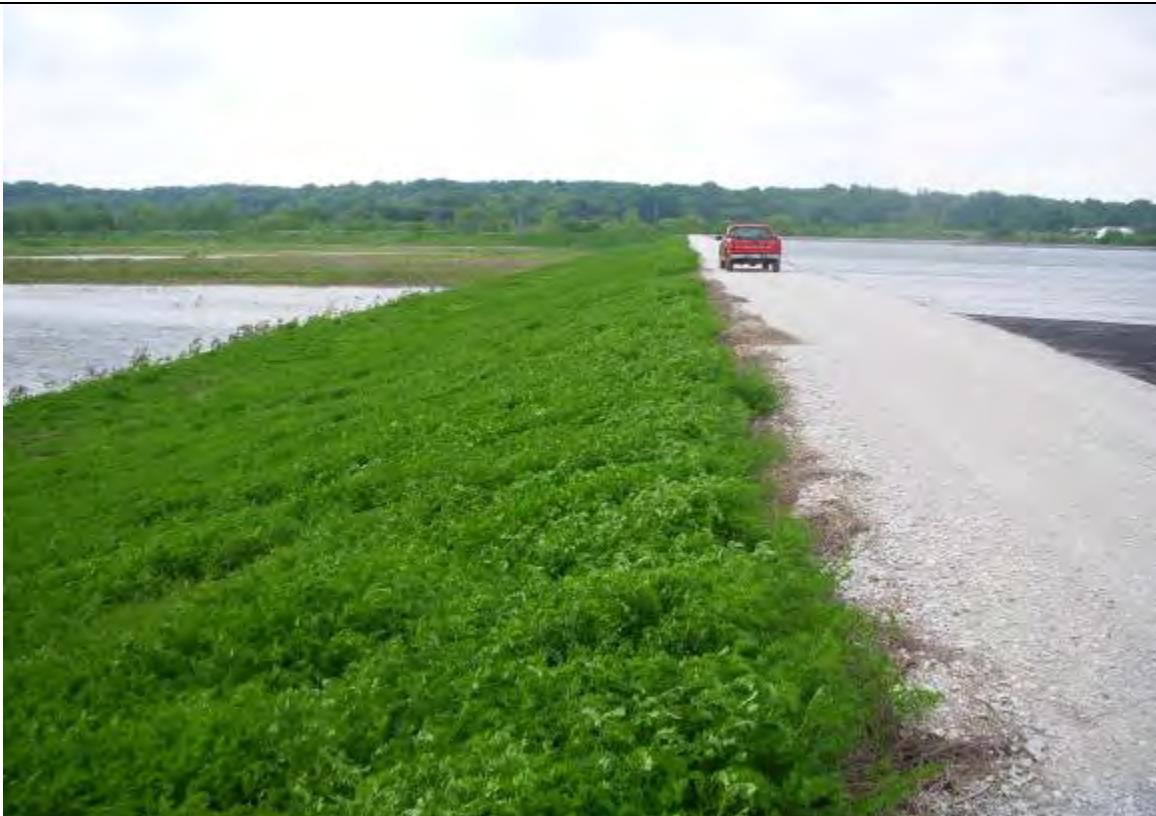
- The gravel on the surface of the crest and lower access roads was thin and exposed geotextile was observed in some locations.
- The outboard slope of the south dike was well-vegetated with crown vetch. (Appendix C, Photo 4) Some sapling trees have taken root near the toe of the slope and in the future expansion area.

South dike of South Ash Pond with crown vetch on downstream slope.

- Place and compact additional gravel road base to provide minimum 6-inches of cover over non-woven geotextile along crest roads and secondary roads.
- Mow vegetated slopes at least twice annually to control vegetation
- Repair erosion along groin on outboard northwest corner of the South Pond

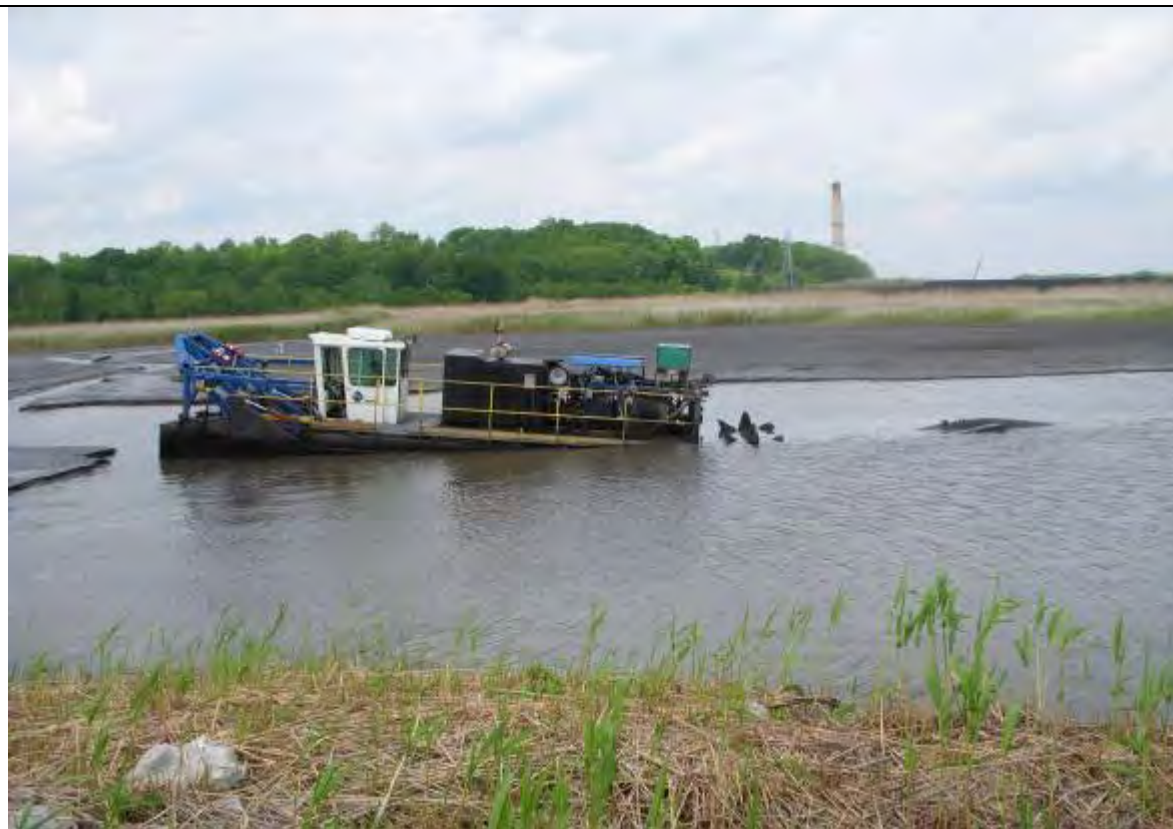
Photo Number:  
6

Description:  
Dredge in  
operation in  
Primary Ash  
Pond B.

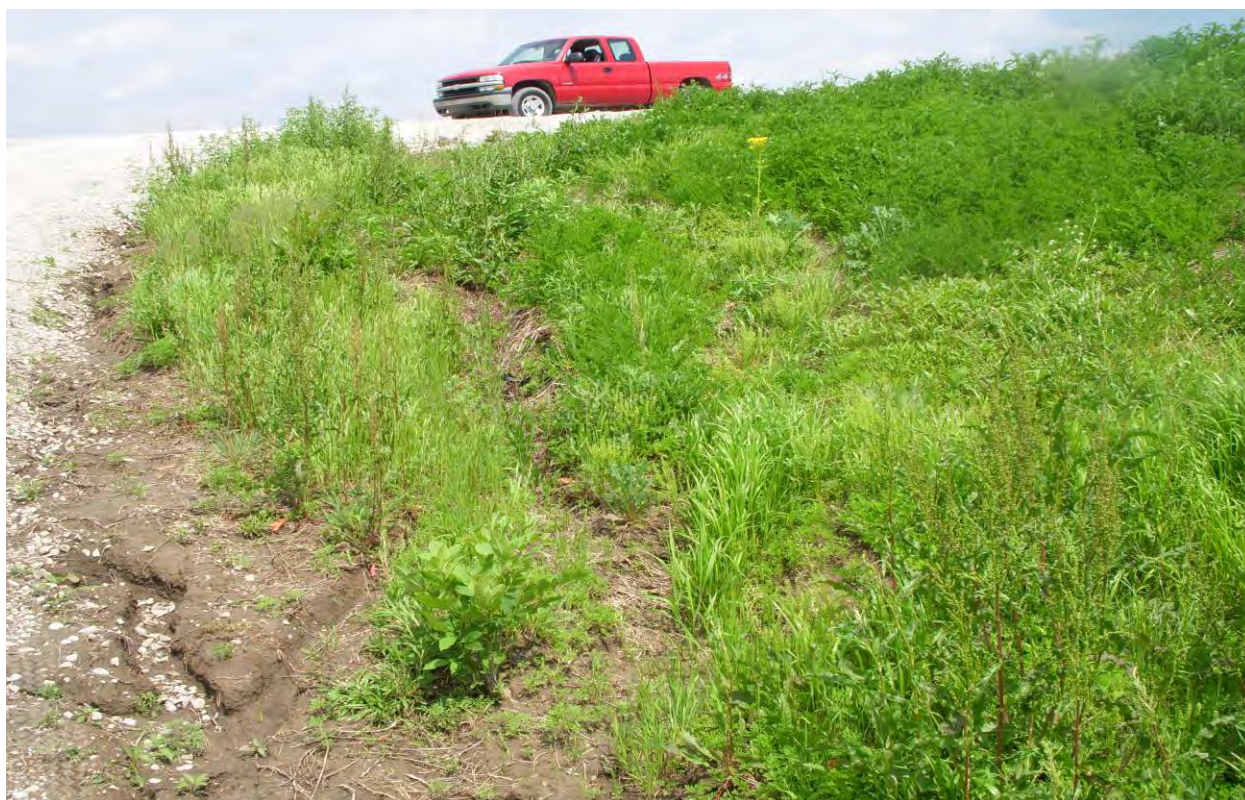
Photo Number:  
8

- Some minor erosion along the groin area between the access road ramp and the northwestern corner of the pond was observed. (Appendix B, Photo 8)

Description:  
Minor erosion  
along groin of  
dike.
