Dam Safety Assessment of CCW Impoundments

Wabash River Generating Station

United States Environmental Protection Agency
Washington, DC

October 12, 2010

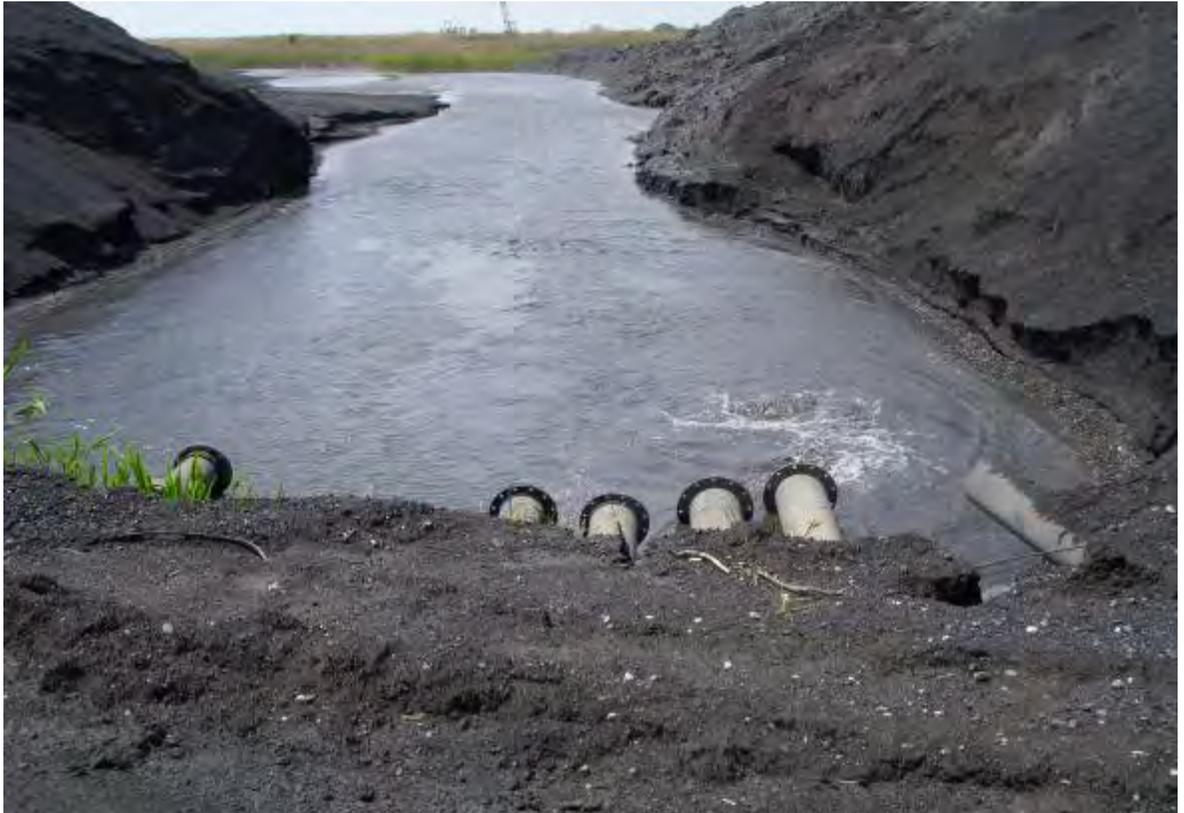
Photo Number:
1

- Sluiced CCW by-product discharge enters the north end of Pond A. (Appendix B, Photo 1)
- Large trees and heavy vegetation are growing through riprap along the outboard slope of the east dike (Appendix B, Photo 3)
- The inboard slope was also generally overgrown with reedy grasses.
- Minor depressions and rutting of crest road was observed along east dike. (Appendix B, Photo 4)
- Ash is being stockpiled up to approximately 10 feet above the crest of the dikes.
- Some minor isolated erosion rills were observed along the outboard slope of the east dike.
- CCW has accumulated above the normal pool level over an estimated 90 percent of the pond area. Surface water in the pond is isolated to ditches excavated through the accumulated CCW (Figure 2).
- The outboard toe area was generally well drained.

Description:
CCW sluice
discharge into
Primary Ash
Pond

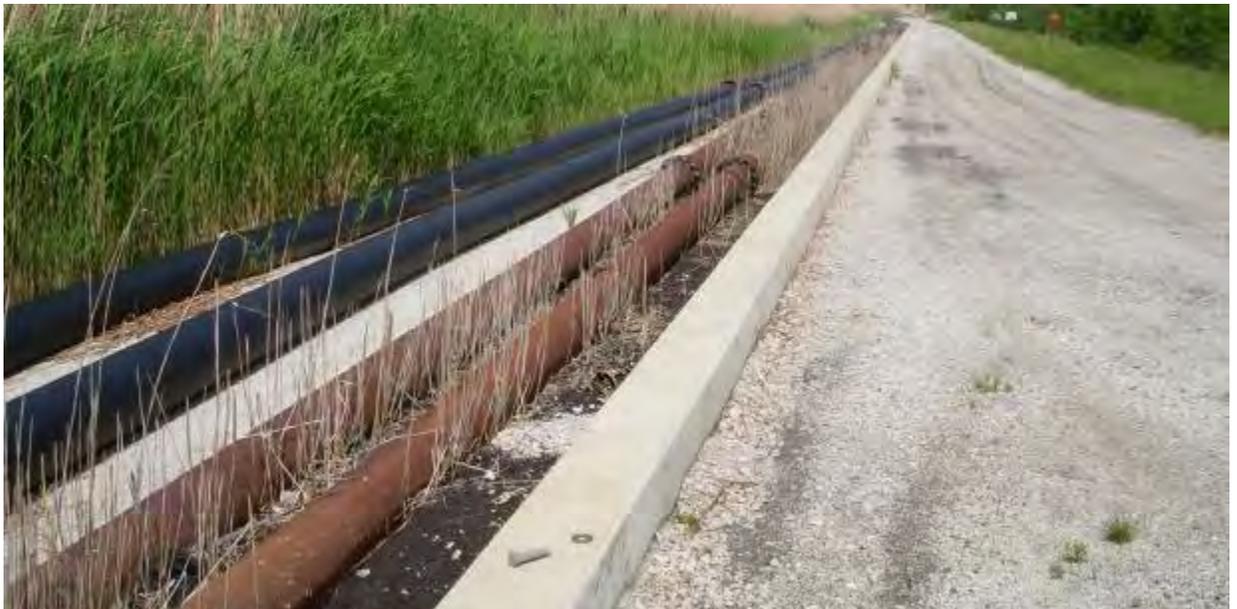
Photo Number:
2

Description:
CCW sluice
pipes with
secondary
concrete wall
containment

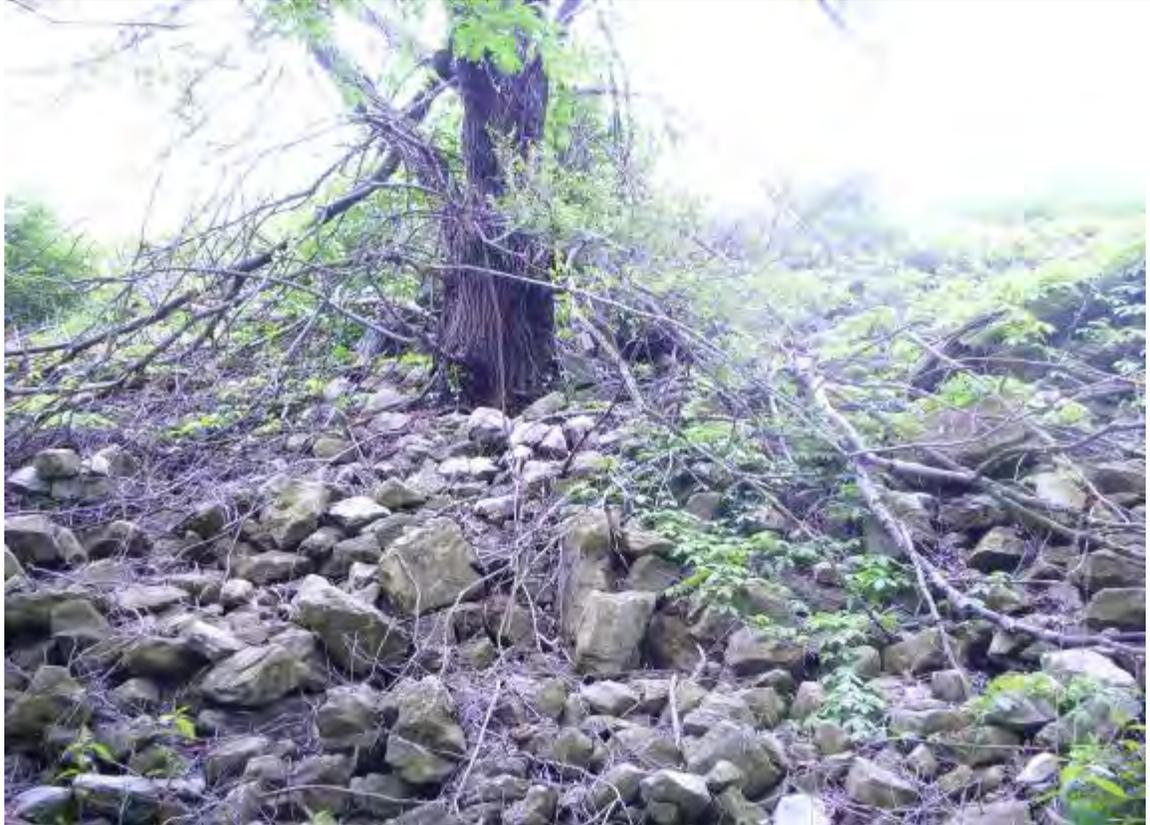
Date:
6/14/2010Photo Number:
3Photographer:
DDWOrientation:
NorthDescription:
Crest of east
dike.

Orientation:
SEDescription:
Large tree in
downstream
slope of east
dike. Riprap
covered slope.

The trees growing along the outboard slope and within 5 feet of the toe of the Secondary Ash Pond dike should be removed. Additional maintenance recommendations are provided below:

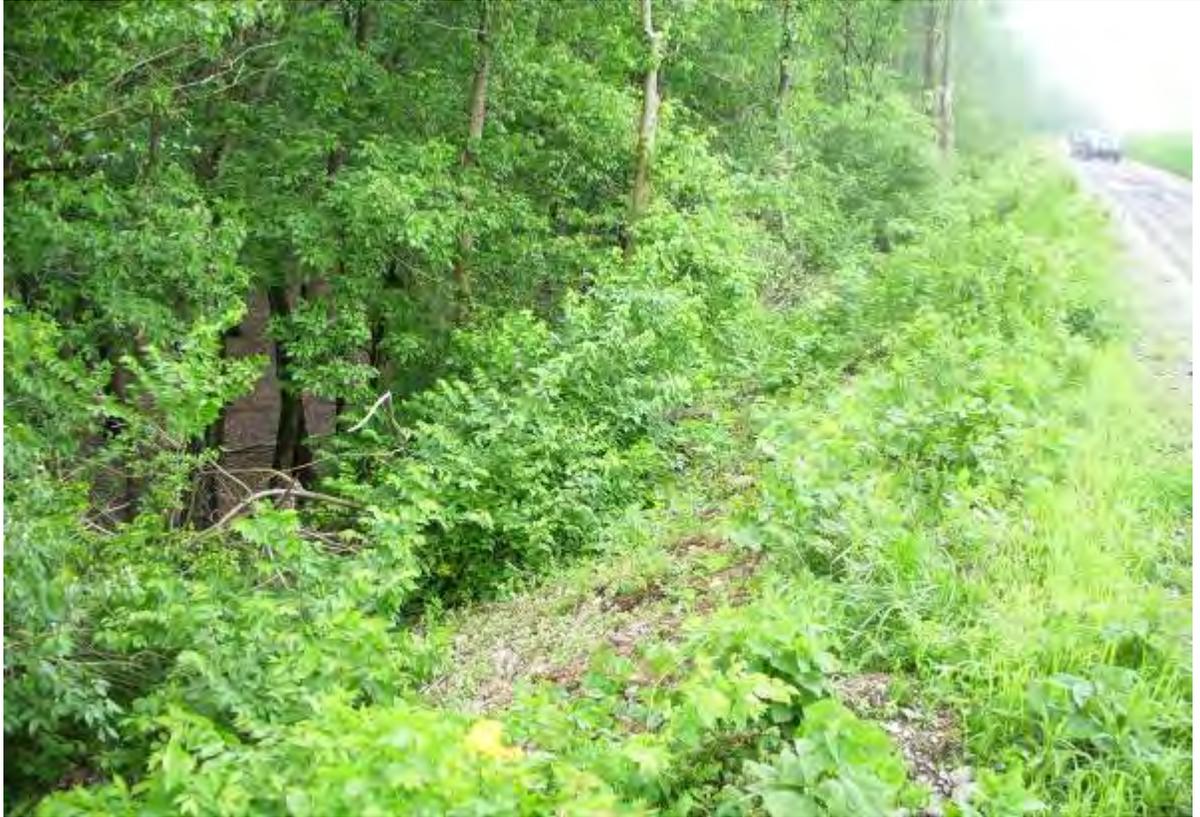
Date:
6/14/2010Photo Number:
5Photographer:
DDWOrientation:
EastDescription:
Decanting weir
outfall.

- The outboard slope of the east dike is covered with riprap, which appeared to be in good condition.
- Several large trees were observed at the outboard toe of the east dike.
- Some small trees and heavy weed growth was observed along the freeboard portion of the interior slopes.
- The outlet structure for the Secondary Pond is located in the northeastern corner of the pond. The structure appeared to be in good condition and operating normally. Discharge of water into the weir was clear.

Orientation:
SouthDescription:
Heavy
vegetation
slope
downstream
slope of east
dike.

- Remove trees/control heavy vegetation along freeboard of upstream slopes
- Place additional gravel road base in low areas on crest and regrade to maintain positive drainage
- Monitor outboard slopes for erosion and repair if conditions worsen

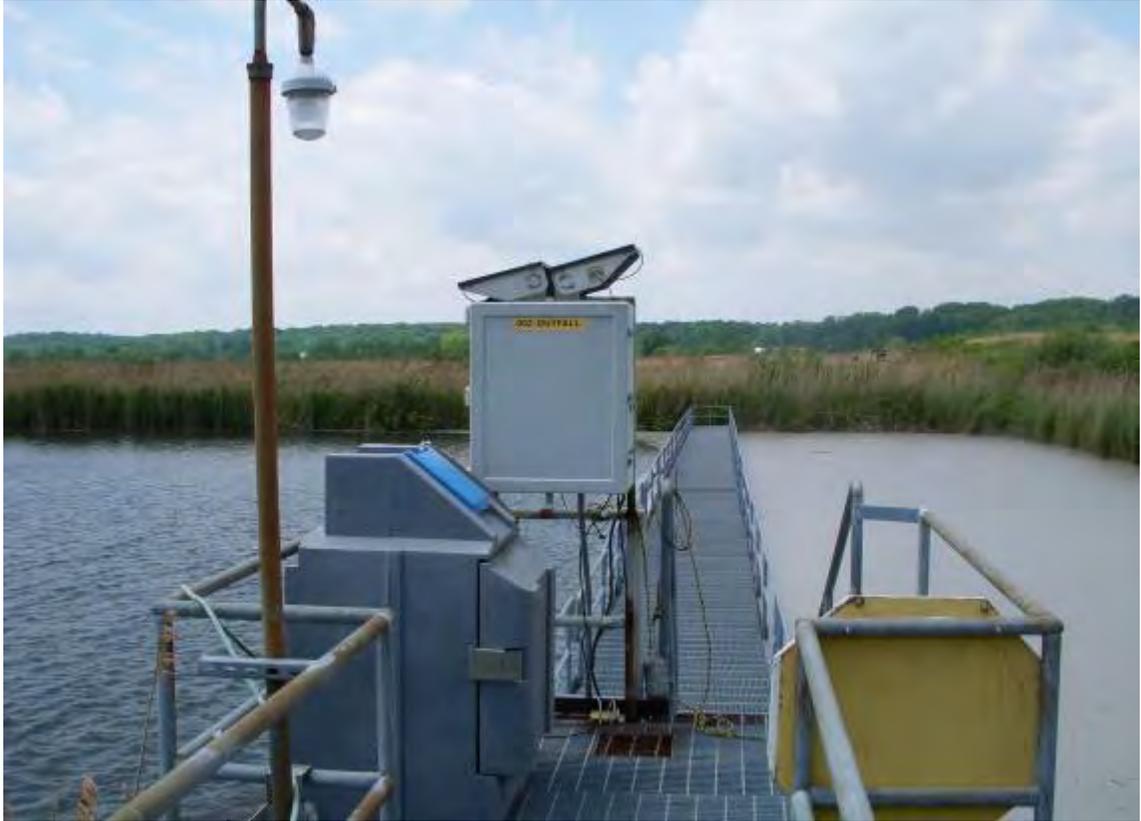
Photo Number:
7

Description:
Overview of
decanting weir.

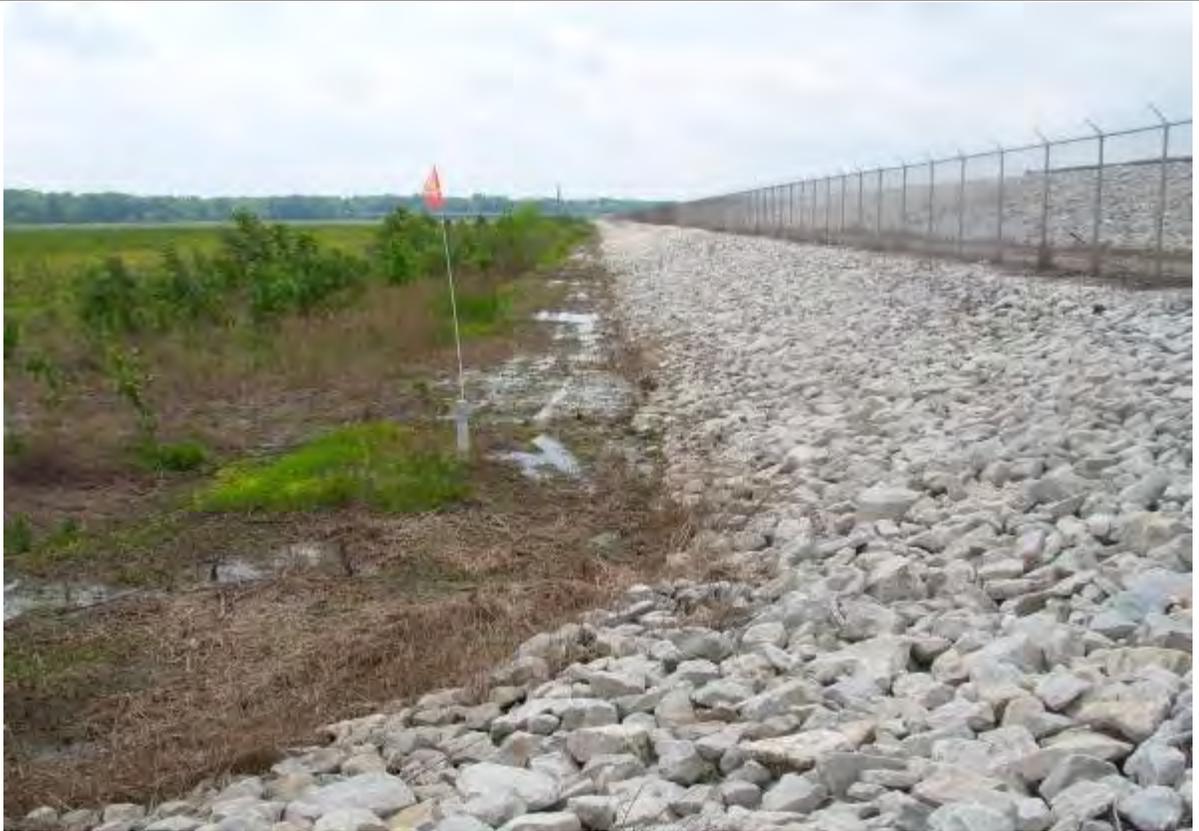
Photo Number:
1

- Some ponding stormwater was observed beyond the toe of the east dike. This condition appears to be due to insufficient surface slope and rutting due to vehicle traffic. (Appendix C, Photo 1)

Description:
Riprap armored downstream slope of east dike. Water at toe due to recent rainfall.

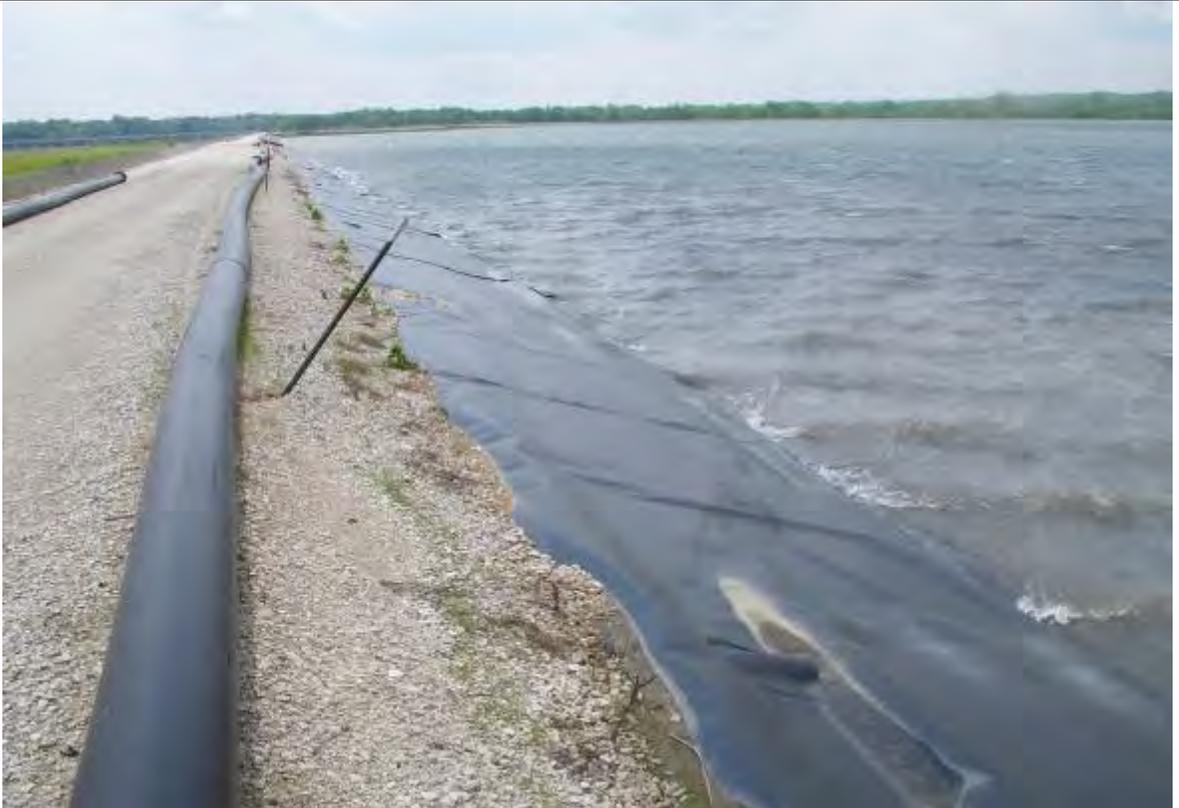
Photo Number:
2

Description:
Crest of east dike .

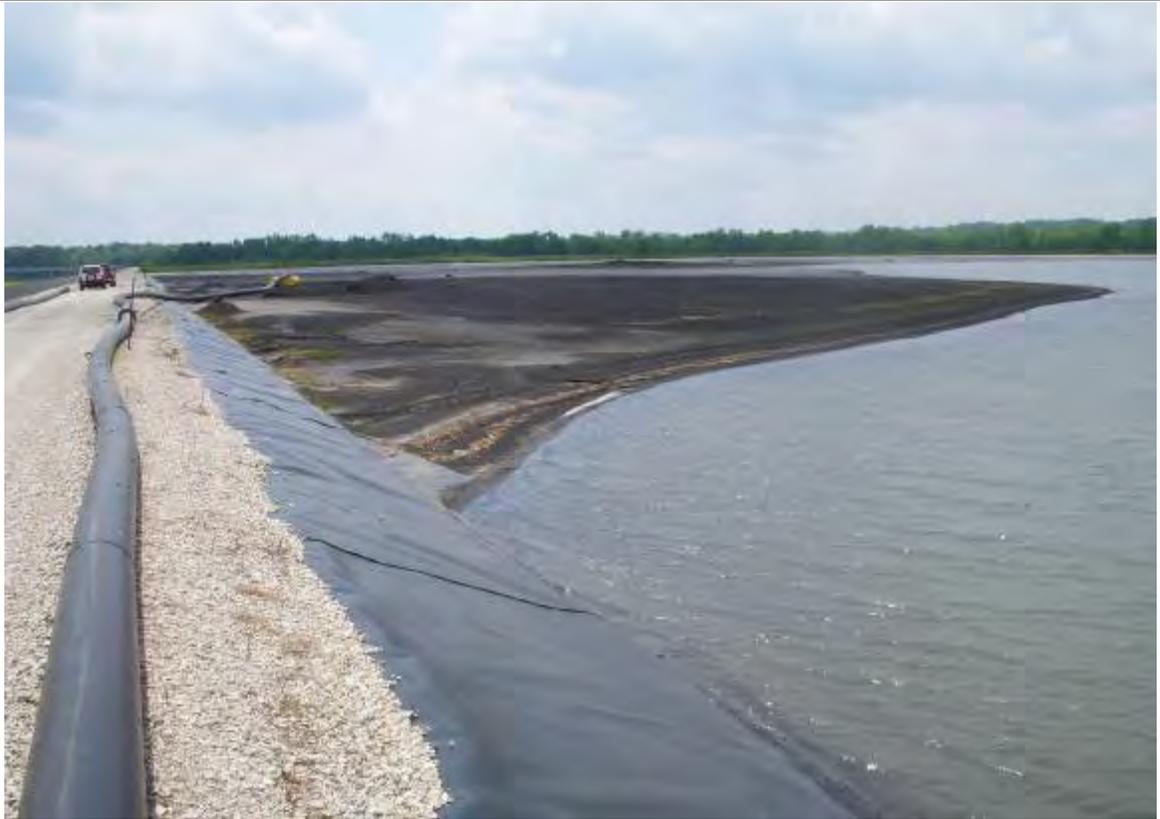
Photo Number:
3

Description:
Dredge discharge line to South Ash Pond. View of HDPE liner.

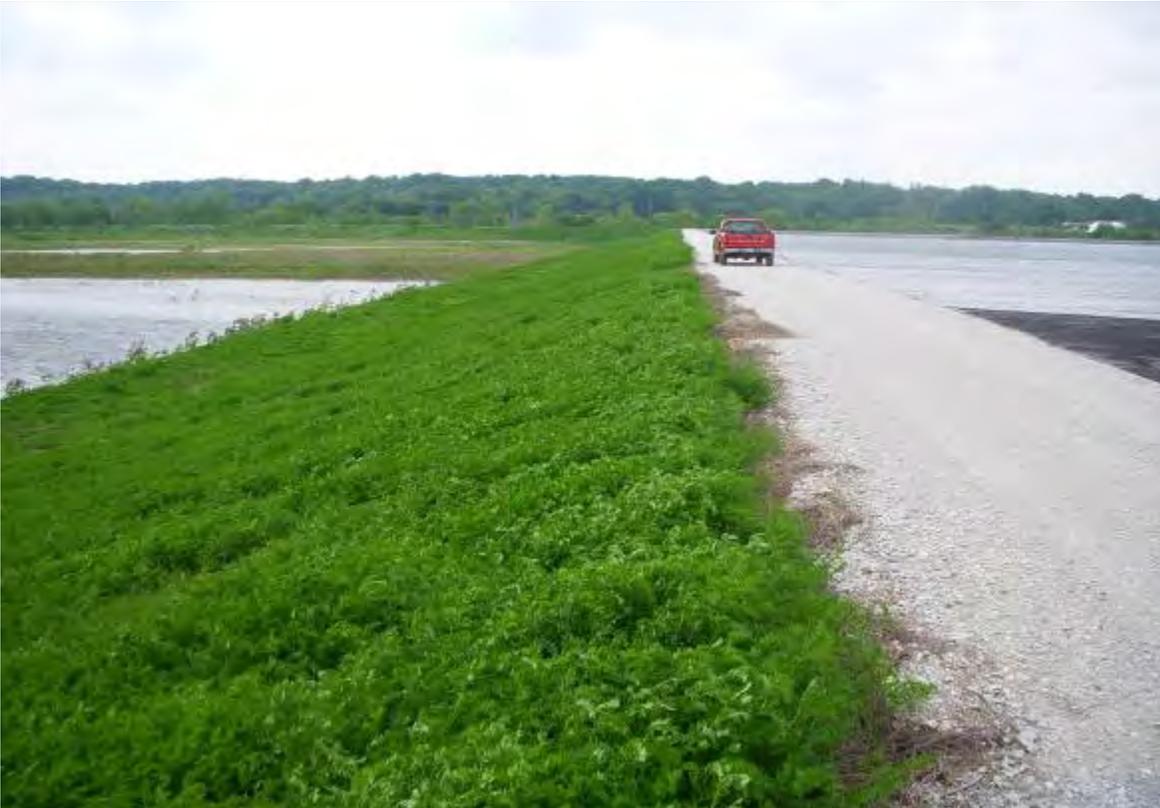
Photo Number:
4

- The gravel on the surface of the crest and lower access roads was thin and exposed geotextile was observed in some locations.
- The outboard slope of the south dike was well-vegetated with crown vetch. (Appendix C, Photo 4) Some sapling trees have taken root near the toe of the slope and in the future expansion area.

Description:
South dike of South Ash Pond with crown vetch on downstream slope.

- Place and compact additional gravel road base to provide minimum 6-inches of cover over non-woven geotextile along crest roads and secondary roads.
- Mow vegetated slopes at least twice annually to control vegetation
- Repair erosion along groin on outboard northwest corner of the South Pond

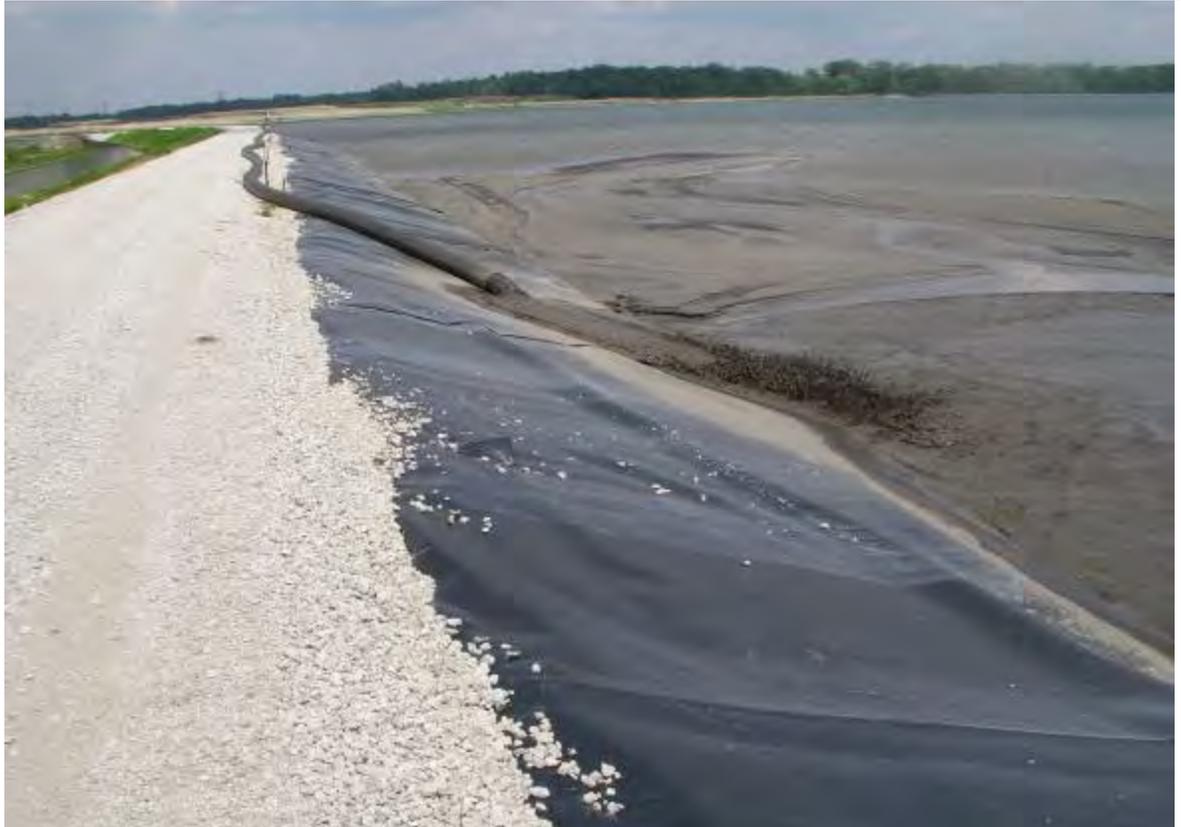
Photo Number:
5

Description:
Dredge
discharge into
South Ash
Pond.

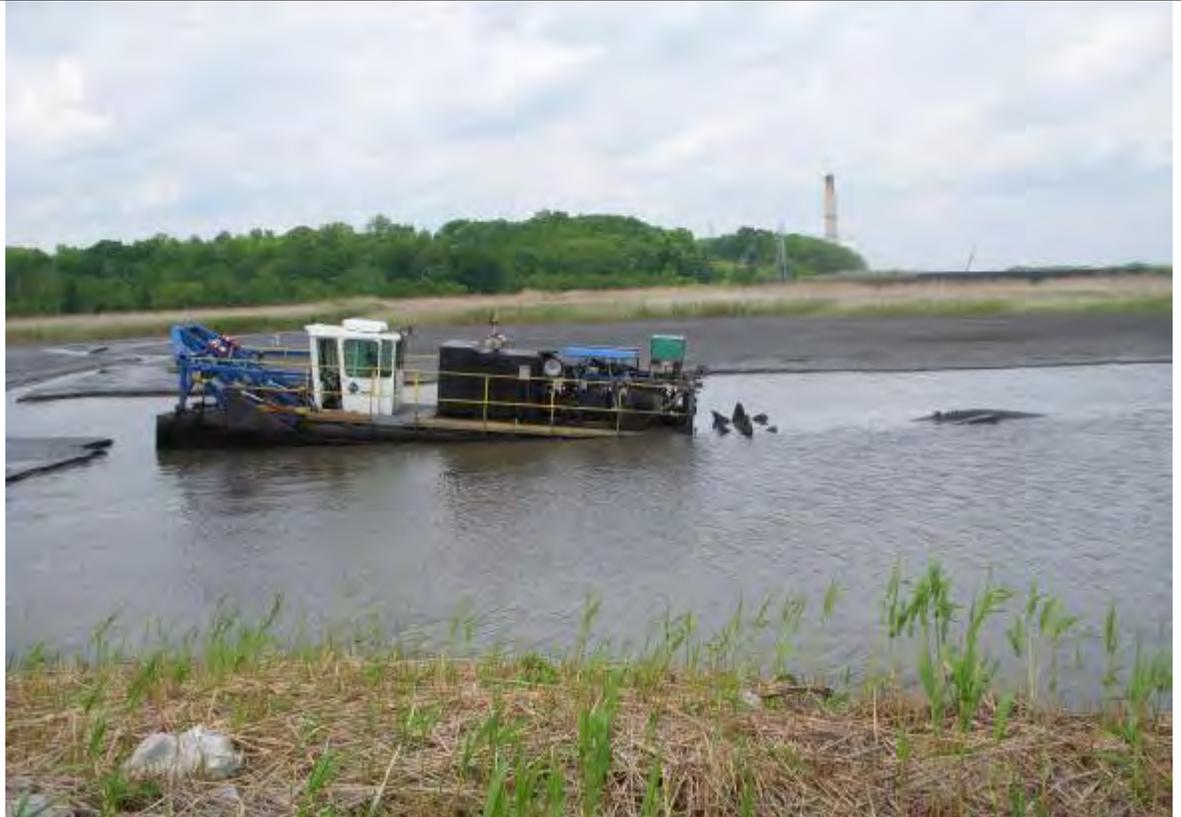
Photo Number:
6

Description:
Dredge in
operation in
Primary Ash
Pond B.

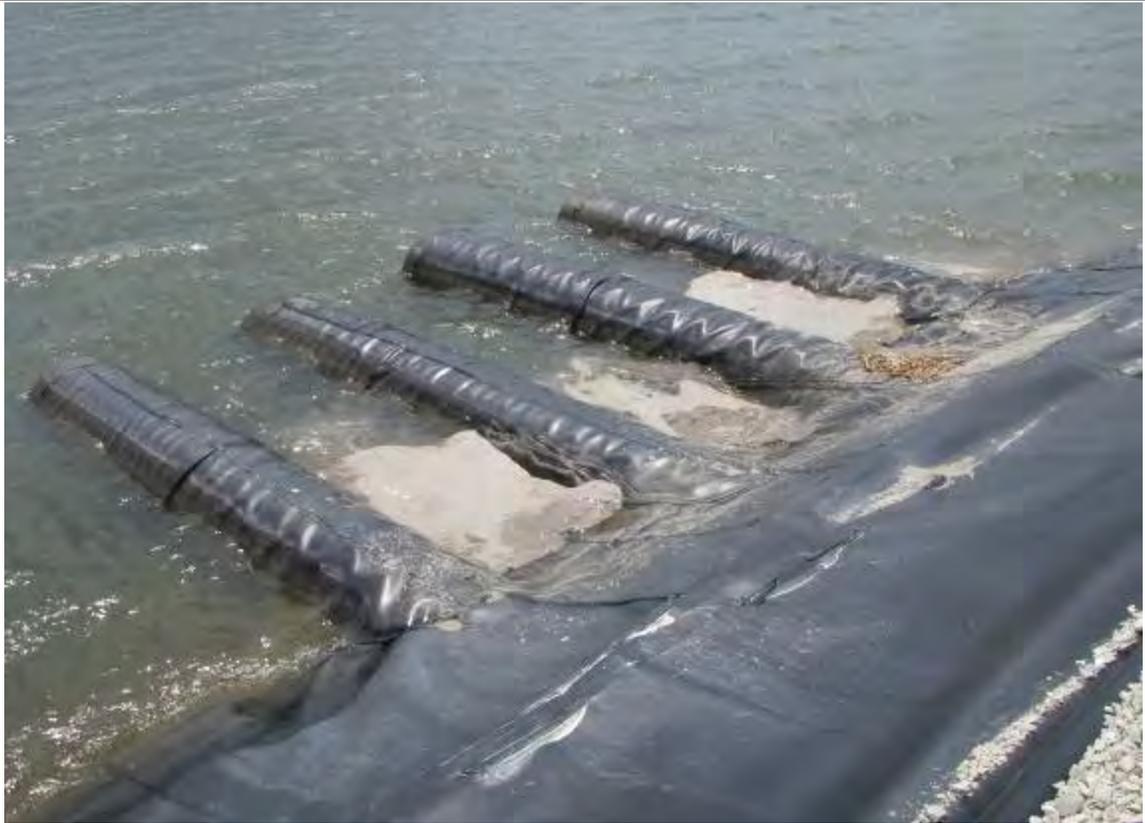
Photo Number:
7

- Four pipes with HDPE liner pipe boots were observed through the common dike between the South Pond and Pond B. The pipe boots appeared to be in good condition.

Description:
Equalization
pipes between
Primary Ash
Pond B and
South Ash
Pond.

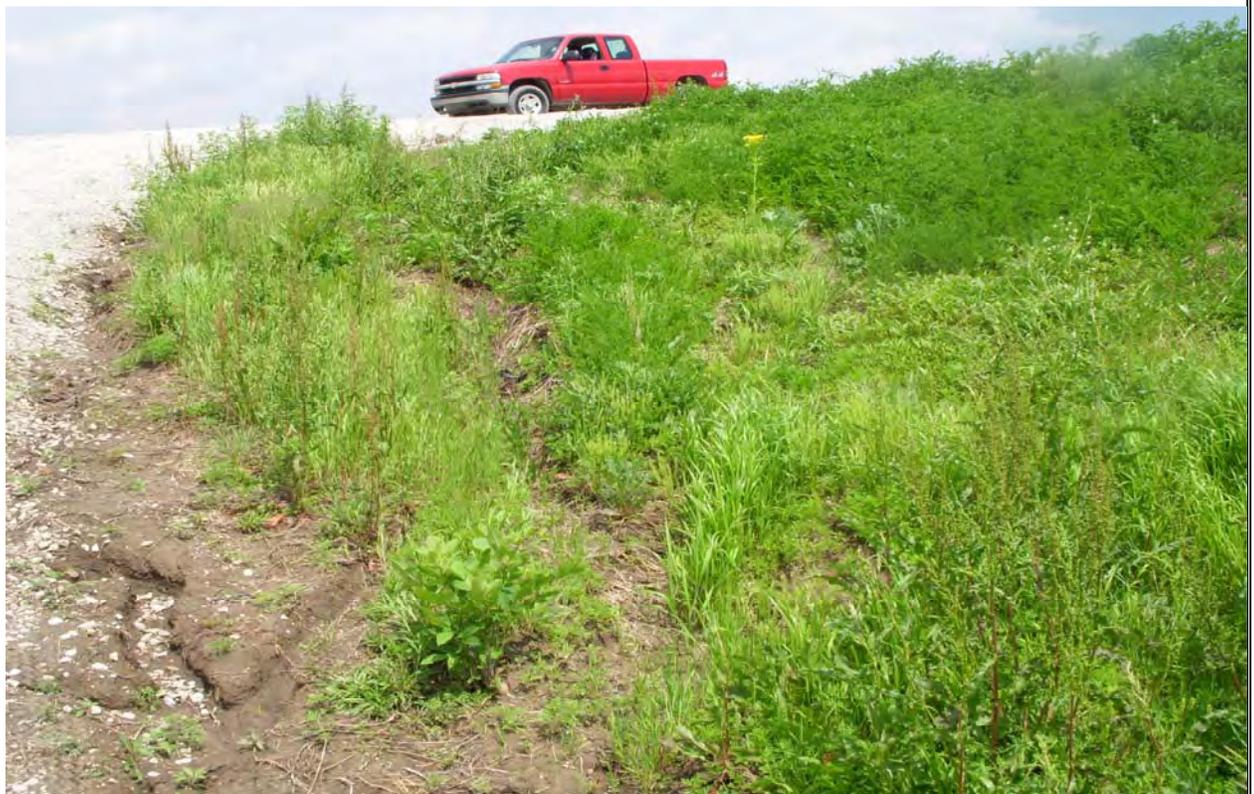
Photo Number:
8

- Some minor erosion along the groin area between the access road ramp and the northwestern corner of the pond was observed. (Appendix B, Photo 8)

Description:
Minor erosion
along groin of
dike.
