Re: Task 3 Dam Assessment Report
Project #0-381
Allen Steam Station Coal Ash Retention Dam
Belmont, North Carolina

EXECUTIVE SUMMARY

This Phase I Inspection/Evaluation Report details the results of a visual dam inspection of the Allen Steam Station Coal Active Ash Basin North and East Dikes located off State Highway 273 in Belmont, North Carolina. The inspection was performed on June 12, 2009 by GZA GeoEnvironmental, Inc (GZA).

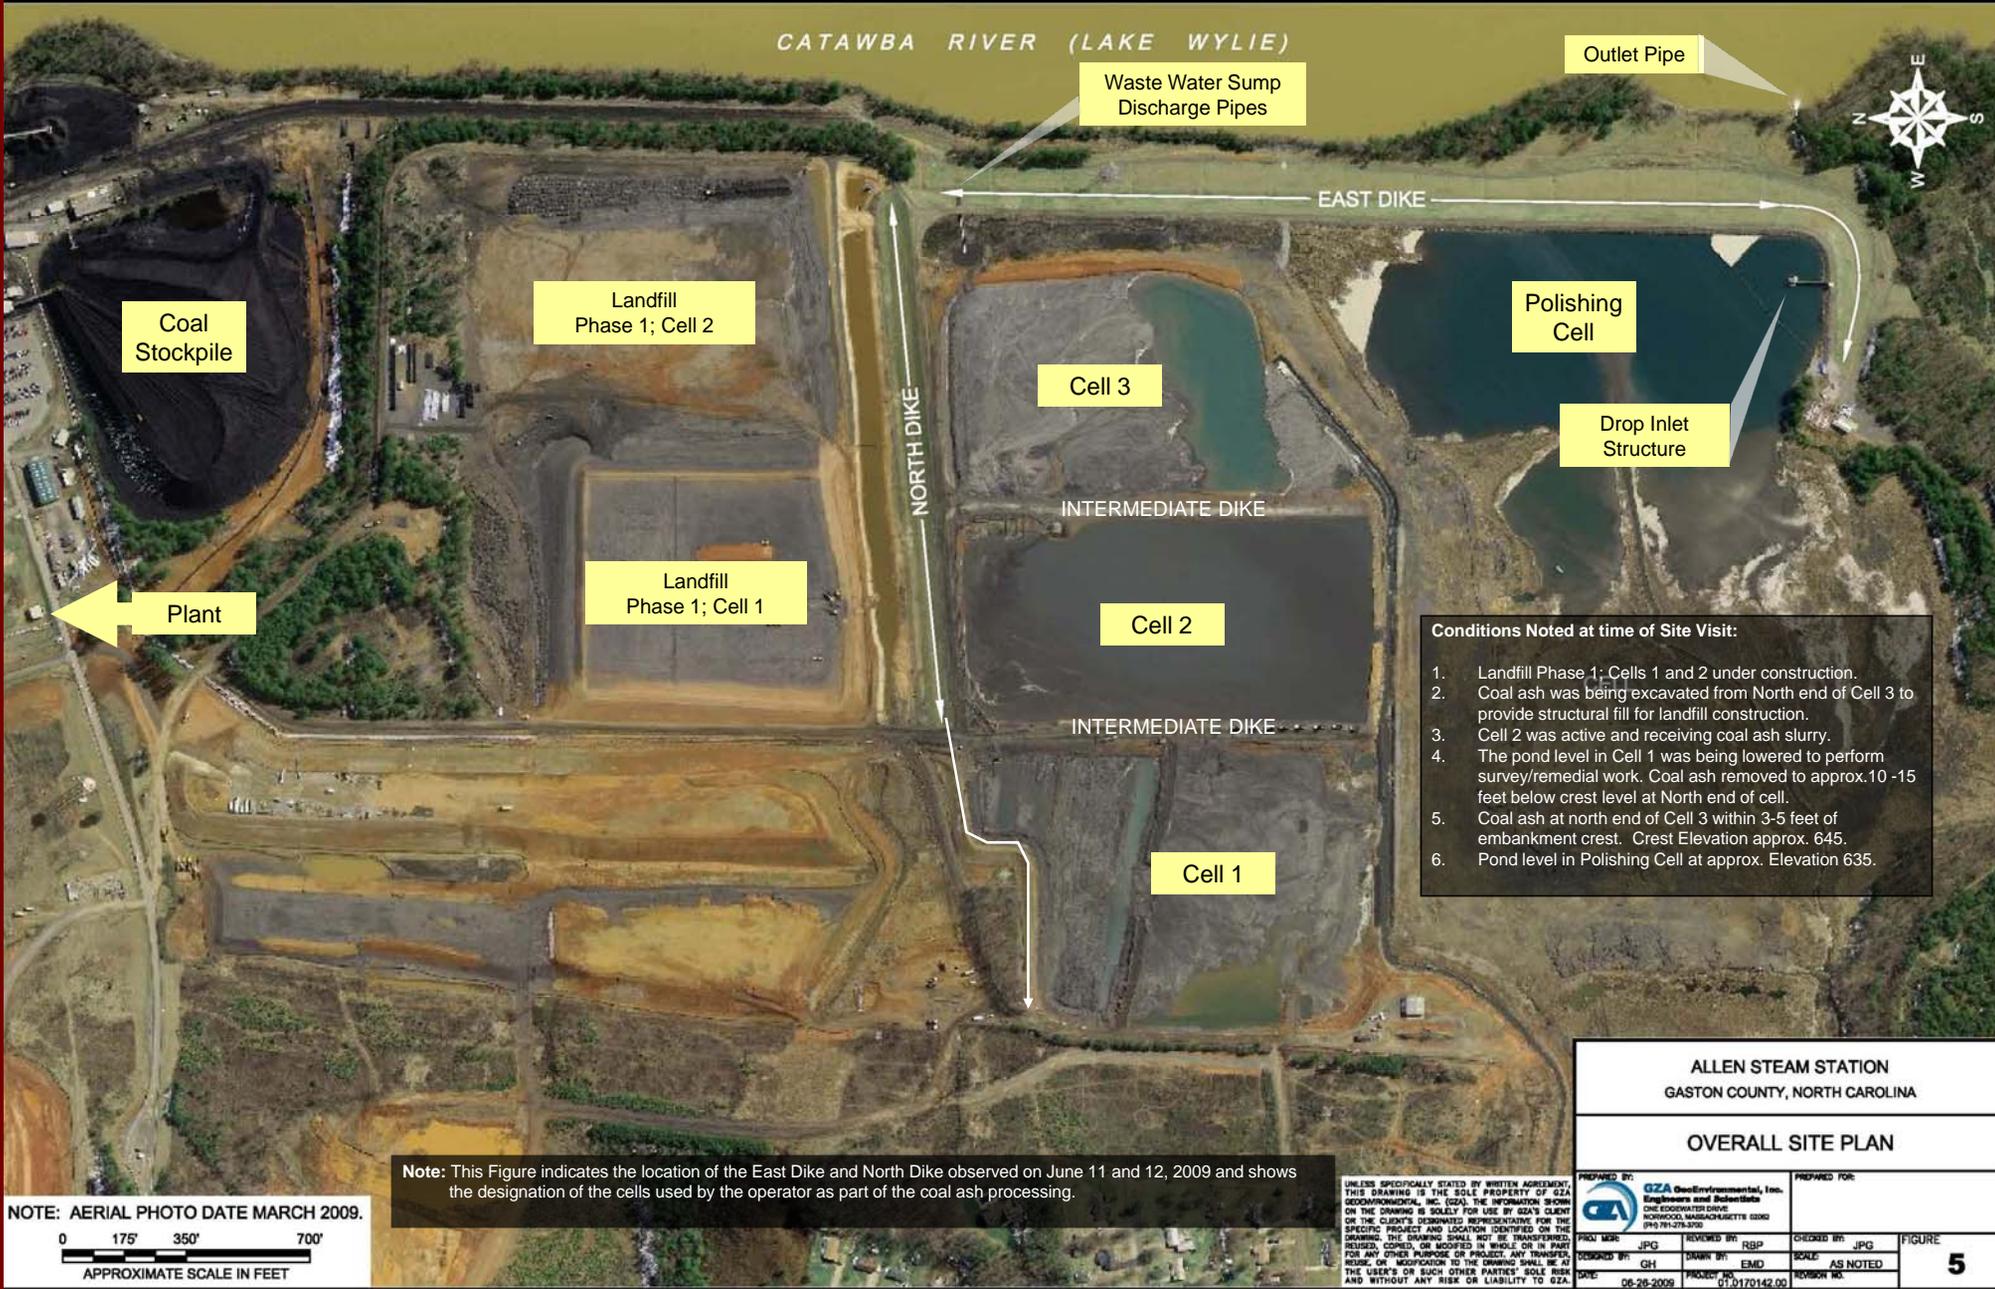
- Conditions Noted at time of Site Visit:**
1. Landfill Phase 1; Cells 1 and 2 under construction.
 2. Coal ash was being excavated from North end of Cell 3 to provide structural fill for landfill construction.
 3. Cell 2 was active and receiving coal ash slurry.
 4. The pond level in Cell 1 was being lowered to perform survey/remedial work. Coal ash removed to approx. 10 -15 feet below crest level at North end of cell.
 5. Coal ash at north end of Cell 3 within 3-5 feet of embankment crest. Crest Elevation approx. 645.
 6. Pond level in Polishing Cell at approx. Elevation 635.

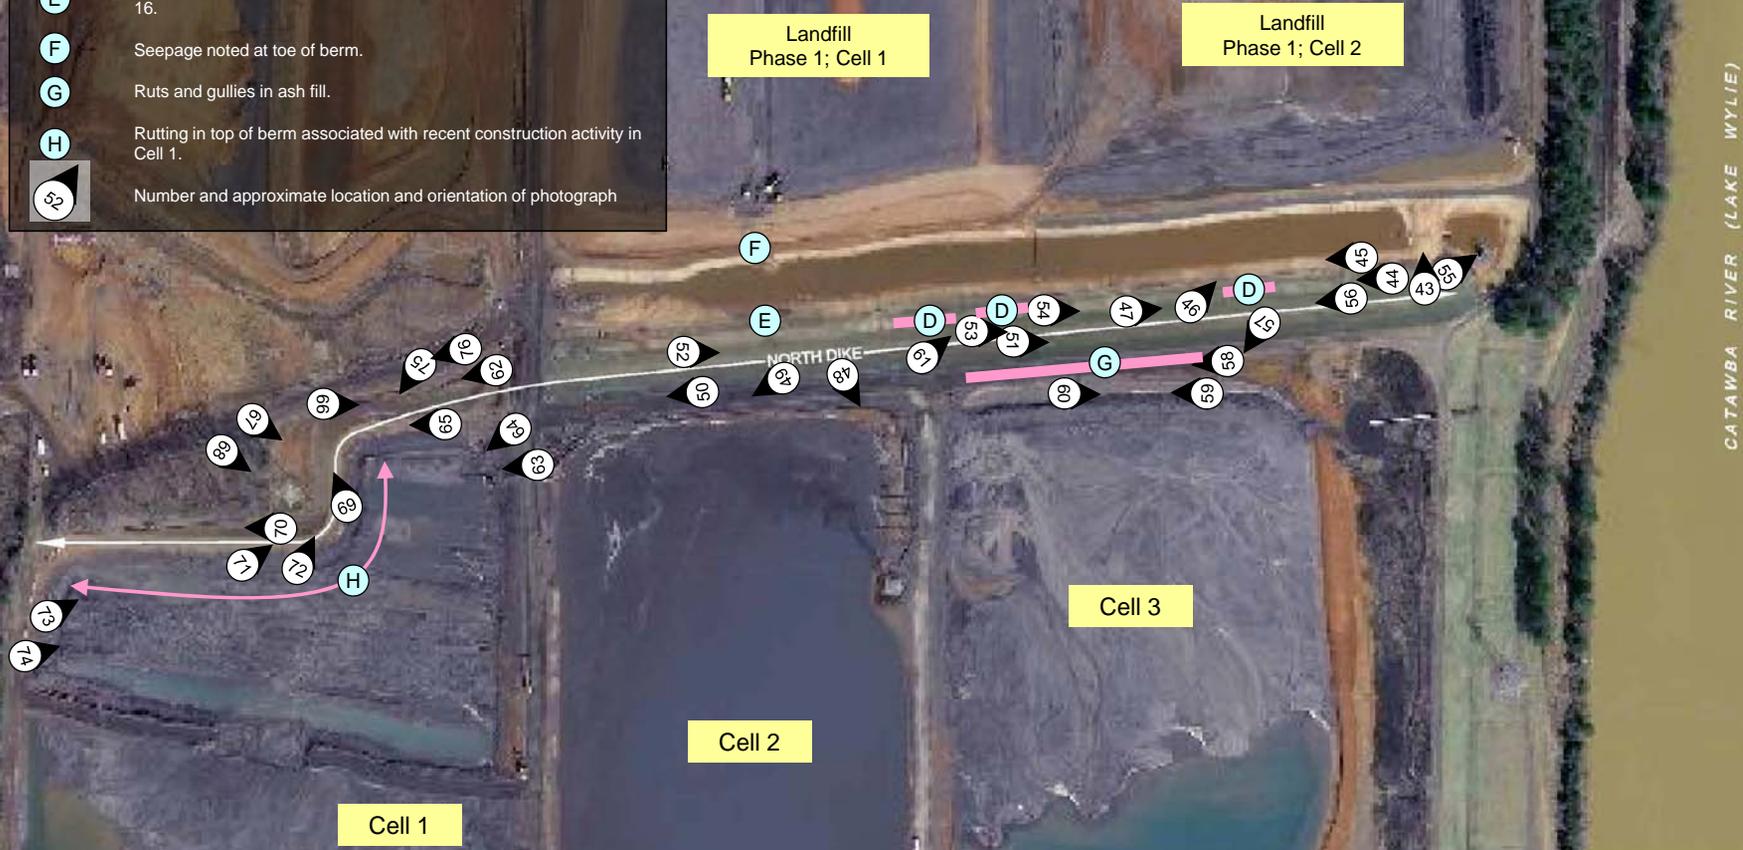
ALLEN STEAM STATION GASTON COUNTY, NORTH CAROLINA			
NORTH DIKE PLAN			
PREPARED BY:

- D** Indicates approximate length downstream slope where prior scarps may have occurred in the upper 10 to 15 feet of the dike.
- E** Small animal hole in berm approximately 30' west of Observation Well 16.
- F** Seepage noted at toe of berm.
- G** Ruts and gullies in ash fill.
- H** Rutting in top of berm associated with recent construction activity in Cell 1.
-

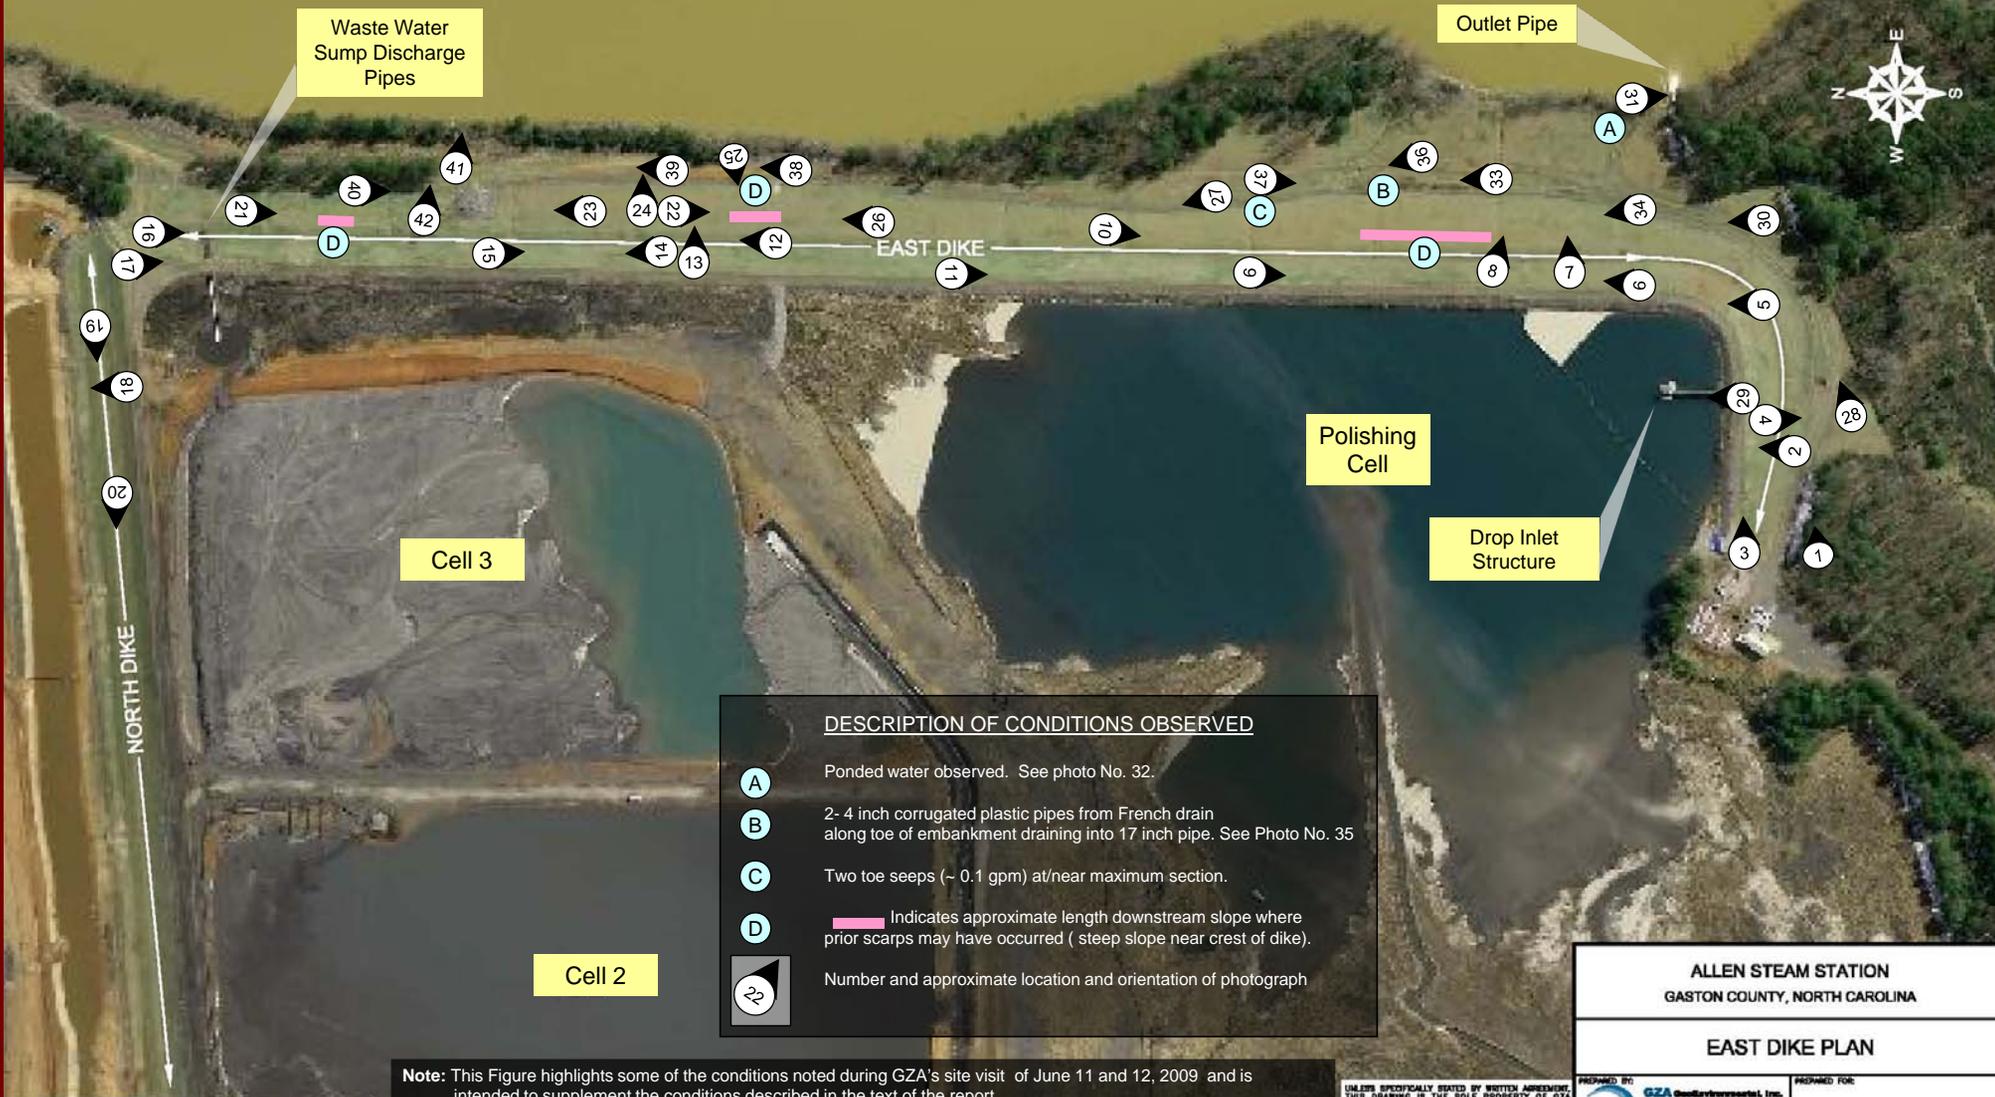
- A** Pounded water observed. See photo No. 32.
- B** 2- 4 inch corrugated plastic pipes from French drain along toe of embankment draining into 17 inch pipe. See Photo No. 53
- C** Two toe seeps (~ 0.1 gpm) at/near maximum section.
- D** Indicates approximate length downstream slope where prior scarps may have occurred (steep slope near crest of dike).
- 22** Number and approximate location and orientation of photograph

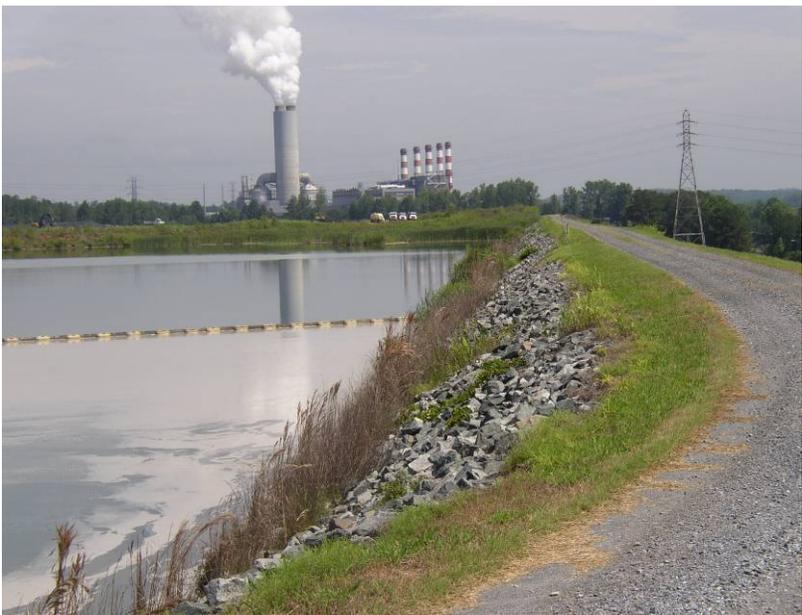
#5 Overview of Crest & Upstream Slope of East Dike – Polishing Cell

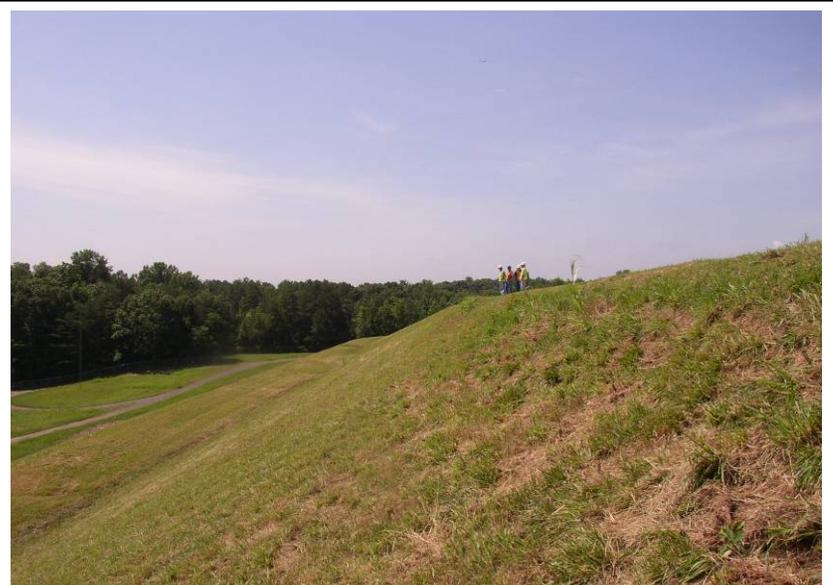
Minor scarps have historically been observed on the upper part of the downstream slope. These scarps are located several feet below the crest and are attributed to shallow slip failures within the upper layers of soil. The scarps remain on the embankment, and appear to have caused minor bulging in the lower section of the 2H:1V slope (above the stability berm). They are reportedly periodically addressed as maintenance items.

#10 Southern Downstream Slope of East Dike - Note Local Scarps in Upper Slope

2. Engineered maintenance repairs of the scarps should be undertaken and a monitoring program implemented to detect potential stability or seepage issues.

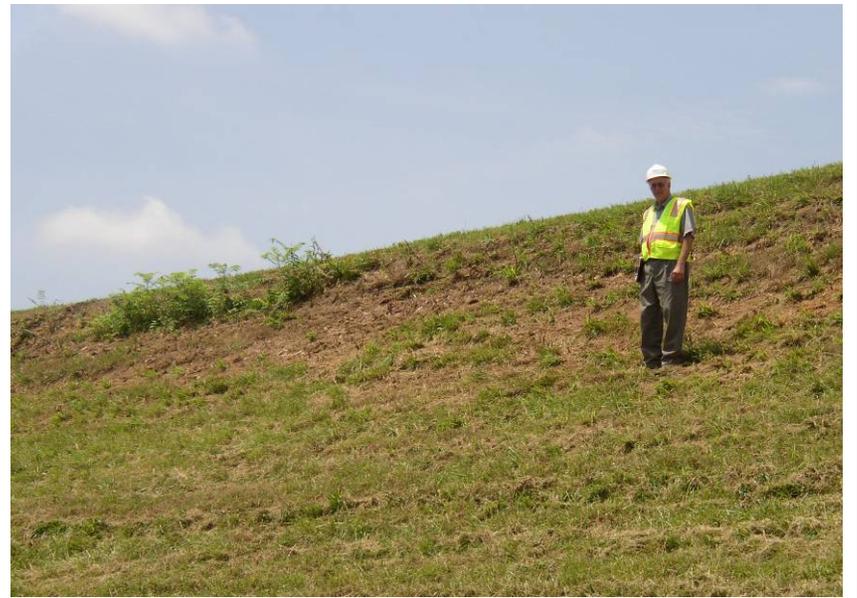
#25 Scarp on Upper Portion of Downstream Slope of East Dike

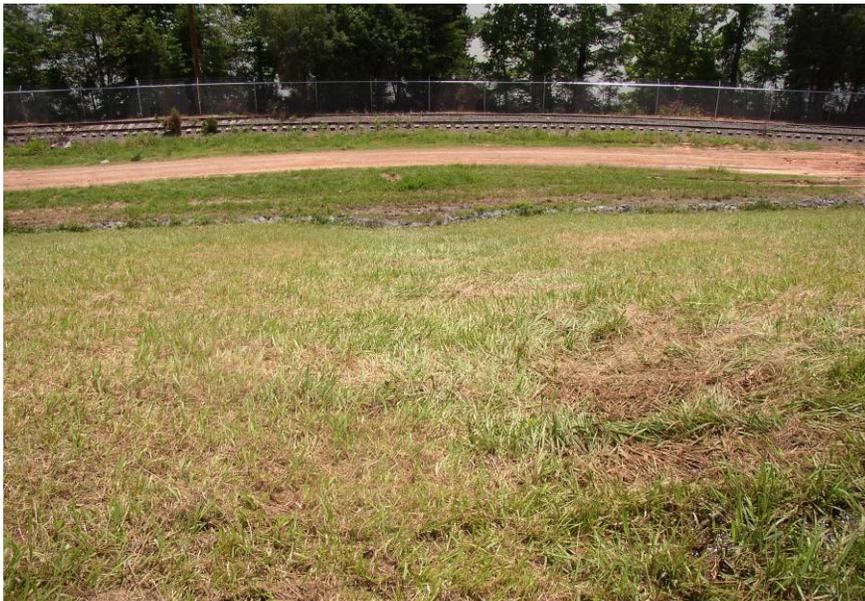
During the visual inspection, potential seepage was observed as part of the downstream blanket drain system along the toe of the North Dike Berm and near the maximum section for the East Dike.

#24 Note Seepage/Ponded Surface Water at Downstream Toe of North Dike

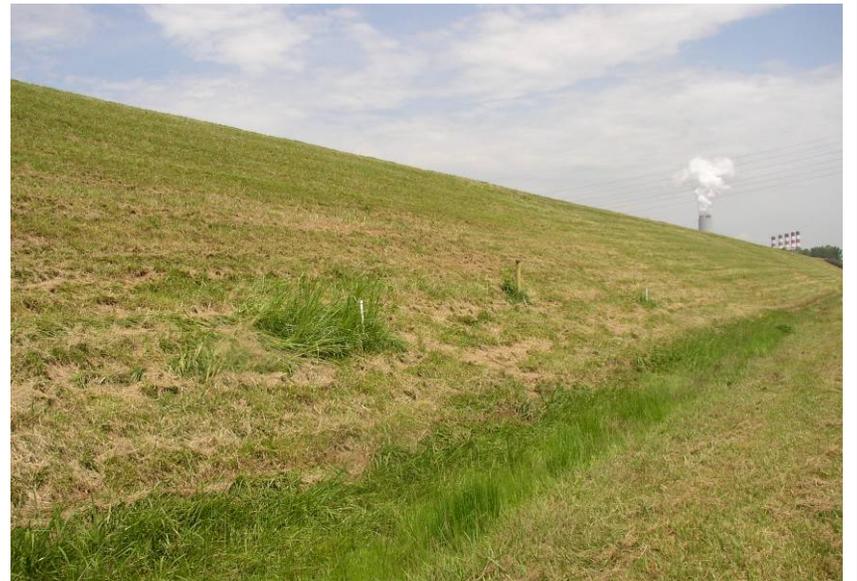
#26 Piezometers and Observation Wells Along Toe Stability Berm at South End of East Dike. (Note Standing Water at Toe)

4. Observations of the upper downstream toe of the East Dike should be made during periods of low rainfall to determine whether the standing water observed at the toe was due to surface water runoff or internal seepage. Seepage conditions should be monitored regularly

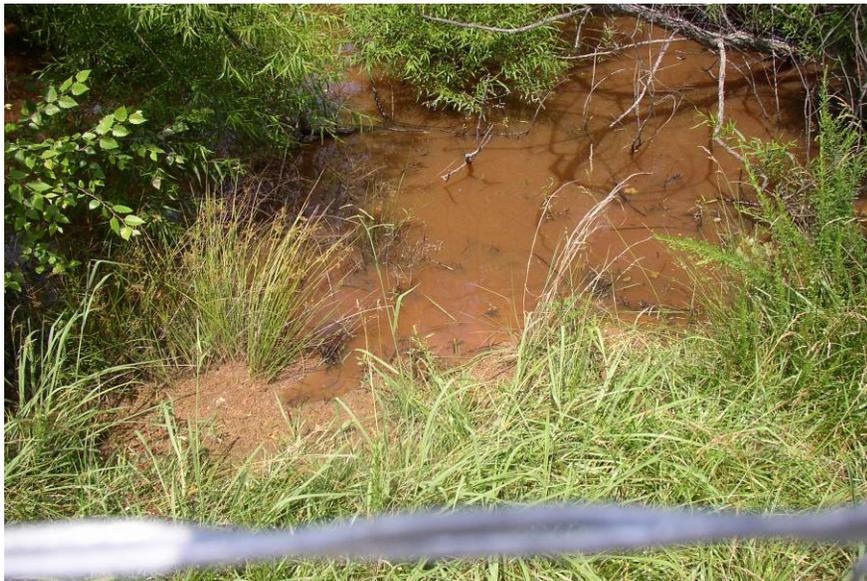
#32 Ponded Surface Water East of Downstream Toe Near Outlet

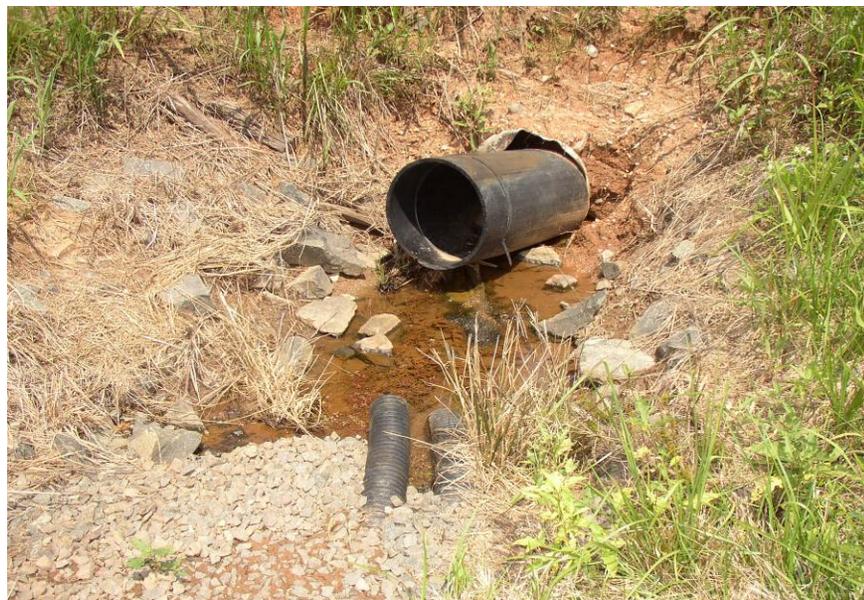
#35 Seepage Collection Area Near Maximum Section of Downstream Toe of East Dike

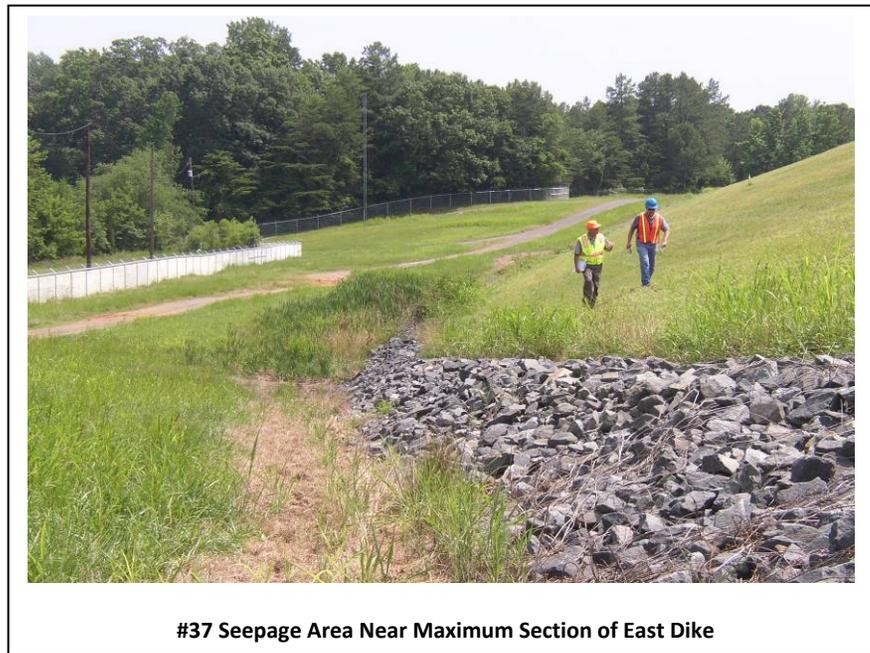
#37 Seepage Area Near Maximum Section of East Dike

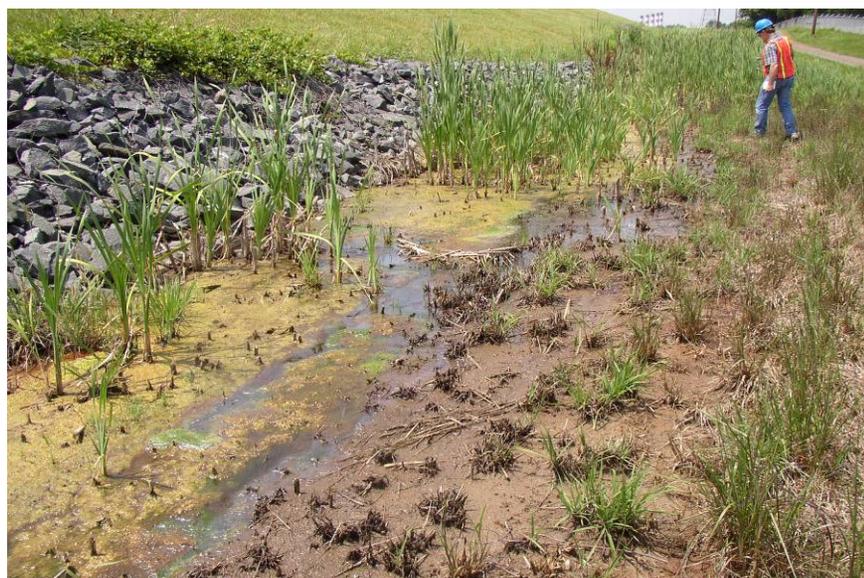
#36 Local Minor Seepage & Standing Drainage Flow at Downstream Toe of South End at East Dike

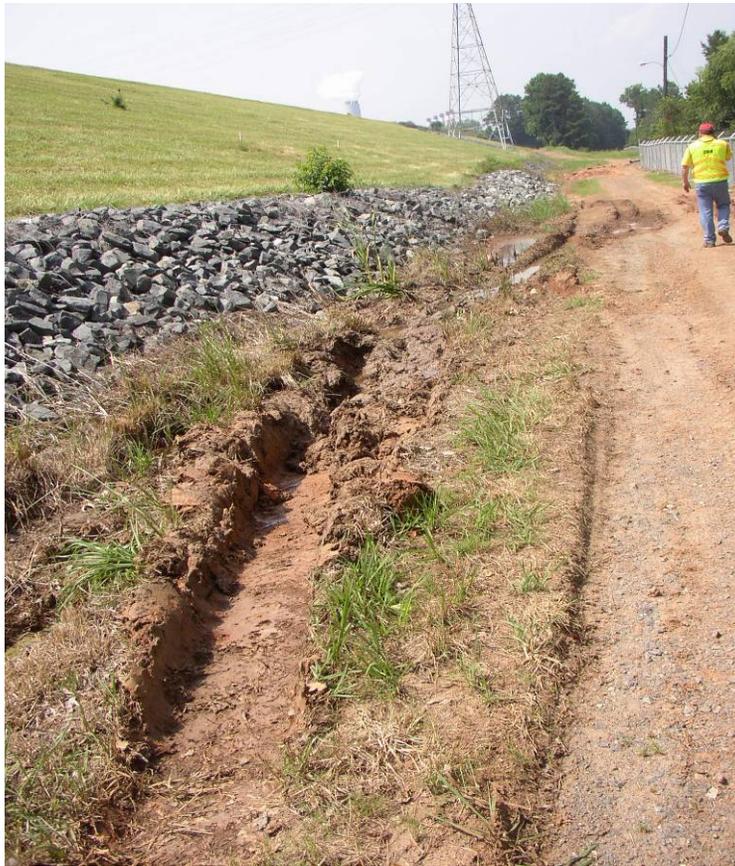
#38 Downstream Toe of East Dike Access Road –
Rutting from Construction Equipment

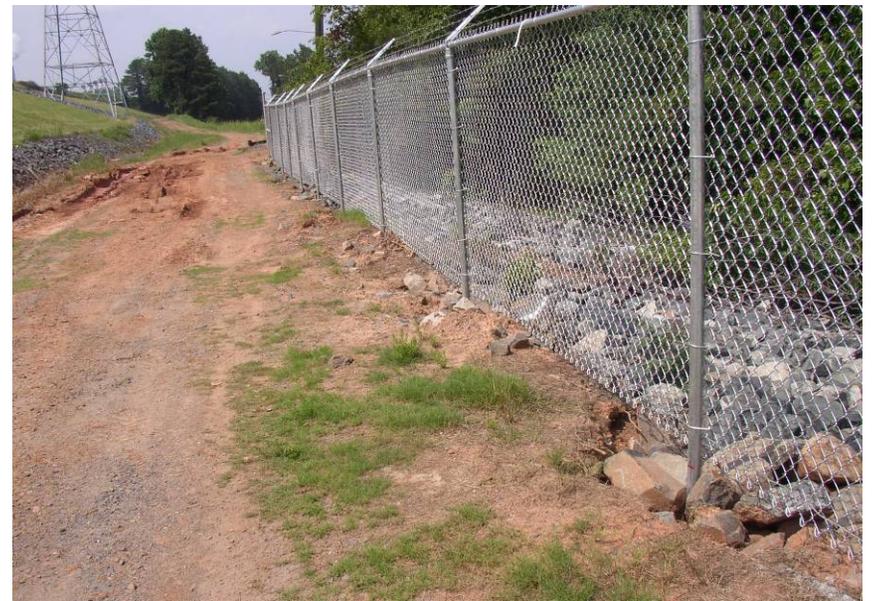
#39 Local Erosion / Rutting of Downstream Toe Road.
Near Central Portion of East Dike

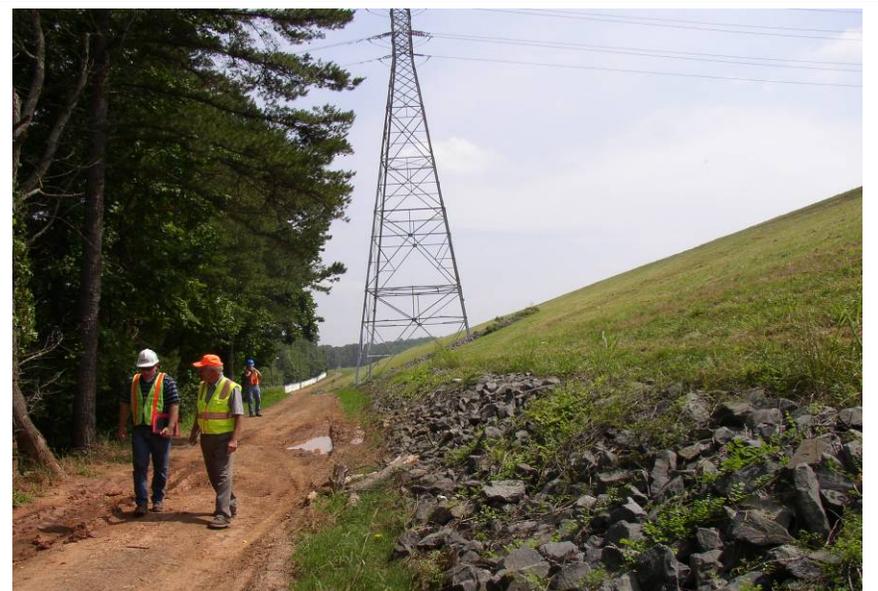
#40 Downstream Toe Road at North End of East Dike - Erosion

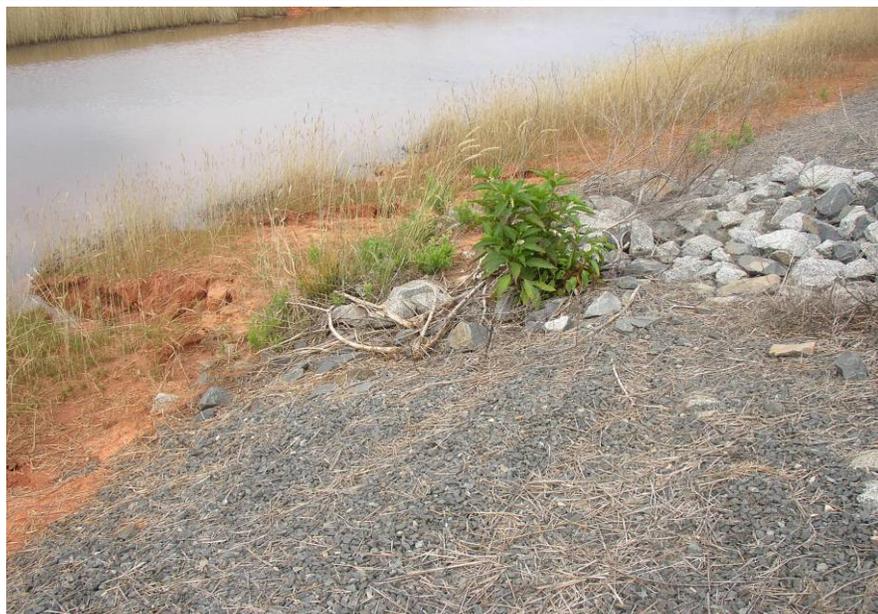
#46 Local Erosion @ Toe of Crushed Stone Drainage Material

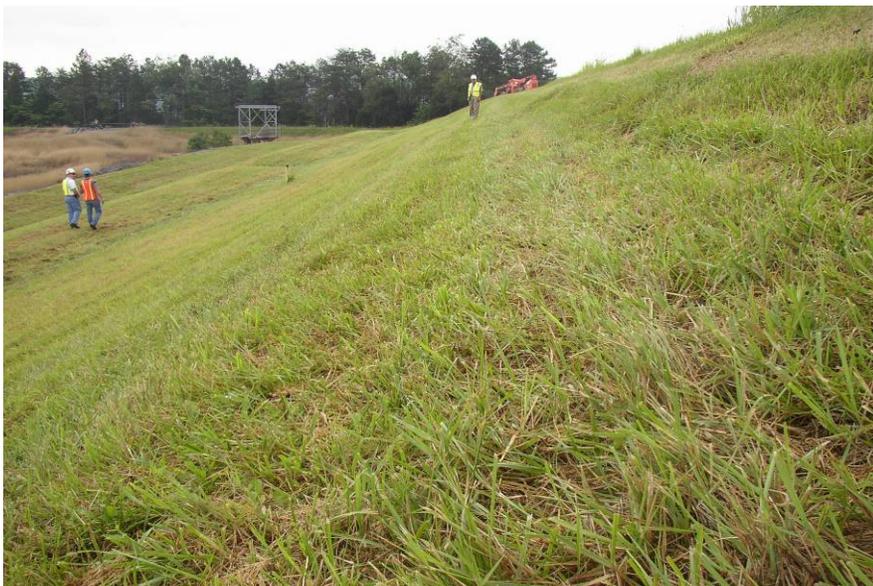
Minor scarps have historically been observed on the upper part of the downstream slope. These scarps are located several feet below the crest and are attributed to shallow slip failures within the upper layers of soil. The scarps remain on the embankment, and appear to have caused minor bulging in the lower section of the 2H:1V slope (above the stability berm). Construction activity in Cell 1 has created ruts on the southern end of the North Dike.

#54 Downstream Slope of North Dike (Note Evidence of Prior Scarps)

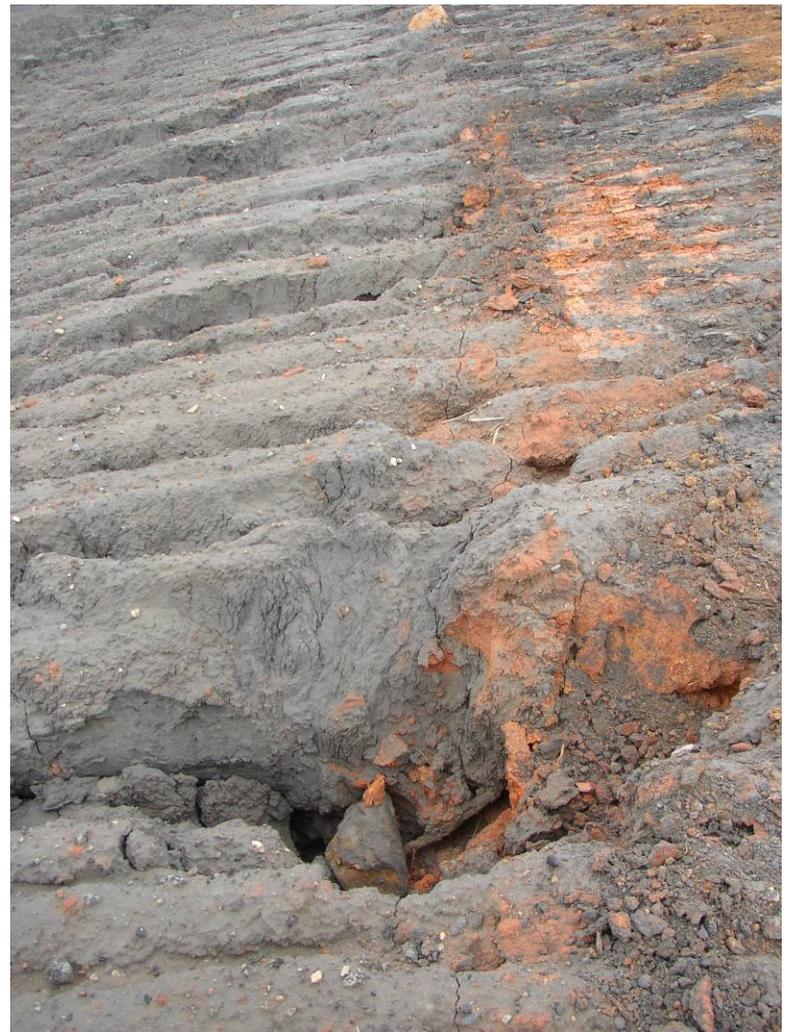
#59 Erosion in Ashfill in Upstream Excavated Slope of Cell 3

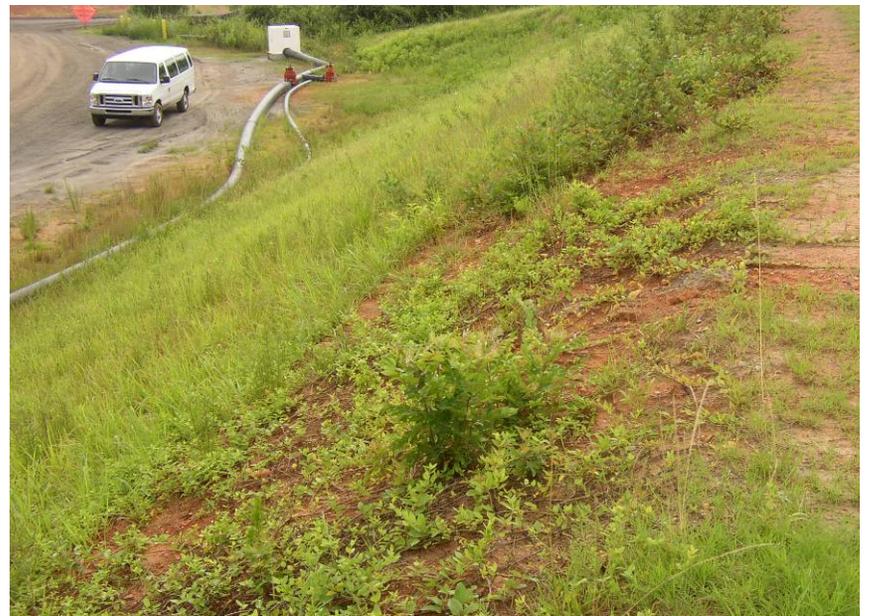
#66 Local Erosion Near Crest of North Dike

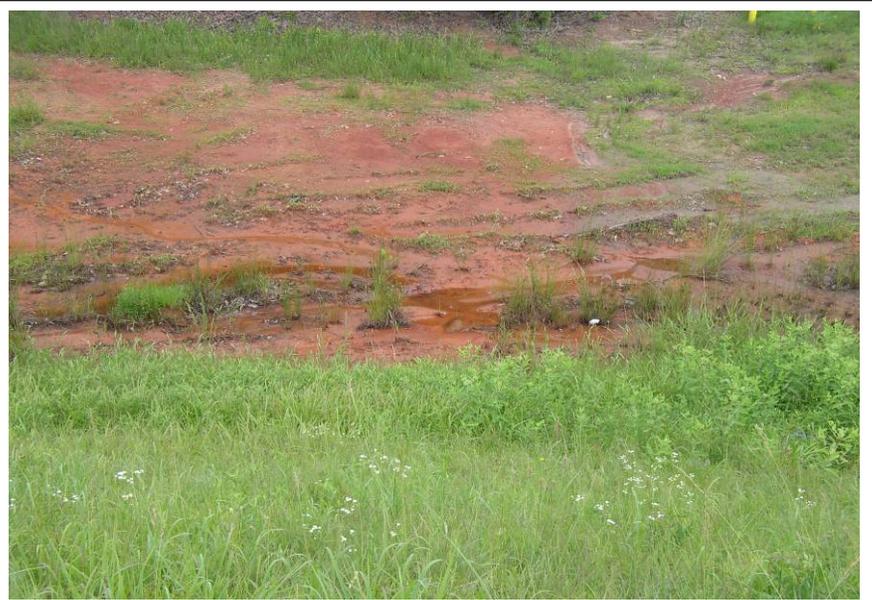
#67 Erosion at Downstream Slope of North Dike

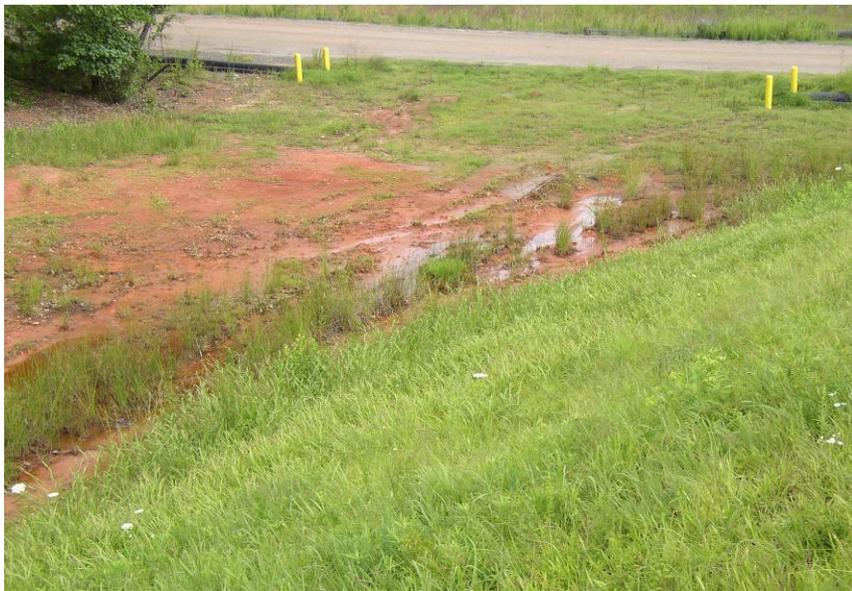
#69 Ponded Surface Drainage & Seepage Near Transmission Tower at West End of North Dike

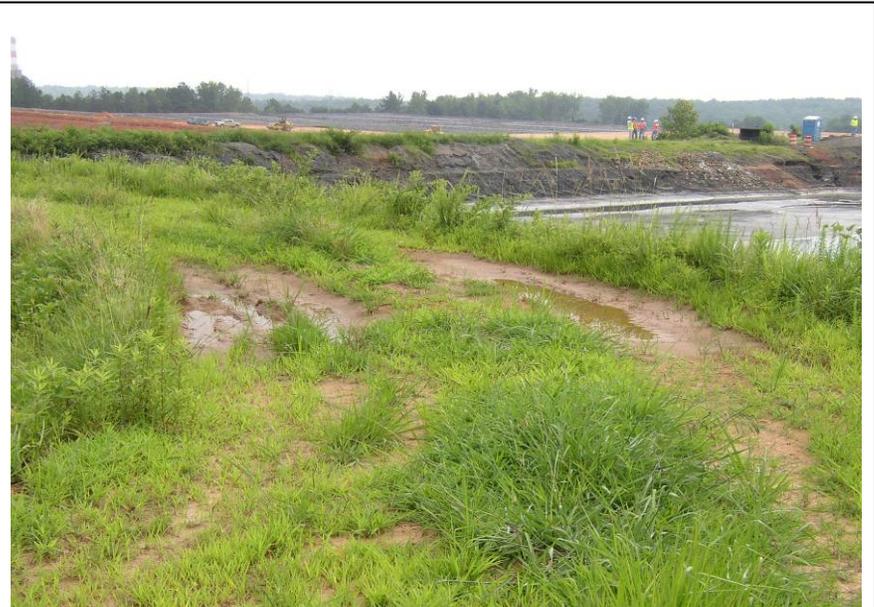
#71 Rutting in Crest at West End of North Dike

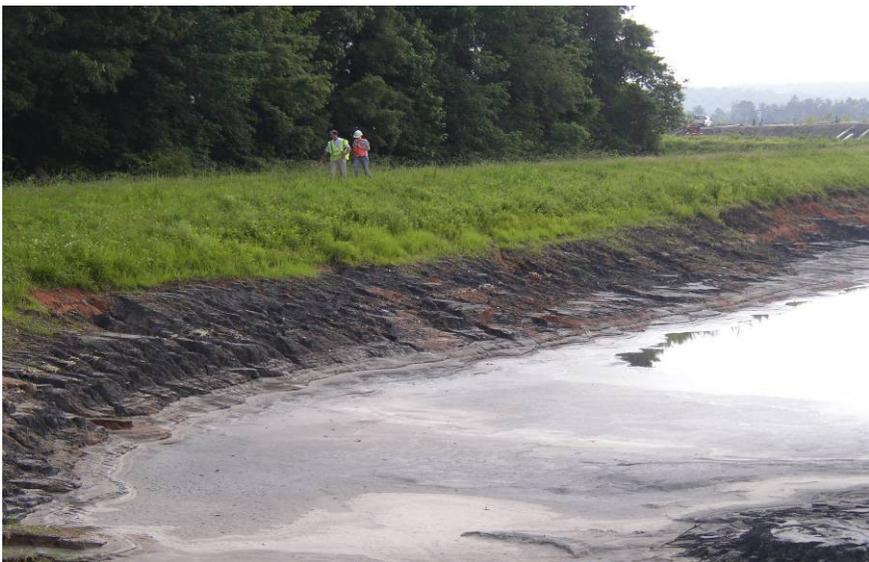
#73 Cell 1 Partially Excavated Ash on Upstream Side of Dike –
Note Surface Erosion on Dike Slope

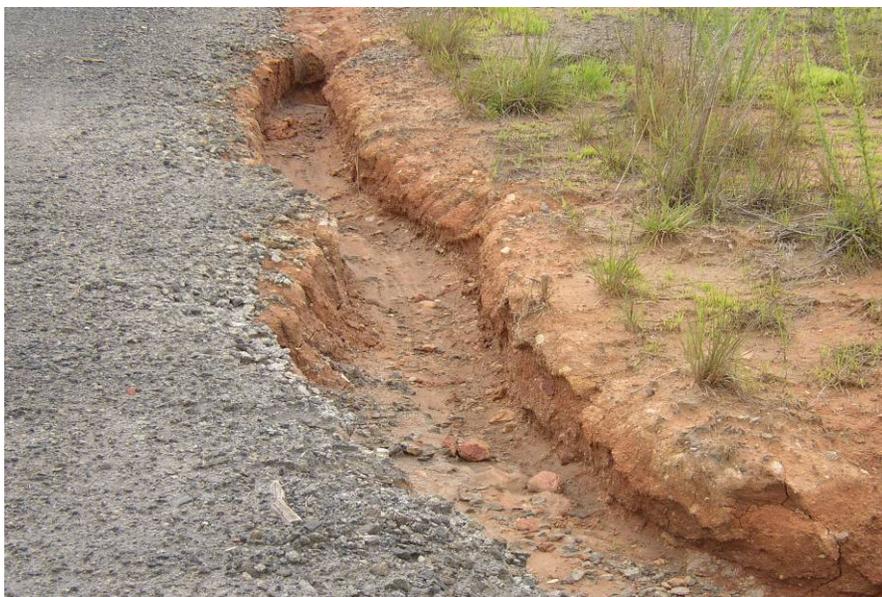
#76 Erosion Adjacent to Road Along Downstream Toe of North Dike
