Re: Task 3 Dam Assessment Report  
Project #0-381  
Allen Steam Station Coal Ash Retention Dam  
Belmont, North Carolina

**FINAL REPORT**

This Phase I Inspection/Evaluation Report presents the results of a visual dam inspection of the Allen Steam Station Coal Active Ash Basin North and East Dikes located off State Highway 273 in Belmont, North Carolina. The inspection was performed on June 11 and June 12, 2009 by representatives of GZA GeoEnvironmental, Inc (GZA).

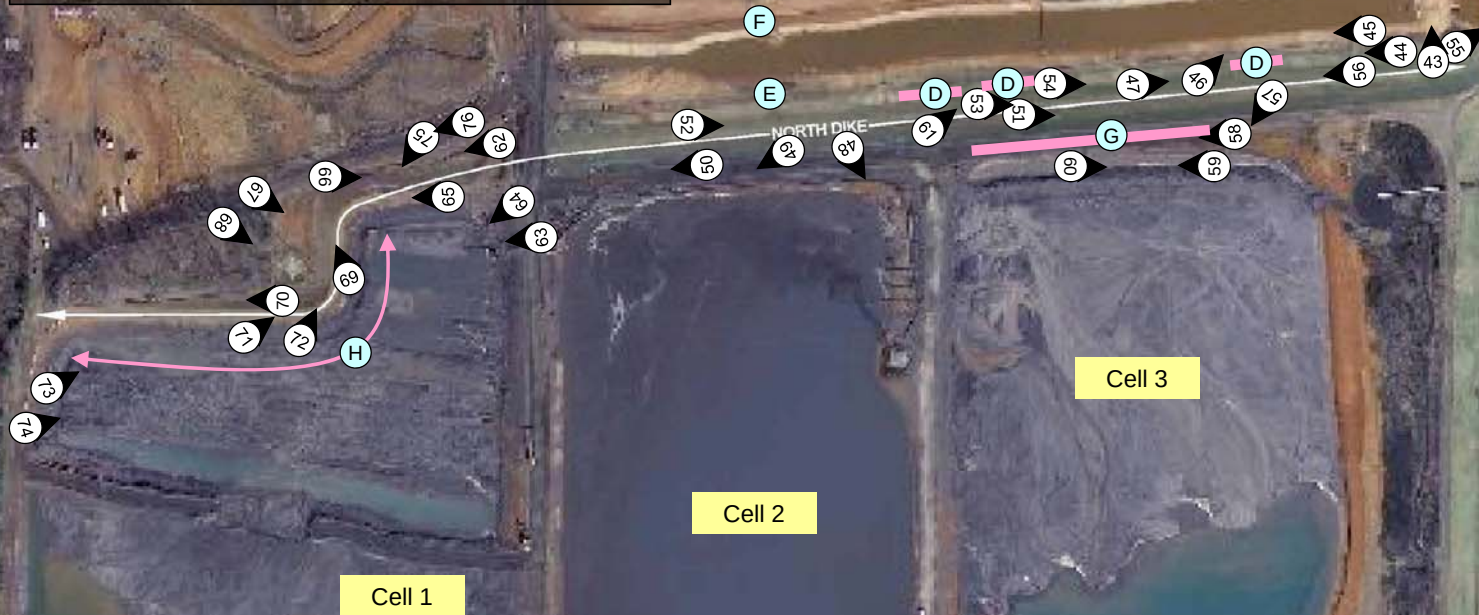
# DESCRIPTION OF CONDITIONS OBSERVED

**Note:** This Figure highlights some of the conditions noted during GZA's site visit of June 11 and 12, 2009 and is intended to supplement the conditions described in the text of the report.

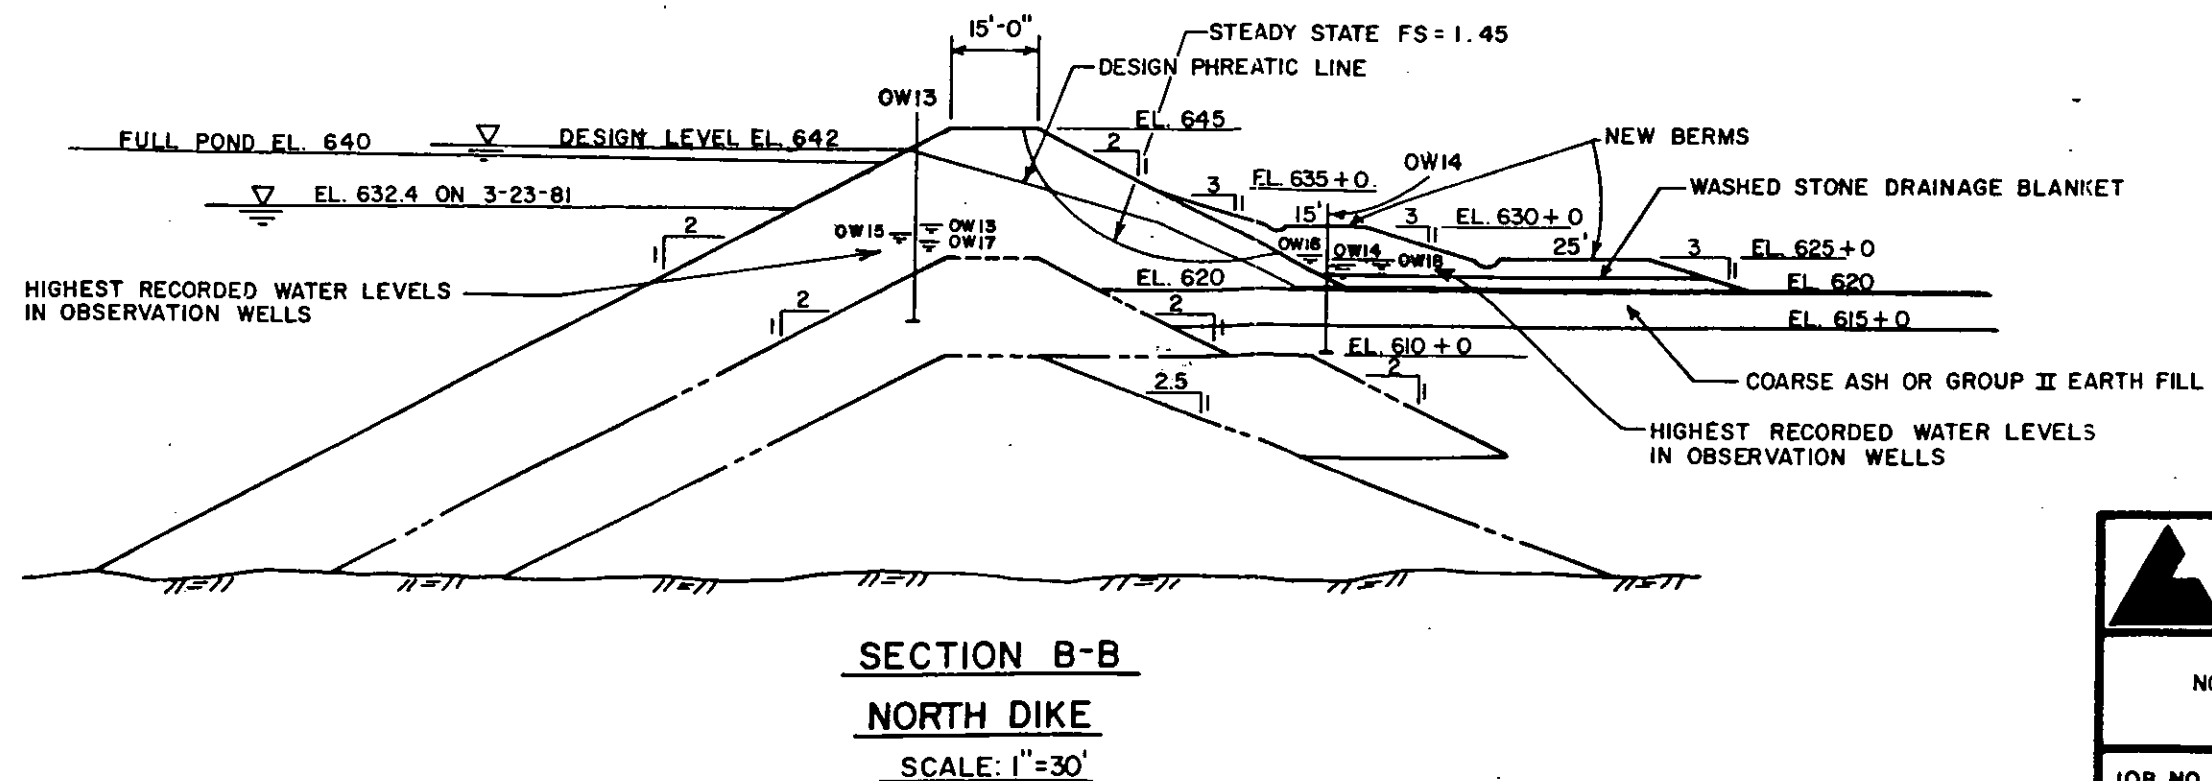
**CROSS SECTIONS**  
**NORTH AND SOUTH DIKES OF PRIMARY BASIN**  
**ALLEN STEAM STATION**  
**GASTON COUNTY, NORTH CAROLINA**

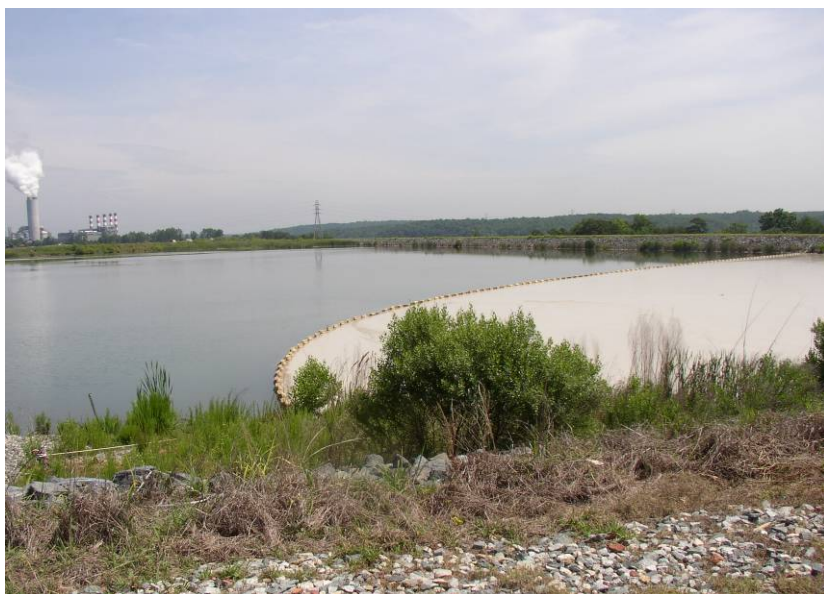
#2 Overview of Polishing Cell

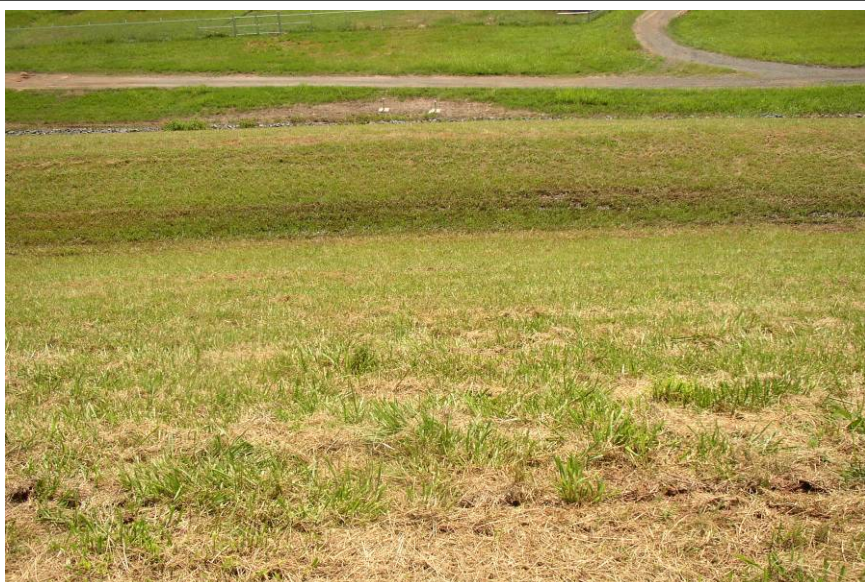
**#9 Southern Portion of Crest & Downstream Slope of East Dike –  
Note Pooled Water on Berm**

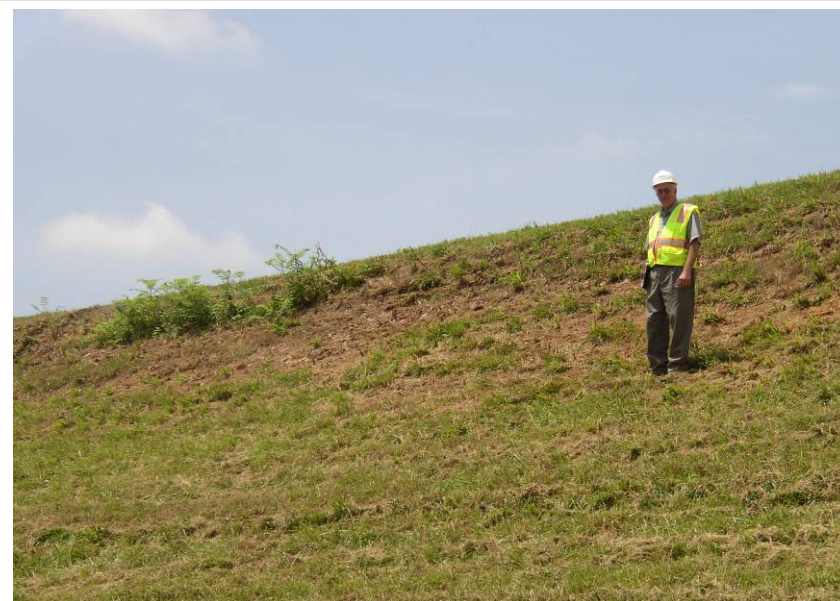
Minor scarps have occurred on the upper part of the downstream slope. These scarps are located several feet below the crest and are attributed to shallow slip failures within the upper layers of soil. The scarps remain on the embankment, and appear to have caused minor bulging in the lower section of the 2H:1V slope (above the stability berm). They are reportedly periodically addressed as maintenance items.

#25 Scarp on Upper Portion of Downstream Slope of East Dike

2. Engineered maintenance repairs of the scarps should be undertaken and a monitoring program implemented to detect potential stability or seepage issues.

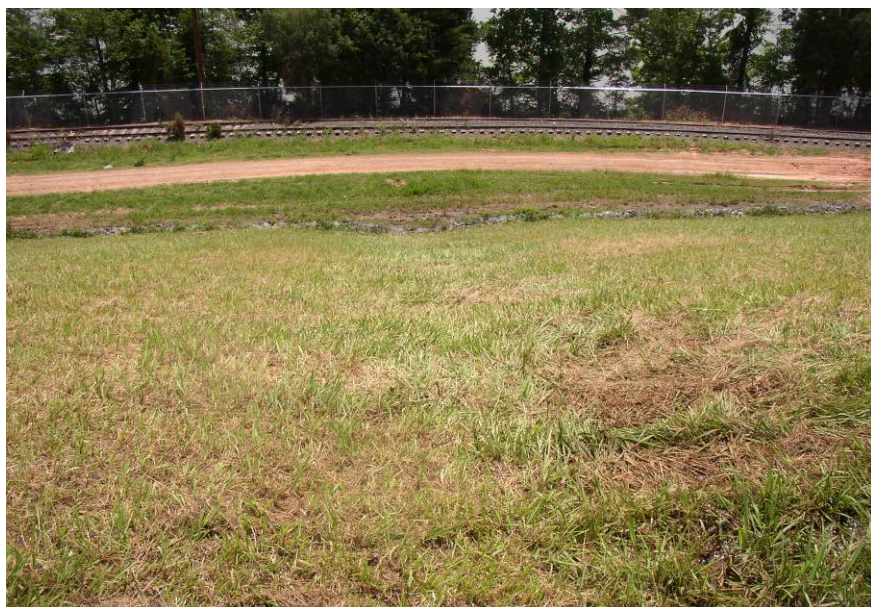
During the visual inspection, potential seepage was observed as part of the downstream blanket drain system along the toe of the North Dike Berm and near the maximum section for the East Dike.

#24 Note Seepage/Ponded Surface Water at Downstream Toe of North Dike

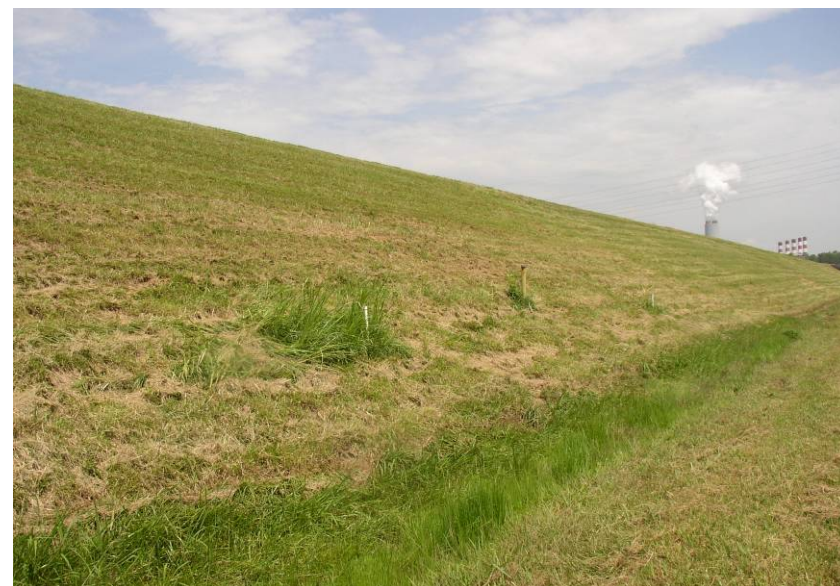
#26 Piezometers and Observation Wells Along Toe Stability Berm at South End of East Dike. (Note Standing Water at Toe)

4. Observations of the upper downstream toe of the East Dike should be made during periods of low rainfall to determine whether the standing water observed at the toe was due to surface water runoff or internal seepage. Seepage conditions should be monitored regularly.

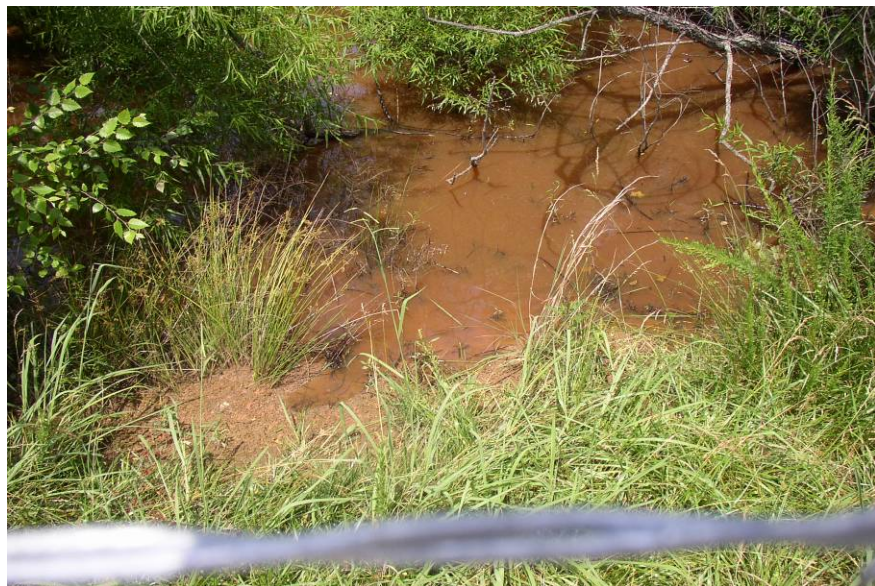
#32 Poned Surface Water East of Downstream Toe Near Outlet

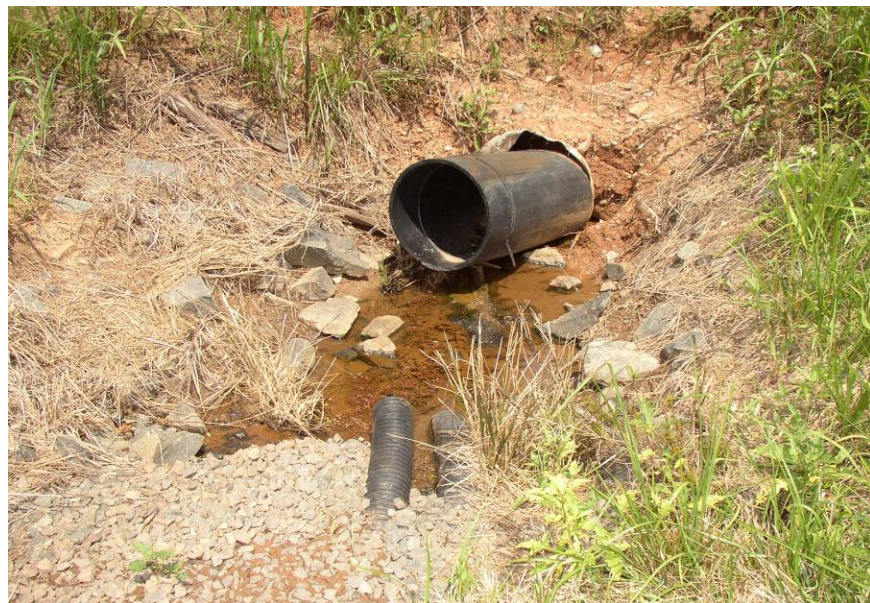
#35 Seepage Collection Area Near Maximum Section of Downstream Toe of East Dike

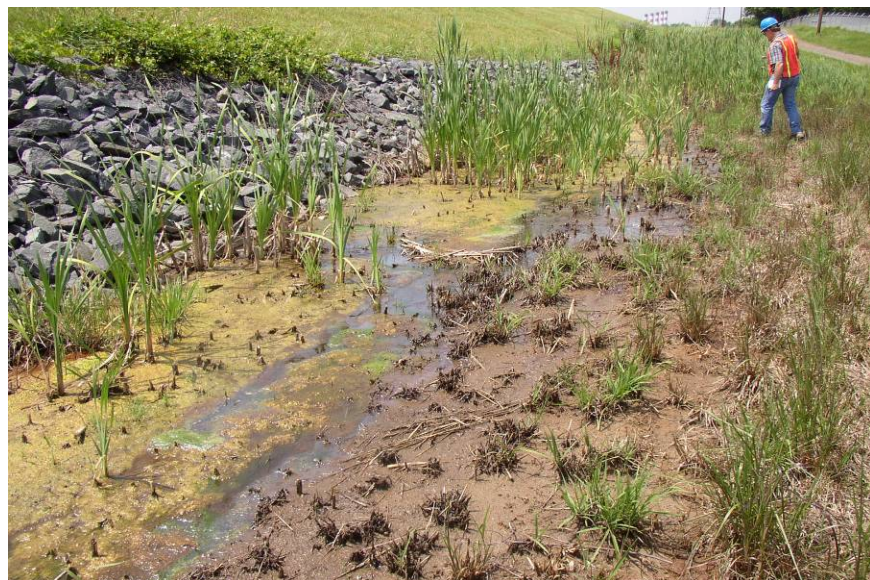
#36 Local Minor Seepage & Standing Drainage Flow at Downstream Toe of South End at East Dike

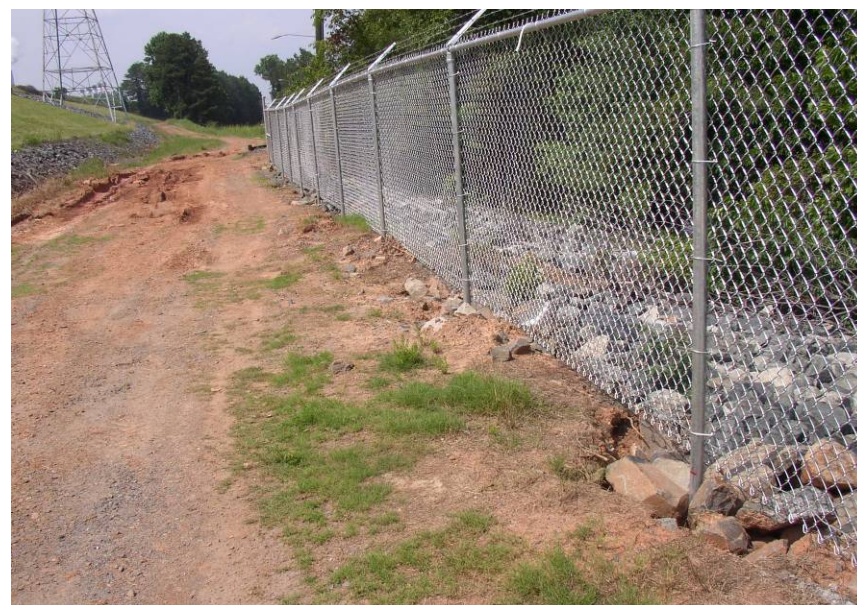
**#39 Local Erosion / Rutting of Downstream Toe Road.  
Near Central Portion of East Dike**

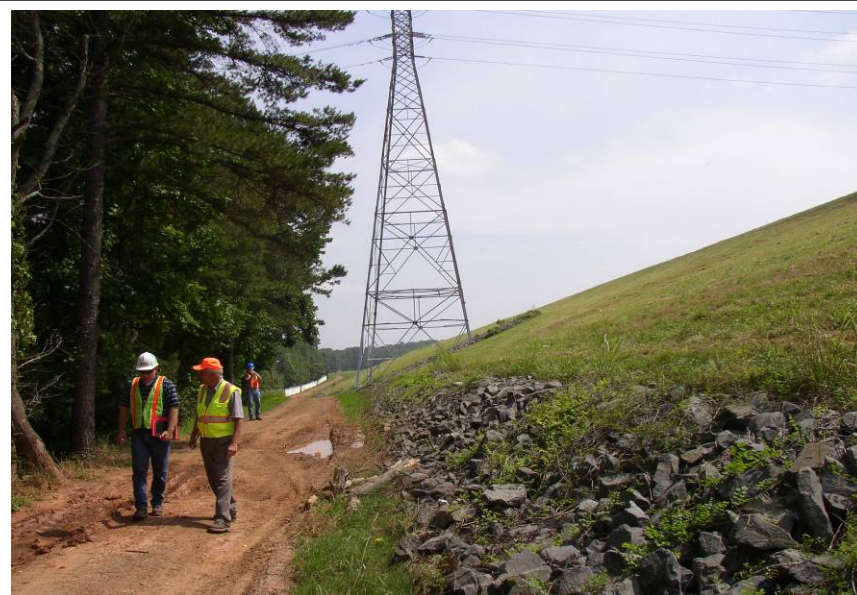
**#40 Downstream Toe Road at North End of East Dike - Erosion**

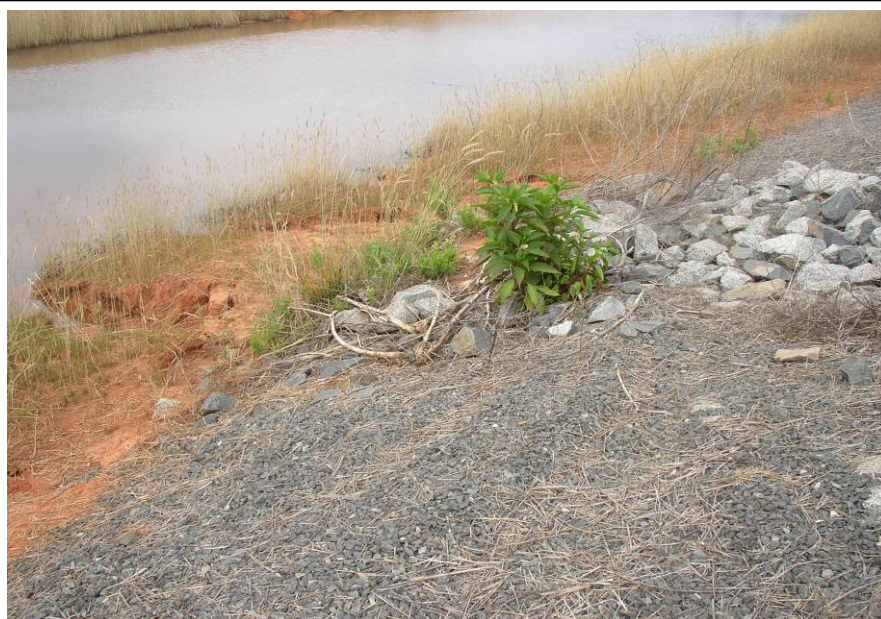
#46 Local Erosion @ Toe of Crushed Stone Drainage Material

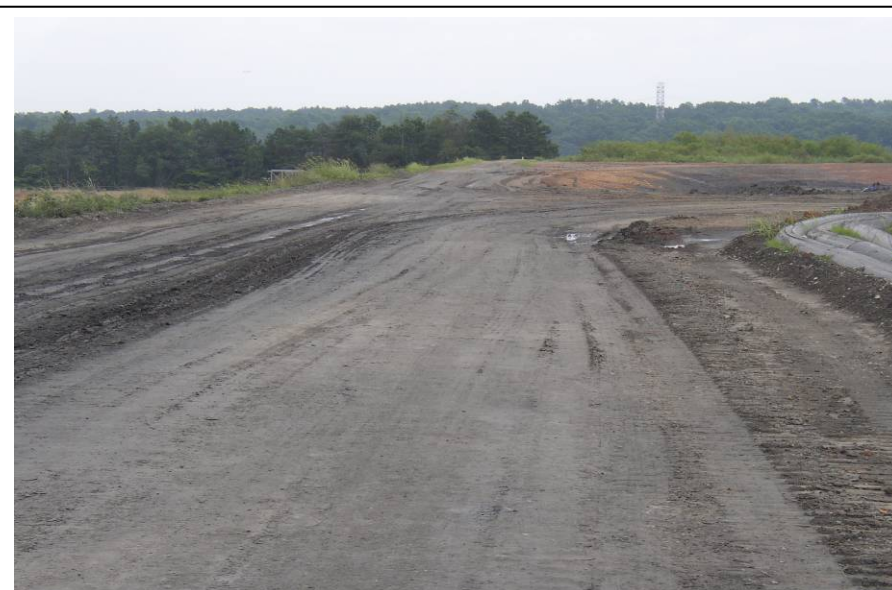
**#51 Widened Crest in Cell 3 to Create Haul Road.  
Width Increased from 15 to about 45 Feet.**

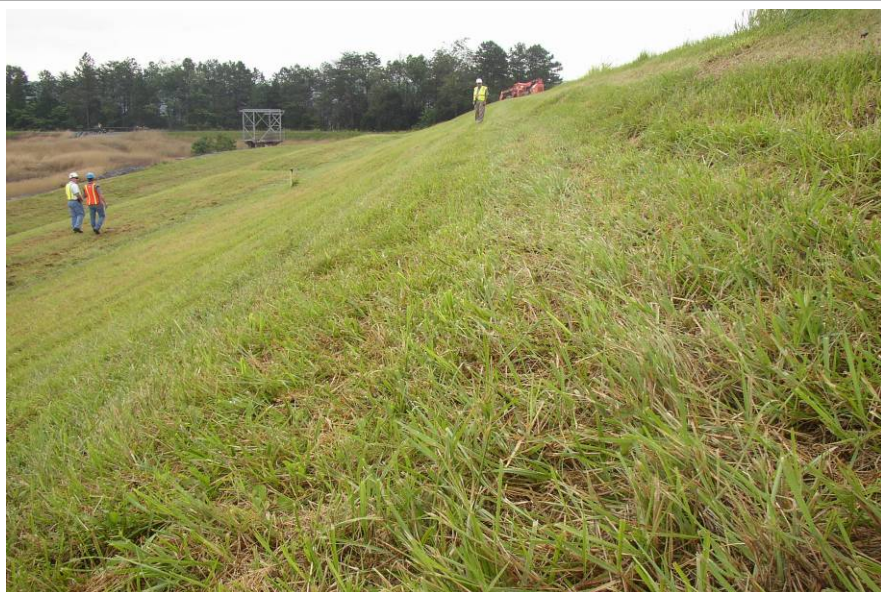
Minor scarps have historically been observed on the upper part of the downstream slope. These scarps are located several feet below the crest and are attributed to shallow slip failures within the upper layers of soil. The scarps remain on the embankment, and appear to have caused minor bulging in the lower section of the 2H:1V slope (above the stability berm). The ongoing construction activity in Cell 1 has also created ruts on the downstream slope at the western end of the North Dike.

#54 Downstream Slope of North Dike (Note Evidence of Prior Scarps)

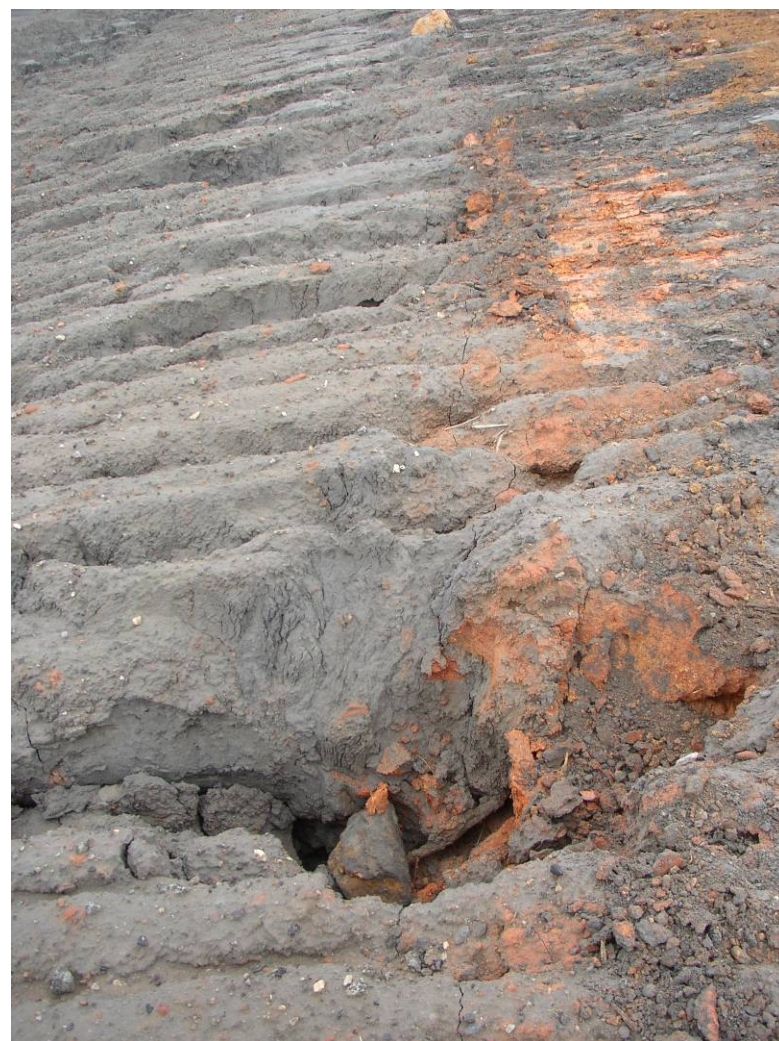
**#59 Erosion in Ashfill in Upstream Excavated Slope of Cell 3**

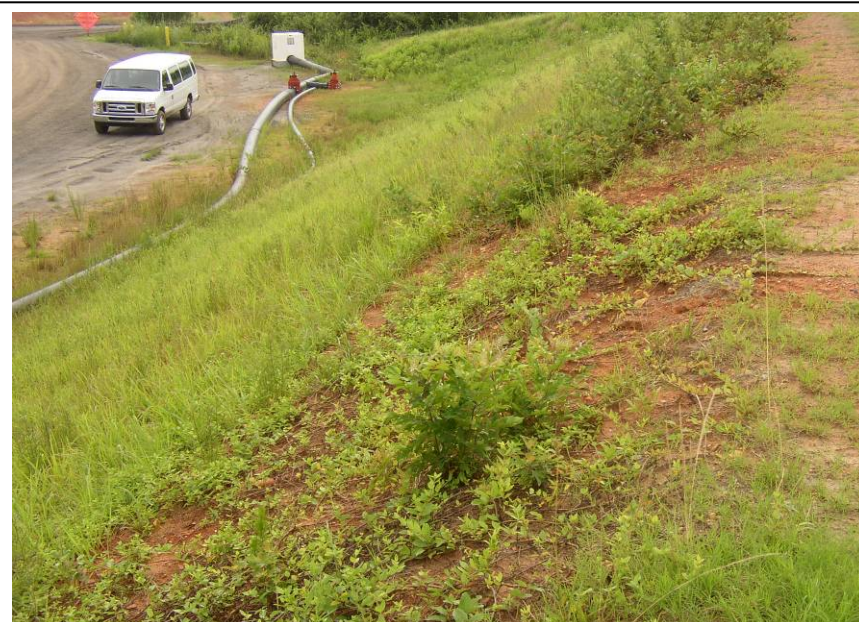
#66 Local Erosion Near Crest of North Dike

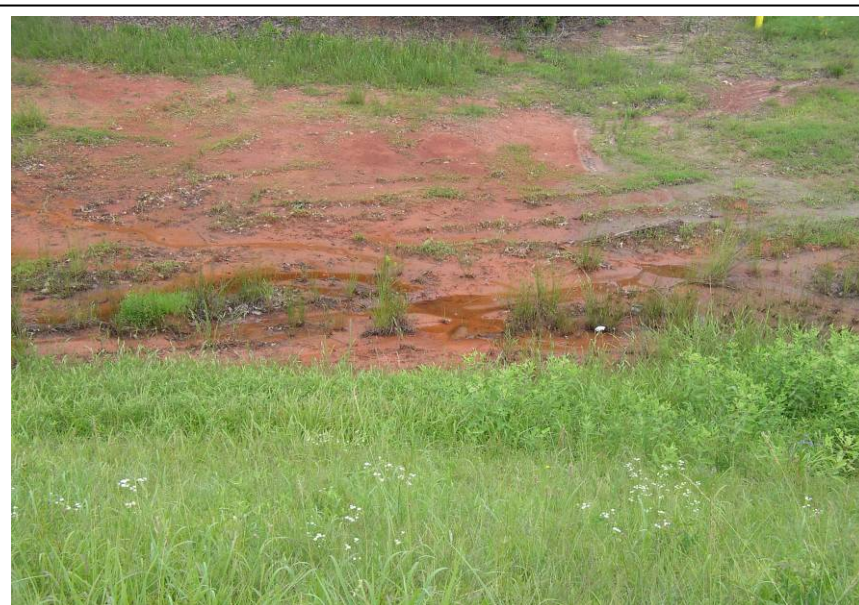
#67 Erosion at Downstream Slope of North Dike

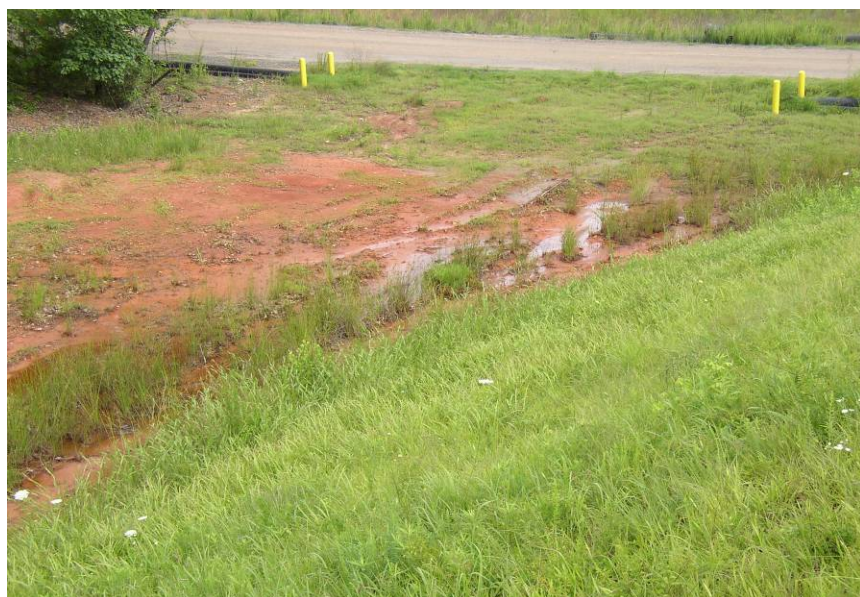
**#69 Ponded Surface Drainage & Seepage Near Transmission Tower at West End of North Dike**

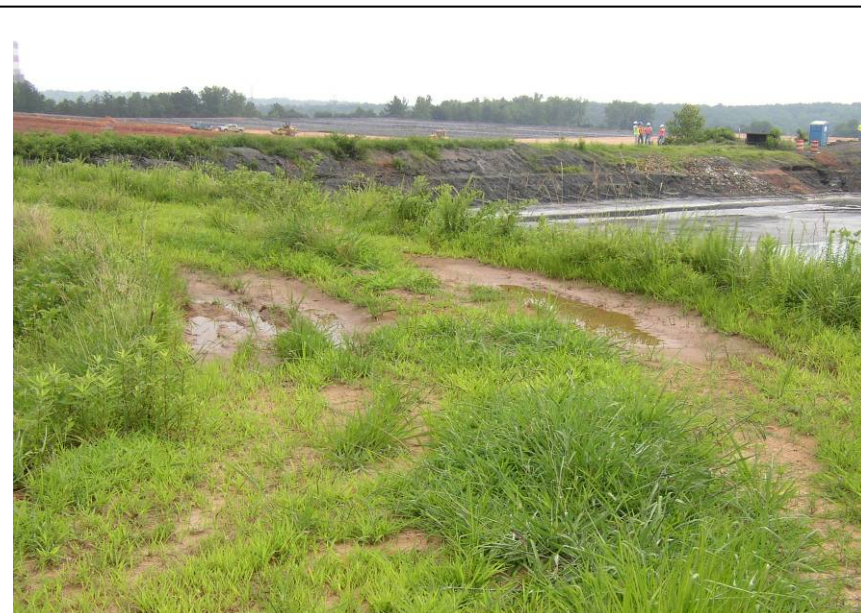
**#71 Rutting in Crest at West End of North Dike**

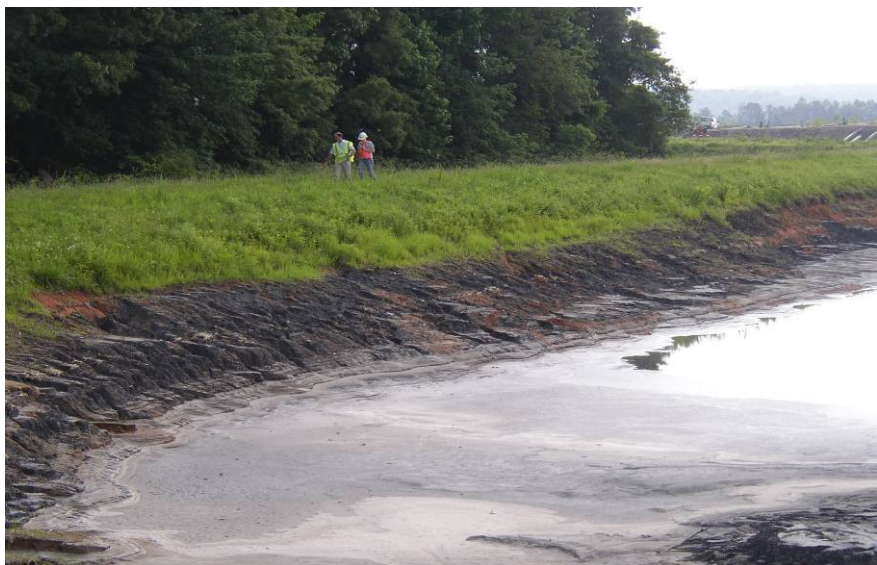
#73 Cell 1 Partially Excavated Ash on Upstream Side of Dike –  
Note Surface Erosion on Dike Slope

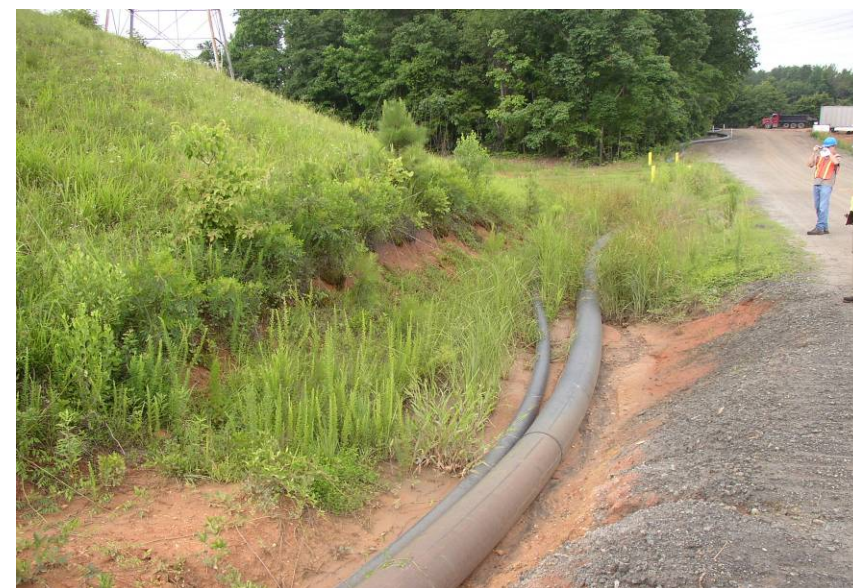
#75 Cut Into Downstream Toe of North Dike For Pipe Installation

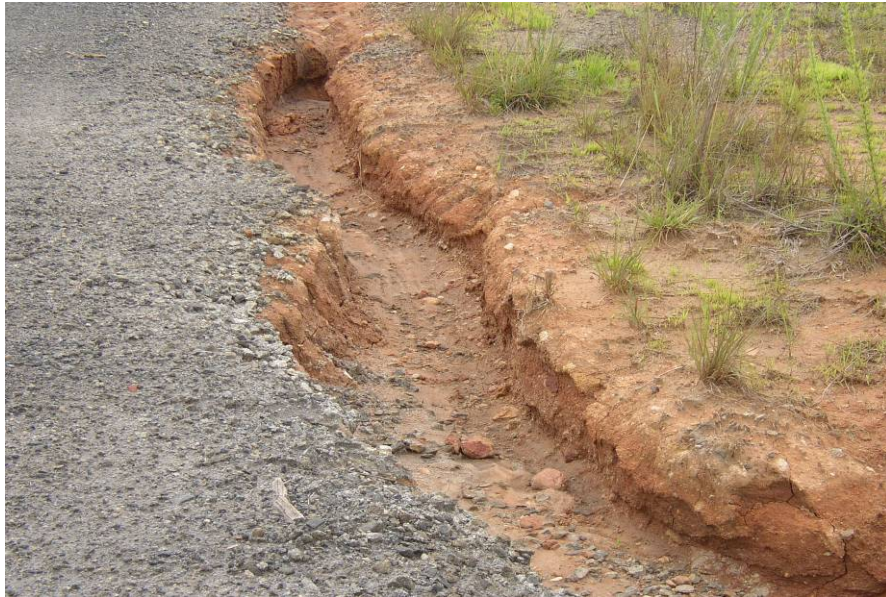
#76 Erosion Adjacent to Road Along Downstream Toe of North Dike
