Assessment of Dam Safety Coal Combustion Surface Impoundments (Task 3) Draft Report

Duke Energy

W.C. Beckjord Station
New Richmond, Ohio

December 7, 2009

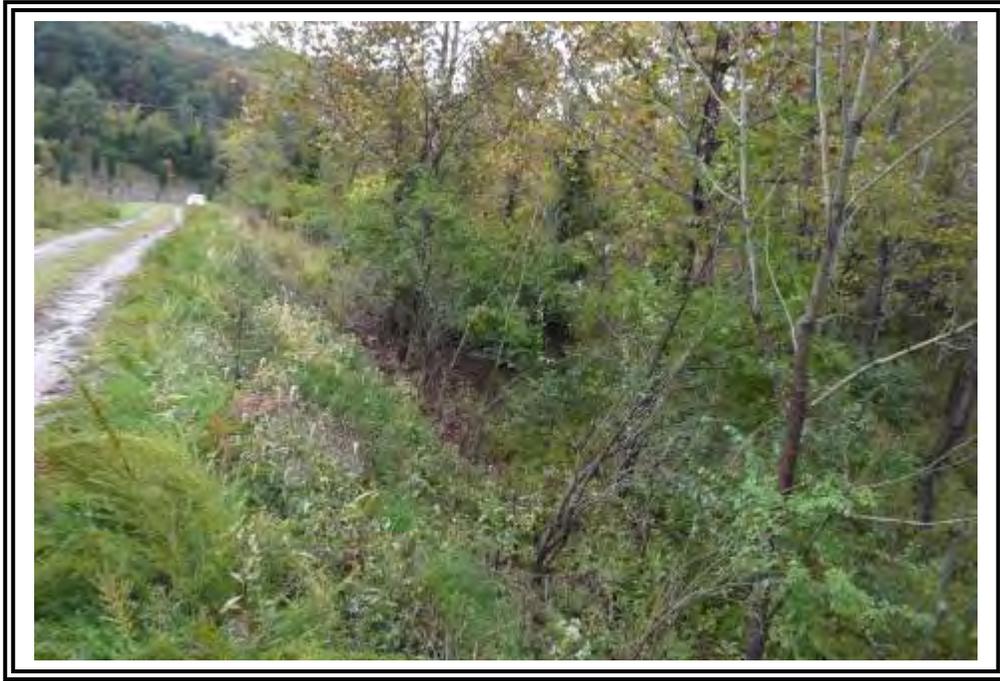
9

North dike crest and interior slope, looking east. Note trees and heavy vegetation on slope.

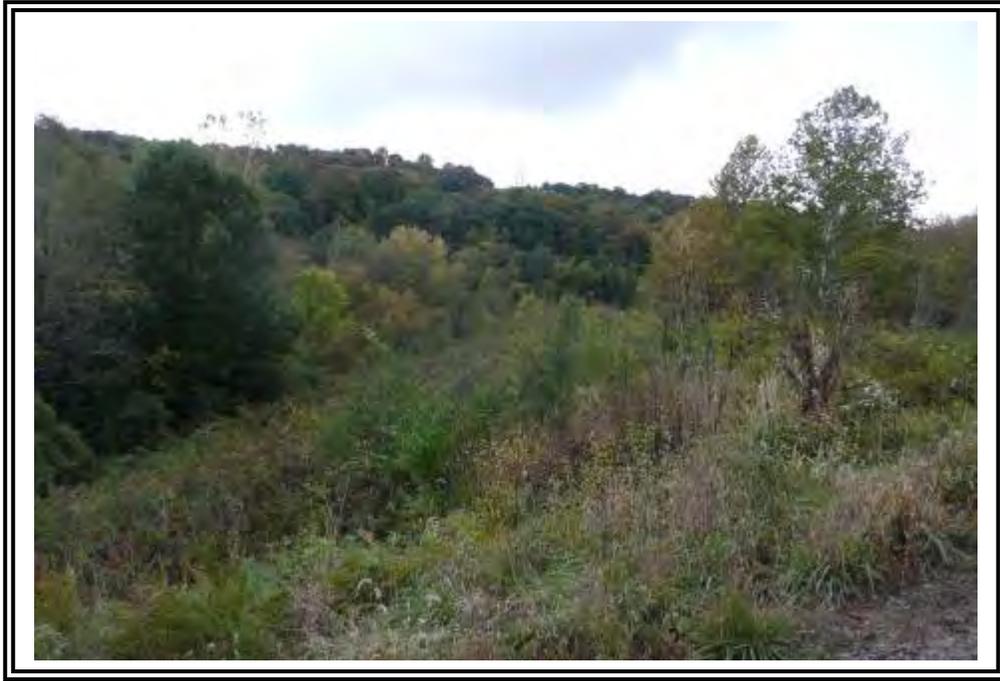
11

Exterior slope of north dike showing heavy vegetation, looking east.

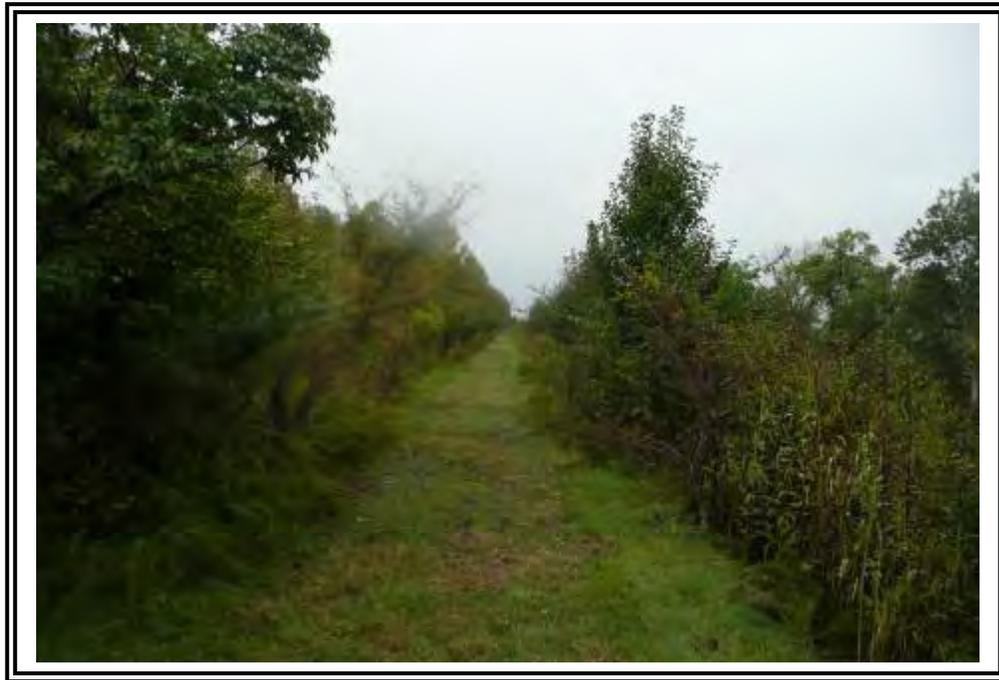
17

Vegetation obscured observations of the north (Photo 14) and west dikes. Heavy vegetation was observed on the exterior slopes along north (Photos 11 and 12), west (Photo 17) and part of south dikes, with larger trees (approximately 12 to 16 inches in diameter) at the toe of the north dike next to the creek. Similar vegetation was found on the interior slope of the north (Photos 9 and 10) and south dikes.

West dike crest, looking south. Note very heavy vegetation overgrowth and trees on interior and exterior slopes.

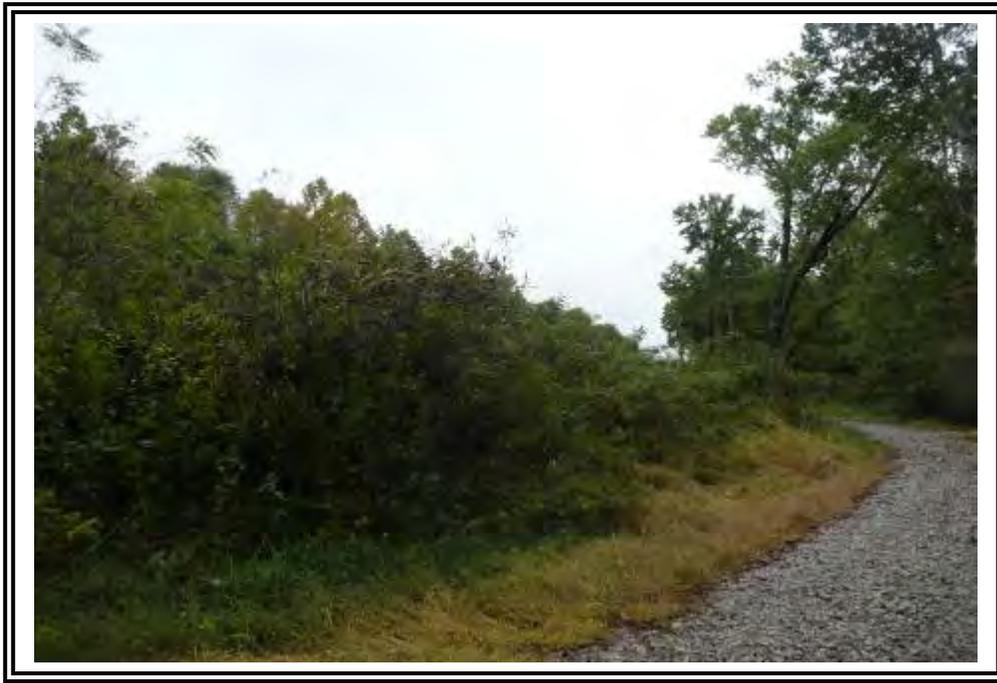
19

Very heavy vegetation and brush growth on west dike exterior slope, looking south.

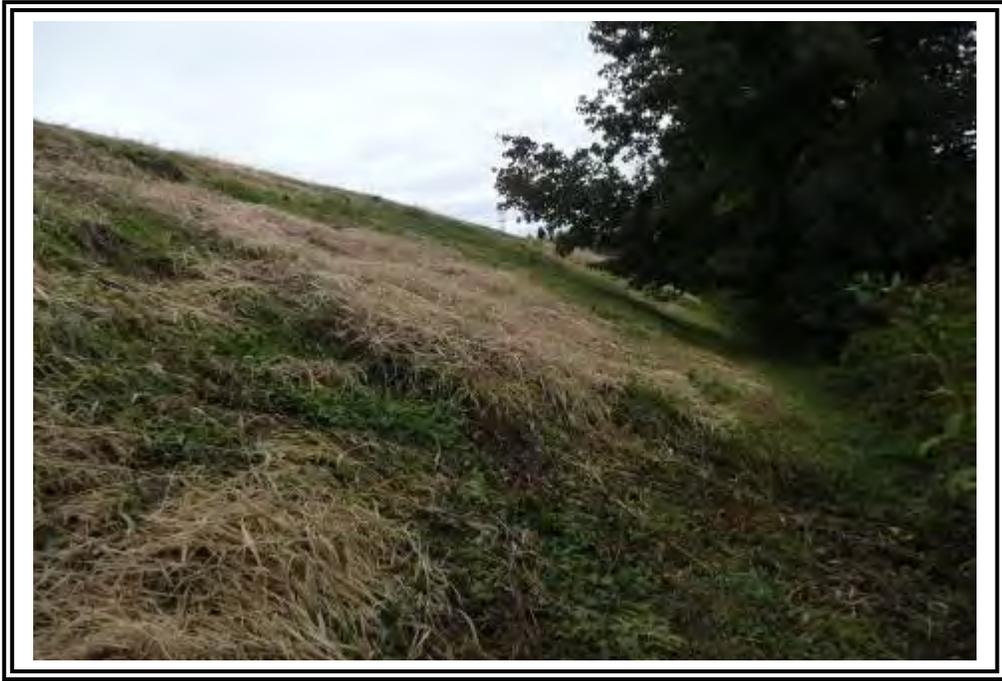
37

A bulge approximately 21 inches wide (along width of the dike) was observed at the toe of the exterior slope of the east dike at approximately one-third the length of the embankment from the north end (Photos 36 and 37). Active scarps were observed in the exterior face of the slope at multiple locations (Photos 34, 35 and 38). About mid-way along the dike an active scarp approximately 25 feet wide was observed. Occasional standing water in the heavily vegetated

Toe bulge expression from active surface scarp and slough in Photo No. 11, looking north.

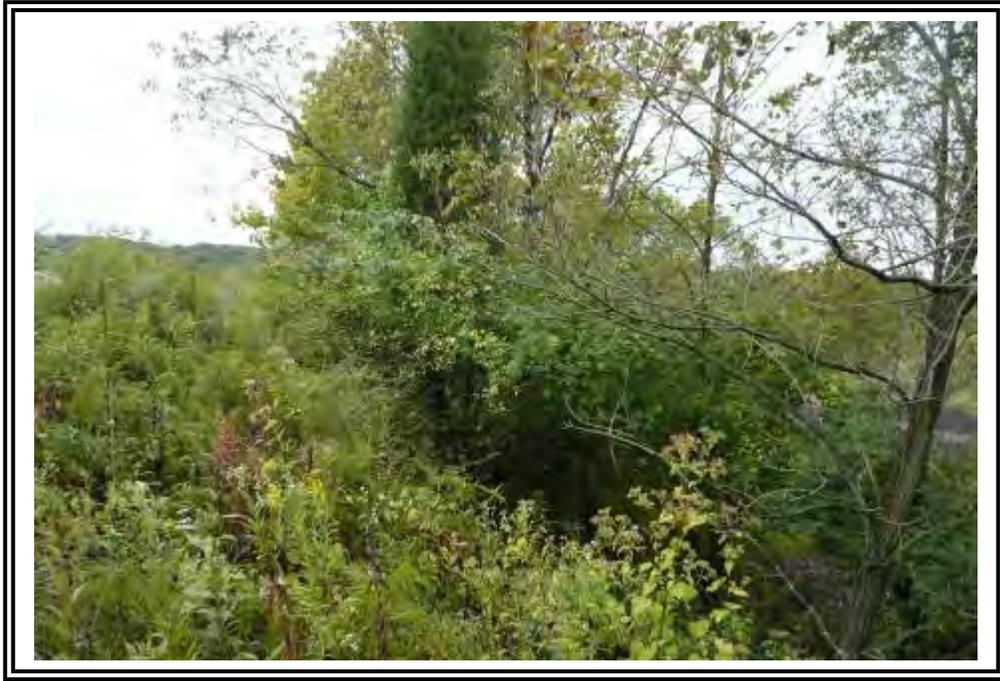
41

The crest of the north dike was measured to be approximately 21 feet wide. Trees, approximately 4 to 8 inches in diameter, and heavy vegetation (brush) was observed on the exterior face of the north dike (Photo 41).

Exterior slope of north dike, looking west. This is also the interior slope of the Ash Pond A south dike. Note heavy vegetation and small tree growth.

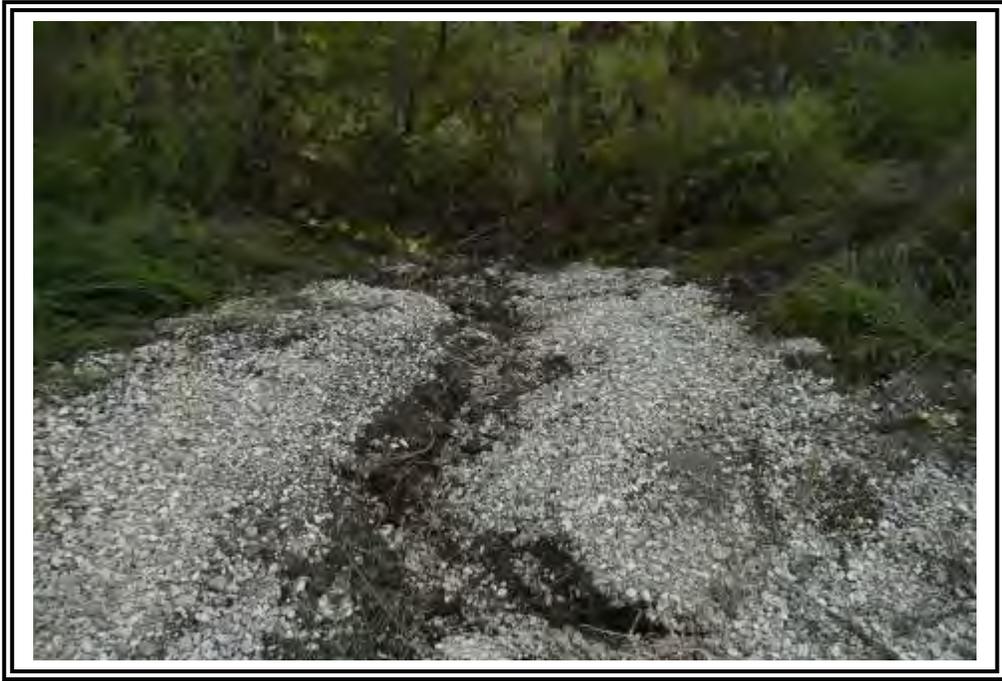
43

Erosion rill on exterior slope of north dike.

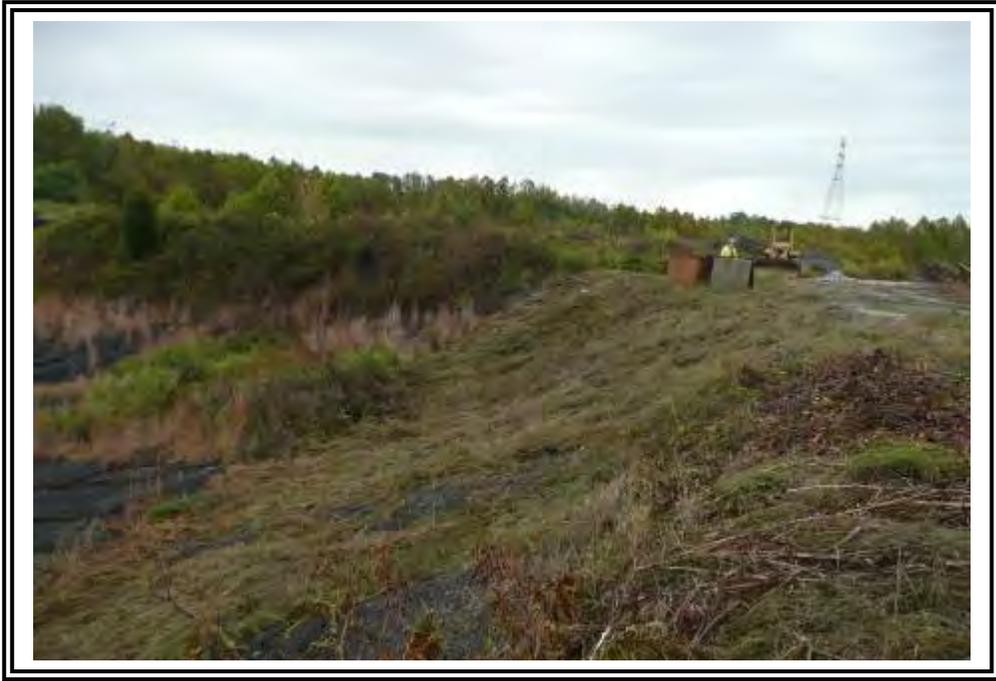
45

Exterior slope of west dike at contact with the Ash Pond A south dike, looking north.
Note exposed bottom ash and slag on slope surface where vegetation is missing.

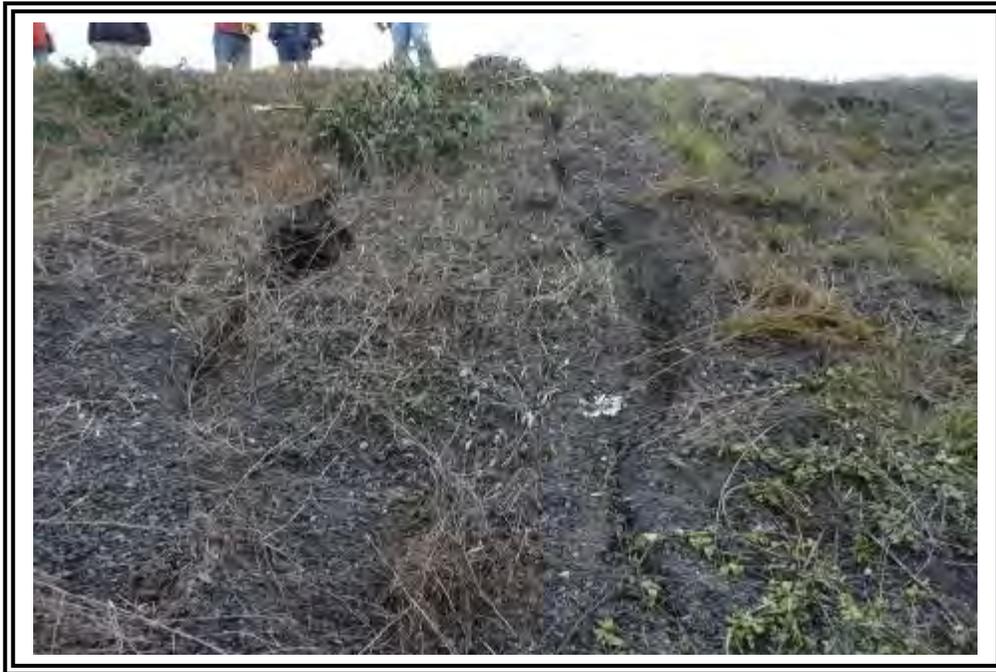
46

Erosion rills on west dike exterior slope where vegetation is sparse in bottom ash/slag surface material.

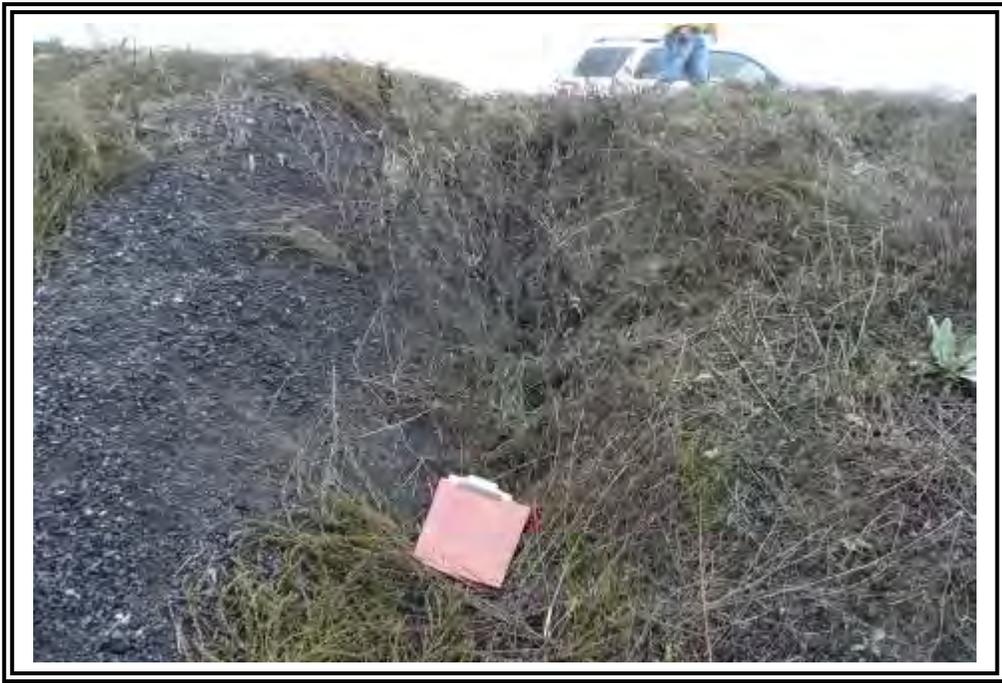
47

Deep erosion gully on west dike, exterior slope.

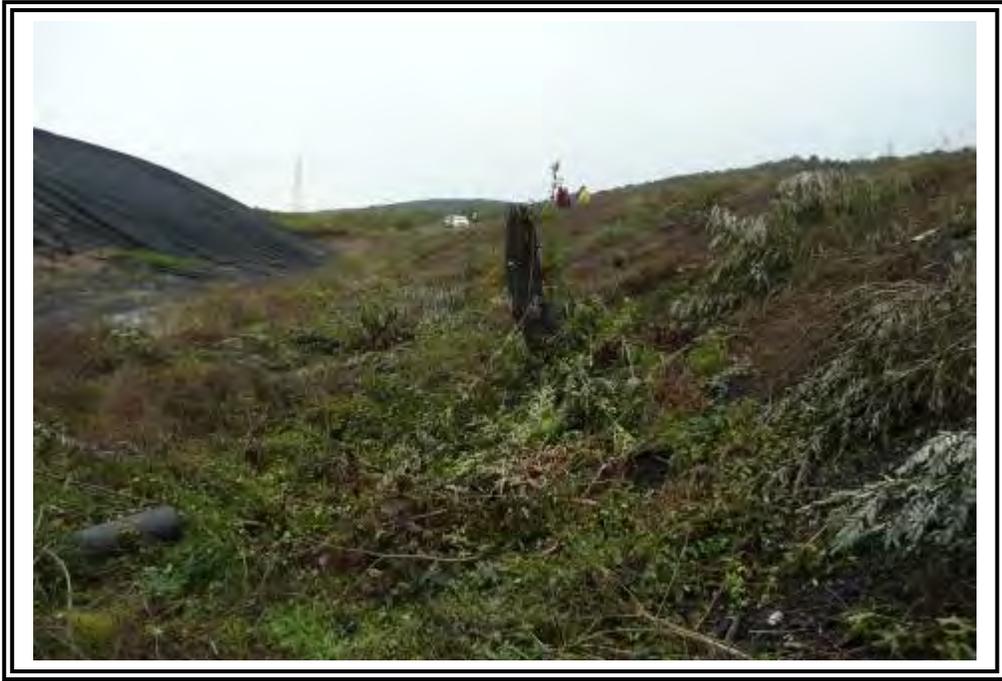
49

Exterior slope of the west dike, looking north. Note vegetation cover and dead/rotten tree trunk.

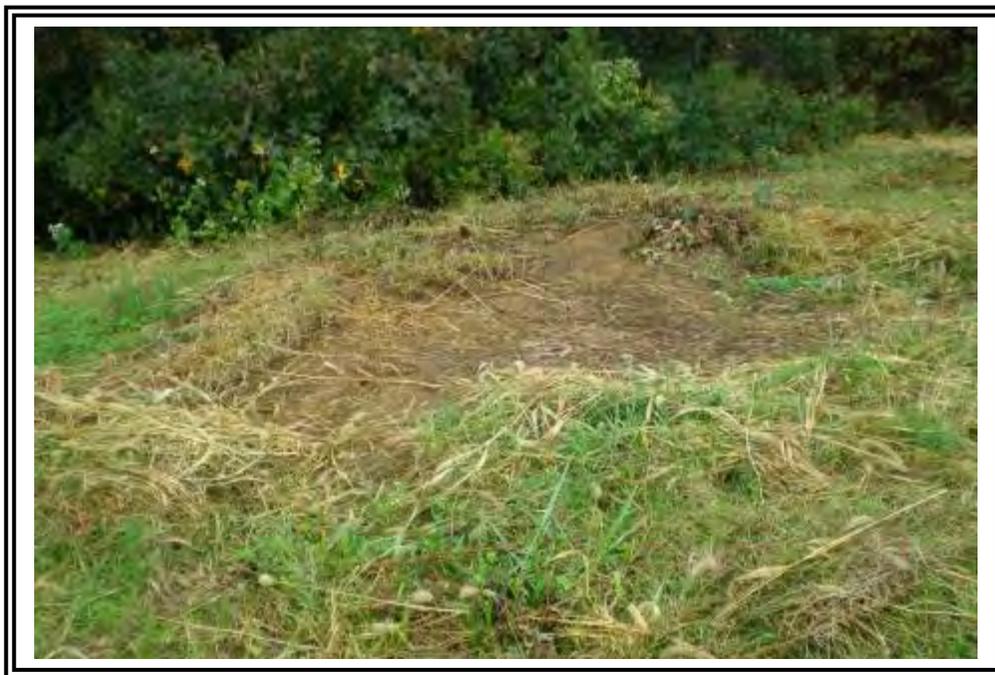
56

Looking east at downstream slope, missing ground cover and slough.

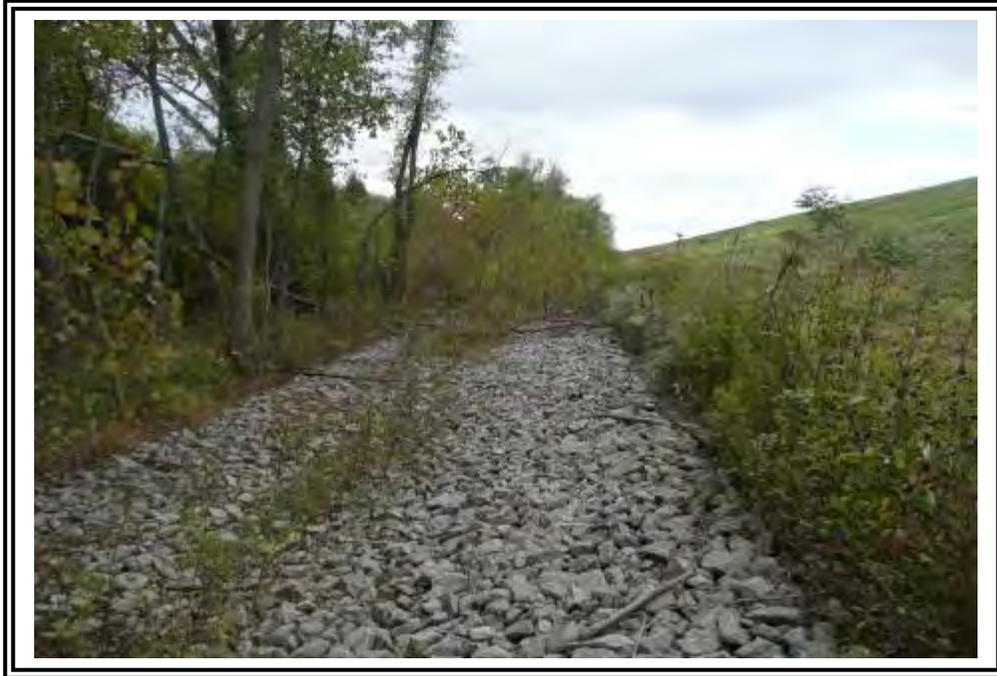
61

The east dike crest was measured to be approximately 18 feet wide. At the north end of east dike there is an area of slide repair (2003, Photo 61). The ditch line was enclosed with a culvert pipe to extend the slope toe and flatten the slope. The slide area was reportedly actively seeping before repair work was performed. A rock lined ditch was also placed in this area and was observed during the site visit (Photo 60). To the north of this area there was a previous slide and repair work made in 1991. To the north of these two repaired areas reinforced slope repair work was conducted in 2002.

Vegetated rock toe drain/ditch placed as part of 2003 slide repair.

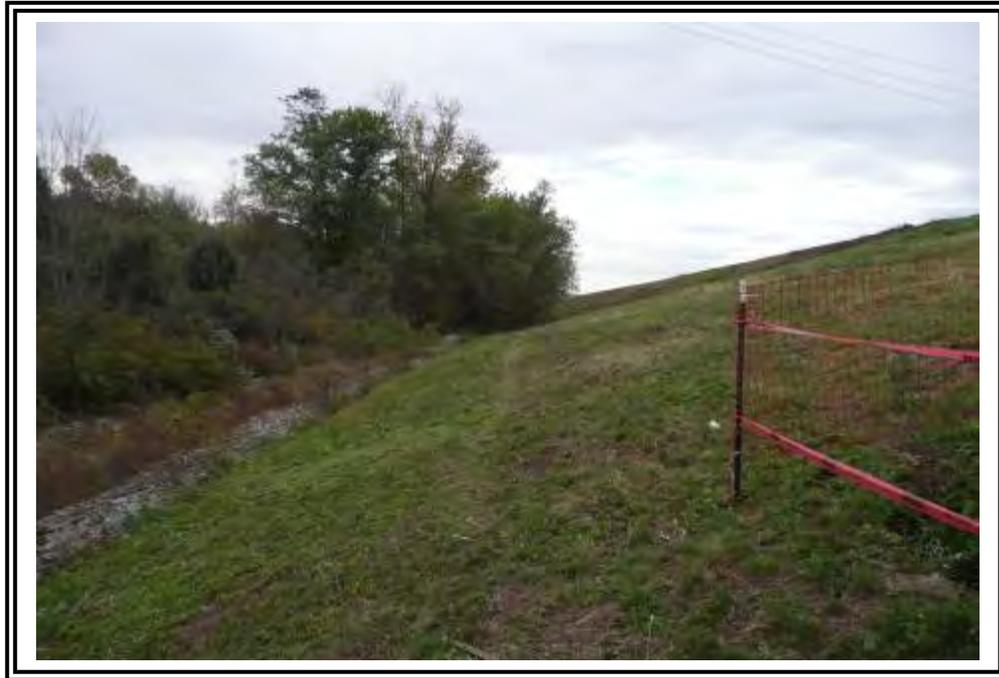
63

Slope repair area on east dike showing rock toe drain and location of sinkhole (right). Southern extent of repair in background where trees are prevalent.

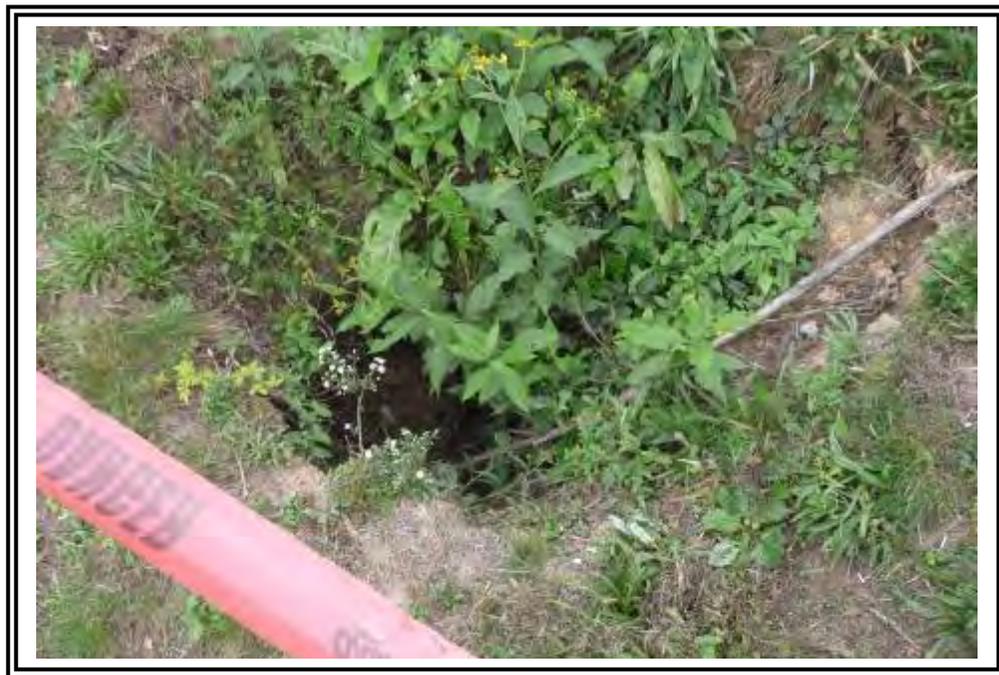
64

About mid-way along the east dike a sink hole, approximately 3 feet deep by 5 feet wide by 5 feet long was observed on the exterior slope (Photo 64). In this location, slope repair work was conducted and the toe of the slope was extended approximately 51 feet beyond the original toe (Photo 62). At the toe of the slope the ditch line water flow which includes effluent from Ash Pond B (Photo 65). The ditch line is located approximately 8 to 9 feet from the toe of the slope. On the interior and exterior slopes of the east dike superficial, grassed-over sloughs were observed. At the mid-point of the exterior slope a possible animal burrow was noted and in the same location an old slide area was observed which measured approximately 20 feet wide (Photo 68). Slightly south of the mid-point of the dike an active area of slough was observed and was measured to be approximately 22 to 23 feet wide. An 8-inch wide animal burrow was noted on the exterior slope just south of the active slough area. Another area of active slough was observed to the south of the animal burrow. The area is approximately 22 feet wide. South of this active area of slough an area of old sloughing was noted which is heavily vegetated and approximately 60 to 70 feet long (Photo 71). Erosion rill and/or animal burrow, approximately 4 feet deep and 2 feet wide, was observed behind the headwall in the slope (Photo 74). South of the headwall, slope repair was performed and continuing south. The repair work included adding a bench and rock at the toe. The bottom 20 to 30 feet of the slope and toe are armored with rock

Close-up of sinkhole in 2003 slide repair area. Appears to be above pipe for seepage collection system.

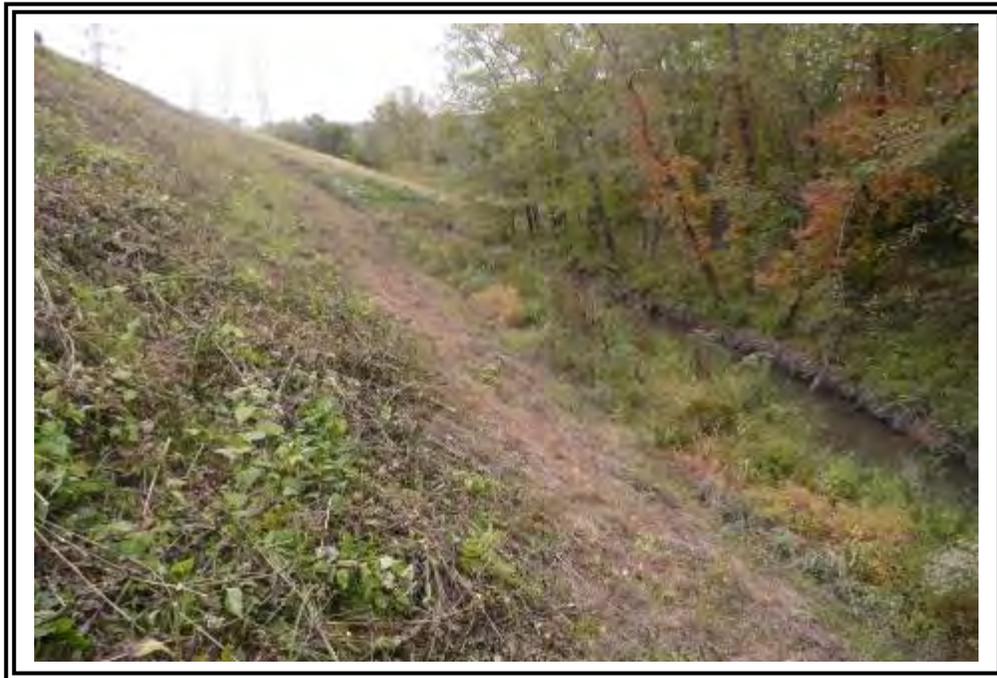
66

East dike, exterior slope, looking north at end of slide repair area. Note steeper slope beyond repair area.

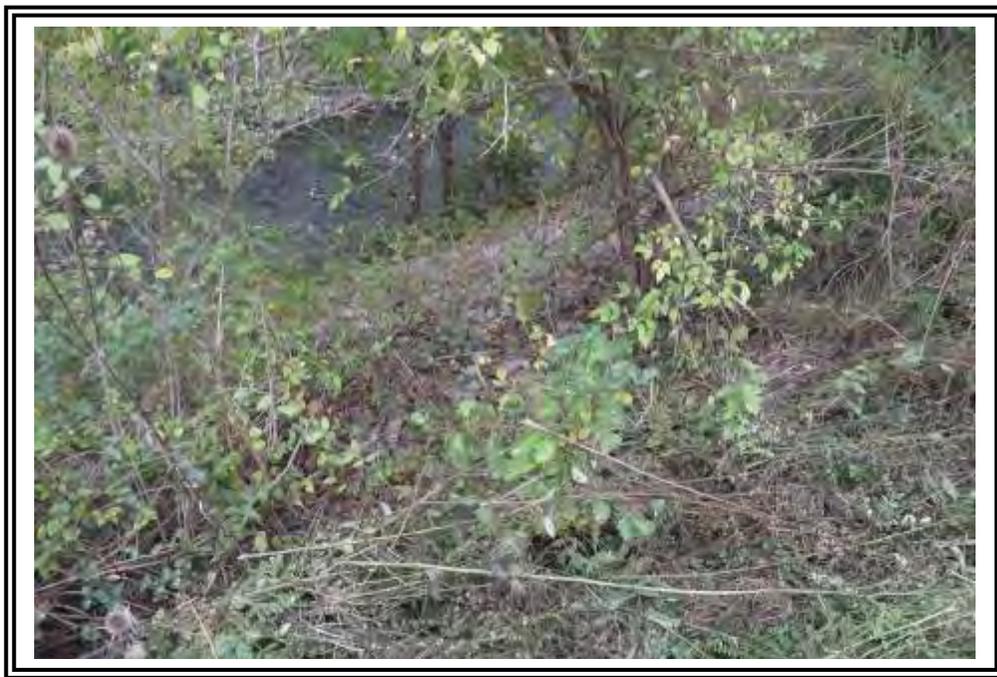
78

Rock slope protection installed as a part of the 1991-1992 slope repair work. Note saplings and brush.

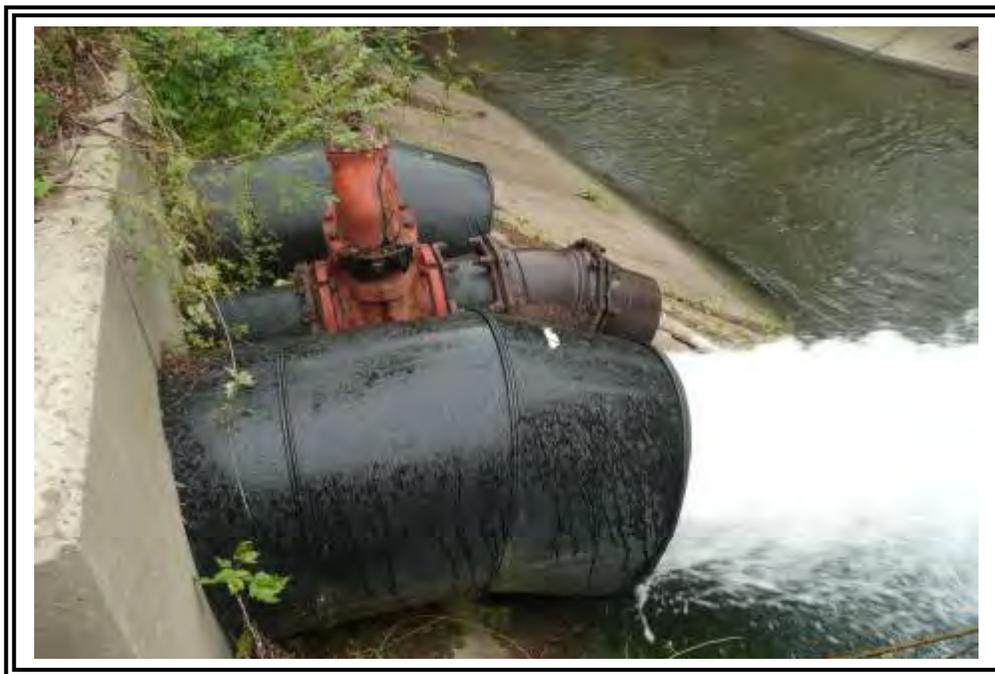
82

The Ash Pond C outlet consists of a 24-inch diameter smooth-walled HPDE slant pipe. There is a 12-inch diameter ductile iron siphon. The valve for the siphon is cracked. There is also a 24-inch diameter smooth-walled HDPE pipe. (Photo 82)

Ash Pond C outlet (near), siphon pipe (middle, note cracked valve), and high water over flow outlet (far).

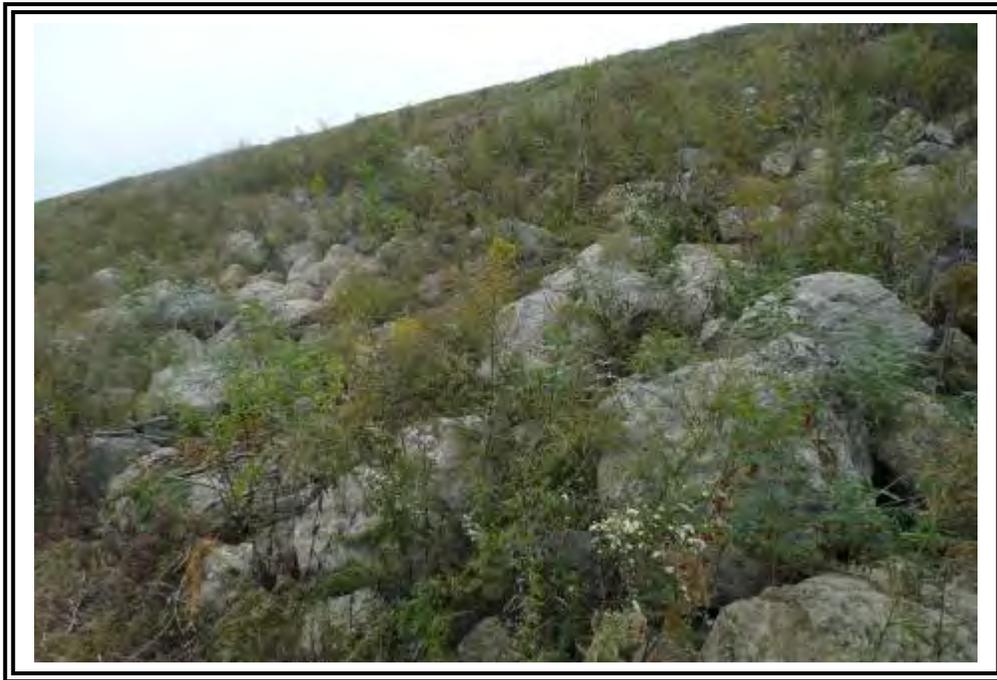
89

On the west exterior slope slightly north of the south end of the dike, repair work was performed with large rip rap (approximately 3 to 4 feet in diameter) being placed (Photo 89). North of this repaired area a vegetated area of slough approximately 42 feet wide was observed. The vegetation on the west dike exterior slope changes from brushy/broad-leaf vegetation to weeds/grass at about the mid-point of the dike. North of the change in vegetation is an area where reinforced slope repair work was performed in 2002. North of the repaired area an area of slope repair/disturbance was observed during the site visit. The erosion control matting was observed to be shredded (Photo 94). At the north end of the west dike the stockpile areas at the toe of the exterior slope have allowed surface water (runoff) to pool (Photo 98).

Close-up of rip-rap buttress slope repair. Note vegetation in rip-rap.

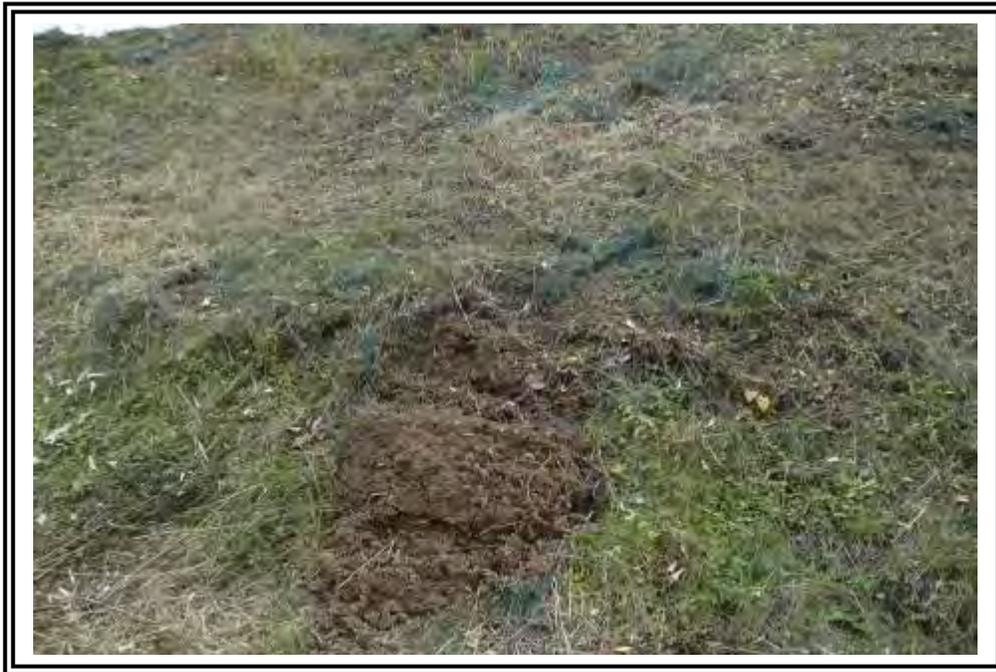
94

Area of exposed and disturbed erosion matting adjacent to 2002 slope repair area.

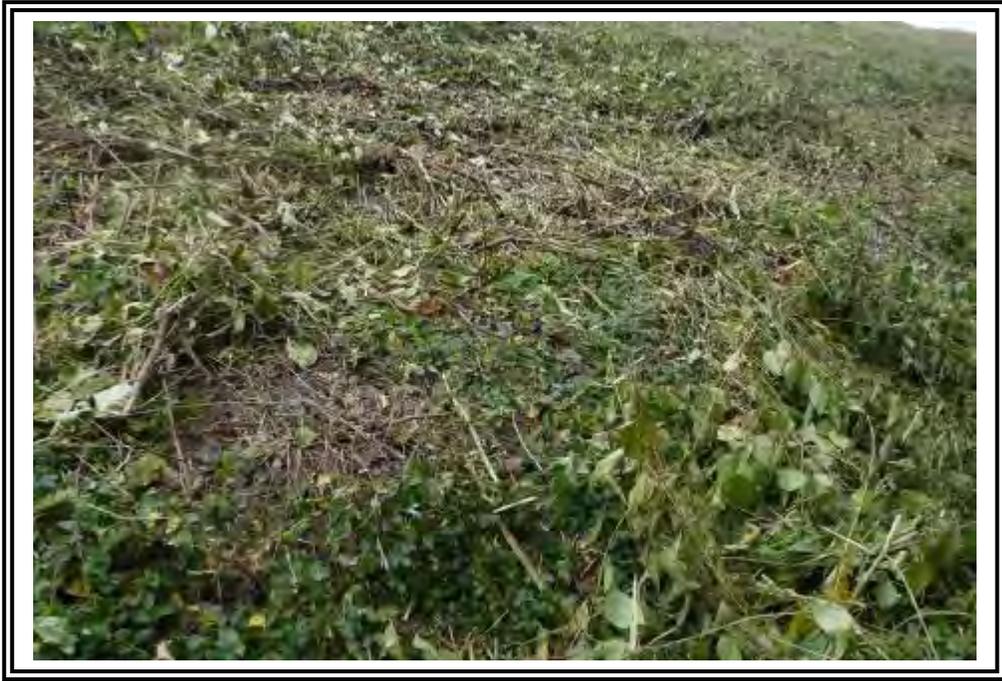
95

Rock toe drain of 2002 repair area of west dike. Barely visible due to vegetation in toe drain.

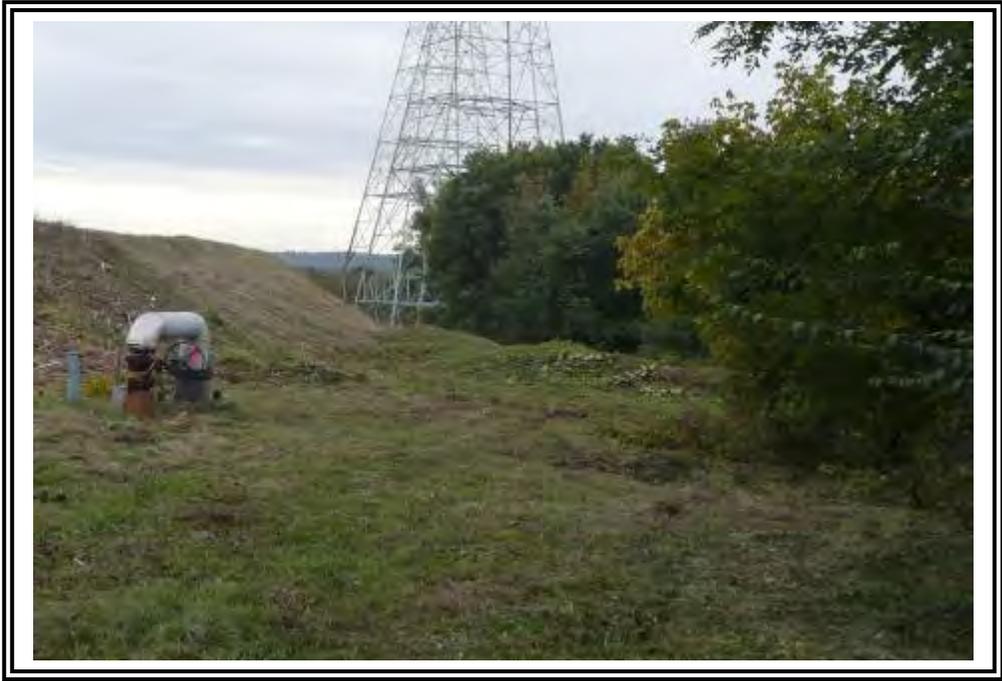
99

West dike outboard slope showing spoil piles that restrict drainage at the slope toe, looking south.

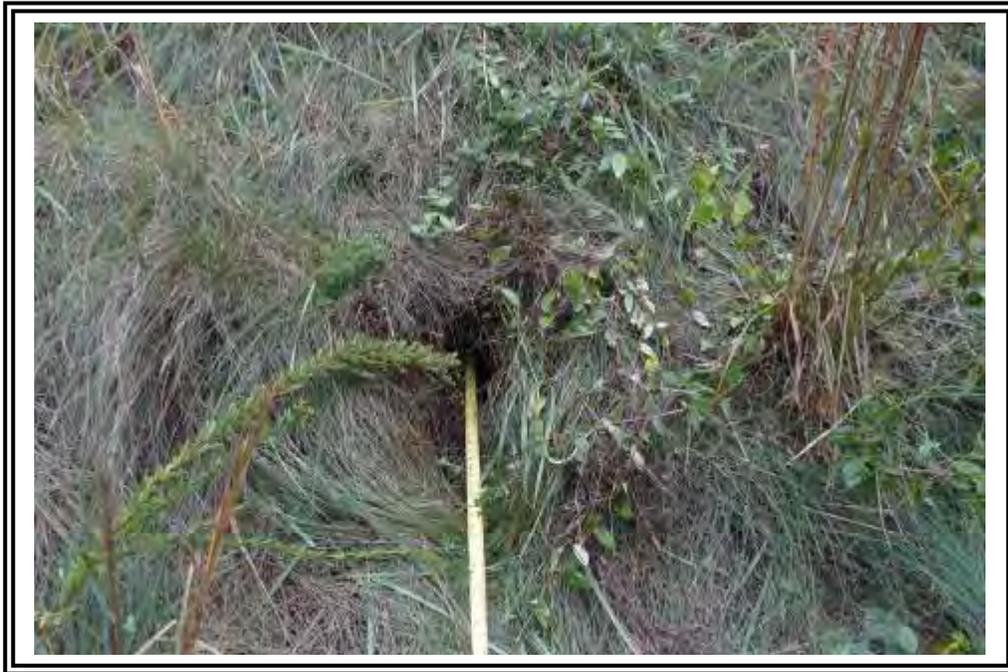
135

The east dike crest was measured to be approximately 14 feet wide. At the north end of the east dike 2 to 6-inch diameter rip rap was observed at the toe of the exterior slope. Standing water was noted at the base of the slope beyond the toe drain in the woody and weedy vegetation. The drain was observed to be moderately to heavily vegetated up to where the old road pavement begins (Photo 130). Near the mid-point of the east dike two slightly grassed-over superficial sloughs/slumps were observed on the exterior slope of the dike. At approximately two-thirds the length of the dike from the north end a grassed-over erosion rill was noted. South of the erosion rill an area of slope disturbance and/or grassed-over sloughing was observed. Holes/depressions up to 4 feet wide and 1 to 2 feet deep were noted along approximately 240 feet of the exterior slope of the dike as measured from the south corner (Photos 134 and 135).

Example of the holes and depressions noted in this area of the east dike.

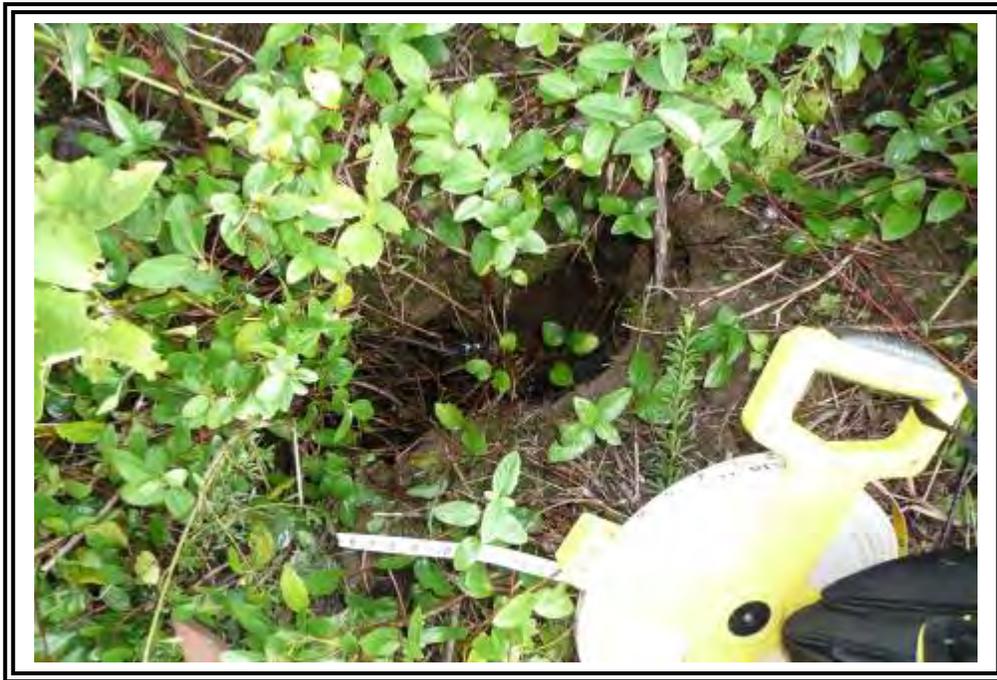
150

Vertical crack/sinkhole holding water approximately 24" long, 10" wide, and 12" deep on west dike, exterior slope.

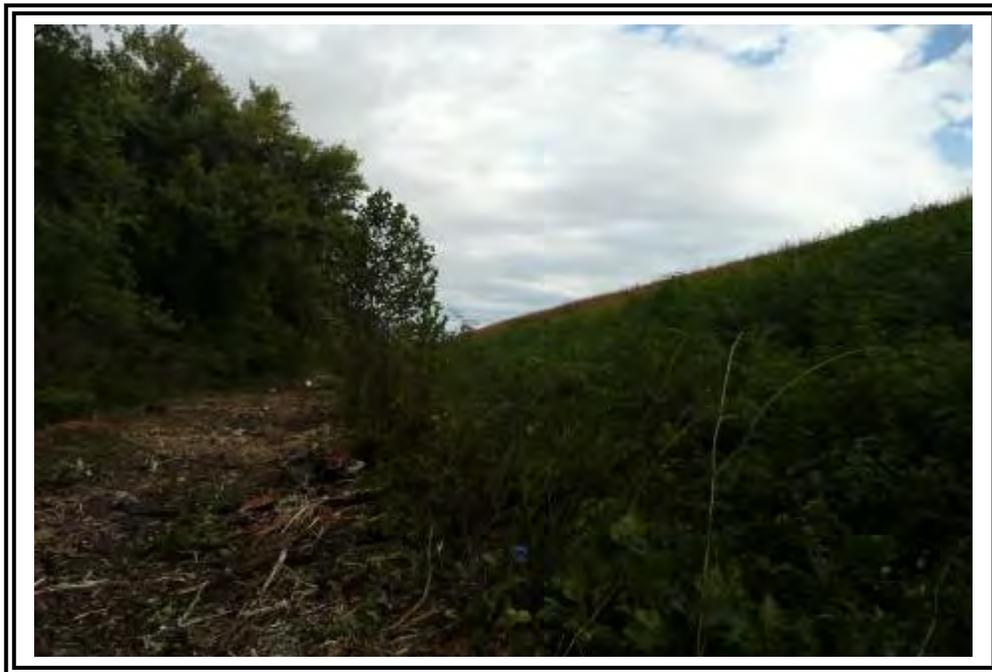
151

Toe of west dike where clearing activities have partially exposed rock toe drain, facing north.

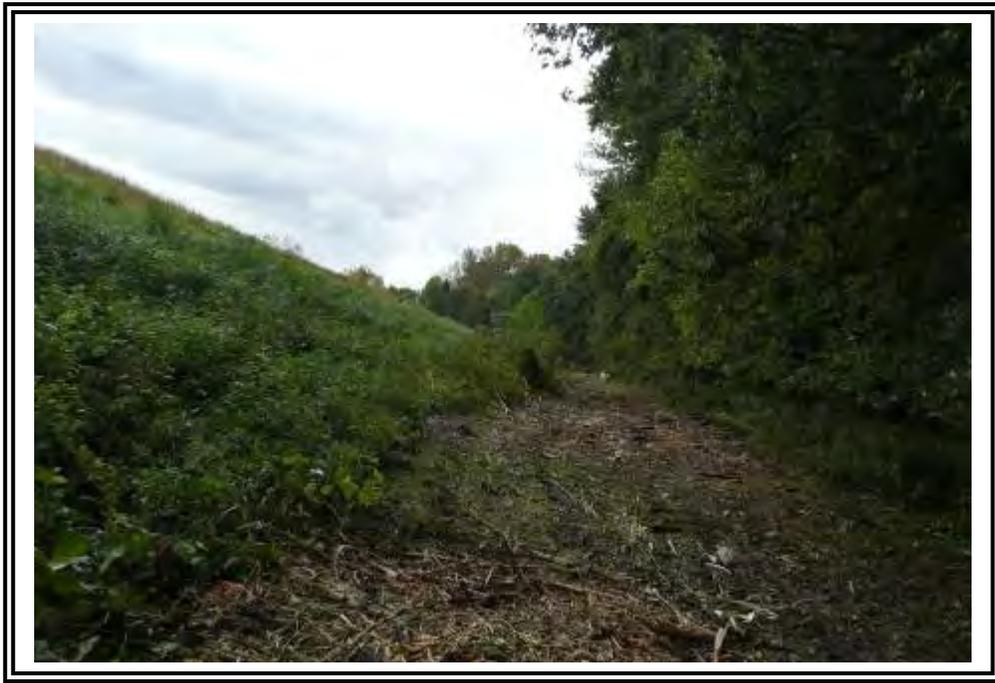
152

Exterior toe of the west dike, looking south showing effect of recent clearing activities.
