Assessment of Dam Safety Coal Combustion Surface Impoundments (Task 3) Draft Report

Duke Energy Corporation

Belews Creek
Steam Station

Walnut Cove, North Carolina

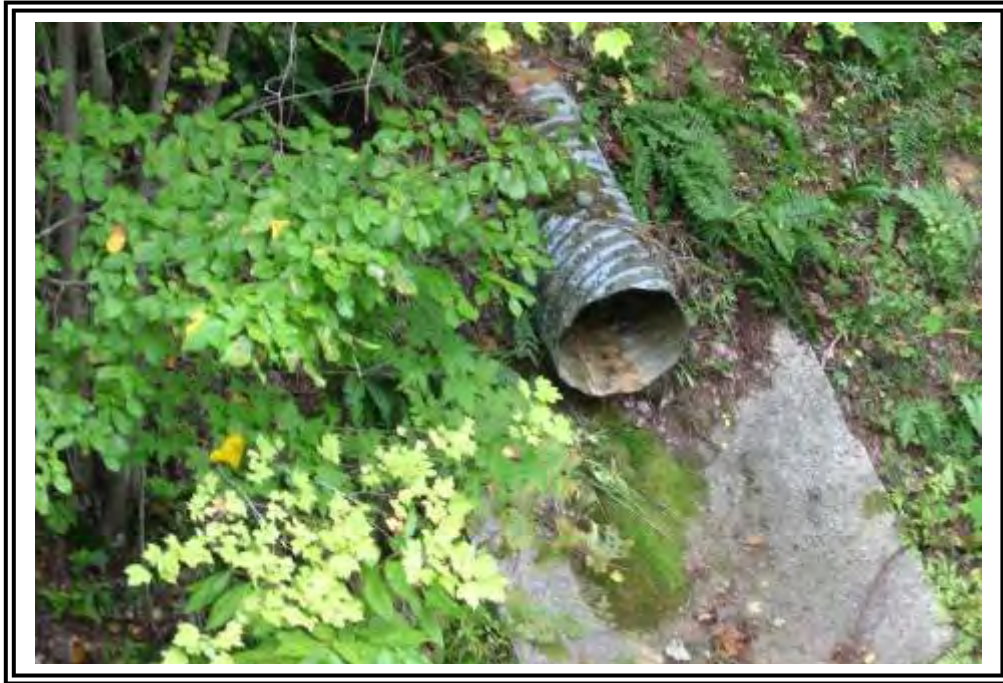
1

Abandoned outfall pipe.

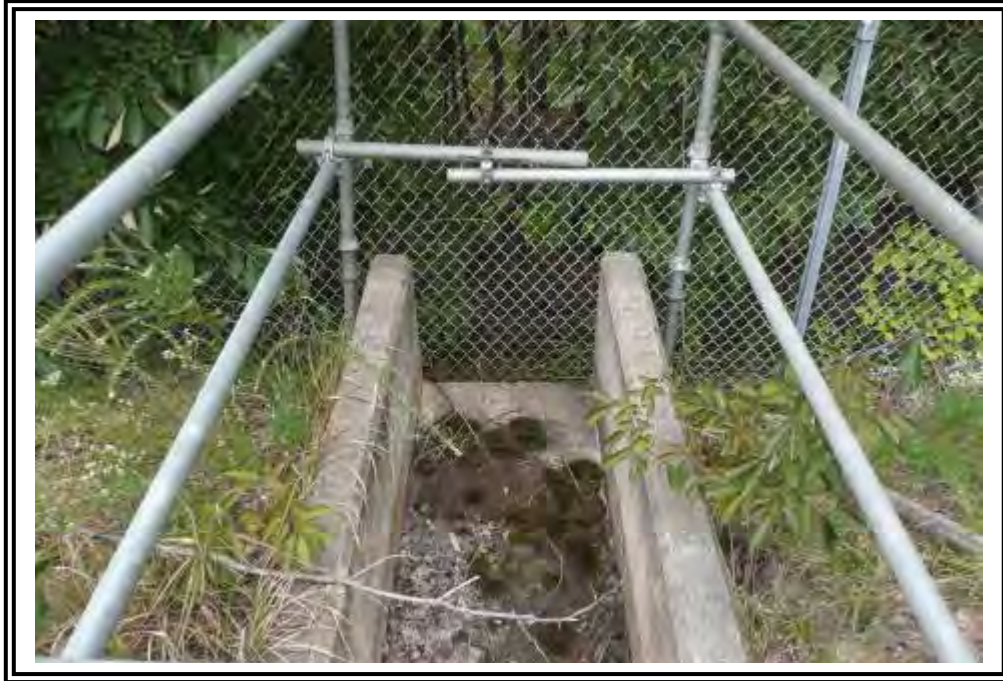
5

The chemical pipe inlet is on the east side of the impoundment. A rip rap inlet and outlet is present (Photo 36). The concrete overflow structure was observed to be in good condition (Photo 5) however was silted in.

Chemical washdown pond overflow structure.

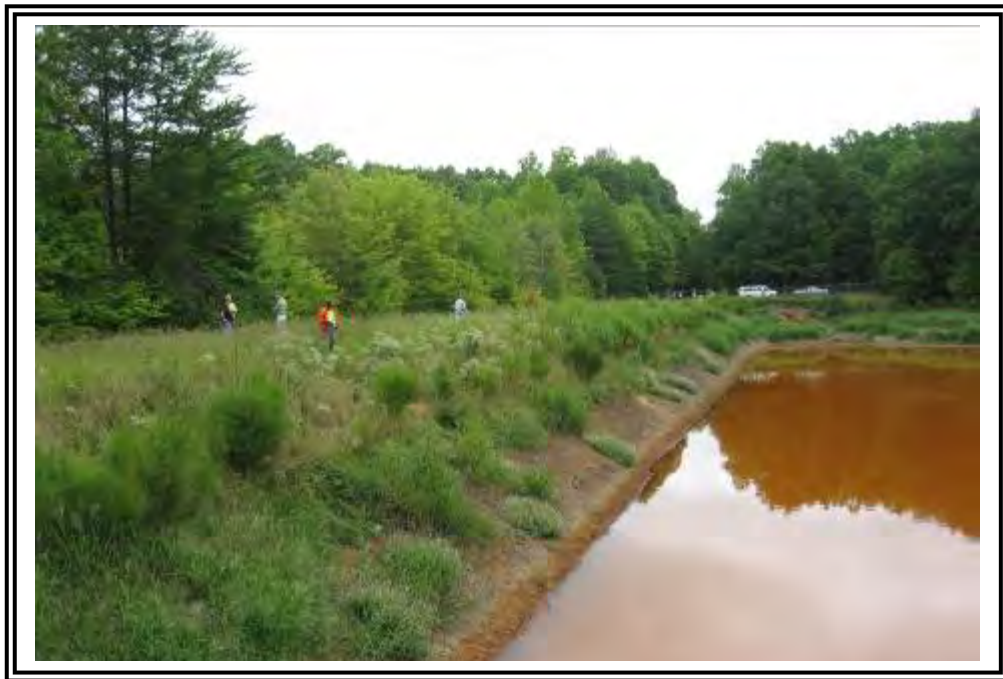
was observed at the time of the site visit. Photo 6 shows the dam crest and general alignment. The upstream slope of the dike was estimated to be between 1.5 and 2 horizontal to 1 vertical with a thick stand of high grass and weeds. Some erosion and localized sloughing was noted. The downstream slope can be viewed through the fence in Photo 7 and is heavily wooded with trees up to 12 inches in diameter.

Upstream face of chemical washdown pond.

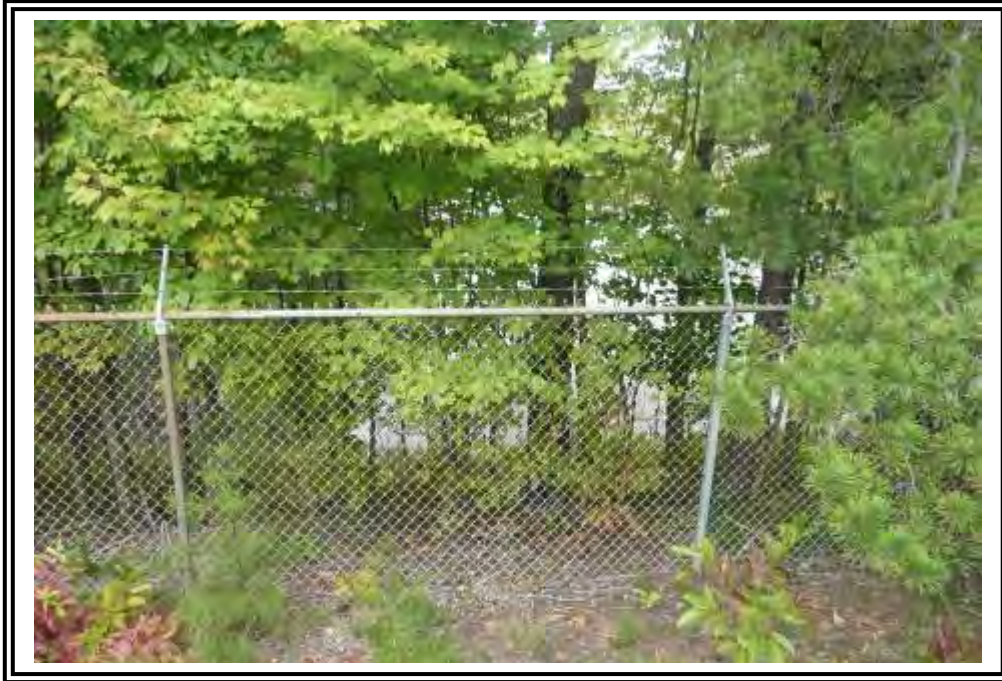
7

Downstream face of chemical washdown pond.

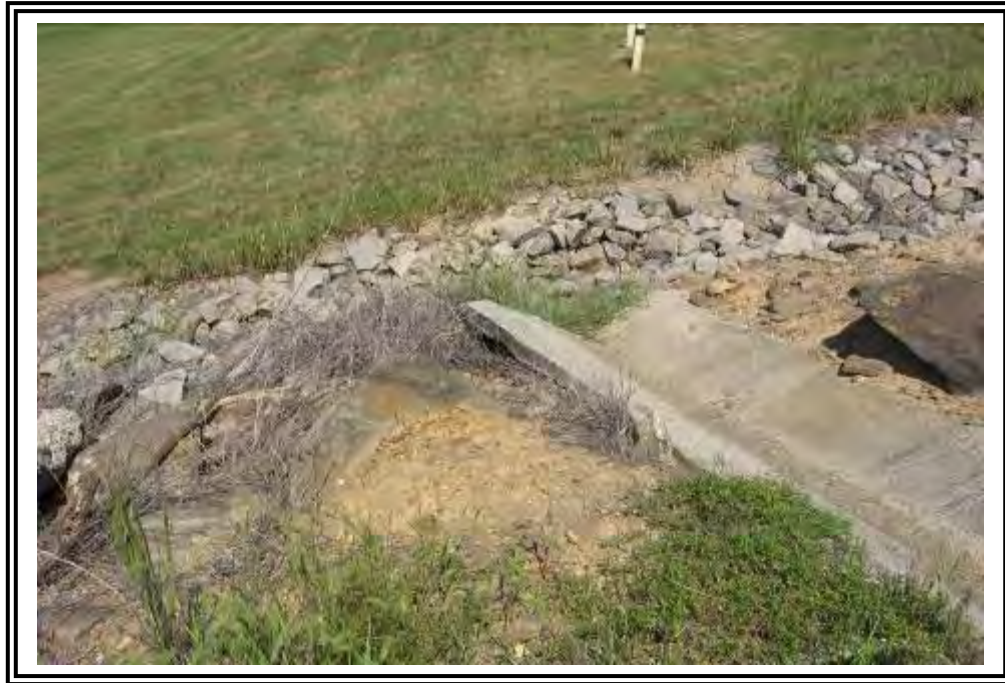
these features and drain towards the groins along the east and west abutments. Water was noted to be flowing in the right (east) and left (west) abutments. Concrete drainage chutes at the intersection with the groins are noted to be moderately undermined at several locations (Photos 17 and 19).

Drainage structure at east groin, undermined of chute.

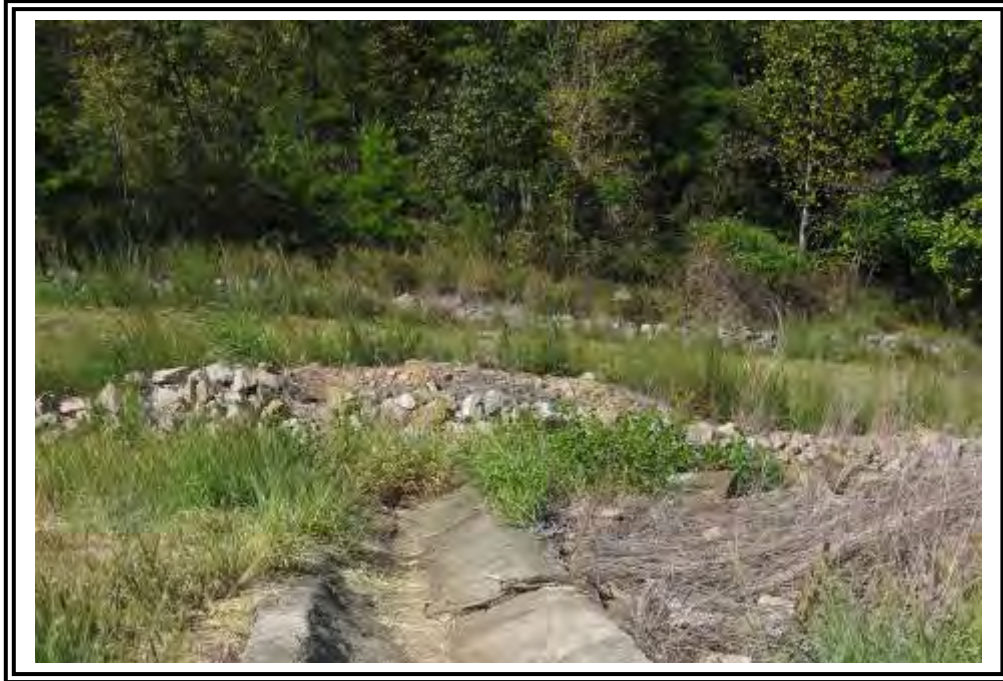
19

Precast drainage structures west (left) groin.

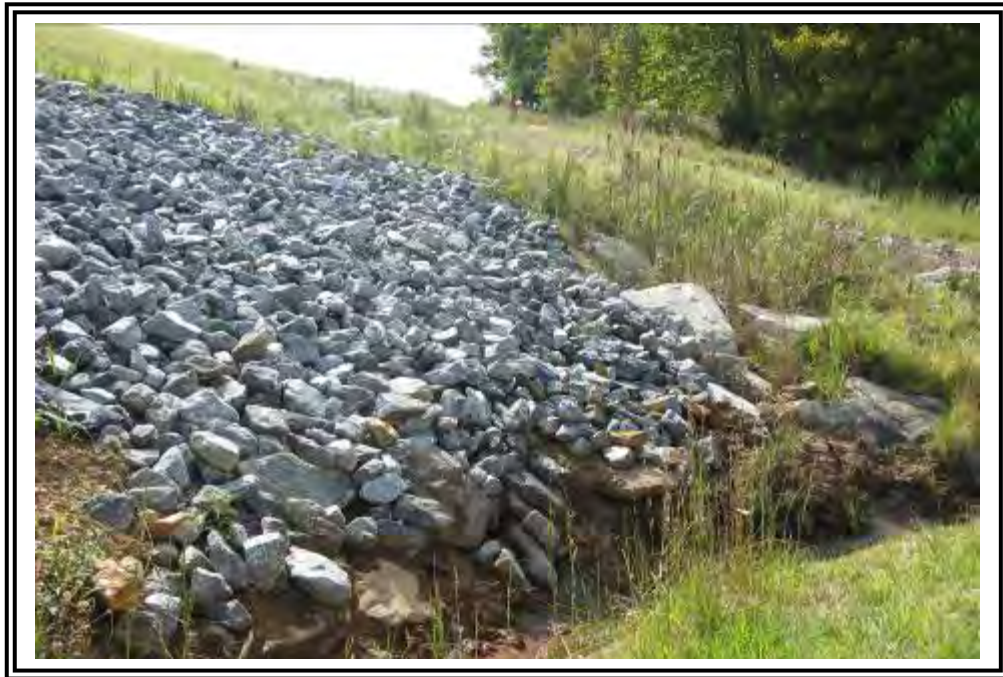
- Wet surface soils on the downstream face have been replaced with rip rap at several locations including between station 6+75 and 8+00. Photos 20 and 24 are representative of these repairs.

Rip rap repair and seepage area.

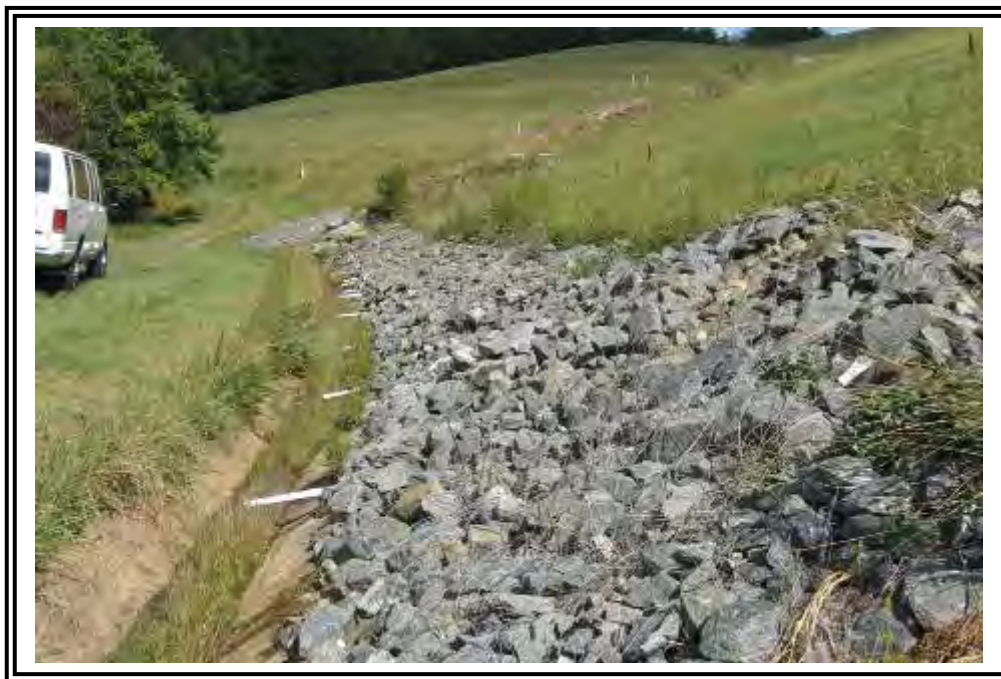
24

Rip rap repair with horizontal drains at EL 670 bench.

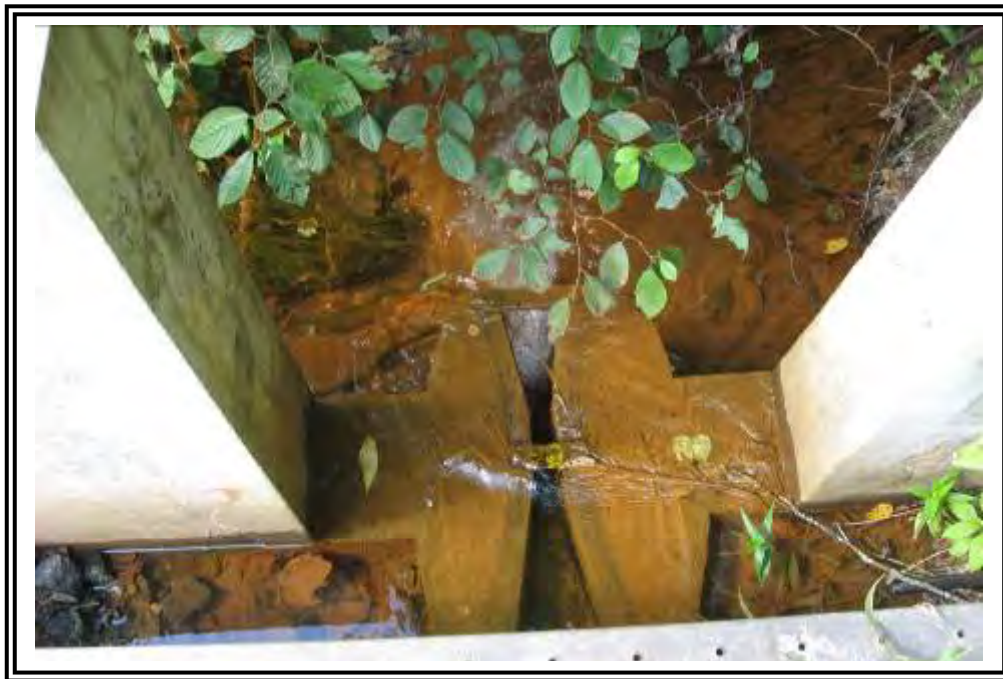
26

The precipitation of iron oxide from the horizontal drains was noted in several areas of the embankment. This condition was noted in the vicinity of horizontal drains HD-18 through 22 however did not exist in the adjacent horizontal drains HD-23 through HD-27. It was also evident at the seepage monitoring point downstream of the embankment (Photo 26).

Parshall Flume.

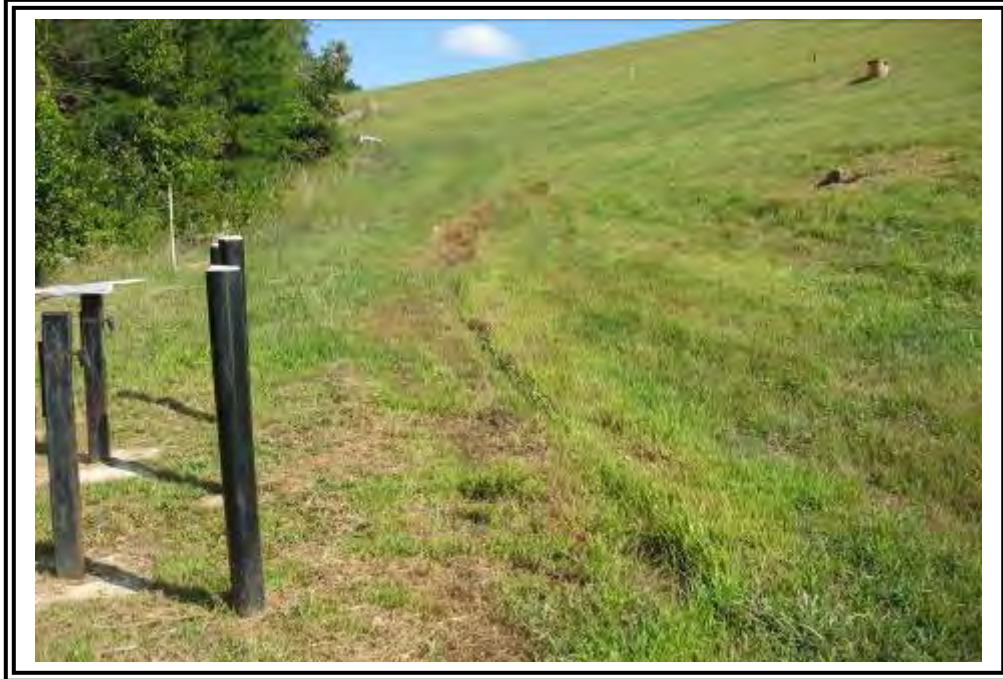
27

Wet rutted area.

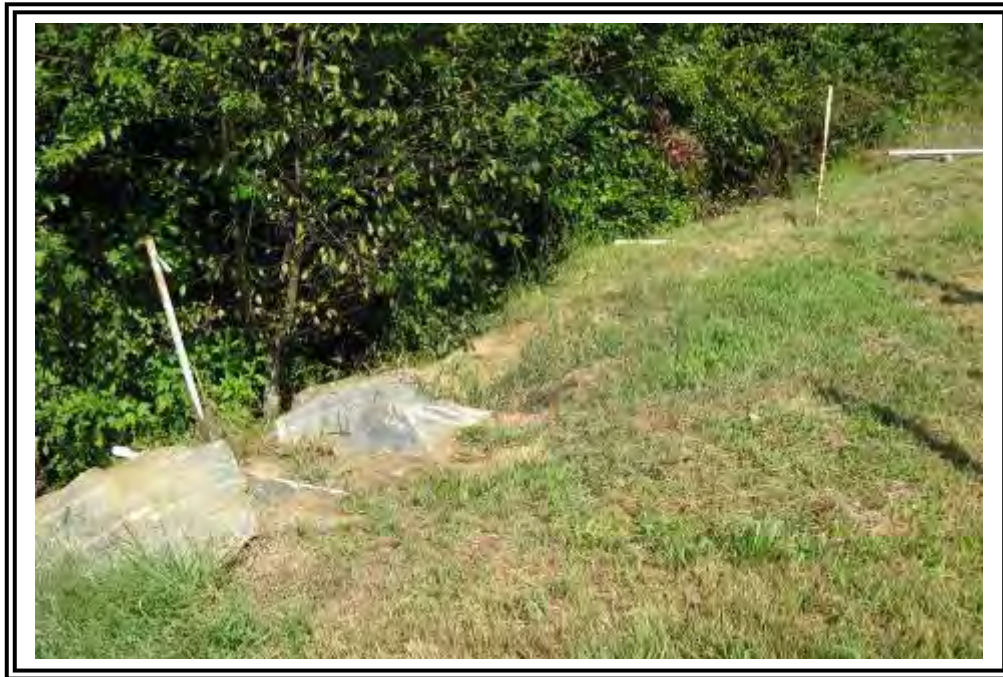
28

Slope instability noted in prior inspection report.

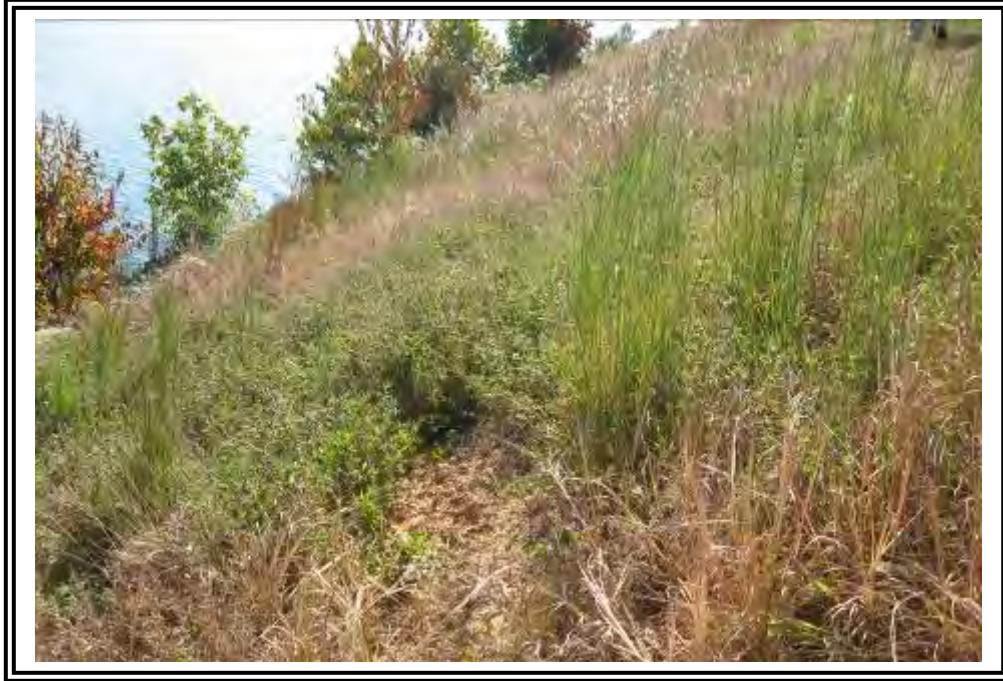
The upstream face of the dam is generally covered with heavier grass, light brush and small trees at the edge of the pond. The slope is generally at 2 horizontal to 1 vertical. As previously discussed, rip rap was placed on the downstream slope as wave protection in 1993. These conditions can be seen on Photos 11, 14 and 15. Minor erosion features were noted near the midpoint of the embankment however these were obscured by heavy grass. Photos 29 and 30 near piezometer P-43 depict this condition.

Upstream face erosion on ash dike.

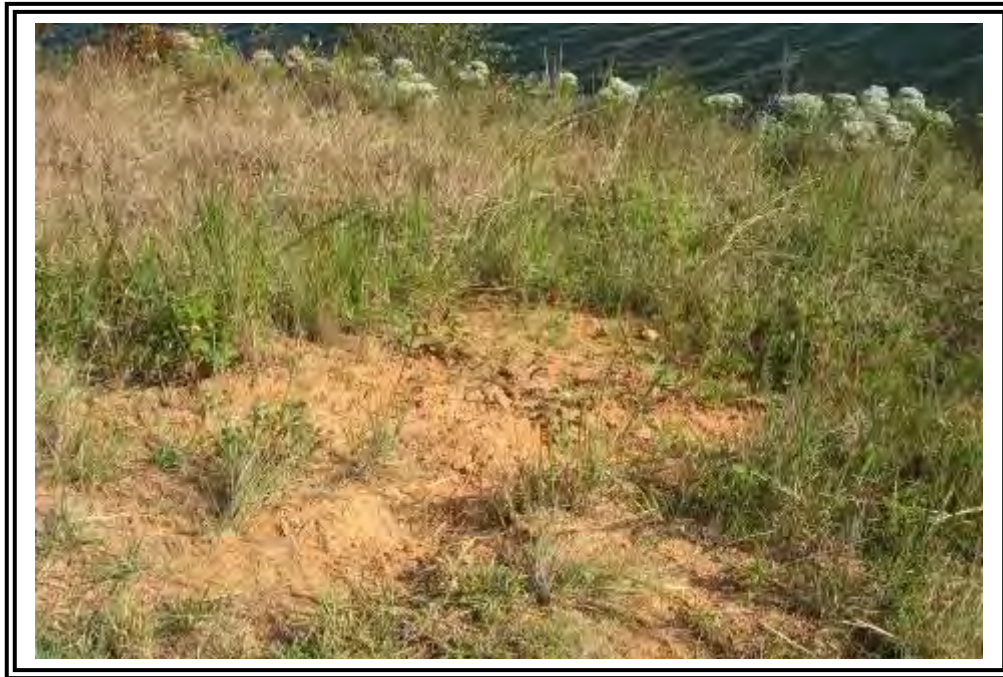
30

Localized sloughing.

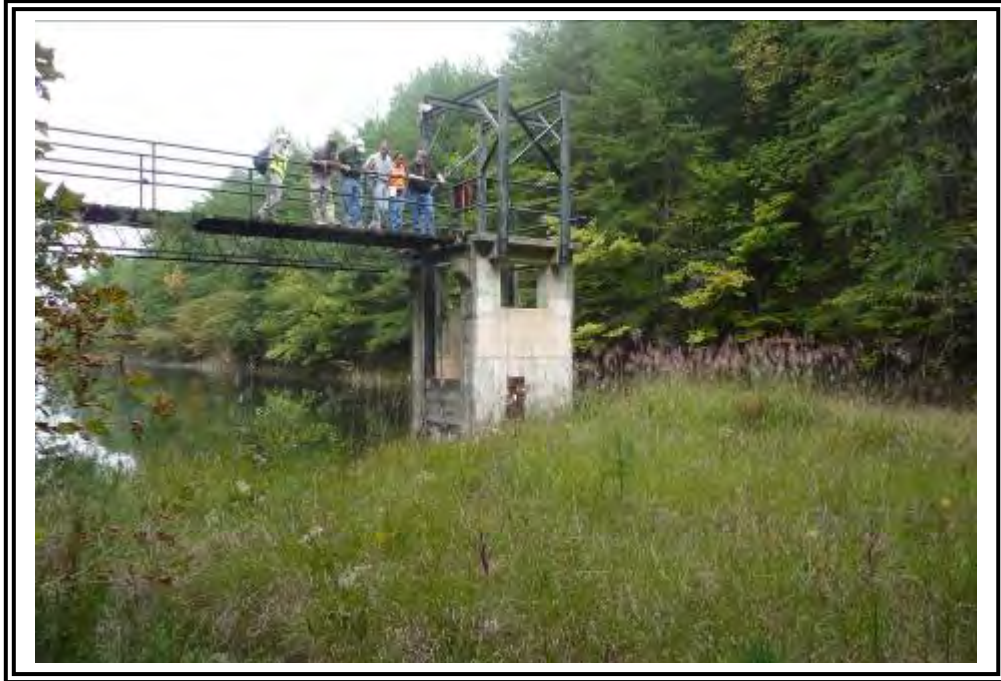
35

The abandoned outlet structure for the Ash Basin is located within a narrow sluice to the east of the Ash Dike as shown on Figure 2A and Photo 35. Stop logs have reportedly been placed within the weir to the highest pond level at Elev. 760 feet. The 36 inch drop inlet and 42 inch outlet structure were filled with flowable fill to Elev. 735 feet. The bridge to the outlet is in poor condition. The outlet tower is plugged with vegetation however it is not intended to be a functional discharge for the impoundment.

Abandoned ash tower outfall structure.

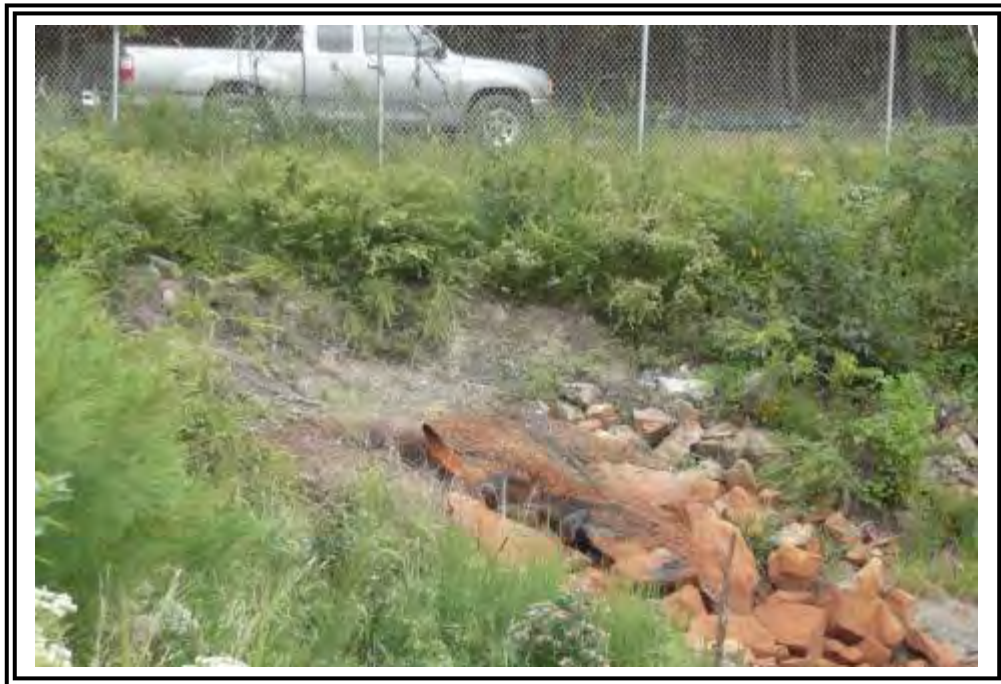
36

Chemical washdown pond inlet.
