# Assessment of Dam Safety

## Coal Combustion Surface Impoundments (Task 3)

Duke Energy Corporation

Belews Creek  
Steam Station

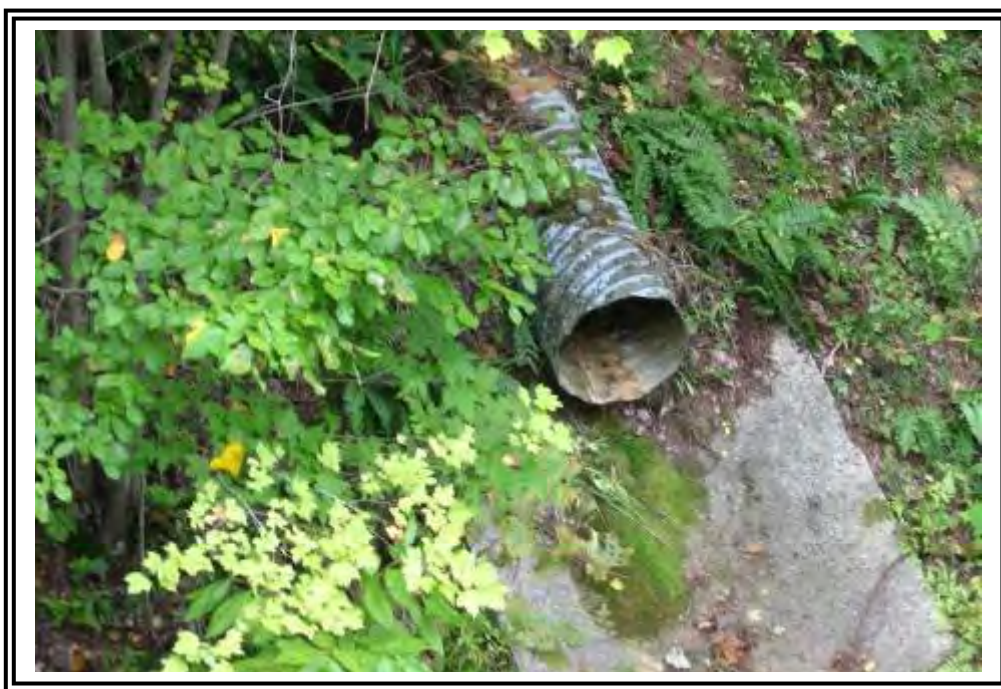
1

The outlet of the 42 inch pipe discharges on the east side of Pine Hall Road in a highly vegetated dry creek bed leading to Belews Lake. The outlet was inspected and the pipe was found to be a 39 inch CMP at the discharge point. The pipe was partially filled with flowable fill material. A minor seepage of water was observed exiting the pipe which could either be from groundwater infiltration through pipe joints or water leaking through the grout placed in 1984.

Abandoned outfall pipe.

The seepage from the abandoned outlet pipe should be monitored. Analytical testing or dye testing may confirm if it is originating from the Ash Basin or is groundwater infiltration into the pipe.

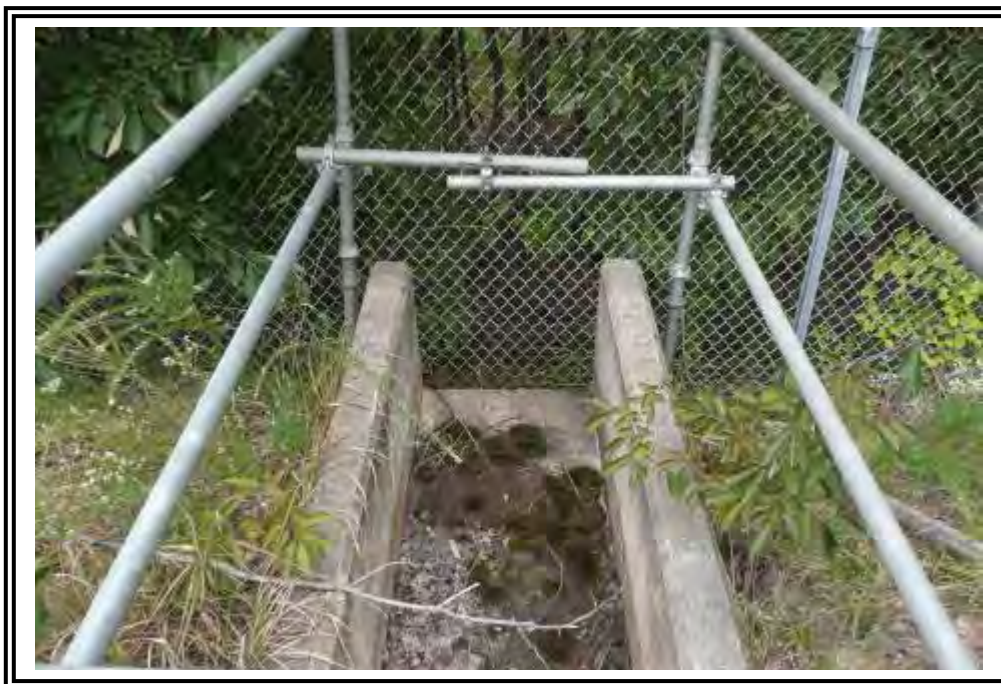
5

The chemical washdown water inlet pipe is on the east side of the impoundment. A rip rap inlet and outlet is present (Photo 36). The concrete overflow structure was observed to be in good condition (Photo 5) however was silted in.

Chemical washdown pond overflow structure.

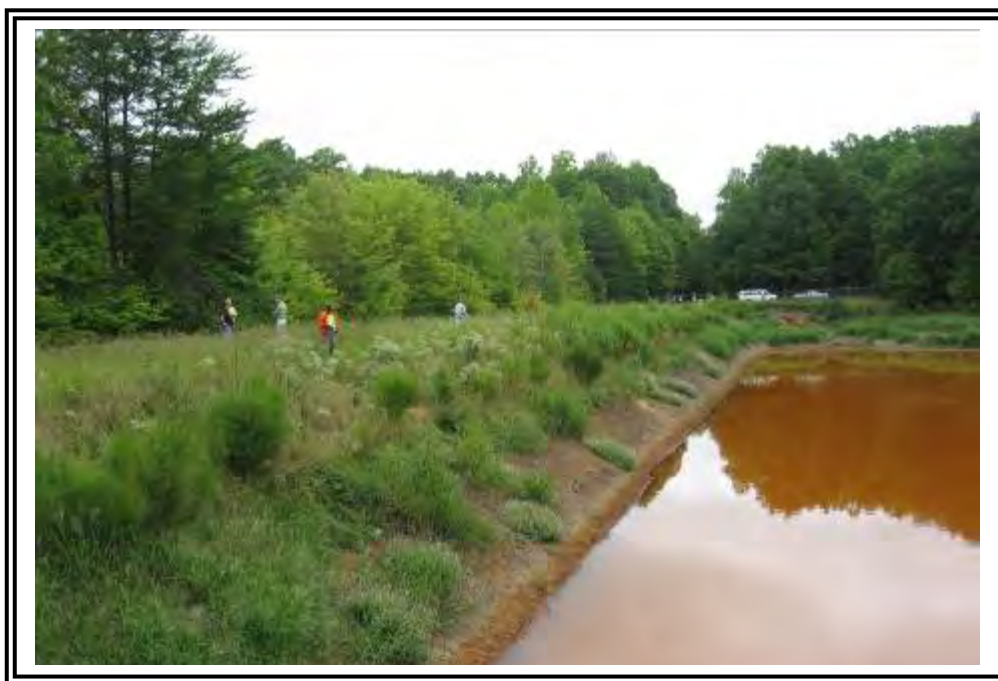
was observed at the time of the site visit. Photo 6 shows the dam crest and general alignment. The upstream slope of the dike was estimated to be between 1.5 and 2 horizontal to 1 vertical with a thick stand of high grass and weeds. Some erosion and localized sloughing was noted. The downstream slope can be viewed through the fence in Photo 7 and is heavily wooded with trees up to 12 inches in diameter.

Upstream face of chemical washdown pond.

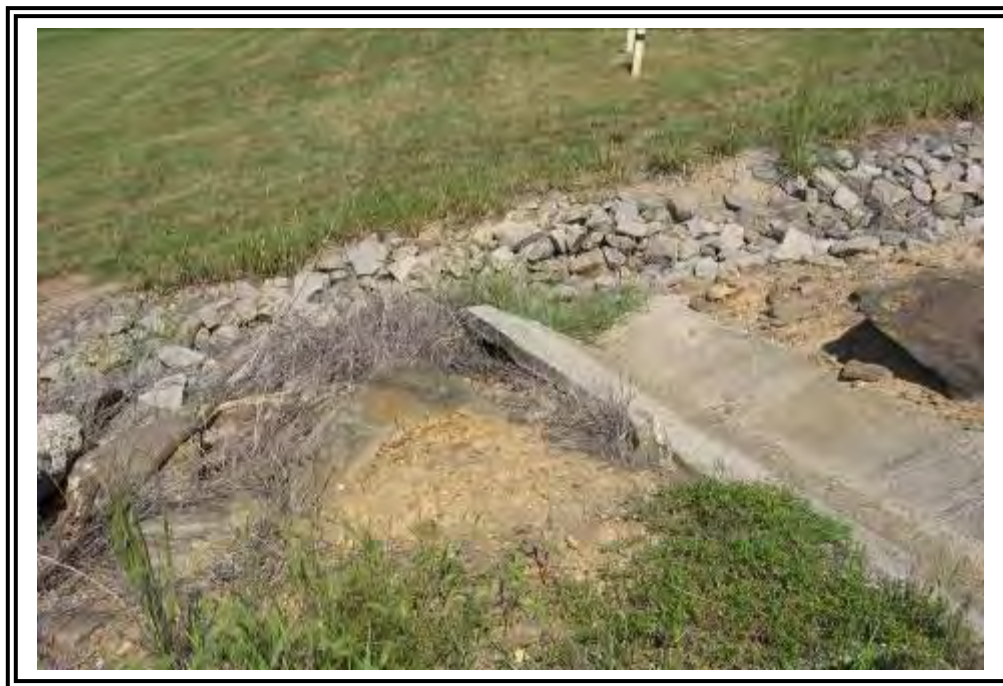
these features and drain towards the groins along the east and west abutments. Water was noted to be flowing in the right (east) and left (west) abutments. Concrete drainage chutes at the intersection with the groins are noted to be moderately undermined at several locations (Photos 17 and 19).

Drainage structure at east groin, undermined of chute.

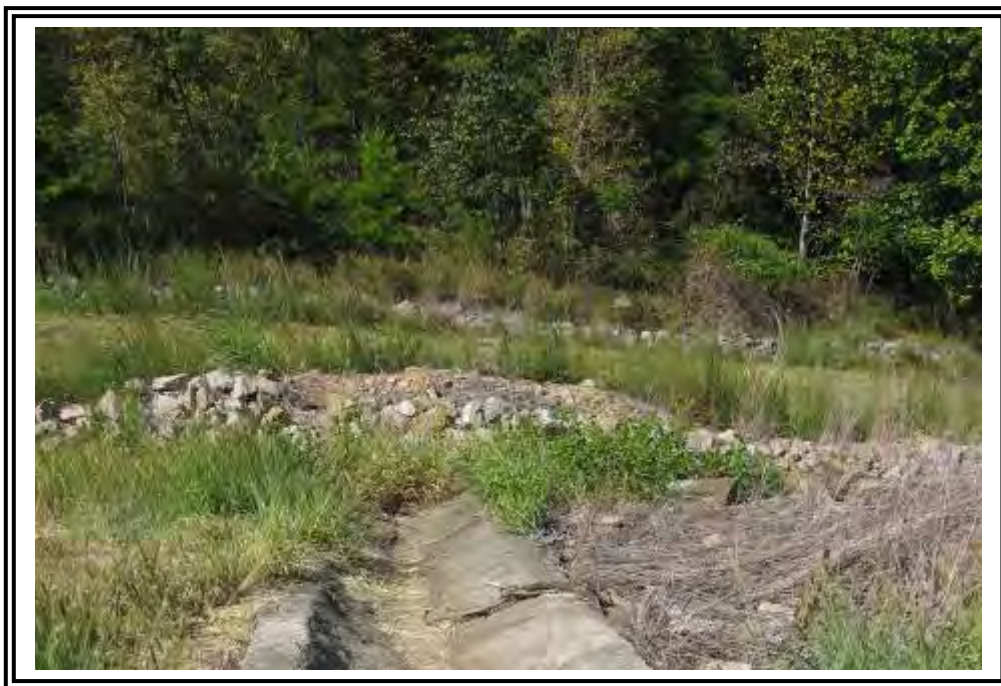
19

Precast drainage structures west (left) groin.

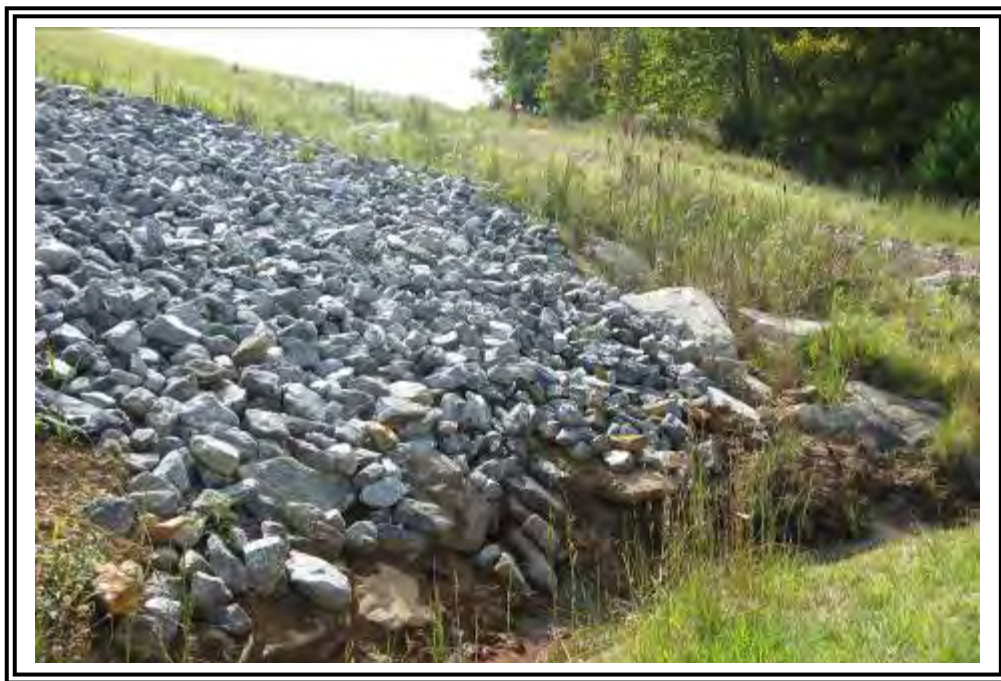
- Wet surface soils on the downstream face have been replaced with rip rap at several locations including between Station 6+75 and 8+00. Photos 20 and 24 are representative of these repairs.

Rip rap repair and seepage area.

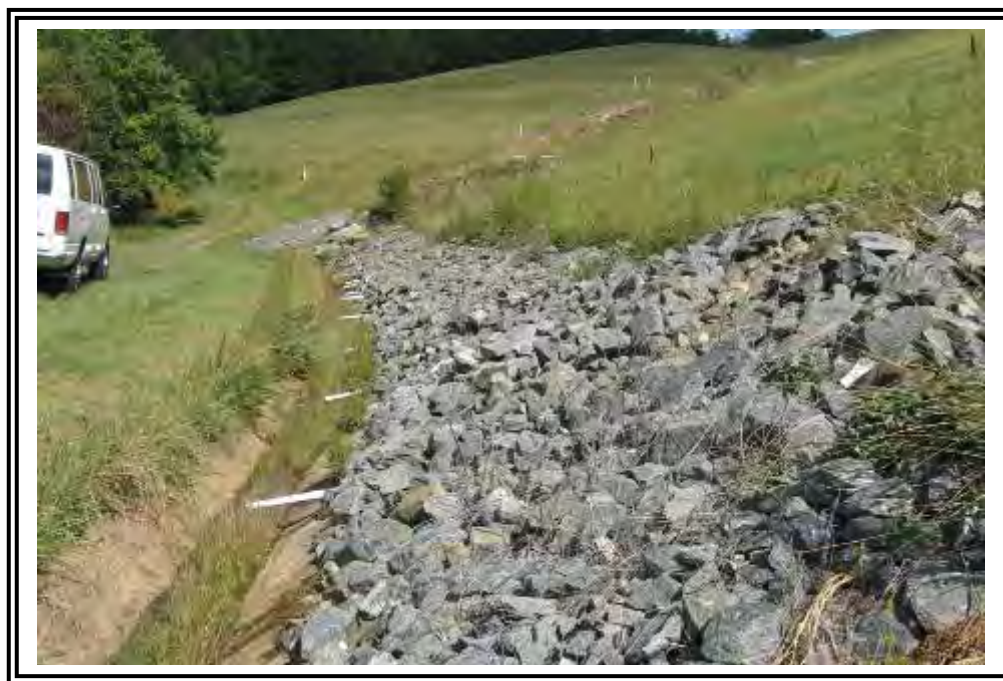
24

Rip rap repair with horizontal drains at EL 670 bench.

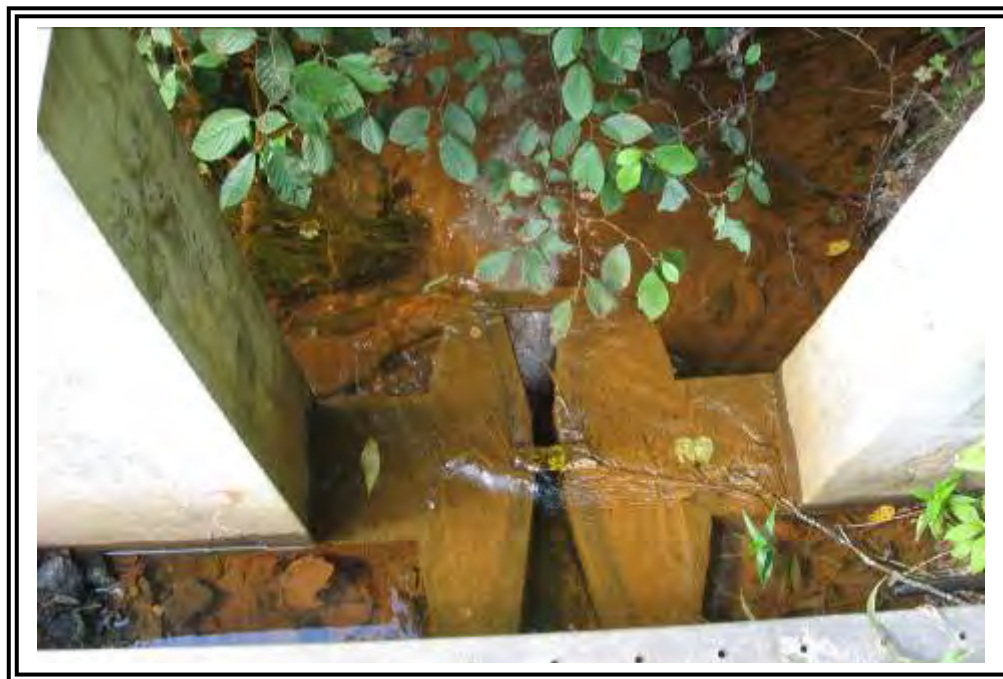
26

The precipitation of iron oxide from the horizontal drains was noted in several areas of the embankment. This condition was noted in the vicinity of horizontal drains HD-18 through 22 however did not exist in the adjacent horizontal drains HD-23 through HD-27. It was also evident at the seepage monitoring point downstream of the embankment (Photo 26).

Parshall Flume.

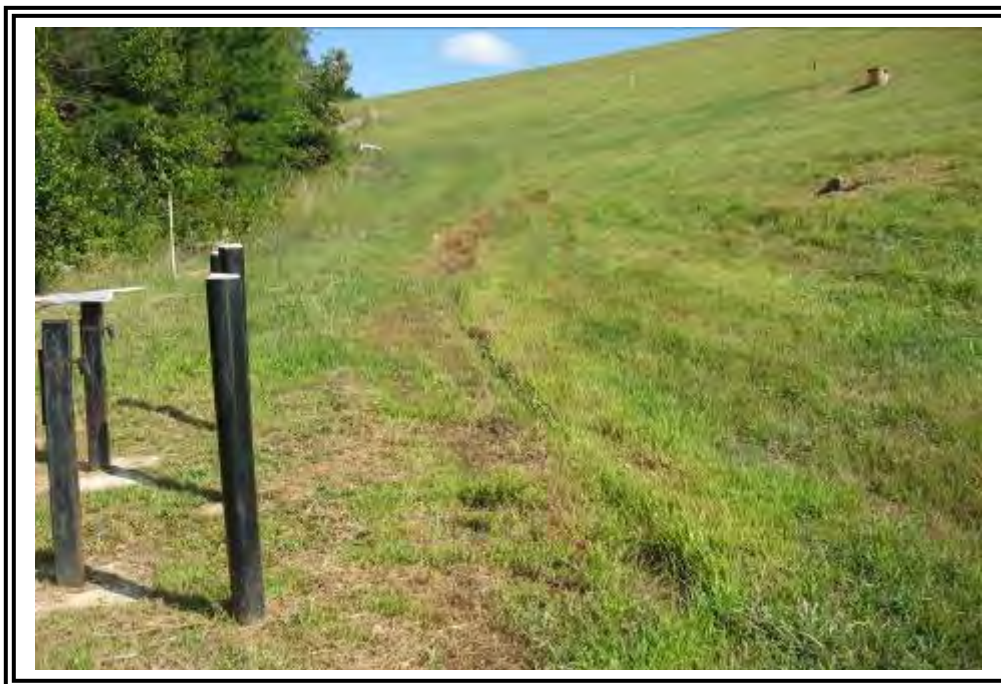
27

Wet rutted area.

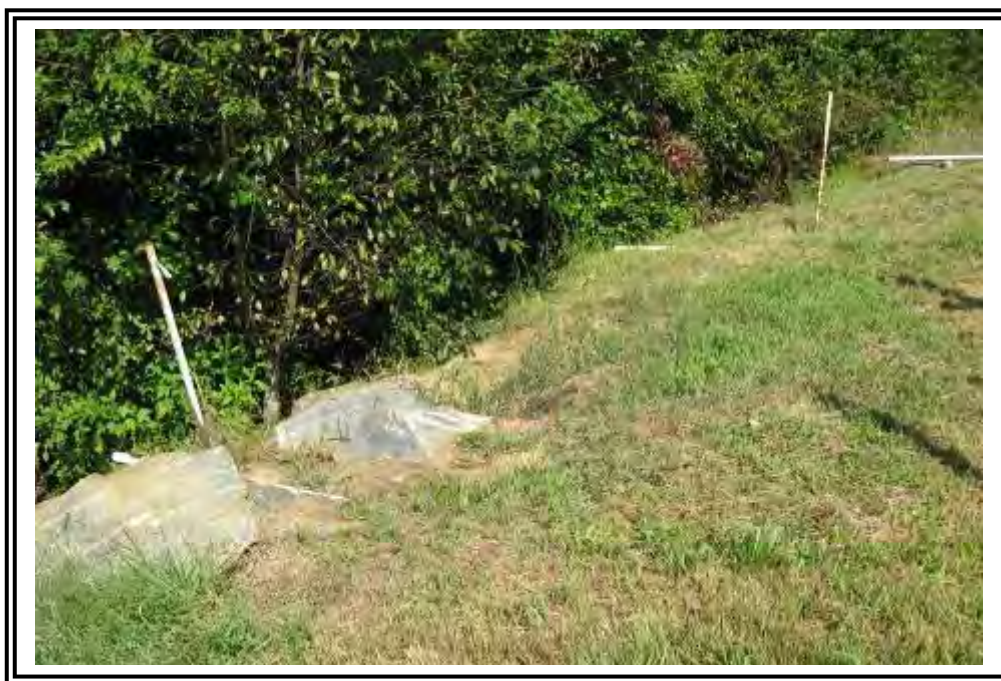
28

Slope instability noted in prior inspection report.

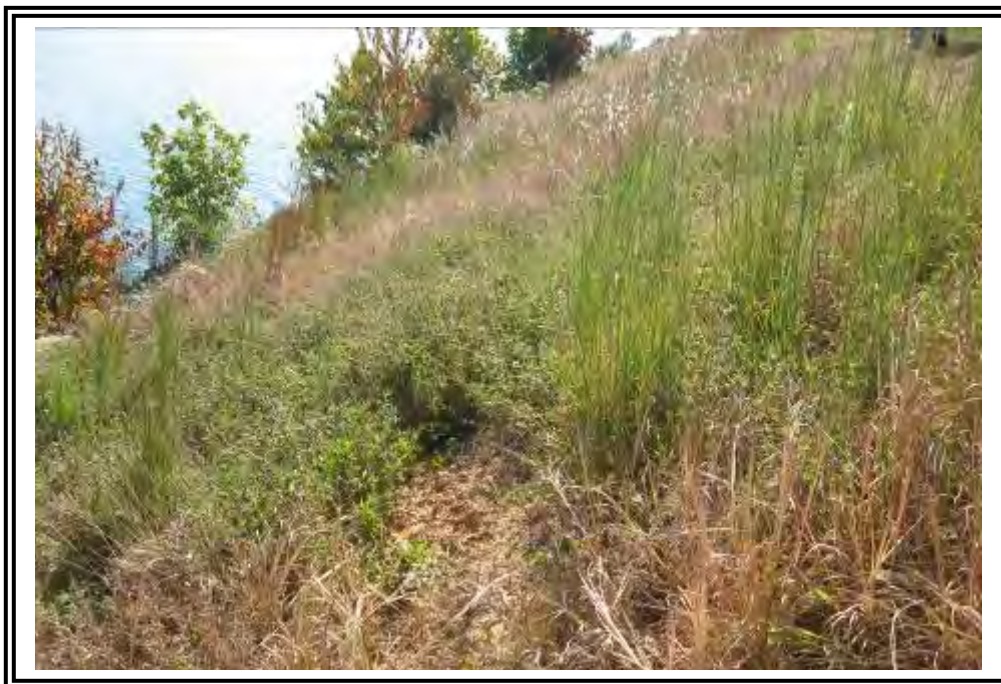
The upstream face of the dam is generally covered with heavier grass, light brush and small trees at the edge of the pond. The slope is generally at 2 horizontal to 1 vertical. As previously discussed, rip rap was placed on the downstream slope as wave protection in 1993. These conditions can be seen on Photos 11, 14 and 15. Minor erosion features were noted near the midpoint of the embankment however these were obscured by heavy grass. Photos 29 and 30 near piezometer P-43 depict this condition.

Upstream face erosion on ash dike.

Small trees and brush has become established over the upstream toe of the Ash Basin Dike and in a portion of the abutment areas. CHA recommends these trees be removed under the direction of a professional engineer.

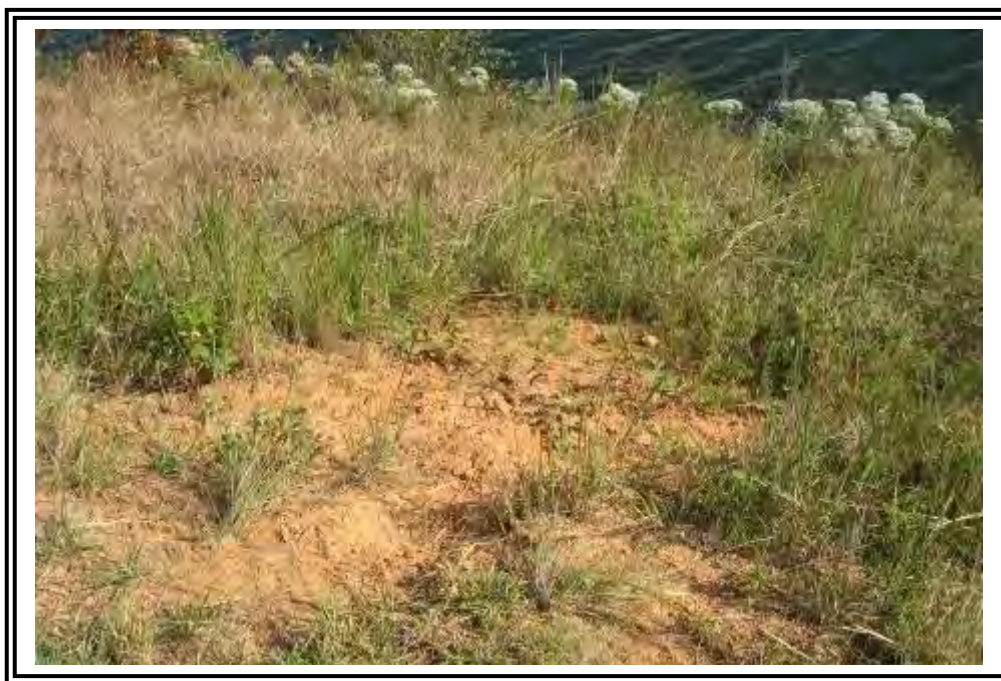
30

Localized sloughing.

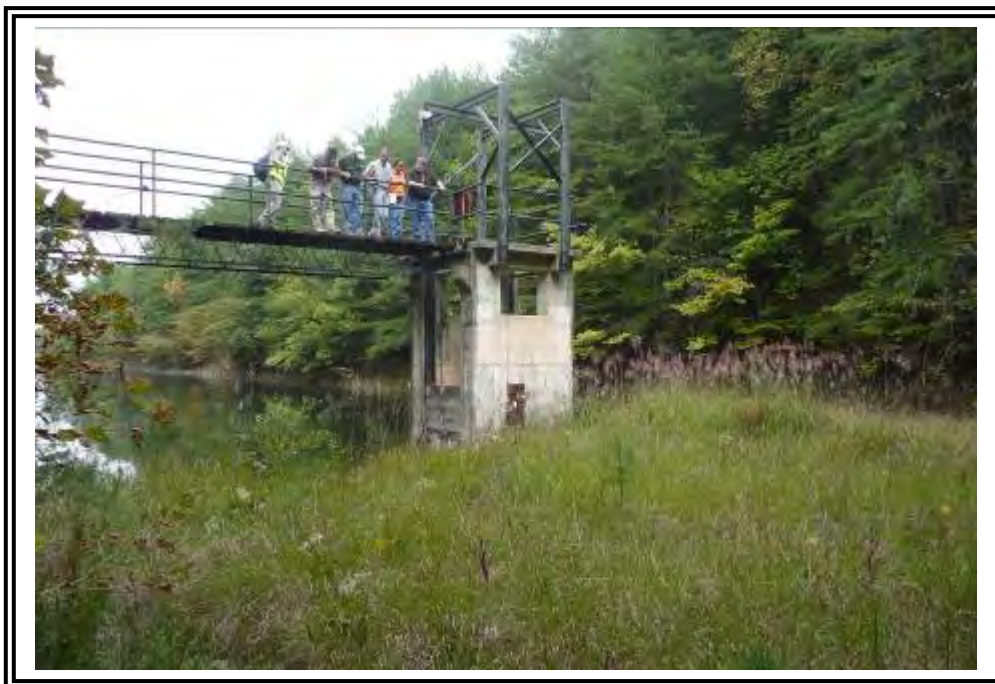
35

The abandoned outlet structure for the Ash Basin is located within a narrow sluice to the east of the Ash Dike as shown on Figure 2A and Photo 35. Stop logs have reportedly been placed within the weir to the highest pond level at Elev. 760 feet. The 36 inch drop inlet and 42 inch outlet structure were filled with flowable fill to Elev. 735 feet. The bridge to the outlet is in poor condition. The outlet tower is plugged with vegetation however it is not intended to be a functional discharge for the impoundment.

Abandoned ash tower outfall structure.
