Assessment of Dam Safety Coal Combustion Surface Impoundments Draft Report

Duke Energy
Buck Steam Station
Spencer, North Carolina

July 13, 2009

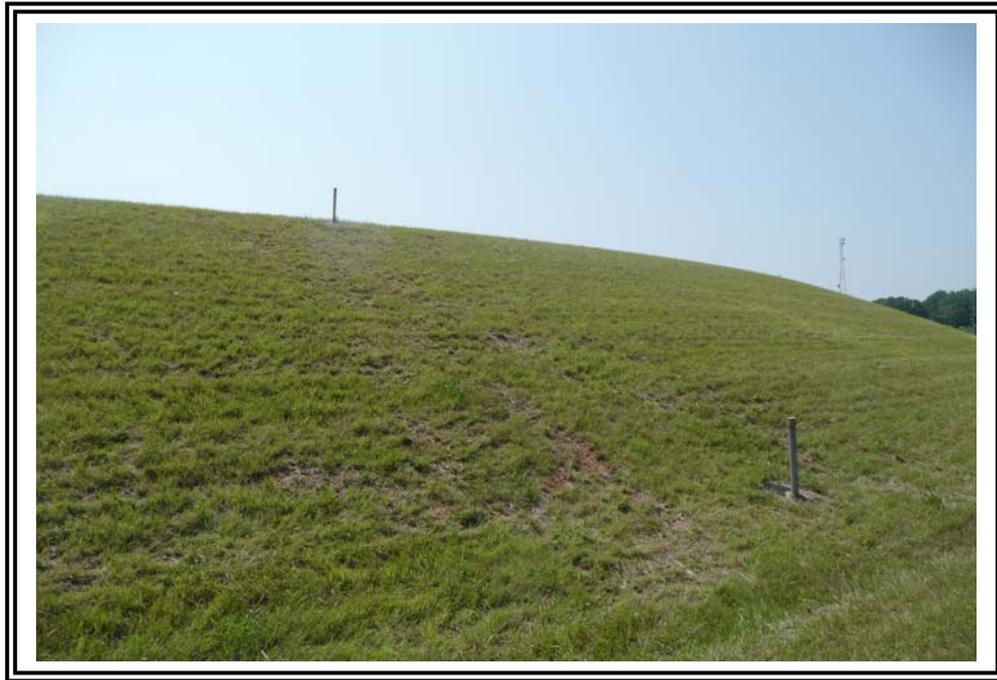
13

Downstream Slope of New Dike looking south. Note sparse grass coverage in some areas.

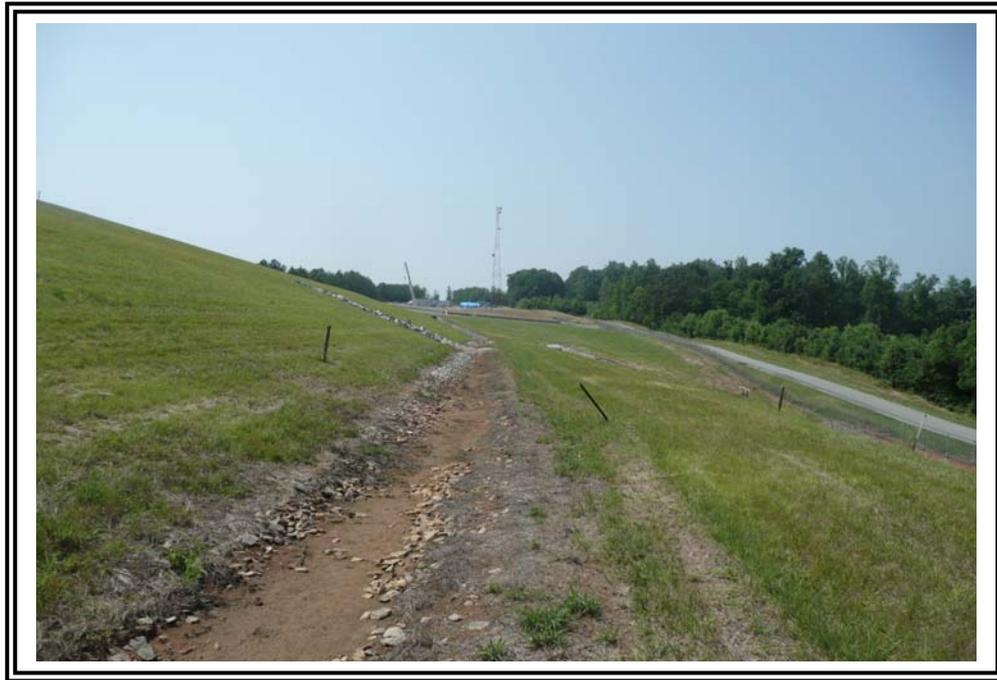
15

Lower Bench of New Dike looking south. Note silt deposited in drainage swale.

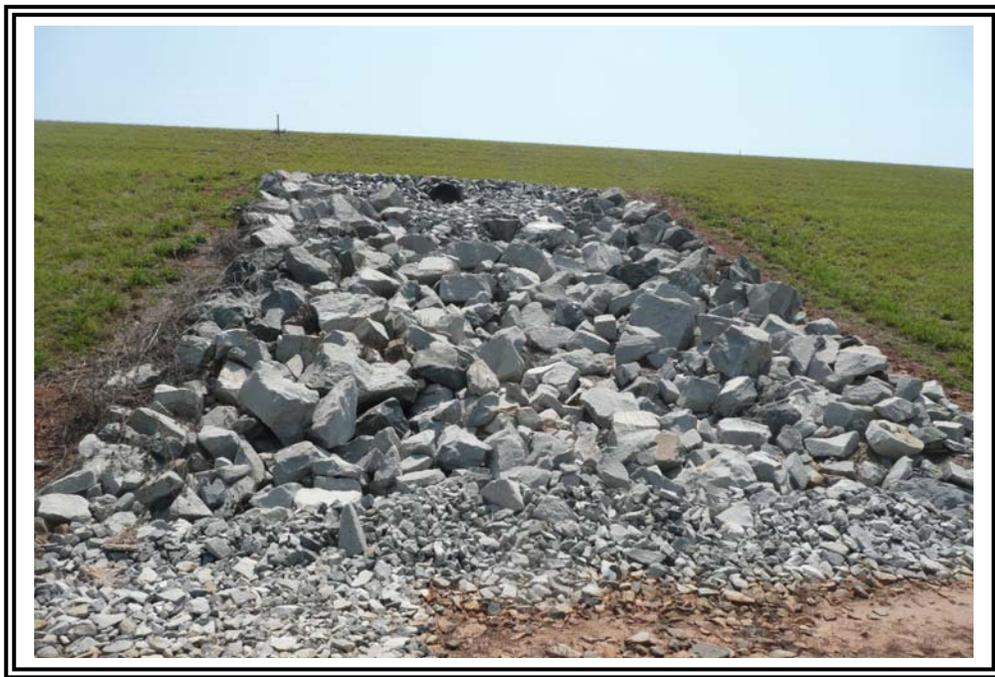
20

Repair area where surface runoff was causing sloughing from Upper Bench to Lower Bench. Repair was completed between 1993 and 1998 based on publically available aerial photos.

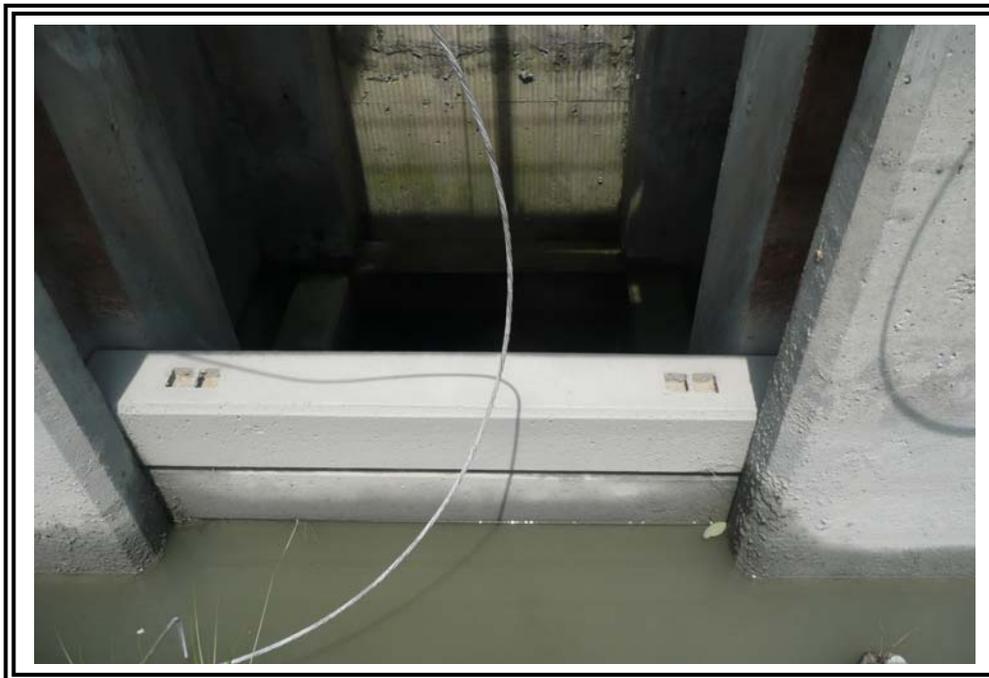
26

The outlet control structure controls the water level in Basin 1 via stop logs in an overflow weir. The water then discharges through a 36-inch diameter concrete pipe into Basin 2. As can be seen in Photo 25, the stop log system experiences significant leakage resulting in the lowering of water in Basin 1 below the normal decant elevation when ash is not being actively sluiced into Basin 1. During our visit, the Buck Steam Station was not generating power so no ash was being sluiced into Basin 1.

Stoplogs in Basin 1 Outlet Tower. During these observations the Buck Plant was not generating power, therefore they were not sluicing CCW into Basin 1. Leakage between the stoplogs had resulted in a lowering of the Basin 1 water level below the normal decant elevation.

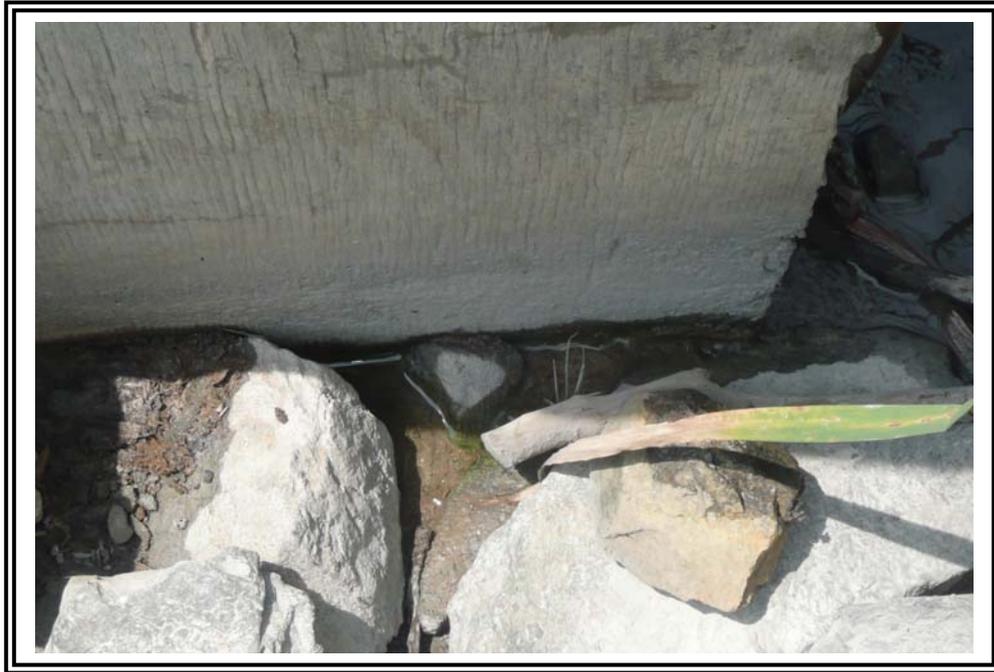
29

Photos 26 and 27 show the downstream end of the outlet pipe, and the discharge channel between the outlet pipe and Basin 2. Seepage was noted adjacent to the downstream end of the outlet pipe headwall. This seepage flow appeared clear at the time of the site visit.

Seepage noted adjacent to downstream end of outlet pipe headwall.

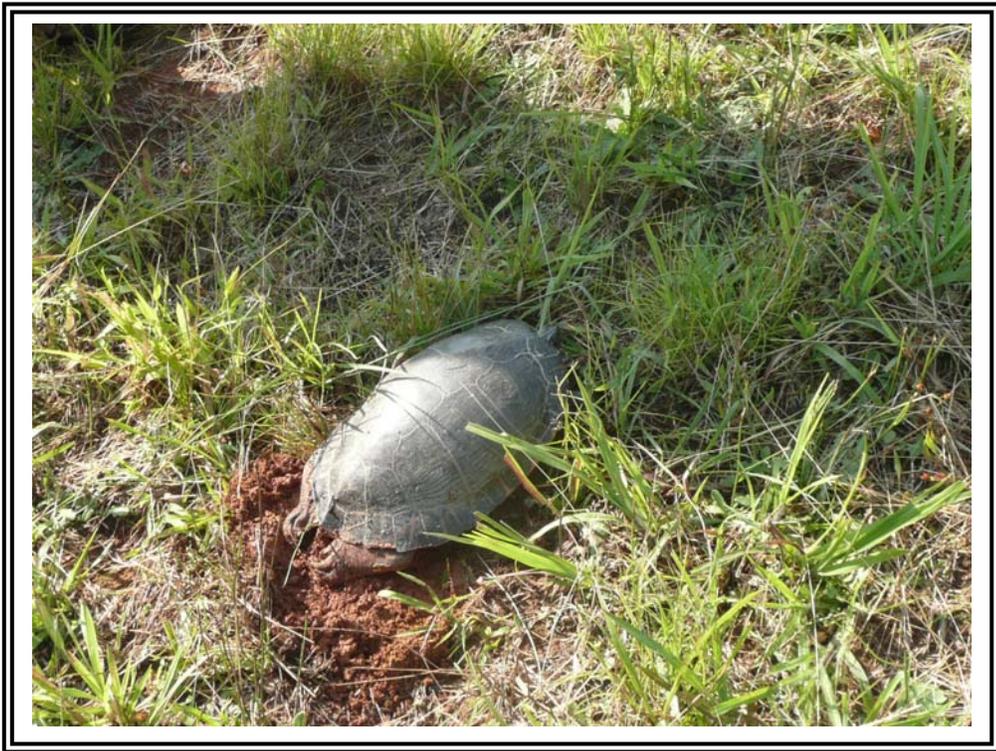
43

The downstream slope of the main dike is reasonably uniform as shown in Photos 41, 44, 48, 50 and 51. Areas of sparse grass coverage were noted as shown in Photos 42, 45, 47 and 50. Areas of animal disturbance were noted in fire ant mounds and by digging turtles (Photo 43).

Close up of animal disturbance on downstream slope of Main Dike.

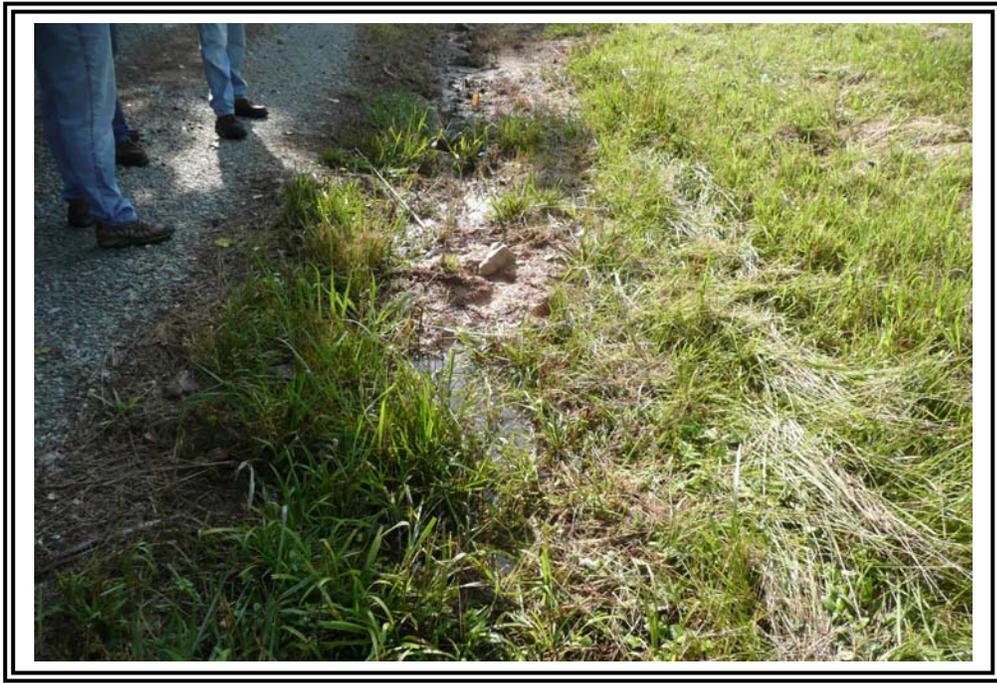
46

Clogged groin drainage swale on west end of Main Dike. Sediment appeared to include bentonite chips, possible runoff from poorly cleaned up drilling at “new” monitoring wells.

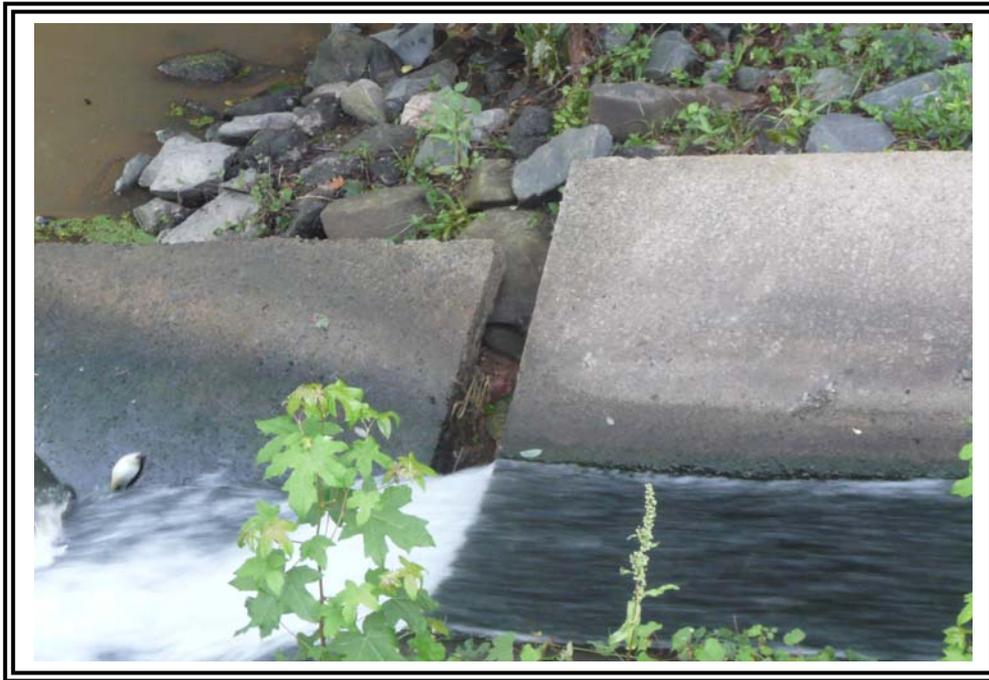
56

Last section of concrete channel has separated. Noted in previous inspection reports.

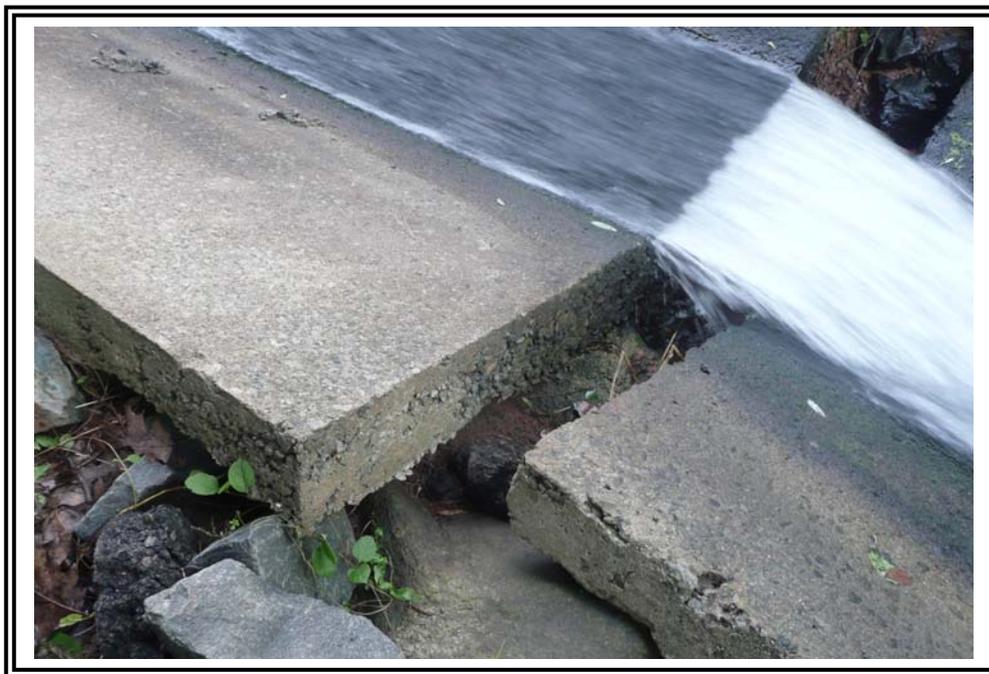
57

Slight undermining of concrete discharge channel at river end.

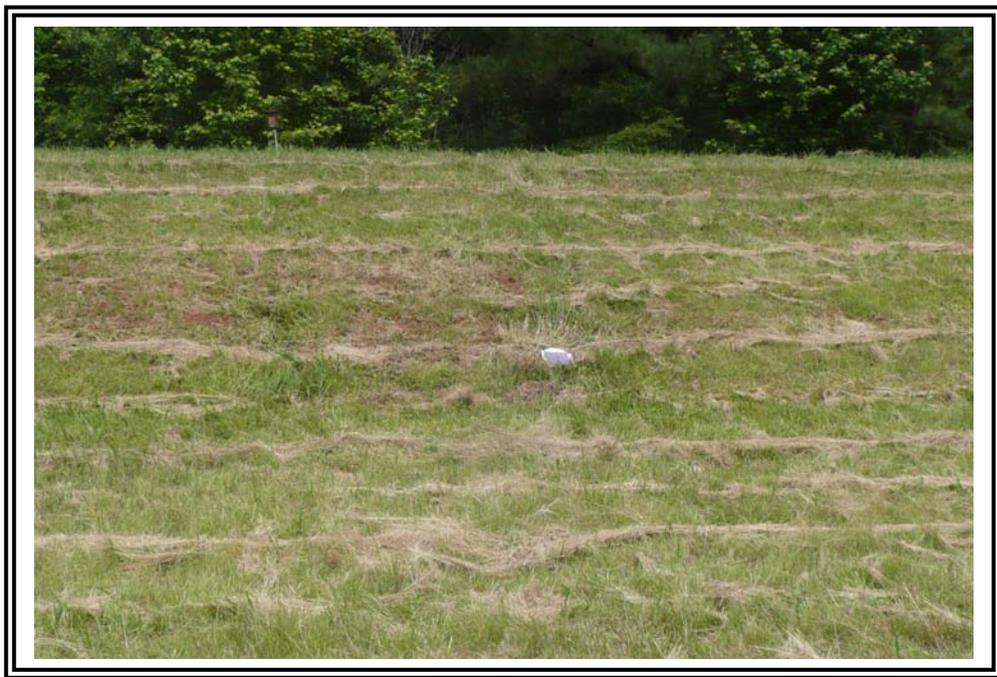
74

at the toe of the diverter dike were noted such as shown in Photo 72 and 74. These depressions were up to 8 inches deep. At some, but not all, of these depressions, surface ponding in ruts on the dam crest was noted. There is a 50-foot bench between the toe of the diverter dike and the water's edge in Basin 3. The upstream slope is reasonably uniform as shown in Photos 75 and 76. The trees seen in these photographs are on the deposited ash in Basin 2.

More erosion or settlement locations on downstream slope of Diverter Dike as noted by clipboard and dark green grass to left of clipboard.
