# Assessment of Dam Safety

## Coal Combustion Surface Impoundments (Task 3)

Duke Energy  
Buck Steam Station  
Spencer, North Carolina

September 14, 2009

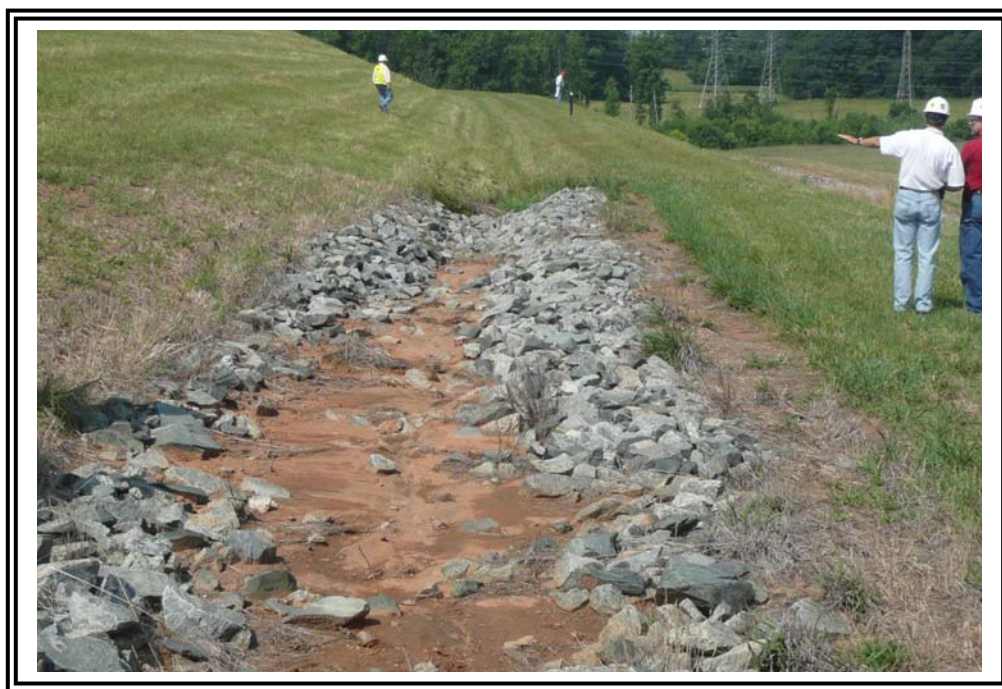
7

Drainage swale at north end of upper bench clogged with silt.

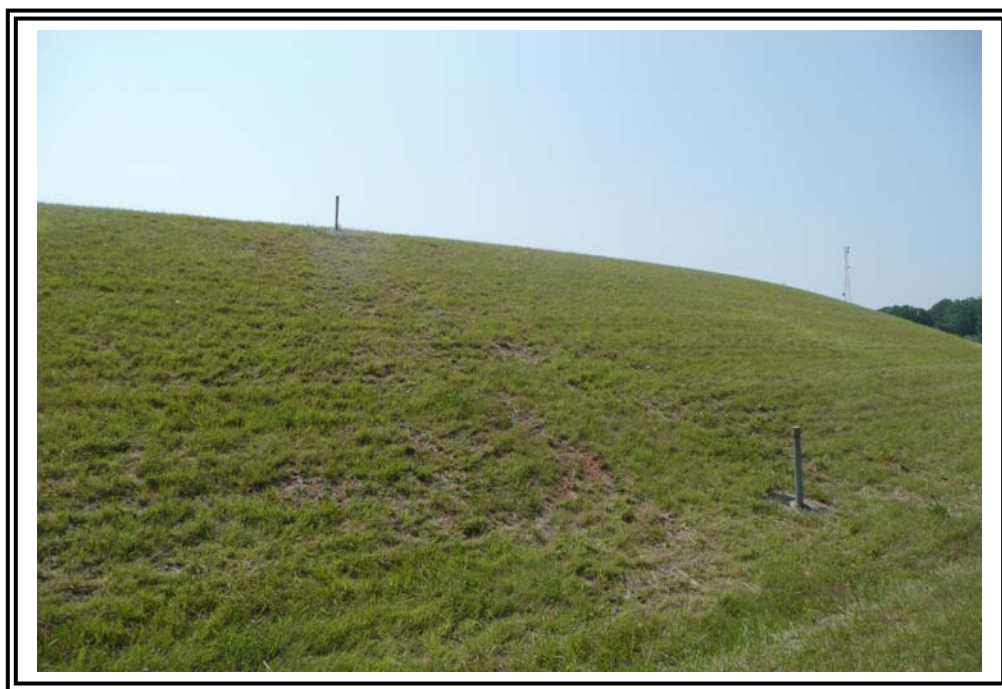
13

Downstream Slope of New Dike looking south. Note sparse grass coverage in some areas.

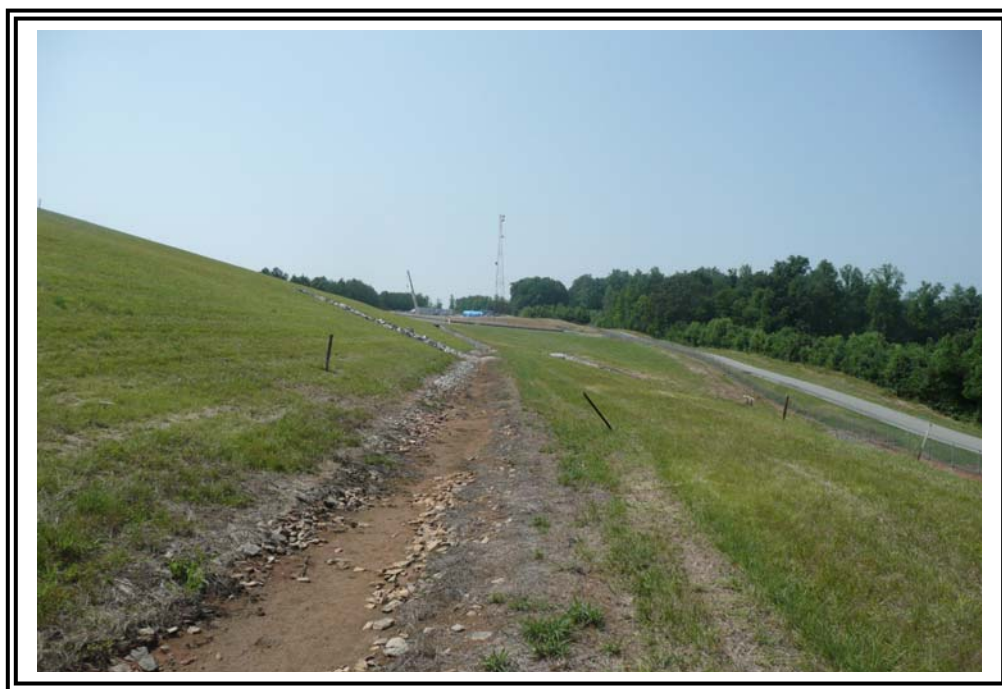
15

Lower Bench of New Dike looking south. Note silt deposited in drainage swale.

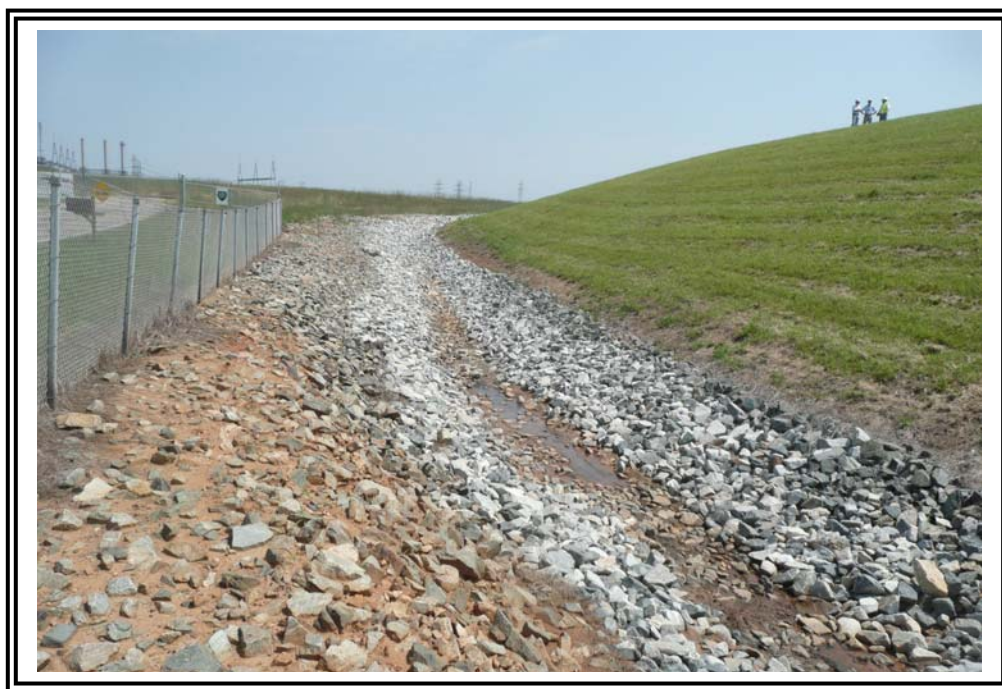
17

Toe swale of New Dike looking north. Area of toe drain seepage. Area starts about 100 feet north of discharge culvert under Dukeville Road.

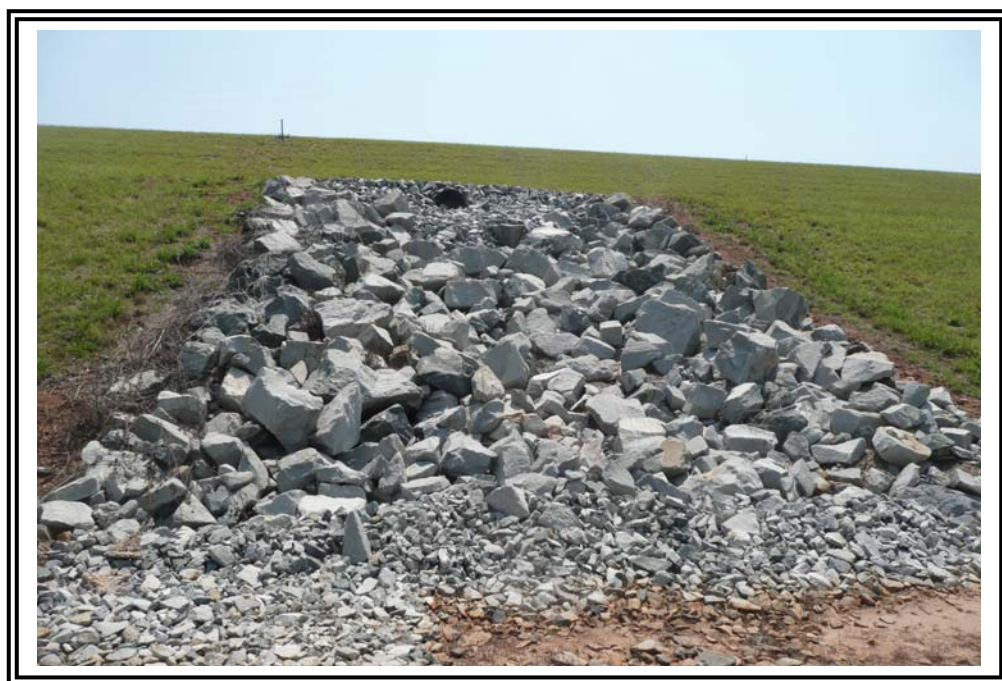
20

Repair area where surface runoff was causing sloughing from Upper Bench to Lower Bench. Repair was completed between 1993 and 1998 based on publically available aerial photos.

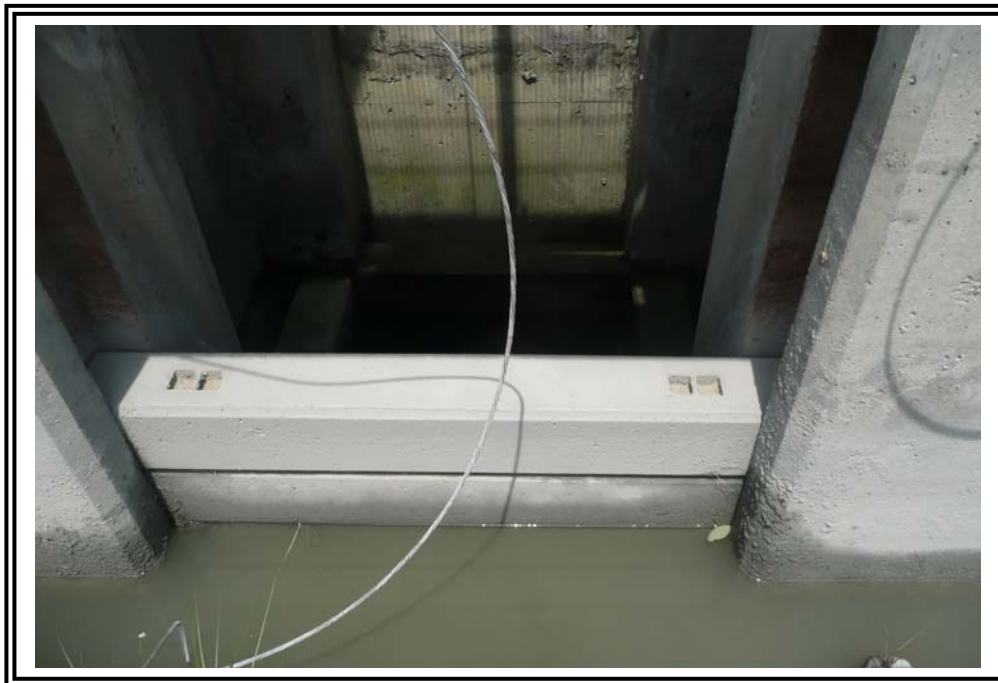
26

Stoplogs in Basin 1 Outlet Tower. During these observations the Buck Plant was not generating power, therefore they were not sluicing CCW into Basin 1. Leakage between the stoplogs had resulted in a lowering of the Basin 1 water level below the normal decant elevation.

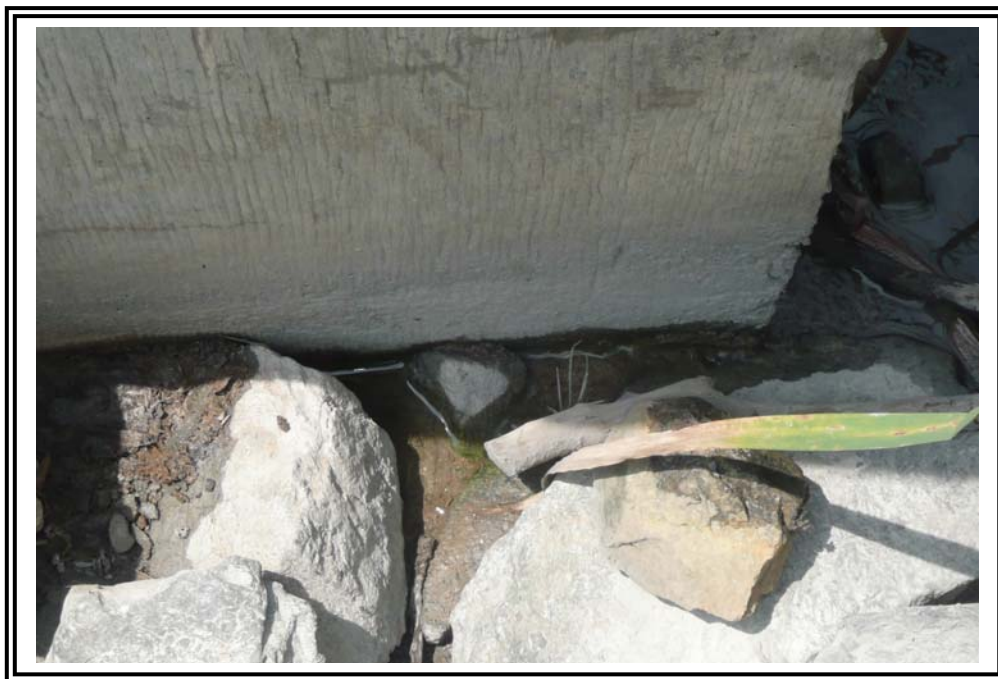
29

Photos 26 and 27 show the downstream end of the outlet pipe, and the discharge channel between the outlet pipe and Basin 2. Seepage was noted adjacent to the downstream end of the outlet pipe headwall. This seepage flow appeared clear at the time of the site visit.

Seepage noted adjacent to downstream end of outlet pipe headwall.

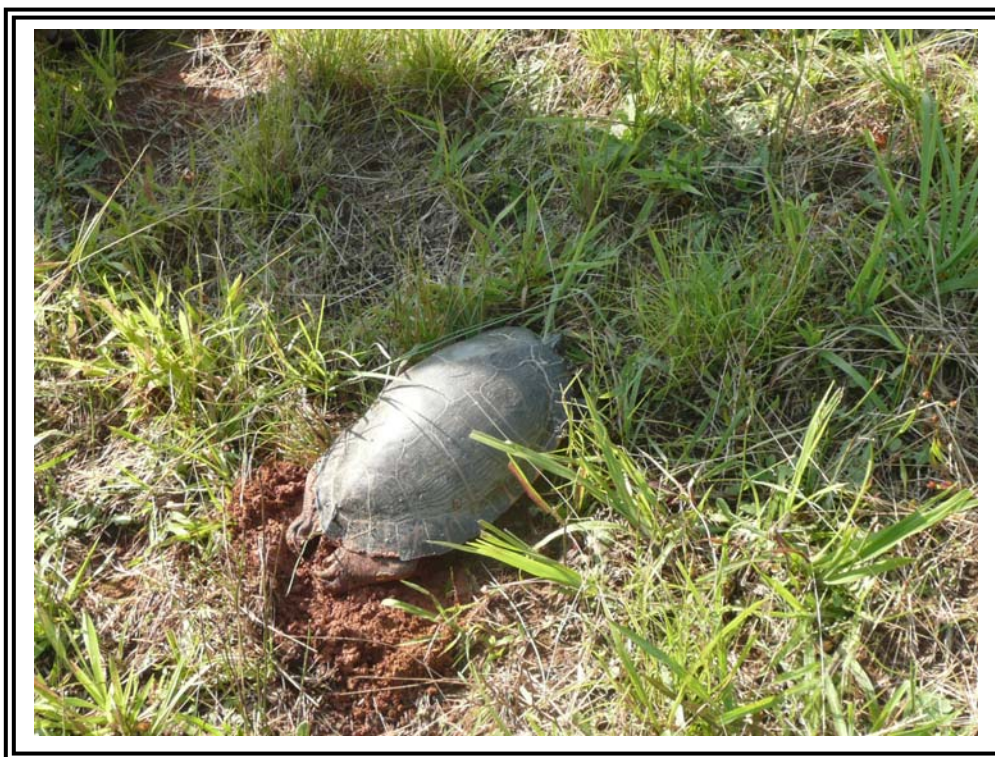
43

The downstream slope of the main dike is reasonably uniform as shown in Photos 41, 44, 48, 50 and 51. Areas of sparse grass coverage were noted as shown in Photos 42, 45, 47 and 50. Areas of animal disturbance were noted in fire ant mounds and by digging turtles (Photo 43).

Close up of animal disturbance on downstream slope of Main Dike.

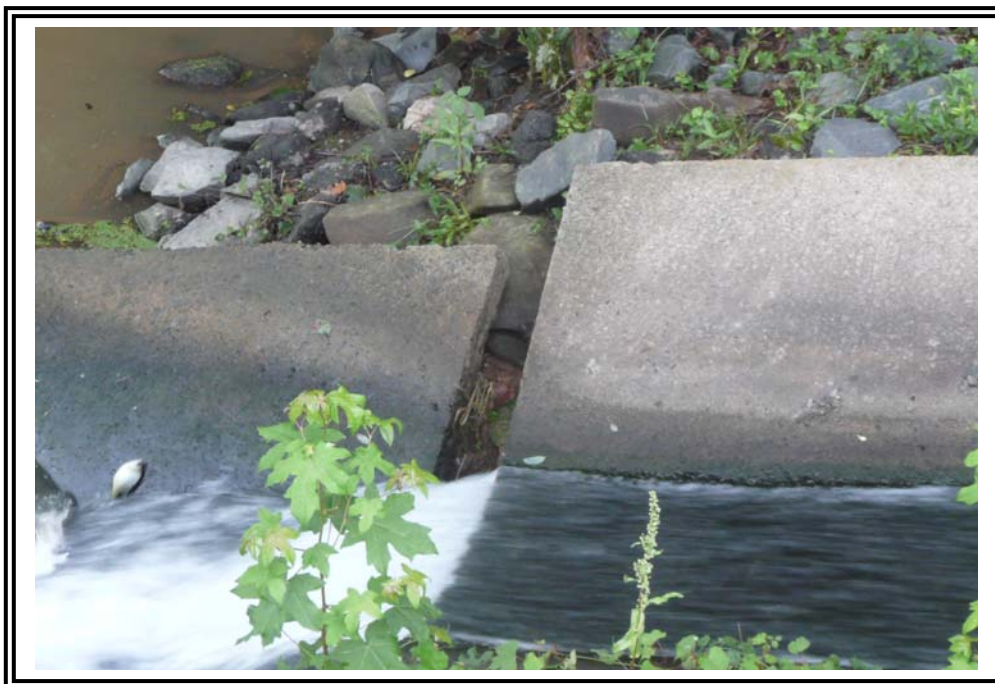
56

Last section of concrete channel has separated. Noted in previous inspection reports.

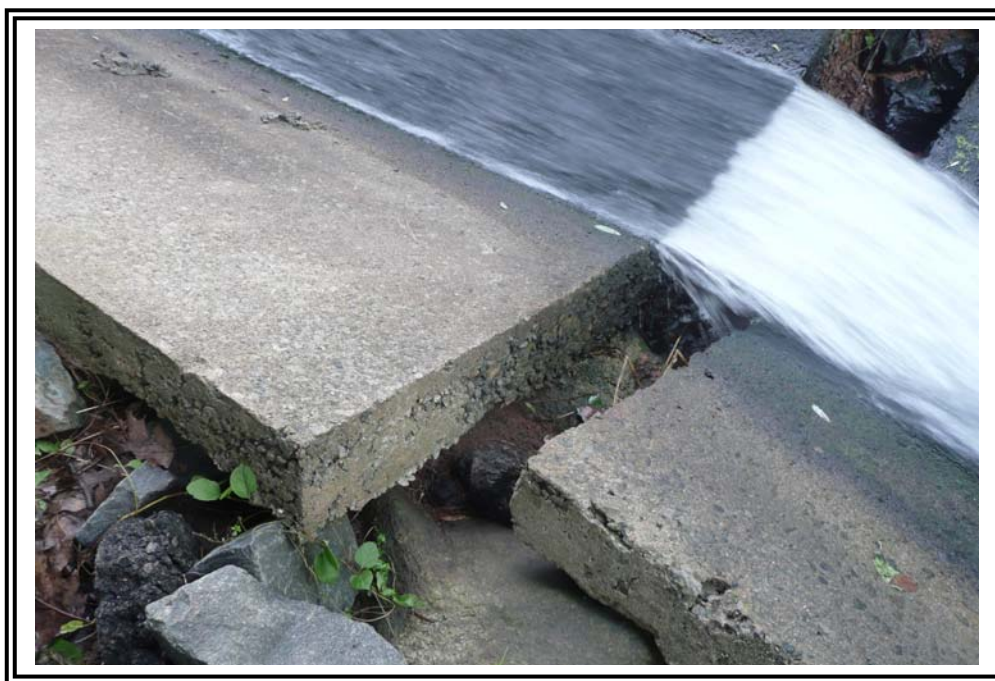
57

Slight undermining of concrete discharge channel at river end.

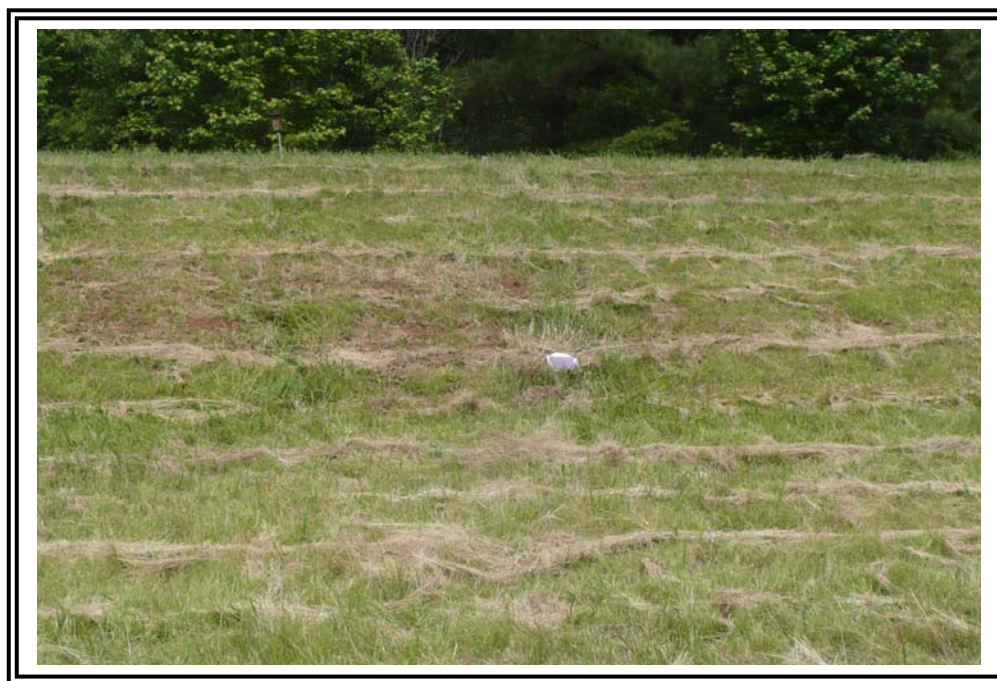
74

More erosion or settlement locations on downstream slope of Diverter Dike  
as noted by clipboard and dark green grass to left of clipboard.
