**Specific Site Assessment for  
Coal Combustion Waste  
Impoundments at Duke Energy  
Carolinas Lee Steam Station**

Williamston, South Carolina

**GEI Consultants, Inc.**  
4601 DTC Blvd., Suite 900  
Denver, CO 80237

July 2010  
Project 092881

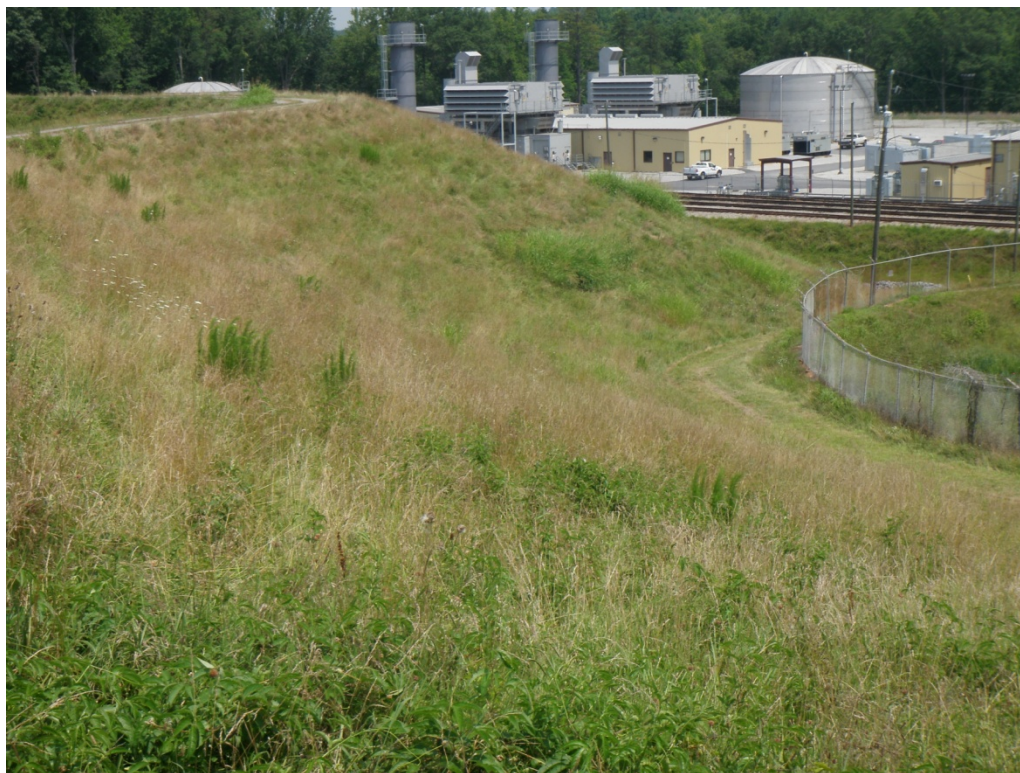
**Photo 1 – Primary Active Ash Pond Dam : Downstream slope near right abutment.**

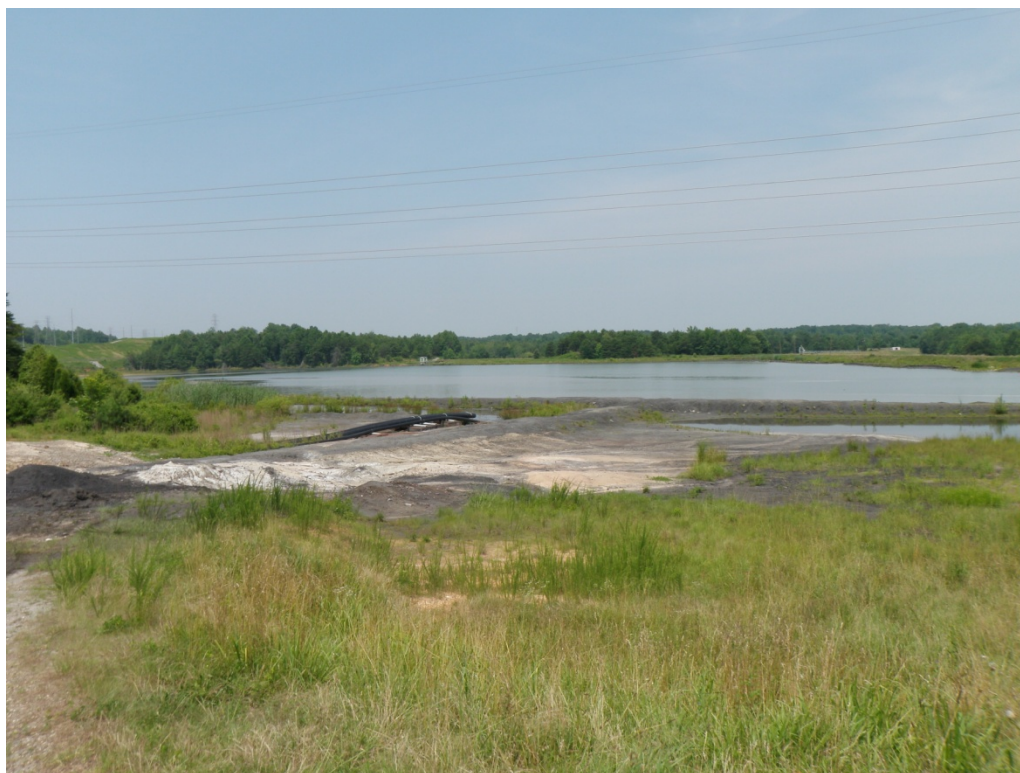
**Photo 2 – Primary Active Ash Pond Dam: Overview from right abutment.**

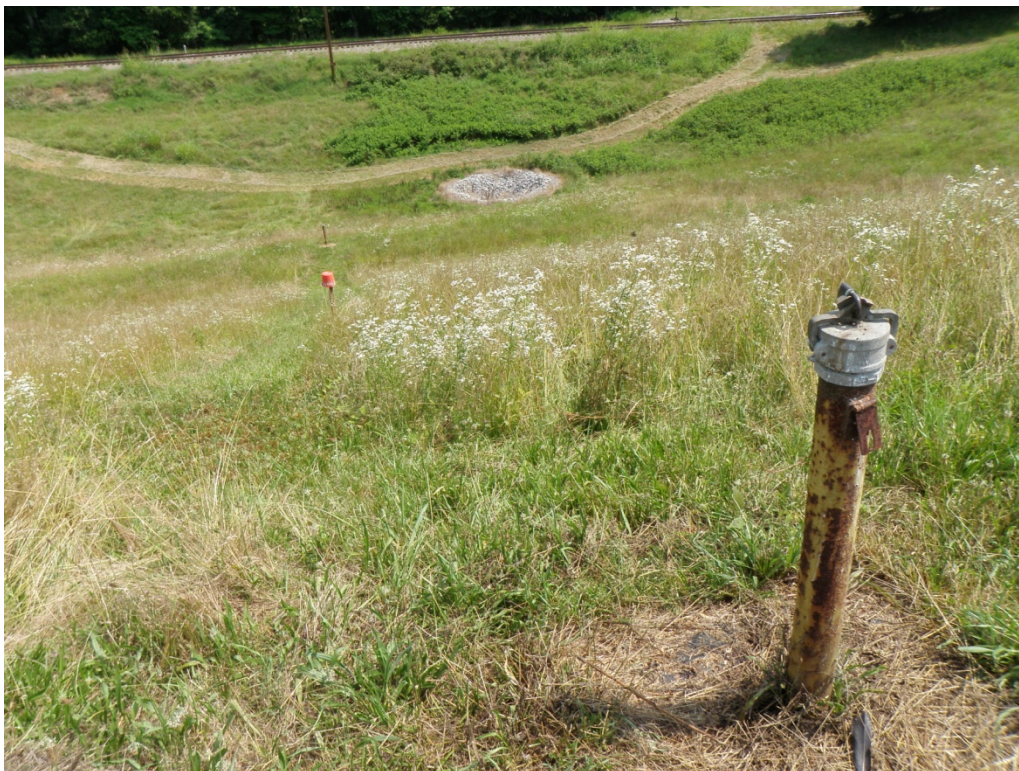
between December 2009 and April 2010 it rose about 17 feet. In April 2010 the water fell back to within several feet of its previous levels. The cause for the sudden rise in water level in piezometer L-4 is unknown.

**Photo 6 – Primary Active Ash Pond Dam: Piezometers L-4, L-5 and L-6 and toe drain inlet.**

5. The water level in piezometer L-4 began rising in October 2009, and was elevated until April 2010. The cause of the elevated water level should be investigated and corrected if necessary, and analyses should be performed to evaluate whether an elevated water level in the vicinity of L-4 could potentially compromise the safety of the Primary Ash Pond Dam.

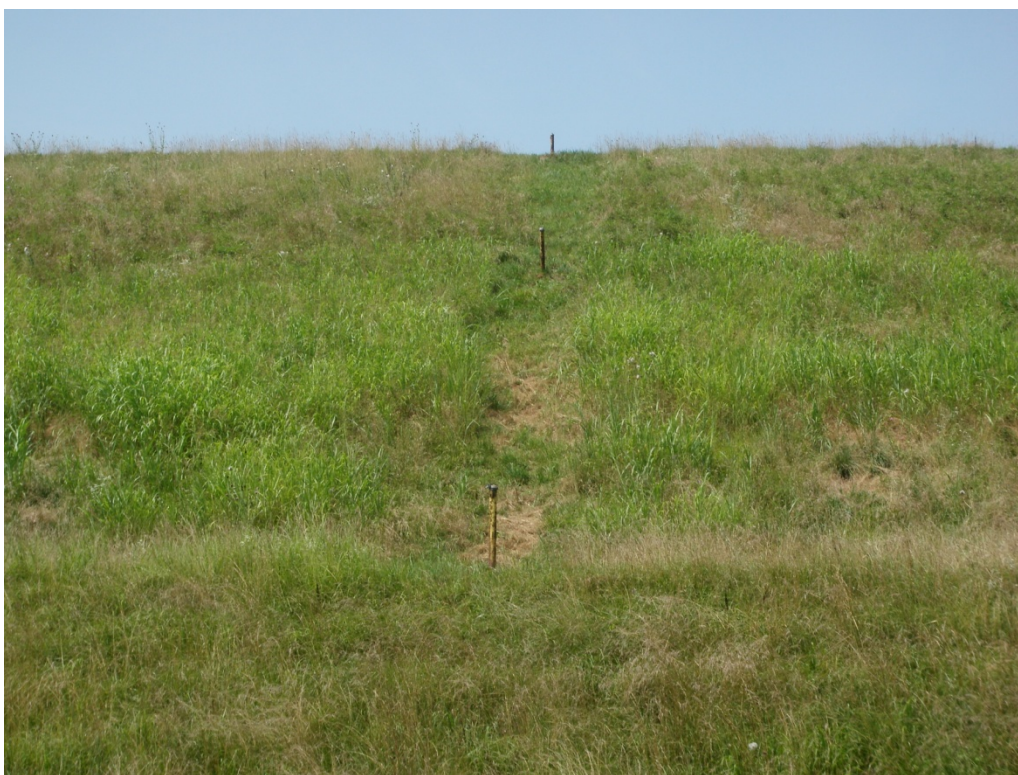
**Photo 16 – Secondary Ash Basin Dam: Piezometers L-7, L-8 and L-9.**

3. The liquefaction potential of the sandy silt comprising the embankment fill and the foundation should be evaluated.
4. The water level in piezometer L-9, near the toe of the Secondary Ash Basin dam, is about ten feet higher than the water levels in the piezometers at the toe of the Primary Active Ash Pond dam, and is higher than the piezometric surface assumed at this location in the stability analyses performed in 1984. The elevated water level may be caused by the seepage downstream of the right abutment of the Secondary Ash Basin dam, and may indicate that the toe drain in this area is not functioning properly. Stability analyses should specifically investigate whether the elevated water level in this area could compromise the stability of the dam.

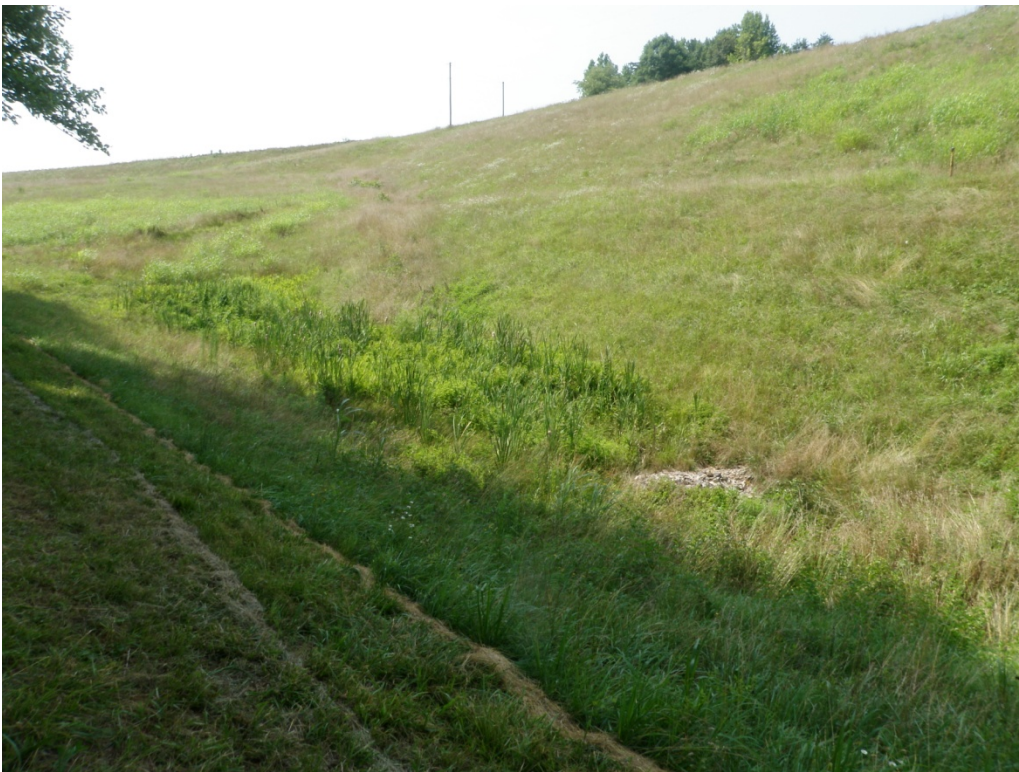
We observed a seepage area on the natural ground surface downstream of the right abutment of the Secondary Ash Basin dam, around El. 680. The ground surface in the seepage area is soft and wet, with flowing water in some areas. The flowing water was clear, and there were no boils, erosion or other signs of movement in the seepage area. Wetland-type vegetation was present in the seepage area. Duke Energy personnel indicated that there has been seepage in this area for at least 24 years, and that based on their visual monitoring, it has not increased, decreased or otherwise changed markedly over this time period. The seepage has never been measured or analyzed by Duke Energy. It is unknown whether the seepage originates from the Primary Active Ash Pond or the Secondary Ash Basin.

**Photo 18 – Secondary Ash Basin Dam: Seepage area downstream of right abutment. Note vegetation.**

1. We recommend formal monitoring and analysis of the seepage area downstream of the right abutment of the Secondary Ash Basin in order to evaluate whether seepage could potentially compromise the stability of the dam. Monitoring should include installation of a weir and grading to direct seepage toward the weir. The weir should then be monitored monthly in order to establish a baseline measurement of seepage quantity. Continued monitoring will then show whether the seepage quantity changes with time. In addition, we recommend measuring turbidity in the seepage. A large amount of fines in the seepage could indicate piping of material through the dam.

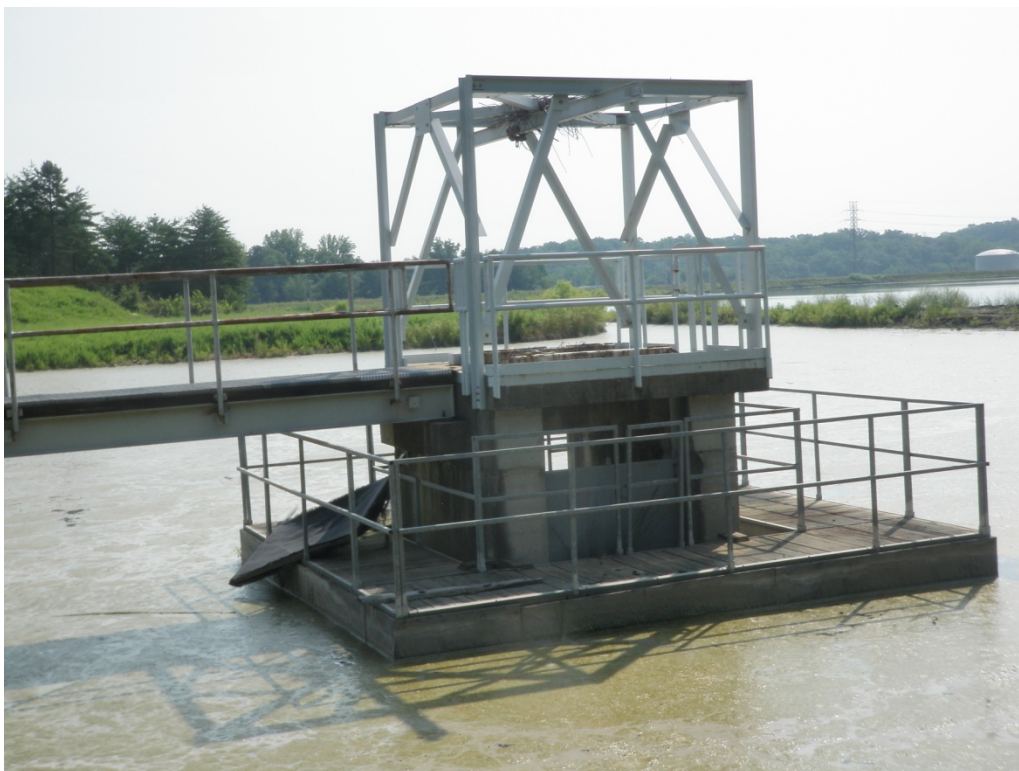
**Photo 22 –Primary Active Ash Pond outlet structure.**
