Specific Site Assessment for Coal Combustion Waste Impoundments at Duke Energy Carolinas Lee Steam Station

Williamston, South Carolina

December 2010
Project 092881

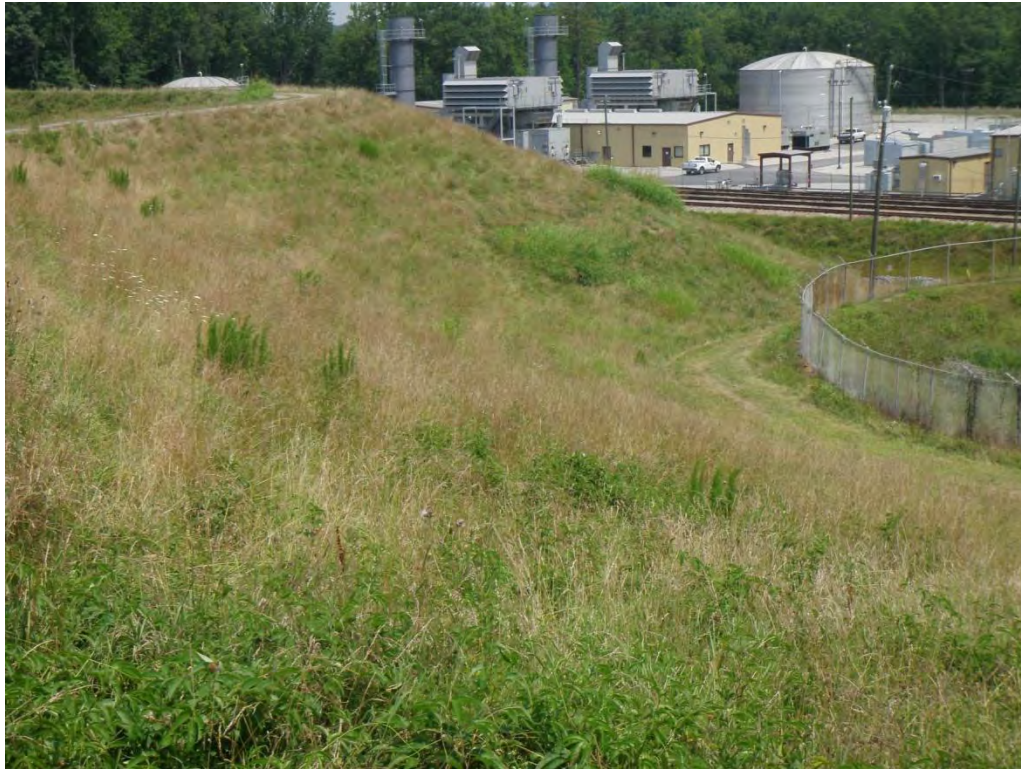
Photo 1 – Primary Active Ash Pond Dam : Downstream slope near right abutment.

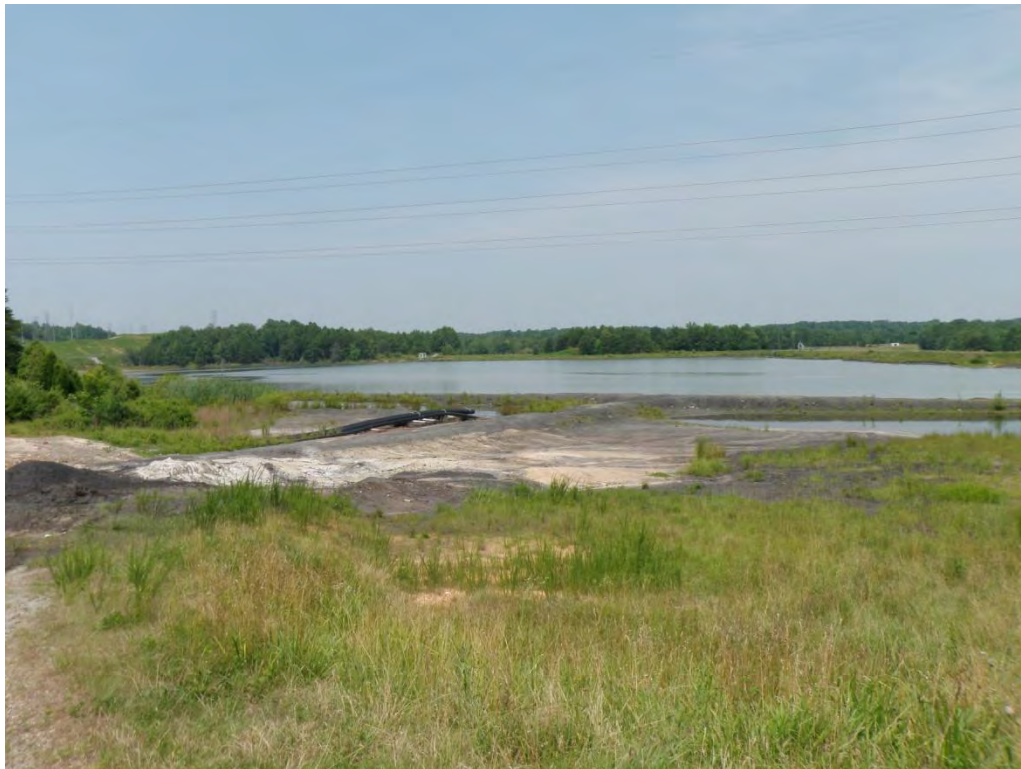
Photo 2 – Primary Active Ash Pond Dam: Overview from right abutment.

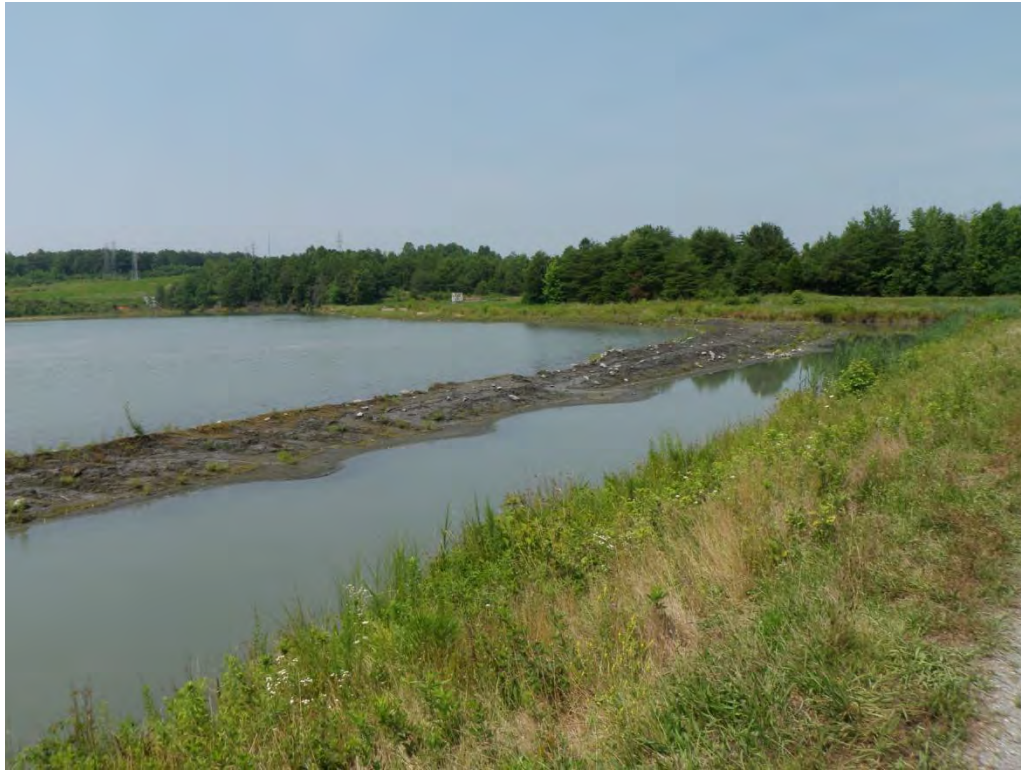
Photo 3 – Primary Active Ash Pond Dam: upstream slope and channel to decant pipe (looking west).

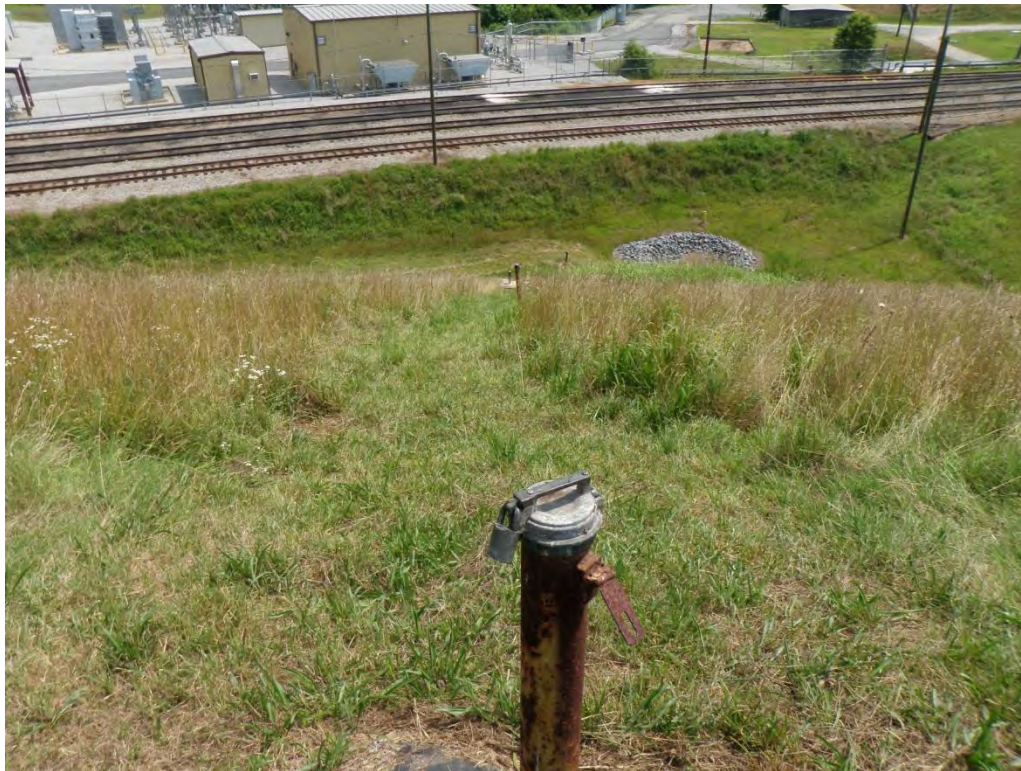
The water levels in piezometers L-1, L-2 and L-3, near the left abutment of the Primary Active Ash Pond dam, have remained relatively steady with time. The water level in piezometer L-3, at the dam toe, rose 6 to 7 feet in December 2005 and February 2010, but returned back to consistent levels in subsequent readings. The cause for these erratic readings is unknown.

Photo 4 – Primary Active Ash Pond Dam: Piezometers L-1, L-2 and L-3 and toe drain inlet.

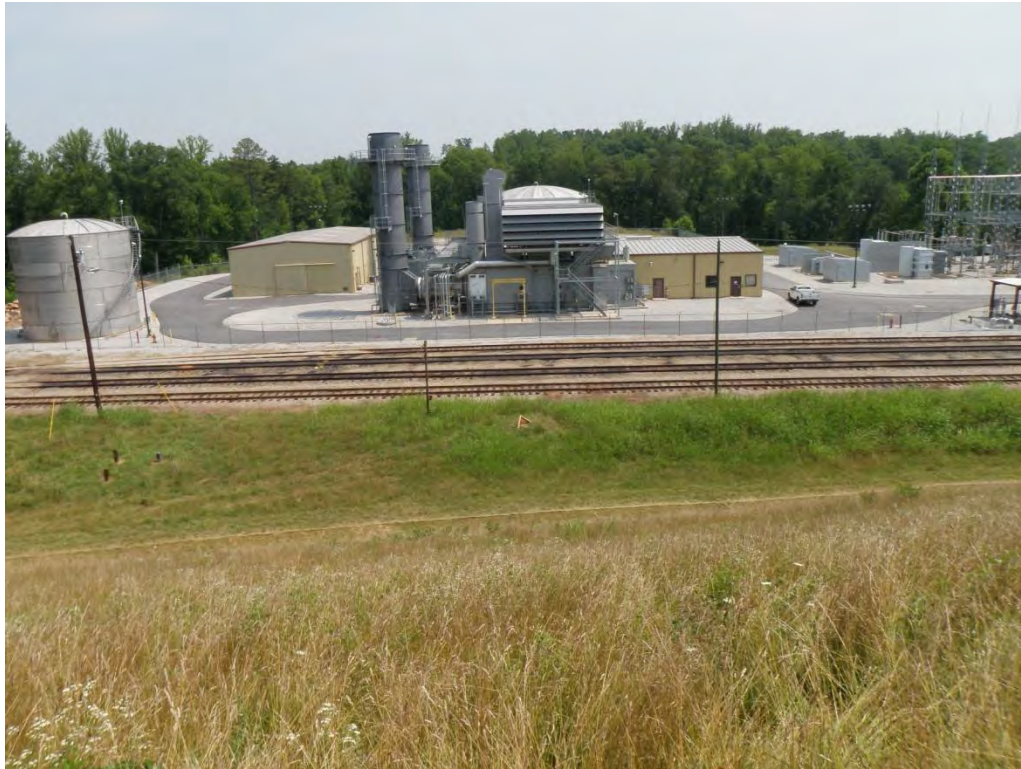
Photo 5 – Primary Active Ash Pond Dam: Plant buildings downstream.

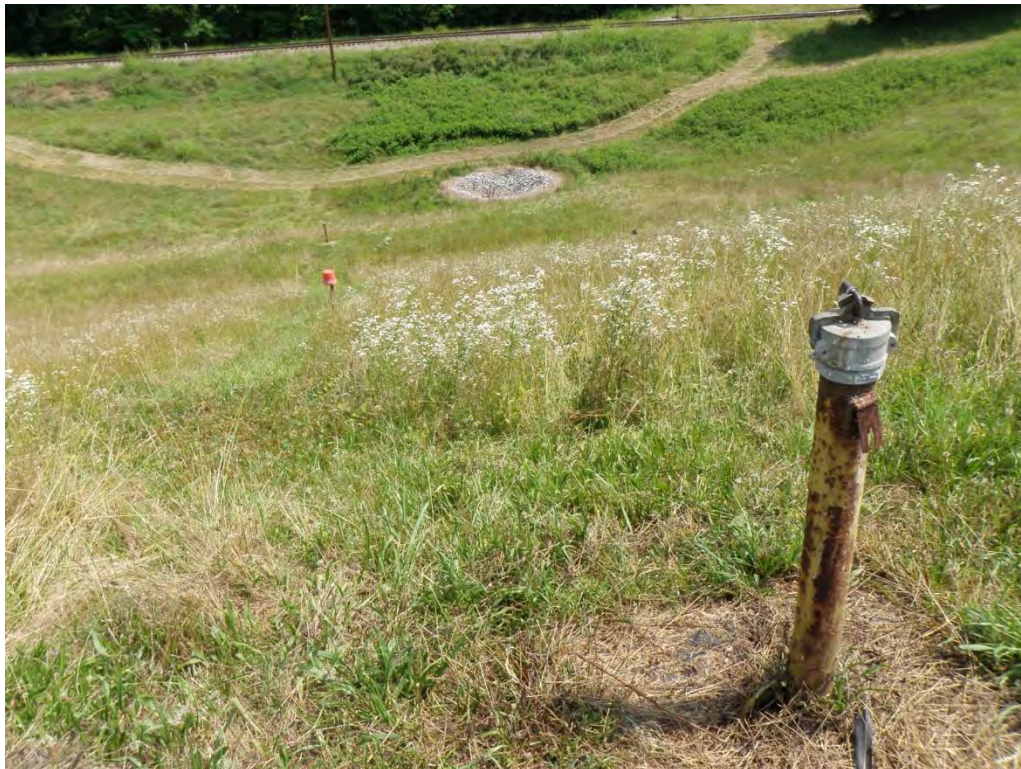
between December 2009 and April 2010 it rose about 17 feet. In April 2010 the water fell back to within several feet of its previous levels. The cause for the sudden rise in water level in piezometer L-4 is unknown.

Photo 6 – Primary Active Ash Pond Dam: Piezometers L-4, L-5 and L-6 and toe drain inlet.

5. The water level in piezometer L-4 began rising in October 2009, and was elevated until April 2010. The cause of the elevated water level should be investigated and corrected if necessary, and analyses should be performed to evaluate whether an elevated water level in the vicinity of L-4 could potentially compromise the safety of the Primary Ash Pond Dam.

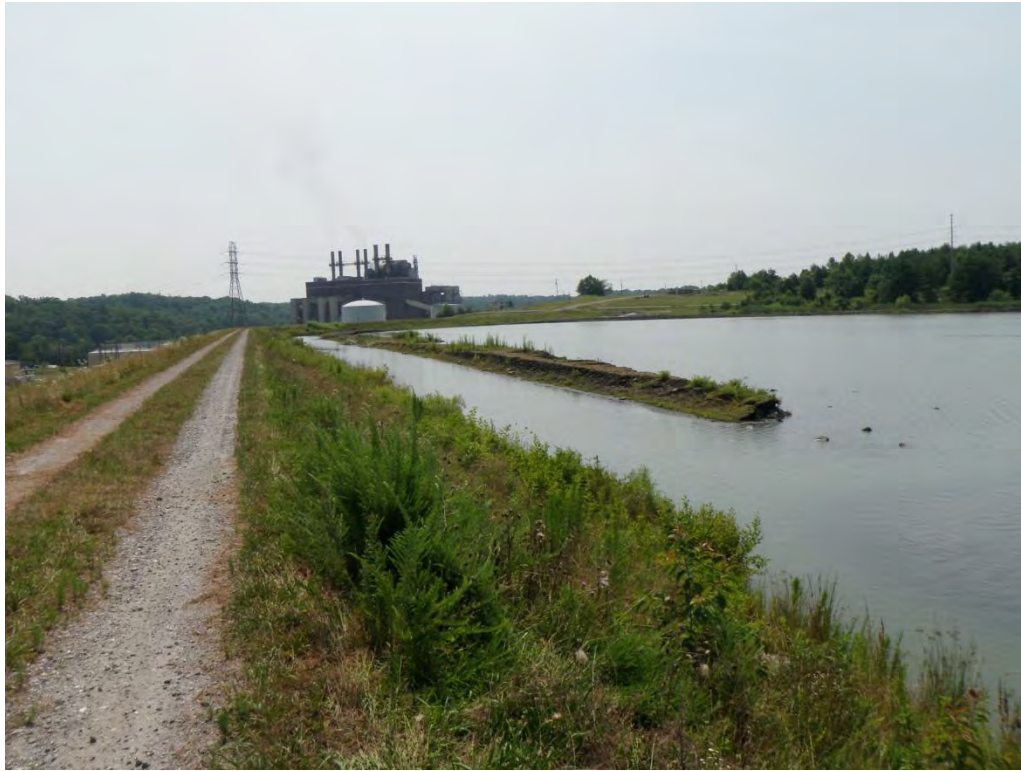
Photo 7 – Primary Active Ash Pond Dam: Upstream face and channel to decant pipe (looking east).

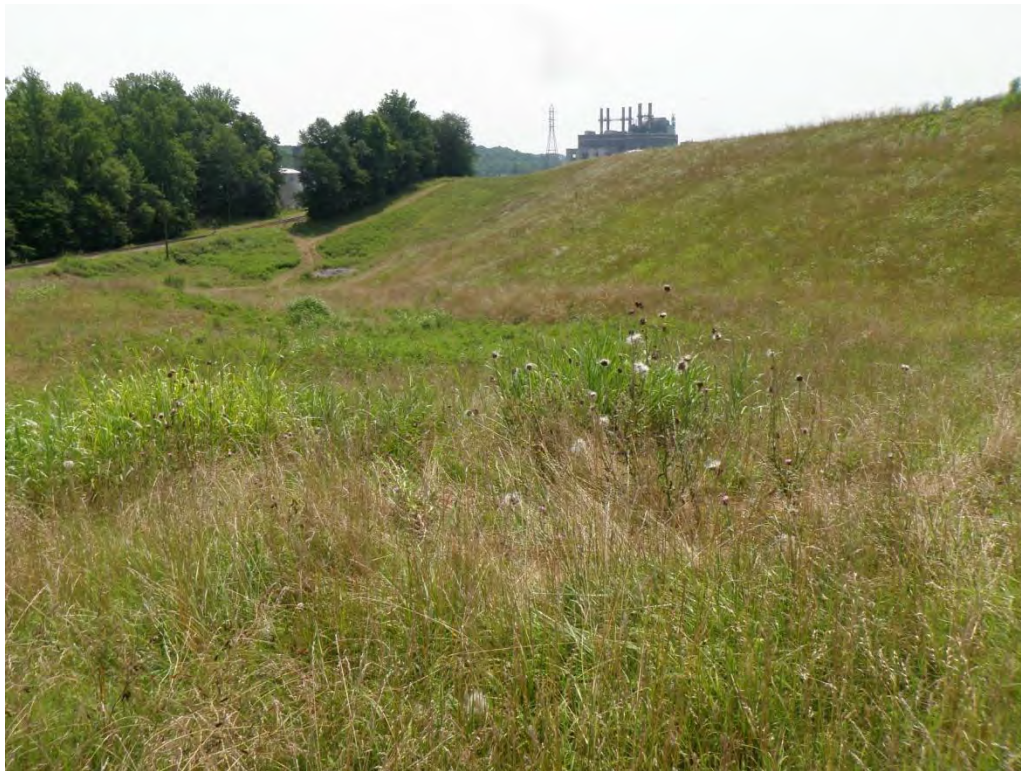
Photo 8 – Primary Active Ash Pond Dam: downstream face from left abutment.

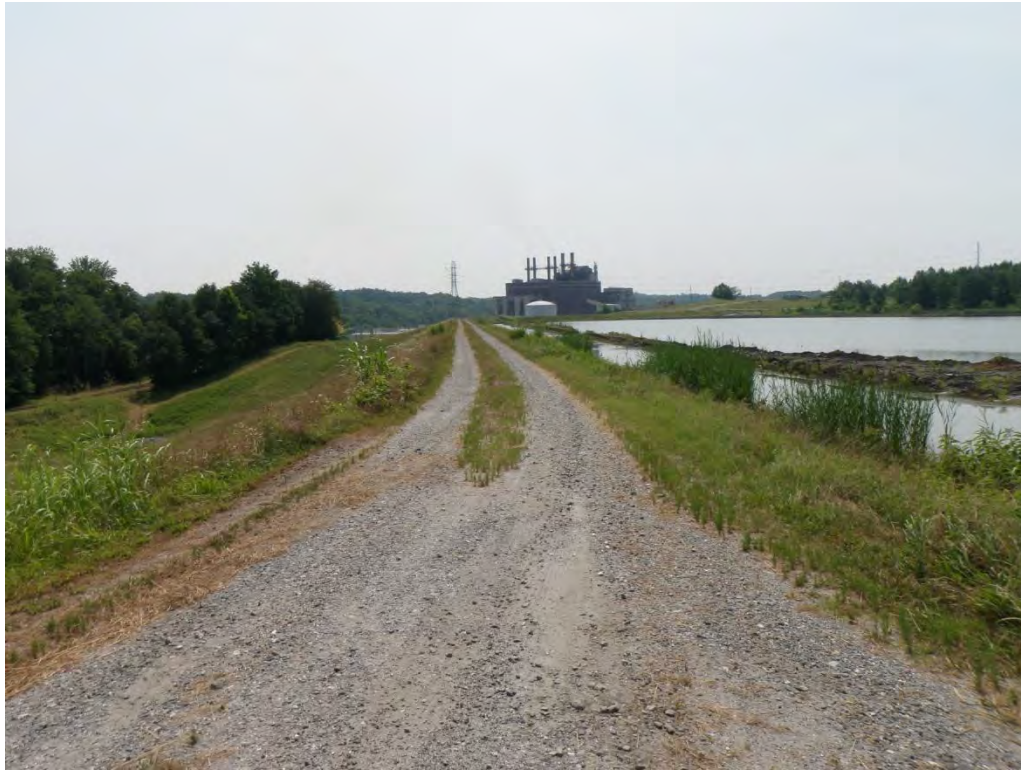
Photo 9 – Primary Active Ash Pond Dam: Crest from left abutment.

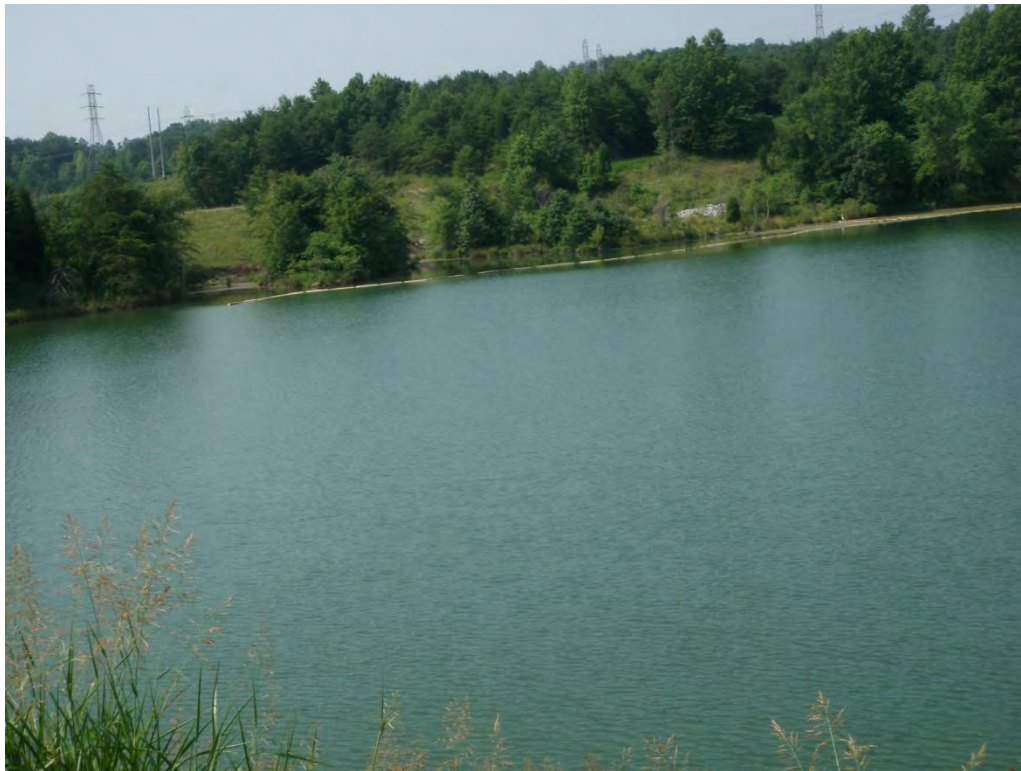
Photo 10 – Secondary Ash Basin: Looking across pond to divider dike.

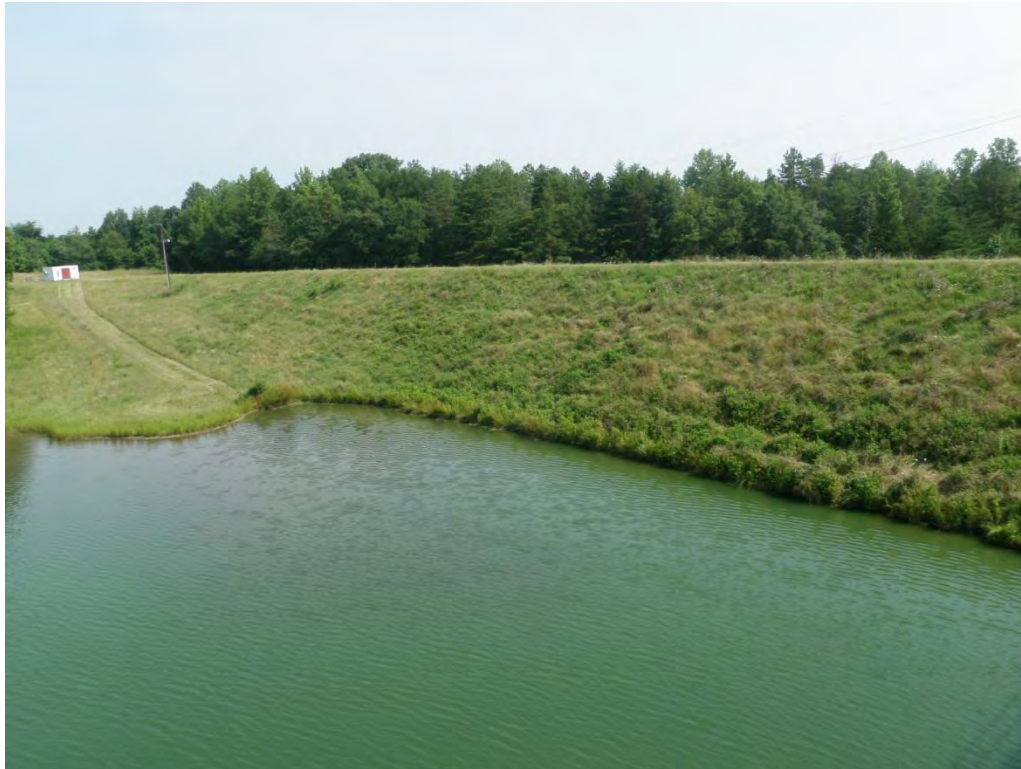
Photo 11 – Secondary Ash Basin Dam: Upstream slope and left abutment.

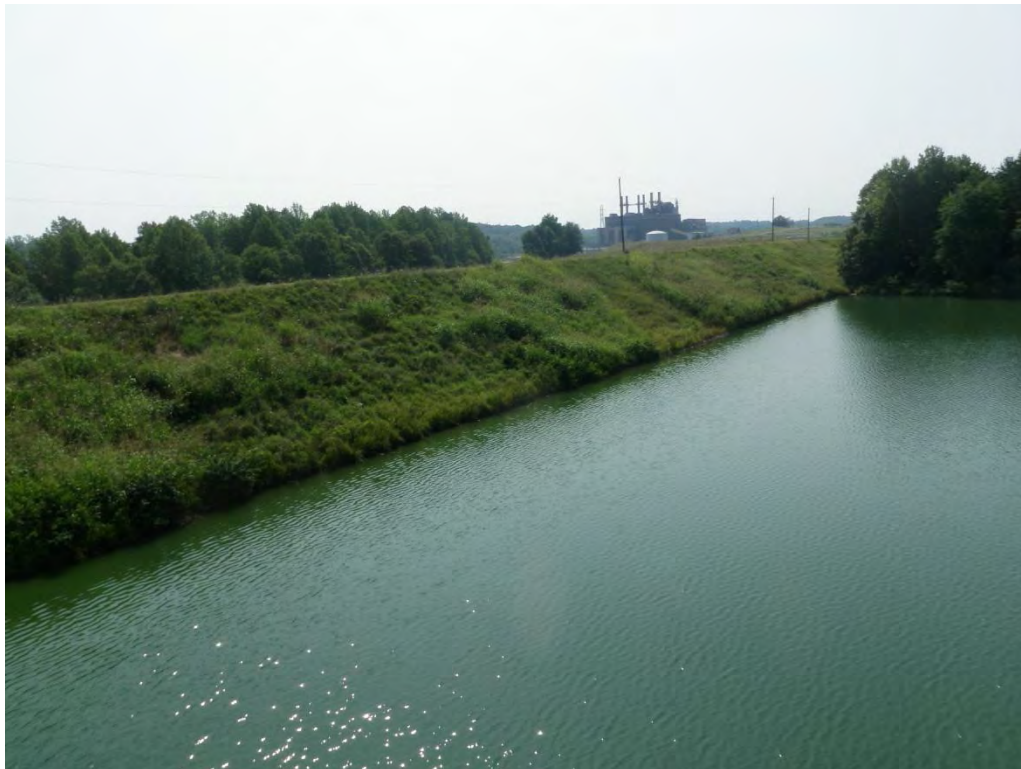
Photo 12 – Secondary Ash Basin Dam: Upstream slope looking toward right abutment.

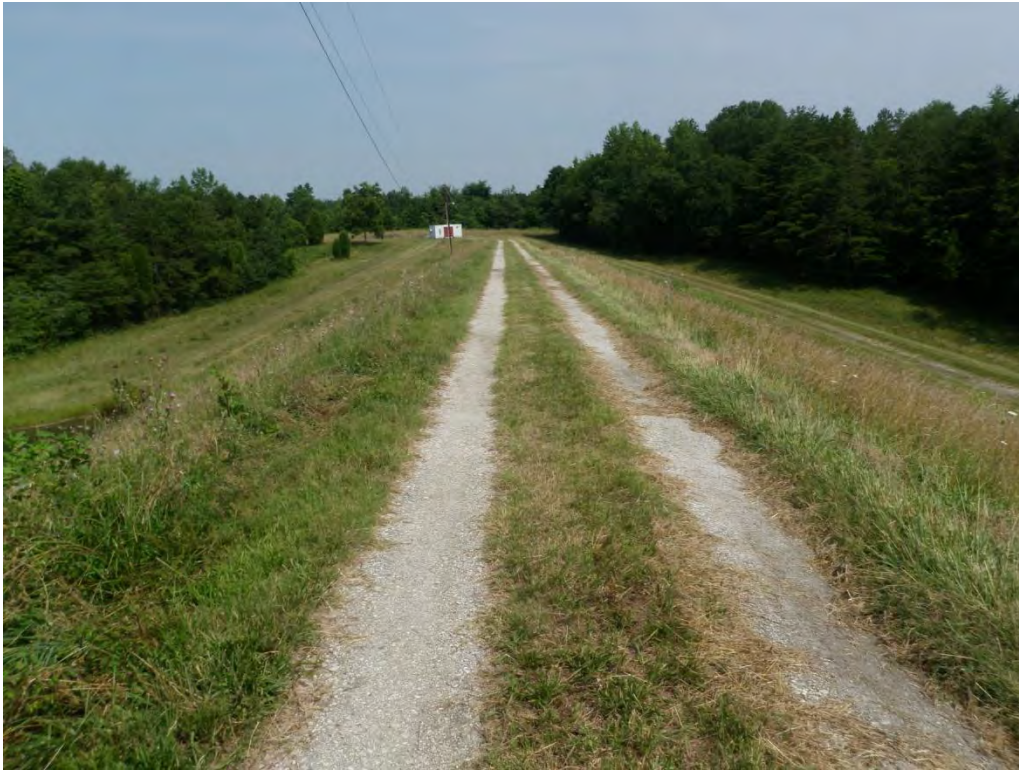
Photo 13 – Secondary Ash Basin Dam: Crest, looking west.

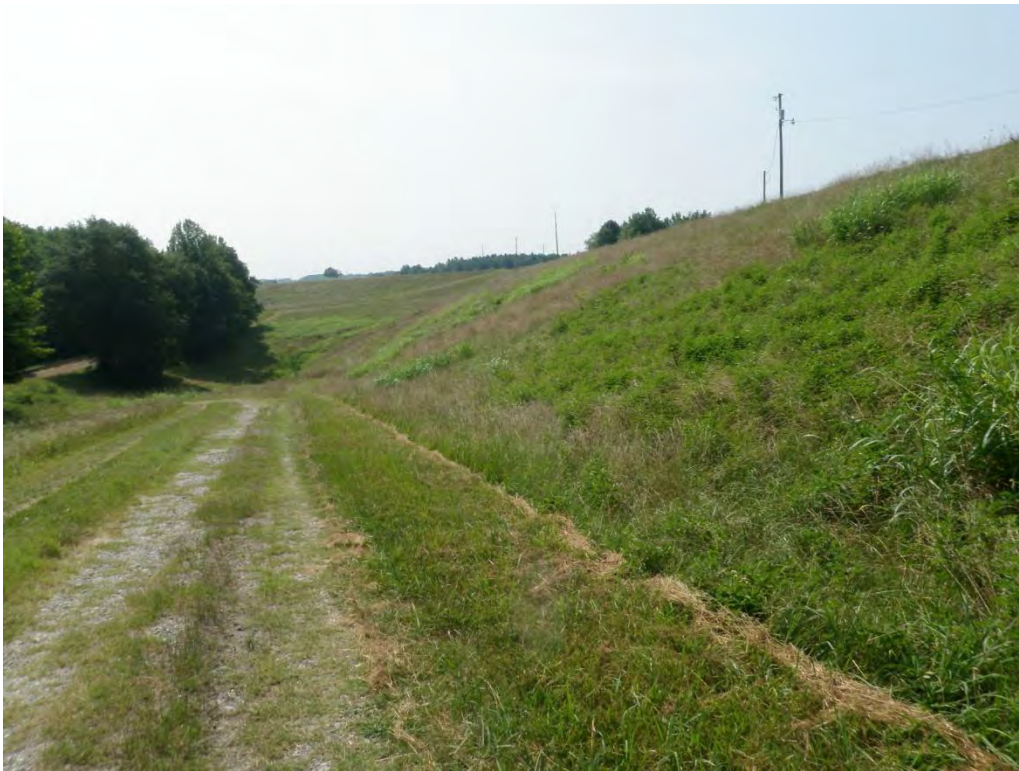
Photo 14 – Secondary Ash Basin Dam: Downstream slope from left abutment.

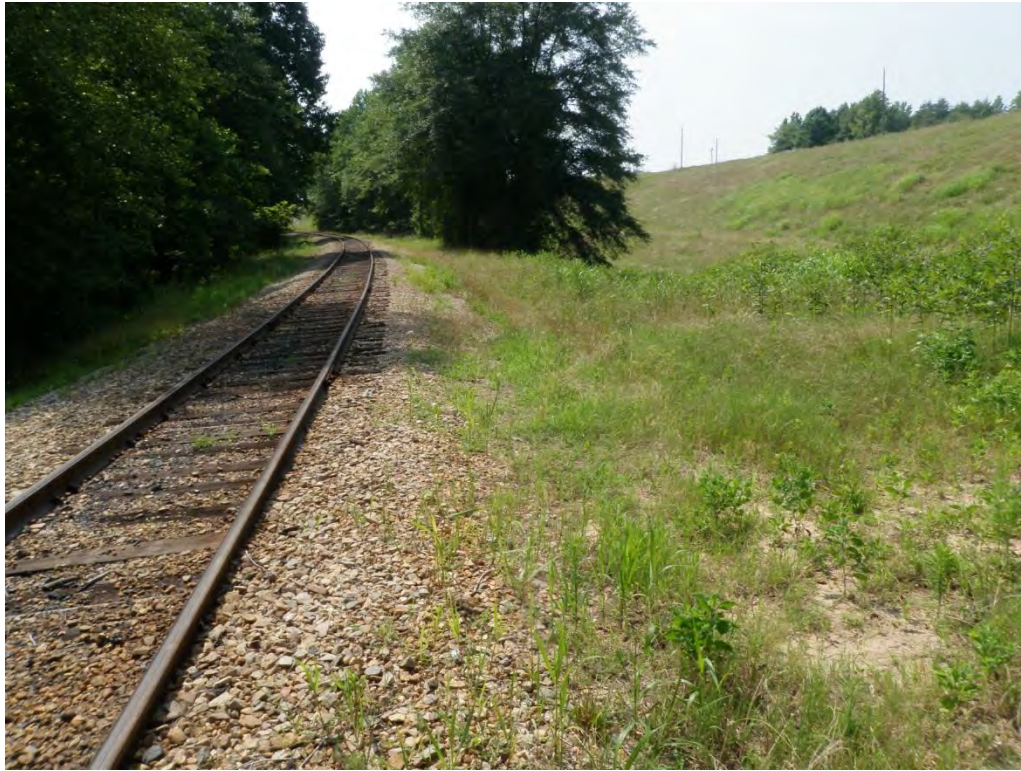
Photo 15 – Secondary Ash Basin Dam: Railroad embankment downstream of toe.

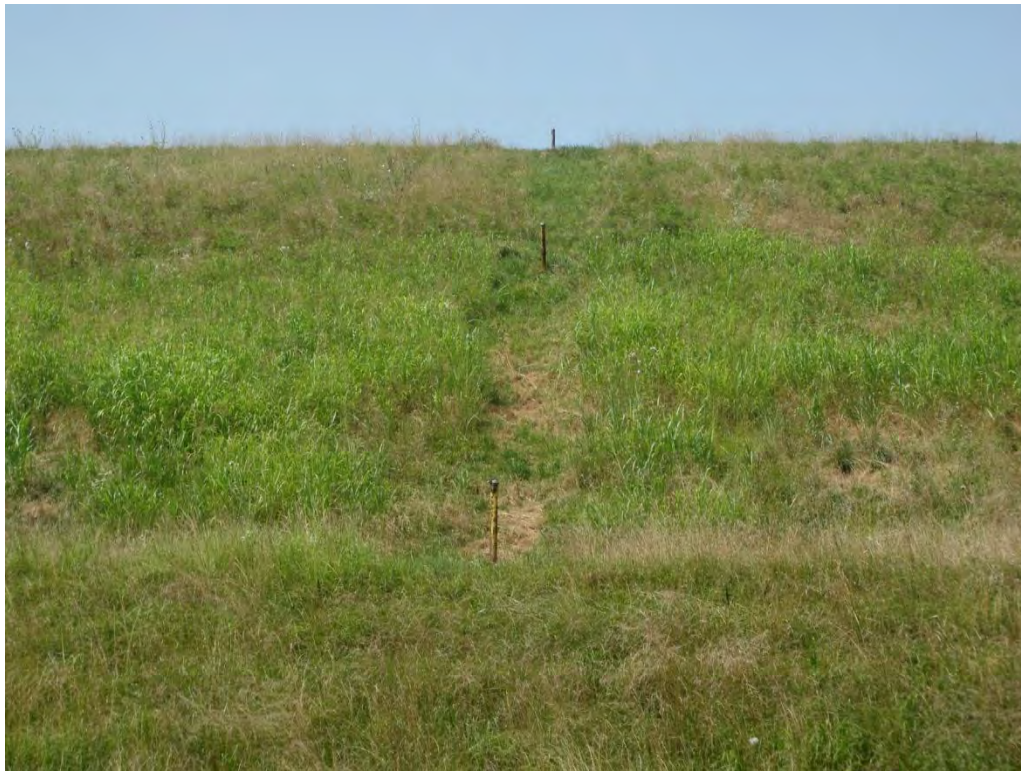
Photo 16 – Secondary Ash Basin Dam: Piezometers L-7, L-8 and L-9.

3. The liquefaction potential of the sandy silt comprising the embankment fill and the foundation should be evaluated.
4. The water level in piezometer L-9, near the toe of the Secondary Ash Basin dam, is about 10 feet higher than the water levels in the piezometers at the toe of the Primary Active Ash Pond dam, and is higher than the piezometric surface assumed at this location in the stability analyses performed in 1984. The elevated water level may be caused by the seepage downstream of the right abutment of the Secondary Ash Basin dam, and may indicate that the toe drain in this area is not functioning properly. Stability analyses should specifically investigate whether the elevated water level in this area could compromise the stability of the dam.

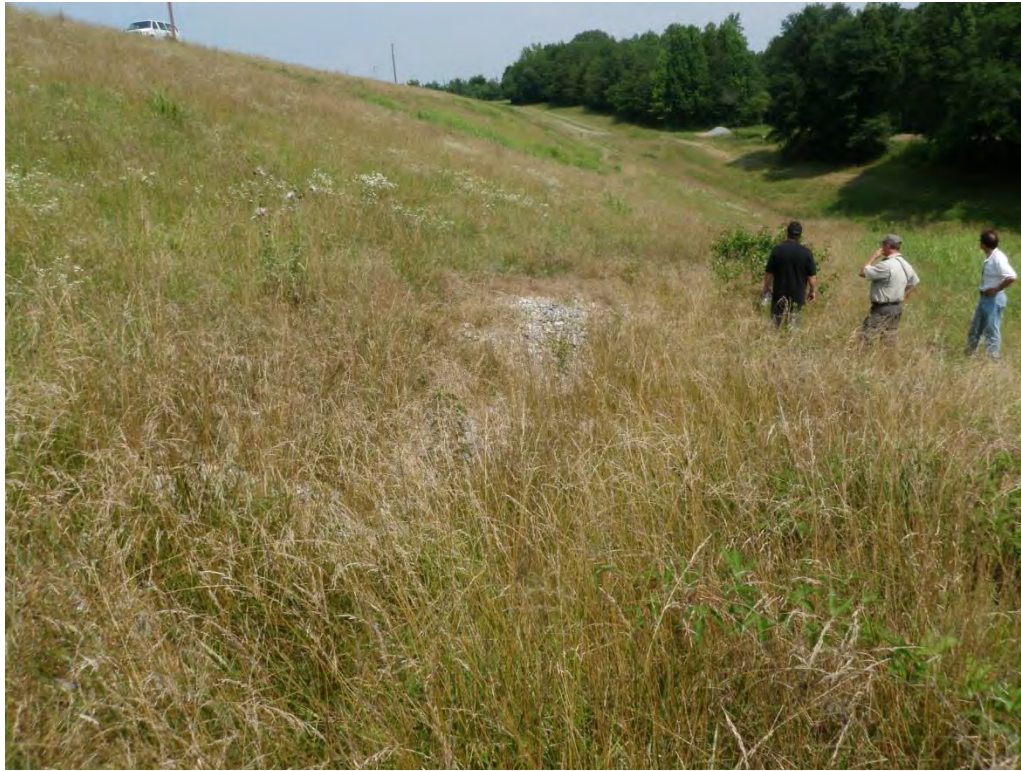
Photo 17 – Secondary Ash Basin Dam: Downstream face from left abutment. Note riprap along abutment contact.

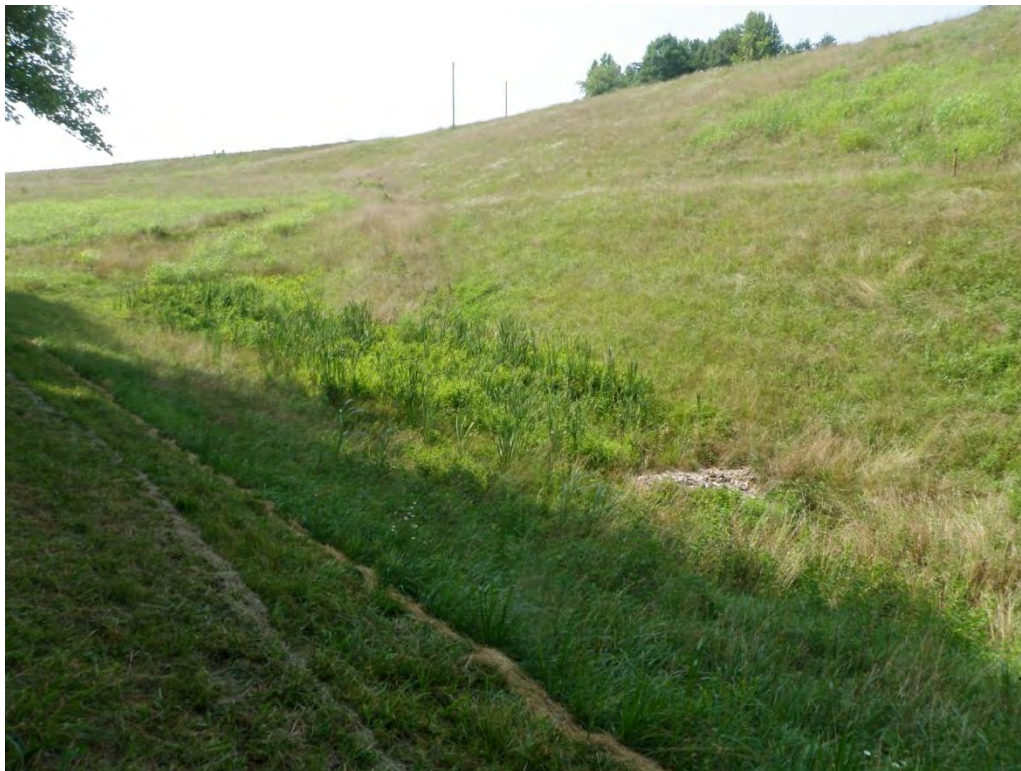
We observed a seepage area on the natural ground surface downstream of the right abutment of the Secondary Ash Basin dam, around El. 680. The ground surface in the seepage area is soft and wet, with flowing water in some areas. The flowing water was clear, and there were no boils, erosion or other signs of movement in the seepage area. Wetland-type vegetation was present in the seepage area. Duke Energy personnel indicated that there has been seepage in this area for at least 24 years, and that based on their visual monitoring, it has not increased, decreased or otherwise changed markedly over this time period. The seepage has never been measured or analyzed by Duke Energy. It is unknown whether the seepage originates from the Primary Active Ash Pond or the Secondary Ash Basin.

Photo 18 – Secondary Ash Basin Dam: Seepage area downstream of right abutment. Note vegetation.

1. We recommend formal monitoring and analysis of the seepage area downstream of the right abutment of the Secondary Ash Basin in order to evaluate whether seepage could potentially compromise the stability of the dam. Monitoring should include installation of a weir and grading to direct seepage toward the weir. The weir should then be monitored monthly in order to establish a baseline measurement of seepage quantity. Continued monitoring will then show whether the seepage quantity changes with time. In addition, we recommend measuring turbidity in the seepage. A large amount of fines in the seepage could indicate piping of material through the dam.

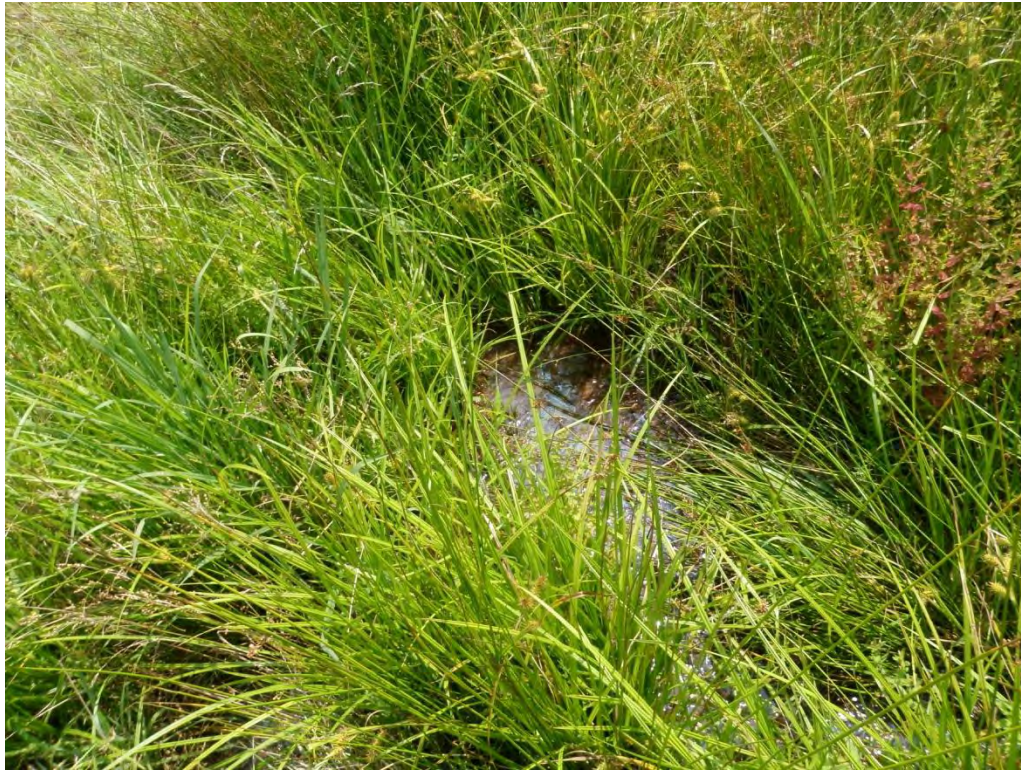
Photo 19 – Secondary Ash Basin Dam: Flowing water in seepage area.

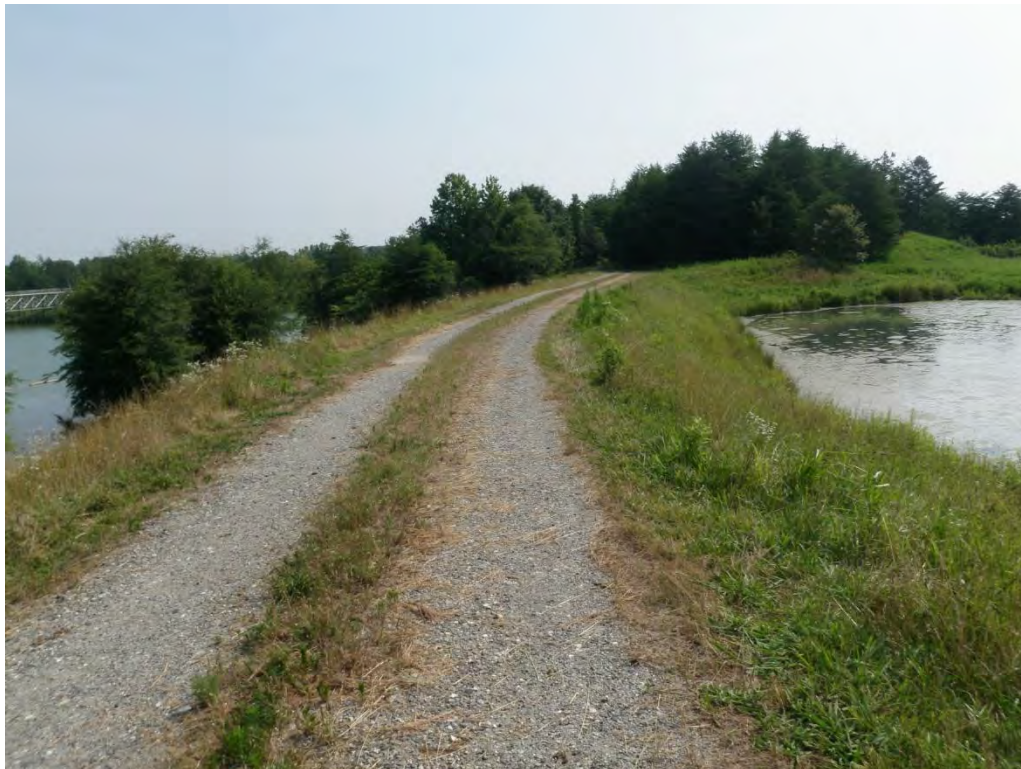
Photo 20- Divider Dike: Crest.

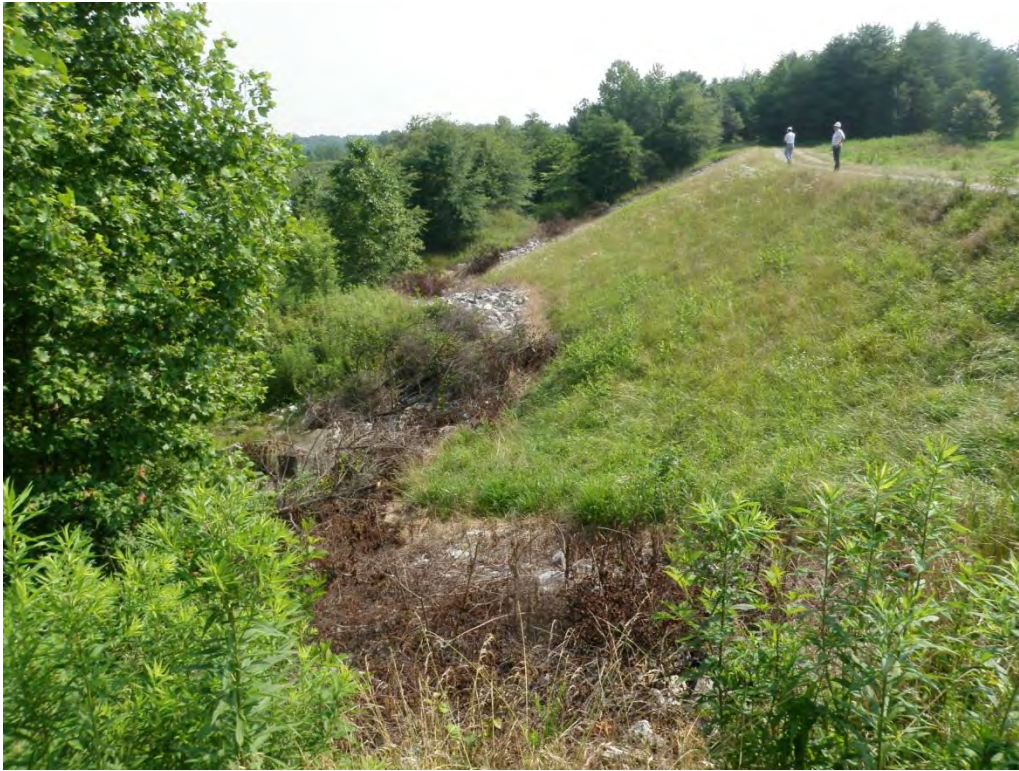
Photo 21 –Divider Dike: Downstream slope.

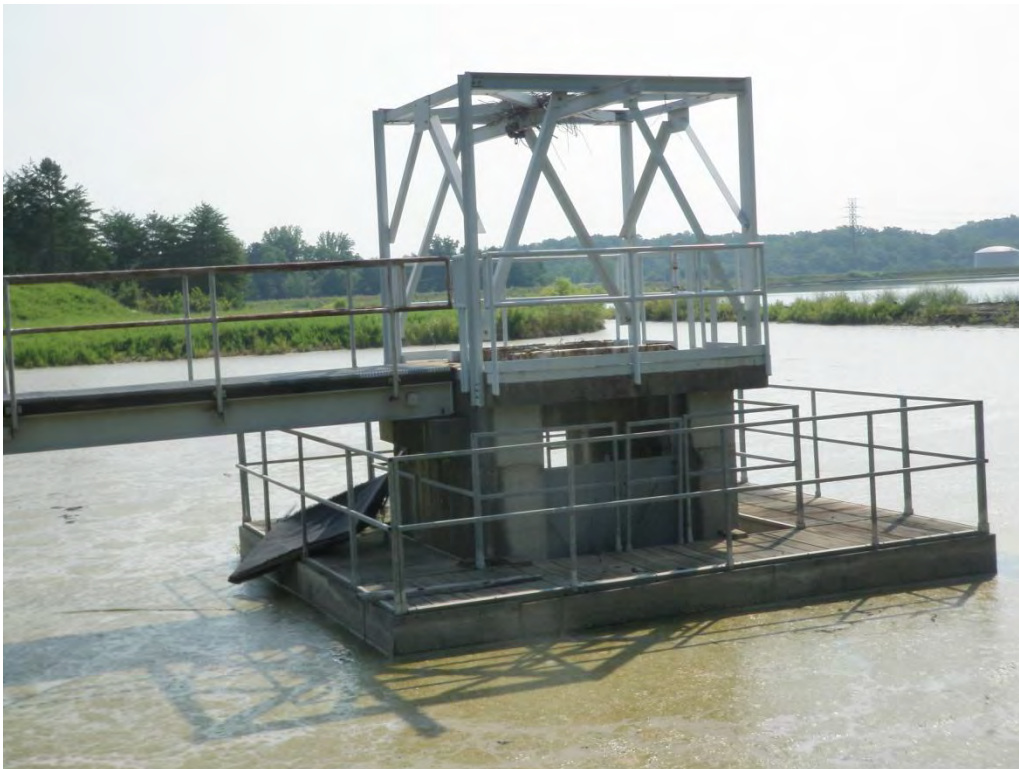
Photo 22 –Primary Active Ash Pond outlet structure.

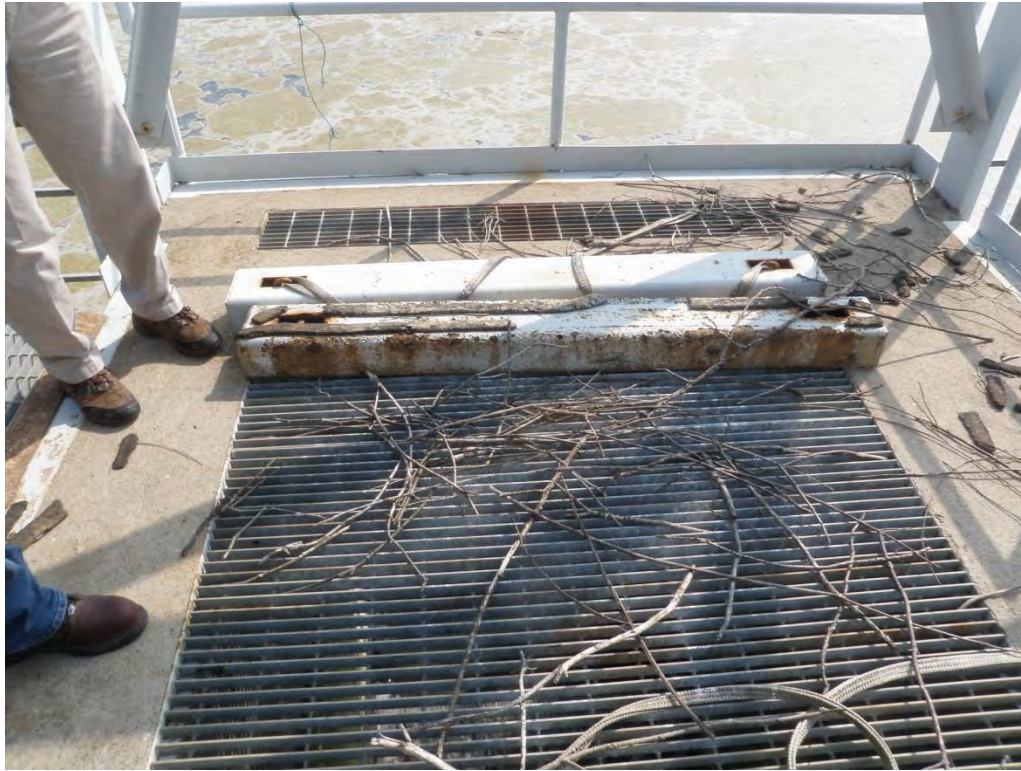
Photo 23 –Primary Active Ash Pond outlet structure – stop logs.

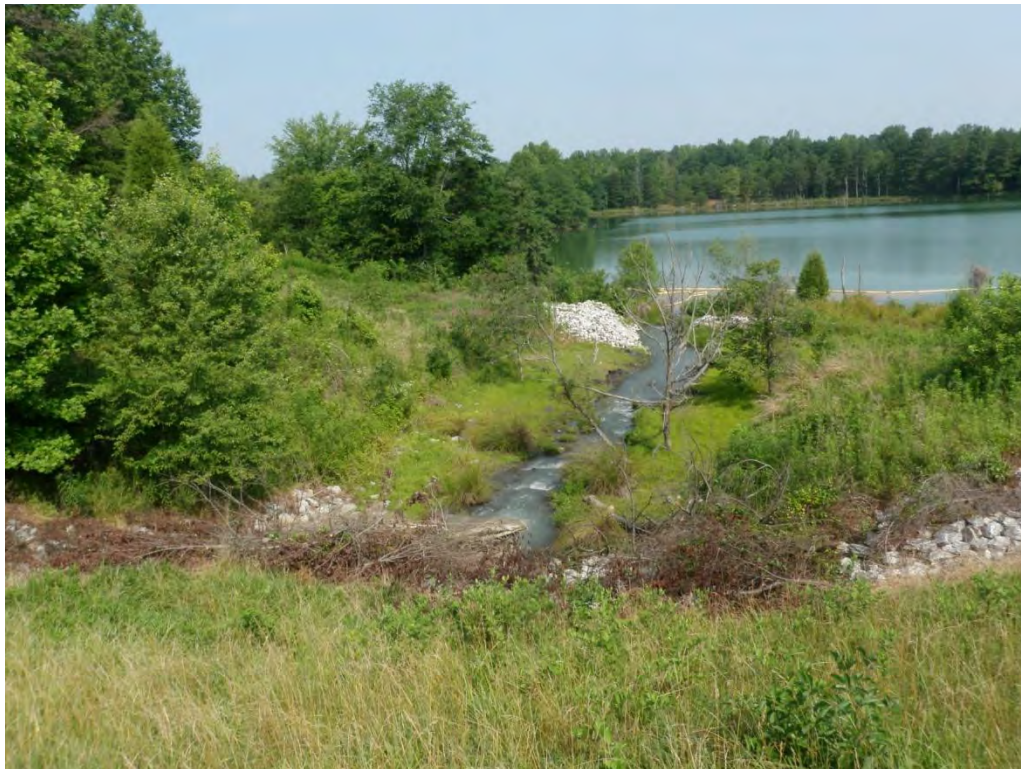
Photo 24 –Primary Active Ash Pond outlet structure – channel to Secondary Ash Basin.

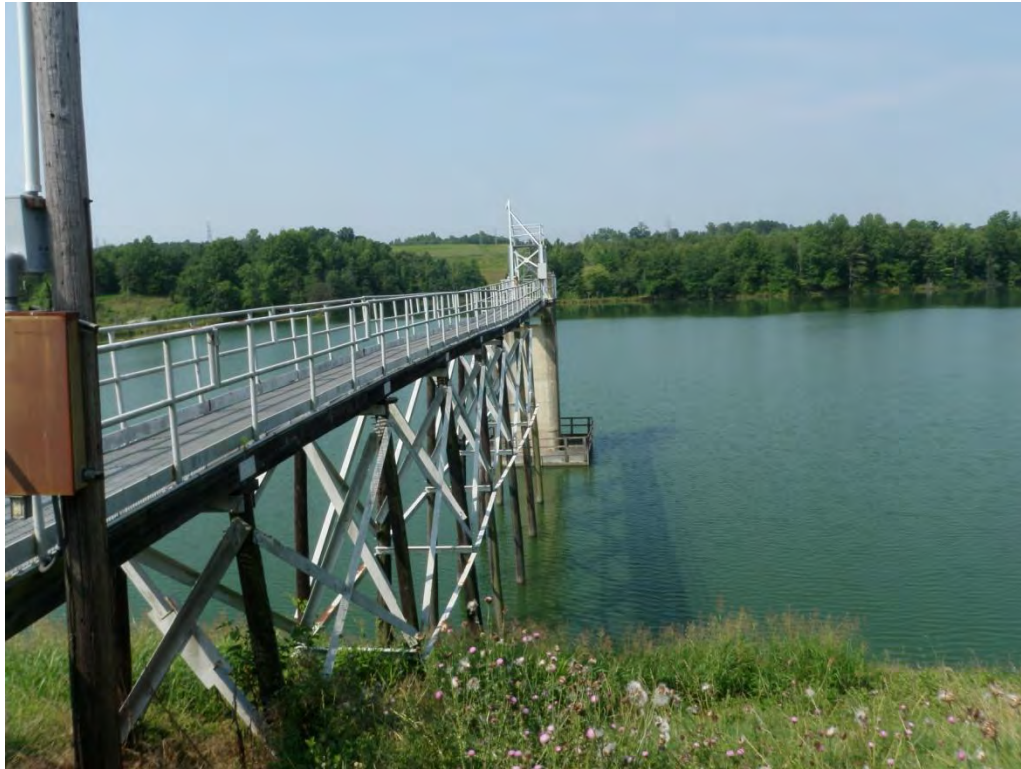
Photo 25 – Secondary Ash Basin outlet structure and bridge.

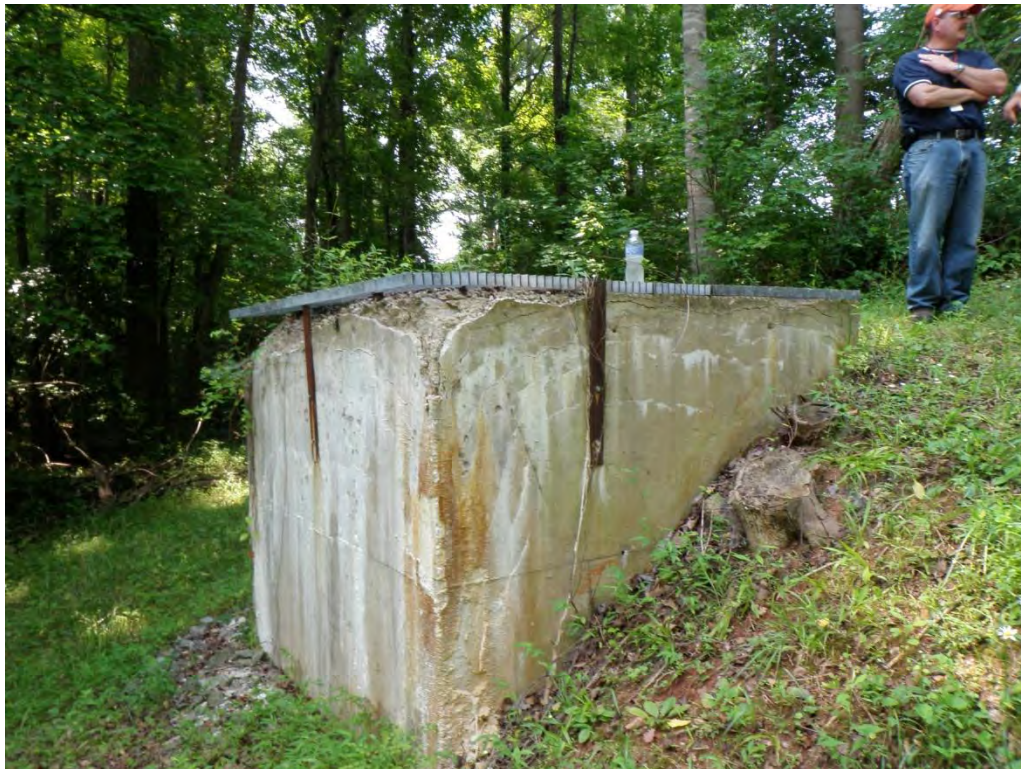
The exterior of the drop box downstream of the Secondary Ash Basin exhibits some degradation. The inside of the box may also be degrading due to turbulent flow.

Photo 26 – Secondary Ash Basin outlet works – drop box downstream of dam. Note spalling.

6. The inside and outside of the drop box downstream of the Secondary Ash Basin should be monitored for continued degradation, and repaired or replaced if necessary.

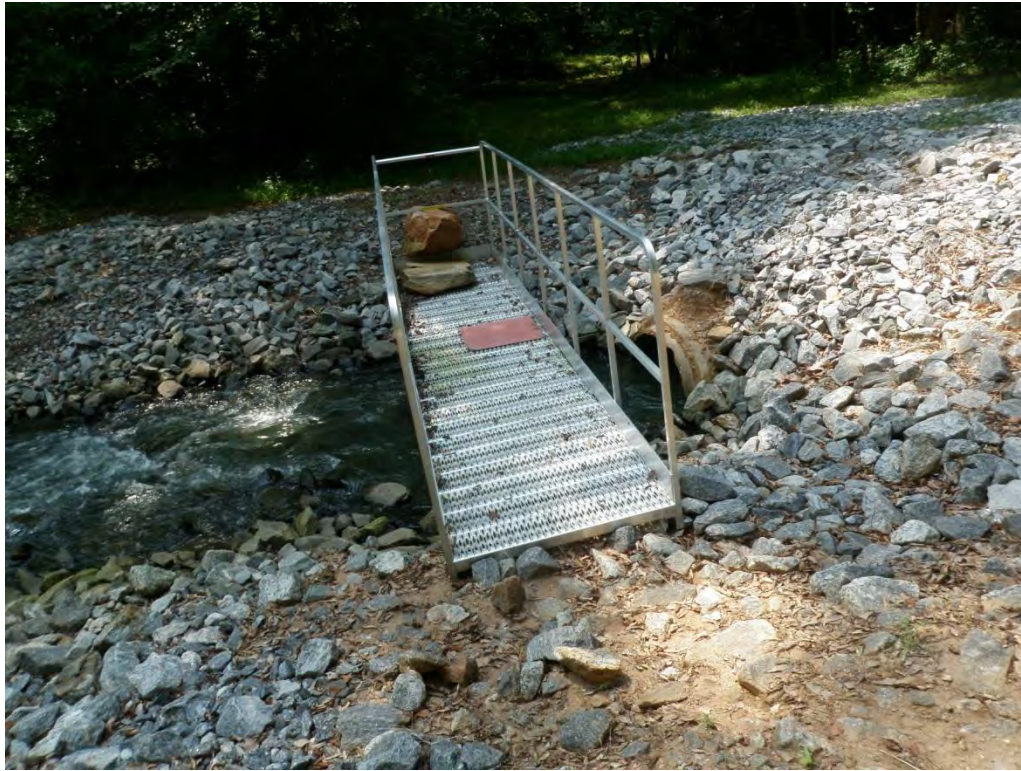
Photo 27 – Secondary Ash Basin outlet works – discharge conduit.
