Specific Site Assessment for Coal Combustion Waste Impoundments at Duke Energy Carolinas Lee Steam Station

Williamston, South Carolina

December 2010
Project 092881

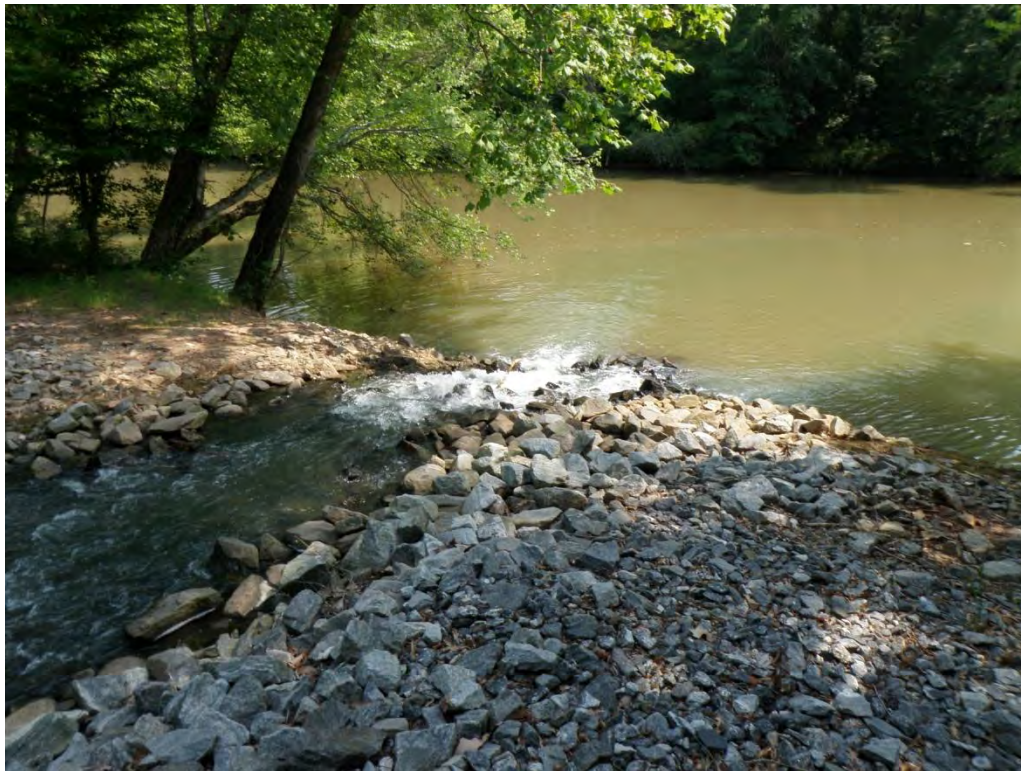
Photo 28 – Secondary Ash Basin outlet works – discharge channel to Saluda River.

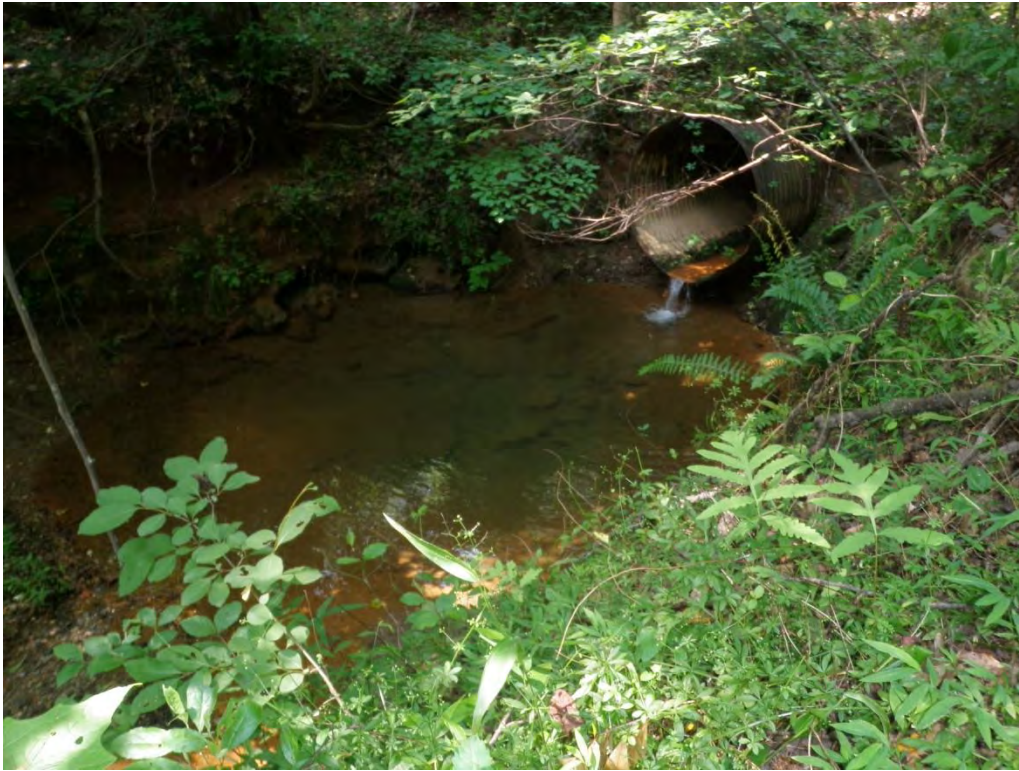
Photo 29 – Secondary Ash Basin toe drain outlet.
