**Coal Combustion Waste Impoundment**

**Round 6 - Dam Assessment Report**

***Vermilion Power Station (Site 015)***

***Fly Ash Dikes***

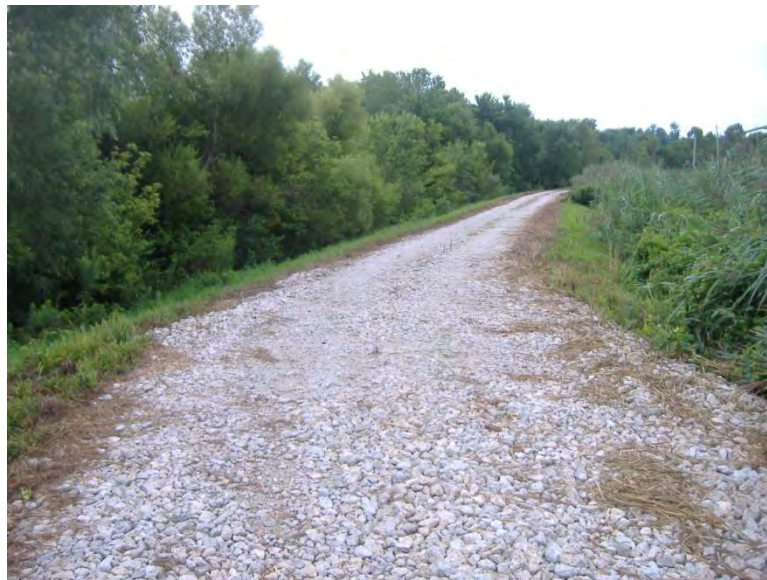
The crest of the embankment had no signs of significant depressions, tension cracks or other indications of settlement or shear failure. A gravel service road covered the majority of the embankment. Figure 5.2.1-1 shows the typical crest conditions.

Figure 5.2.1-1: Photograph of Crest of North Ash Pond System Embankment

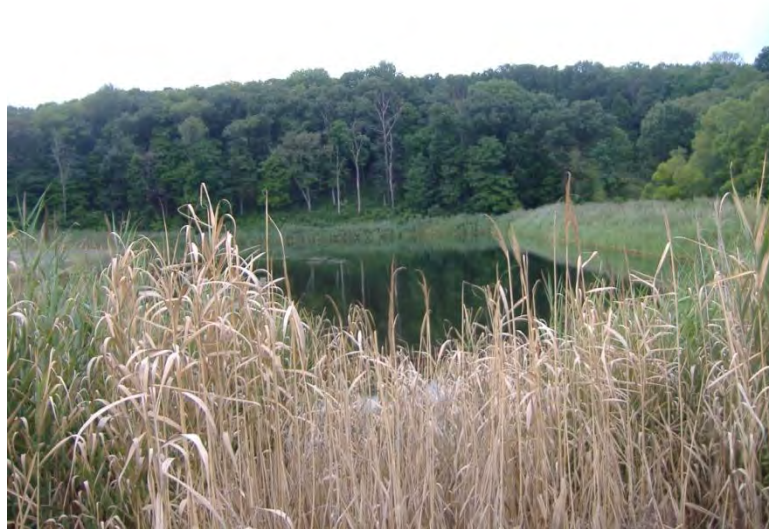
The inside slope of the North Ash Pond System embankment is vegetated with various species of tall grass and weeds. Heavy overgrowth in the primary cell of the North Ash Pond System made close observation of embankment conditions difficult. There were no observed scarps, sloughs, bulging, cracks, depressions or other indications of slope instability. Figure 5.2.2-1 shows a representative section of the inside slope of the primary cell embankment. Figure 5.2.2-2 shows a representative section of the inside slope of the secondary cell embankment.

Figure 5.2.2-1: Photograph of the Inside Slope of the North Ash Pond System Primary Cell Embankment

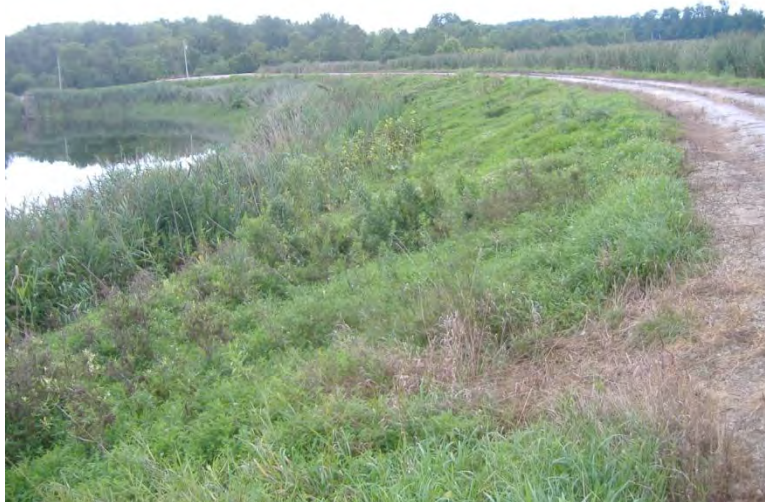
Figure 5.2.2-2: Photograph of the Inside Slope of the North Ash Pond System Secondary Cell Embankment

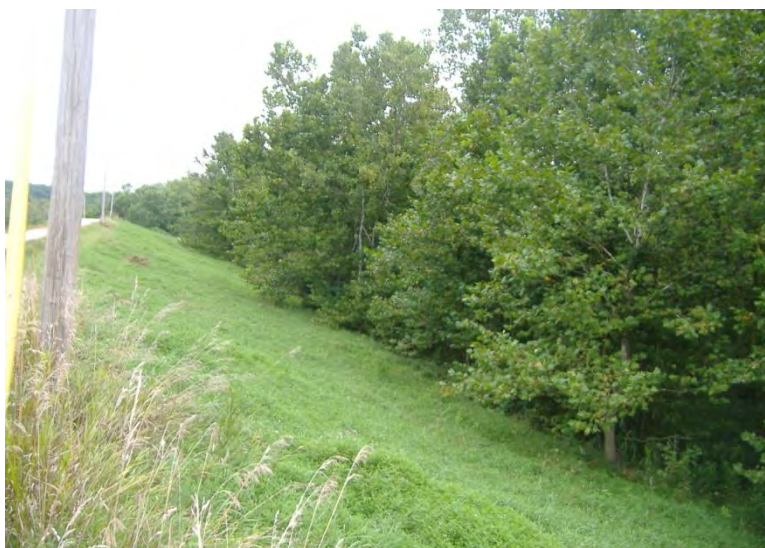
The outside slope of the embankment is vegetated with various species of tall grass and weeds. No major scarps, sloughs, bulging, cracks, depressions or other indications of slope instability, or signs of uncontrolled seepage were observed. Figure 5.2.3-1 shows a representative section of the outside slope of the embankment.

Figure 5.2.3-1: Photograph of the Outside Slope of the North Ash Pond System Embankment.

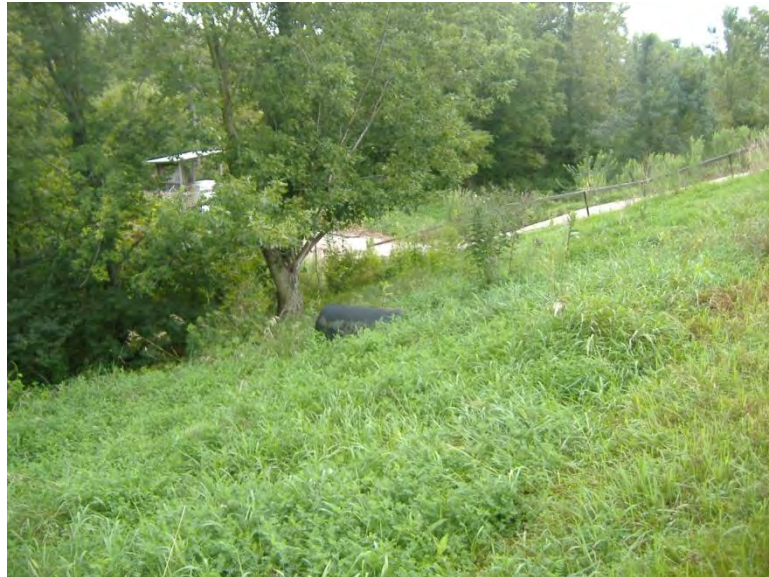
One large tree was observed near the emergency spillway of the North Ash Pond System. Figure 5.2.3-2 shows the tree.

Figure 5.2.3-2: Photograph of Large Tree Near Emergency Spillway on North Ash Pond System Embankment.

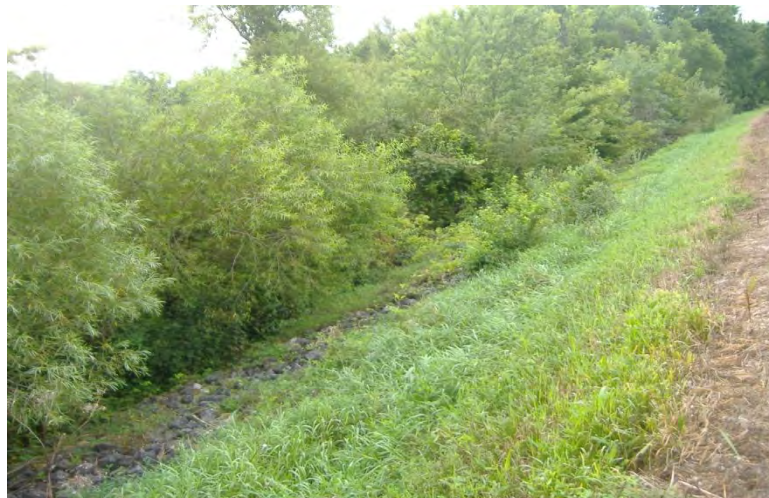
Most of the toe of the embankment is densely vegetated with various species of trees, grass, and weeds. In some sections, the toe is also armored with riprap. Figure 5.2.3-3 shows a portion of the toe that is armored with riprap and also covered in dense vegetation.

Figure 5.2.3-3: Photograph of Riprap and Dense Vegetation at the Toe of the North Ash Pond System Embankment.

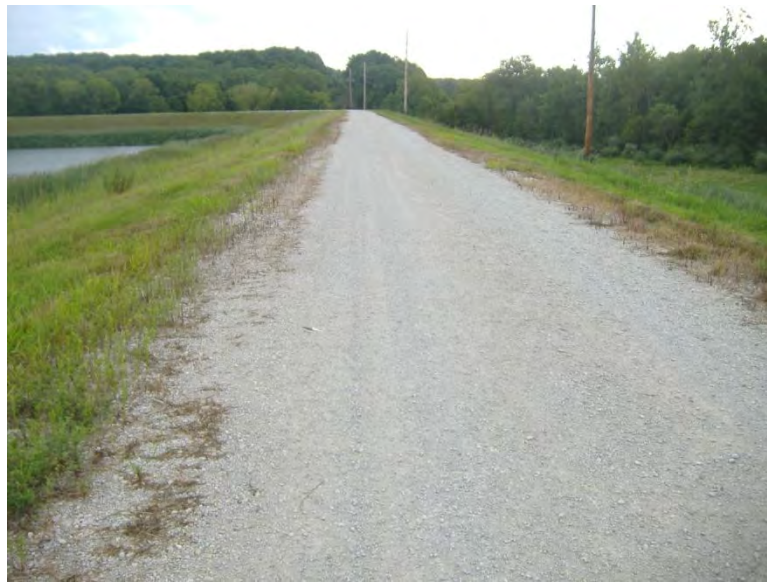
The crest of the embankment had no signs of significant depressions, tension cracks or other indications of settlement or shear failure. Figure 5.3.1-1 shows the typical crest conditions.

Figure 5.3.1-1: Photograph of the Crest of the East Ash Pond System Embankment.

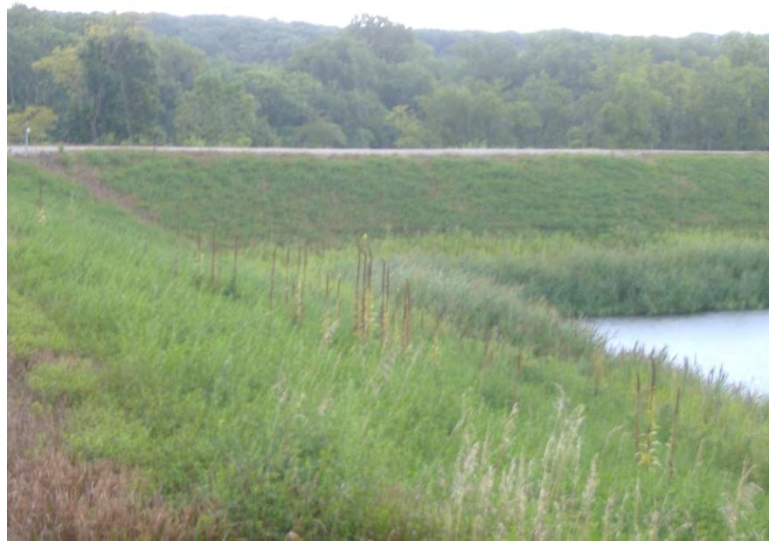
The inside slope of the East Ash Pond System embankment is vegetated with various species of tall grass and weeds. There were no observed scarps, sloughs, bulging, cracks, depressions or other indications of slope instability. Figure 5.3.2-1 shows a representative section of the inside slope of the primary cell embankment. Figure 5.3.2-2 shows a representative section of the inside slope of the secondary cell embankment.

Figure 5.3.2-1: Photograph of the Inside Slope of the East Ash Pond System Primary Cell Embankment.

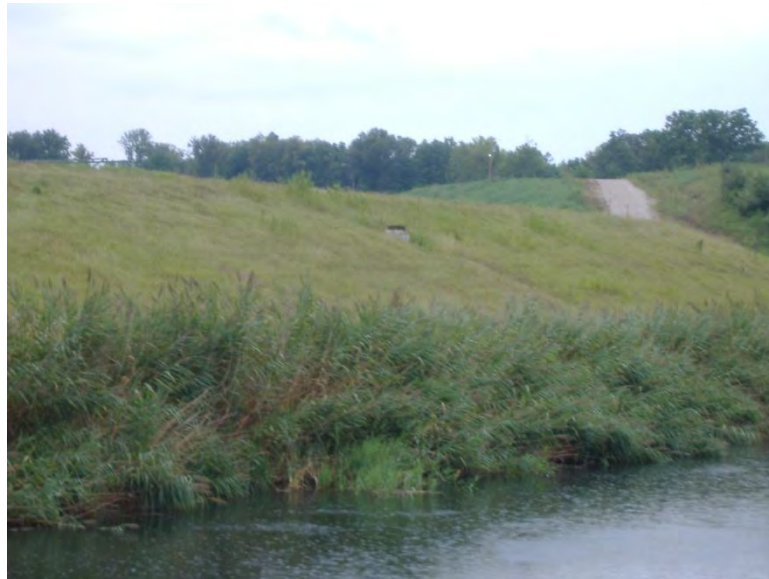
Figure 5.3.2-2: Photograph of the Inside Slope of the East Ash Pond System Secondary Cell Embankment.

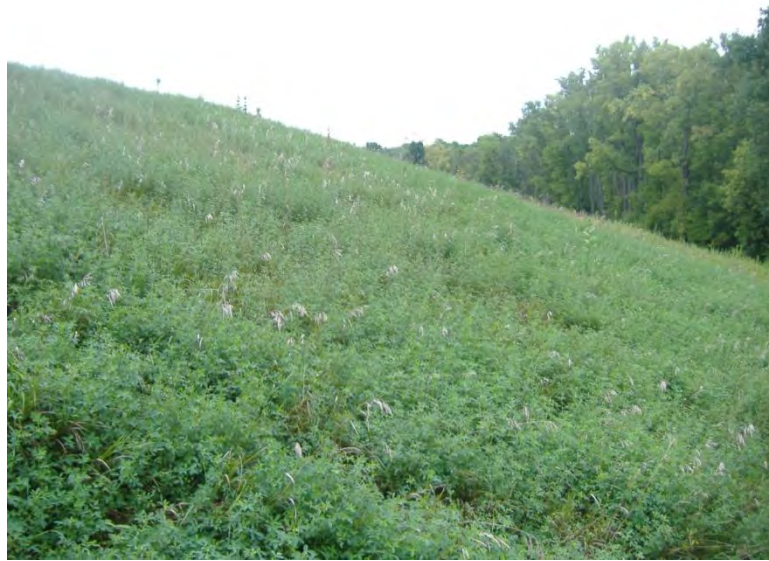
uncontrolled seepage were observed. Figure 5.3.3-1 shows a representative section of the outside slope of the embankment.

Figure 5.3.3-1: Photograph of the Outside Slope of the East Ash Pond System Embankment.

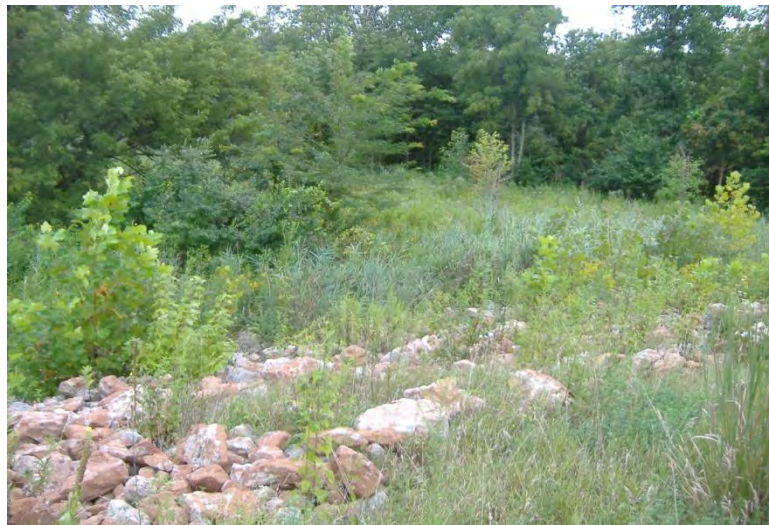
Most of the toe of the embankment is densely vegetated with various species of trees, grass, and weeds. In some sections, the toe is also armored with riprap. Figure 5.3.3-2 shows a portion of the toe that is armored with riprap and also covered in dense vegetation.

Figure 5.3.3-2: Photograph of Riprap and Vegetation at the Toe of the East Ash Pond System Embankment.

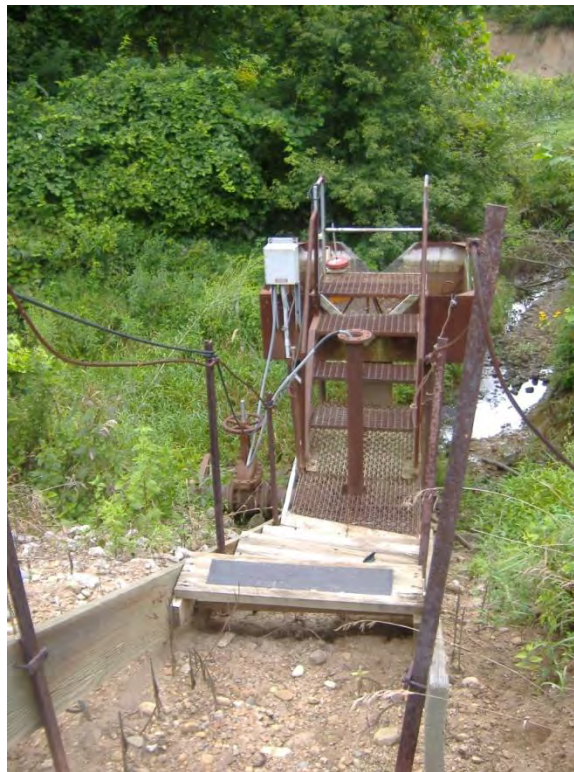
The North Ash Pond System overflow structure was observed to be working properly, discharging flow from the pond, and visually appeared to be in satisfactory condition. There was no sign of clogging of the spillway and the water exiting the outlet was flowing clear. Figure 5.4.1-1 shows the main outlet structure.

Figure 5.4.1-1: Photograph of the North Ash Pond System Overflow Structure.

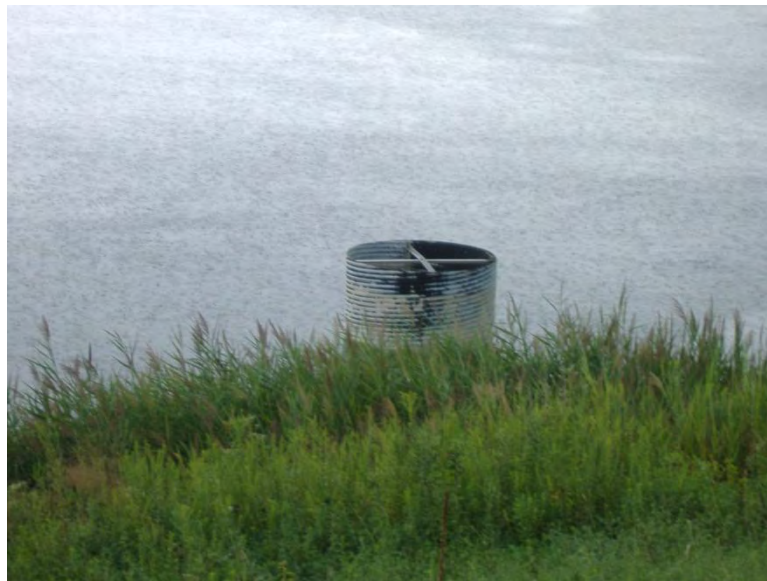
The East Ash Pond System overflow structure was observed to be working properly, discharging flow from the pond, and visually appeared to be in satisfactory condition. There was no sign of clogging of the spillway and the water exiting the outlet was flowing clear. Figure 5.4.1-2 shows the main outlet structure.

Figure 5.4.1-2: Photograph of the East Ash Pond System Primary Outfall Structure.

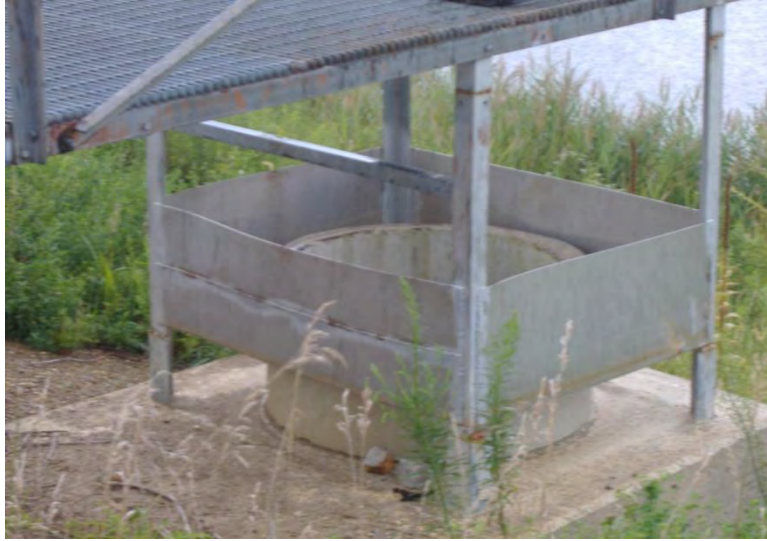
An emergency outfall pipe is present in the East Ash Pond System, directly below the primary outfall structure. Figure 5.4.1-3 shows the emergency outfall pipe.

Figure 5.4.1-3: Photograph of the East Ash Pond System Emergency Outfall Pipe.

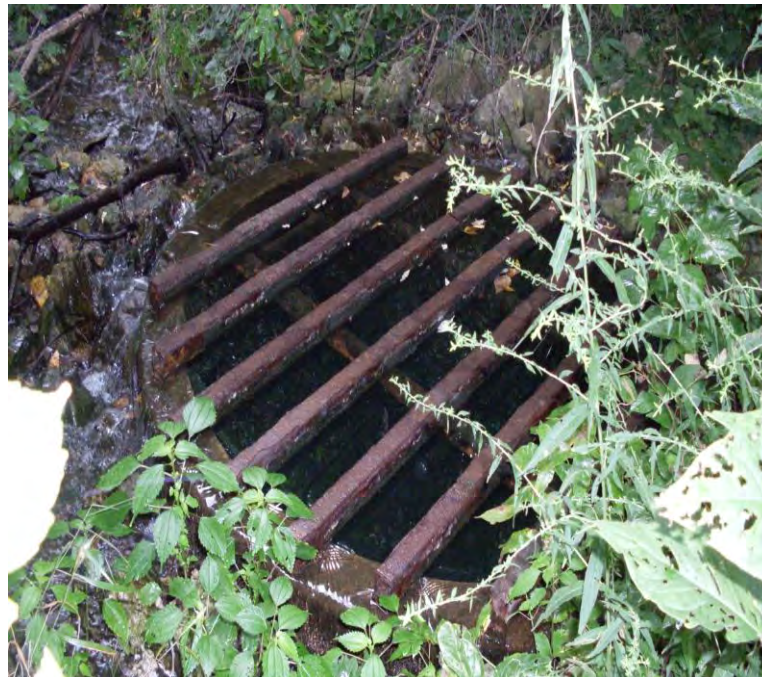
The outlet conduit appeared to be in good shape and operating normally with no sign of clogging and the water exiting the outlet was flowing clear. Figure 5.4.2-1 shows the spillway outfall pipe discharge.

The design of the spillway outfall pipe includes a vertical bend upward at the discharge end. The upward bend provides energy dissipation that reduces potential erosion along the receiving drainageway.

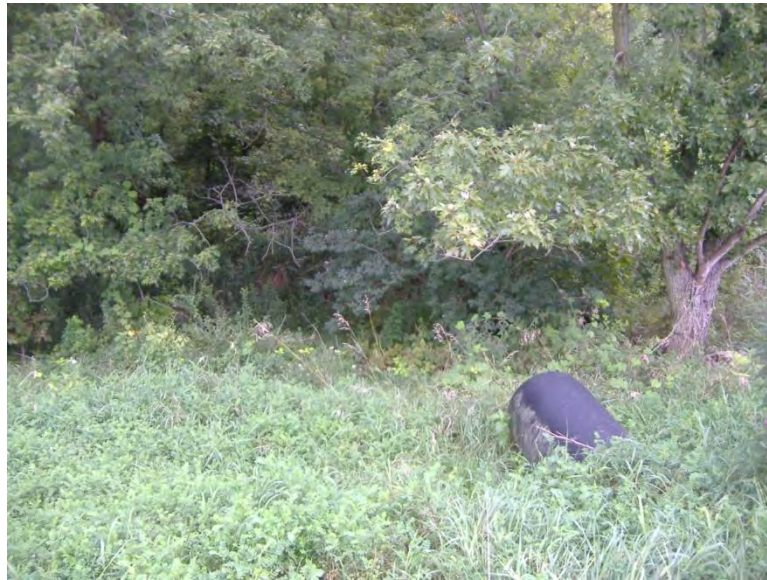
A corrugated metal pipe serves as the emergency spillway for the North Ash Pond System. The spillway has not been used in recent memory. Figure 5.4.3-1 shows the North Ash Pond System emergency spillway.

Figure 5.4.3-1: Photograph of the North Ash Pond System Emergency Spillway.
