**DRAFT REPORT
ROUND 10 DAM ASSESSMENT – MAY 24, AND 25, 2011
DYNEGY MIDWEST GENERATION, INC. – BALDWIN ENERGY COMPLEX
PRIMARY FLY ASH POND, SECONDARY FLY ASH POND, SECONDARY POND,
INTERMEDIATE POND, FINAL POND
BALDWIN, ILLINOIS**

RE: DRAFT Assessment of Dam Safety of Coal Combustion Surface Impoundments at the
Baldwin Energy Complex

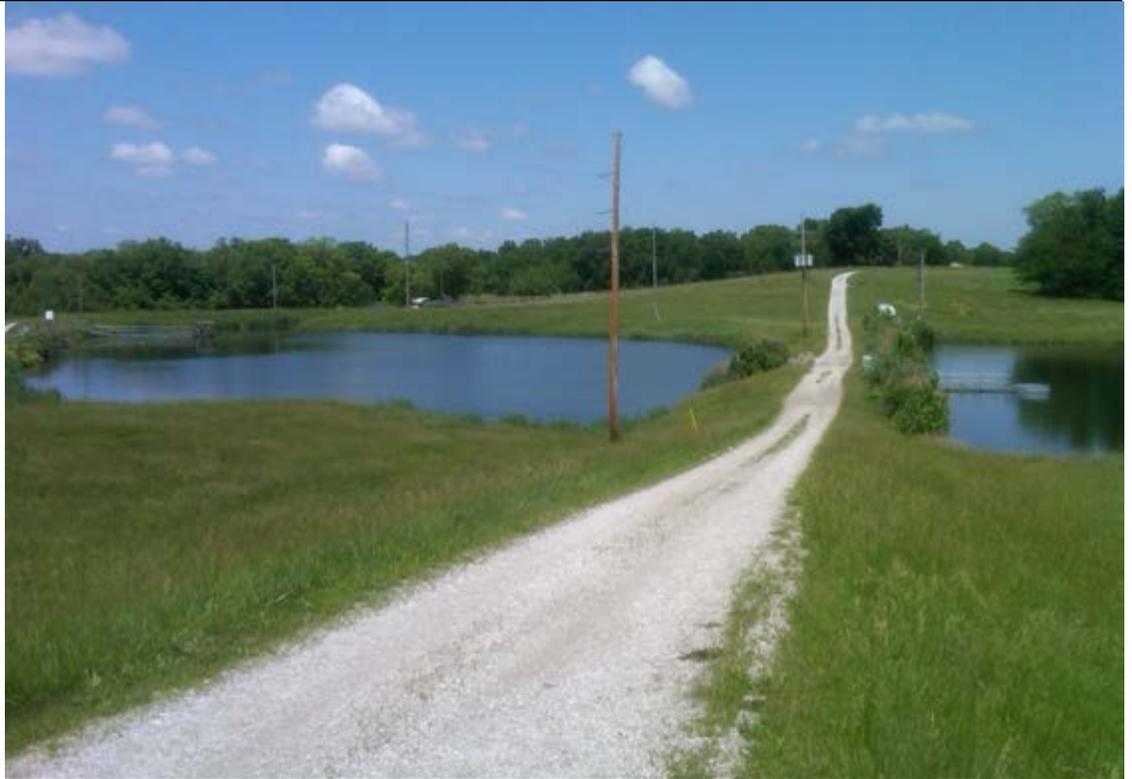
Photo No.
2

Downstream slope of the
Ash Pond Dike.

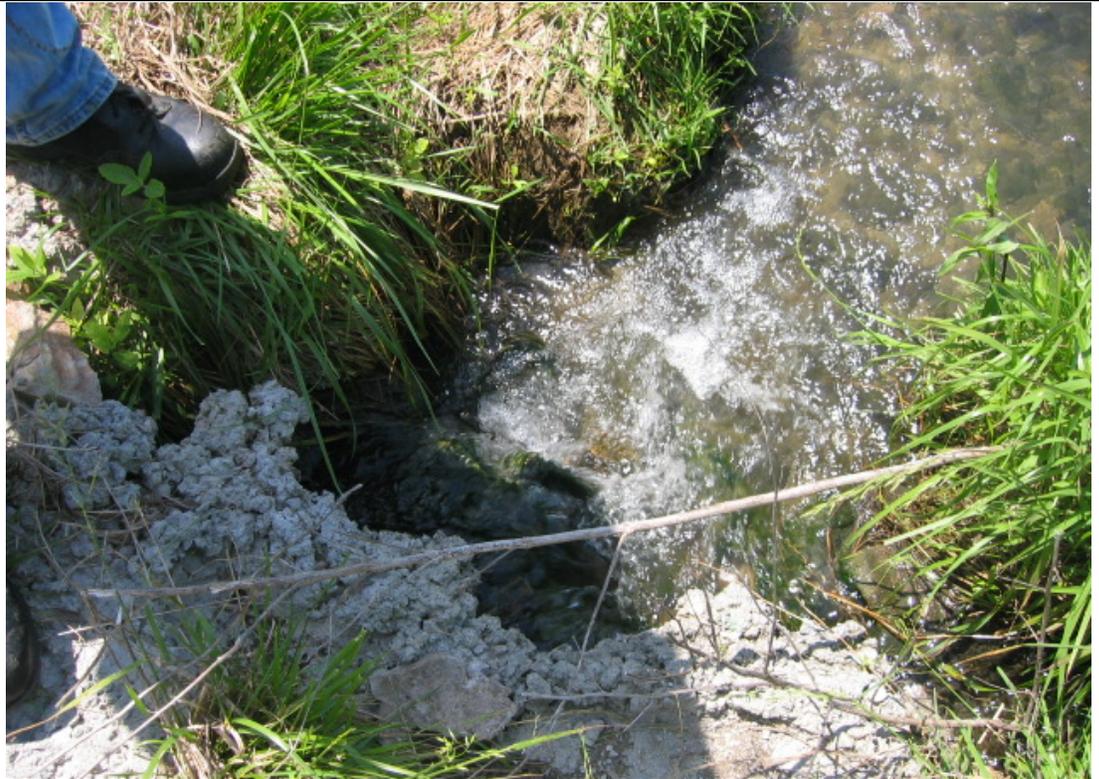
Photo No.
4

Surface grouting/concrete along the downstream slope of Ash Pond Dike. Seepage present beneath the surface grouting in several locations.

1. Repair the discharge pipe and the embankment erosion near the discharge pipe from PFAP's northern decant. Protect the embankment with riprap or other erosion control features.
2. Remove the concrete located on the downstream slope of the Ash Pond Dike. Repair any erosion observed beneath the concrete and replace with fill engineered to provide a stable embankment that is not susceptible to erosion or piping.
3. Pending the results of the hydraulic/hydrologic analysis, modify the design or operation of the impoundments to provide adequate capacity.
4. Pending the results of the complete seepage and stability analysis for each impoundment, modify the design or operation of the impoundments to provide conditions that result in embankments that meet the generally accepted factors of safety.

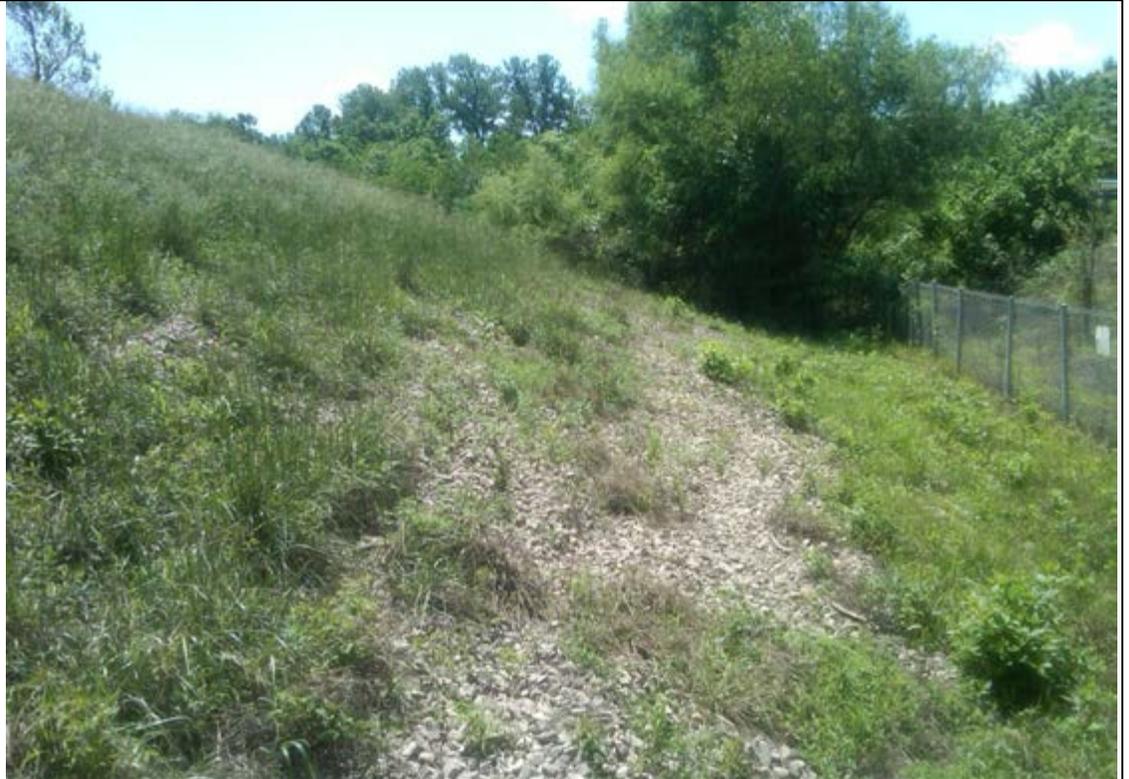
Photo No.
12

Description:
Seepage on downstream
slope of the Final Pond.

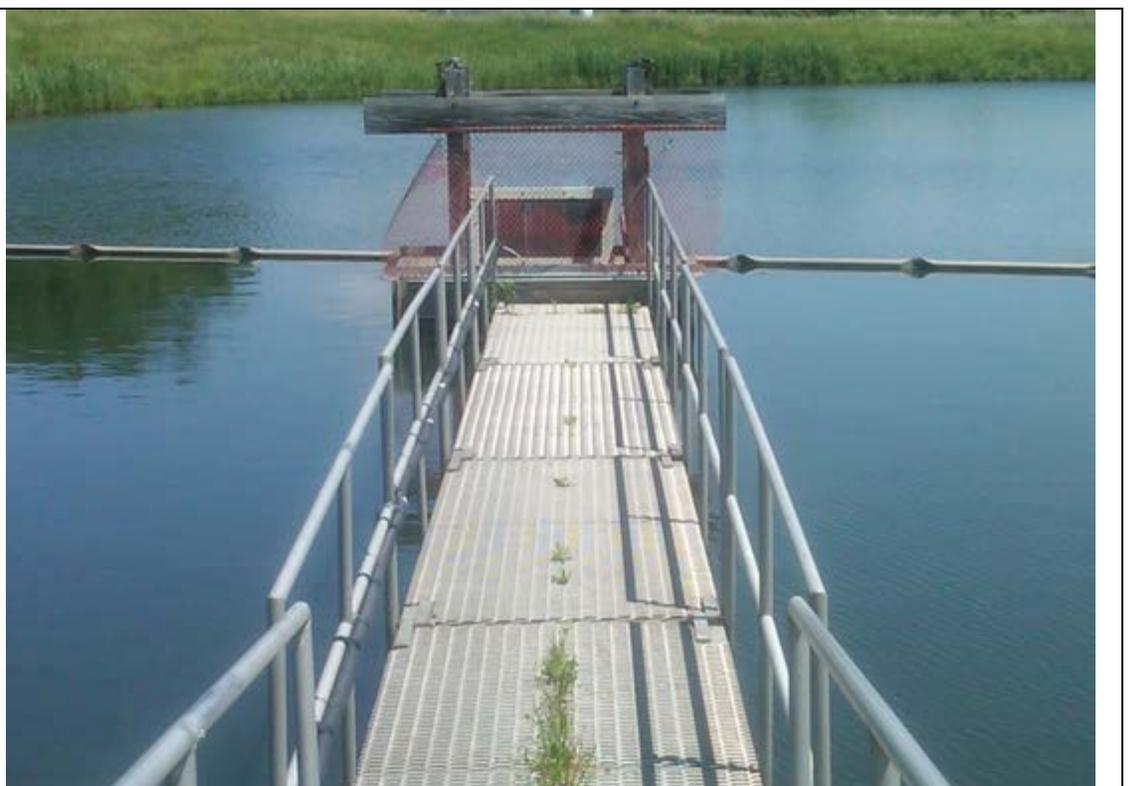
Description:
Decant structure of the Final Pond showing the decant pipe appears to be nearly at capacity.

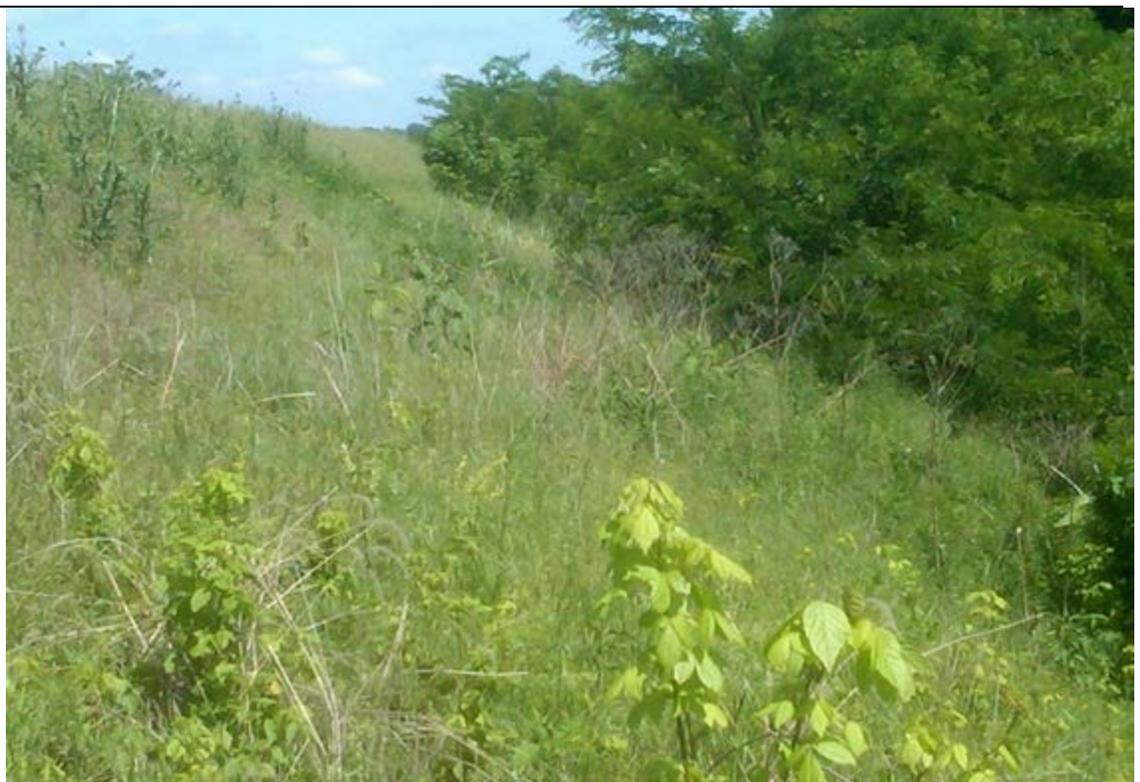
4. Moist soil conditions were observed along the downstream slope and/or toe of the southern embankment of the SFAP. This condition may indicate the presence of seepage in that area and should be evaluated. We recommend removing all trees on the downstream slope and toe area and evaluation of the moist soil conditions.

Description:
Conditions at the downstream toe of the southern embankment of the Secondary Fly Ash Pond.

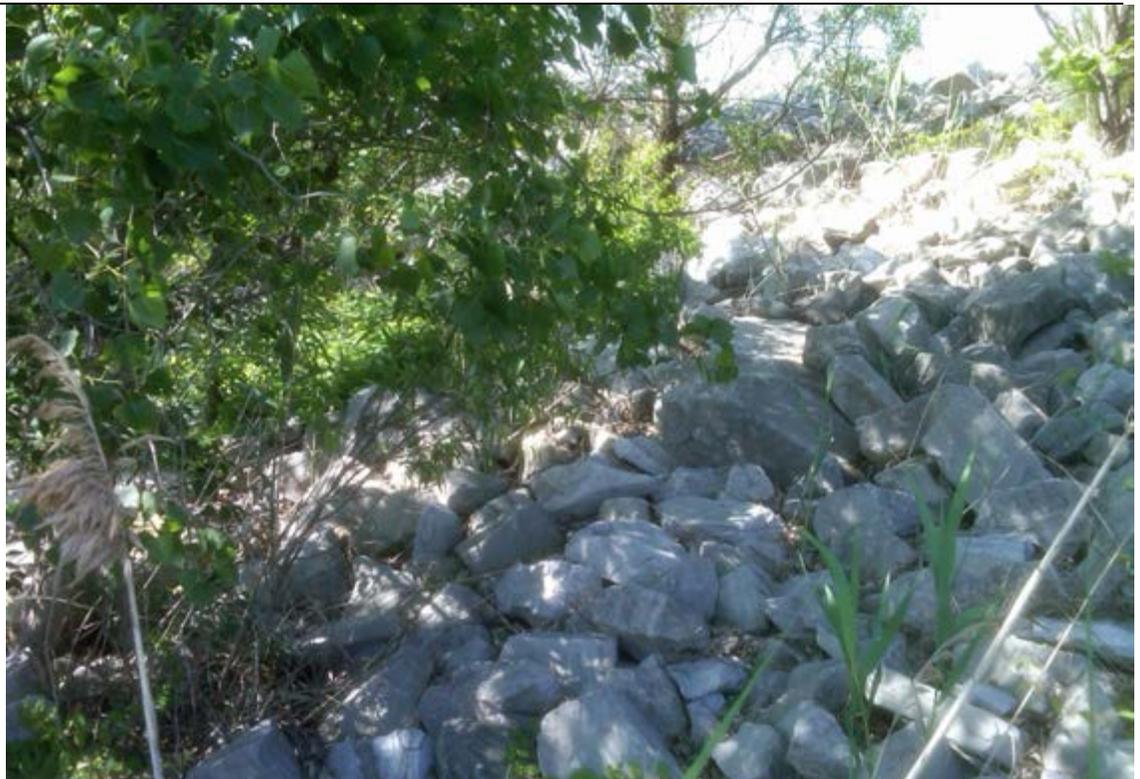
Description:
Downstream slope of the
Intermediate Embankment
showing an area that had
been armored with riprap.

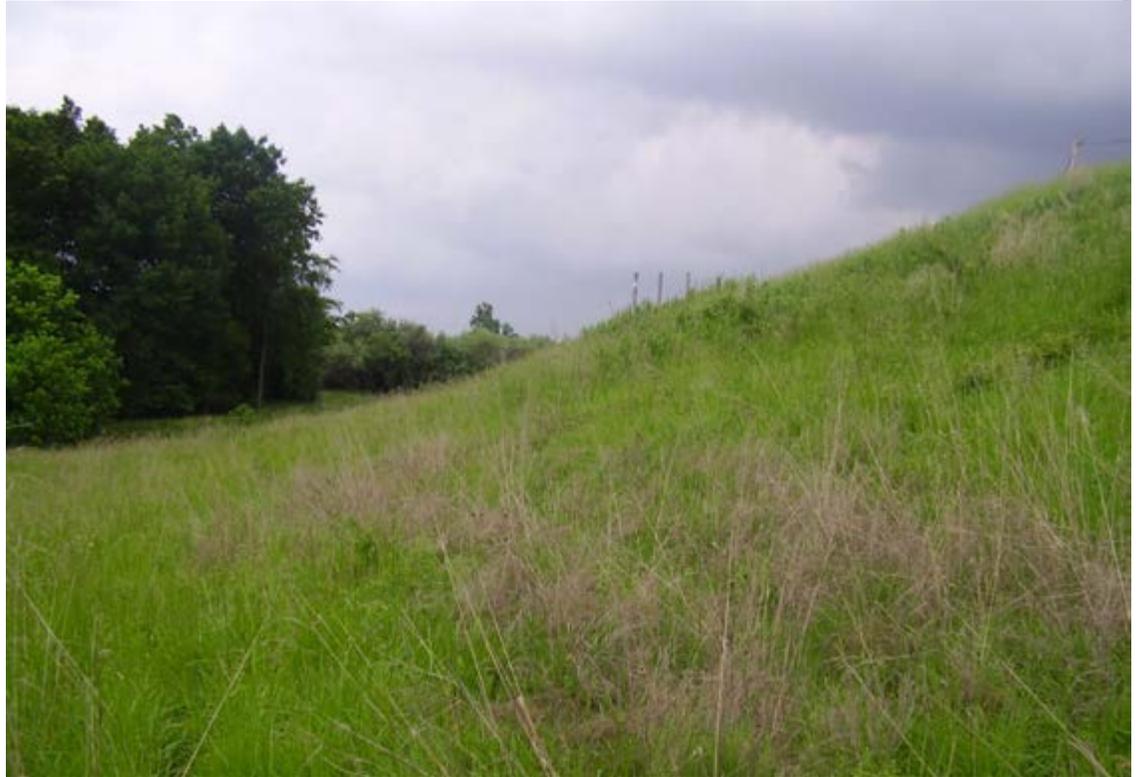
Photo No.
42

Description:
Scarp on downstream slope
of the Northern Dike.

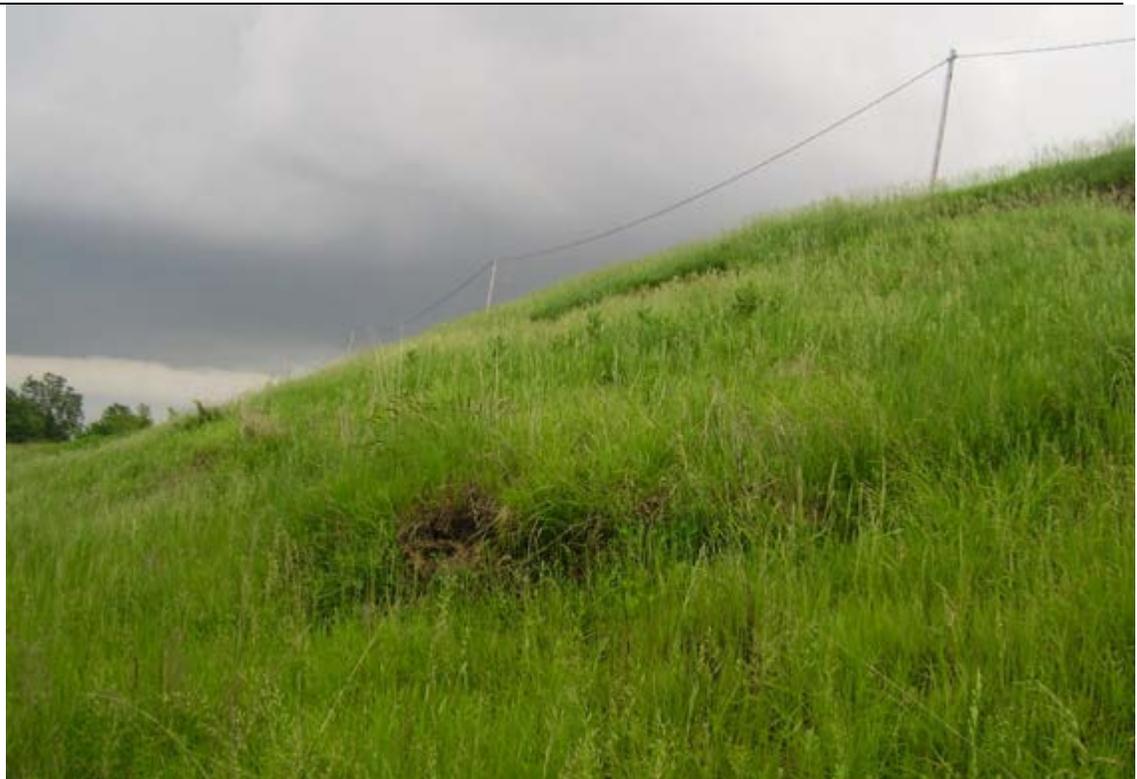
Description:
Scarp on downstream slope
of the Northern Dike.

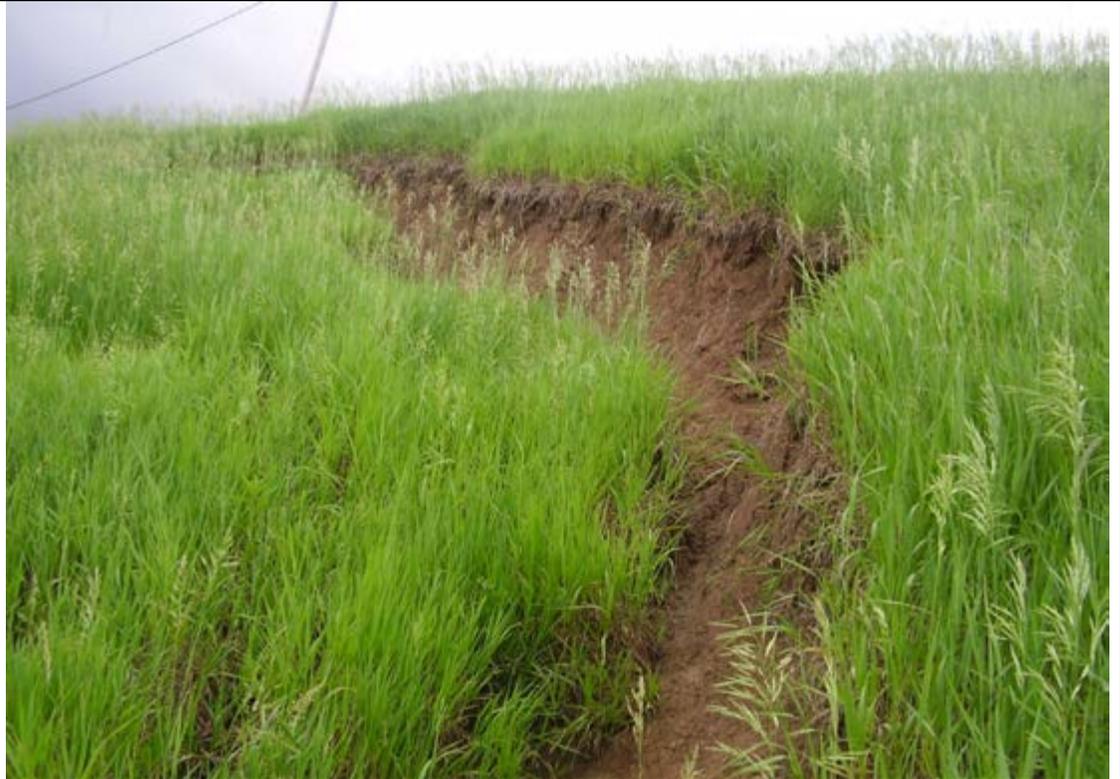
Photo No.
44

Description:
Scarp on downstream slope
of the Northern Dike.

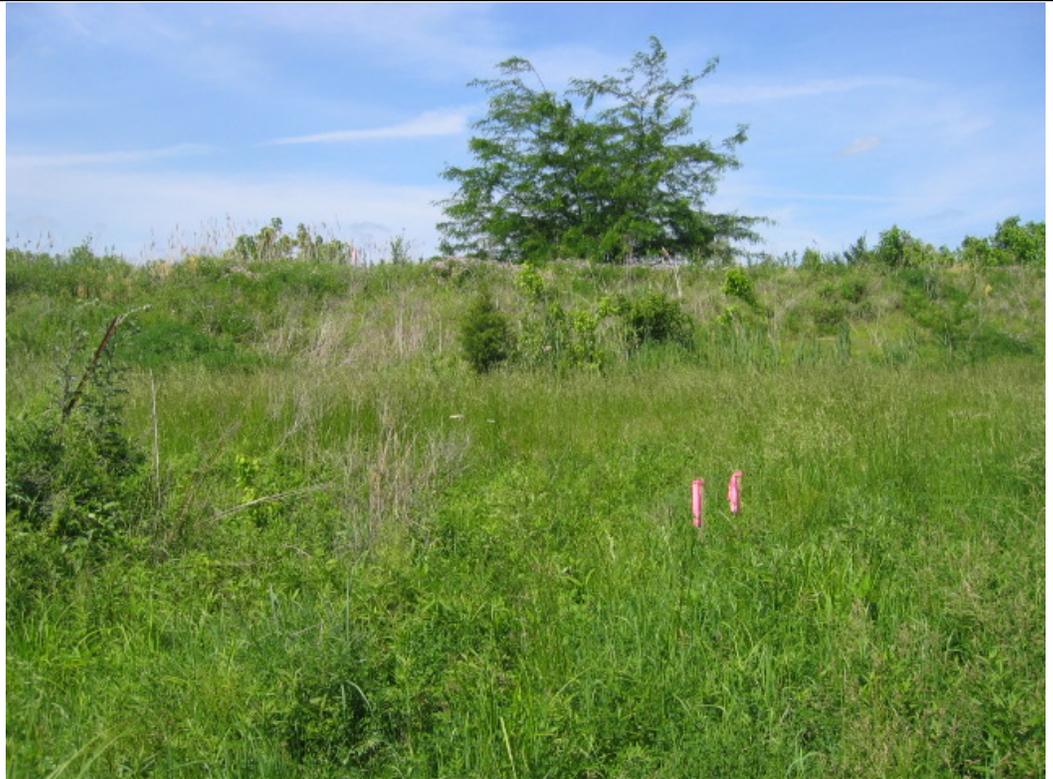
Downstream slope of the southern embankment of the Secondary Fly Ash Pond. Looking up slope in the area of the 1995 Failure.
