**FINAL REPORT  
ROUND 10 DAM ASSESSMENT  
DYNEGY MIDWEST GENERATION, LLC – BALDWIN ENERGY COMPLEX  
PRIMARY FLY ASH POND, SECONDARY FLY ASH POND, SECONDARY POND,  
INTERMEDIATE POND, FINAL POND  
BALDWIN, ILLINOIS**

December 21, 2012  
GZA File No. 170142.30

RE: FINAL Assessment of Dam Safety of Coal Combustion Surface Impoundments at the Baldwin Energy Complex

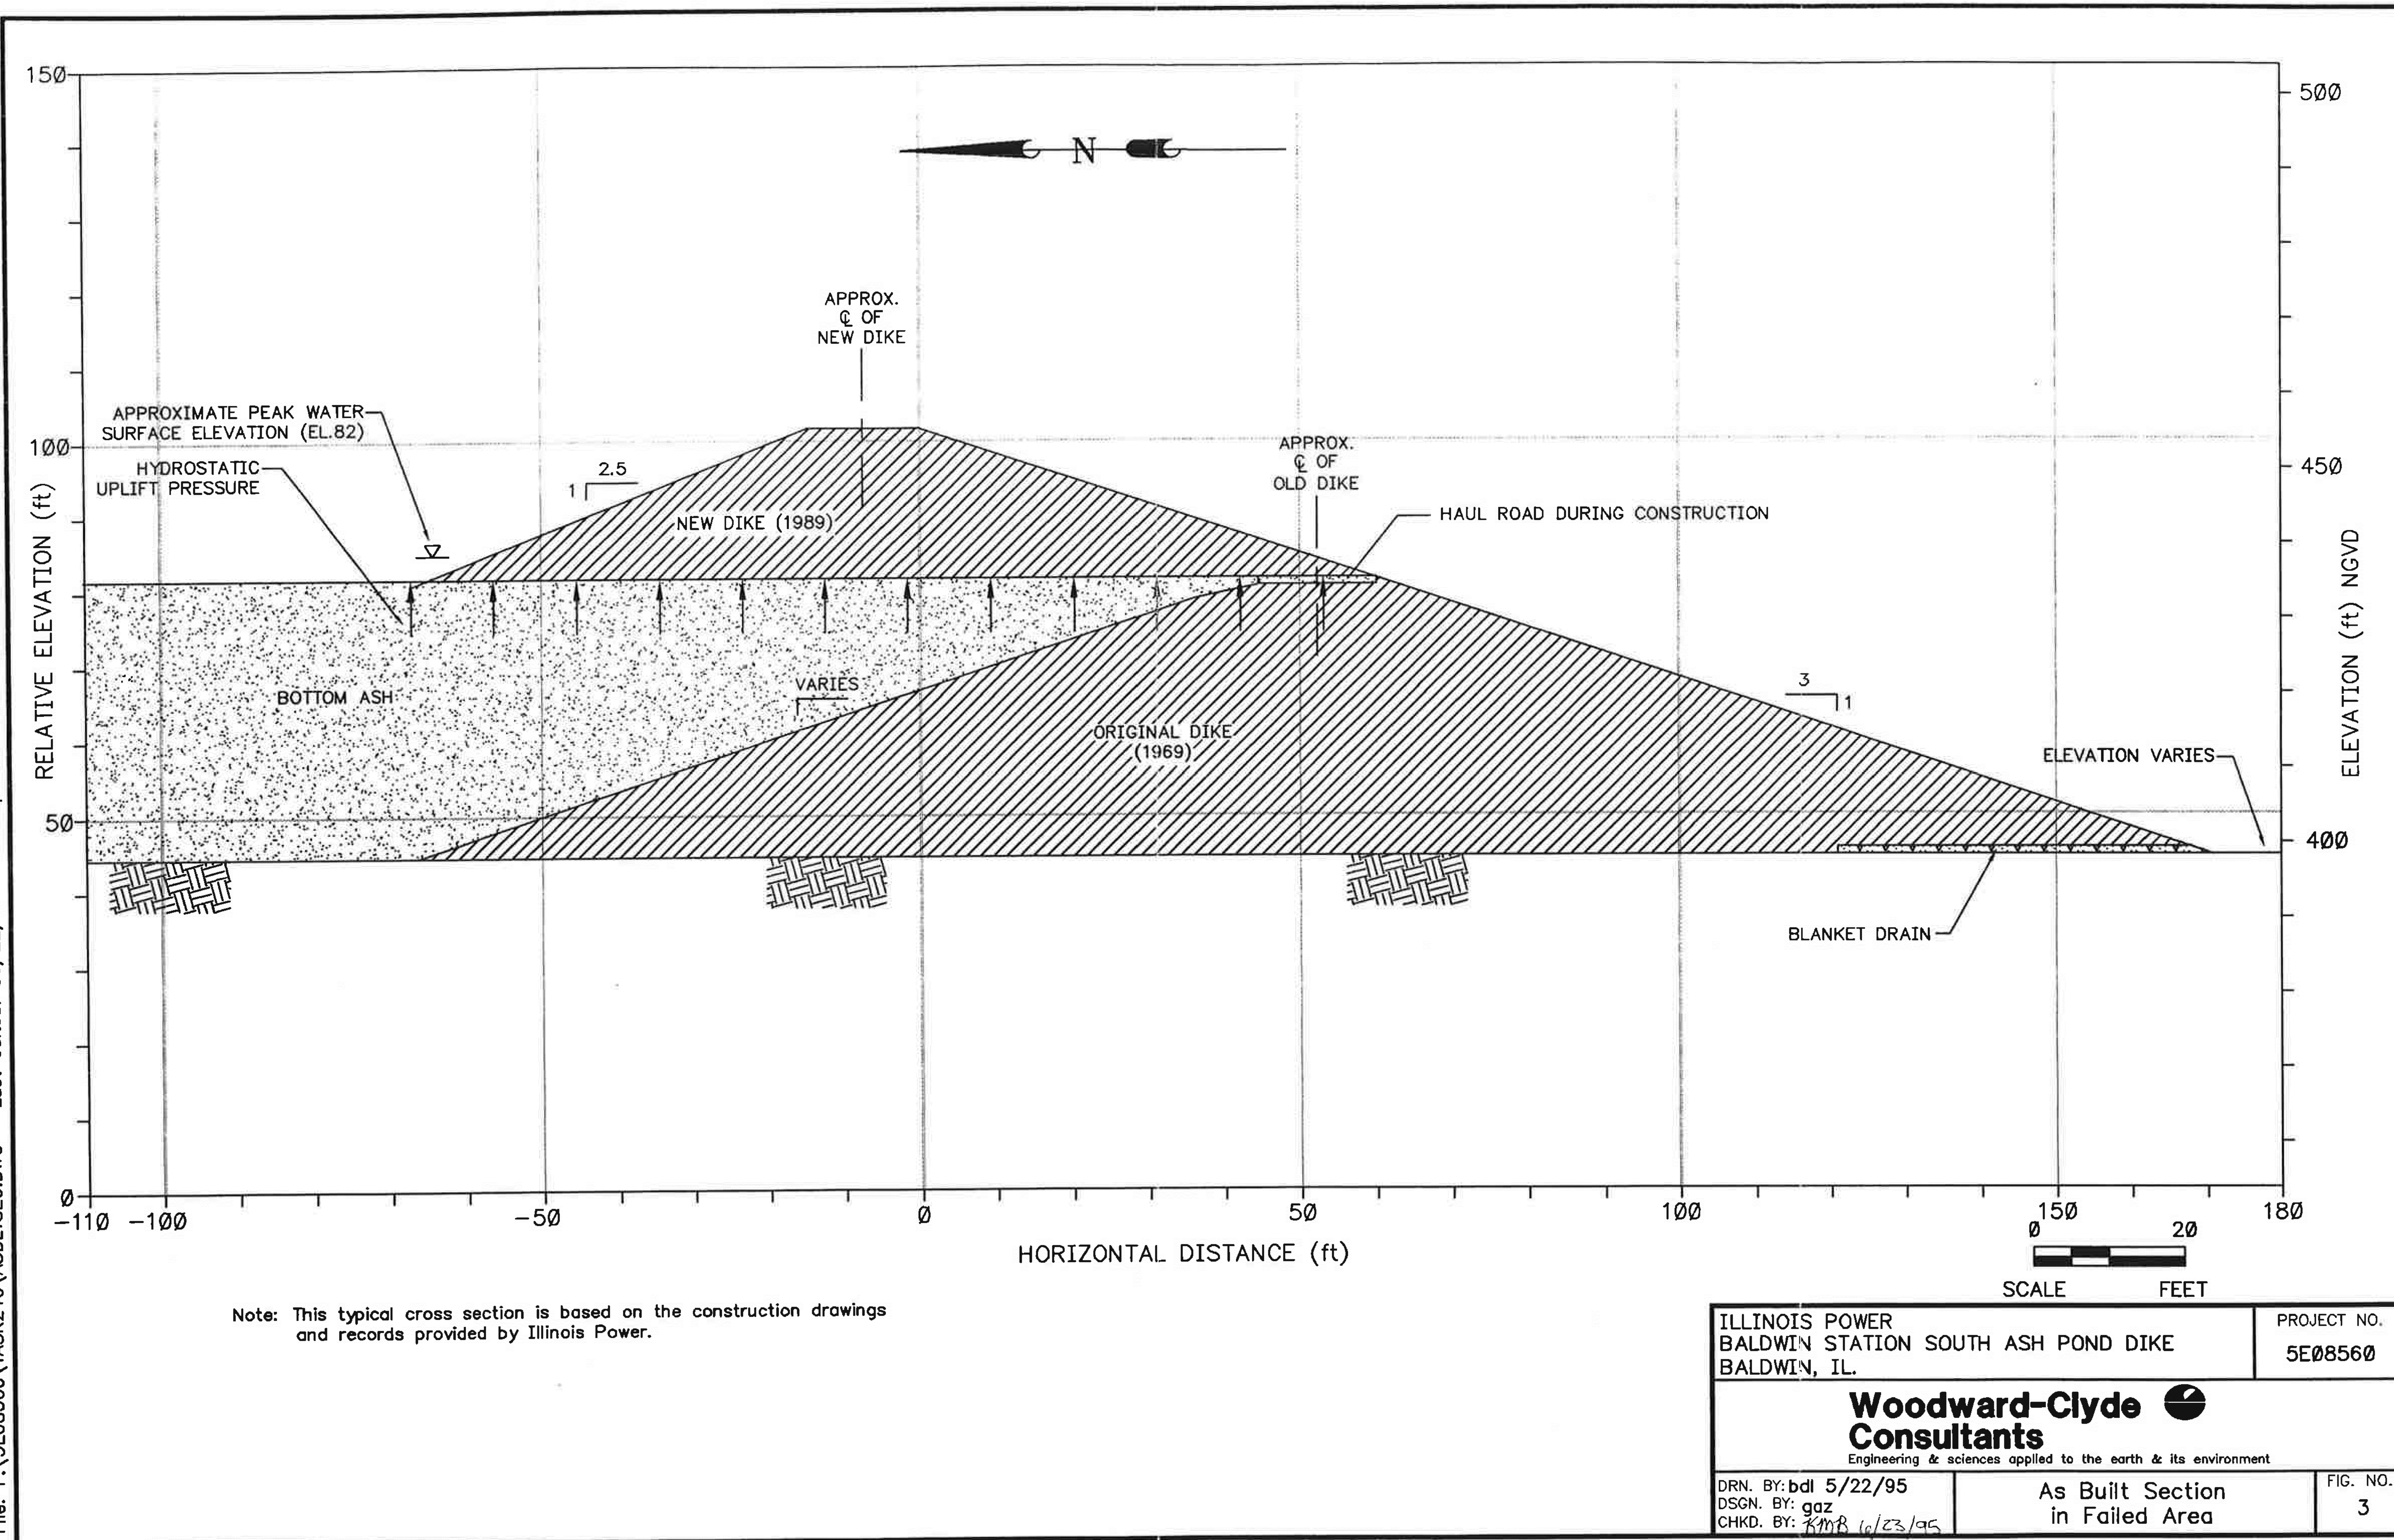
A typical design cross section of the 1969 southern embankment of the PFAP is shown in **Figure 4**. The 'as built' cross section of the embankments after the 1989 raise, as recreated by Woodward Clyde and documented in the Failure Analysis, is provided as **Figure 5**. Based on the upstream construction shown on Figure 5, the 1989 raise was partially constructed over wet CCW.

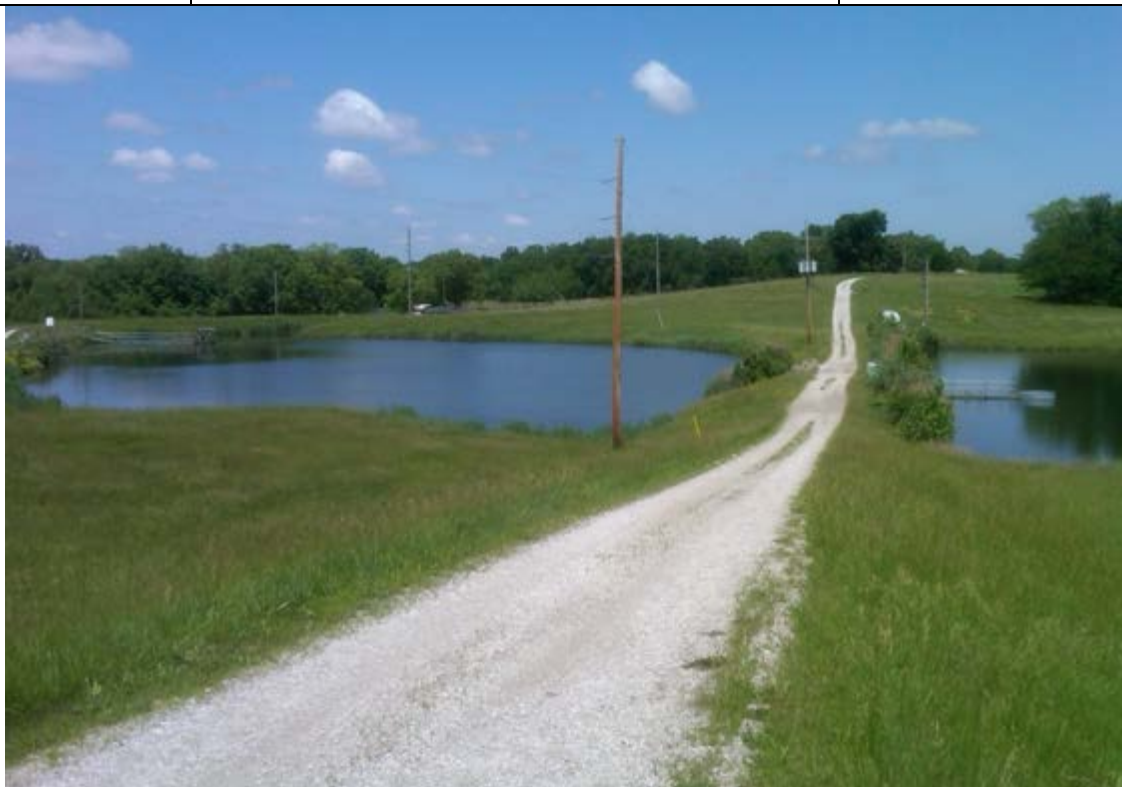
**Photo No.**  
**2**

**Description:**  
Downstream slope and crest  
of the Ash Pond Dike which  
retains the water that forms  
the Intermediate Pond.

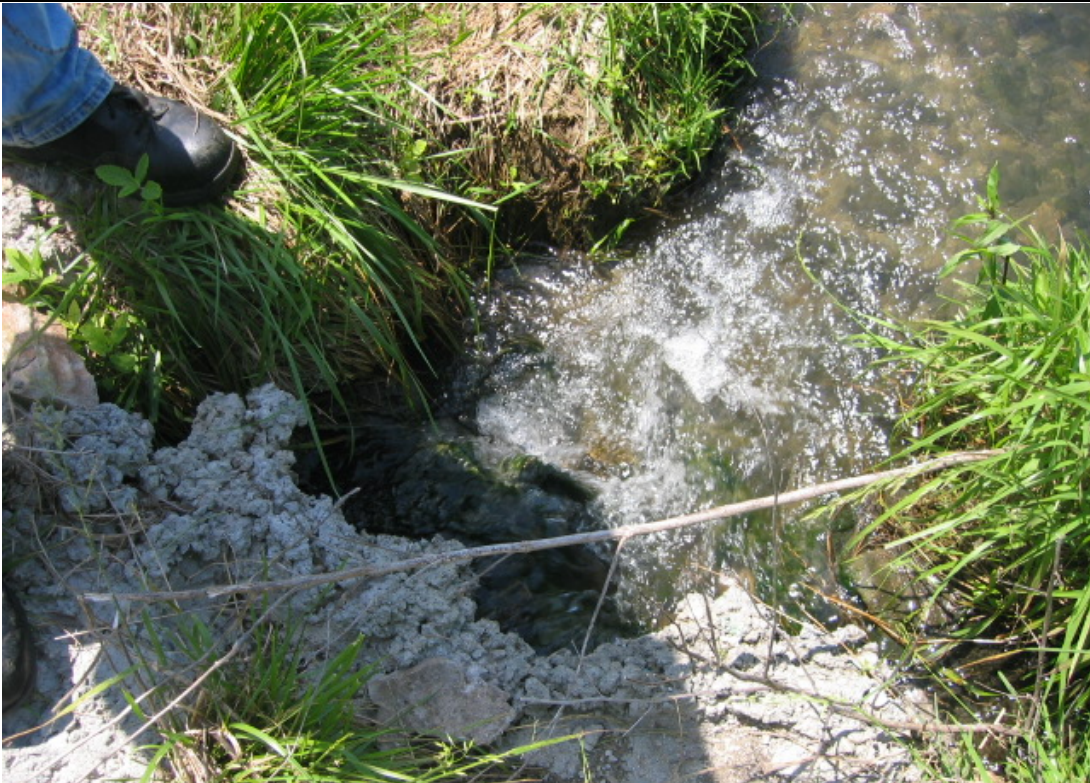
| <b>Photo No.</b><br><b>3</b> | <b>Date:</b><br>5/24/11 | | |

| <b>Description:</b><br>Seepage from the downstream slope of the Ash Pond Dike. | | | |

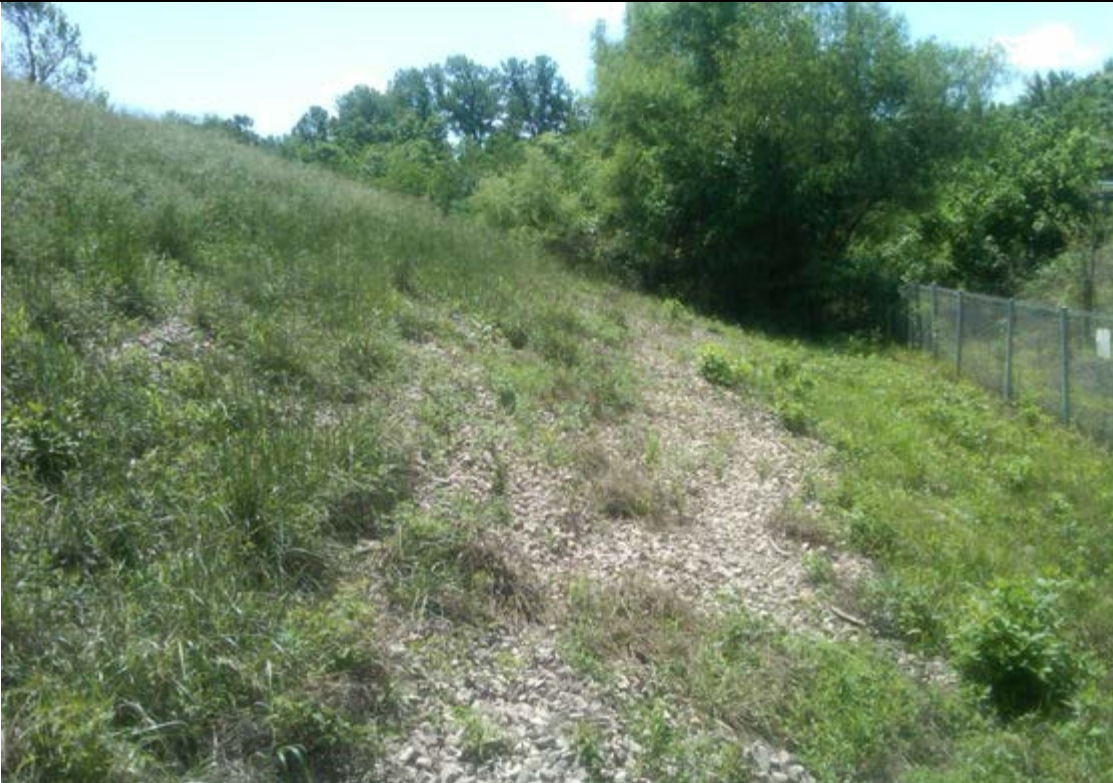
| <b>Photo No.</b><br><b>11</b> | <b>Date:</b><br>5/24/11 | | |

| <b>Description:</b><br>Downstream slope of the Final Pond. | | | |

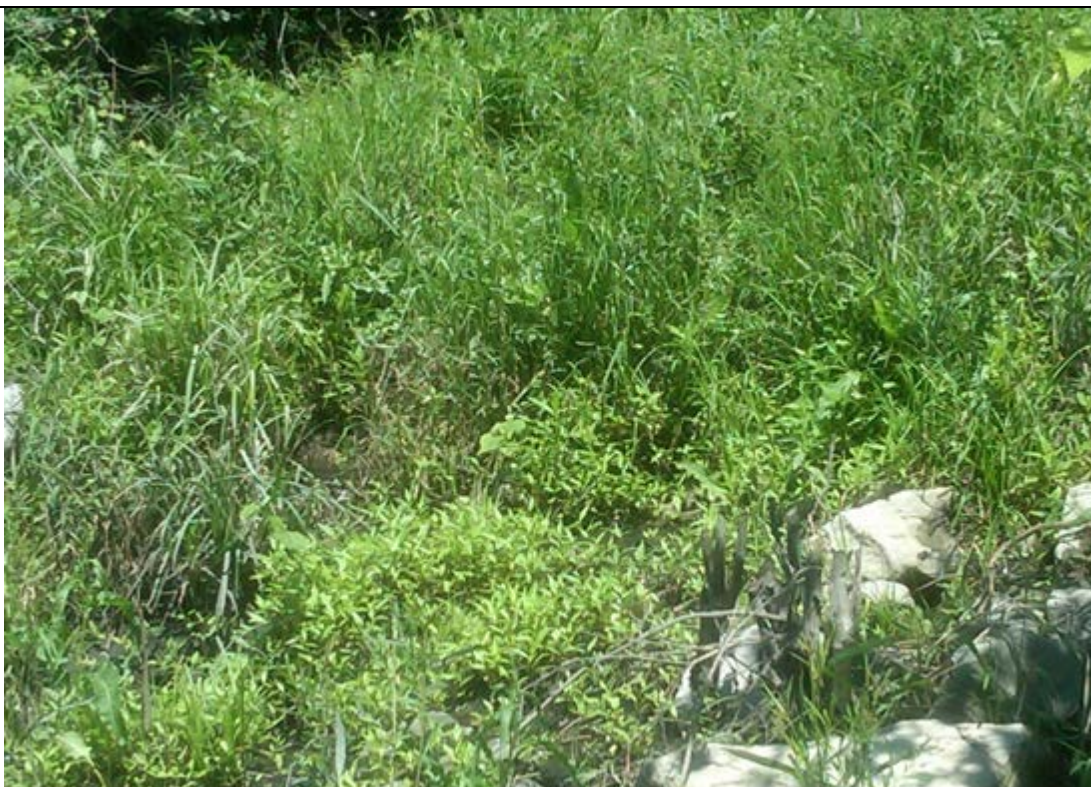
**Description:**  
Seepage on downstream  
slope of the Final Pond.

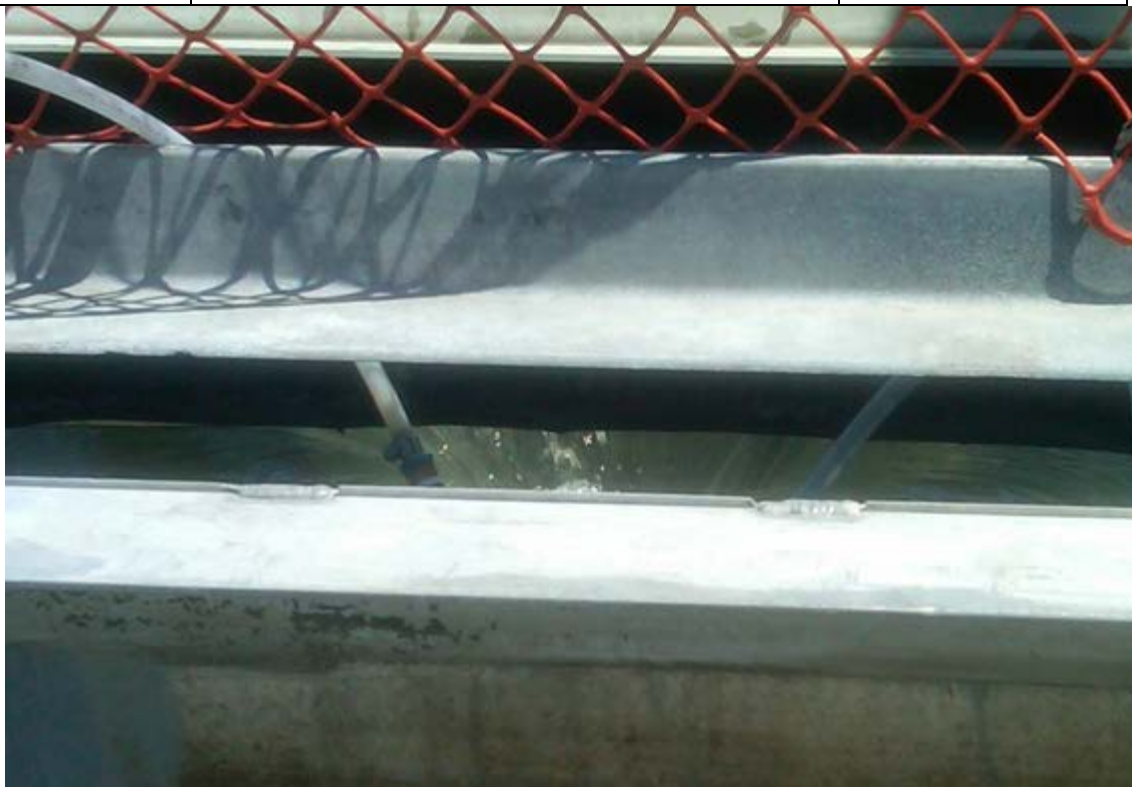
**Photo No.**  
**18**

Decant structure of the Final  
Pond showing the decant  
pipe appears to be nearly at  
capacity.

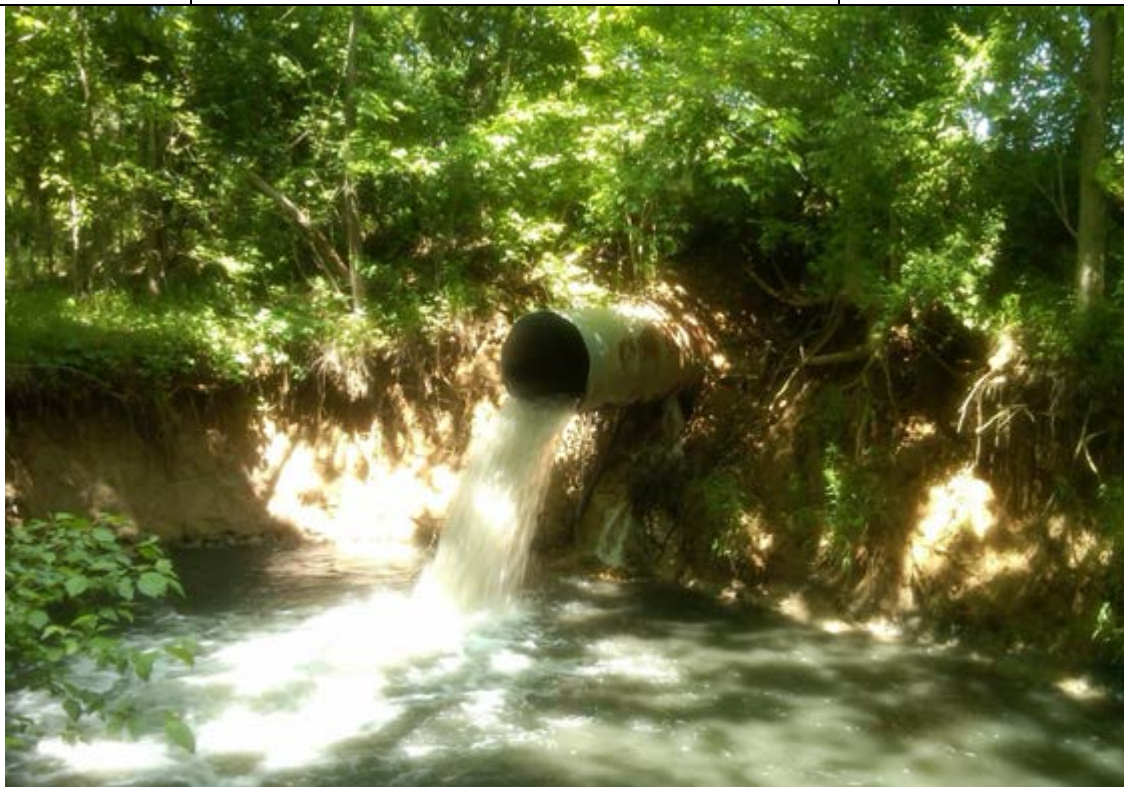
**Photo No.**  
**30**

1. Thick vegetation and trees along the upstream and downstream slopes;
2. Minor potholes and rutting along the crest gravel access road;
3. Damaged discharge pipe from the northern decant;
4. The absence of erosion protection on the embankment near the discharge location of the northern decant has allowed erosion of the embankment;
5. No hydraulic/hydrologic analysis has been performed to confirm adequate freeboard and decant capacity at the design storm event;
6. The stability analysis completed does not account for storm event loading conditions; and,
7. No stability analysis was provided for the Intermediate Embankment.

Discharge pipe for Bottom  
Ash Process water from the  
northern part of the Primary  
Fly Ash Pond to the  
Secondary Pond.

1. Repair the discharge pipe and the embankment erosion near the discharge pipe from PFAP's northern decant. Protect the embankment with riprap or other erosion control features.
2. Remove the concrete located on the downstream slope of the Ash Pond Dike. Repair any erosion observed beneath the concrete and replace with fill engineered to provide a stable embankment that is not susceptible to erosion or piping.
3. Pending the results of the hydraulic/hydrologic analysis, modify the design or operation of the impoundments to provide adequate capacity.
4. Pending the results of the complete seepage and stability analysis for each impoundment, modify the design or operation of the impoundments to provide conditions that result in embankments that meet the generally accepted factors of safety.

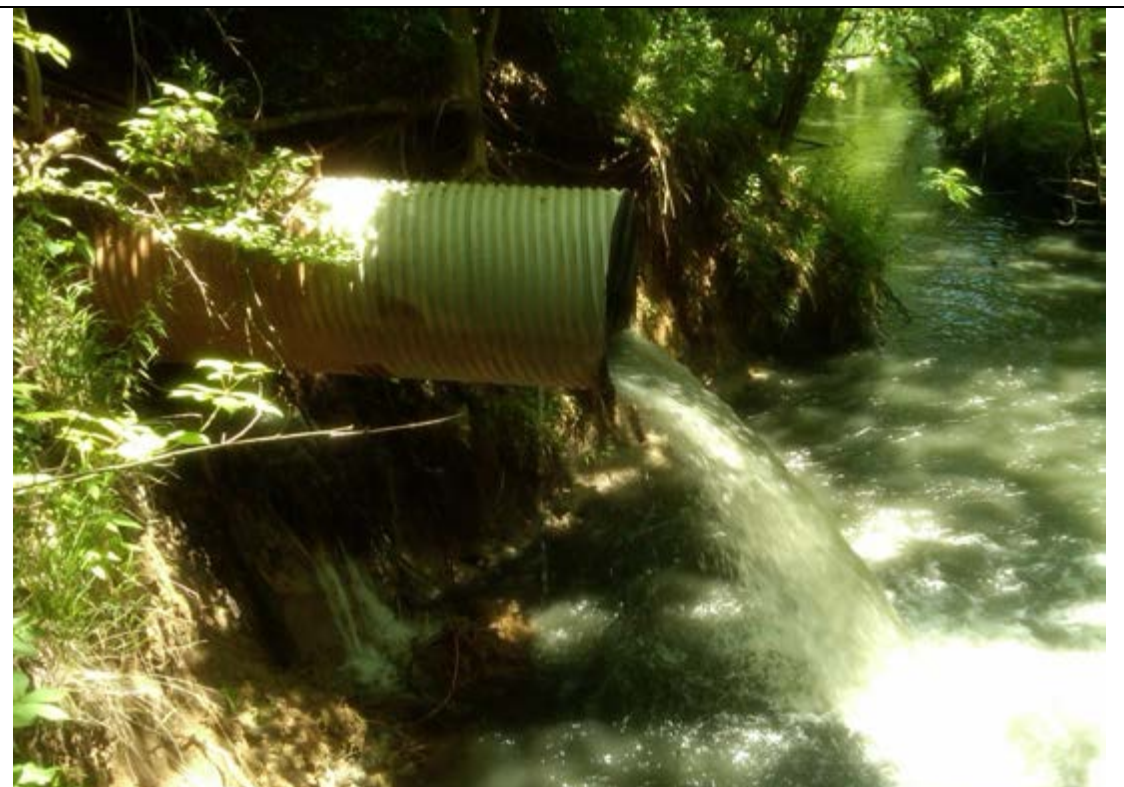
Discharge pipe for Bottom  
Ash Process water from the  
northern part of the Primary  
Fly Ash Pond to the  
Secondary Pond.

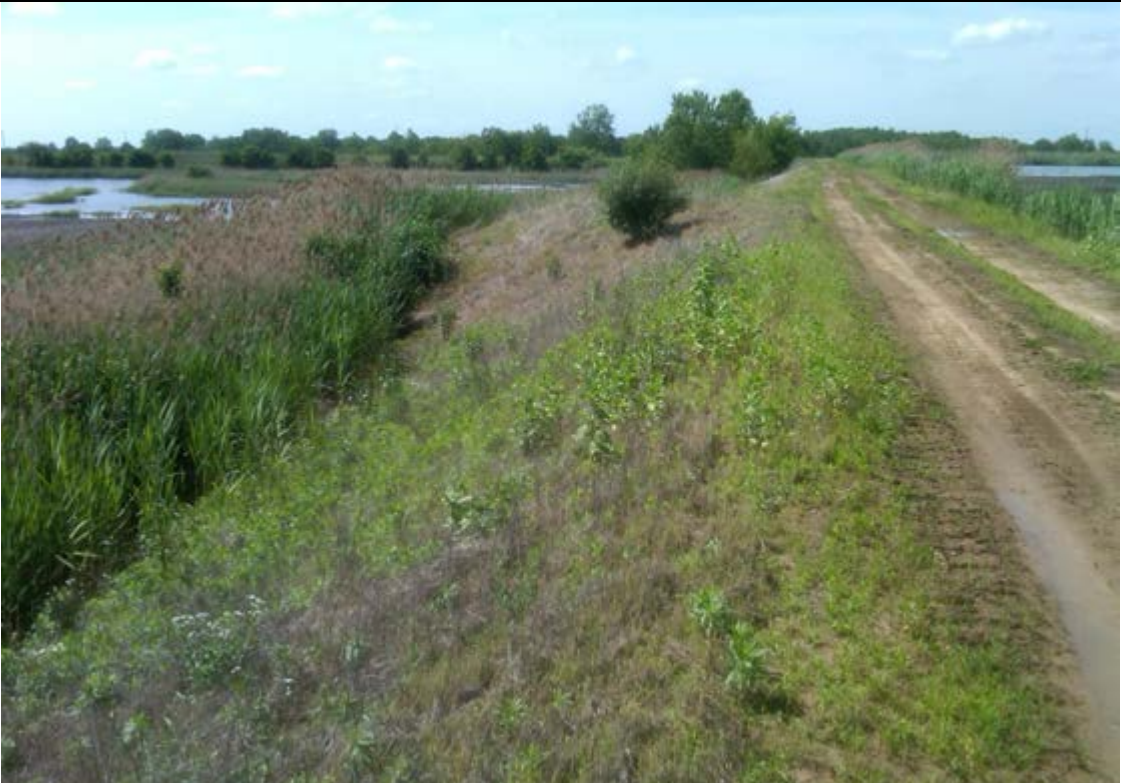
| <b>Photo No.</b><br><b>37</b> | <b>Date:</b><br>5/24/11 | | |

| <b>Description:</b><br>Downstream slope and crest of the Intermediate Embankment. | | | |

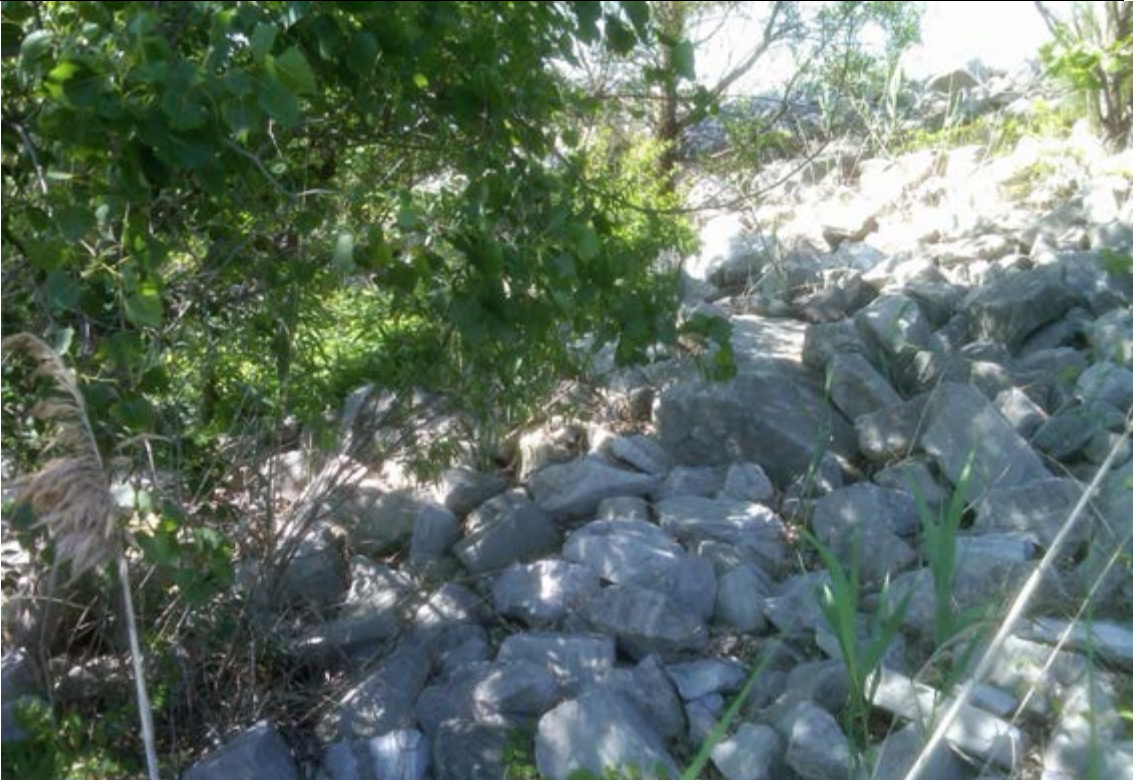
| <b>Photo No.</b><br><b>38</b> | <b>Date:</b><br>5/24/11 | |

| <b>Description:</b><br>Downstream slope of the Intermediate Embankment showing an area that had been armored with riprap. | | |

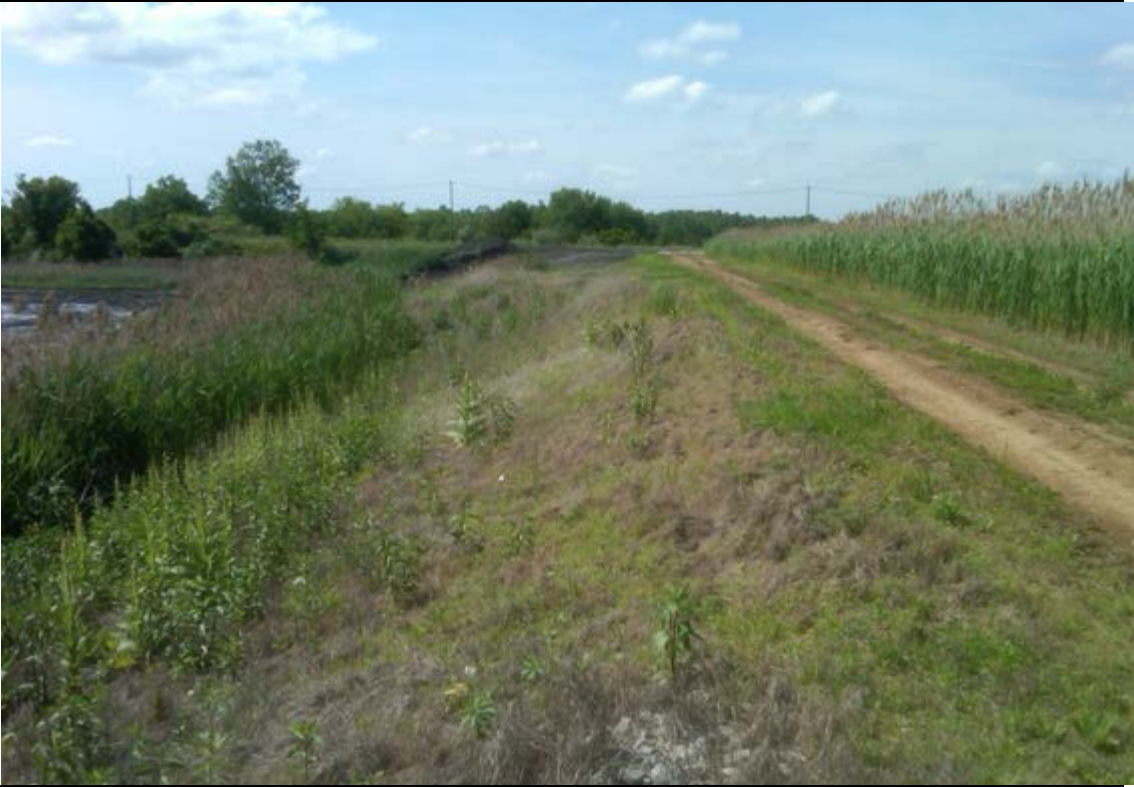
| <b>Photo No.</b><br><b>39</b> | <b>Date:</b><br>5/24/11 | |

| <b>Description:</b><br>Downstream slope and crest of the Intermediate Embankment. | | |

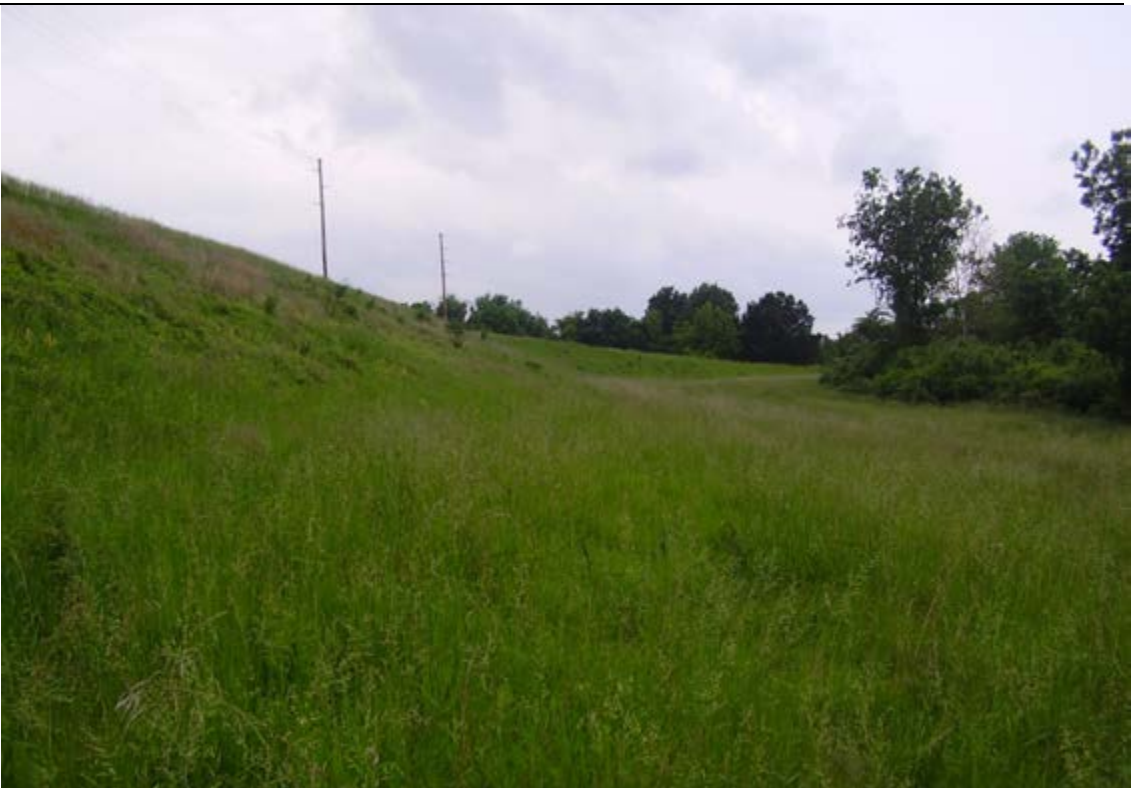
| <b>Photo No.</b><br><b>40</b> | <b>Date:</b><br>5/24/11 | |

| <b>Description:</b><br>Downstream slope and toe of the northern embankment of the Secondary Fly Ash Pond | | |

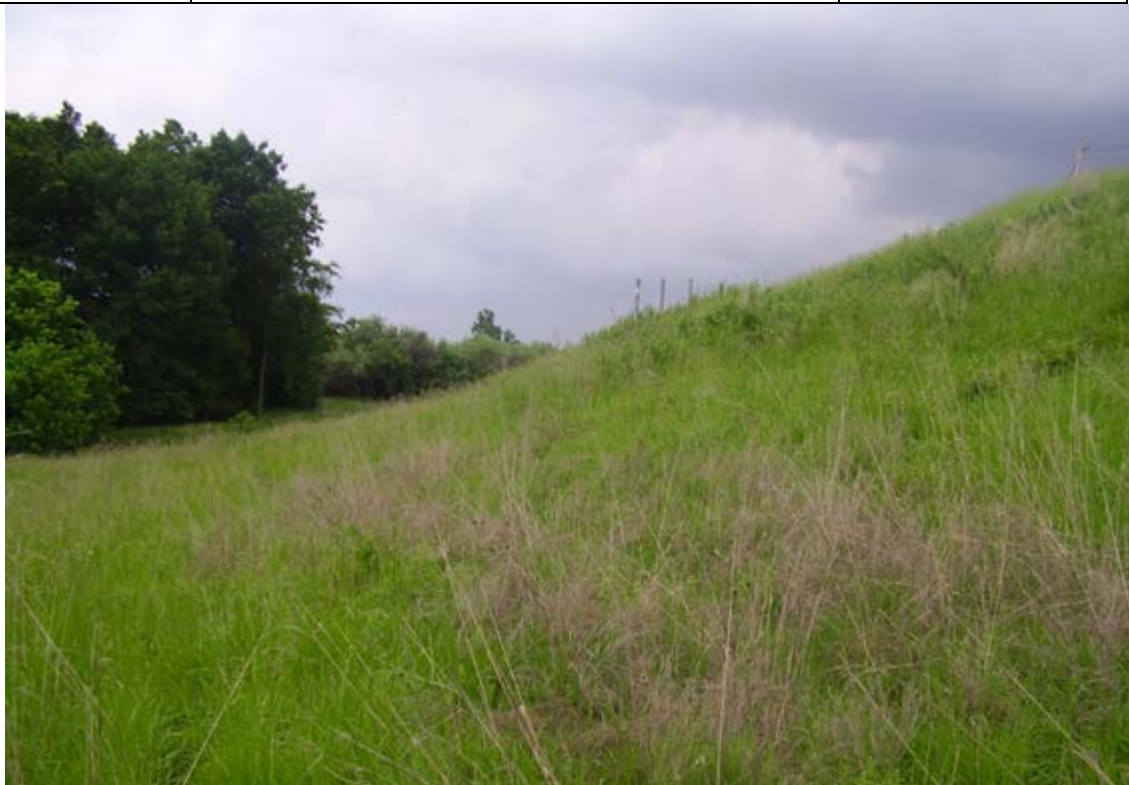
**Photo No.**  
**42**

**Description:**  
Downstream slope and toe of  
the northern embankment of  
the Secondary Fly Ash Pond.

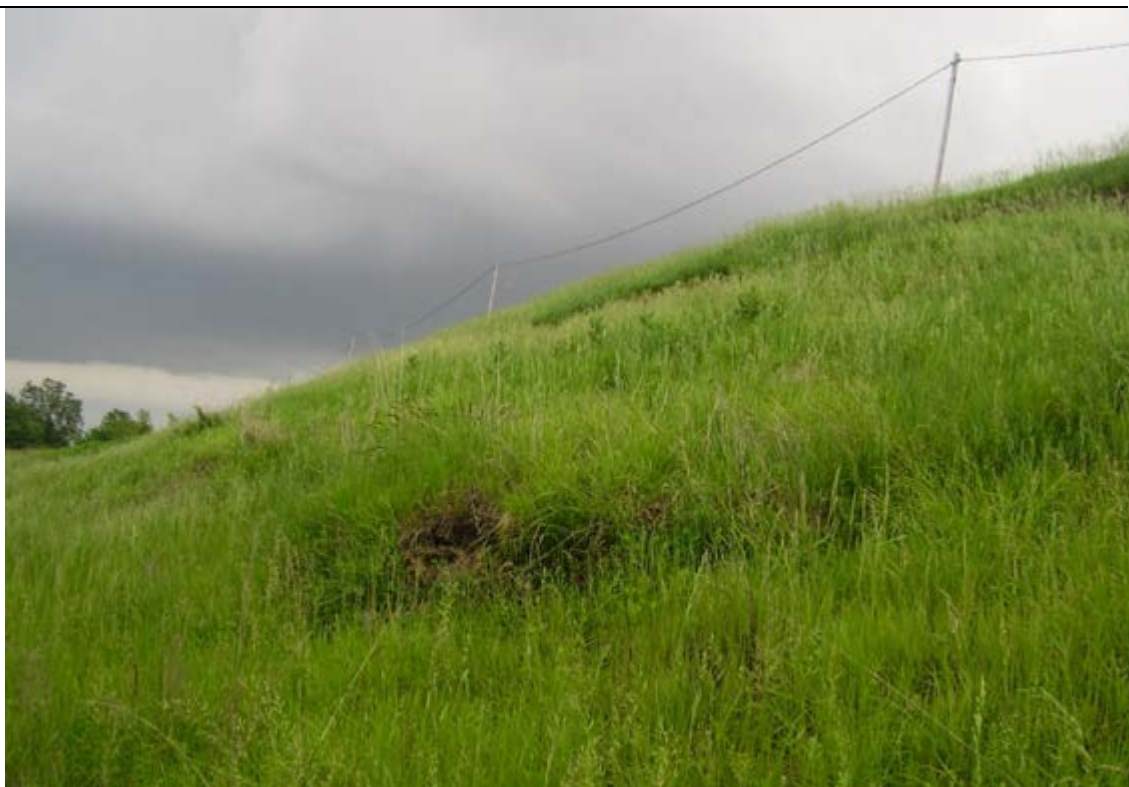
**Description:**  
Scarp on downstream slope  
of the Northern Dike.

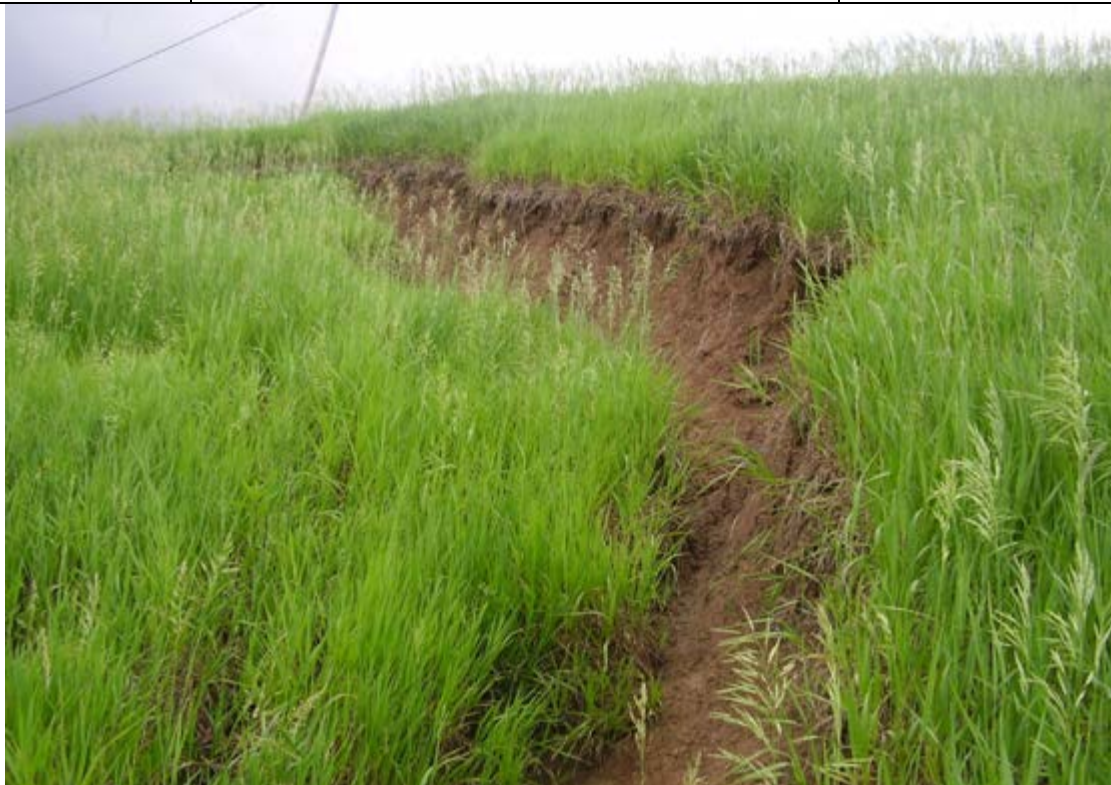
**Photo No.**  
**44**

**Description:**  
Scarp on downstream slope  
of the Northern Dike.

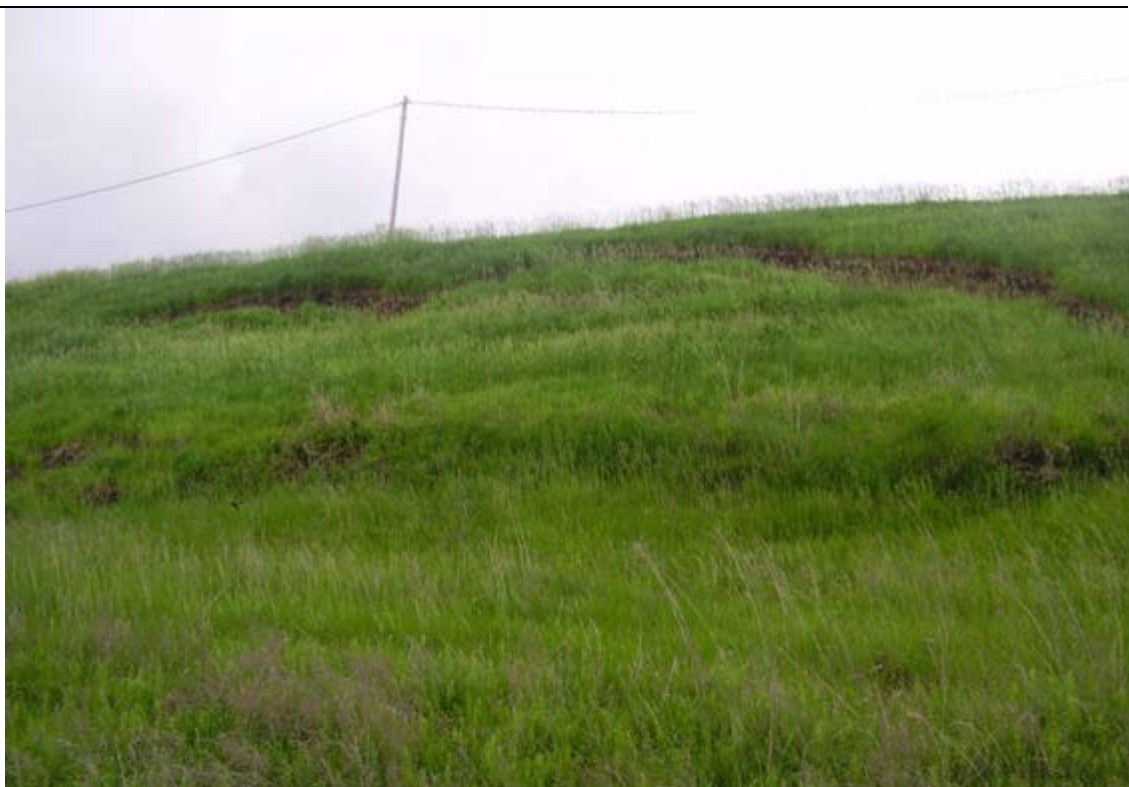
**Description:**  
Scarp on downstream slope  
of the Northern Dike.
