**DRAFT REPORT
ROUND 10 DAM ASSESSMENT - MAY 23, 2011
DYNEGY MIDWEST GENERATION, INC. – HENNEPIN POWER STATION
ACTIVE EAST ASH POND SYSTEM, EAST ASH POND SYSTEM, WEST ASH POND
SYSTEM
HENNEPIN, ILLINOIS**

March 15, 2012
GZA File No. 170142.30

RE: DRAFT Assessment of Dam Safety of Coal Combustion Surface Impoundments at the
Hennepin Power Station

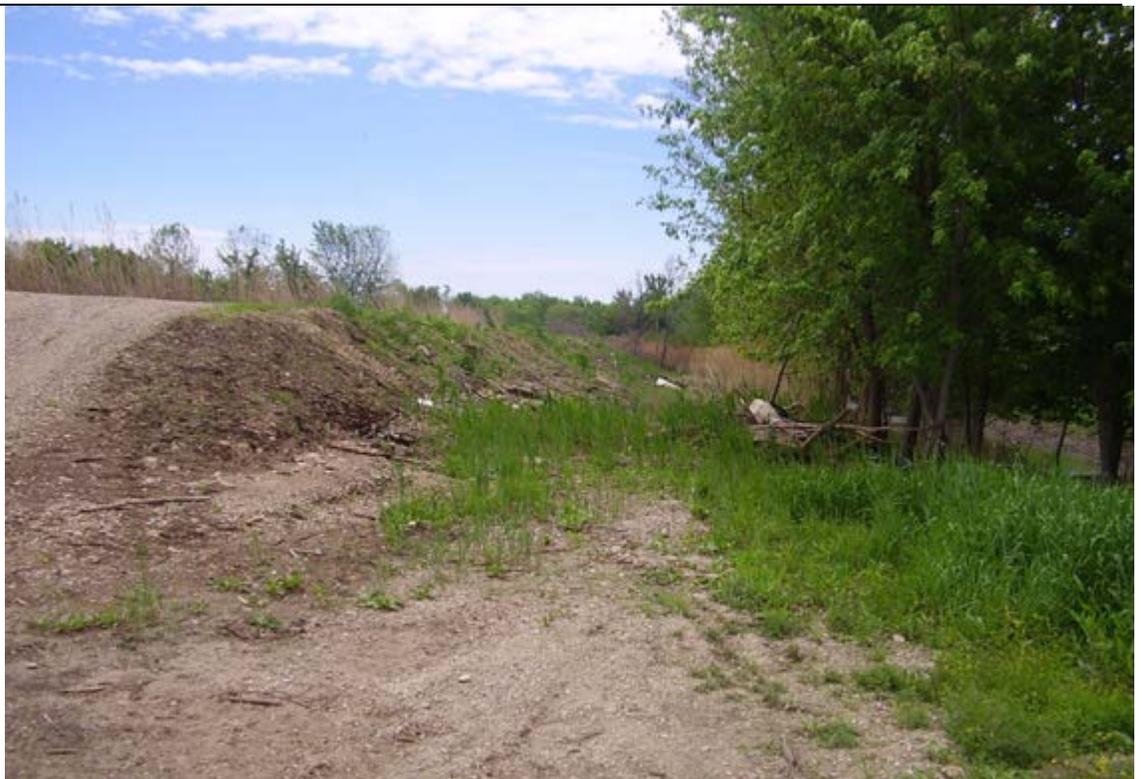
Photo No.
2

Description:
Downstream slope of the WAPS.

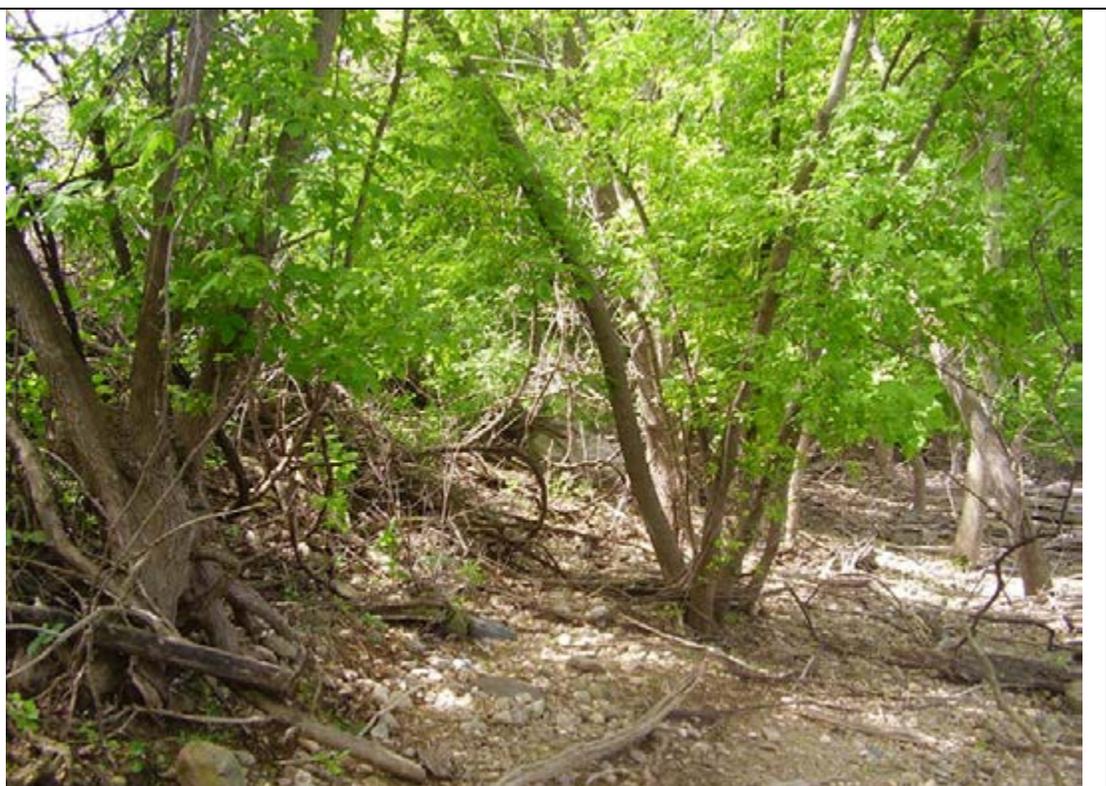
Photo No. 10	Date: 5/23/11
Direction Photo Taken: Southwest

Description:
Downstream slope of the WAPS.

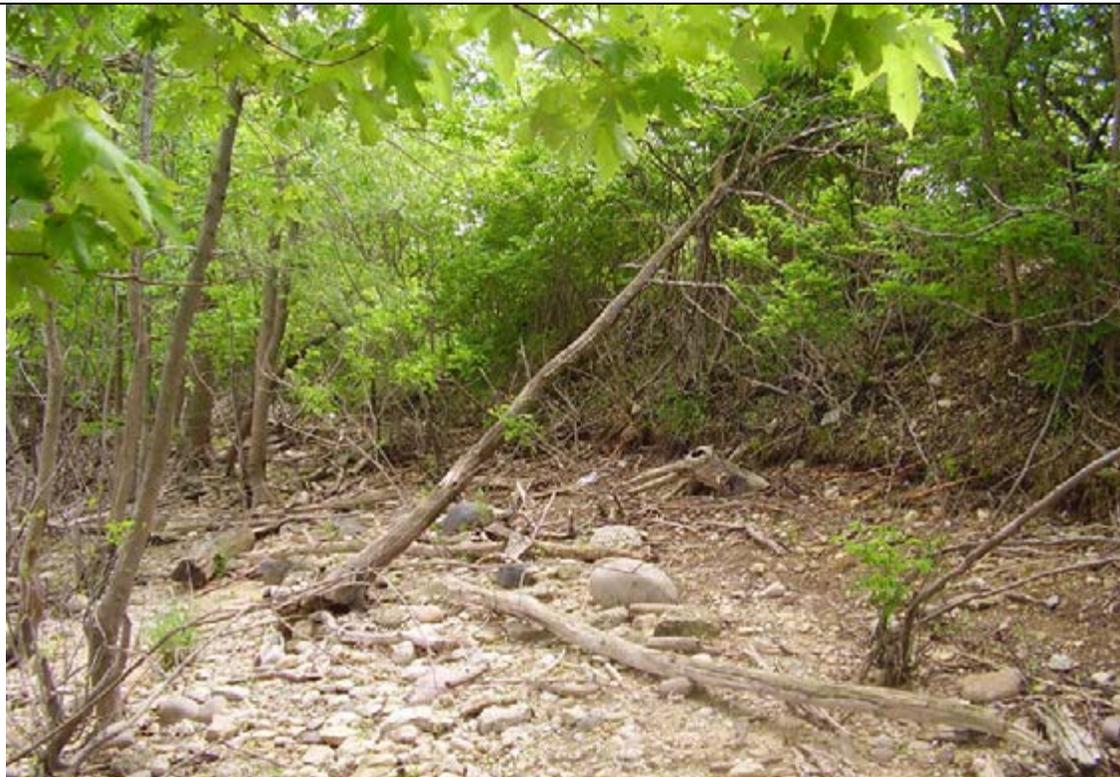
Photo No. 12	Date: 5/23/11
-------------------------------	-------------------------

Description:
Downstream slope of the WAPS.

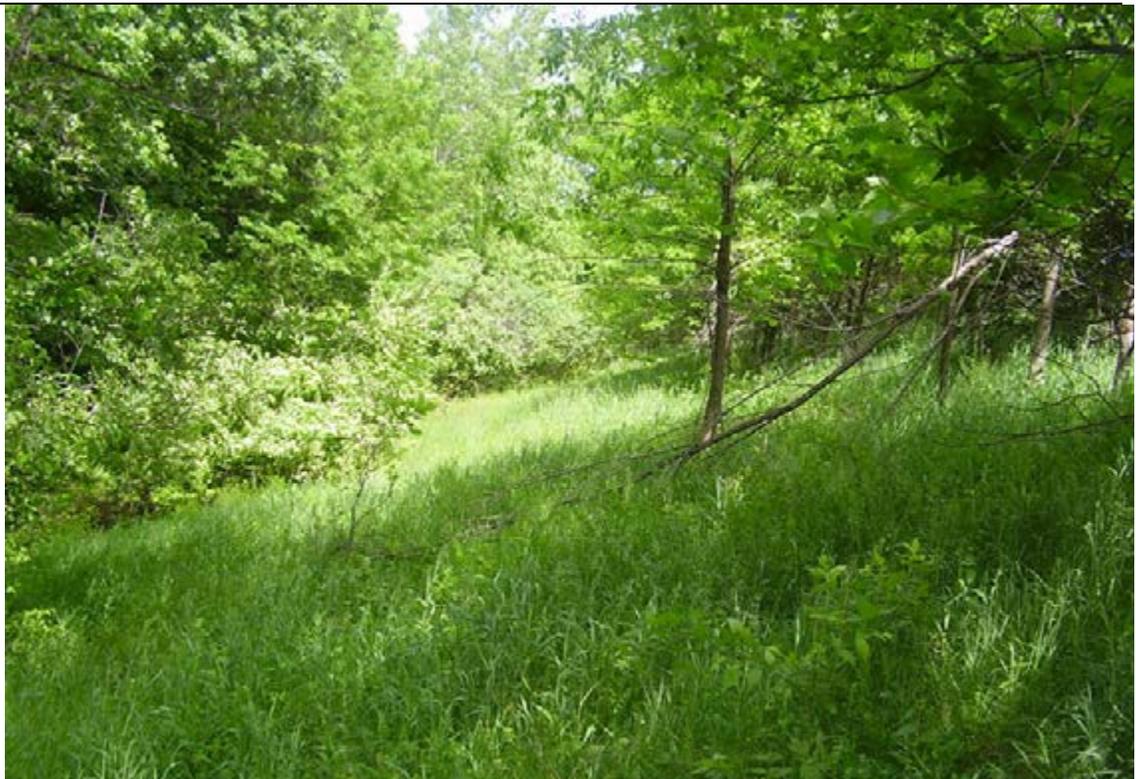
Photo No.
26

Description:
Downstream slope of the
EAPS.

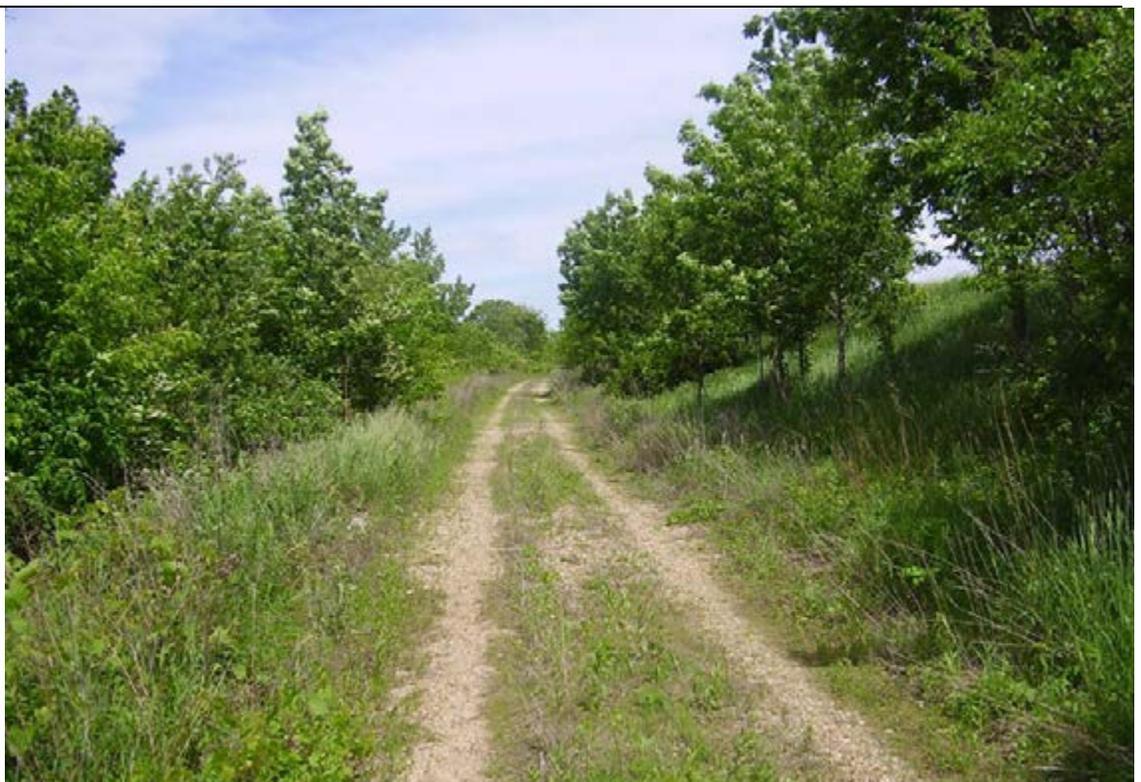
Photo No.
28

Description:
Crest of the 1978
embankment and
downstream slope of the
1995 embankment along the
EAPS.

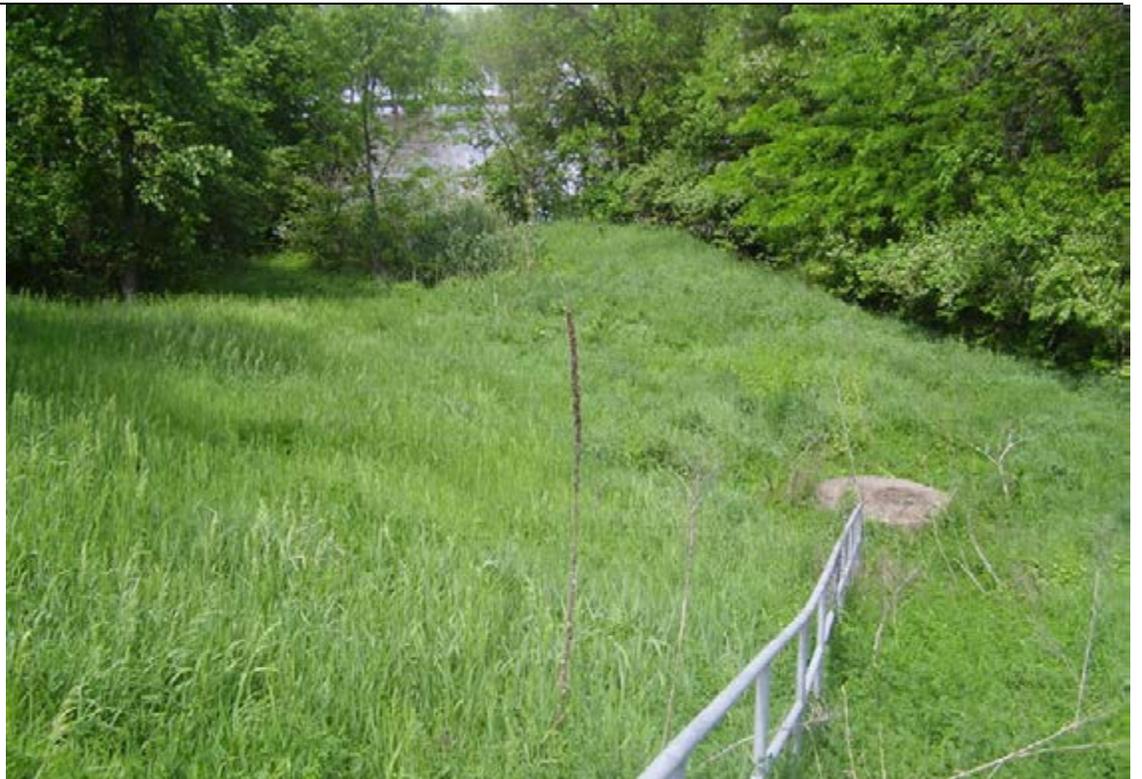
Photo No.
30

Downstream slope of Pond
2E.

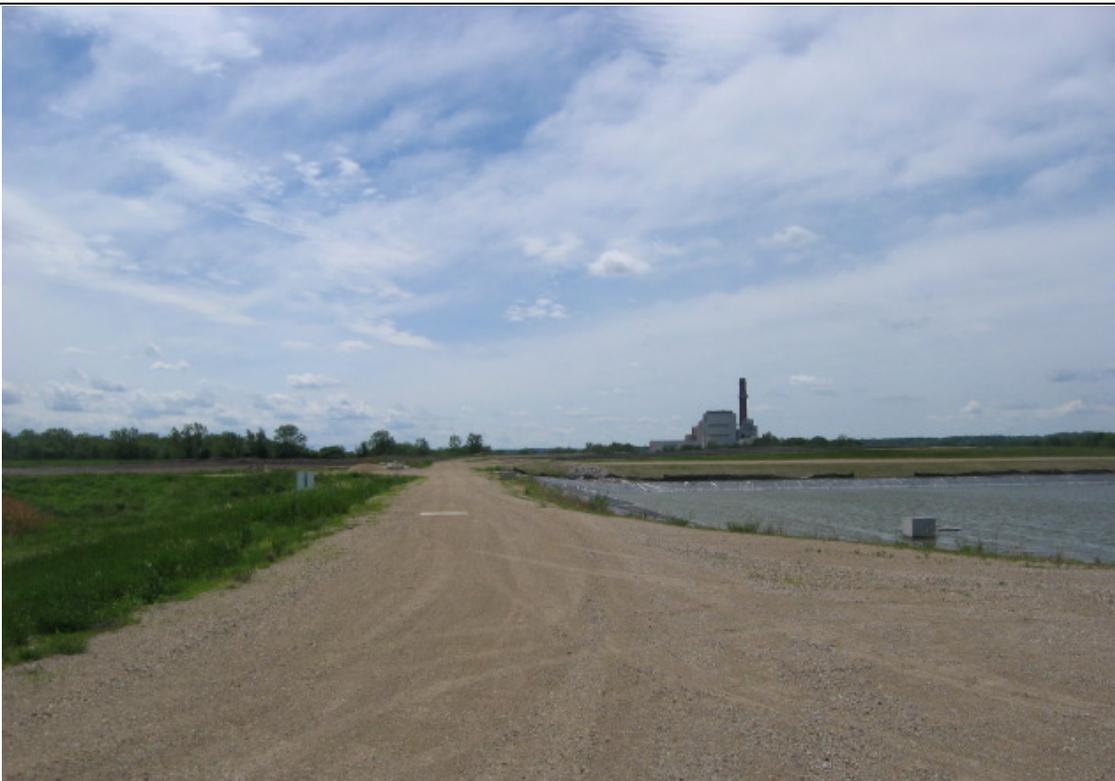
Photo No. 38	Date: 5/23/11
Direction Photo Taken: West

Description:
Crest of the embankment between Pond 2E and Secondary Cell.

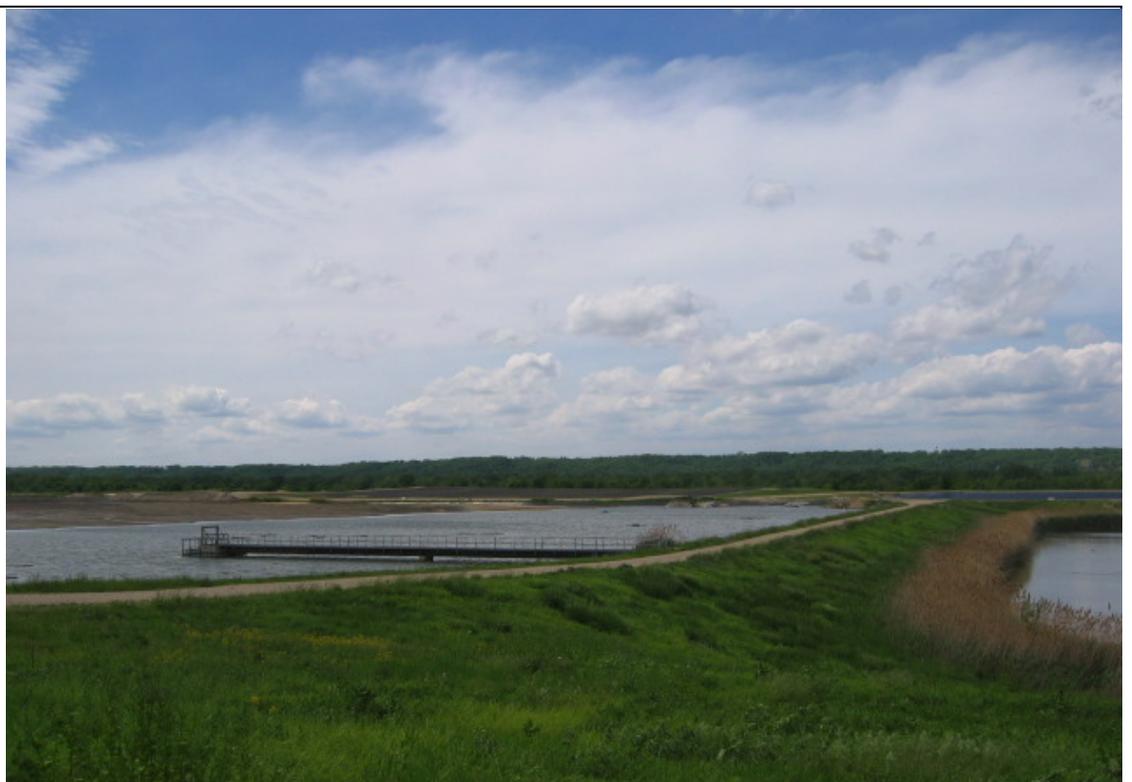
Photo No.
42

Description:
Crest and upstream slope of
the Secondary Cell.

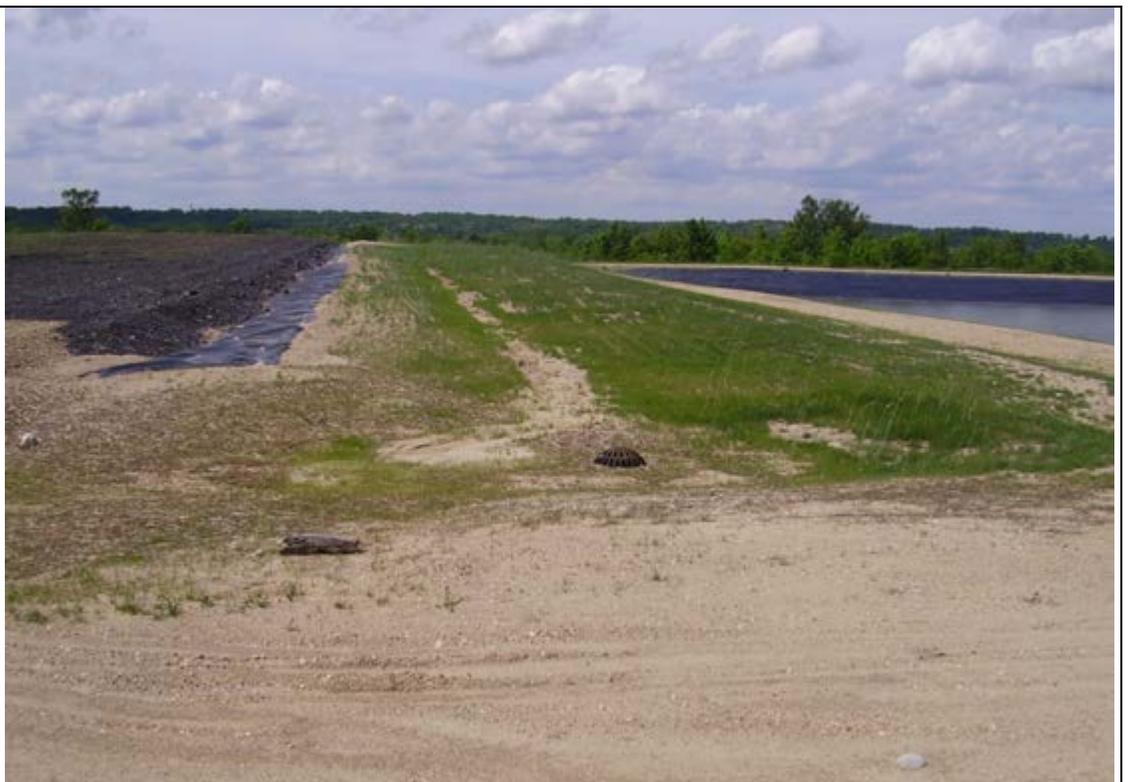
Photo No.
44

Upstream slope of the EAPS.

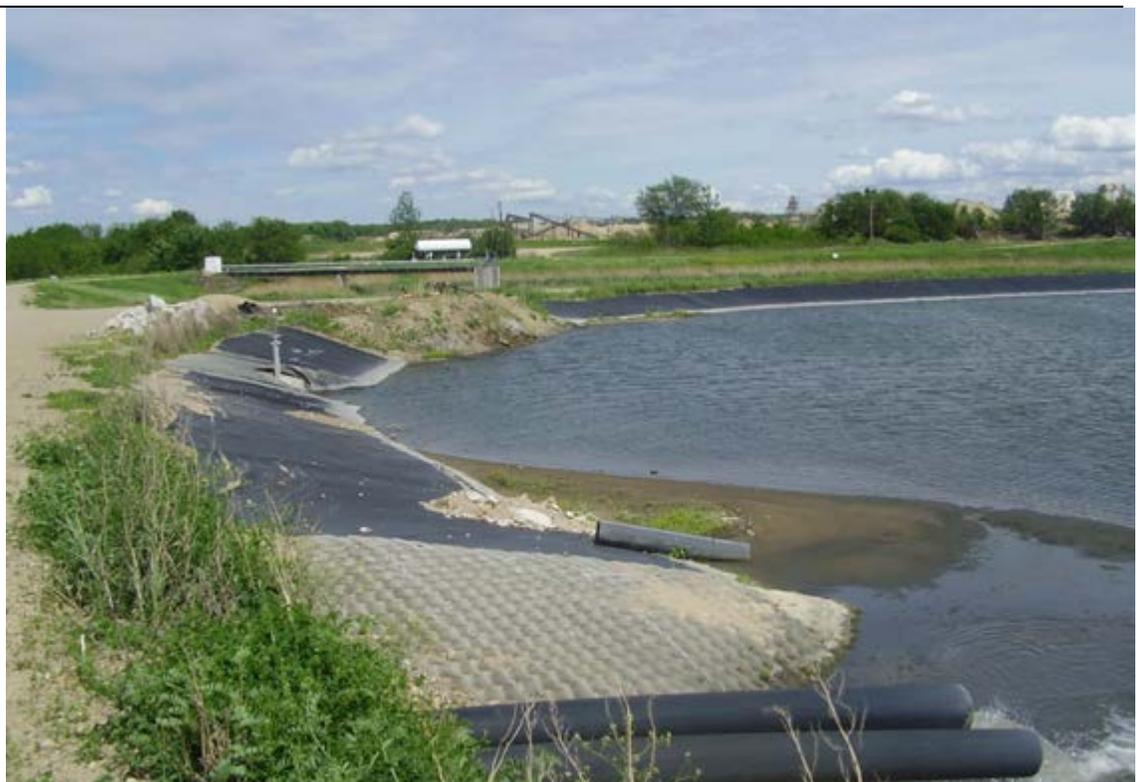
Photo No.
46

Description:
Upstream slope of the
Primary Cell.

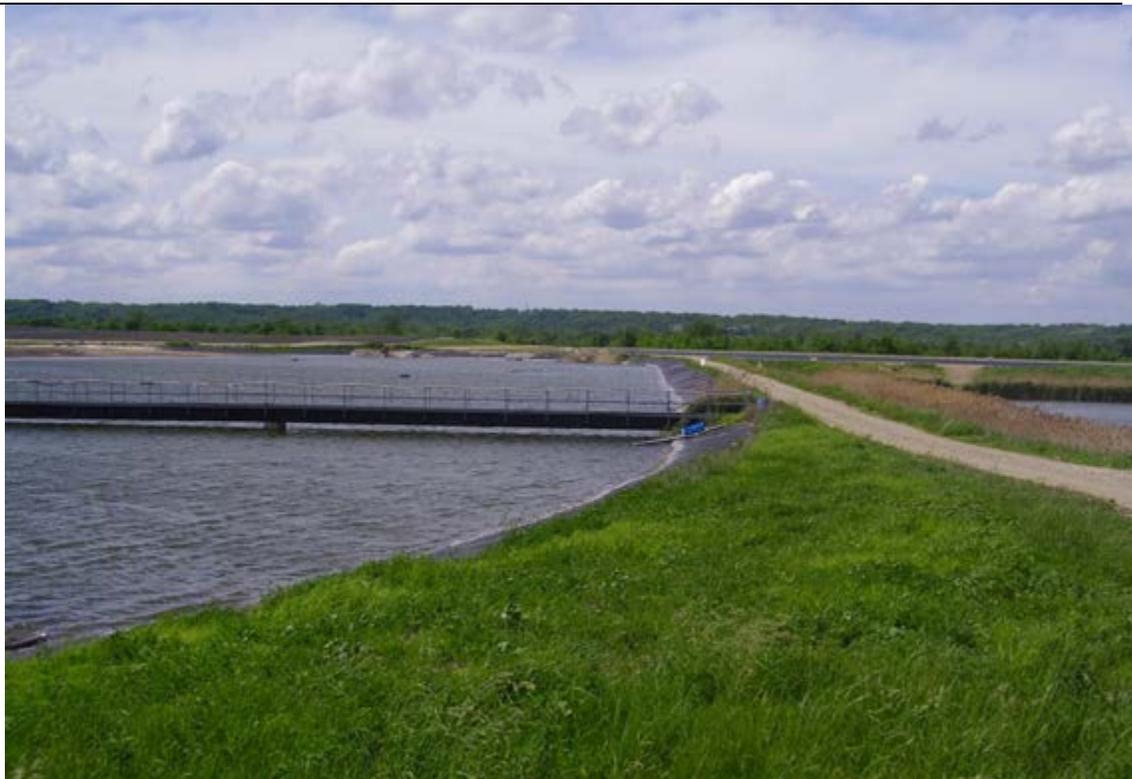
Photo No.
48

Description:
Upstream slope of the
Primary Cell near the decant
structure.

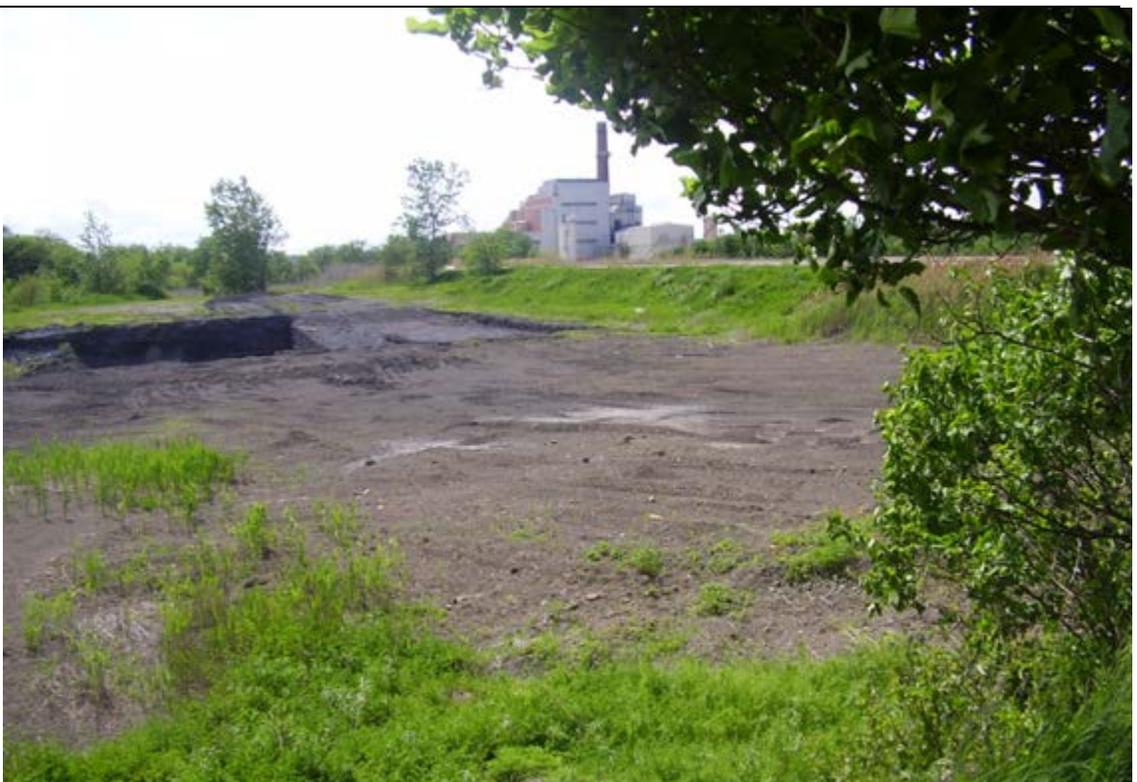
Photo No.
54

Description:
Downstream slope of the
EAPS.

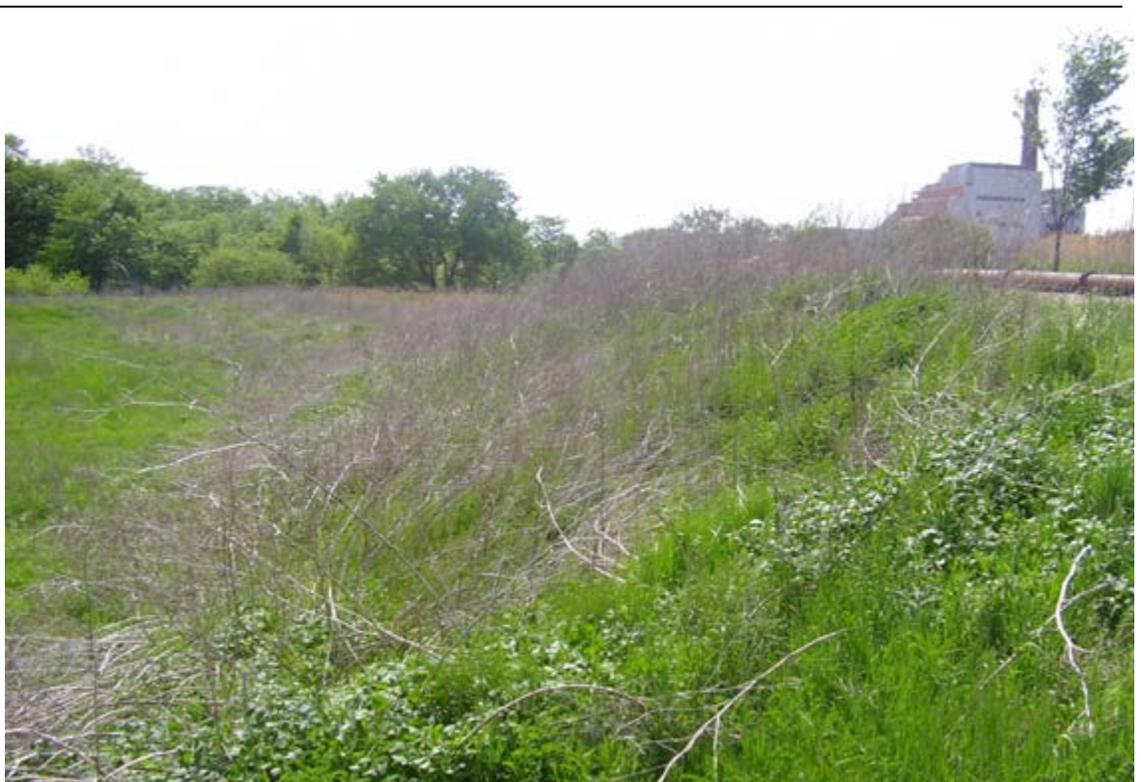
Photo No.
56

Downstream slope of the
EAPS.

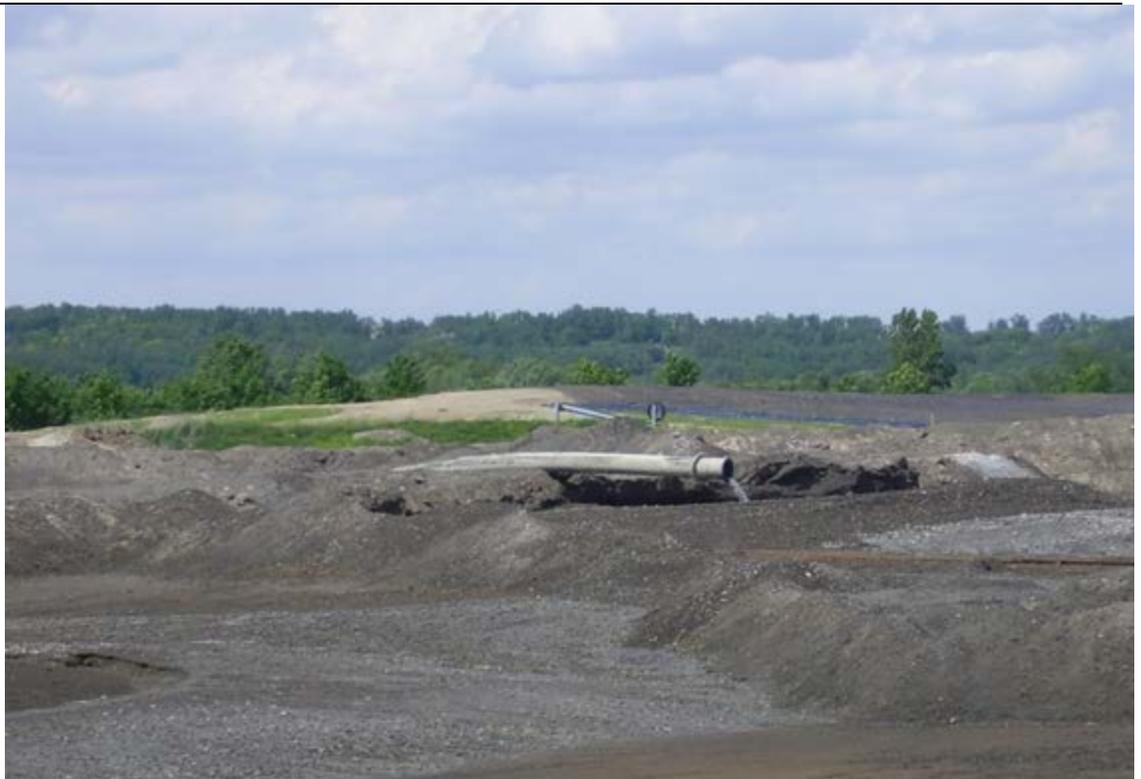
Photo No.
58

Description:
Discharge pipe into the
northwest portion of the
Primary Cell.

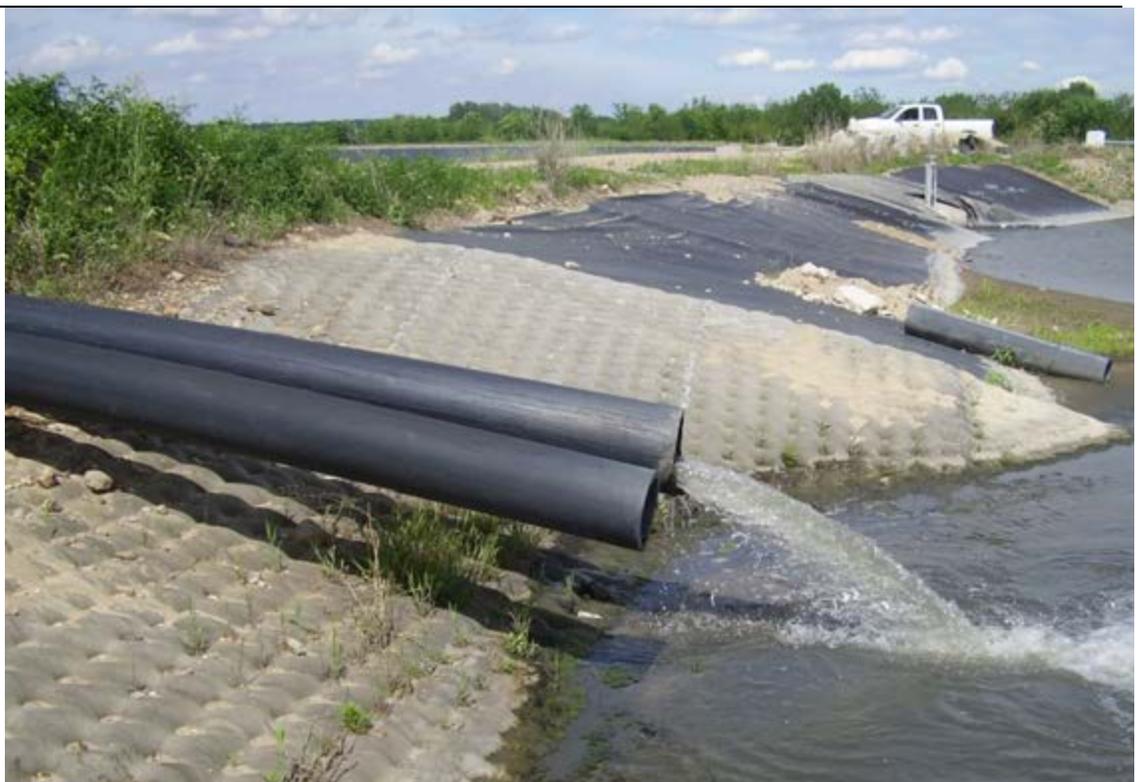
Photo No.
60

Description:
Discharge pipe into the
Primary Cell near the
northeast corner.

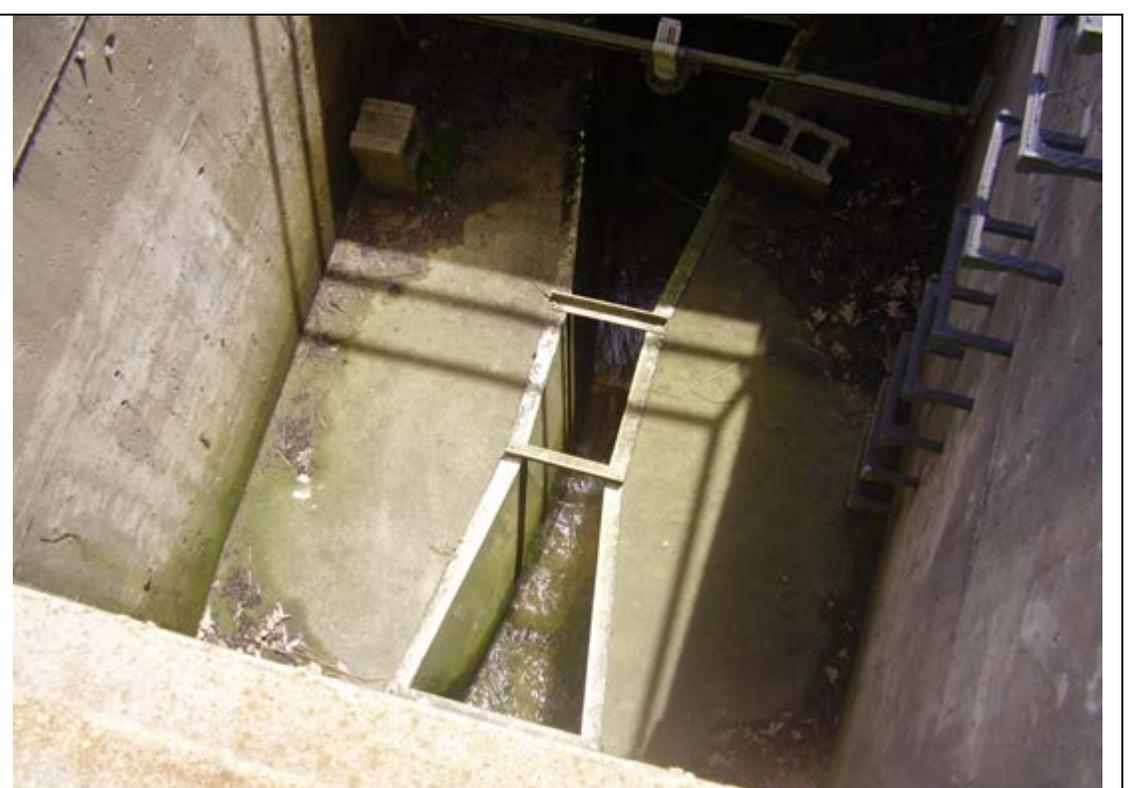
Photo No. 66	Date: 5/23/11
Direction Photo Taken: Down

Description:
Flume structure in the discharge line from the Secondary Cell to the Illinois River.

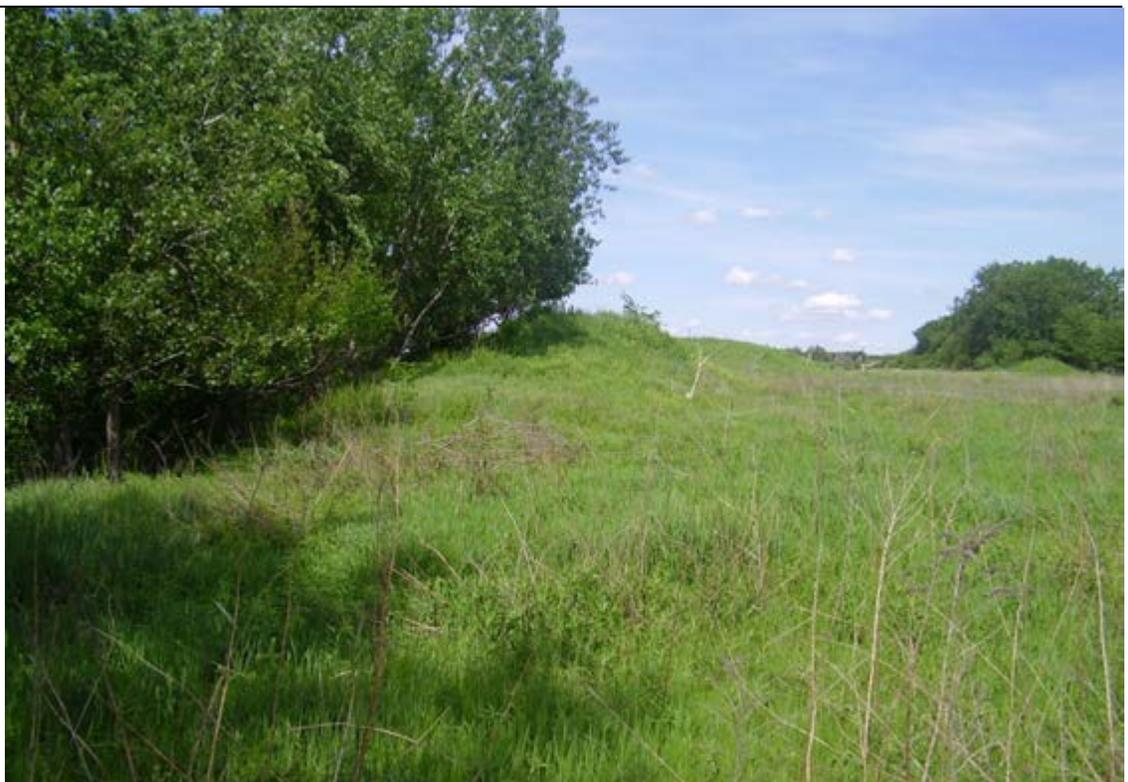
Photo No.
72

Description:
Crest of the EAPS near Pond
4.
