**FINAL REPORT
ROUND 10 DAM ASSESSMENT
DYNEGY MIDWEST GENERATION, LLC – HENNEPIN POWER STATION
ACTIVE EAST ASH POND SYSTEM, EAST ASH POND SYSTEM, WEST ASH POND
SYSTEM
HENNEPIN, ILLINOIS**

December 6, 2012
GZA File No. 170142.30

RE: FINAL Assessment of Dam Safety of Coal Combustion Surface Impoundments at the
Hennepin Power Station

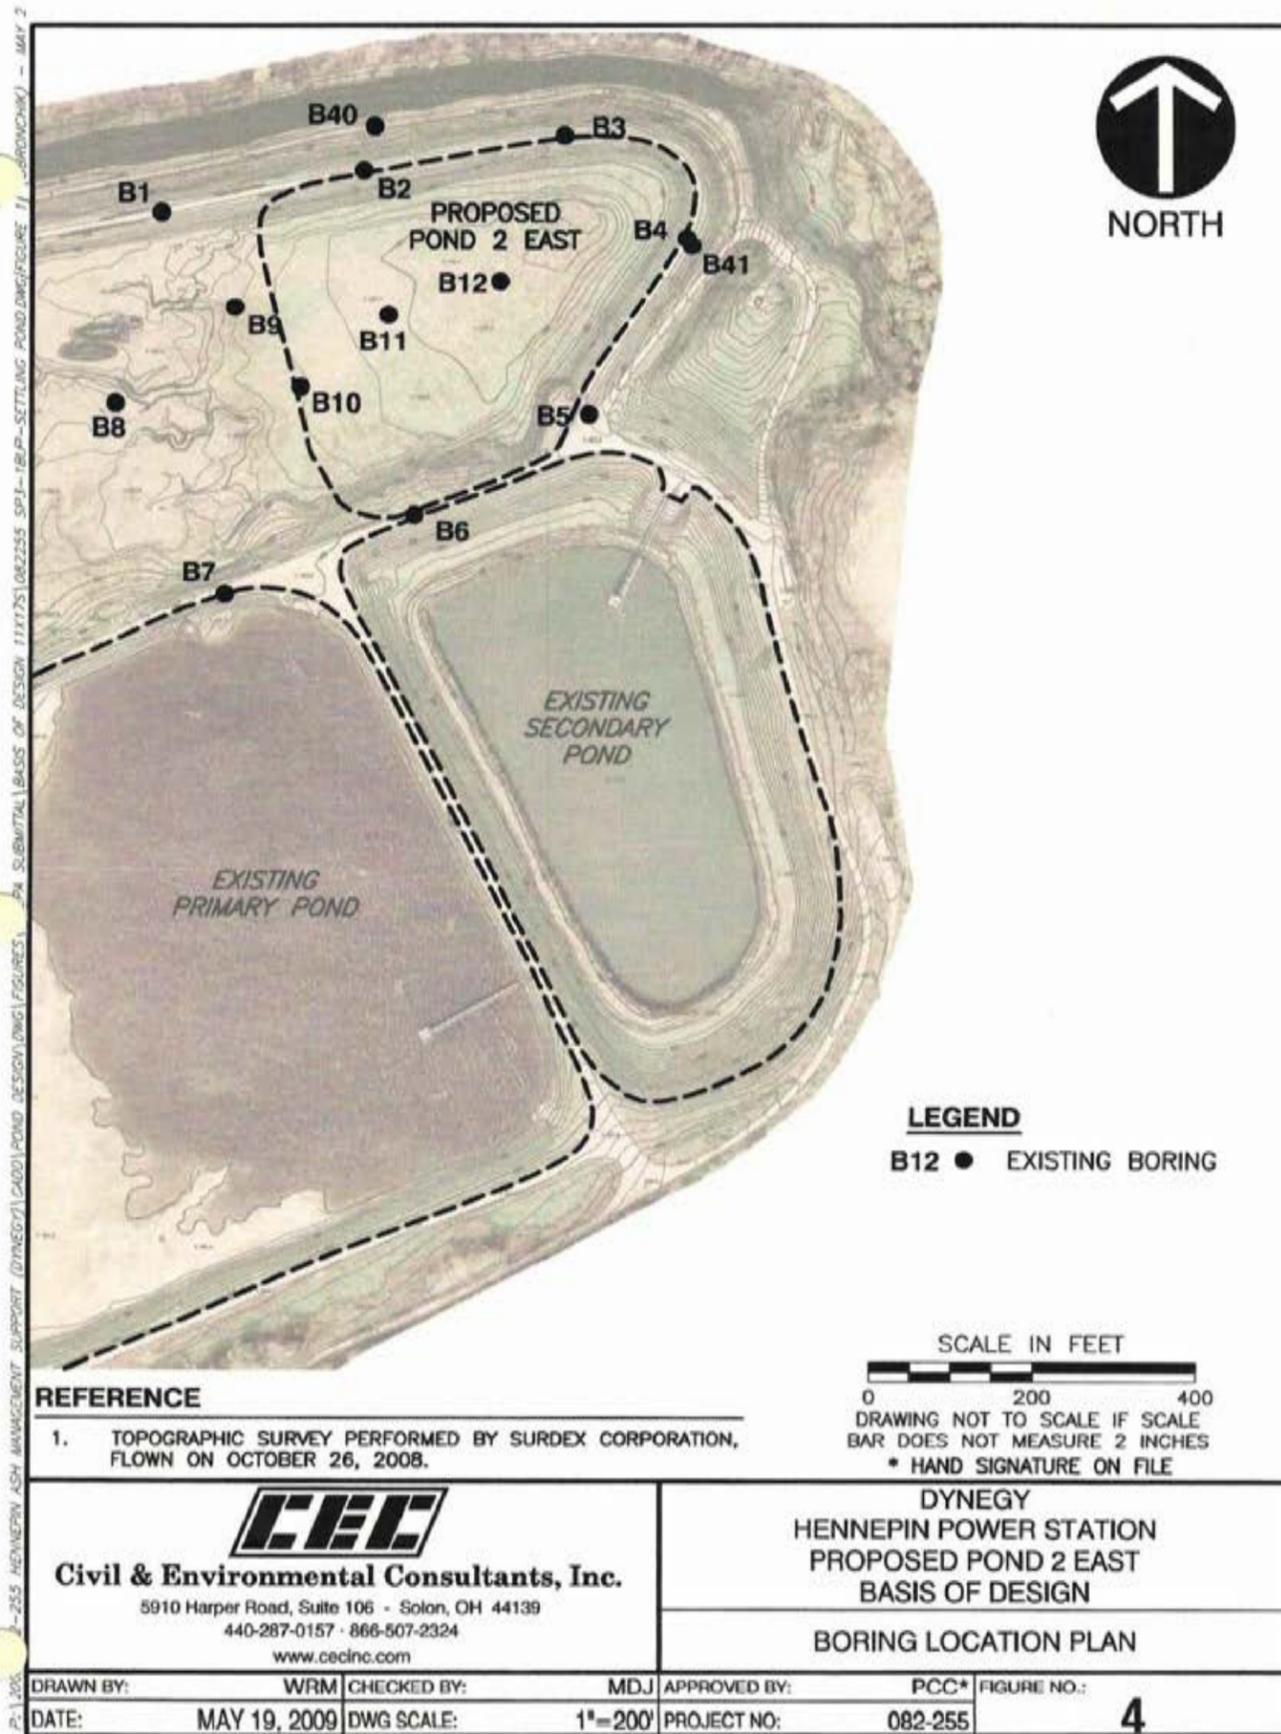
Borings were performed in 2009 by CEC in the area of the EAPS as part of the design for Pond 2E. Seven of the borings were drilled through the top of the 1989 embankment (at approximate elevation 494 (MLS)) and two borings through the 1978 embankment (at approximate elevation 484 (MLS)). The borings encountered gravelly clays and sands interbedded with layers of loose to medium dense sand, gravel and gravelly sands and clays; stiff to very stiff sandy and silty clays; and loose to very loose, moist to wet, laminated silt with zones of fly ash with a consistency of fine and/or silty sand. There was no evidence that the impoundment embankments were built over wet ash or slag. Several other borings drilled in the EAPS disposal area encountered CCW materials to depths ranging from about 24 to 35 feet below the existing surface grades or elevations ranging about 456 to 453 (MSL), respectively. The boring locations are provided on **Figure 5**.

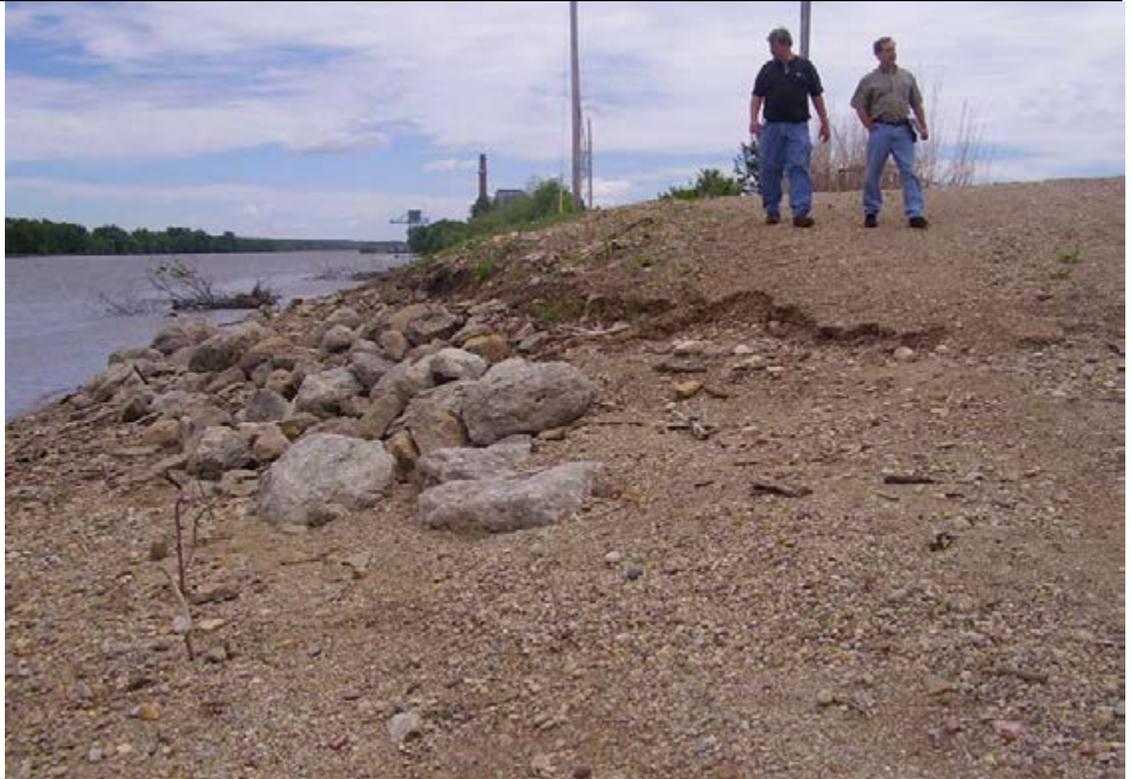
Description:
Downstream slope of the
West Ash Pond System
(WAPS) Impoundment.

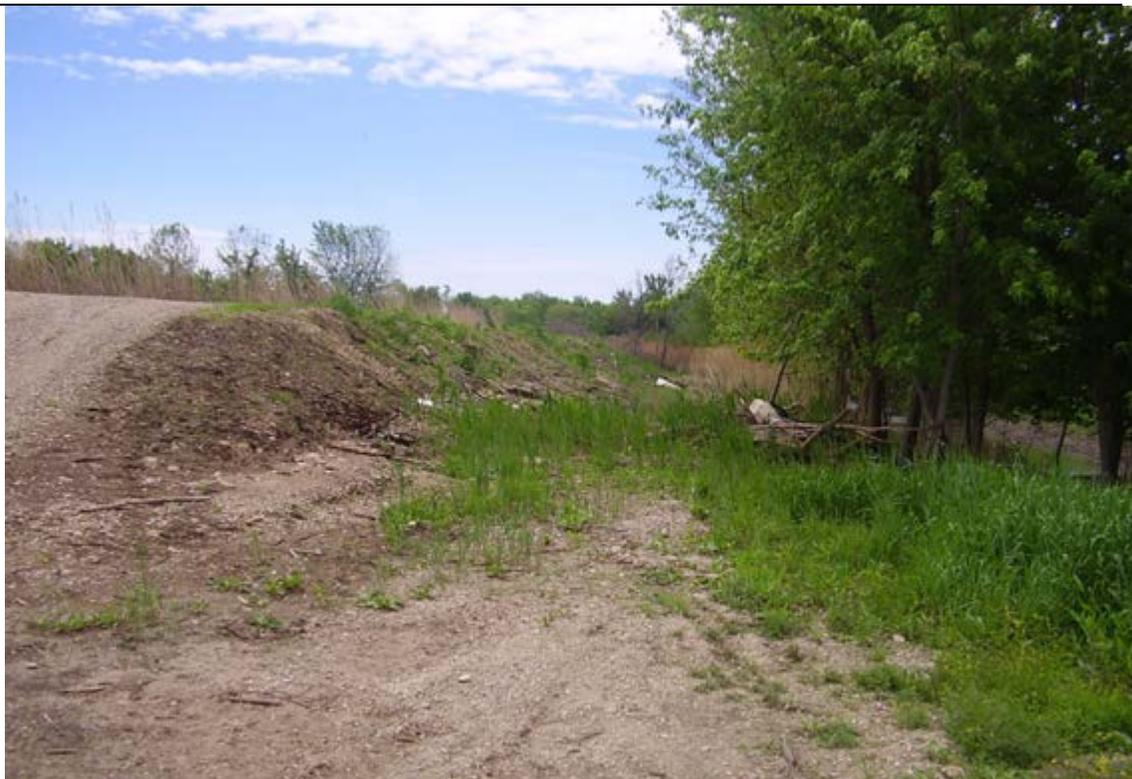
Photo No.
2

Description:
Downstream slope of the
WAPS.

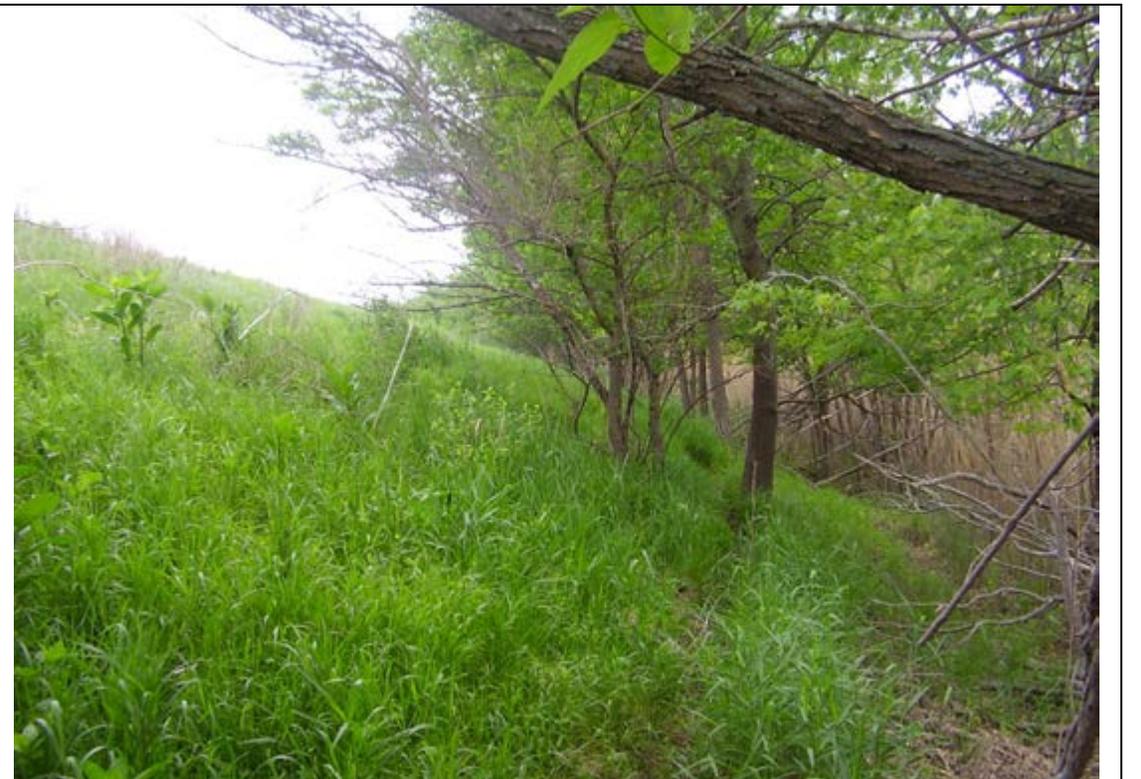
Photo No.
4

Description:
Downstream slope of the
WAPS.

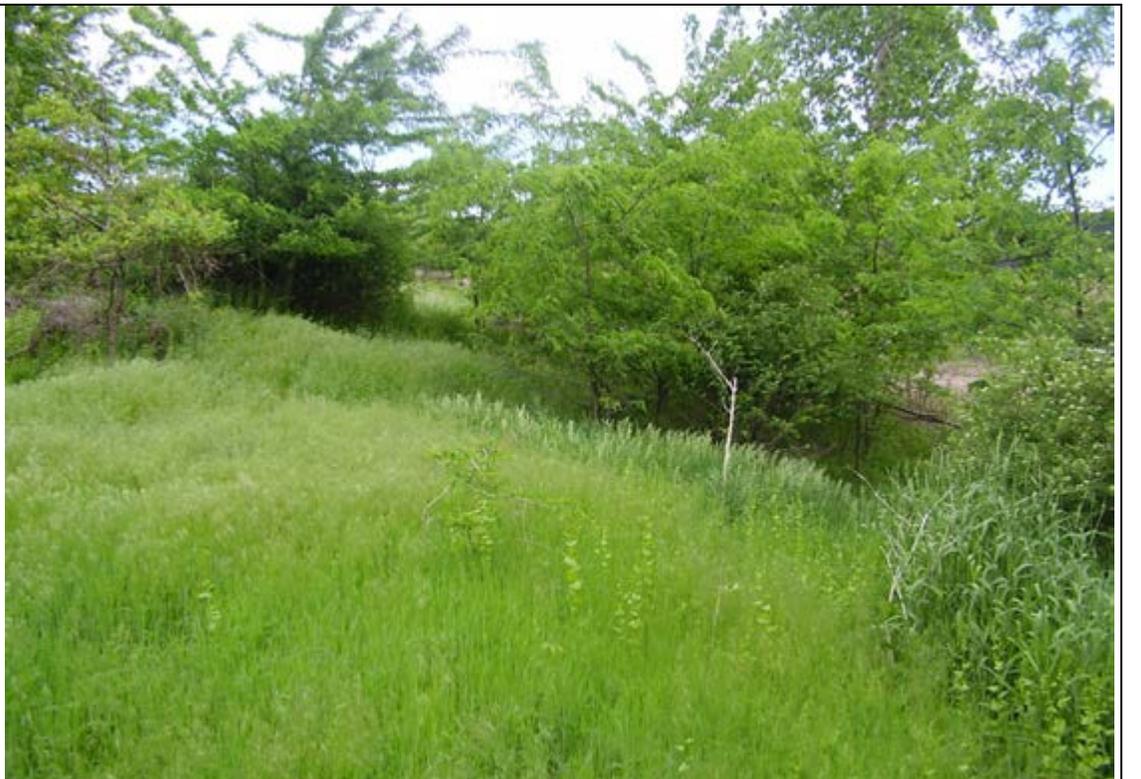
Photo No.
6

Description:
Crest and downstream slope
of the WAPS.

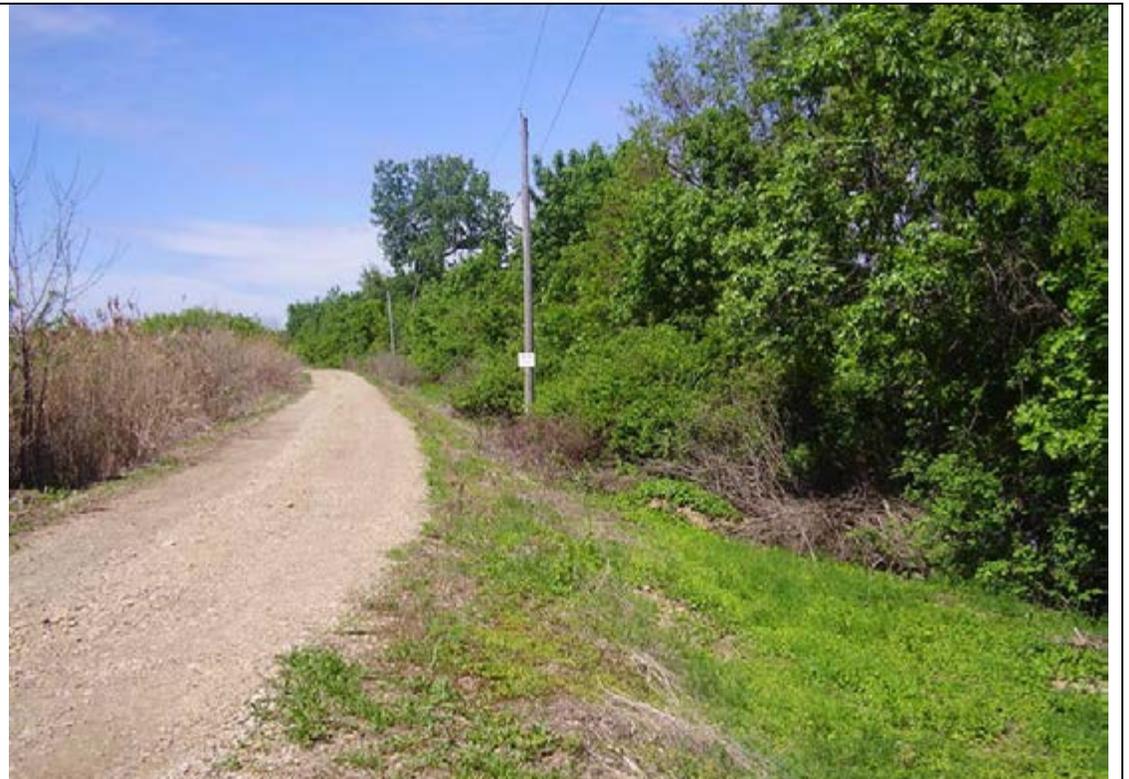
Photo No.
8

Description:
Crest and downstream slope
of the WAPS.

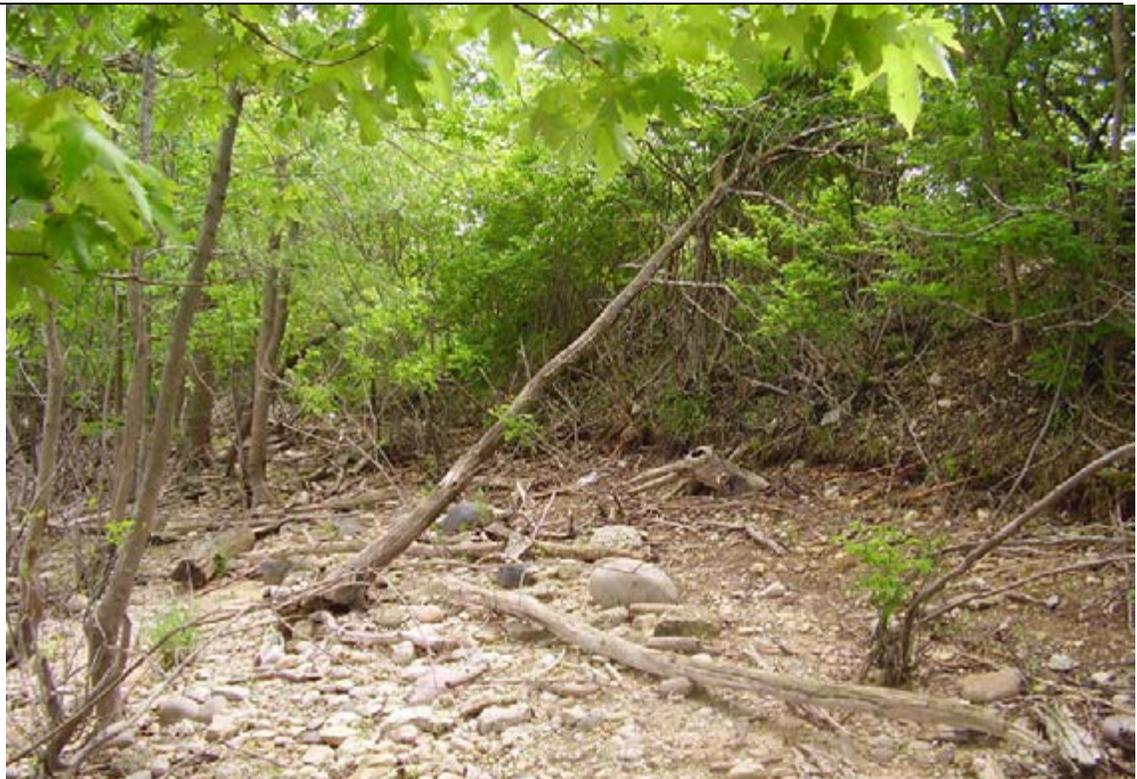
Photo No.
12

Description:
Downstream slope of the
WAPS.

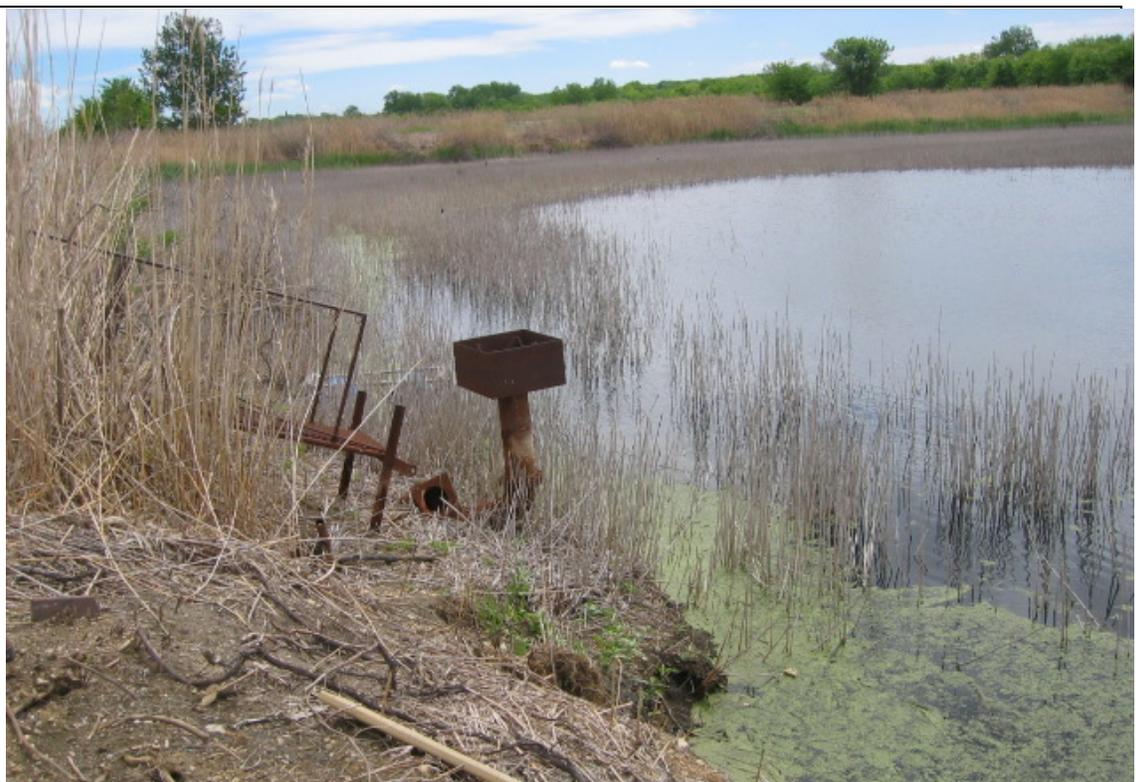
Photo No.
22

Description:
Decant structure in the
WAPS.

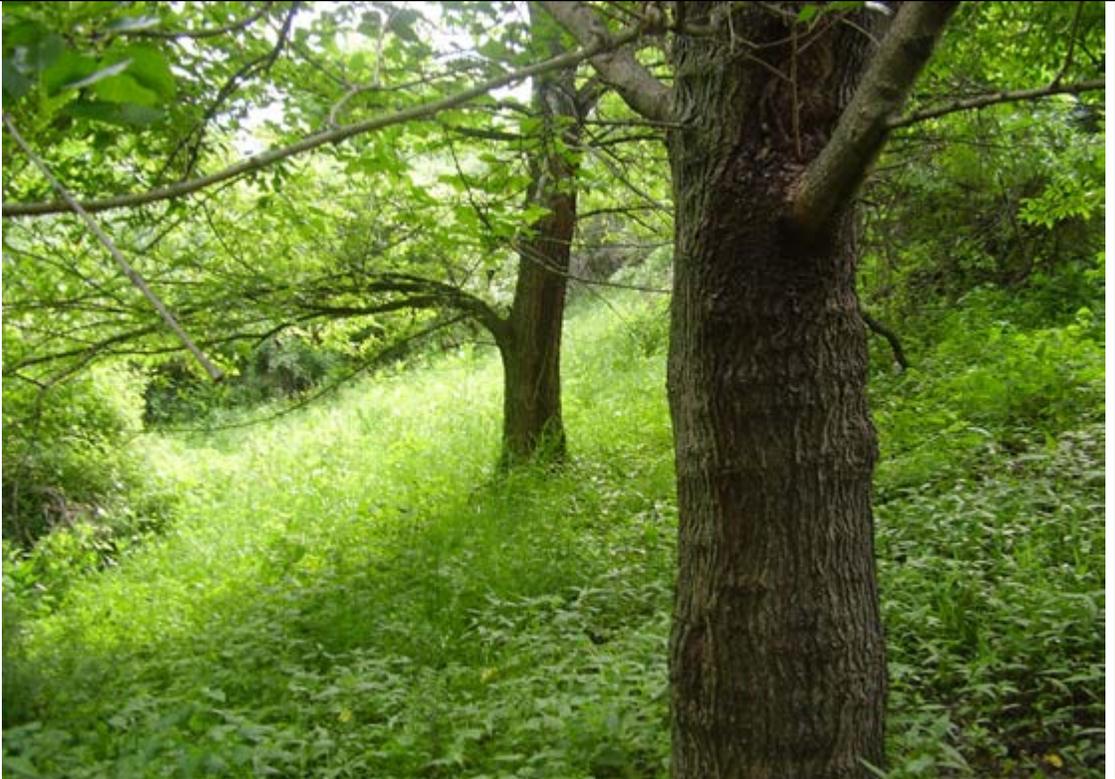
Photo No. 25	Date: 5/23/11
Direction Photo Taken: Northeast

Description:
Downstream slope of the EAPS.

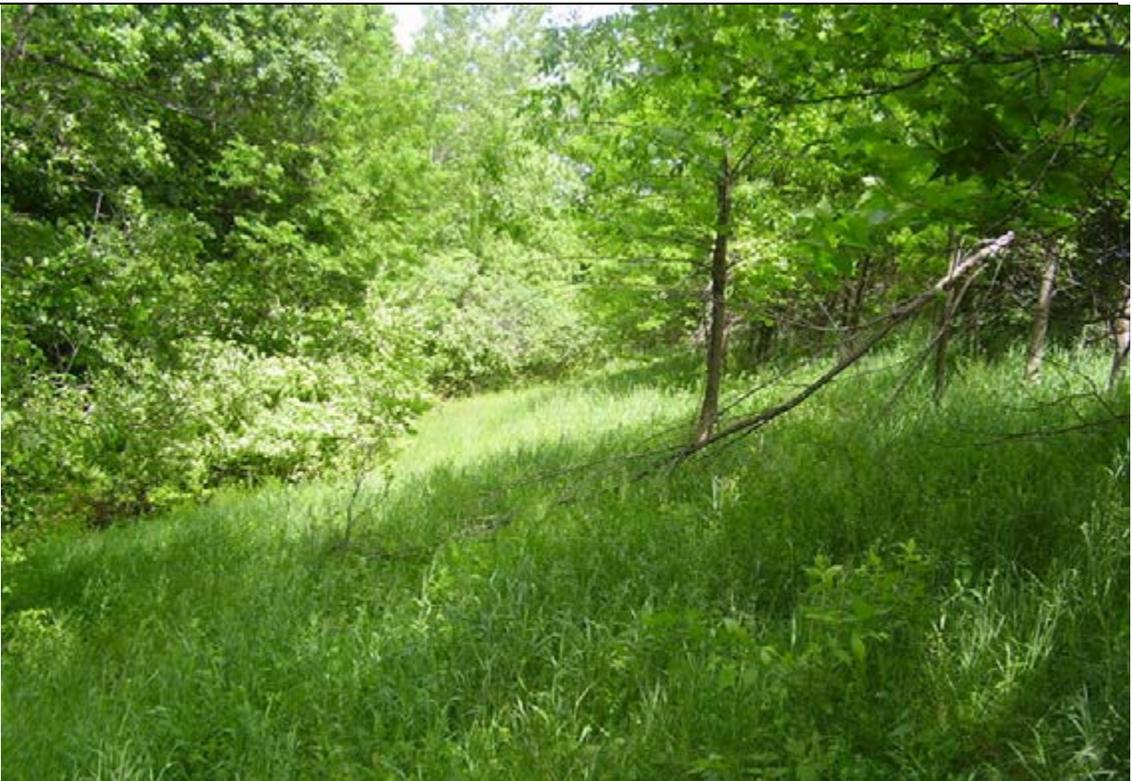
Photo No. 26	Date: 5/23/11
Direction Photo Taken: Northeast

Description:
Downstream slope of the EAPS.

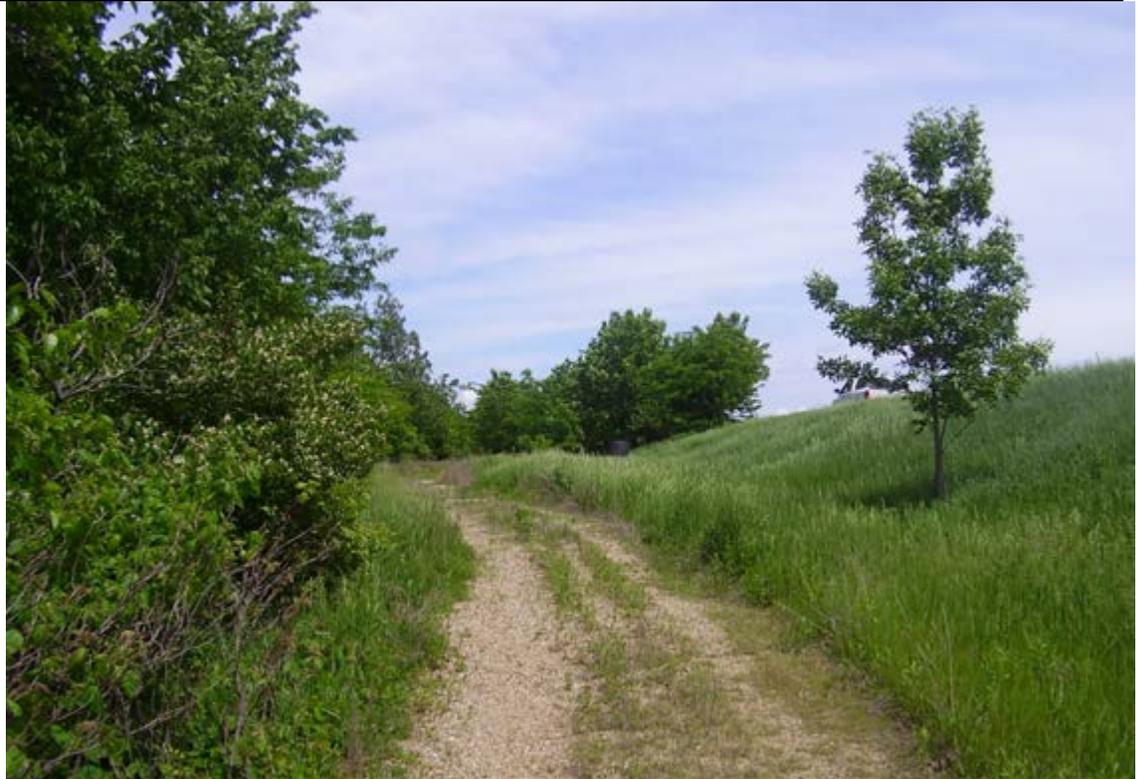
Photo No. 27	Date: 5/23/11
Direction Photo Taken: Northeast

Description:
Crest of the 1978 embankment and downstream slope of the 1995 embankment along the EAPS.

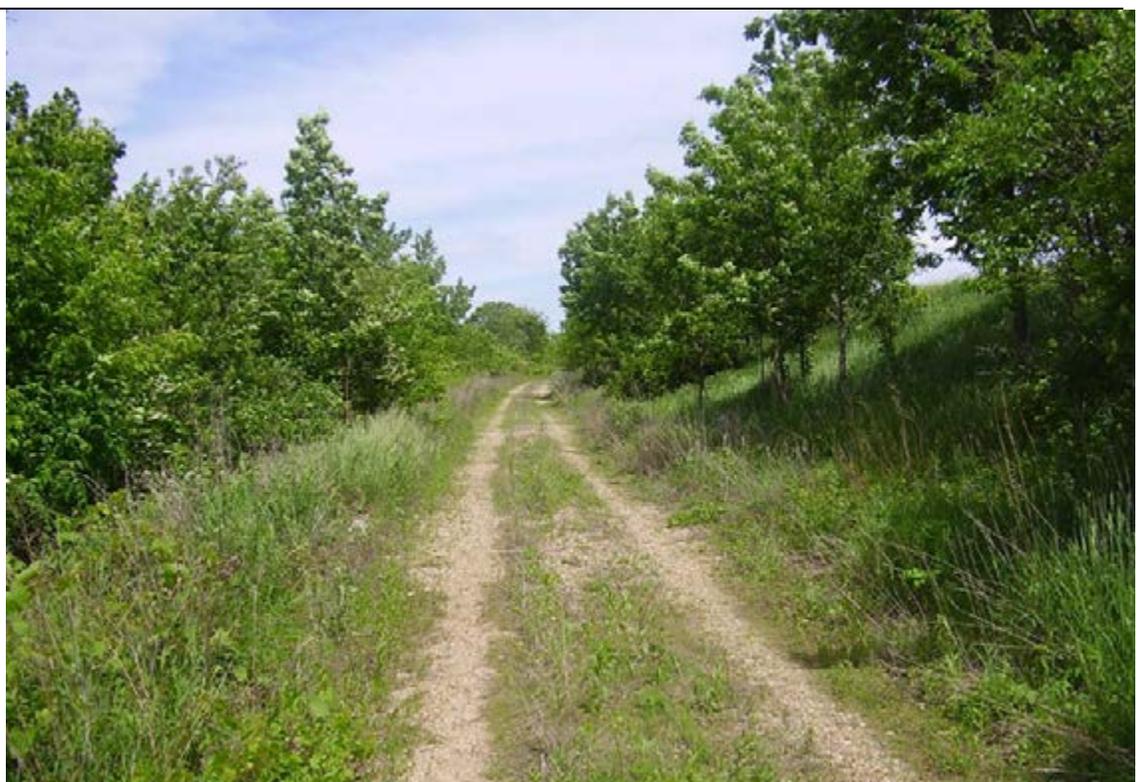
Photo No. 28	Date: 5/23/11
Direction Photo Taken: Northeast

Description:
Crest of the 1978 embankment and downstream slope of the 1995 embankment along the EAPS.

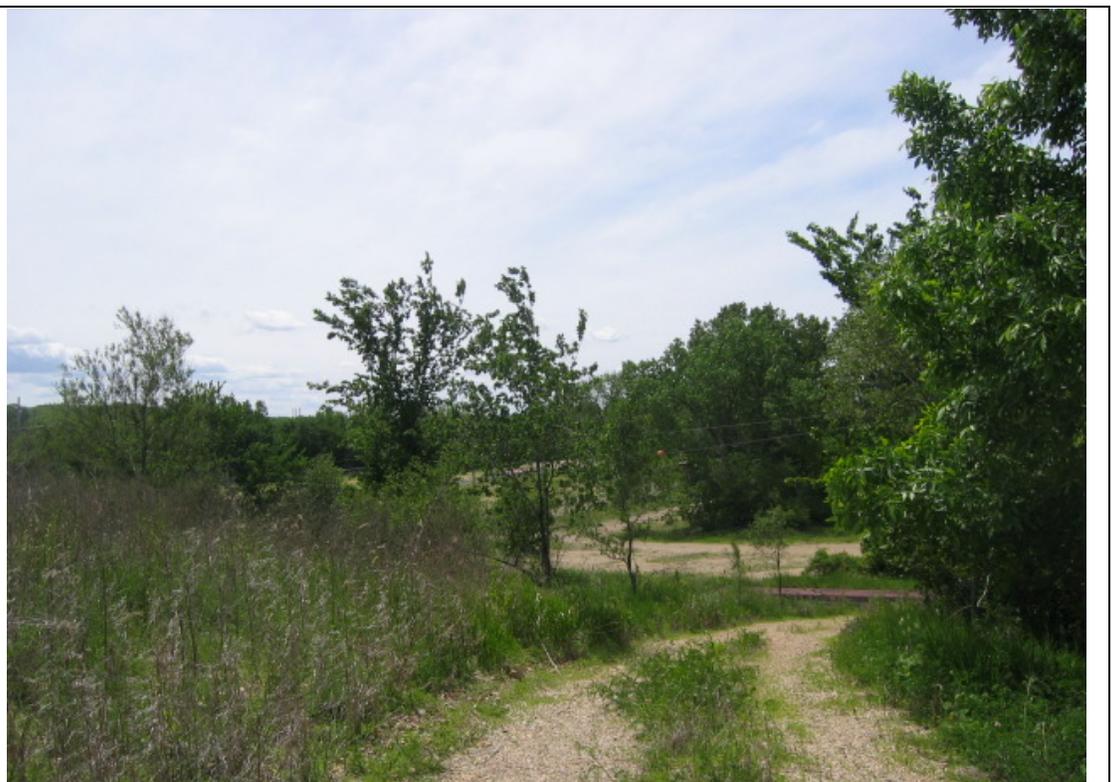
Photo No.
32

Description:
Crest of the EAPS.

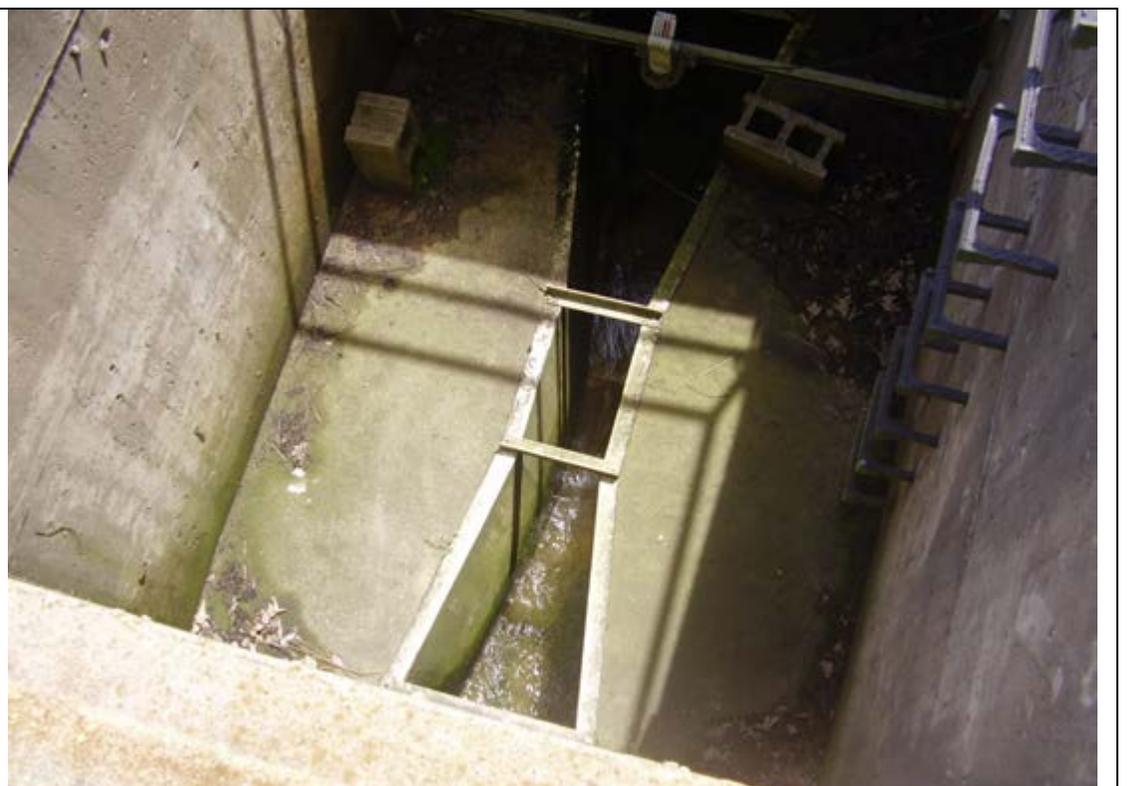
Photo No. 66	Date: 5/23/11
Direction Photo Taken: Down

Description:
Flume structure in the discharge line from the Secondary Cell to the Illinois River.
