**DRAFT REPORT
ROUND 10 DAM ASSESSMENT - MAY 16, 2011
EME HOMER CITY GENERATION L.P.
HOMER CITY GENERATING STATION
ASH DISPOSAL SITE PONDS, COAL REFUSE SITE PONDS
AND ASH RECYCLE PONDS
HOMER CITY, PENNSYLVANIA**

RE: Assessment of Dam Safety of Coal Combustion Surface Impoundments at the
Homer City Generating Station

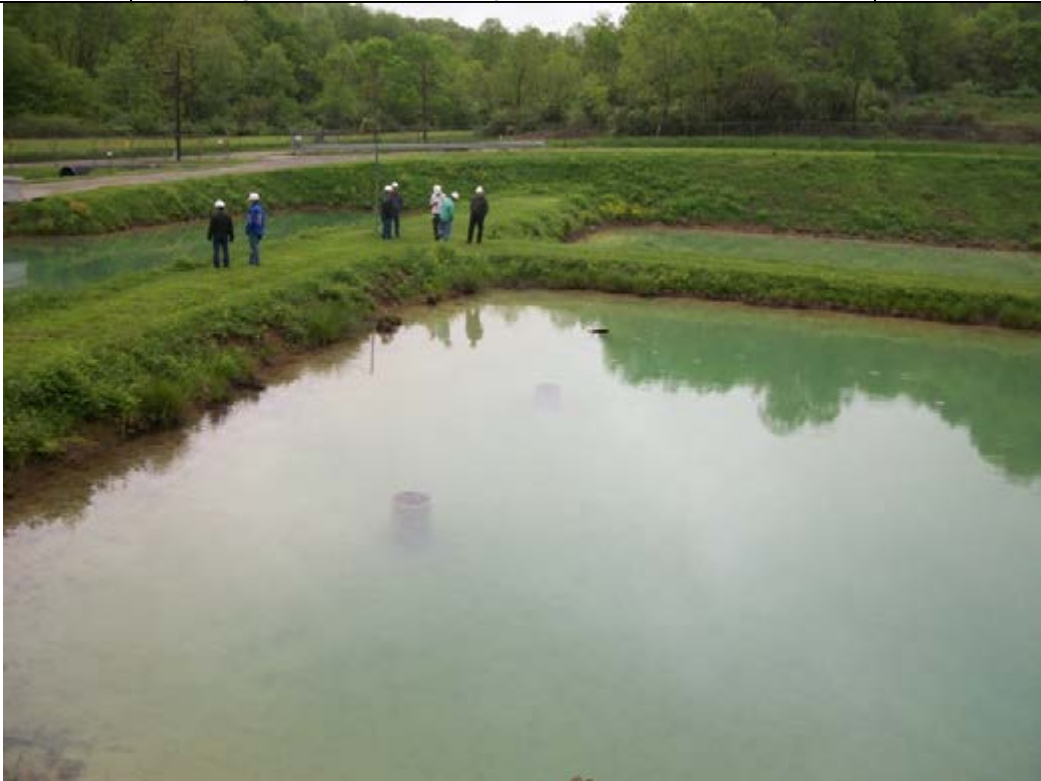
Client Name: U.S. Environmental Protection Agency		Site Location: EME Homer City Station Treatment Pond No. 1 (Ash Disposal Site), Homer City, PA	Project No. 170142.30
Photo No. 9	Date: 5/16/2011

Direction Photo Taken: Southwesterly			
Description: Vertical riser intake pipes at the south end of Treatment Pond No. 1. Flow from pipes is discharged to the Polishing Pond (upper left of photo).

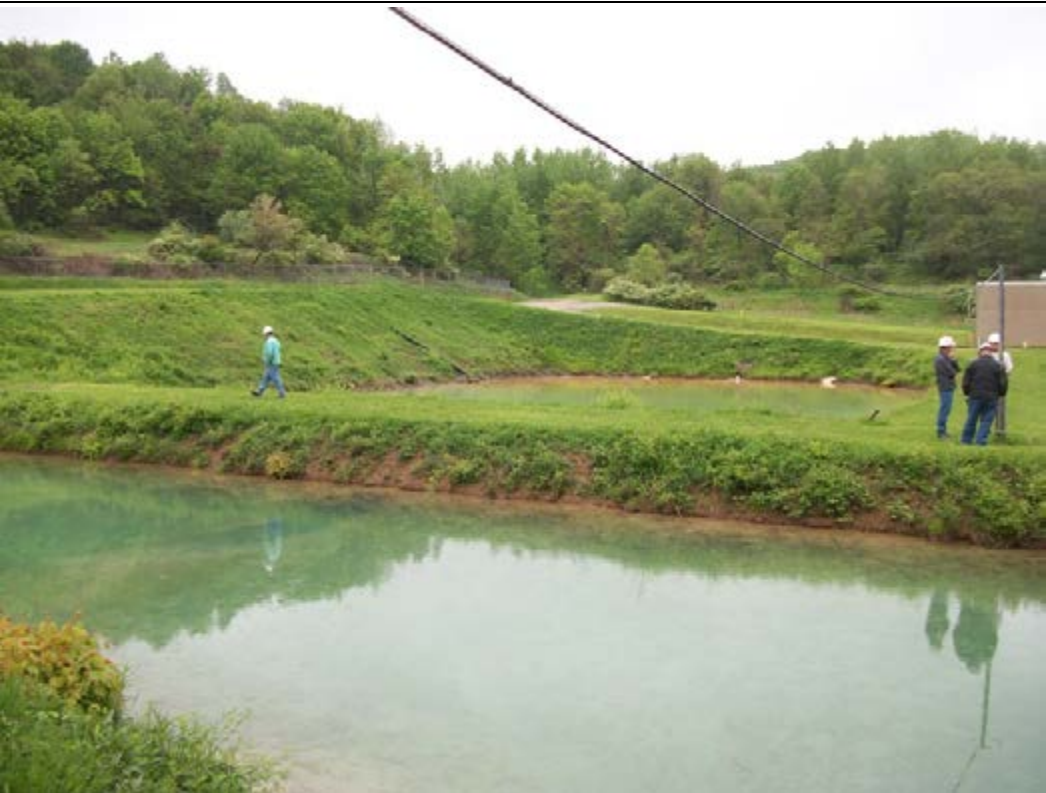
Photo No. 16	Date: 5/16/2011

Direction Photo Taken: Northwesterly		
Description: Overview of west and north inside slopes of Treatment Pond No. 2. Note how the Pond has been incised below original existing grade. Polishing Pond in the foreground.

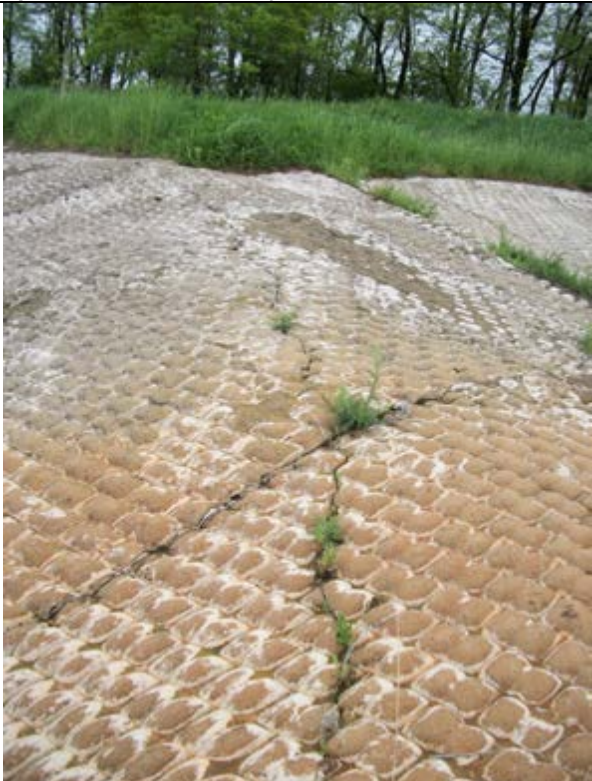
Direction Photo Taken: Northeasterly				
Description: Crack observed in concrete erosion control revetment matting at transition from Emergency Spillway crest to the overflow discharge channel.

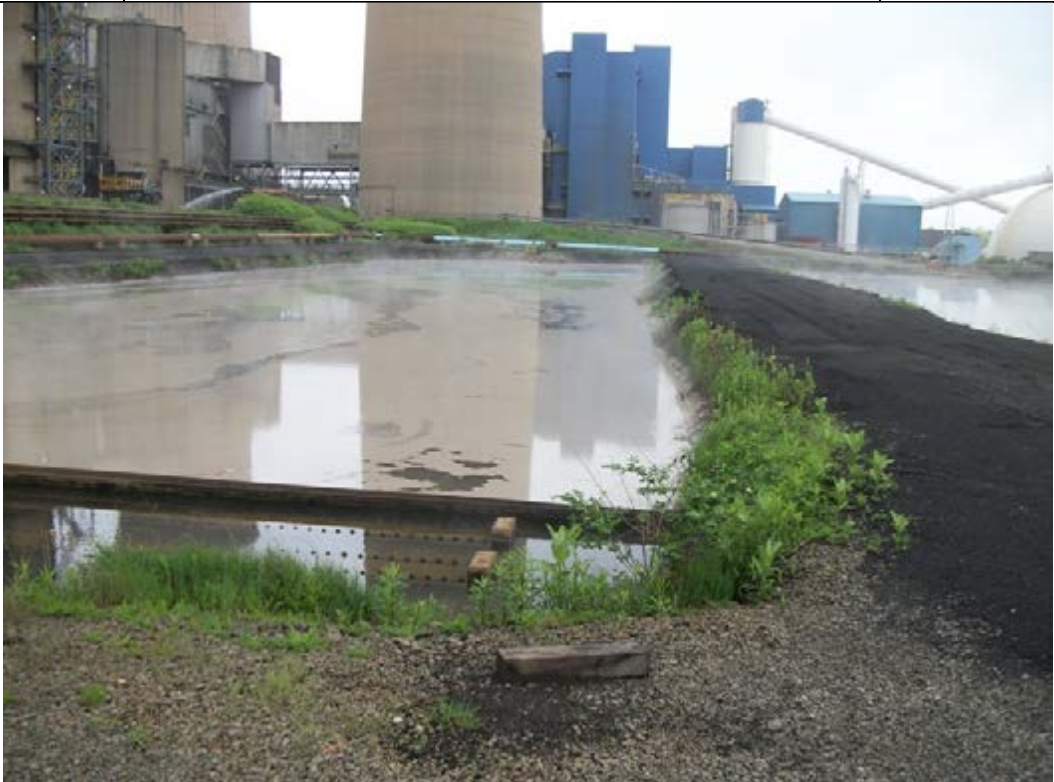
Direction Photo Taken: Southerly			
Description: Overview of Ash Recycle Pond No. 1 from the north end. Note skimmer in foreground.

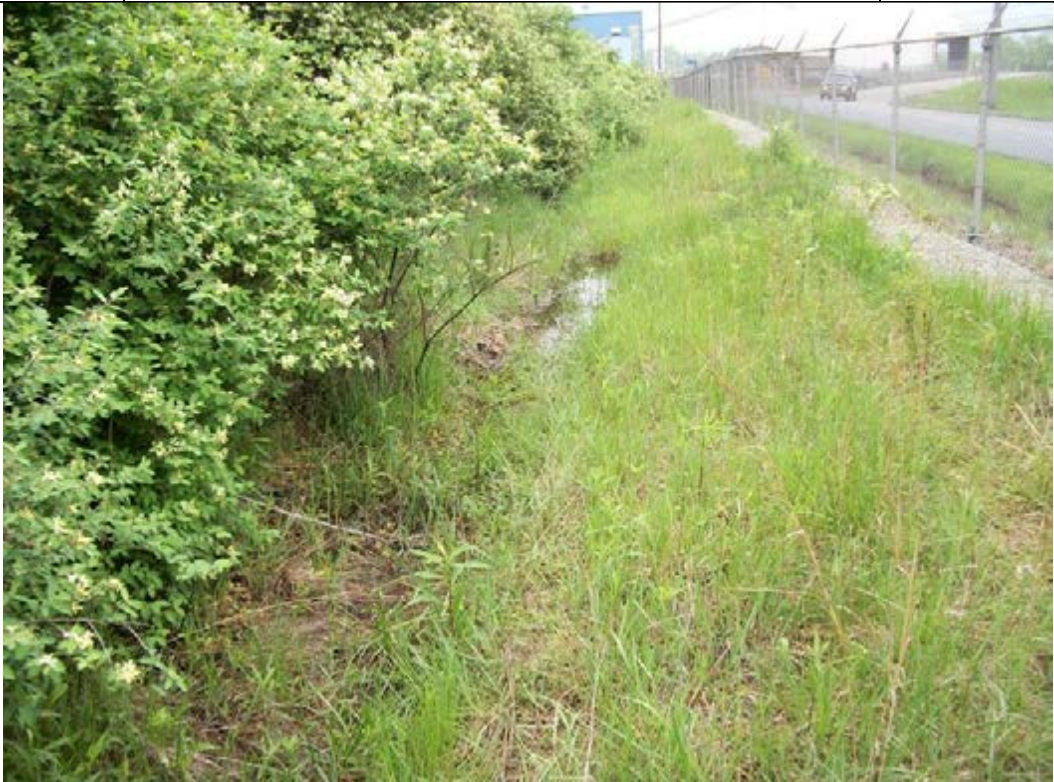
1. Shallow standing water observed near the toe along portions of the west embankment.
2. Overgrown, woody vegetation, brush, small trees/shrubs, and weeds observed along the outside slope of the western embankment with areas of exposed earth.
3. Minor erosion observed at areas of exposed earth on the outside slope of the western embankment.
4. Ruts and depressions observed near the toe of the western embankment.
5. Stumps (with associated below grade root balls) approximately 2- to 4-inches in diameter observed at the outside slope of the western embankment from past vegetative maintenance activities.

Direction Photo Taken: Northerly			
Description: Standing water observed at the toe of the west side embankment associated with Ash Recycle Pond No. 2.

1. Monitor sloughing and areas of erosion, ruts or depressions on the embankments and maintain a schedule for addressing deficiencies observed.
2. Monitor shallow standing water and wet spongy ground at the toe of the common western embankment of Ash Recycle Ponds 2 and 4.

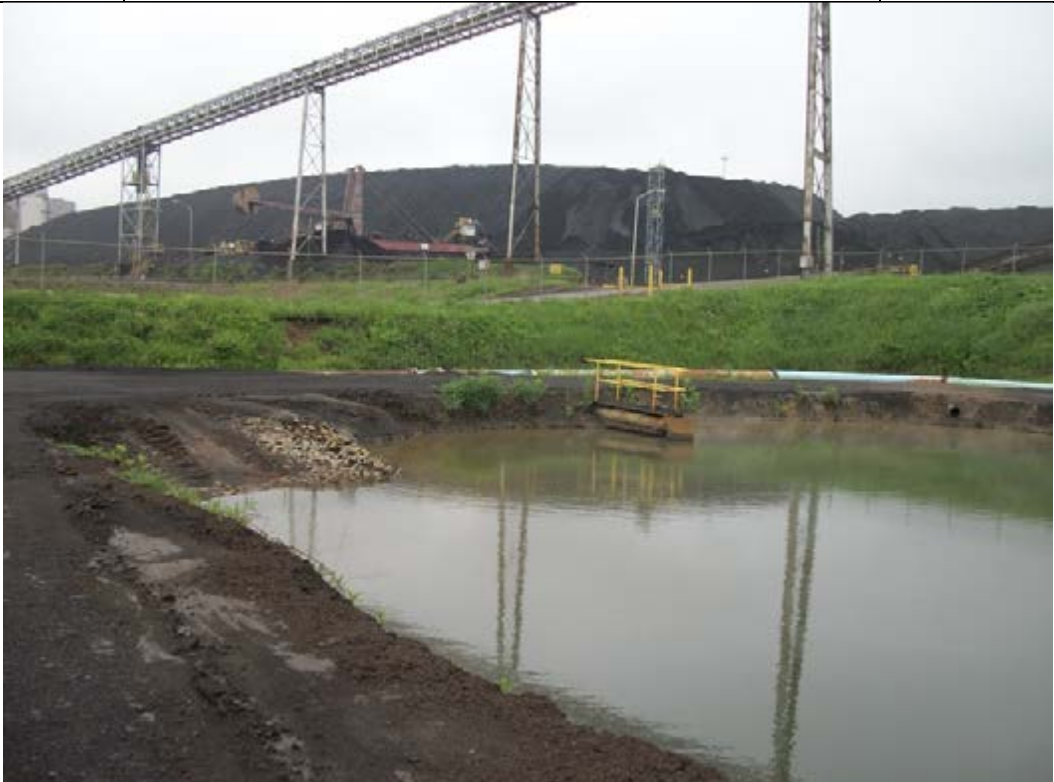
Direction Photo Taken: Northeasterly			
Description: North end of Ash Recycle Pond No. 3 as viewed from the common dike separating Pond Nos. 3 and 4. Note outfall from Bottom Ash Hydrobin/Centrifuge Treatment System at center of photo. Ramp into pond in foreground allows for equipment access during annual cleaning.

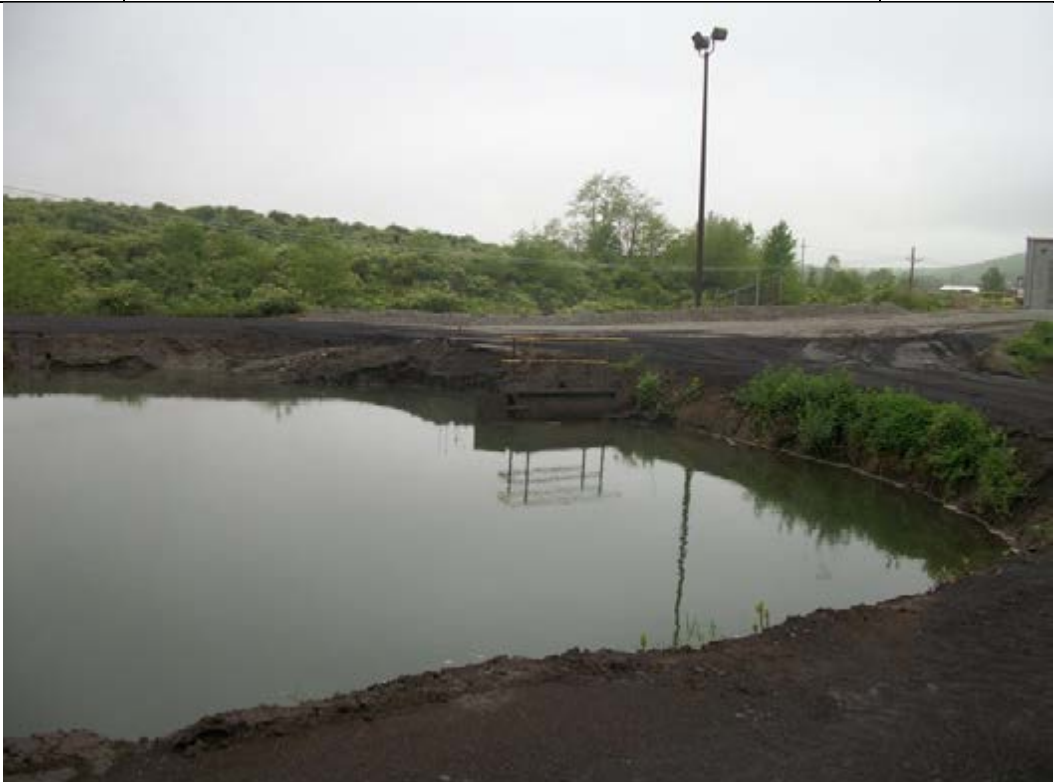
Direction Photo Taken: Westerly			
Description: View of northern portion of Ash Recycle Pond No. 4. Note near vertical, partially eroded inside slope along portions of the north end.

1. Regularly repair sloughs and erosion observed on the embankments. Consideration should be given to providing permanent erosion protection (i.e. revetment matting or similar) as necessary.
2. Clear and grub woody vegetation from outside slope of the western embankments of Ponds 2 and 4 and fill depressions from root balls with compacted sand and gravel. Provide loam as necessary and seed and maintain a healthy grass cover.
3. Re-grade inside and outside slopes of all Ponds as necessary to achieve 2H:1V geometry as specified of the original design drawings. This is best achieved during times when the Ponds are dewatered for cleaning/dredging.
4. Repair railings around wet wells.

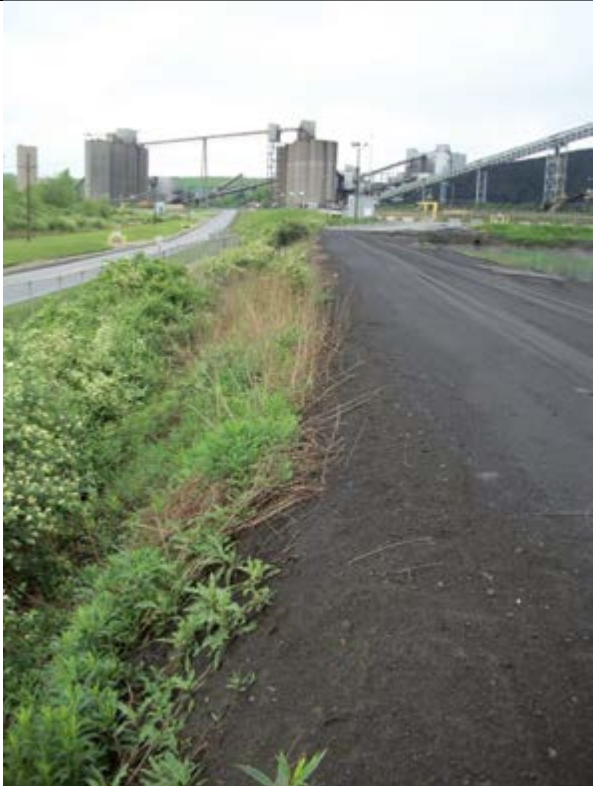
Direction Photo Taken: Northerly			
Description: View of outside slope along the west embankment at Ash Recycle Pond No. 4. Note bottom ash used as surface treatment along crest. Presumably (based on discussion with Plant Representatives and review of available drawings) the embankment is formed of earthen material.

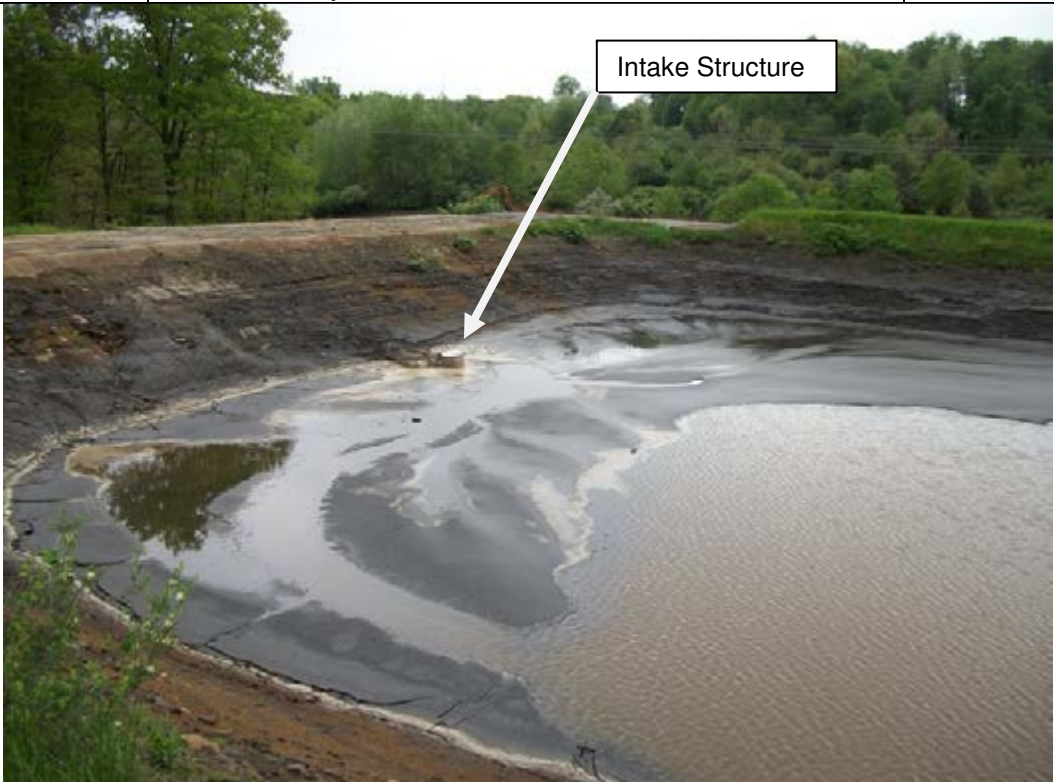
Direction Photo Taken: Southerly			
Description: Upstream face of the southern embankment and emergency spillway. Note capped concrete pipe intake structure near the middle of the embankment.

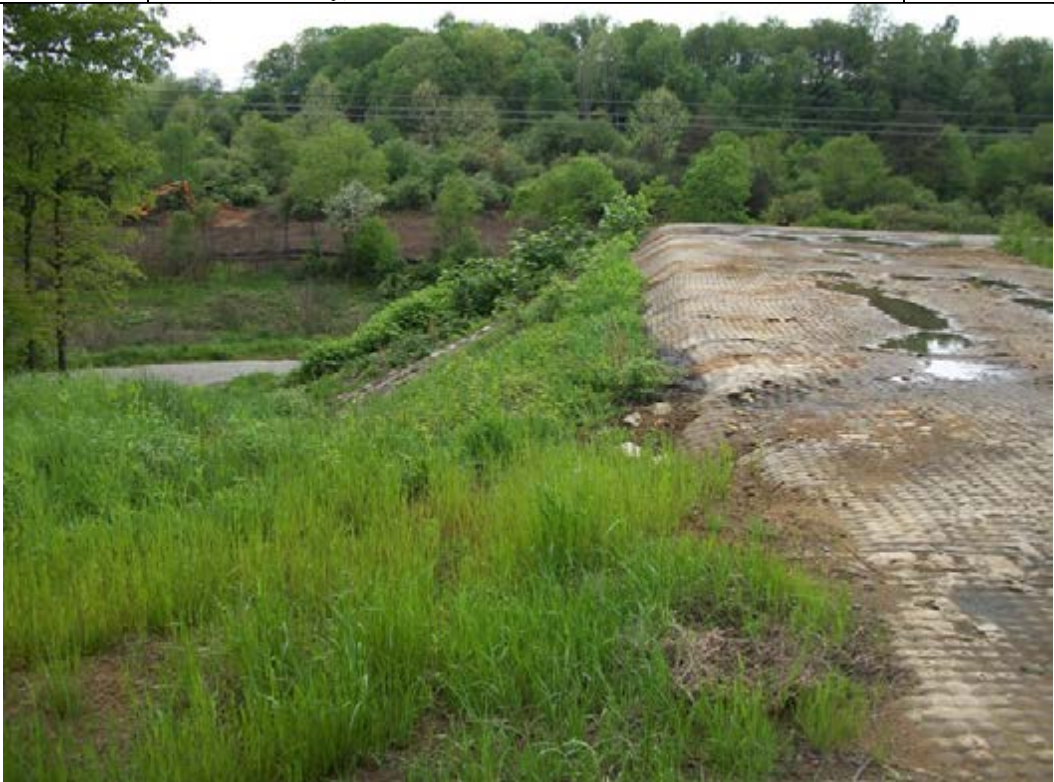
Direction Photo Taken: Southwesterly			
Description: Emergency Spillway weir with concrete revetment erosion protection. Revetment transitions to stone riprap protection on outside slope/toe portions.

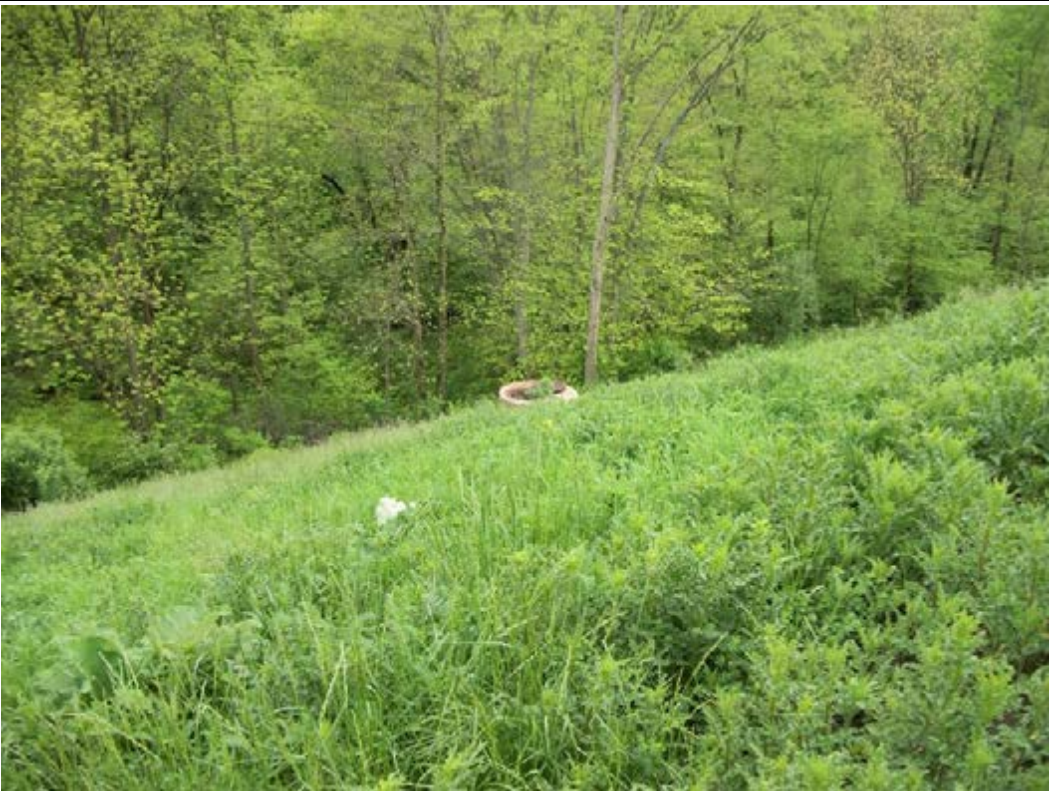
Photo No. 87	Date: 5/16/2011

Direction Photo Taken: Southwesterly		
Description: Manhole structure on the south embankment slope. Outfall pipe from concrete intake structure passes through this manhole on its way to its outfall into Storage Pond No. 1.

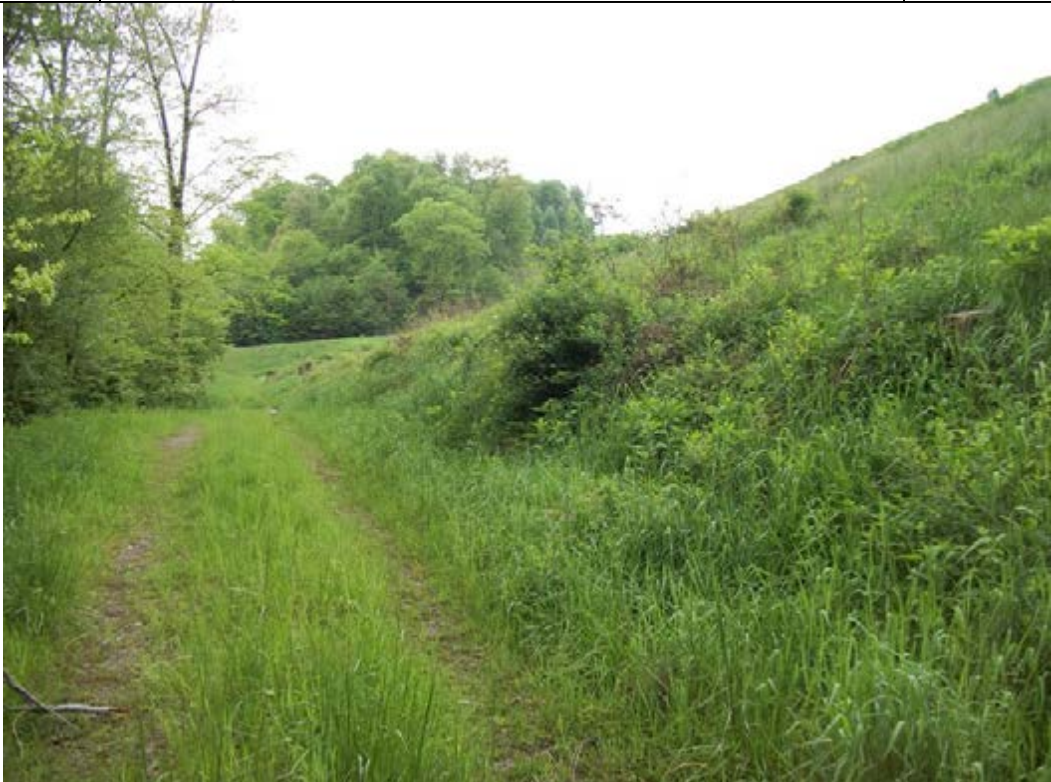
Direction Photo Taken: Westerly			
Description: Overview of the south embankment from the toe, looking west. Note high vegetation on slope and apparent cut into embankment toe to construct access roadway.			
Photo No. 93	Date: 5/16/2011

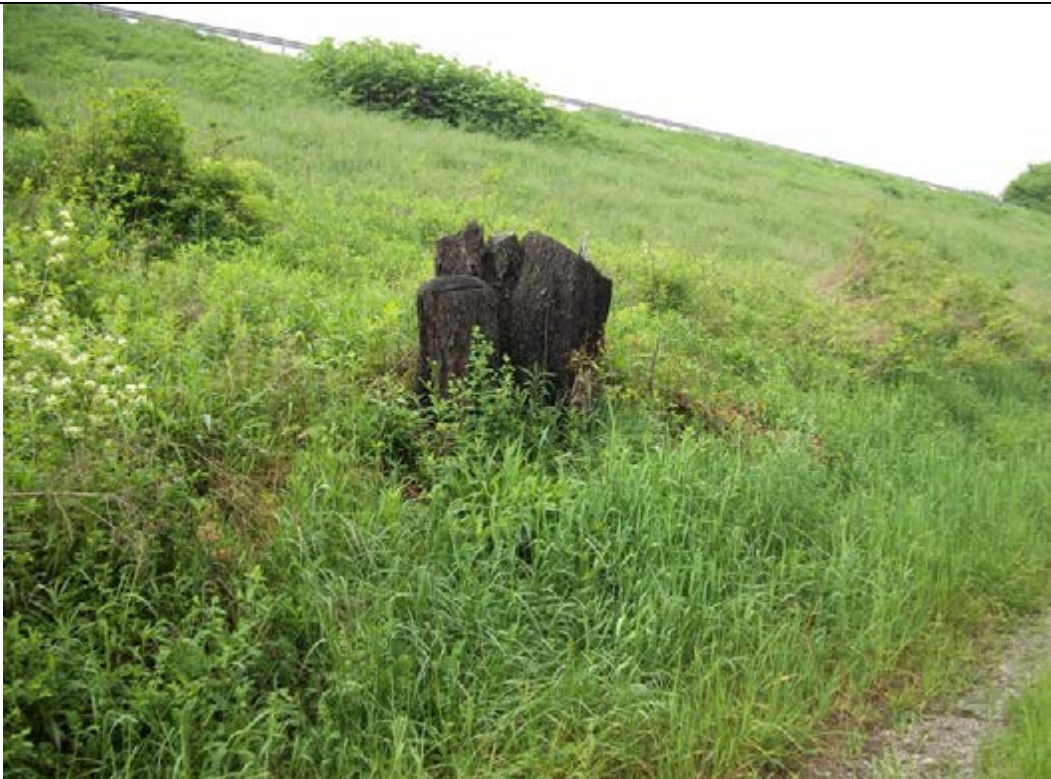
Direction Photo Taken: Northerly			
Description: Large tree stump observed near western end at toe of the south embankment.

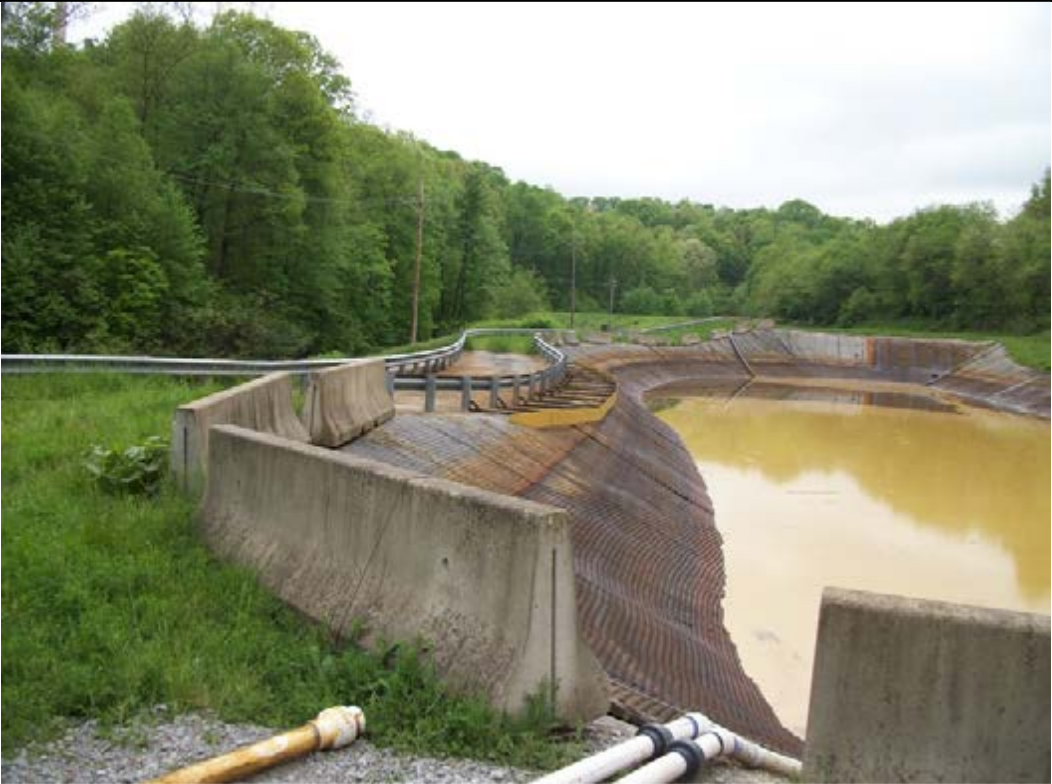
Direction Photo Taken: Westerly			
Description: South end crest, inside slope and approximately 100-foot-wide Emergency Spillway. Note two PVC pipes in foreground. These serve as supplemental siphons to convey effluent to adjacent Leachate Pump Pond. A similar set-up is used to siphon water from Storage Pond No. 1 into Storage Pond No. 2.			
Photo No. 108	Date: 5/16/2011

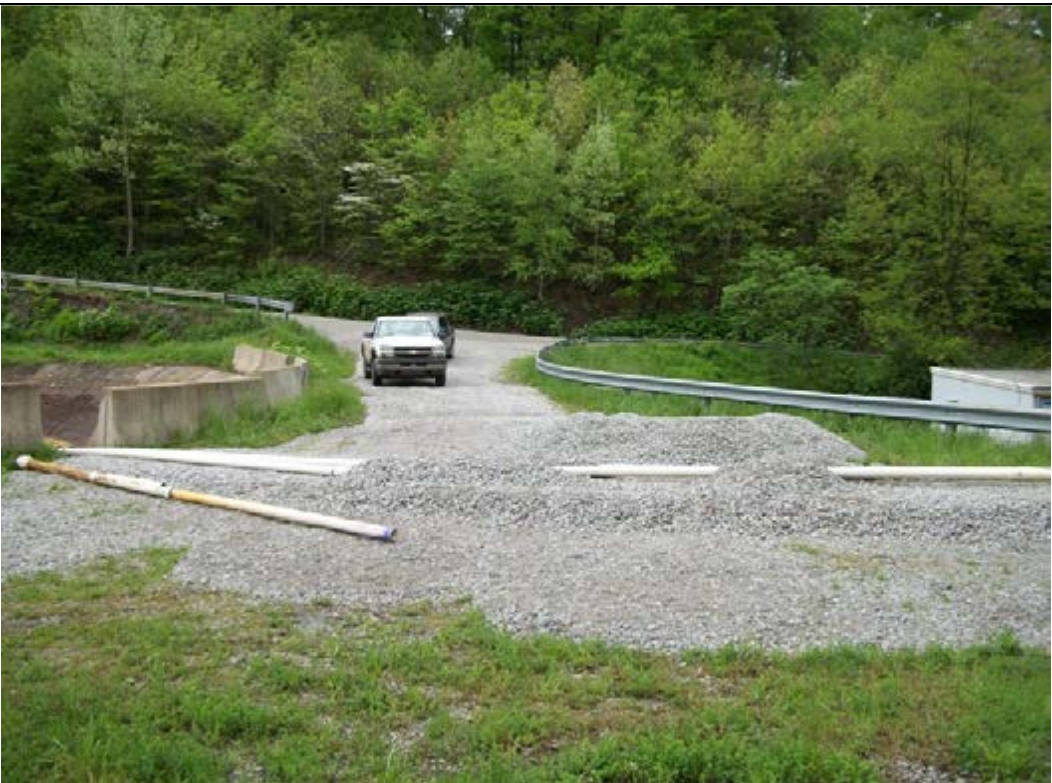
Direction Photo Taken: Northerly			
Description: View of crest of eastern embankment. Note PVC siphons pipes.

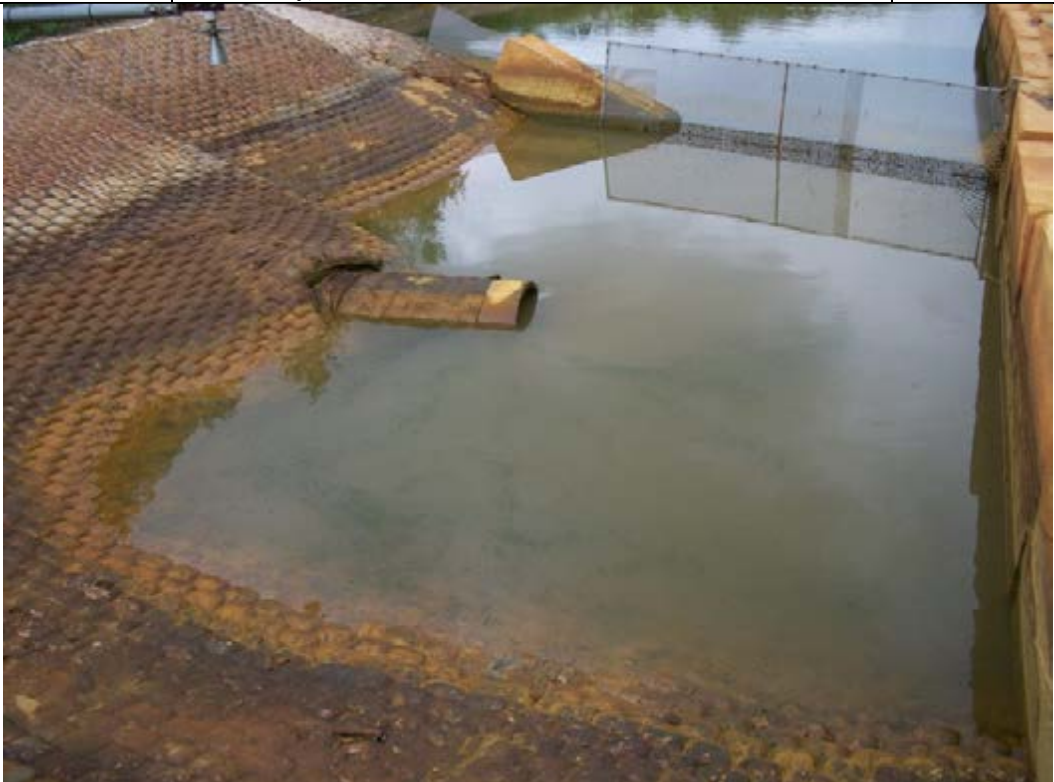
Direction Photo Taken: Northeasterly			
Description: Intake pipe to the Leachate Pump Pond Pump House at the northwestern corner of the pond. Note mesh screen which mitigates leave/debris from entering intake.
