Re: East Kentucky Power Cooperative
Geotechnical Investigation at the Dale Facility
Response to Final Report Recommendations

Responses of East Kentucky Power Cooperative to the
Dale Final Report Recommendations

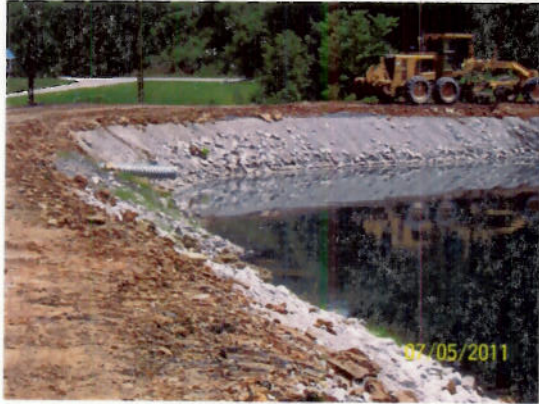
Raising Dam Height to 595.2' on Ash Pond No. 2

EKPC has taken these actions regarding Ash Pond 2: 1) the embankment has been raised to an elevation of 595.2'; 2) the north embankment has been modified to achieve the S&ME recommended safety factor; and 3) the interior slope has been repaired and channel lining has been placed for protection. See the attached photographs.

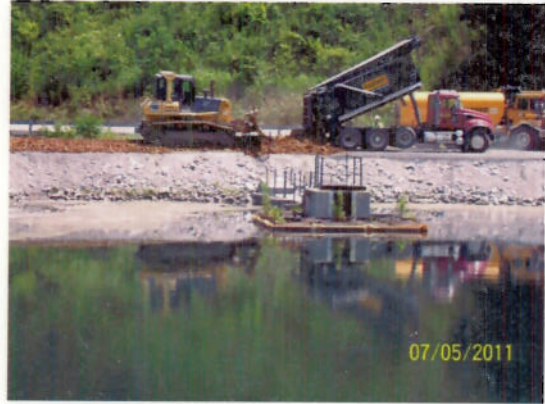
Placing Clay to Raise Dam Height on Ash Pond No. 2

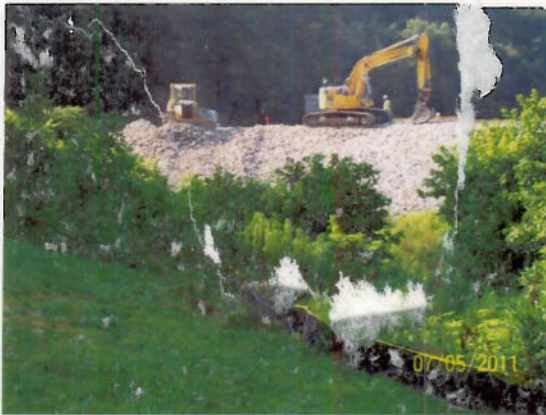
Installing Toe Berm at Ash Pond No. 2

EKPC disagrees that the design stability studies for Ash Pond 2 do not meet the KDOW minimum requirements for all cases. S&ME recommended in the Dale Ash Pond No. 2 Stability Report to have a static factor of safety of 1.4, and recommended construction of a toe berm to achieve the higher static factor of safety. EKPC has constructed the toe berm (drawing attached) as recommended by S&ME to increase the static factor of safety on both cases for the north section. S&ME will perform a new stability analyses for the north section to confirm the as-built conditions meet the recommended safety factor.

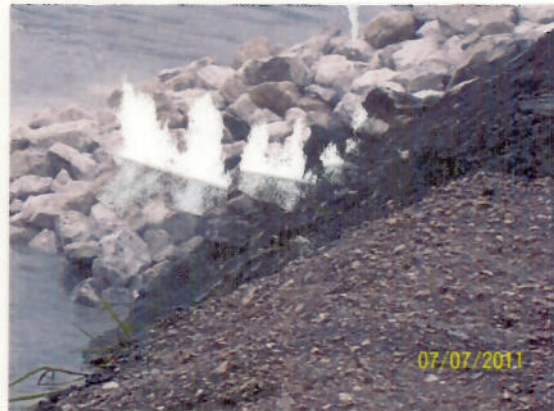
Channel Lining Placed on Interior Slope for Erosion Protection at Ash Pond No. 2

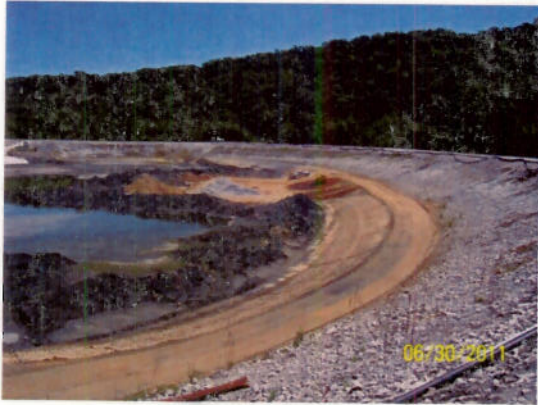
Recompaction of Interior Slopes to Repair
Erosion on Ash Pond No. 4

EKPC has completed the repairs on Ash Pond 4. The scarp on the outside of the embankment next to the river was repaired, and a stability analysis of the repair was performed. The wet areas at the toe of the embankment were regraded to drain toward the river. The clay on the interior slopes of the embankment was regraded and compacted to repair erosion damage. A 2 acre area of the Northeast Interior Slope was repaired by: 1) excavating to a new subgrade; 2) compacting the new subgrade to 92% of Standard Proctor; 3) the subgrade was proof rolled; 4) density tests were performed on the subgrade; 5) an HDPE liner was installed; 6) 18" of #11 stone was installed on the liner; and 7) 18" of Class 2 channel lining was placed on the stone. See the attached photographs.

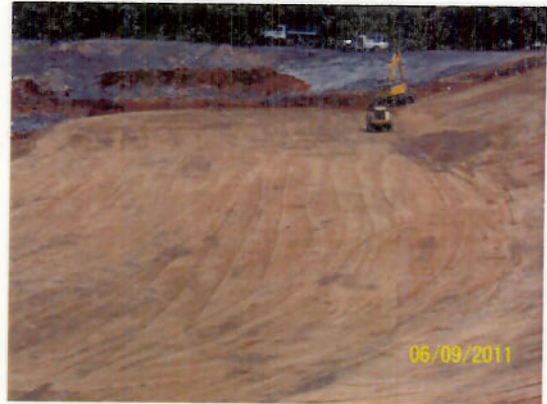
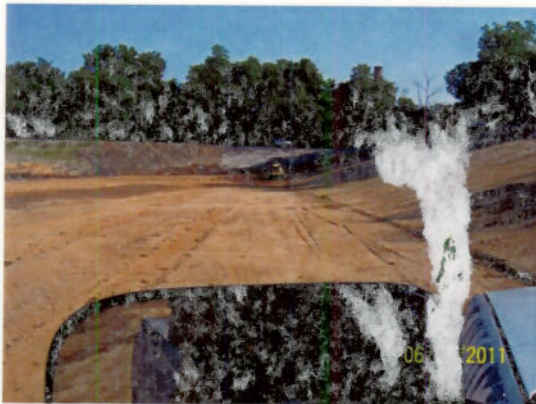
Preparing Subgrade for Liner at Ash Pond No. 4

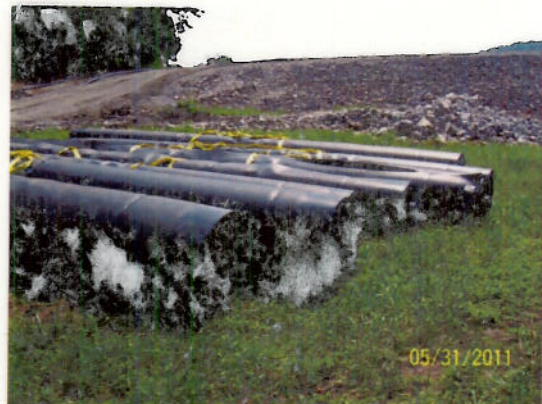
HDPE Liner On-Site for Ash Pond No. 4
Conformance Samples Taken While Stockpiled
and All Materials were Approved

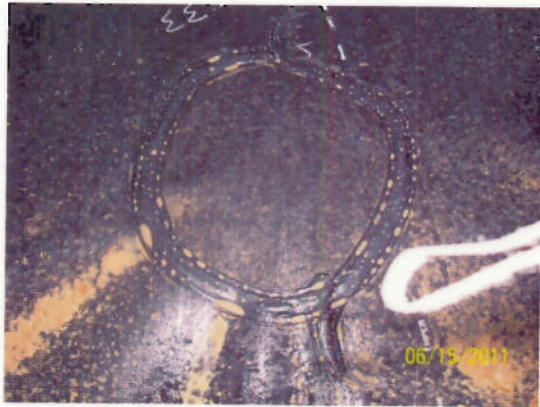
Repair Where Destructive Sample was Taken
from Seam at Ash Pond No. 4

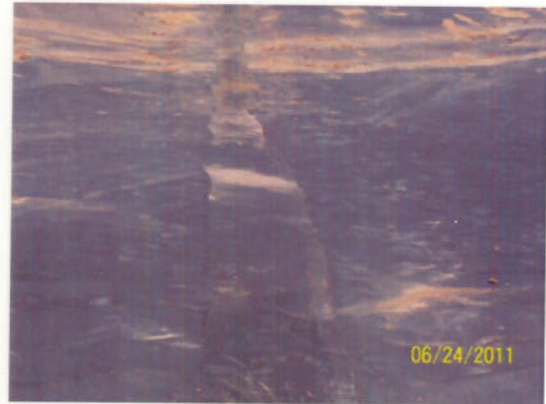
Cap Over Seam Where Destructive Sample
Failed Testing at Ash Pond No. 4
Cap Was Tested and Approved

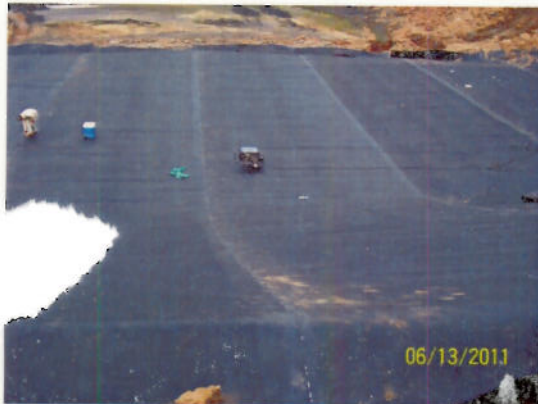
Liner Installation at Ash Pond No. 4

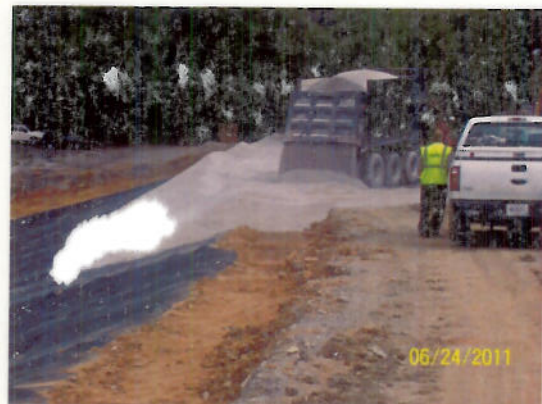
Placing 18" of #11 Stone on Liner and Anchor
Trench at Ash Pond. No. 4

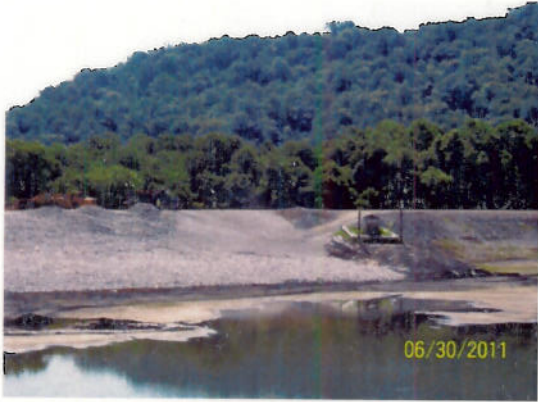
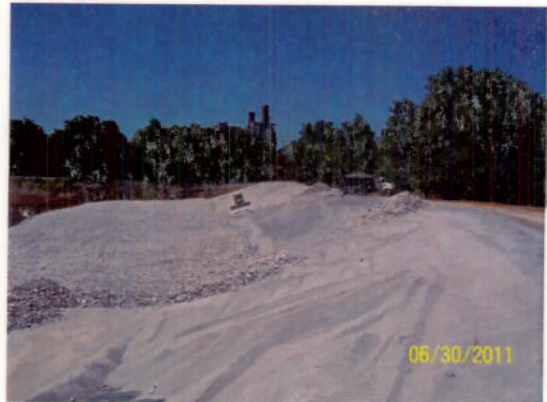
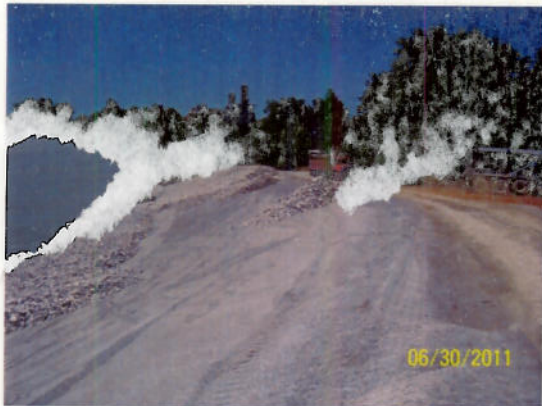
Placing 18" of Class 2 Channel Lining Ontop of #11 Stone at Ash Pond No. 4

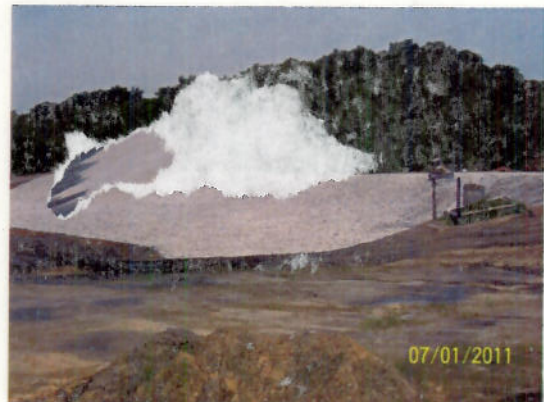
Finished Interior Slope at Ash Pond No. 4

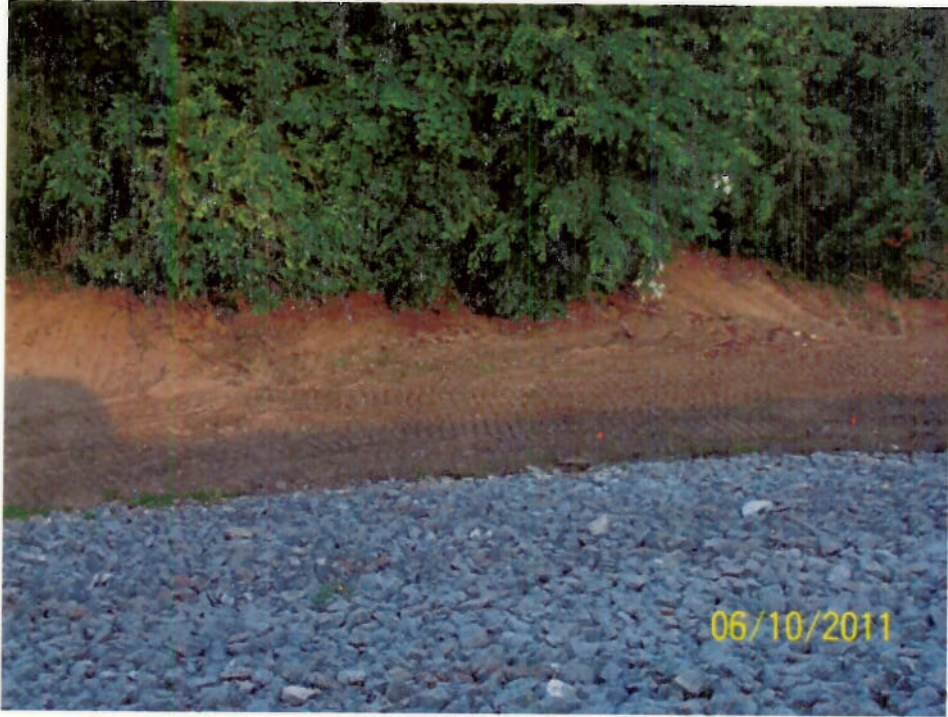
Re-grade to Achieve Positive Drainage Away
from Pond No. 4 Dam

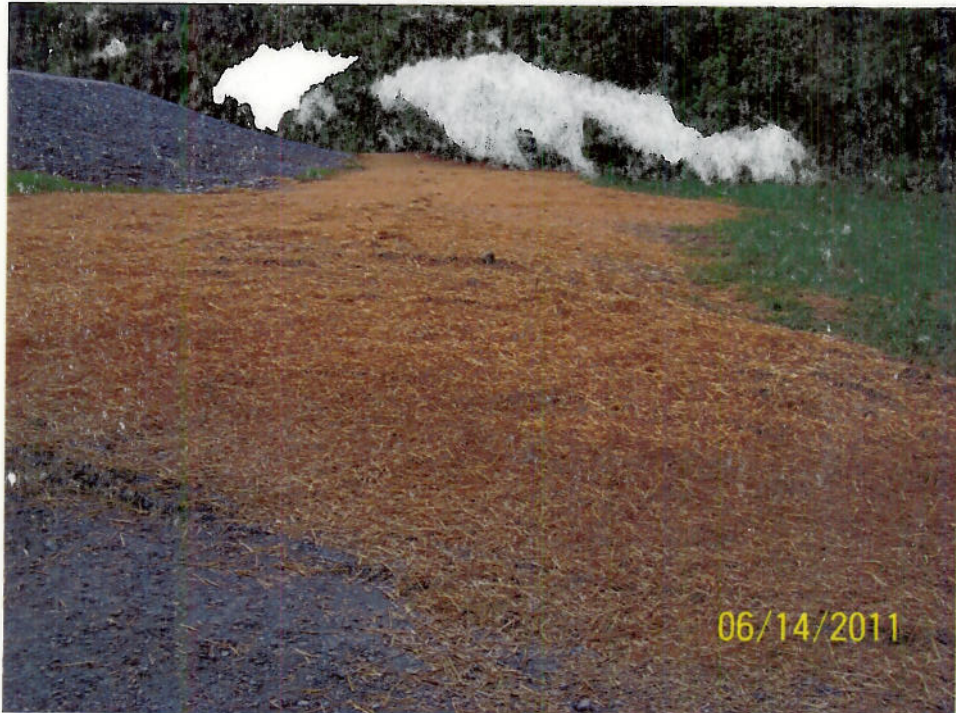
Seed and Straw Re-graded Areas at Pond No. 4
