Report of Geotechnical Investigation
Dam Safety Assessment of Coal Combustion
Surface Impoundments
East Kentucky Power Cooperative
William C. Dale Power Station, Winchester, KY

AMEC Project No. 3-2106-0177.0001

September 2010

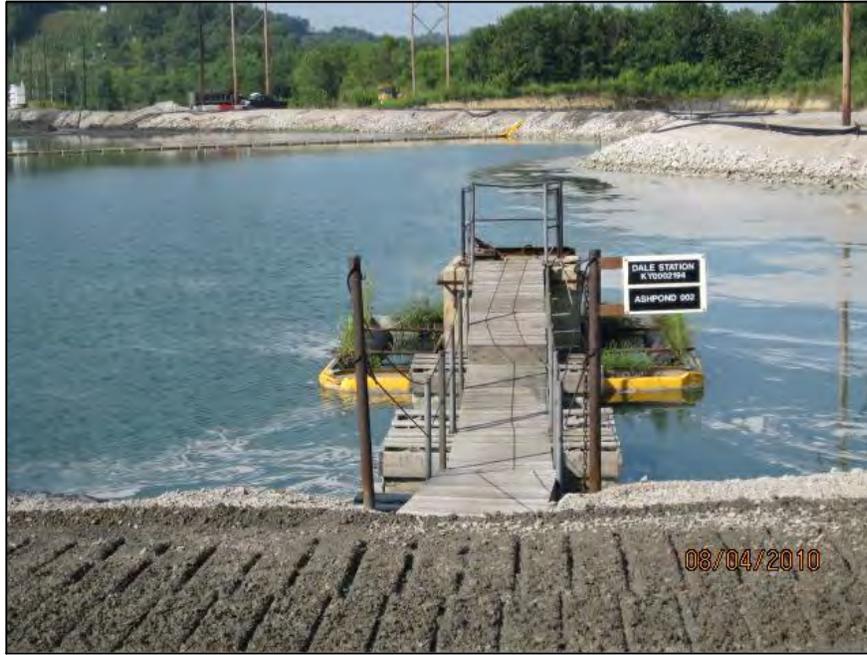
2-1

NORTH DIKE OF POND LOOKING SOUTHWEST AT PRIMARY OUTLET STRUCTURE

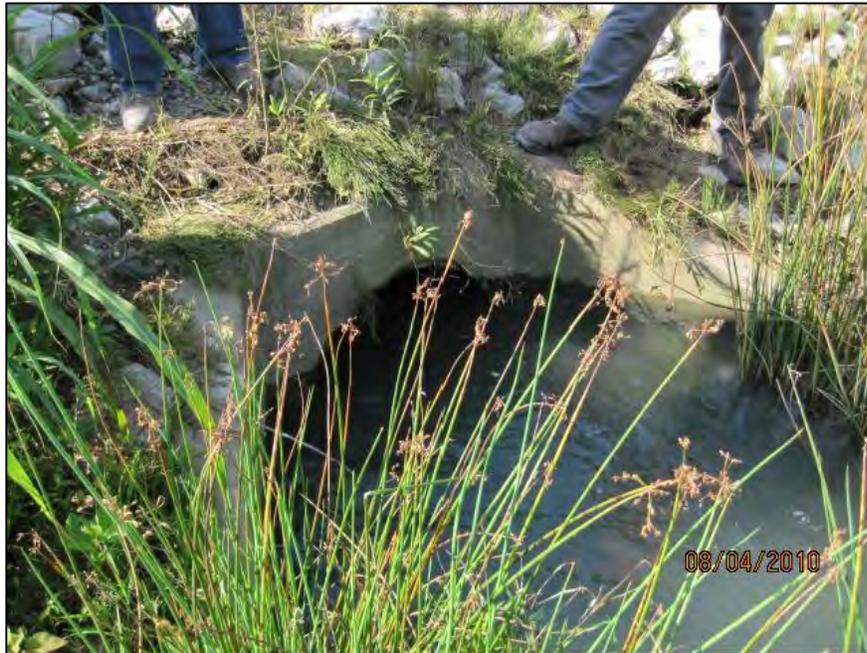
2-2

POND NPDES OUTFALL AT TOE OF NORTH DIKE

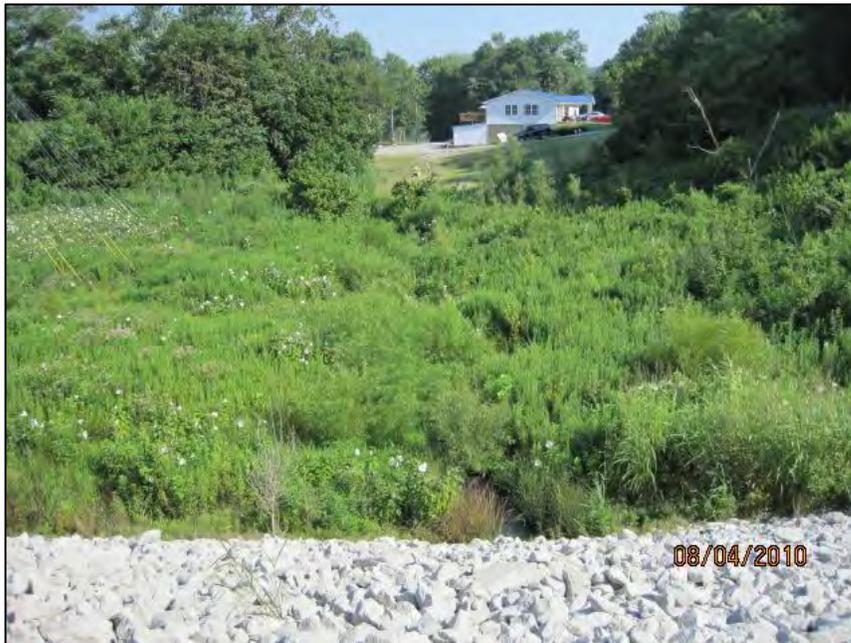
2-3

FROM NORTHERN DIKE LOOKING NORTH AT OUTFALL CHANNEL TO KENTUCKY RIVER

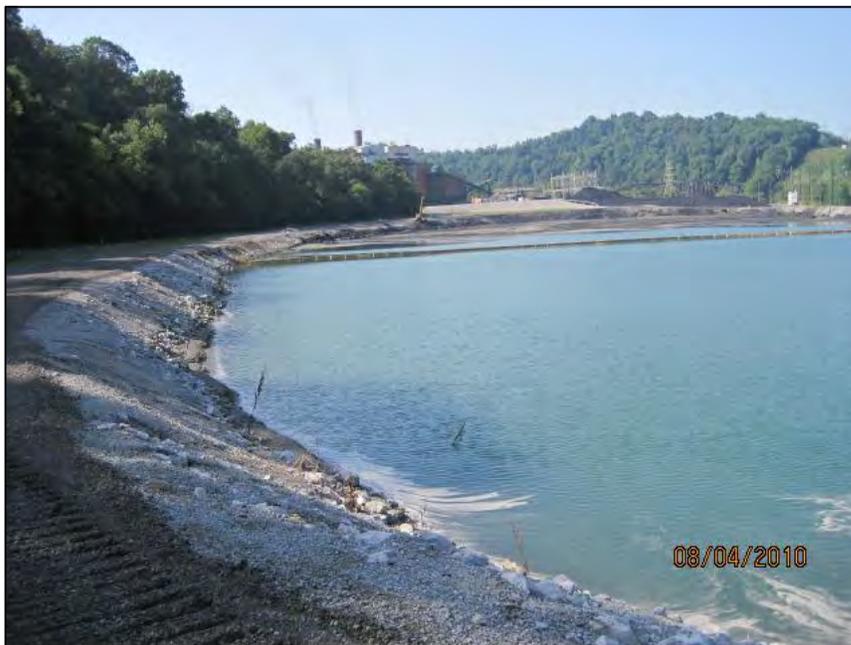
2-4

**LOOKING SOUTH FROM NORTHERN BANK AT POND INTERIOR,
AND CREST AND UPSTREAM SLOPE OF EASTERN DIKE**

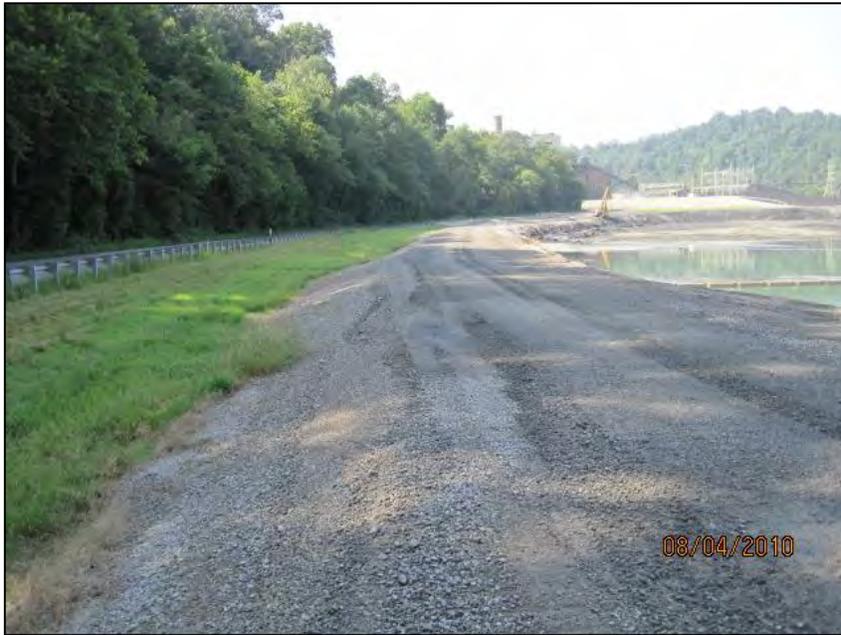
2-5

FROM EASTERN DIKE LOOKING SOUTH AT CREST AND DOWNSTREAM SLOPE, FORD ROAD LOCATED TO THE EAST

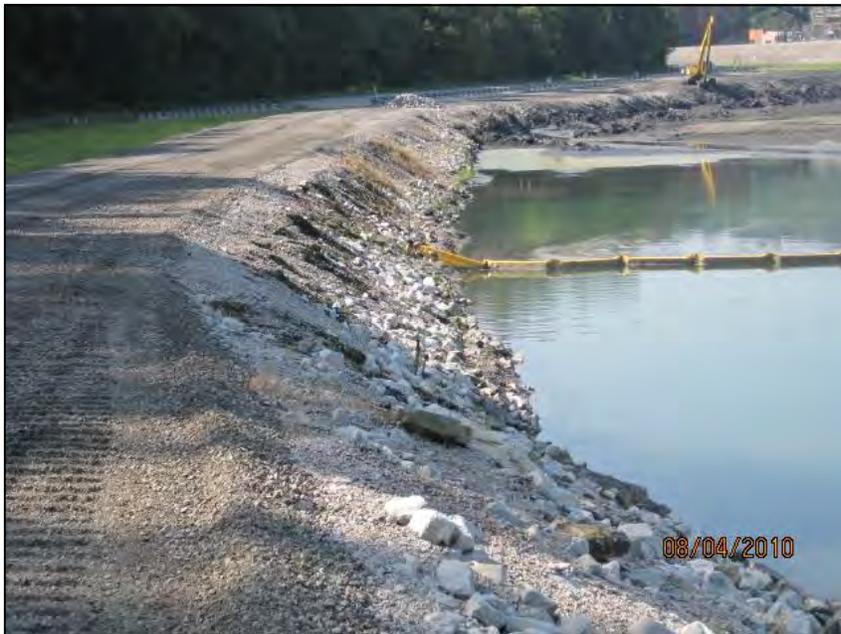
2-6

FROM NORTHEAST DIKE LOOKING SOUTH AT UPSTREAM SLOPE, CREST AND FORD ROAD

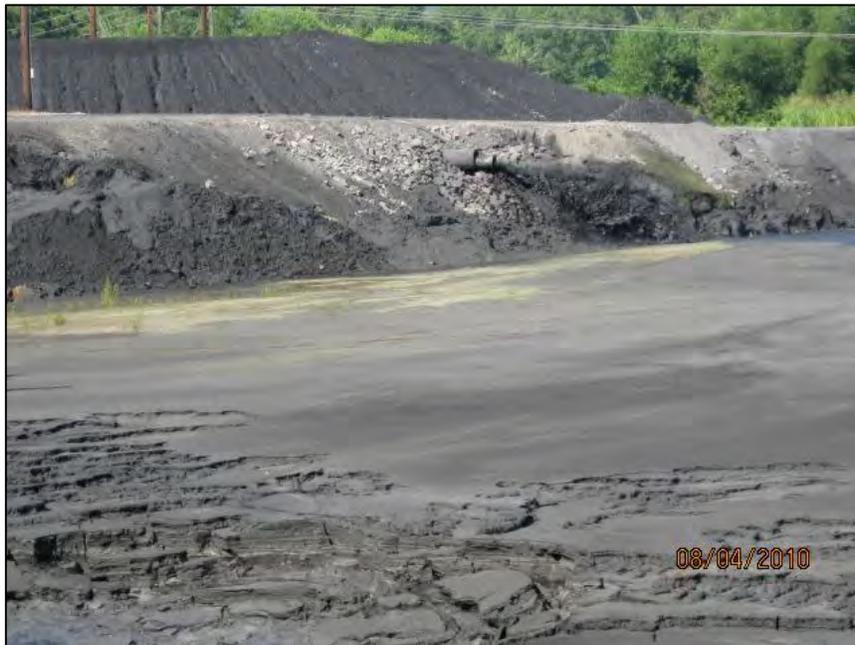
2-9

ASH INLET PIPES FROM POWER PLANT ON SOUTH DIKE

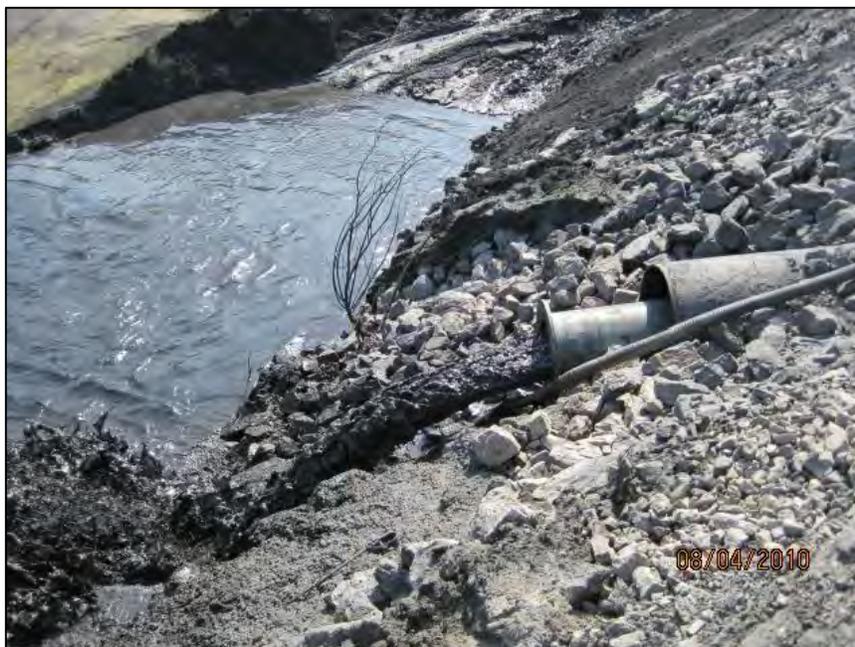
2-10

CLOSE-UP OF ASH INLET PIPES FROM POWER PLANT

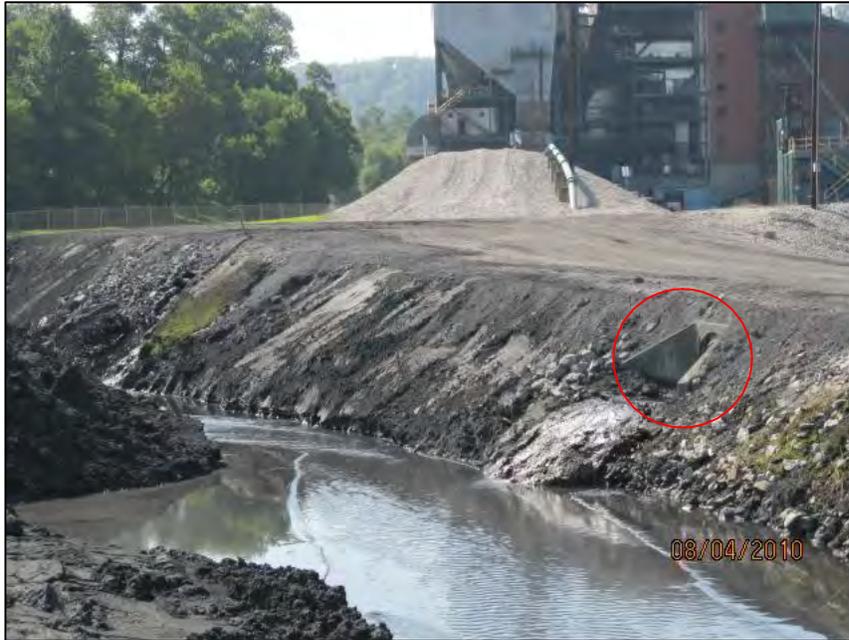
2-11
COAL PILE RUNOFF INLET ON SOUTH DIKE

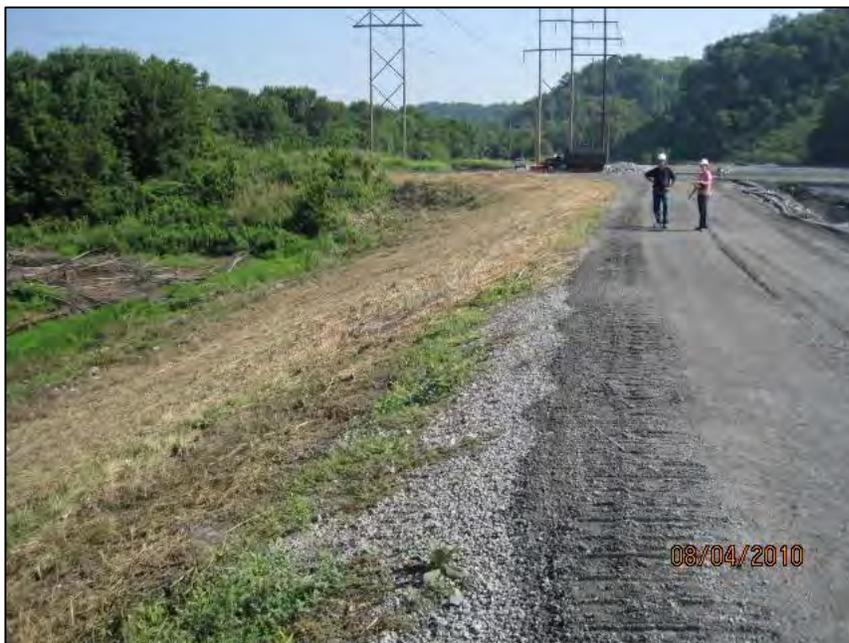
2-12
SOUTH END OF WEST DIKE LOOKING NORTH AT CREST AND DOWNSTREAM SLOPE

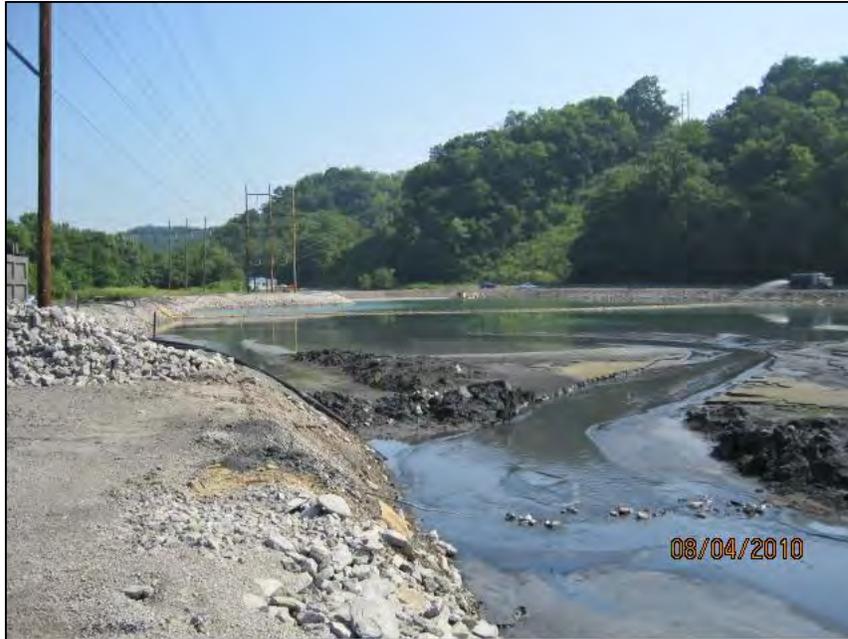
2-13

FROM MIDDLE OF WEST DIKE LOOKING NORTH

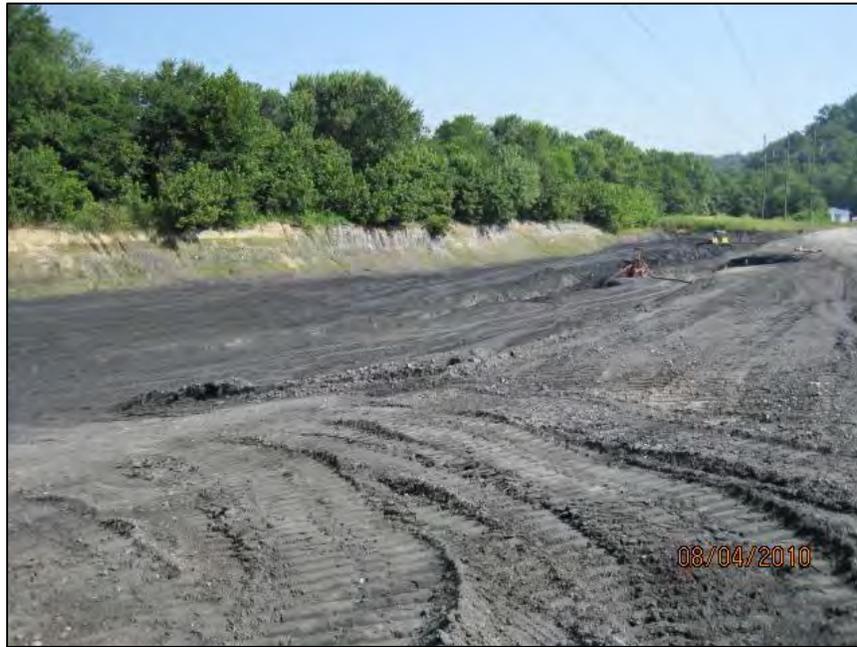
3-1
FROM SOUTH END OF COMMON DIKE LOOKING NORTHWEST

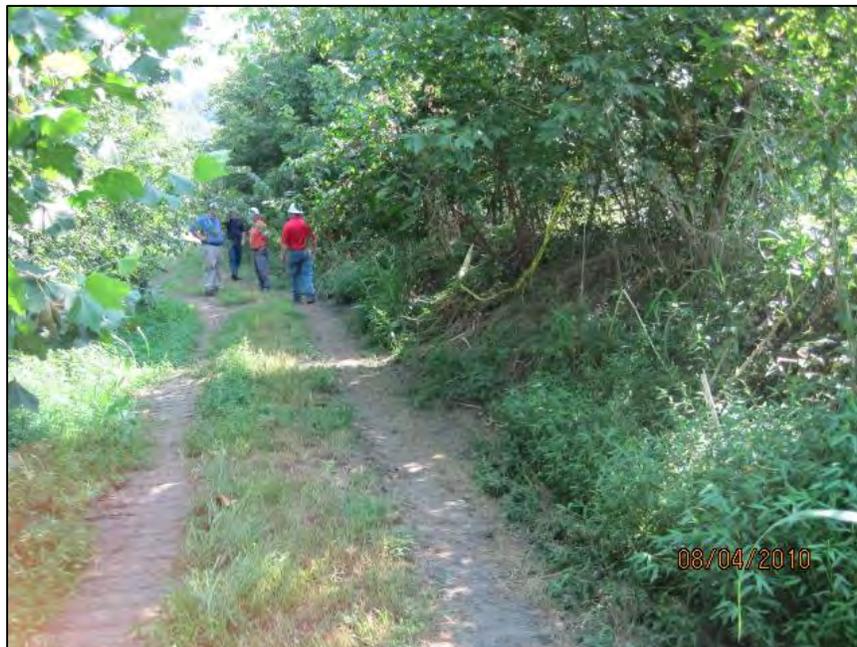
3-2
BEHIND WEST DIKE LOOKING NORTHWEST. VEGETATION AND TREES ON WEST DIKE (ON RIGHT SIDE OF PHOTO)

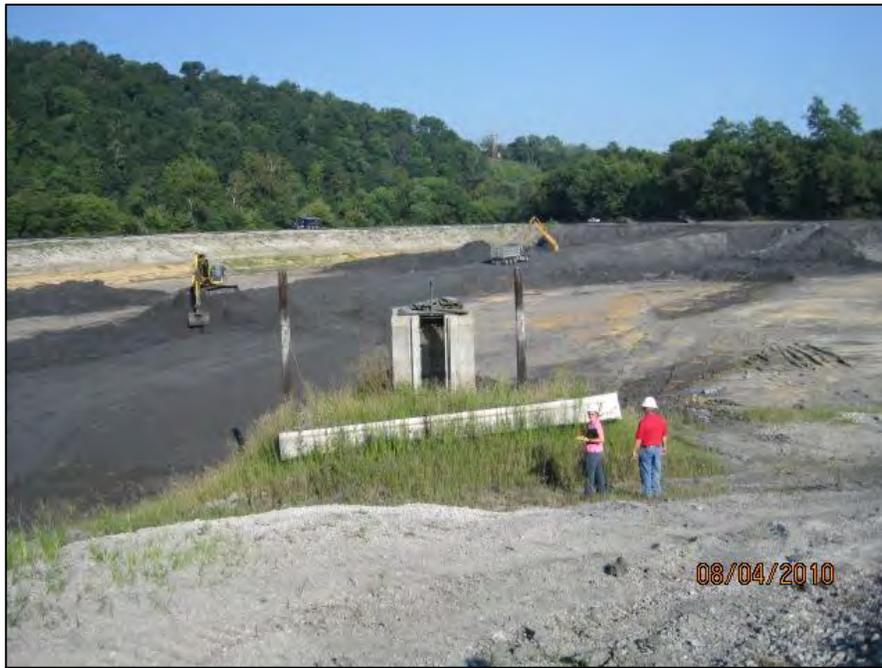
4-1

FROM SOUTHEAST DIKE LOOKING NORTHWEST AT INACTIVE OUTLET STRUCTURE AND POND INTERIOR

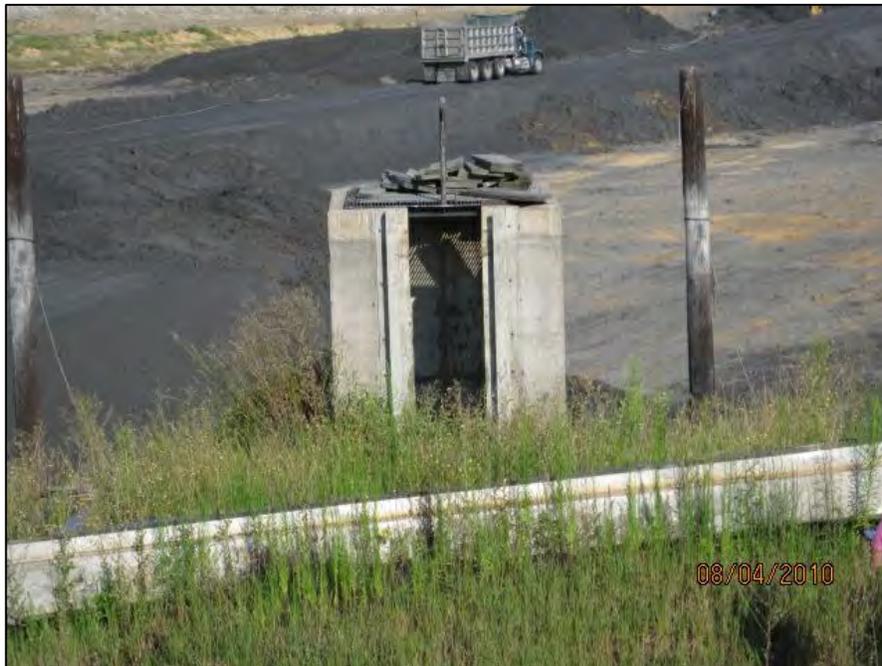
4-2

INACTIVE OUTLET STRUCTURE

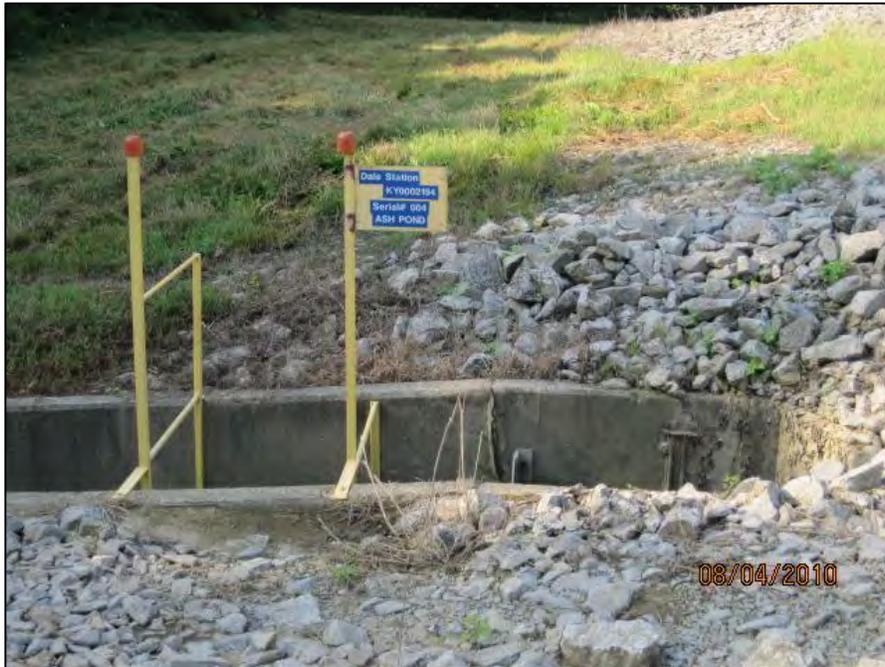
4-3

POND DISCHARGE/OUTFALL 004 AND TOE OF SOUTHEAST DIKE

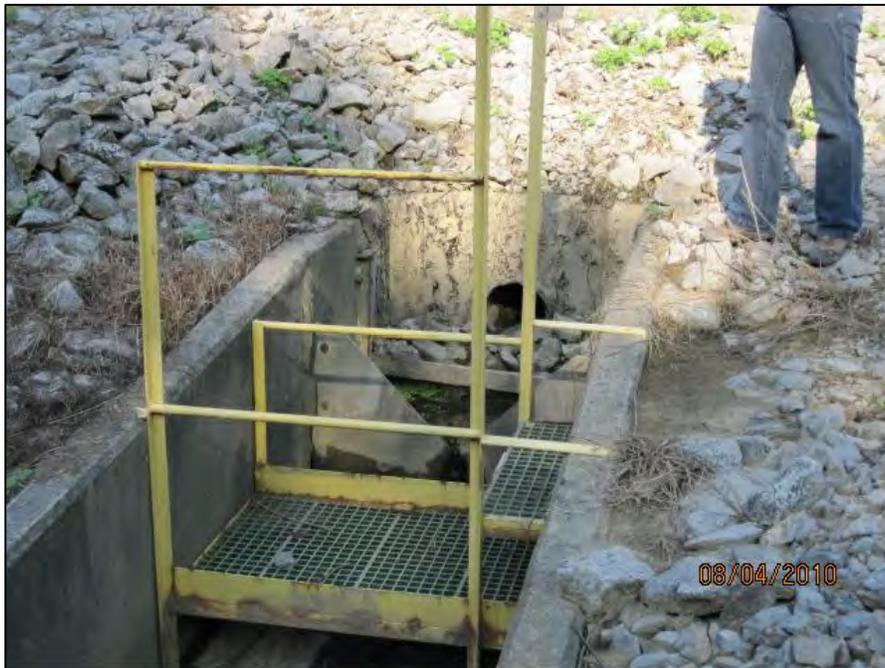
4-4

POND DISCHARGE/OUTFALL 004 WEIR

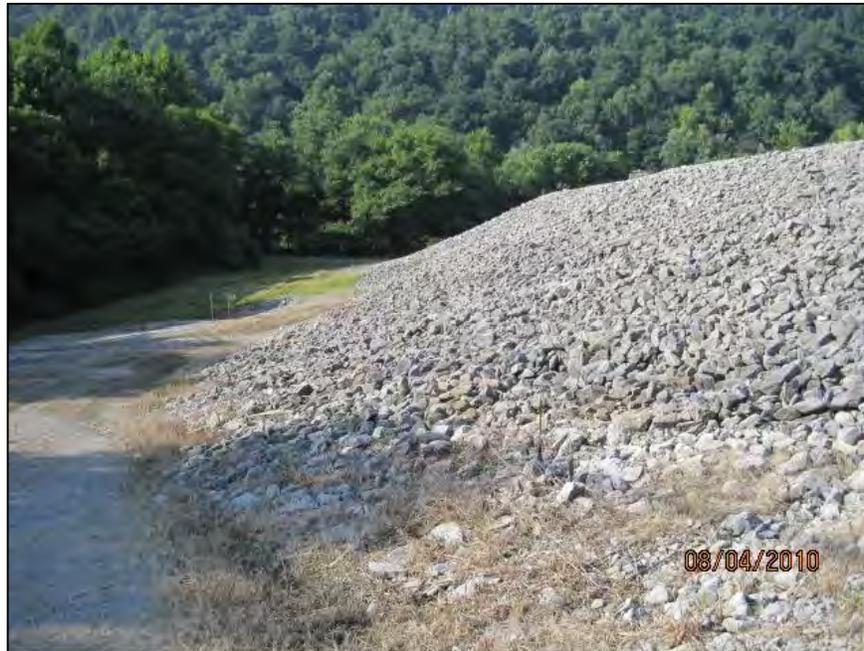
4-6

TYPICAL SOUTHEAST DOWNSTREAM EMBANKMENT

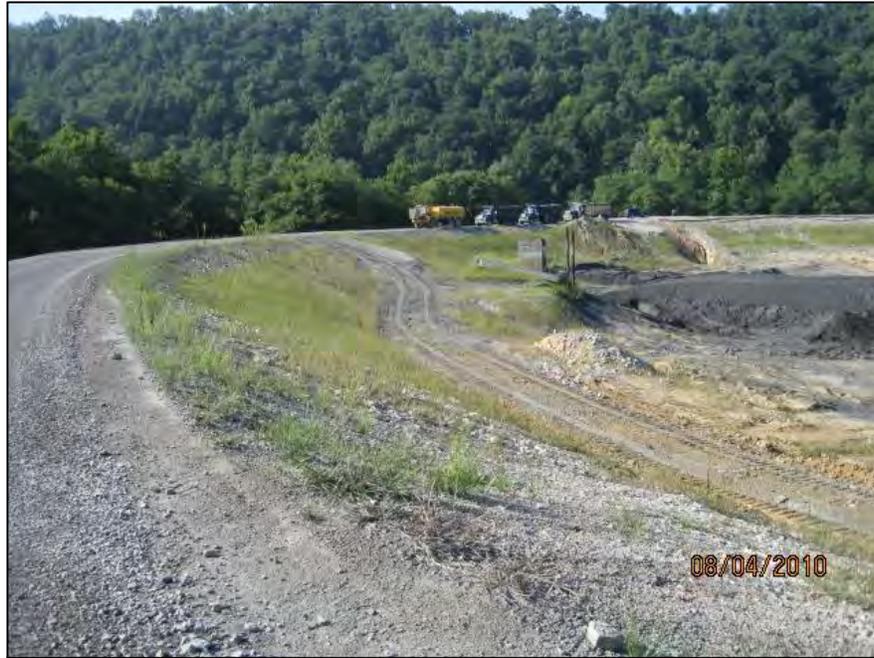
4-7
LOOKING SOUTH FROM EASTERN DIKE

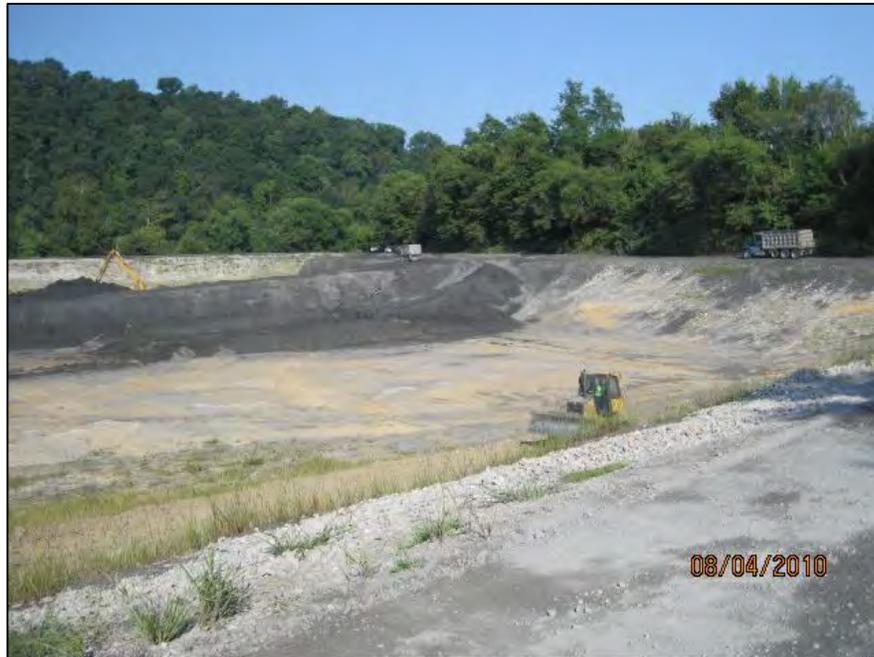
4-8
LOOKING NORTHWEST FROM EASTERN DIKE

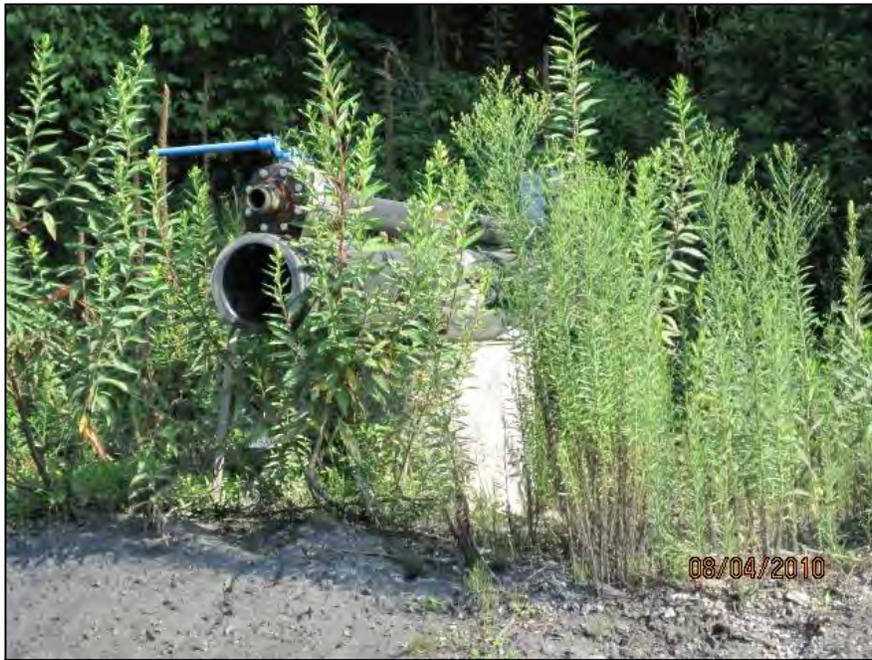
4-9

INLET STRUCTURE FROM PLANT ON NORTH DIKE

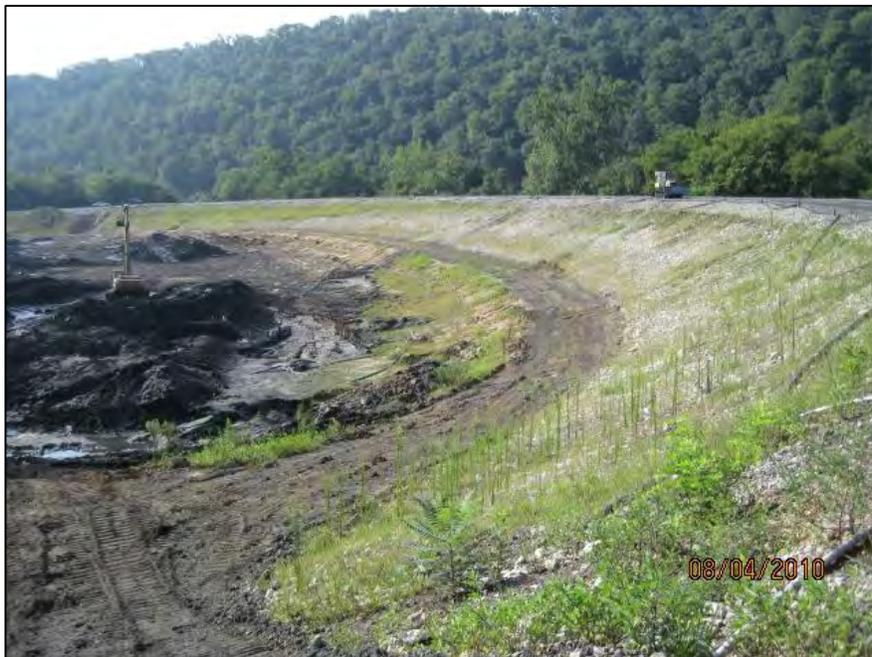
4-10

LOOKING SOUTH FROM NORTH DIKE

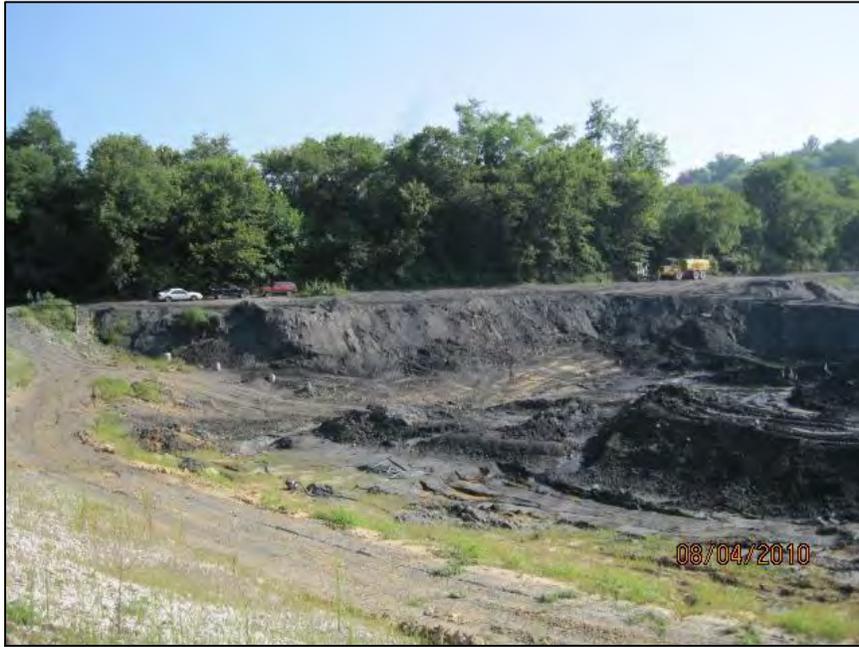
4-11

LOOKING NORTH FROM WESTERN BANK

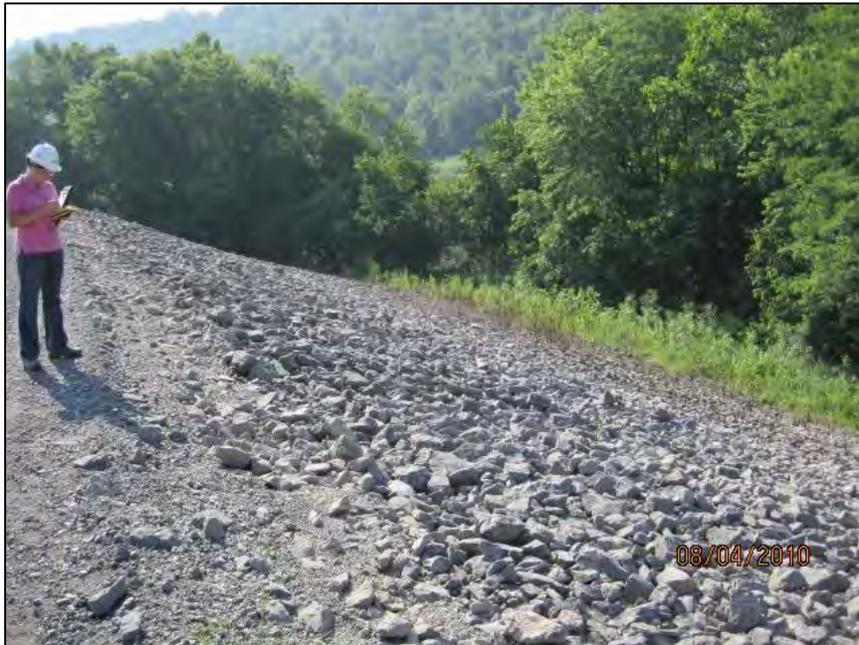
4-12

TYPICAL SOUTHERN DOWNSTREAM EMBANKMENT

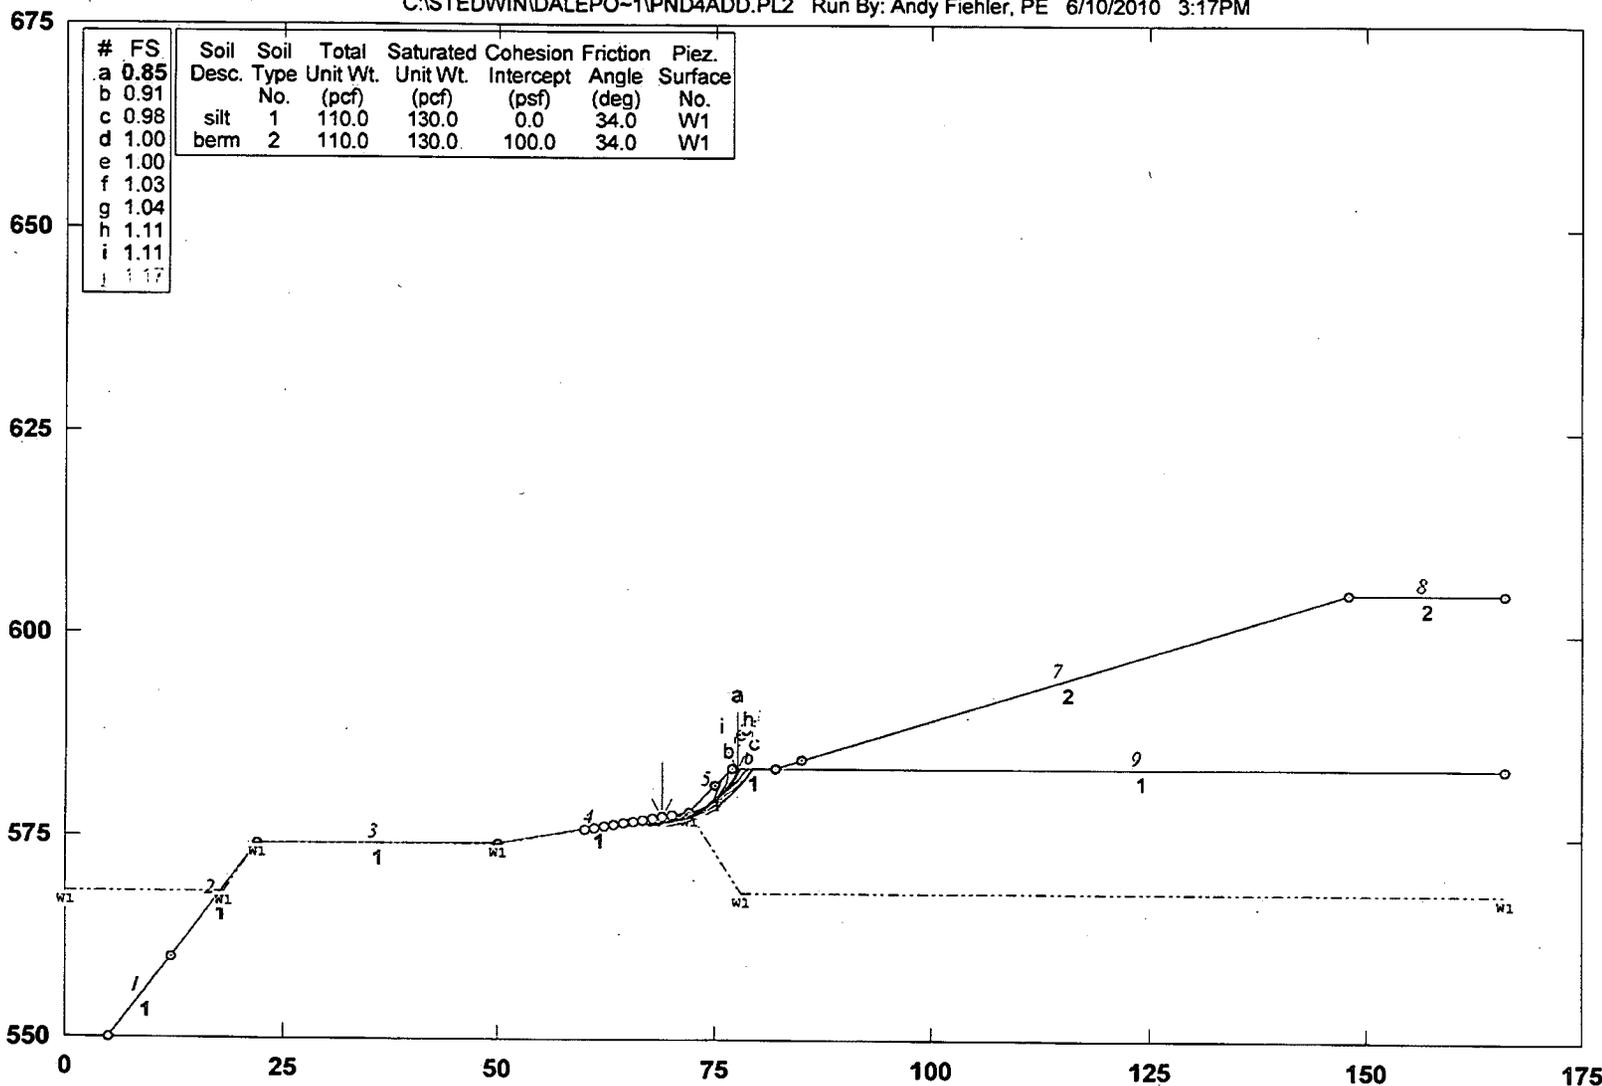
STABL6H FSmin=0.85
