Report of
Dam Safety Assessment of Coal Combustion Surface
Impoundments

East Kentucky Power Cooperative
William C. Dale Power Station, Winchester, KY

AMEC Project No. 3-2106-0177.0001

April 2011

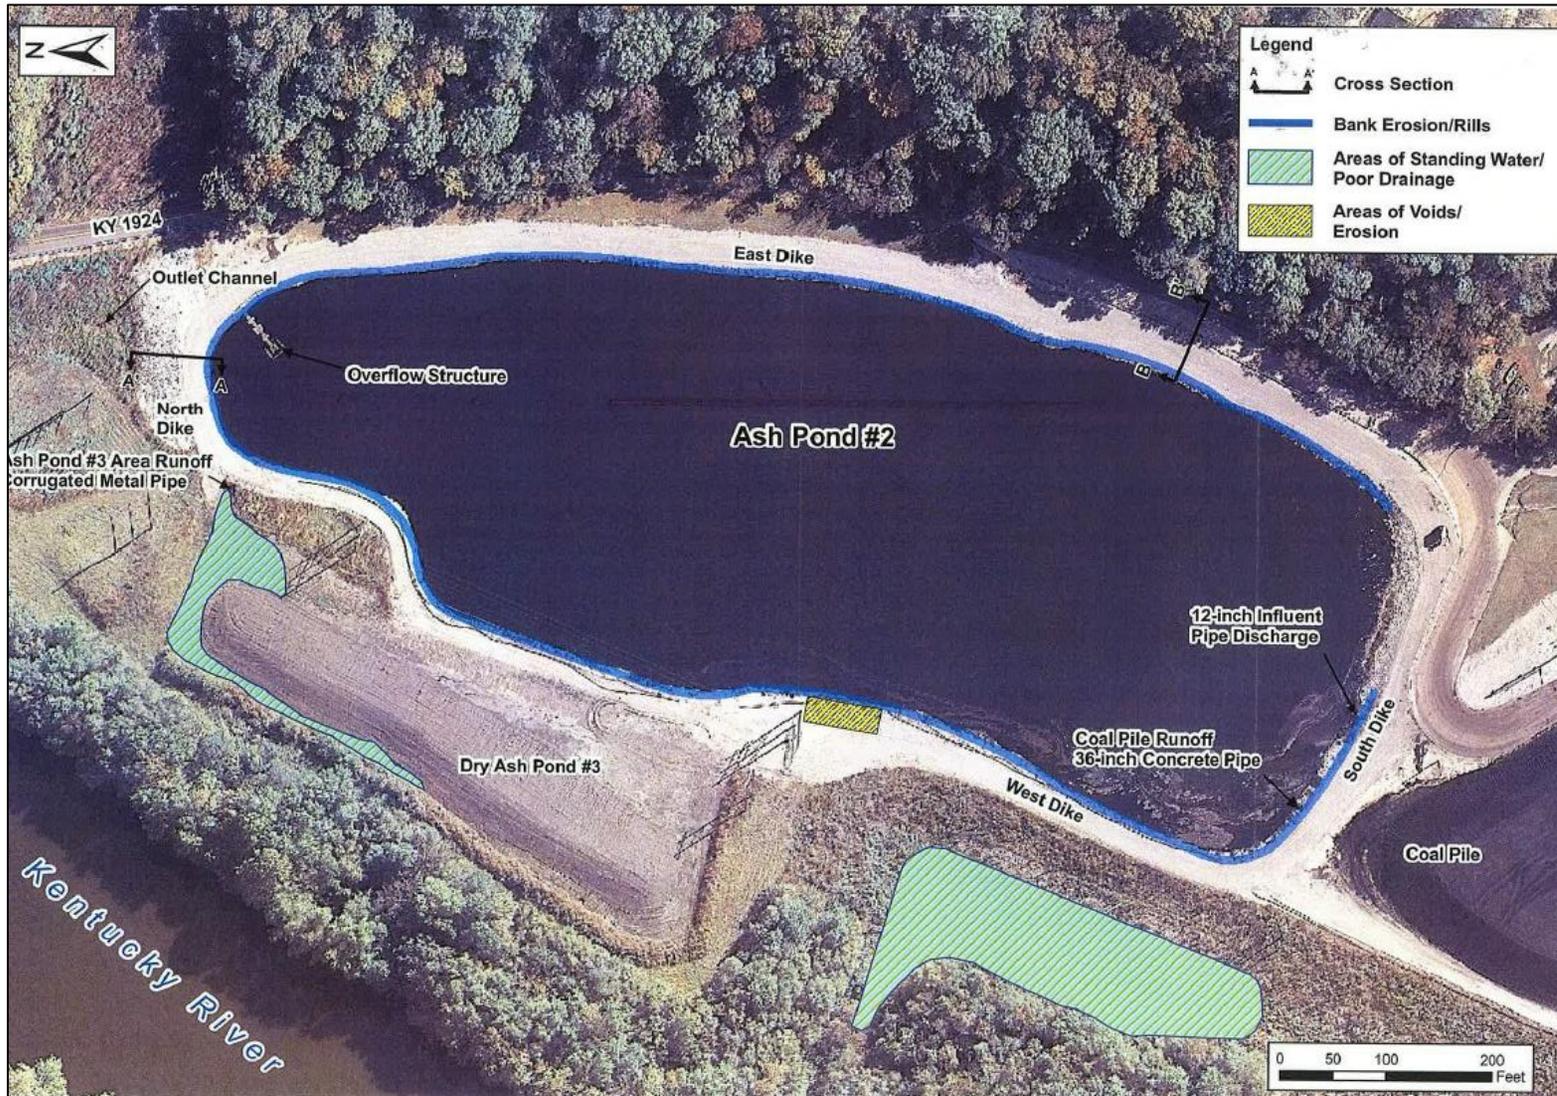
DATUM:	TITLE EAST KENTUCKY POWER COOPERATIVE WILLIAM C. DALE POWER PLANT, FORD, KY 2009 ASSESSMENT ISSUES MAP ASH POND 2	PROJECT NO.: 3-2106-0177-0001
		PROJECTION:		FIGURE No. 5
		SCALE: AS SHOWN

2. Erosion rills and gullies were noted "throughout the interior slopes", with some areas considered "excessive".
3. Although northern exterior slopes ranged from 2.6:1 (H:V) to 2.1:1 (H:V) based on Stantec's survey results, these slopes were noted to be "well protected with Class III channel lining and appeared to be uniform with no signs of erosion or instability."

5. An area of ponded water was observed along the southern half of the western exterior slope. Poor drainage conditions and a water discharge or process piping system (possibly abandoned) seemed to be the source of the ponding.

7. Possible instability or settlement on the western crest was observed in an area that, after review of aerial images and old drawings, appeared to be near the limits of the original divider dike that existed in Ash Pond 2. "This area contained two cracks or voids within the crest of the dike and signs of interior slope erosion." Recent construction appeared to have taken place along approximately 40 feet at the location and included "regrading and the placement of fill material on the crest and interior slope. Fill material appeared to consist of soil, rock, ash, coal particles, and crushed limestone," as well as a few pieces of wood and metal pipe.

1. Completion of an engineering study to determine sources of cracking and voids, as well as the source of water that was observed in two areas outside the ash pond.

6. Improve monitoring of the interior slopes where erosion is occurring. Repair these areas promptly to prevent continuation of the erosion. Additionally, monitor crest for potholes and rutting and provide prompt repair by re-grading to promote flow toward the ash pond.

7. Improve mowing frequency of toe and external slope areas to three to four times per year to enhance monitoring and observation capabilities.
8. Continued monitoring of observed wet areas outside Ash Pond 2 in the vicinity of Ash Pond 3 to determine if conditions change.

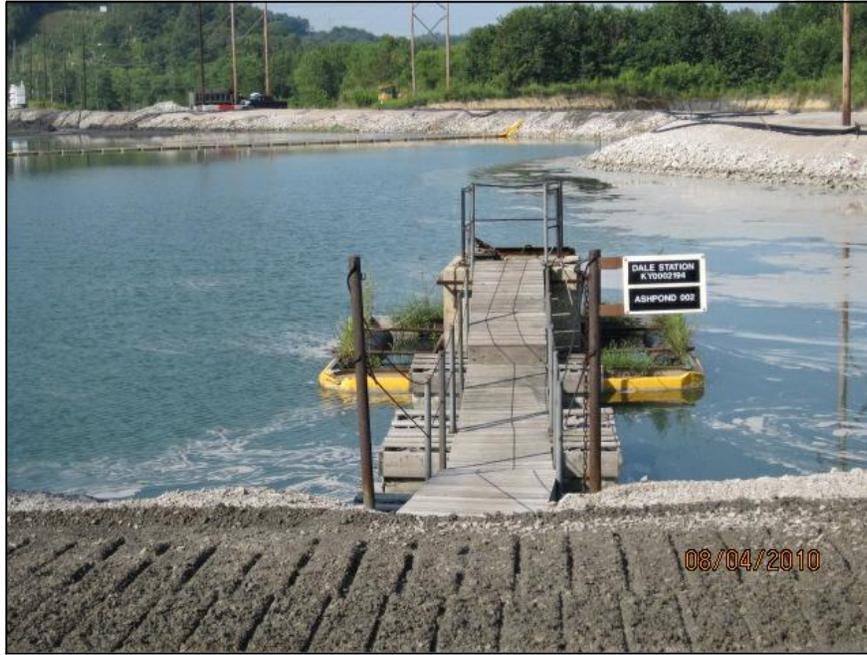
2-1

NORTH DIKE OF POND LOOKING SOUTHWEST AT PRIMARY OUTLET STRUCTURE

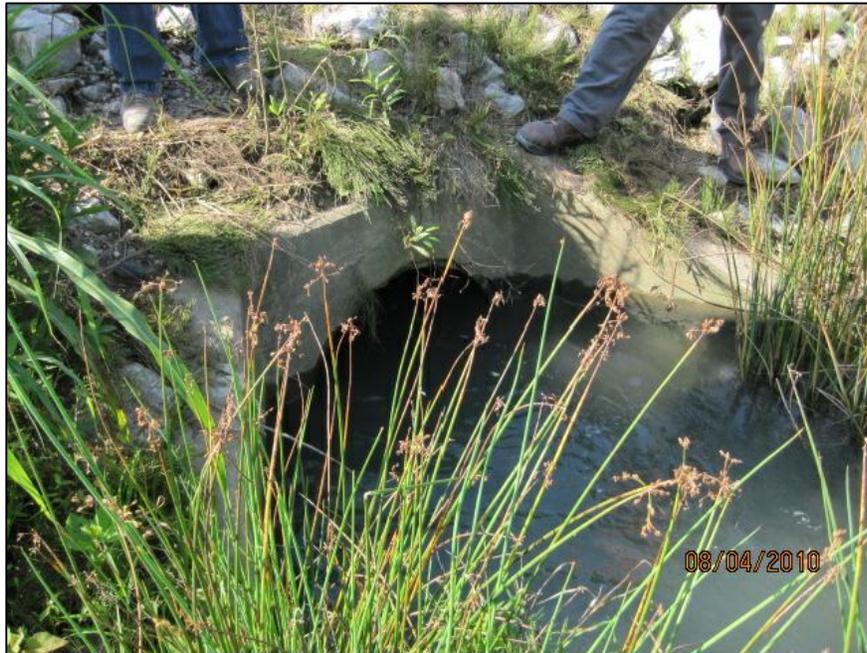
2-2

POND NPDES OUTFALL AT TOE OF NORTH DIKE

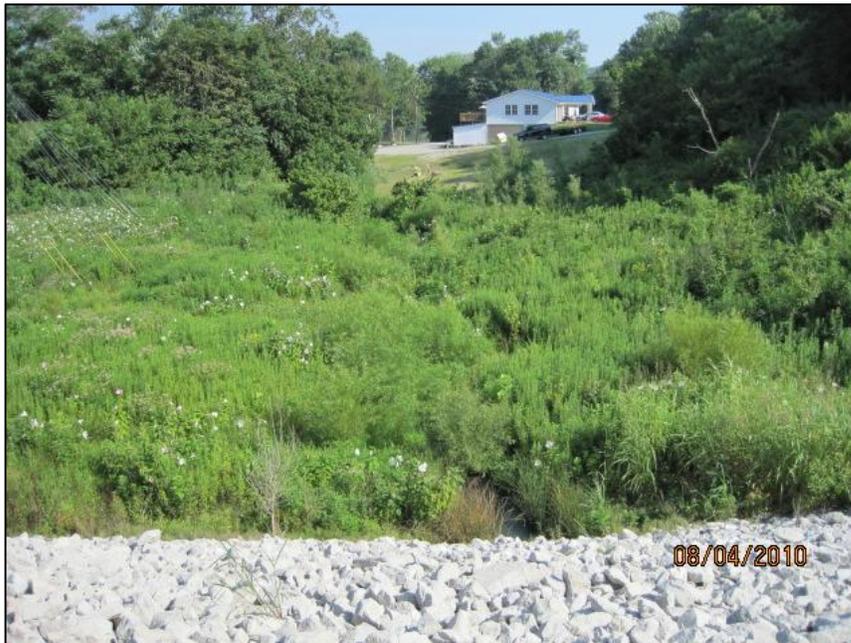
2-3

FROM NORTHERN DIKE LOOKING NORTH AT OUTFALL CHANNEL TO KENTUCKY RIVER

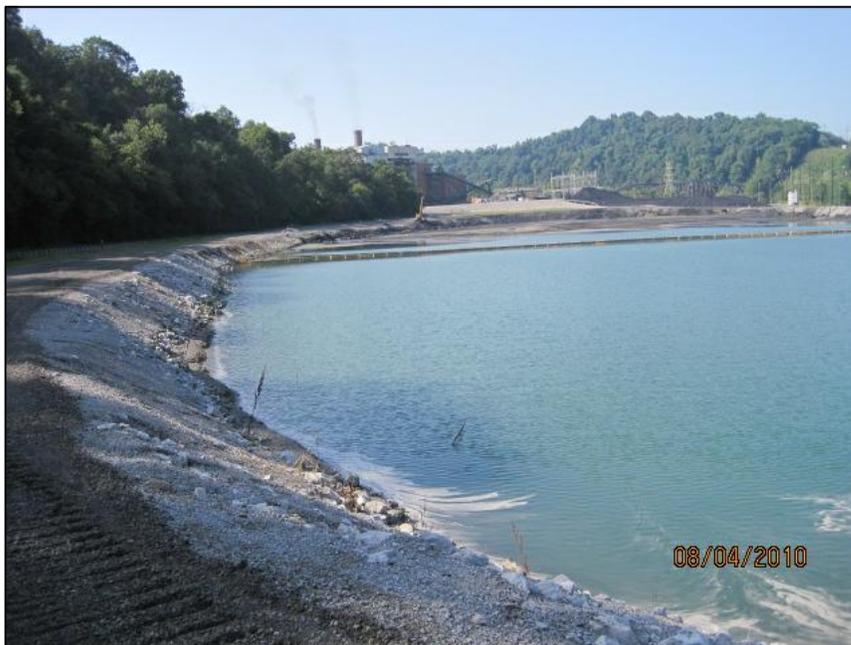
2-4

**LOOKING SOUTH FROM NORTHERN BANK AT POND INTERIOR,
AND CREST AND UPSTREAM SLOPE OF EASTERN DIKE**

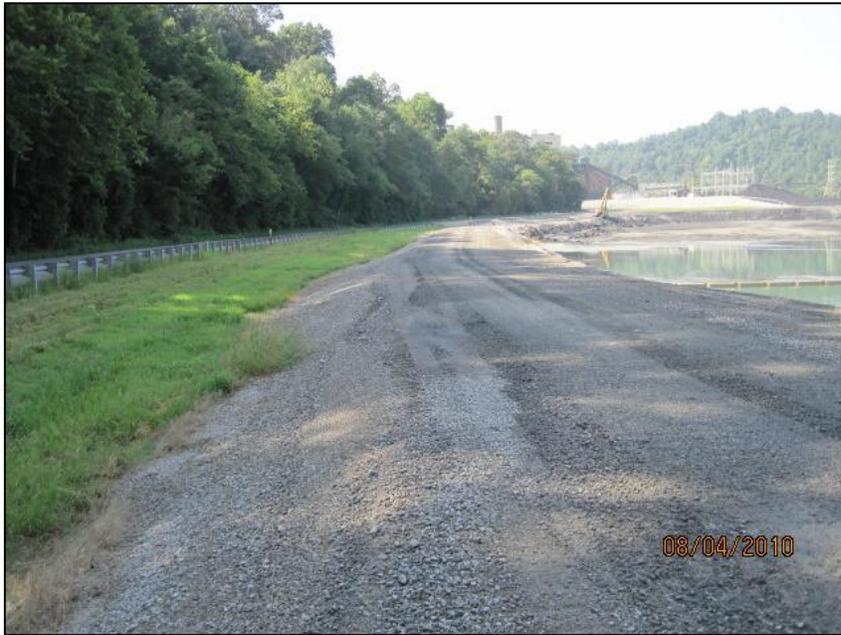
2-5

FROM EASTERN DIKE LOOKING SOUTH AT CREST AND DOWNSTREAM SLOPE, FORD ROAD LOCATED TO THE EAST

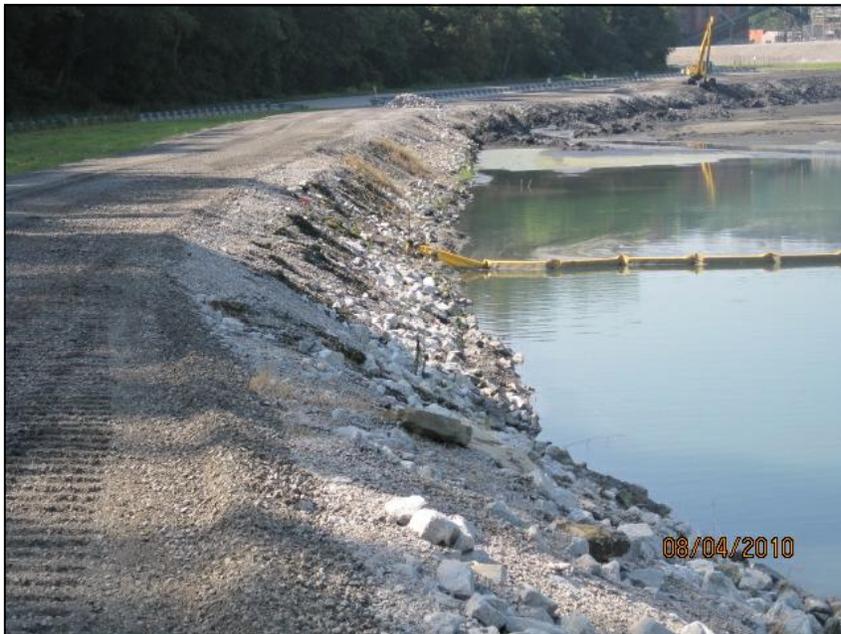
2-6

FROM NORTHEAST DIKE LOOKING SOUTH AT UPSTREAM SLOPE, CREST AND FORD ROAD

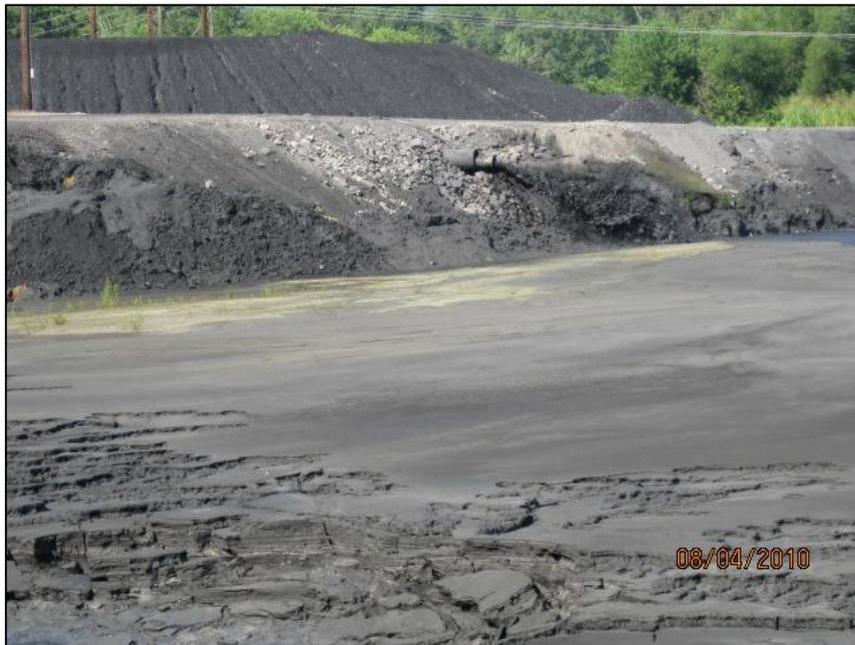
2-9

ASH INLET PIPES FROM POWER PLANT ON SOUTH DIKE

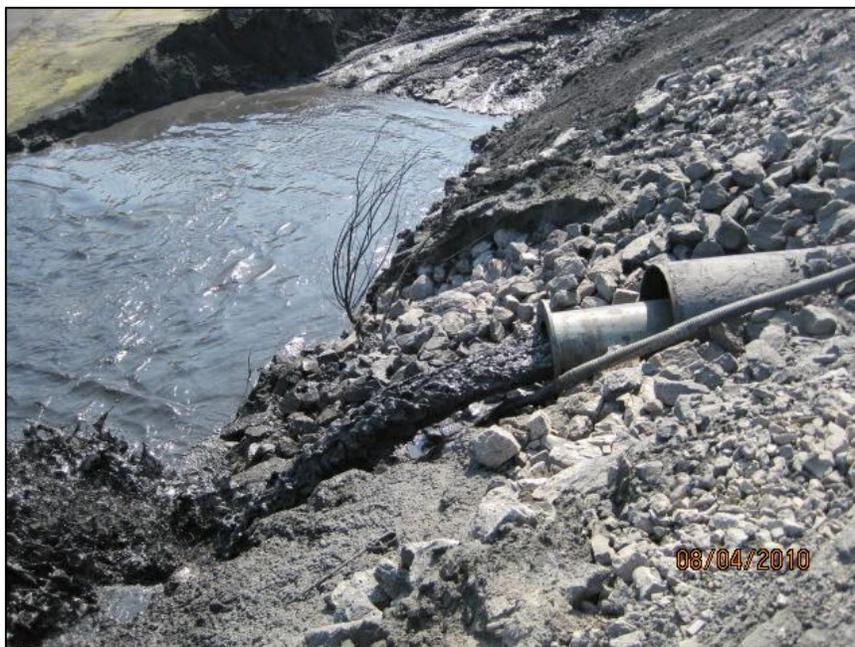
2-10

CLOSE-UP OF ASH INLET PIPES FROM POWER PLANT

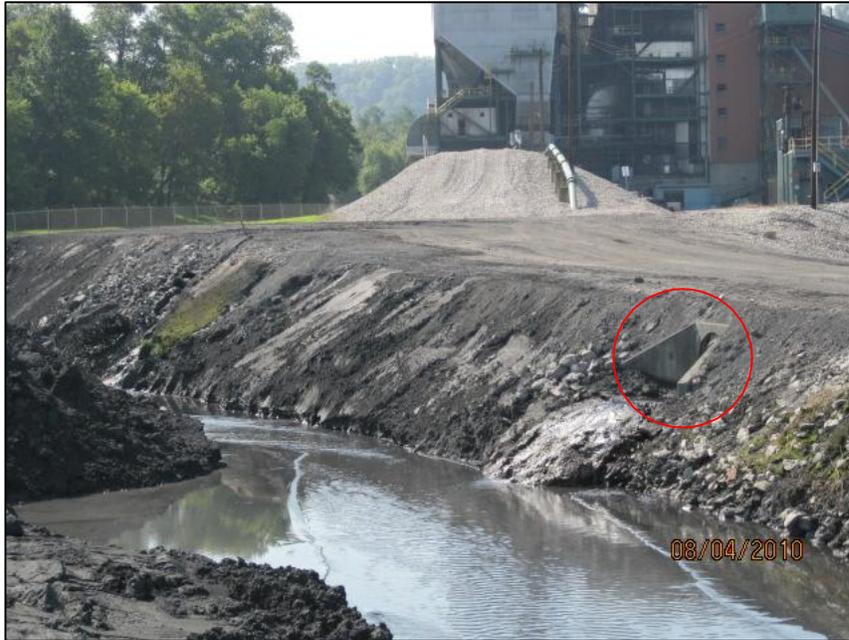
2-11
COAL PILE RUNOFF INLET ON SOUTH DIKE

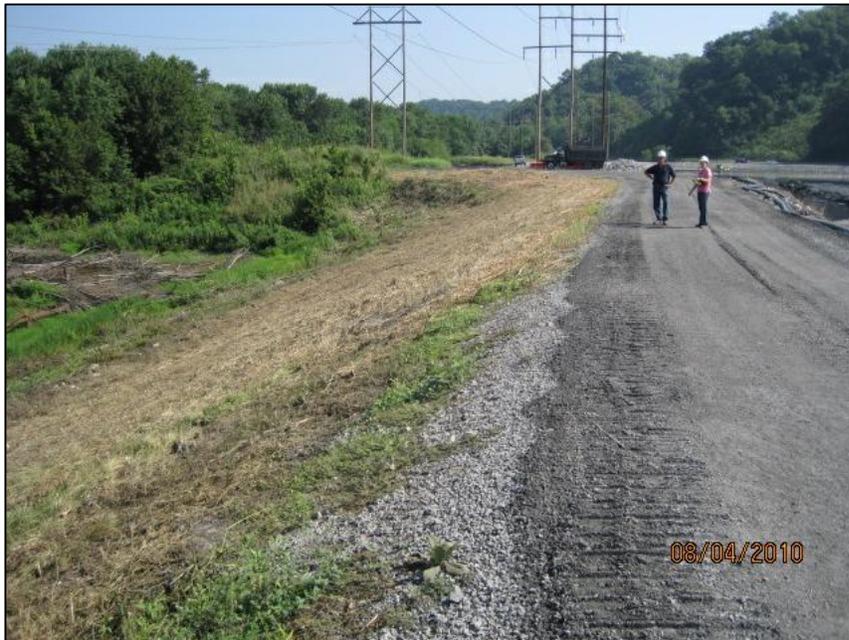
2-12
SOUTH END OF WEST DIKE LOOKING NORTH AT CREST AND DOWNSTREAM SLOPE

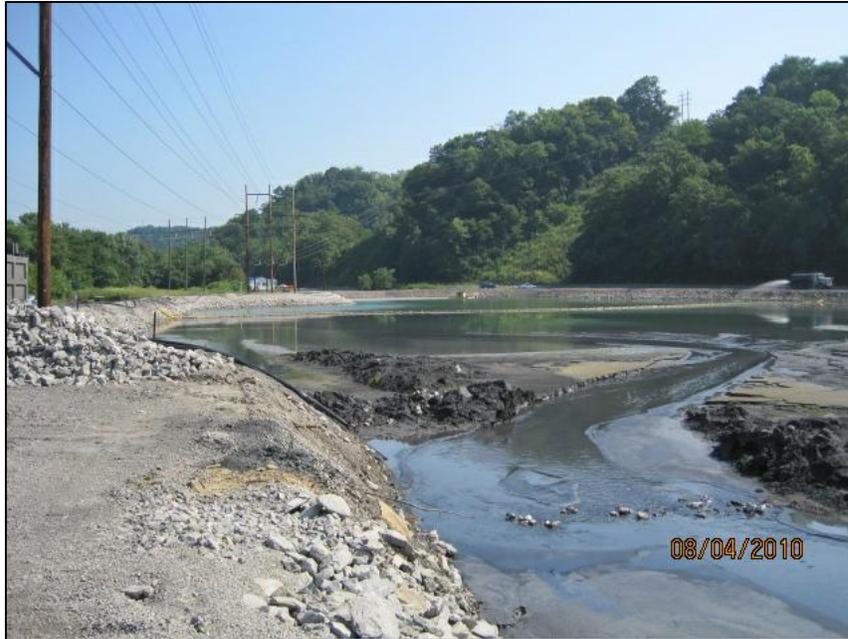
2-13

FROM MIDDLE OF WEST DIKE LOOKING NORTH

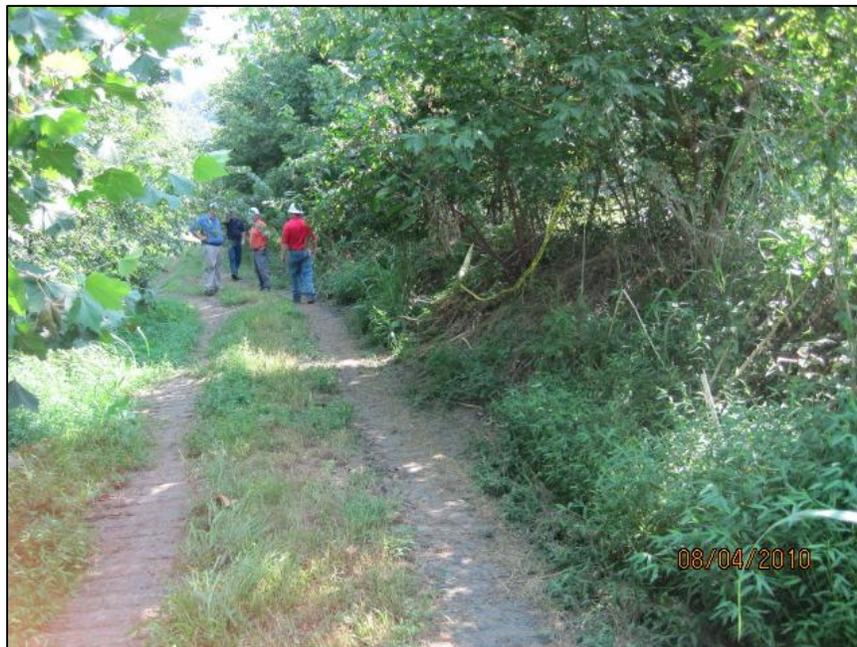
3-2
BEHIND WEST DIKE LOOKING NORTHWEST. VEGETATION AND TREES ON WEST DIKE (ON RIGHT SIDE OF PHOTO)

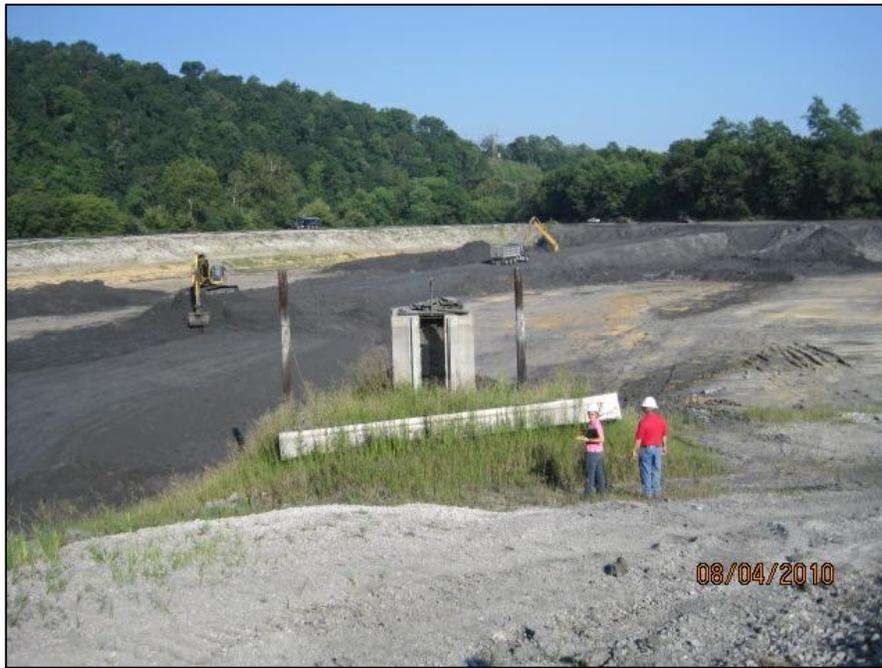
4-1

FROM SOUTHEAST DIKE LOOKING NORTHWEST AT INACTIVE OUTLET STRUCTURE AND POND INTERIOR

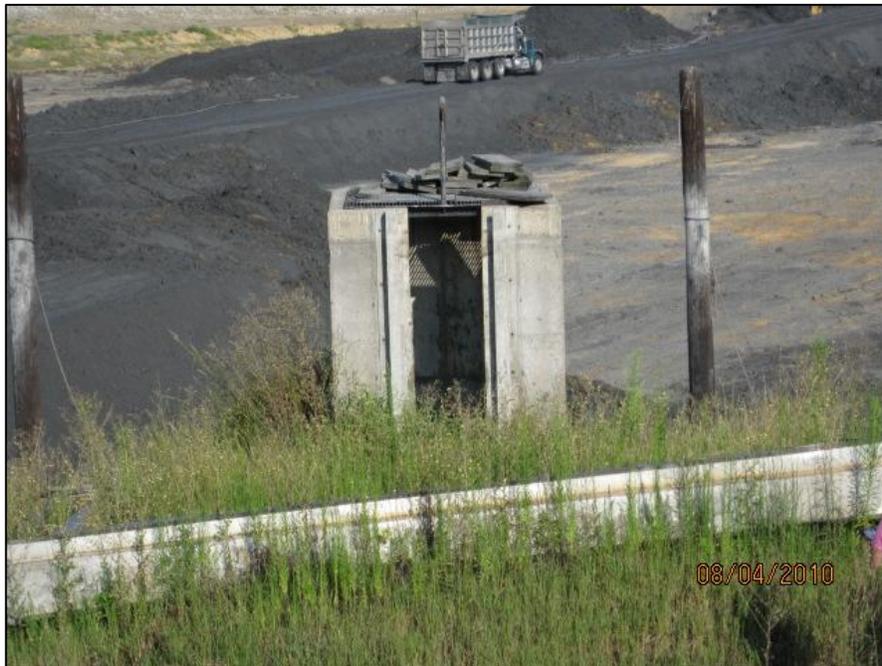
4-2

INACTIVE OUTLET STRUCTURE

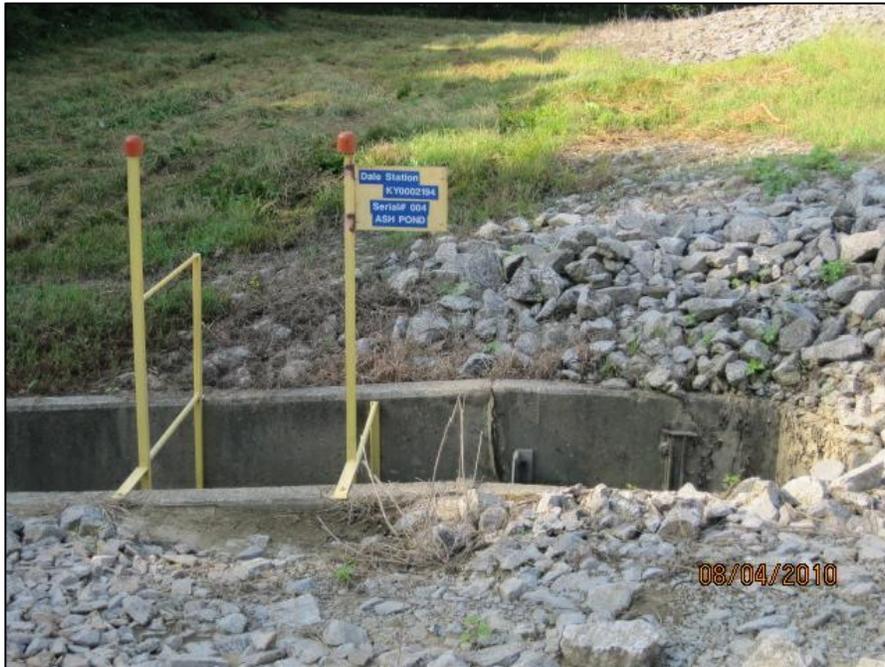
4-3

POND DISCHARGE/OUTFALL 004 AND TOE OF SOUTHEAST DIKE

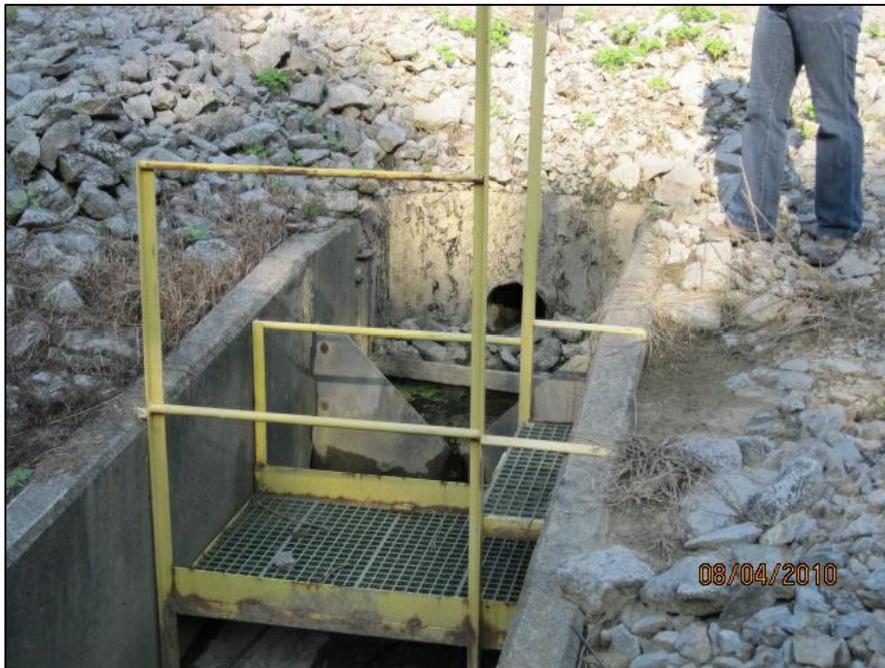
4-4

POND DISCHARGE/OUTFALL 004 WEIR

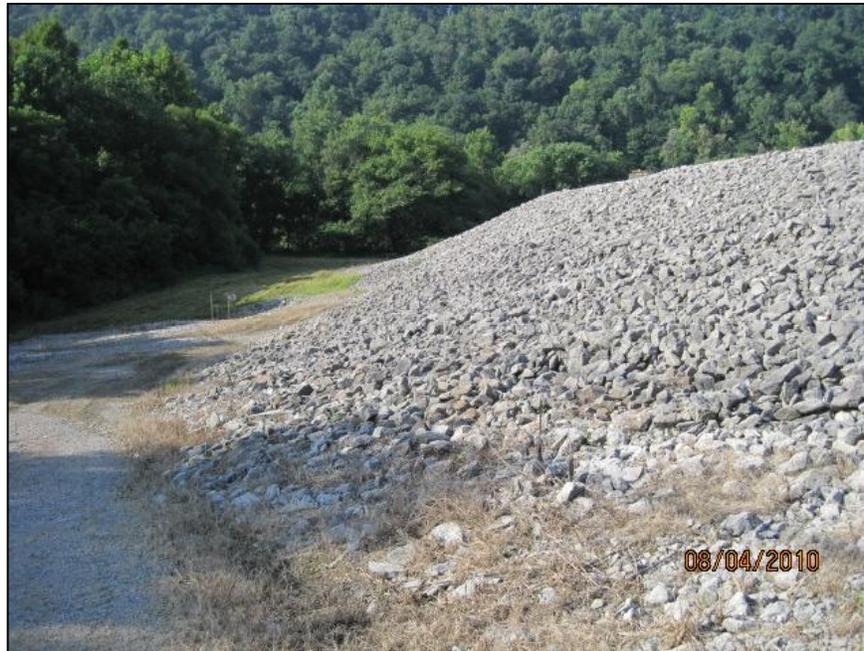
4-6

TYPICAL SOUTHEAST DOWNSTREAM EMBANKMENT

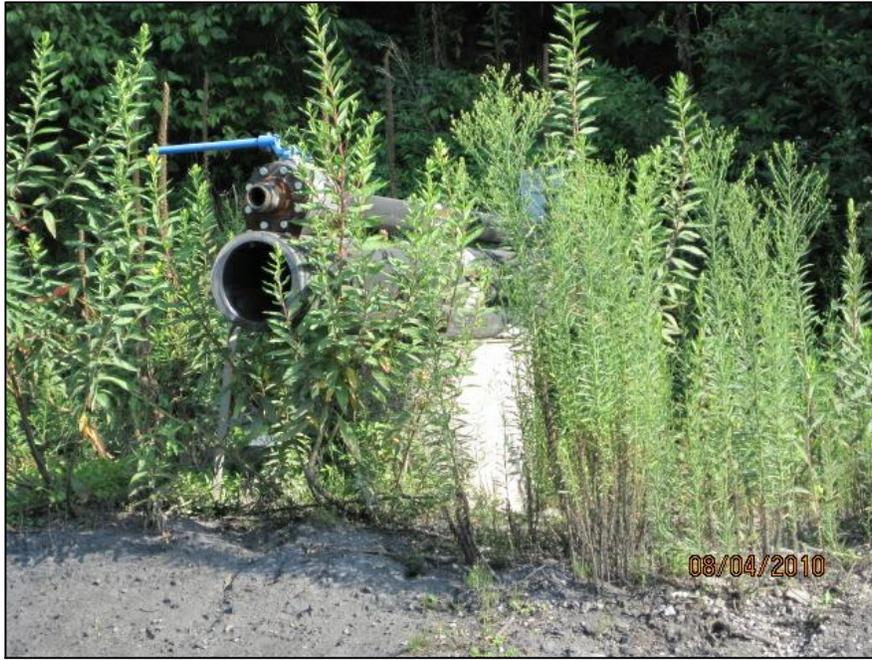
4-9

INLET STRUCTURE FROM PLANT ON NORTH DIKE

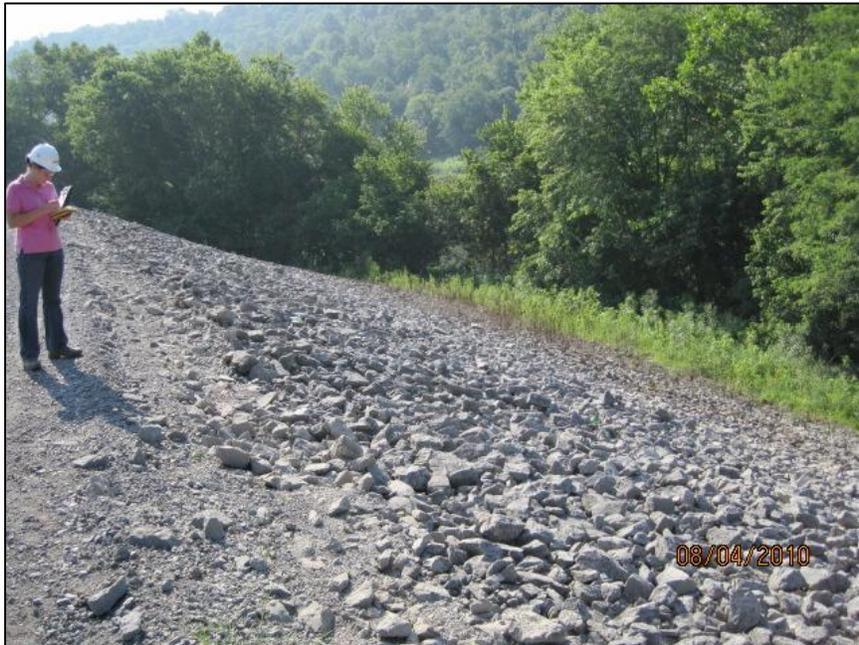
4-12

TYPICAL SOUTHERN DOWNSTREAM EMBANKMENT
