**Coal Combustion Residue Impoundment
Round 9 - Dam Assessment Report**

H.L. Spurlock Power Station
Spurlock Ash Pond
East Kentucky Power Cooperative
Maysville, Kentucky

Dewberry & Davis, LLC
Fairfax, Virginia

Under Contract Number: EP-09W001727
March 2011

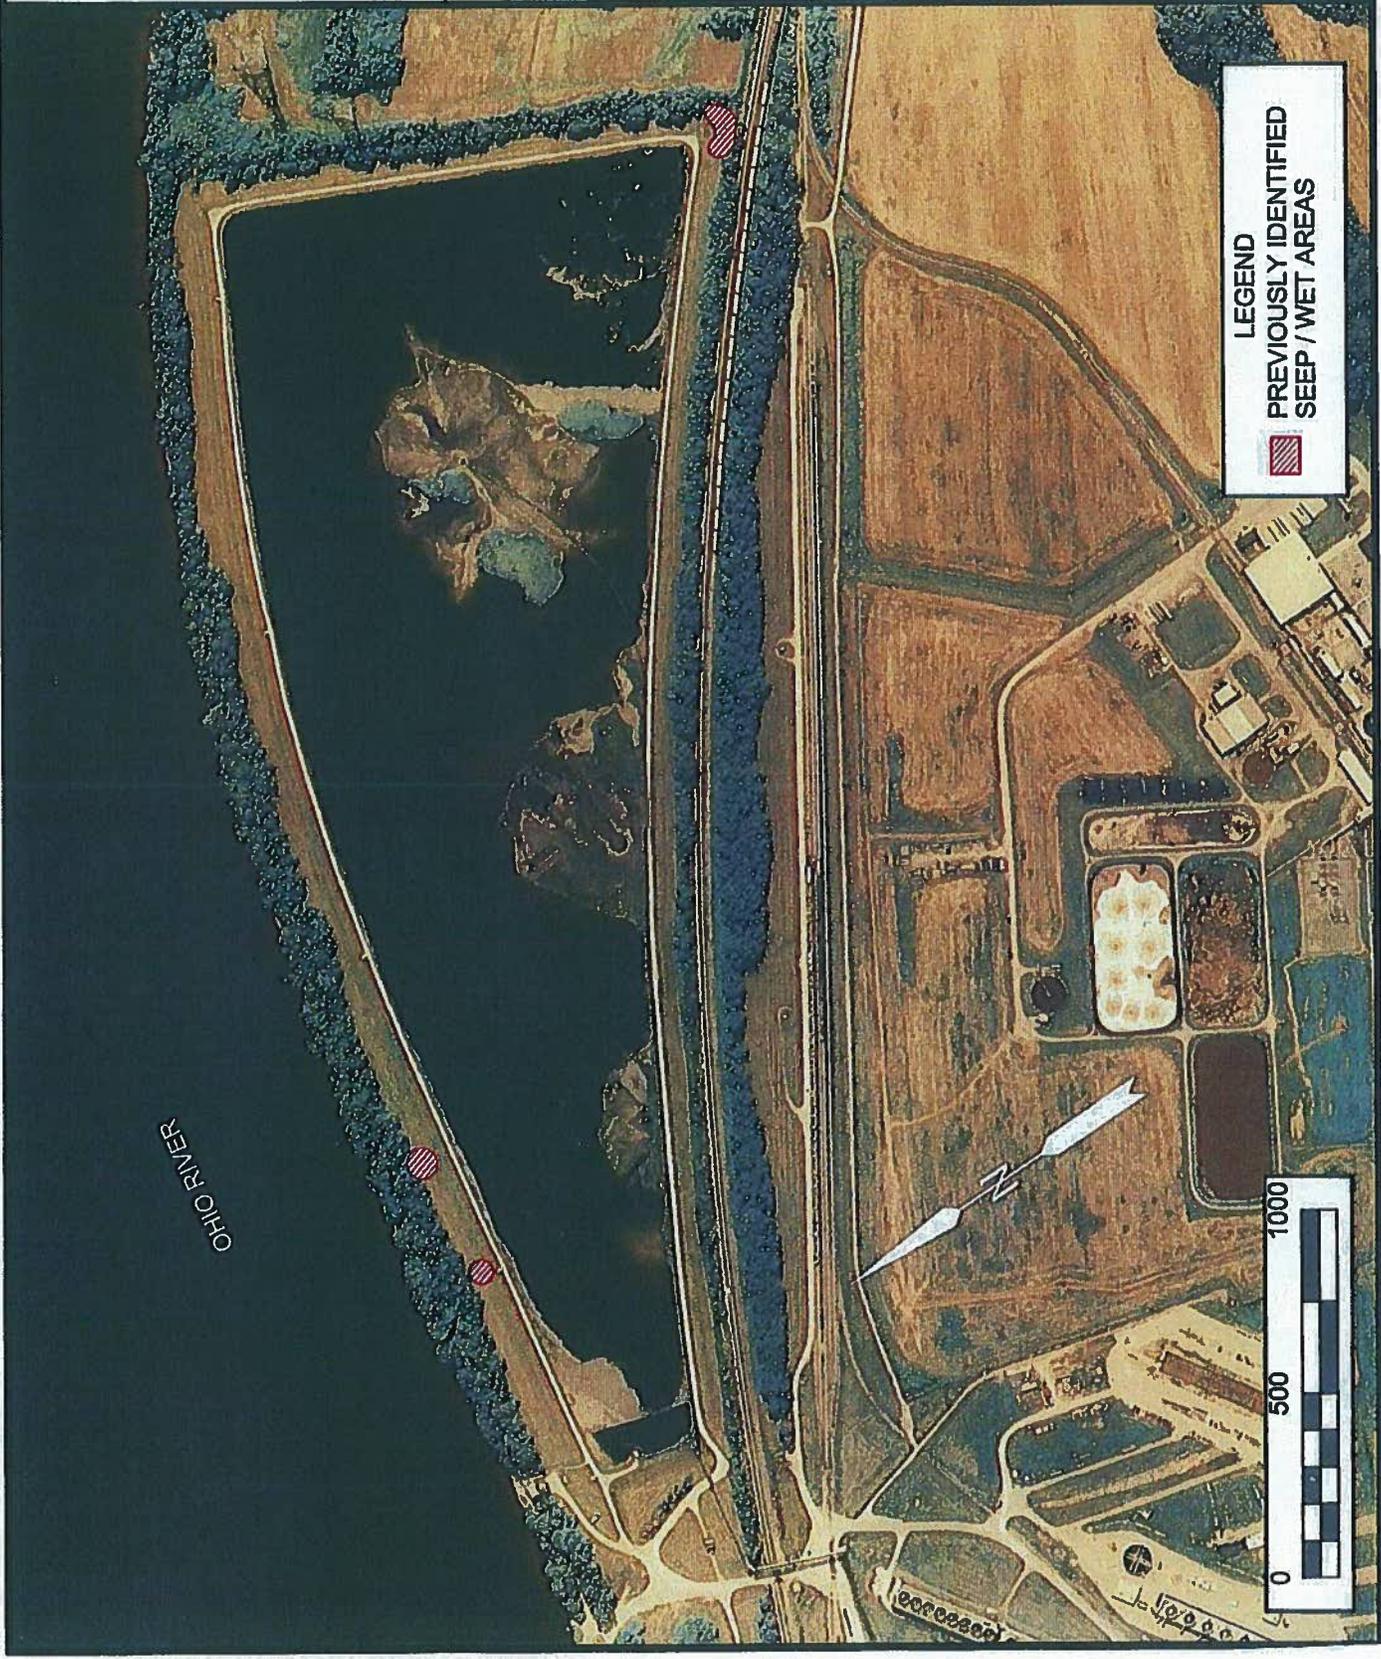
FIGURE
2

PREVIOUSLY IDENTIFIED
 SEEP / WET AREAS

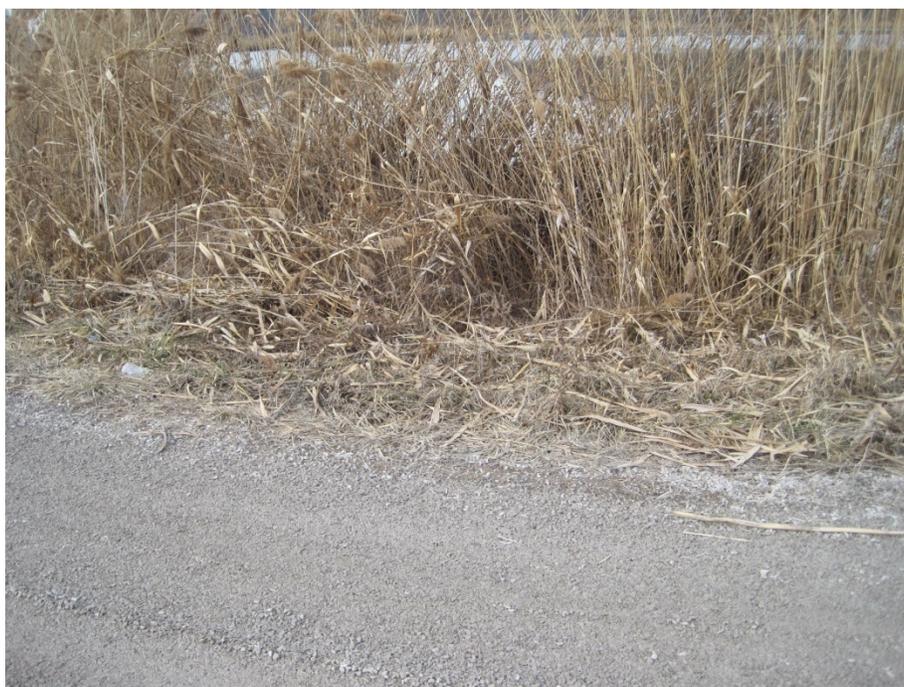
The visible parts of the embankment dikes and outlet structure (pump station) were observed to have no signs of overstress, significant settlement, shear failure, or other signs of instability. However, visual observations of the floodside embankments were restricted by the presence of thick vegetation, specifically phragmites, in some areas (See Appendix C, Photos 02 and 03).

Photo 02: Phragmites Along Inside perimeter of Ash Pond (1 of 2)
H.L. Spurlock Power Station Ash Pond; February 15, 2011

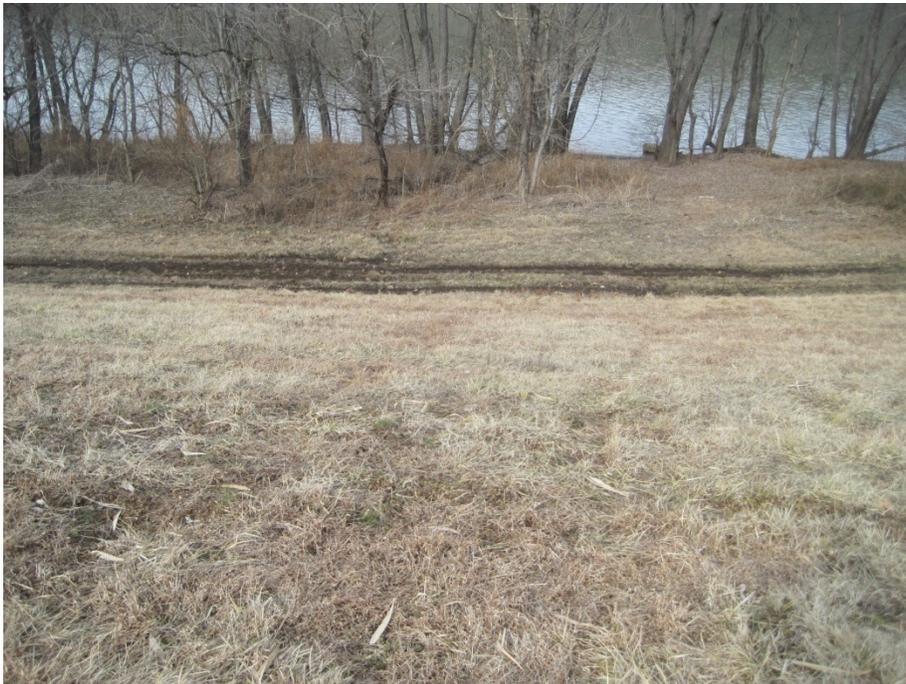
Photo 03: Phragmites Along Inside perimeter of Ash Pond (2 of 2)
H.L. Spurlock Power Station Ash Pond; February 15, 2011

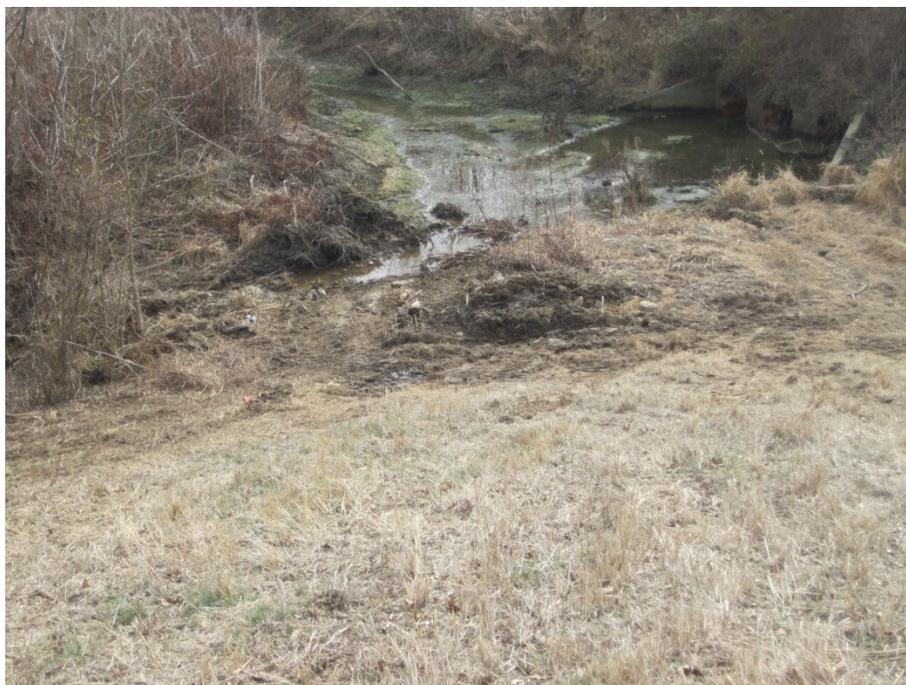
Wet areas were observed at two locations during observations of the exterior slopes along the north dike (See Appendix C, Photo 04). Section 5.2.3 addresses this observation further.

As discussed further in Sections 1.1.5, 1.2.1 as well as 1.2.2, wet areas were observed in two locations: one at the toe of the exterior slope along the north dike (See Appendix C, Photo 04), and one in the southeast corner of the outside embankment that appears to be associated with the adjacent ditch running parallel to the east dike as well as the ditch parallel to the railroad/ south dike, intersect coincidentally with the beaver habitat, thus water accumulates from the dams constructed by the beaver habitation, slowing drainage to the Ohio River (See Appendix C, Photo 05). Recent precipitation suggests that these locations are susceptible to the ponding of water from natural run-off and not indicative of leaks or seepage from the Spurlock Ash Pond.

Photo 04: Observed Area at Toe of Exterior Slope of North Dike
H.L. Spurlock Power Station Ash Pond; February 15, 2011

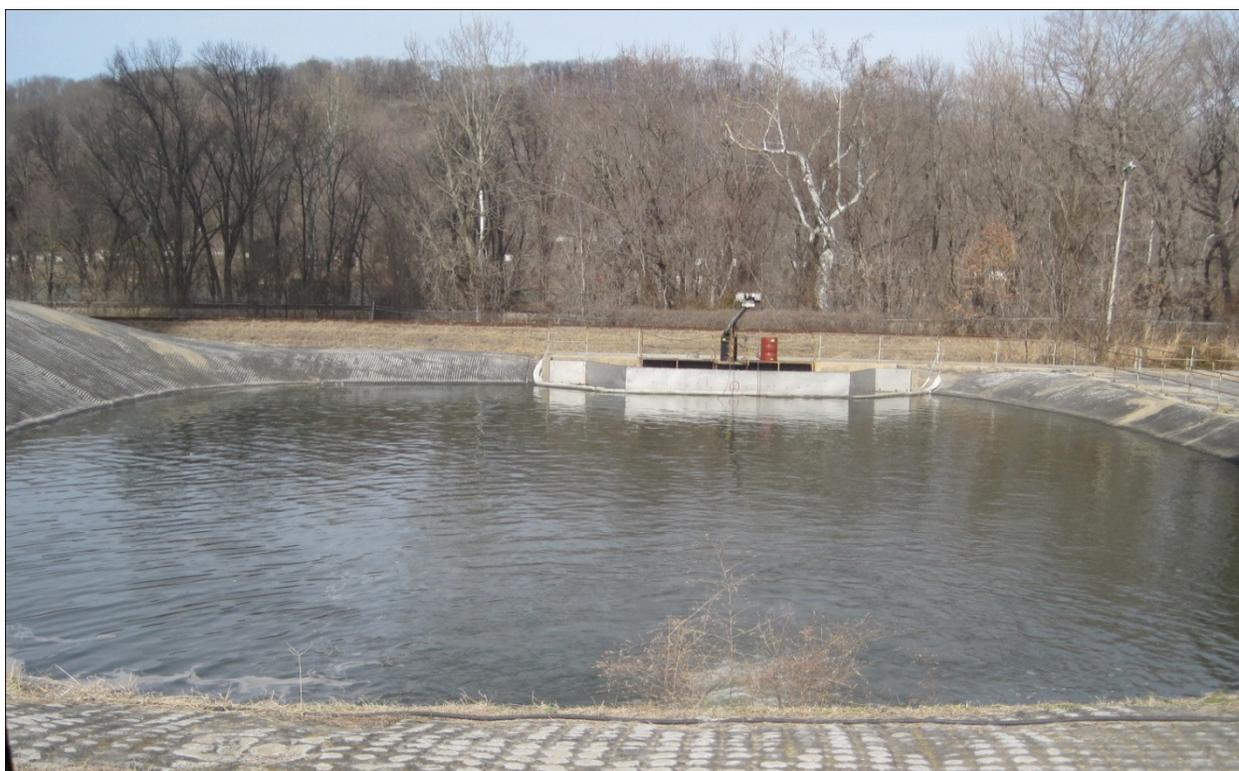
Embankments appear structurally sound. There are no apparent indications of unsafe conditions or conditions needing remedial action. There was, however, some concern about past beaver habitation in/near the bottom of the southeast corner of the impoundment (See Appendix C, Photos 05 and 08). The beaver dam had recently been removed at the time of Dewberry's visual assessment.

Photo 05: Area Observed Near Toe of SE Corner of Outside Embankment
H.L. Spurlock Power Station Ash Pond; February 15, 2011

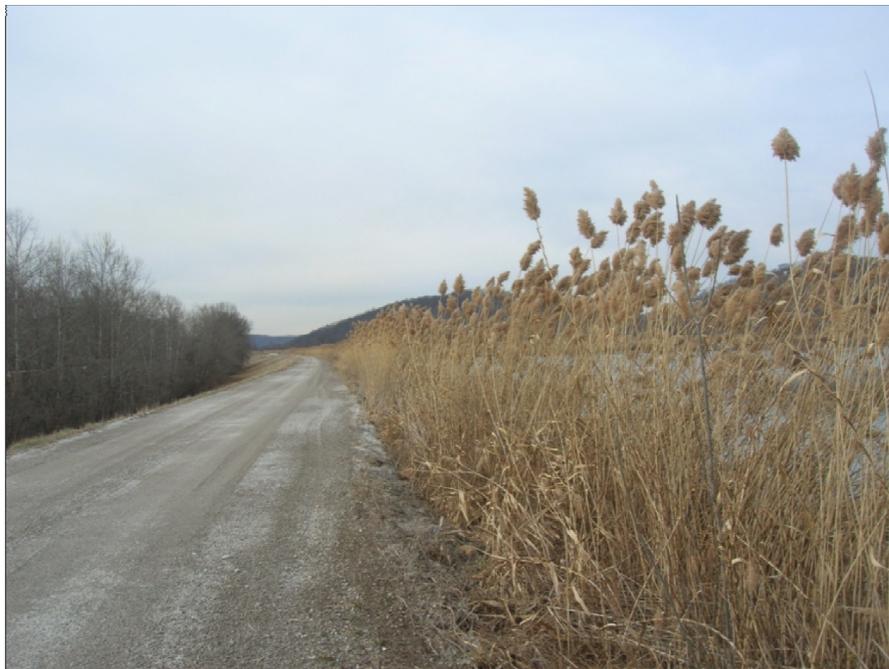
The crest of the Ash Pond had no signs of depressions, tension cracks, or other indications of settlement or shear failure, and appeared to be in satisfactory condition at the time of this assessment. Typical conditions of the Ash Pond's North, South, East, and West crests can be seen within Appendix C, as Photos 22, 23, 24, and 25, respectively.

Photo 22: Looking NE from Western Crest at Northern Crest Typical Conditions (See Top Left Corner of Photo)
H.L. Spurlock Power Station Ash Pond; February 15, 2011

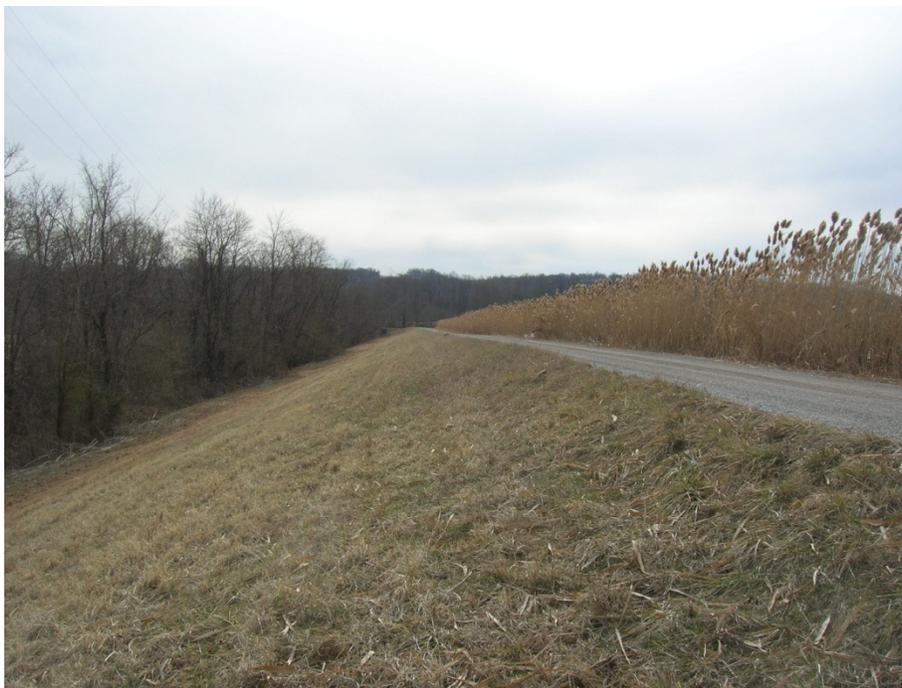
Photo 23: Looking down South Crest; Typical Conditions
H.L. Spurlock Power Station Ash Pond; February 15, 2011

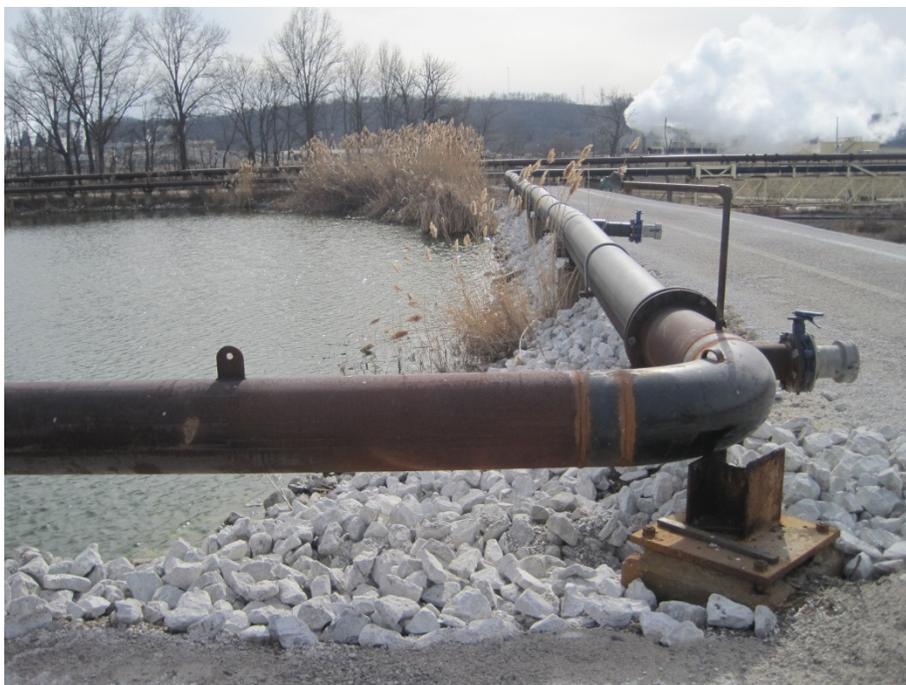
Photo 24: Looking down East Crest from NE Corner; Typical Conditions
H.L. Spurlock Power Station Ash Pond; February 15, 2011

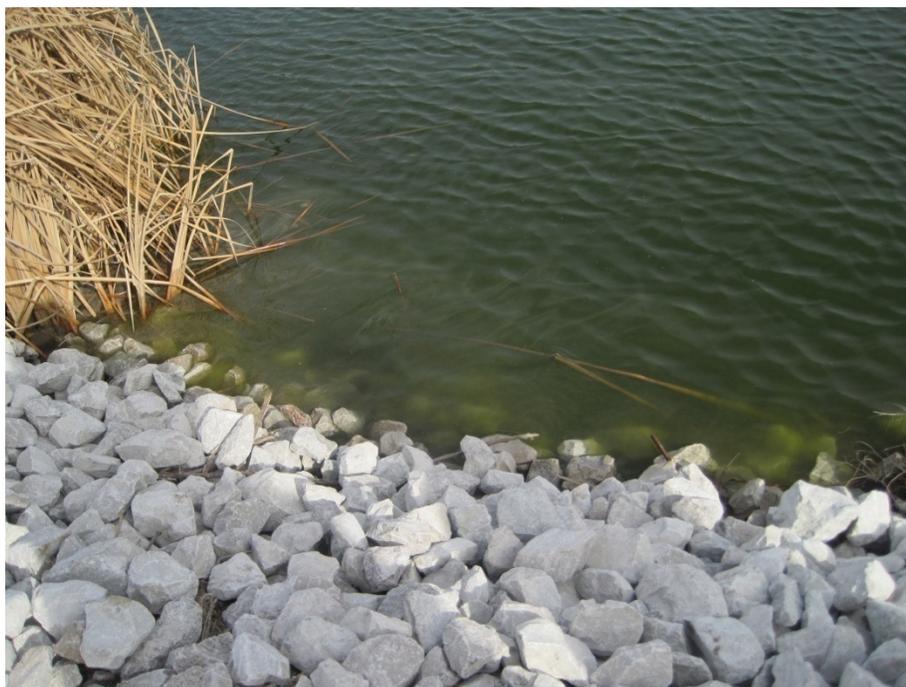
Photo 25: Looking down West Crest from NW Corner; Typical Conditions
H.L. Spurlock Power Station Ash Pond; February 15, 2011
