DRAFT
Specific Site Assessment for
Coal Combustion Waste
Impoundments at Empire
District Electric Company
Asbury Power Station
Asbury, Missouri

Submitted by:
GEI Consultants, Inc.
4601 DTC Boulevard, Suite 900
Denver, CO 80237

January 2011
Project 092884

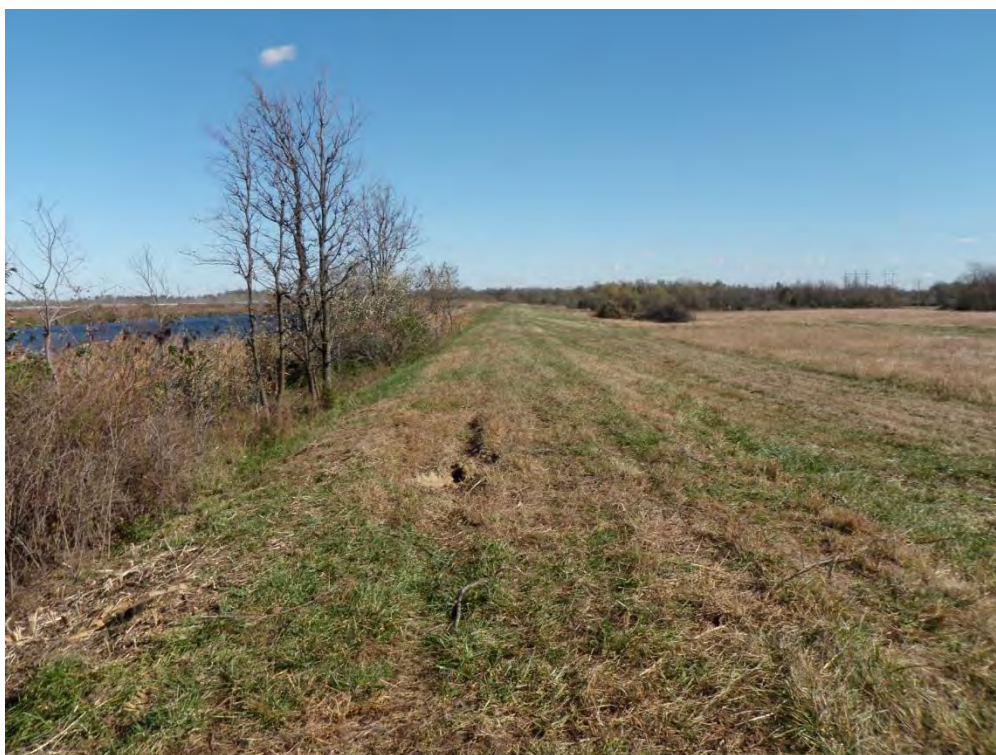
Photo 1: Lower Pond crest and upstream slope at southwest corner of pond looking east.

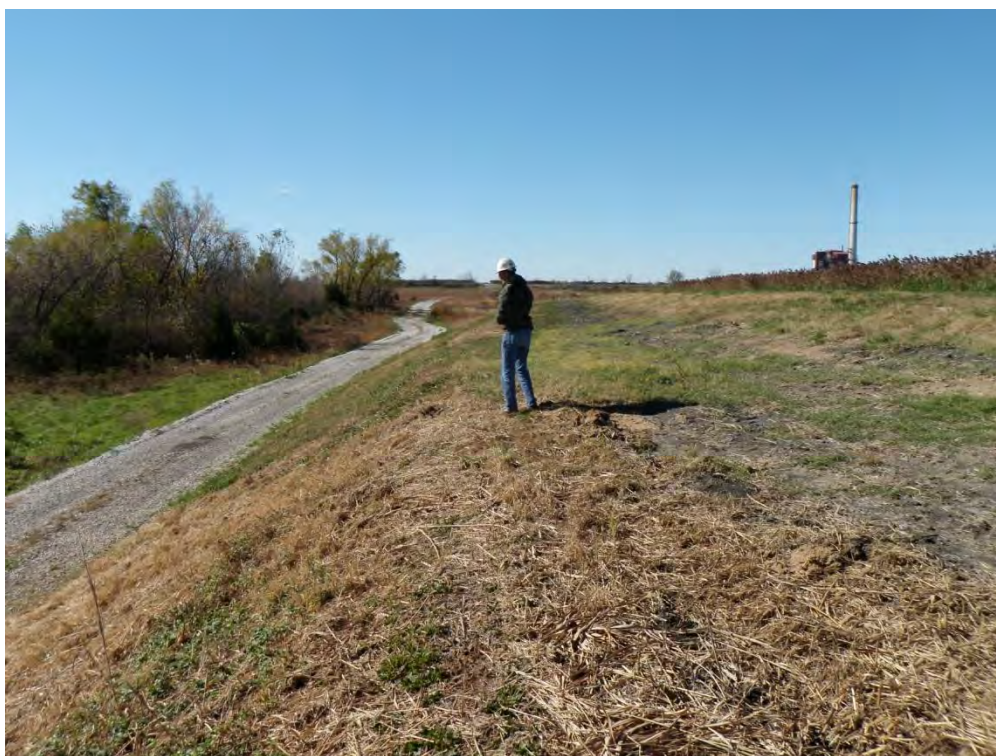
Photo 2: Lower Pond downstream slope at southeast corner of pond looking west.

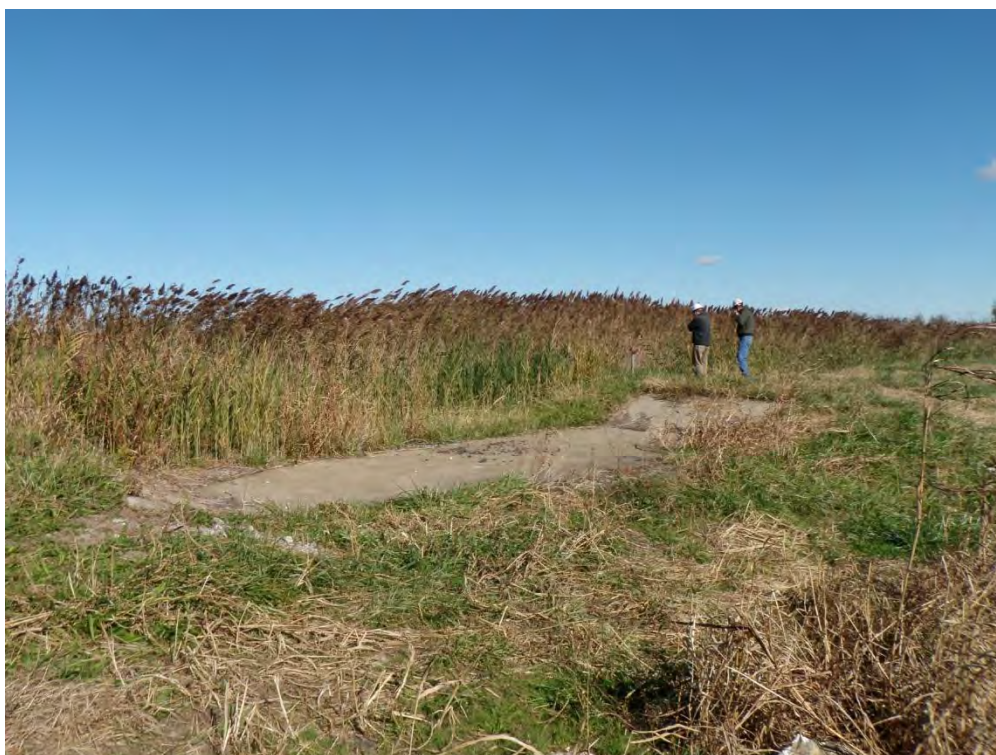
The emergency spillway near the southeast corner of the Lower Pond was covered with vegetation, but the structure appeared to be in generally good condition.

Photo 3: Lower Pond overflow spillway near southeast corner of pond.

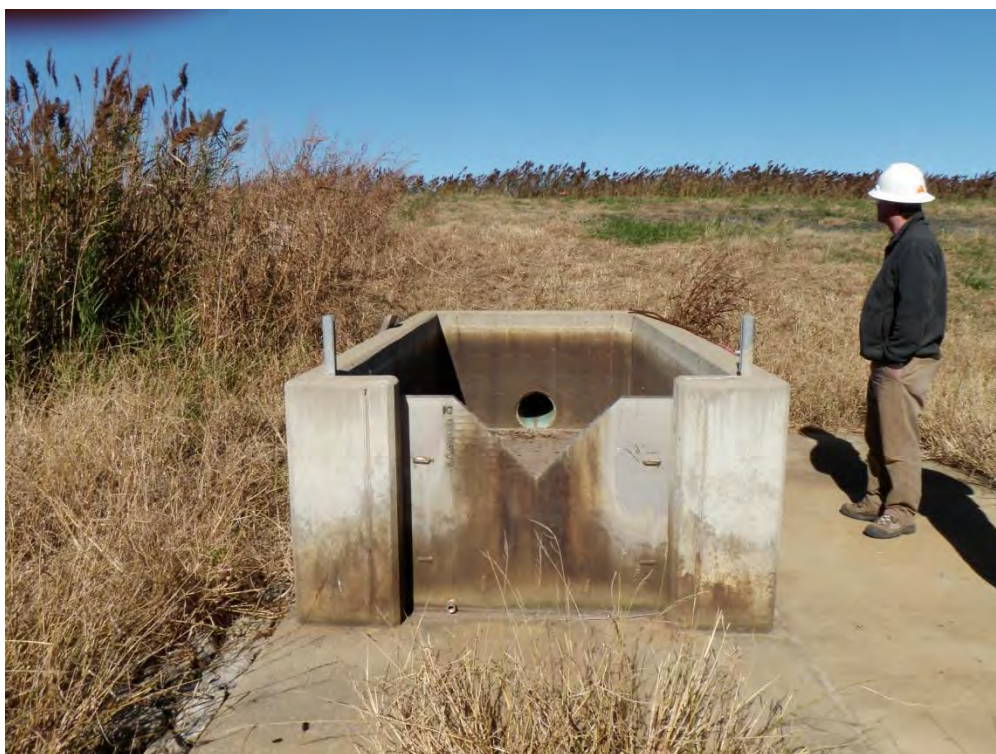
Photo 4: Lower Pond V-notch weir next to overflow spillway.

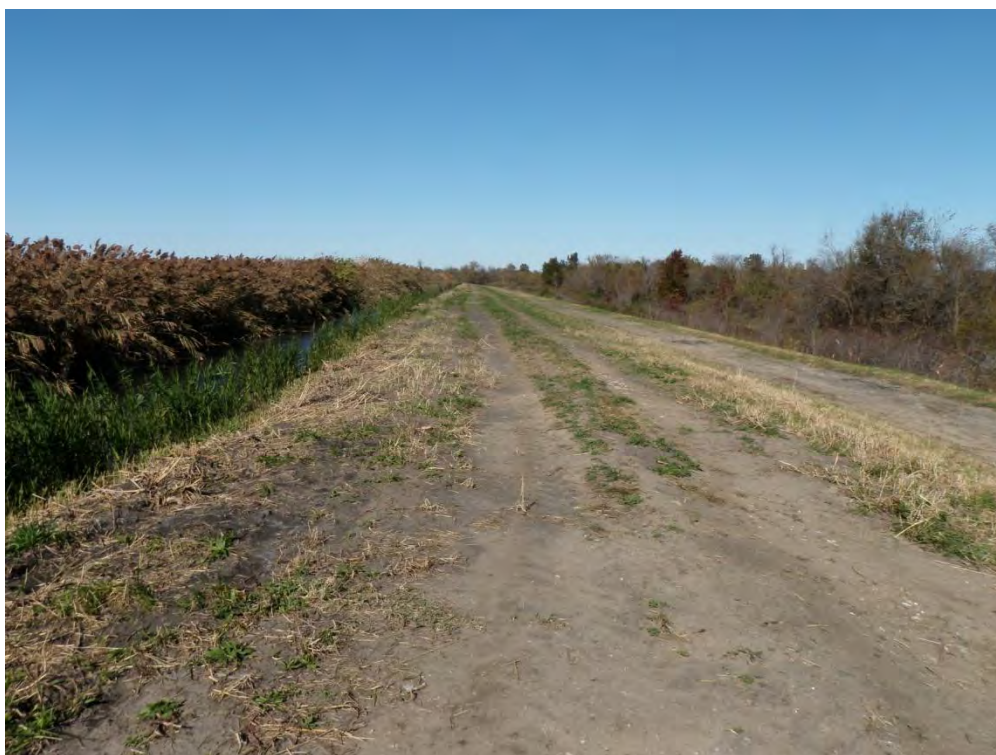
Photo 5: Lower Pond upstream slope and crest at southeast corner looking north.

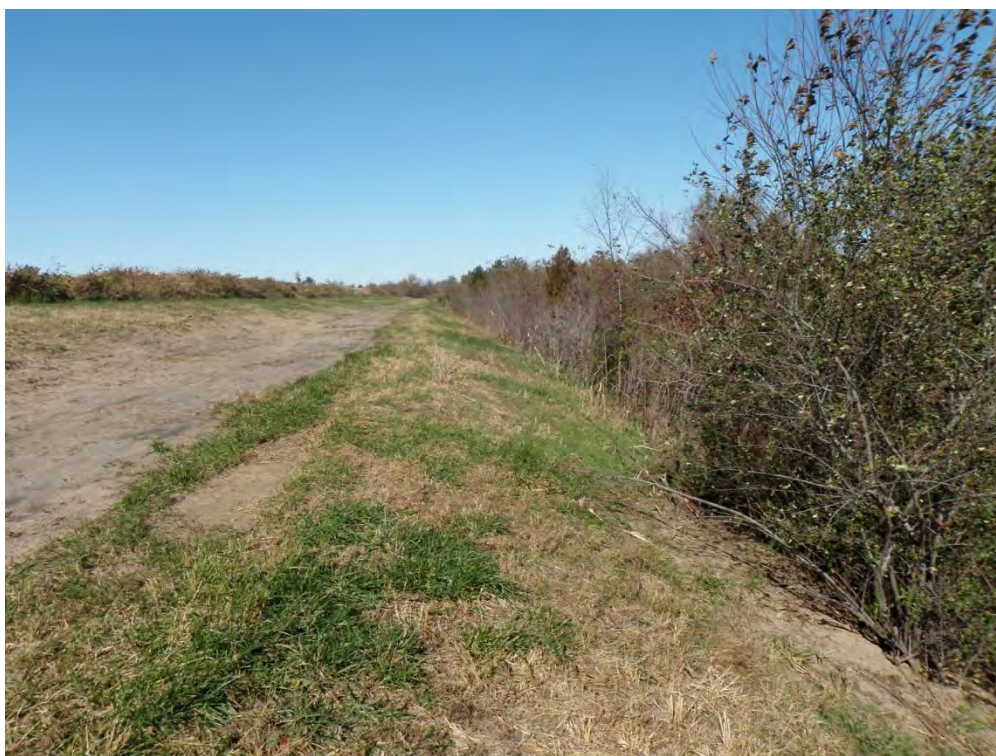
**Photo 6: Lower Pond downstream slope at southeast corner of pond looking north.
Note heavy tree growth at the downstream toe.**

1. Continue and improve vegetation control efforts to maintain the downstream embankment slopes free of heavy vegetation and tree growth. Existing trees should be removed to prevent the root systems from creating seepage paths through the embankment slopes. A minimum of about 25 feet of clear space should be provided between the downstream toe and the tree line. Removal of root balls of large trees can cause additional damage to an embankment and removal is not recommended without appropriate engineering planning and consideration.

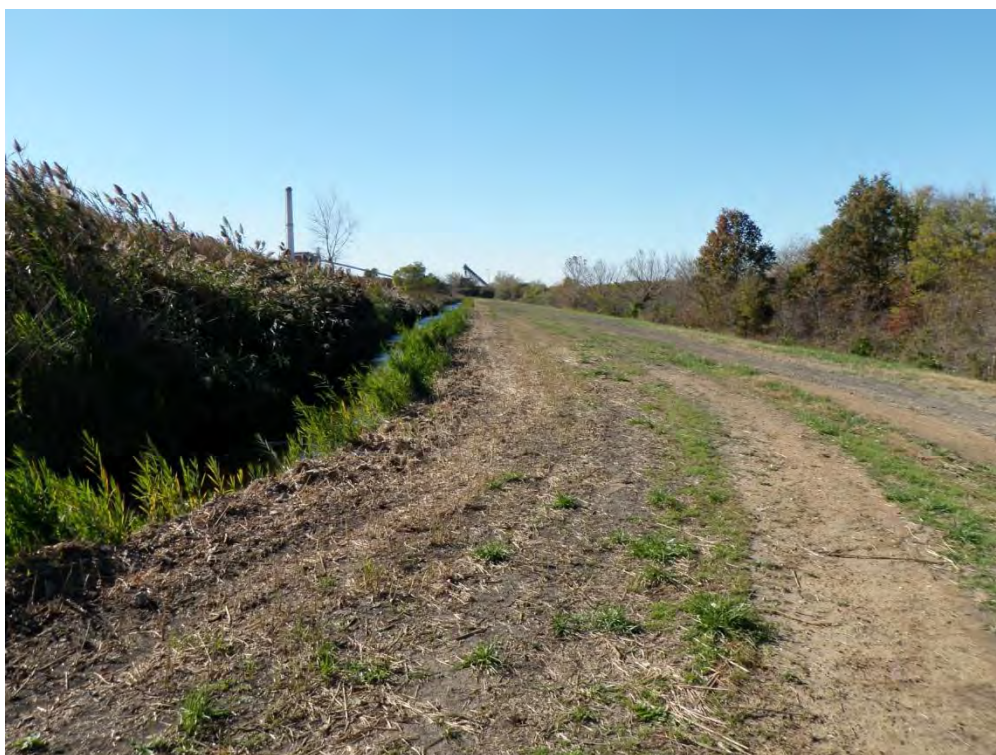
Photo 7: Lower Pond crest and interior perimeter ditch at northeast corner looking west.

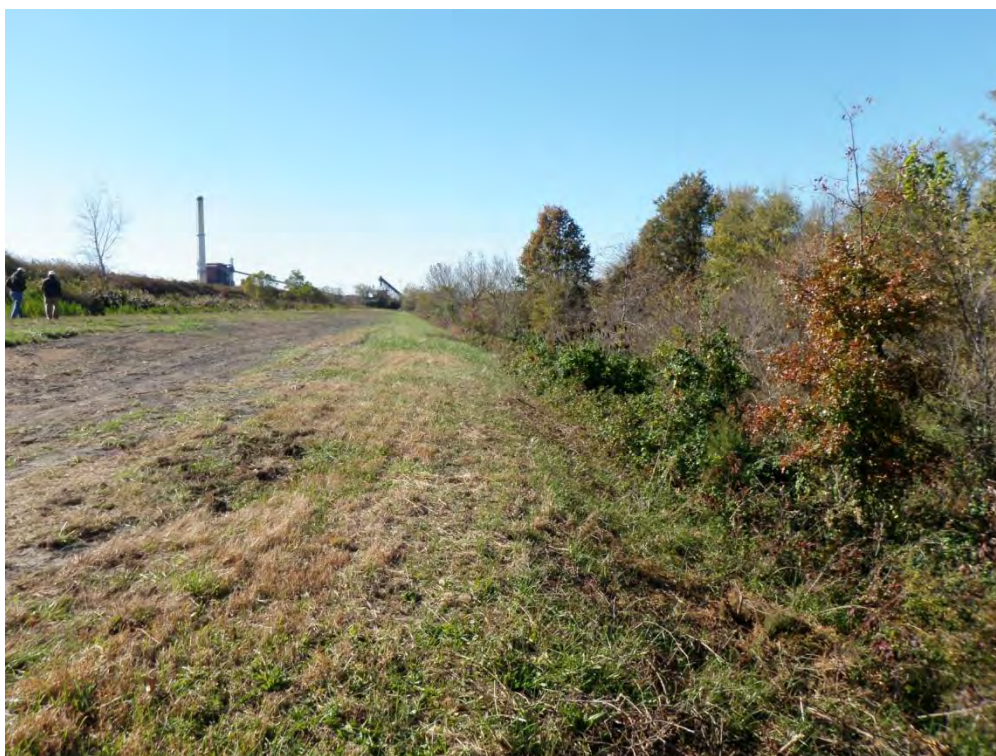
Photo 8: Lower Pond downstream slope and exterior perimeter ditch (at right) at northeast corner looking west.

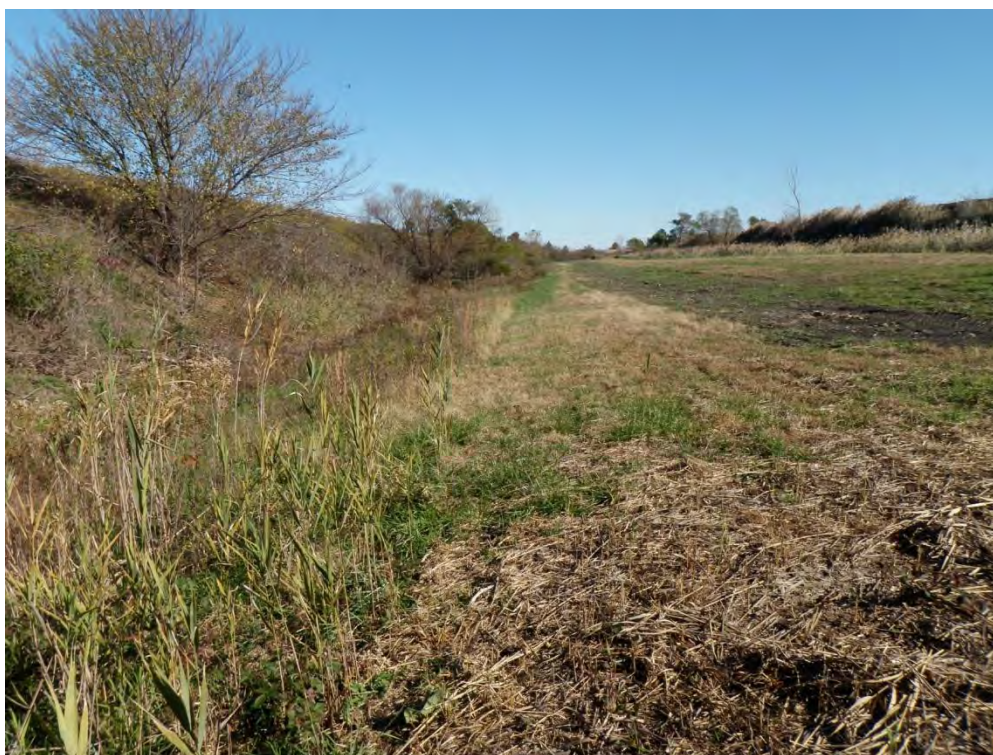
Photo 9: Lower Pond downstream slope at northwest corner of pond looking east.

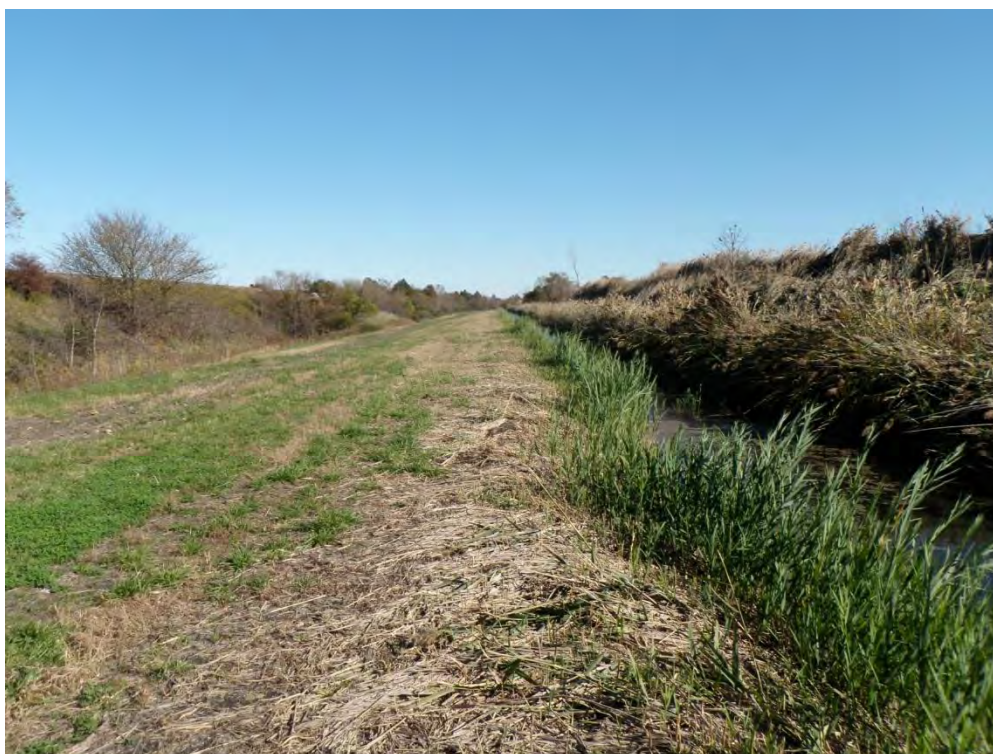
Ash stored in the Lower Pond is stored in large piles approximately 25 feet high along the north and east portions of the storage cell. These storage piles create an inner ash basin which was observed to be higher than the perimeter embankments. This ash could potentially become saturated during storm events and induce higher than anticipated loads on the perimeter embankments, most notably the east embankment.

Photo 10: Lower Pond crest and interior perimeter ditch at northwest corner of pond looking east. Note ash pile built up to the right of the ditch.

3. Perform slope stability analyses for the perimeter embankments of the CCW impoundments. Analyses should be made for the maximum section of each embankment with a phreatic surface representative of steady seepage under normal water surface conditions. Stability analyses should be performed for the full range of expected loading conditions, including appropriate application of equipment and surcharge loads related to the storage of CCW in the Lower Pond. The analyses should also evaluate stability of the existing ash stockpiles within the perimeter embankments.

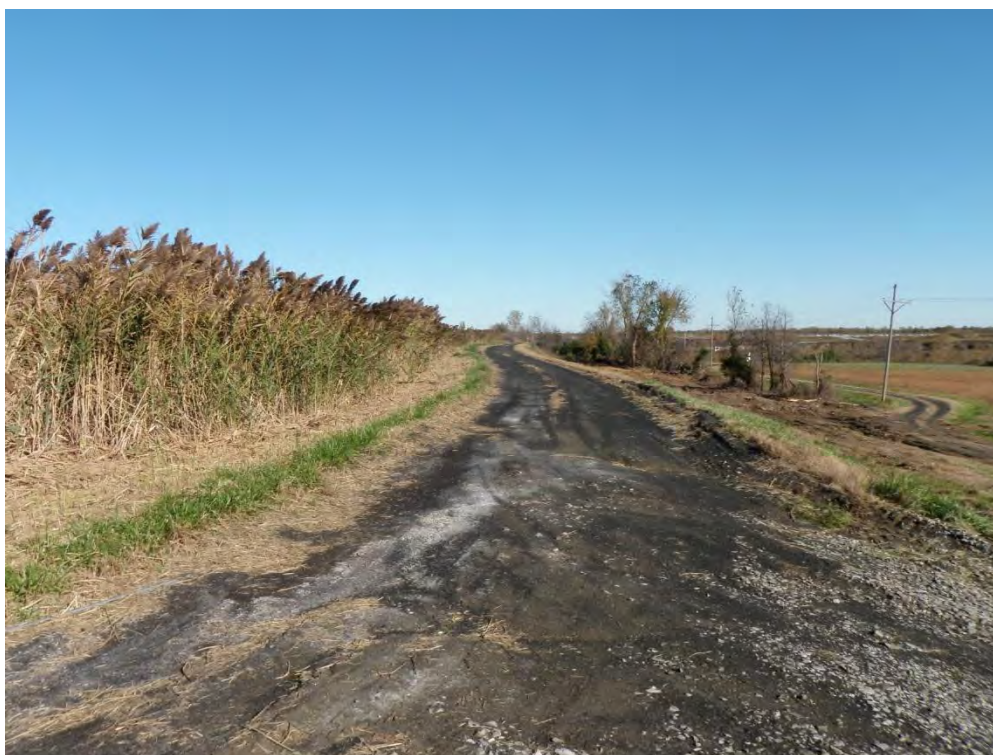
Photo 11: Upper Pond crest and upstream vegetation at southeast corner of pond looking north.

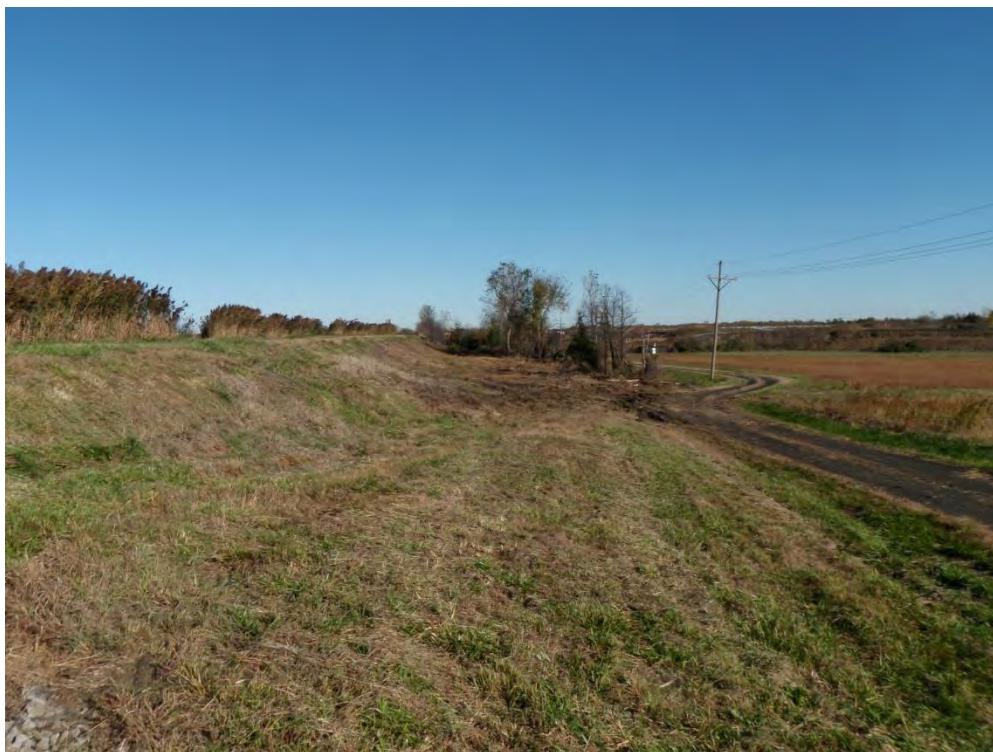
Photo 12: Upper Pond downstream slope and tree growth at southeast corner of pond looking north.

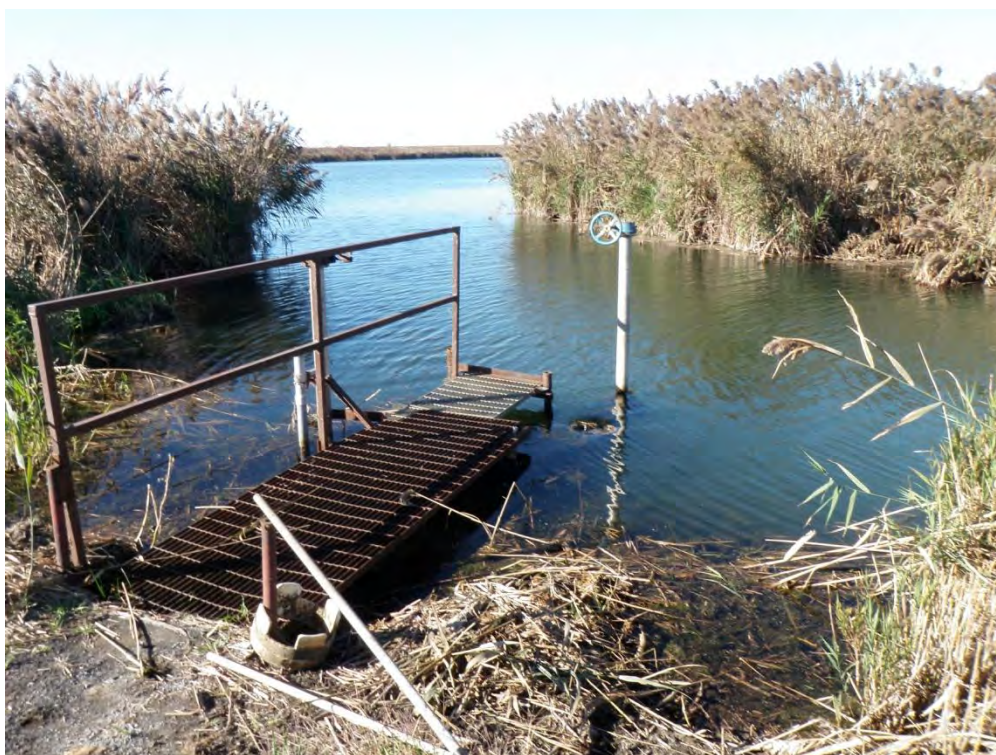
Photo 13: Upper Pond overflow drop inlet and outlet valve.

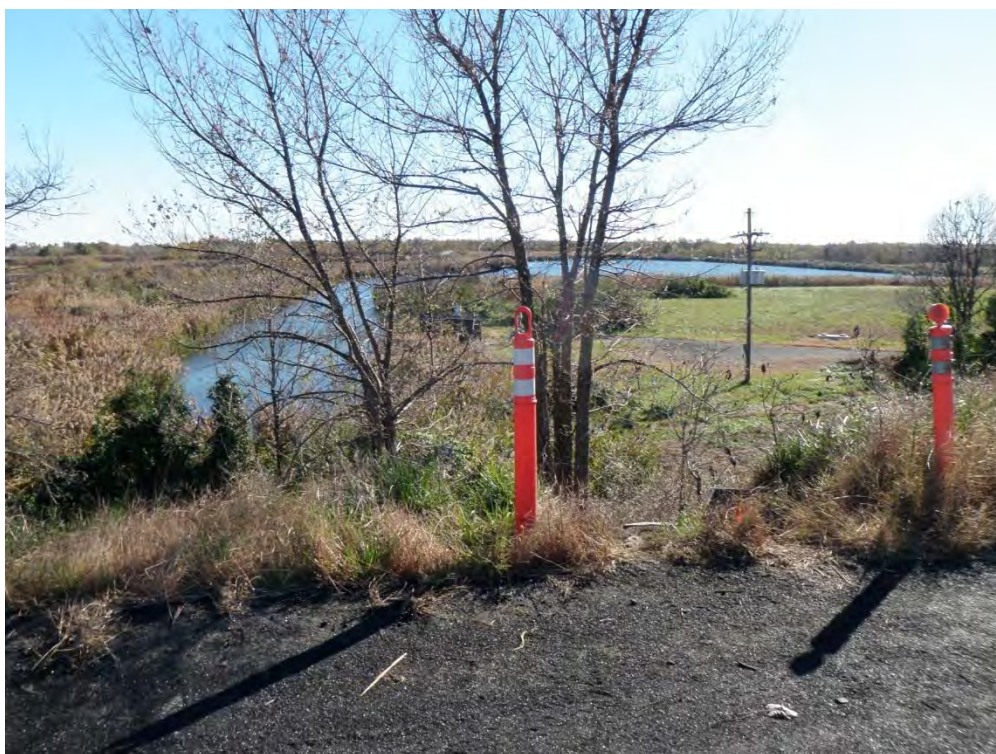
Photo 14: Upper Pond crest looking east at the Lower Pond, Upper Pond outlet discharge point (in Photo 13), and pump house (middle of photo behind trees).

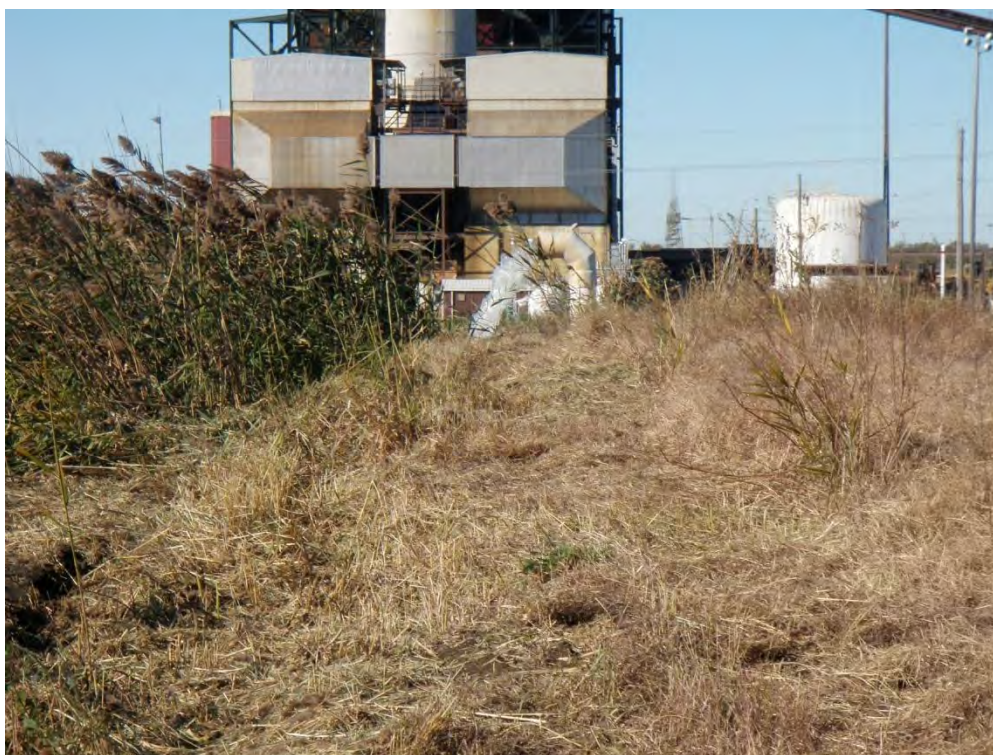
Photo 15: Upper Pond discharge flow from Lower Pond pumphouse.

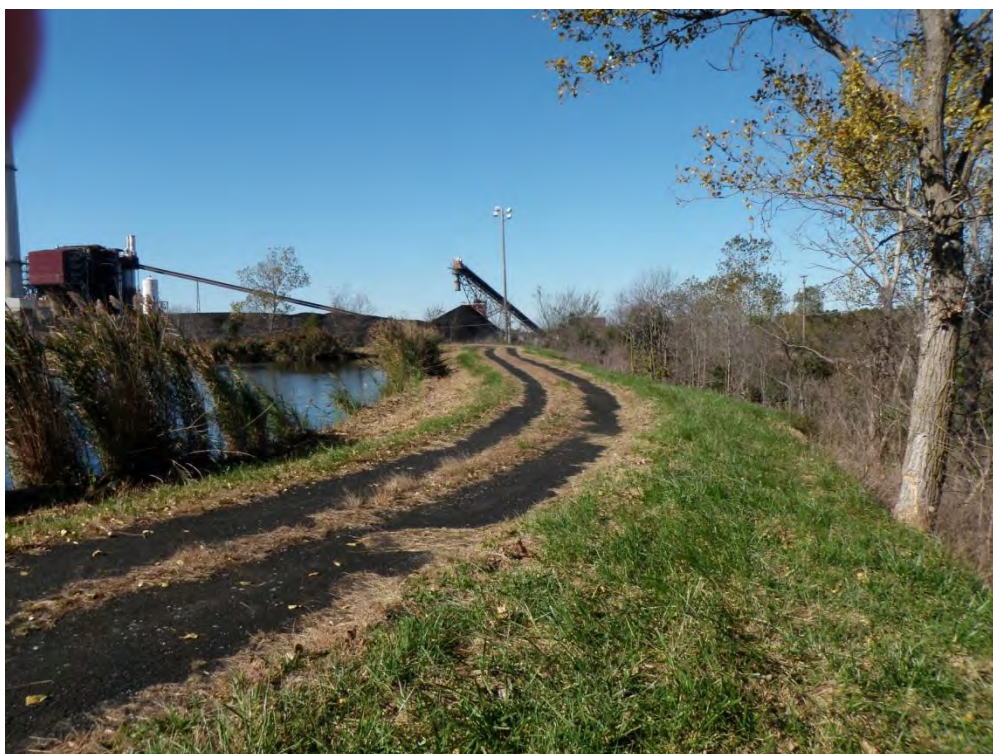
Photo 16: Upper Pond crest and upstream slope at northeast corner of pond looking west.

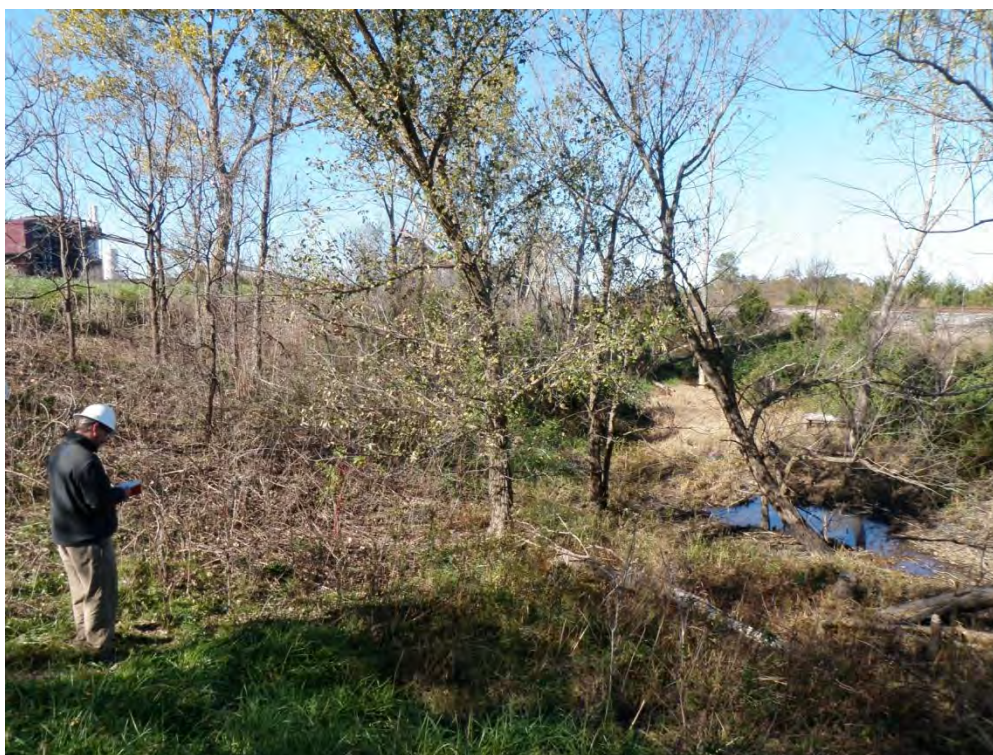
Photo 17: Upper Pond downstream slope at northeast corner looking west.

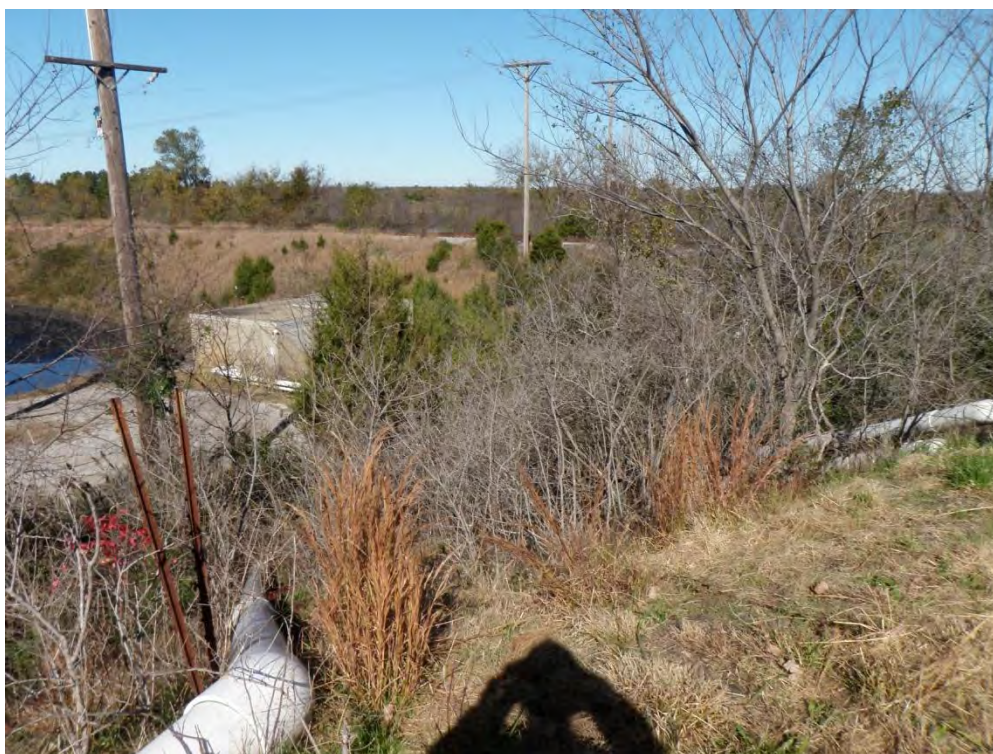
Photo 18: Upper Pond coal pile sump at northwest corner. Note sump discharge pipes aligned into Upper Pond.

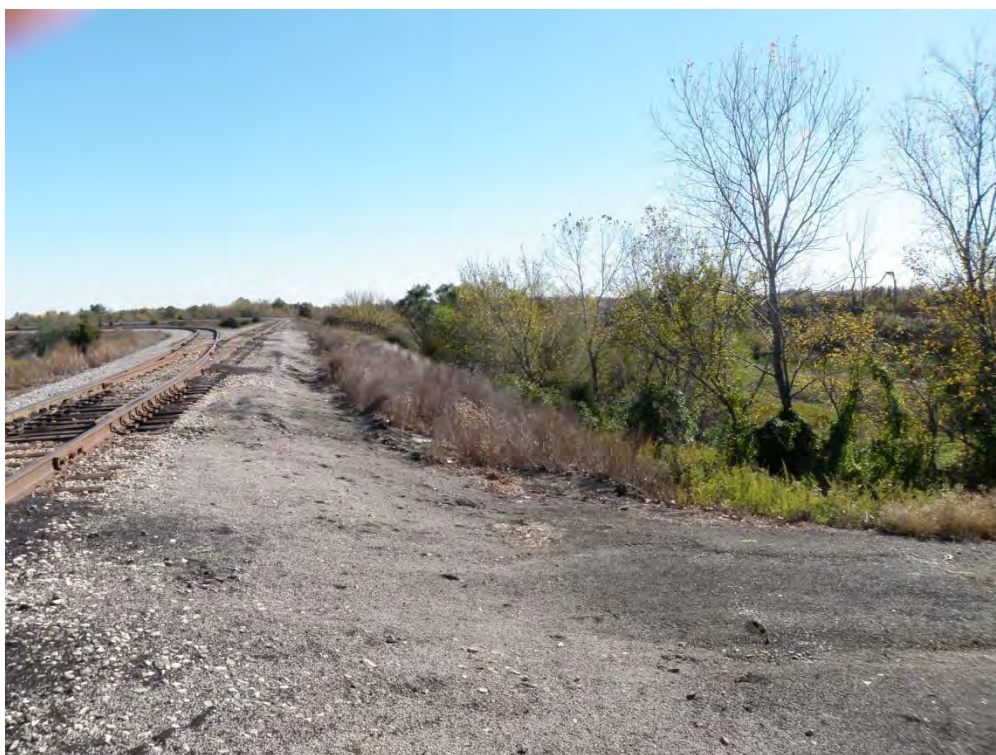
Photo 19: Railroad grade along north side of Upper and Lower Ponds.

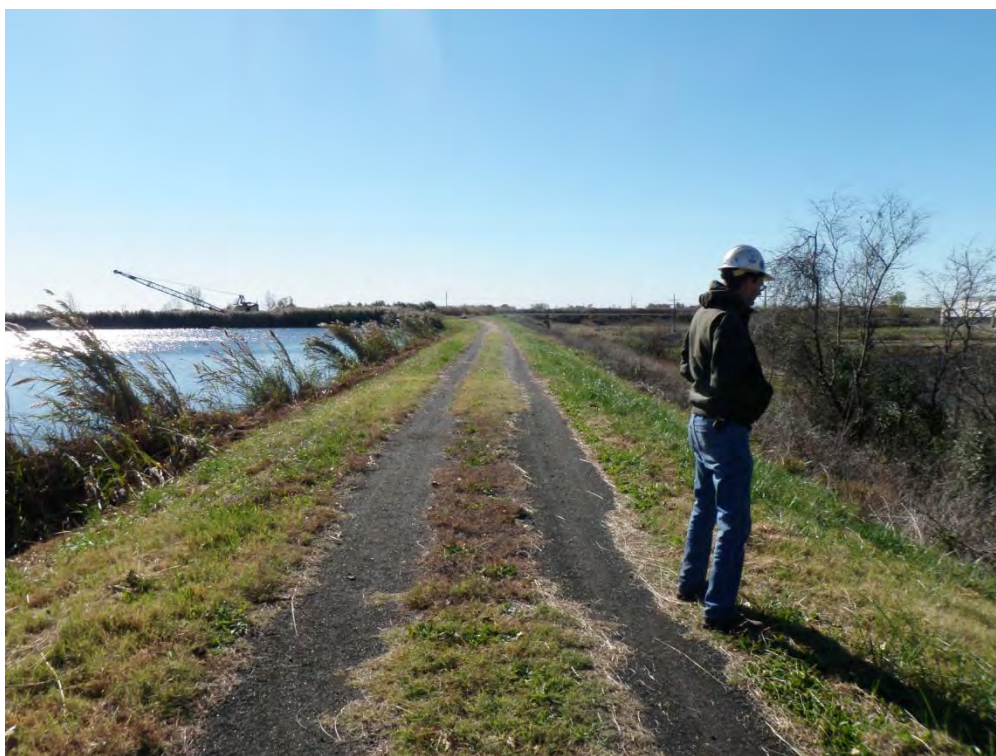
Photo 20: Upper Pond upstream and crest at northwest corner looking south. Note tree growth on downstream slope.

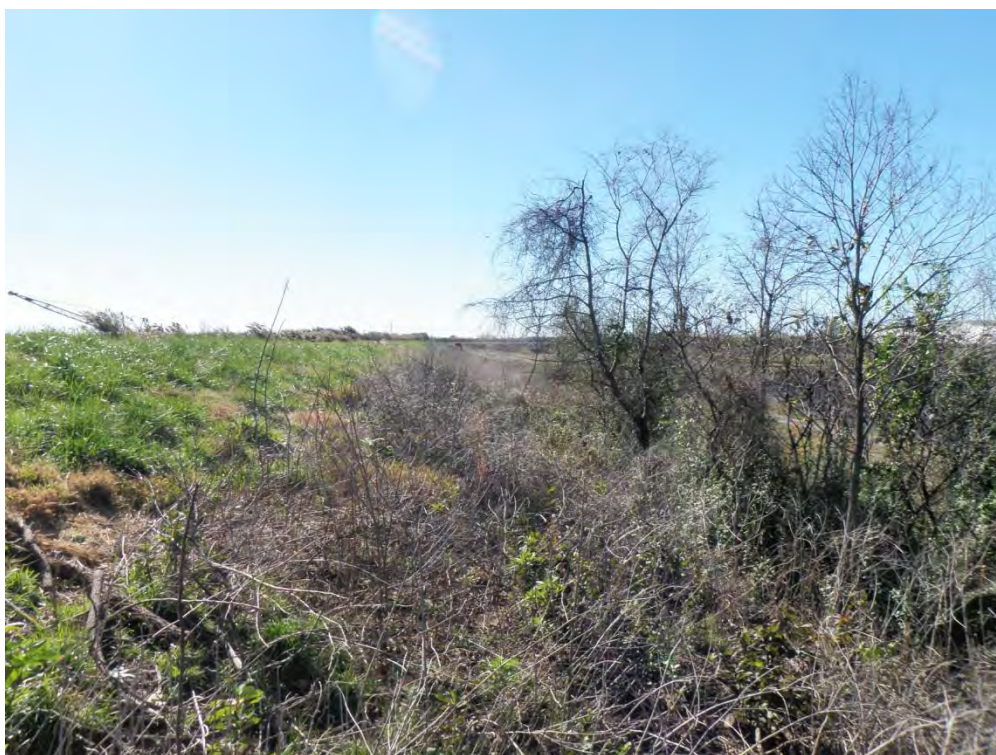
Photo 21: Upper Pond downstream slope at northwest corner looking south.

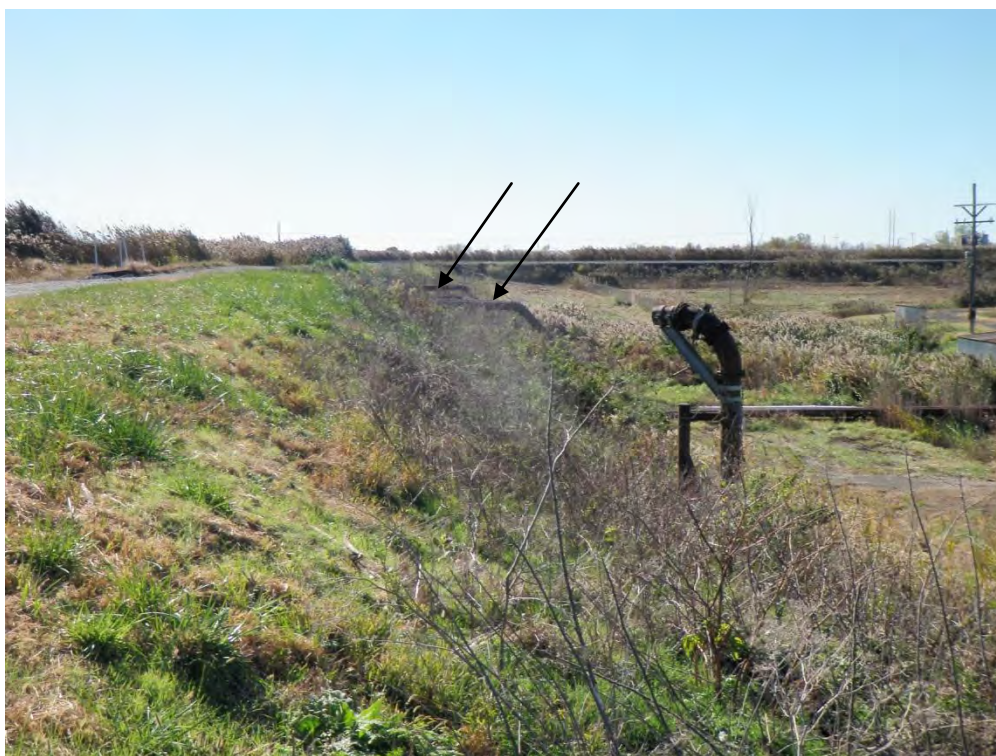
Photo 22: Upper Pond downstream slope where CCW discharge pipes (note arrows) cross through and continue to the Lower Pond.

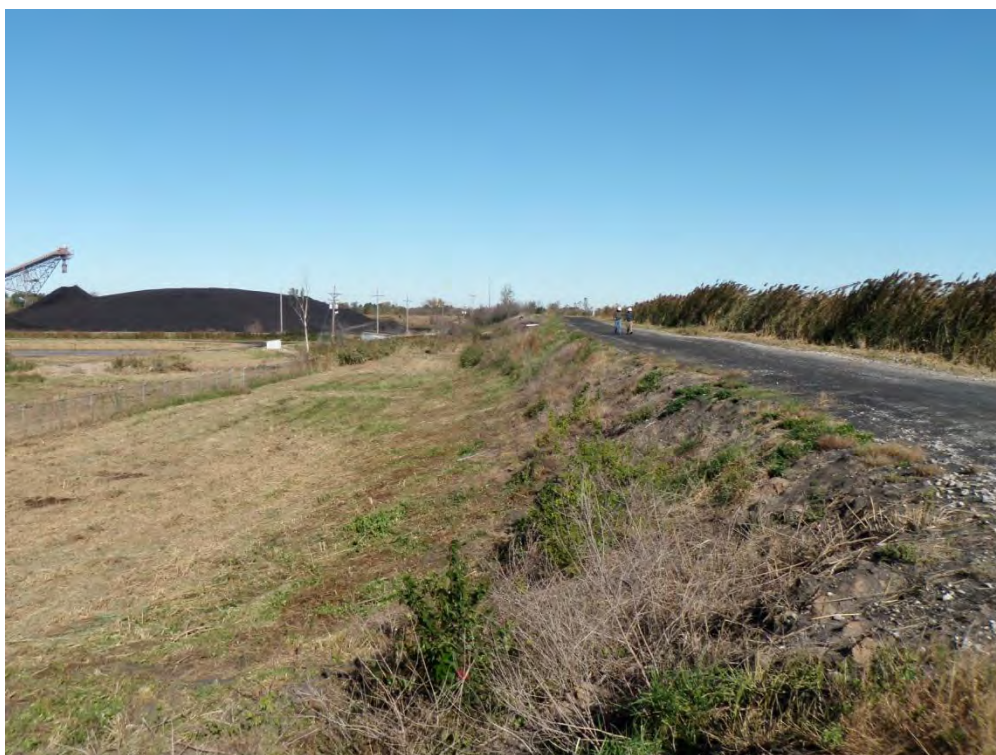
Photo 23: Upper Pond crest and downstream slope at inside corner looking north.

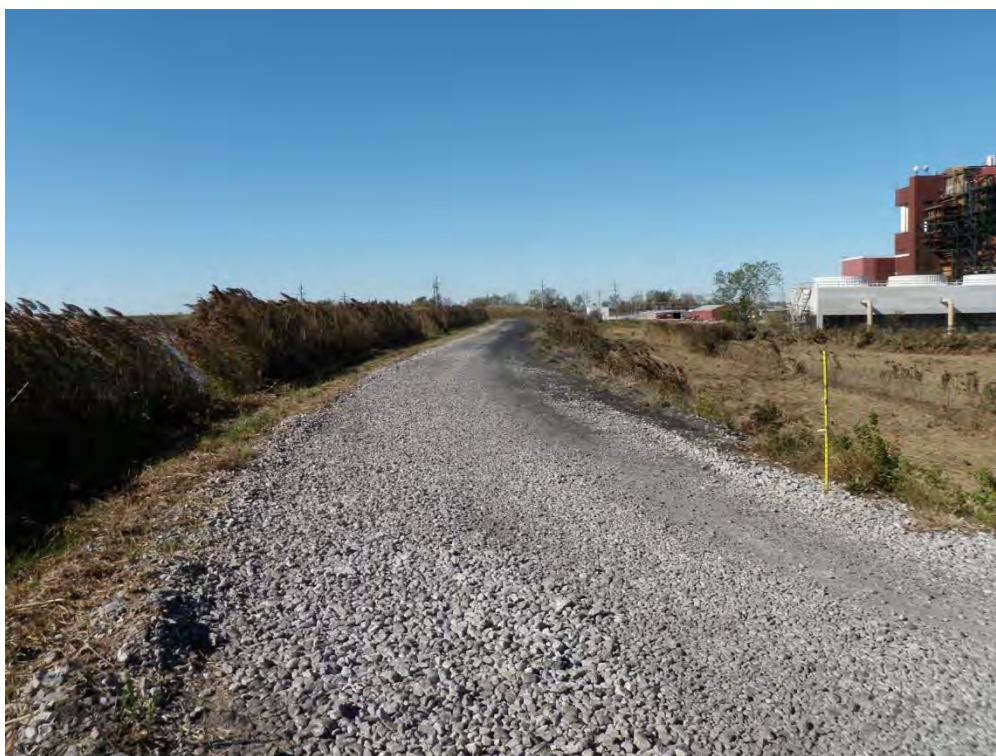
Photo 24: Upper Pond crest and downstream slope at inside corner looking west. Note heavy vegetation on upstream slope.

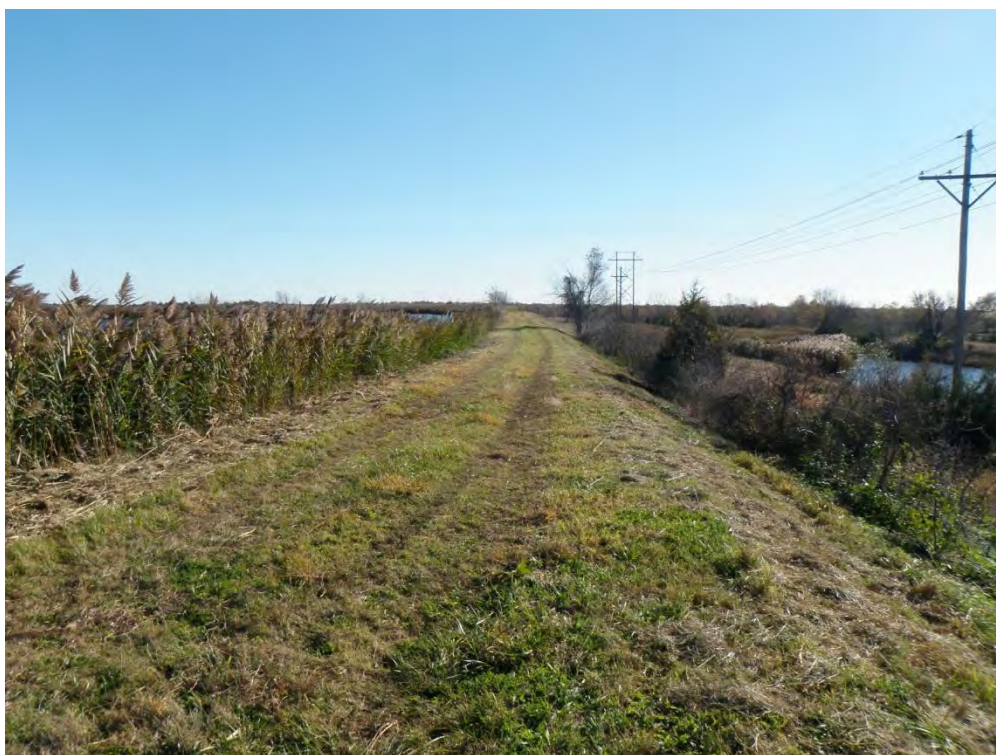
Photo 25: South Pond upstream slope and crest at southwest corner of pond looking east.

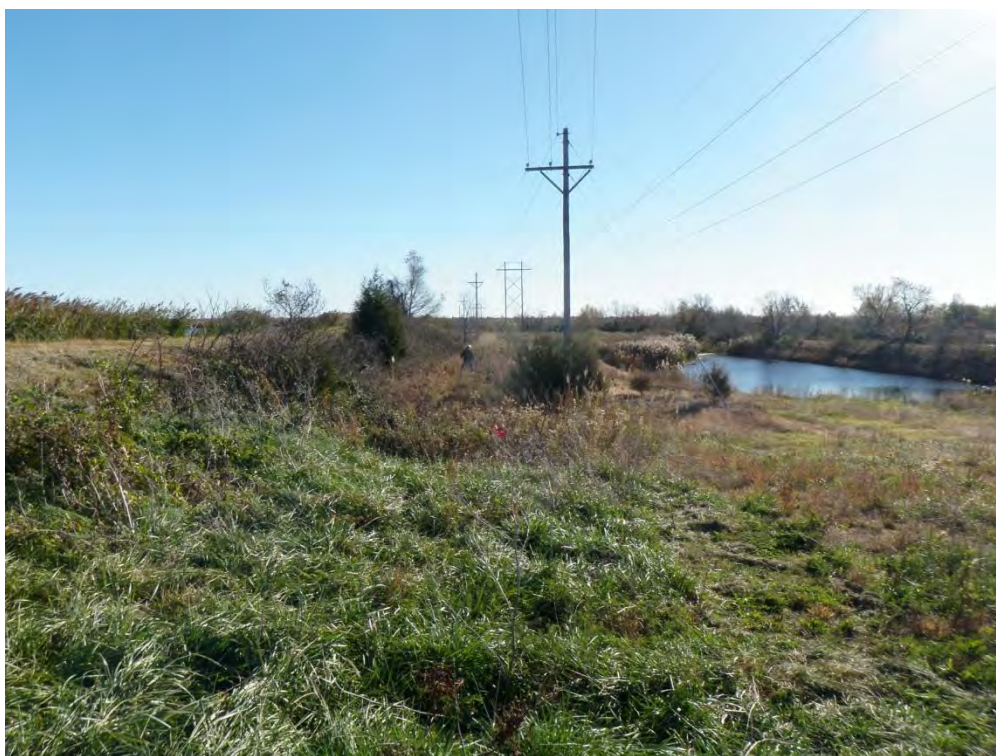
Standing water was also observed in an excavated borrow area approximately 50 feet downstream of the south embankment section. The origin of the water is unknown, but appeared to be surface runoff from adjacent areas.

Photo 26: South Pond downstream slope at southwest corner looking east. Note heavy vegetation on downstream slope and standing water in excavated borrow area.

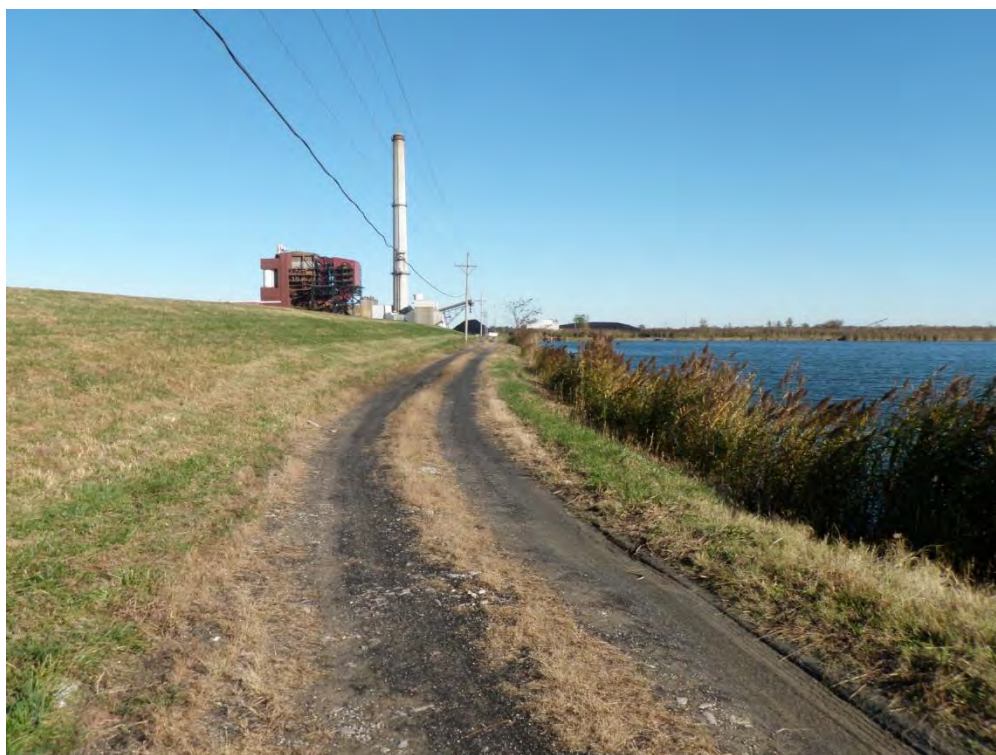
Photo 27: South Pond west section crest adjacent to Cooling Water Reservoir (on left).

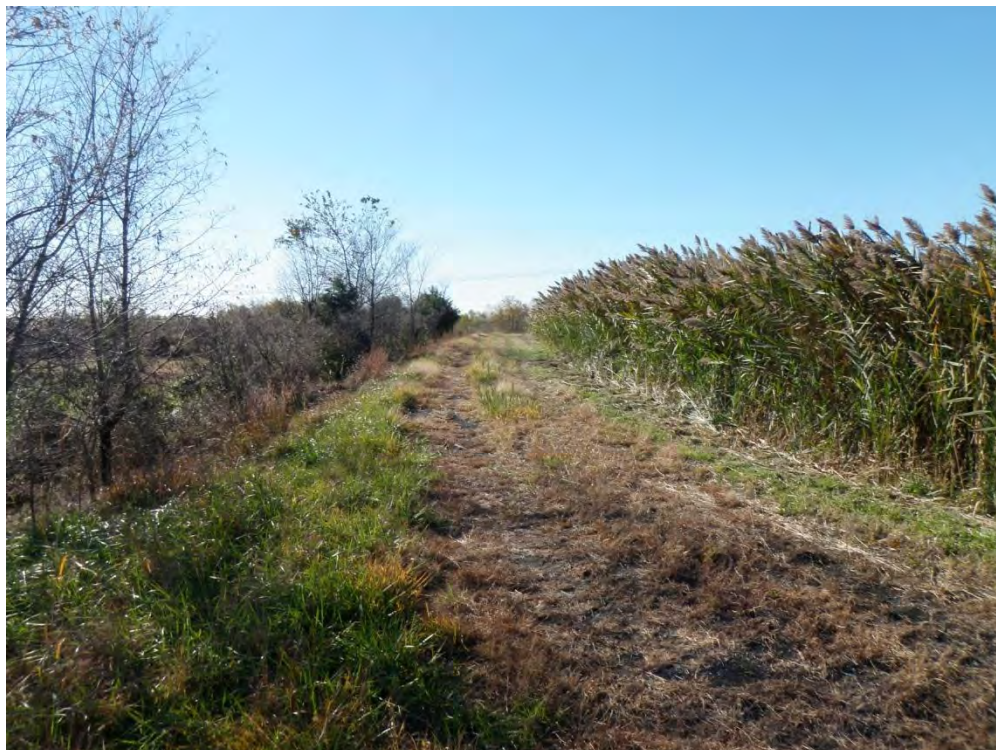
Photo 28: South Pond crest and downstream slope at northeast corner of pond looking south. Note heavy vegetation on upstream and downstream slopes.
