# **Specific Site Assessment for Coal Combustion Waste Impoundments at Empire District Electric Company Asbury Power Station Asbury, Missouri**

March 2011  
Project 092884

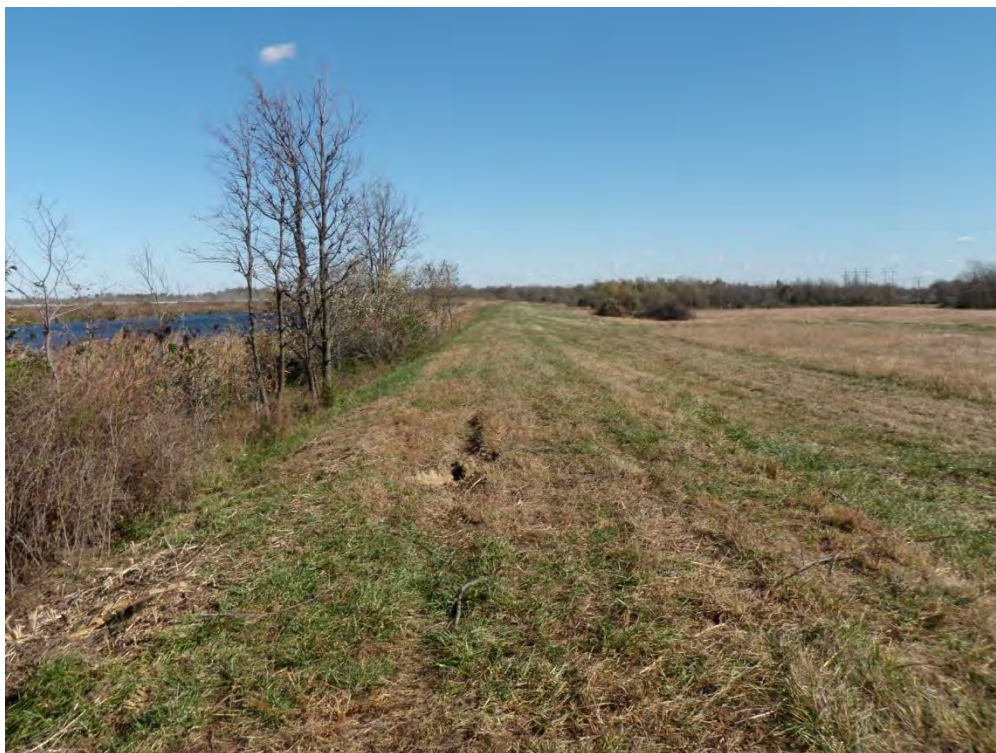
**Photo 1: Lower Pond crest and upstream slope at southwest corner of pond looking east.**

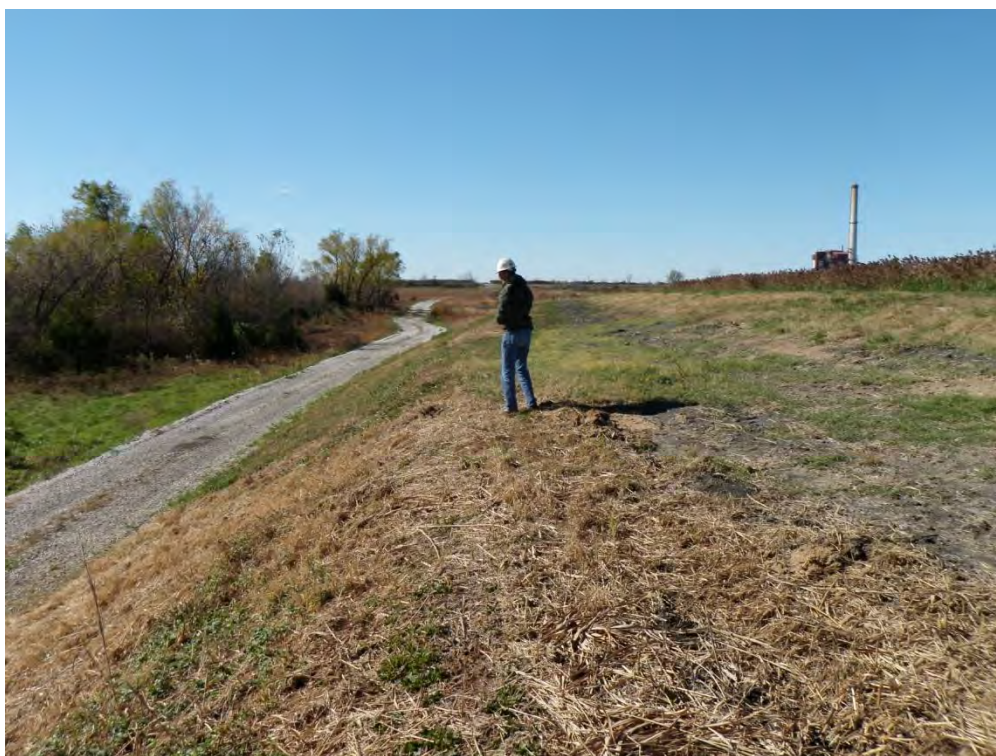
**Photo 2: Lower Pond downstream slope at southeast corner of pond looking west.**

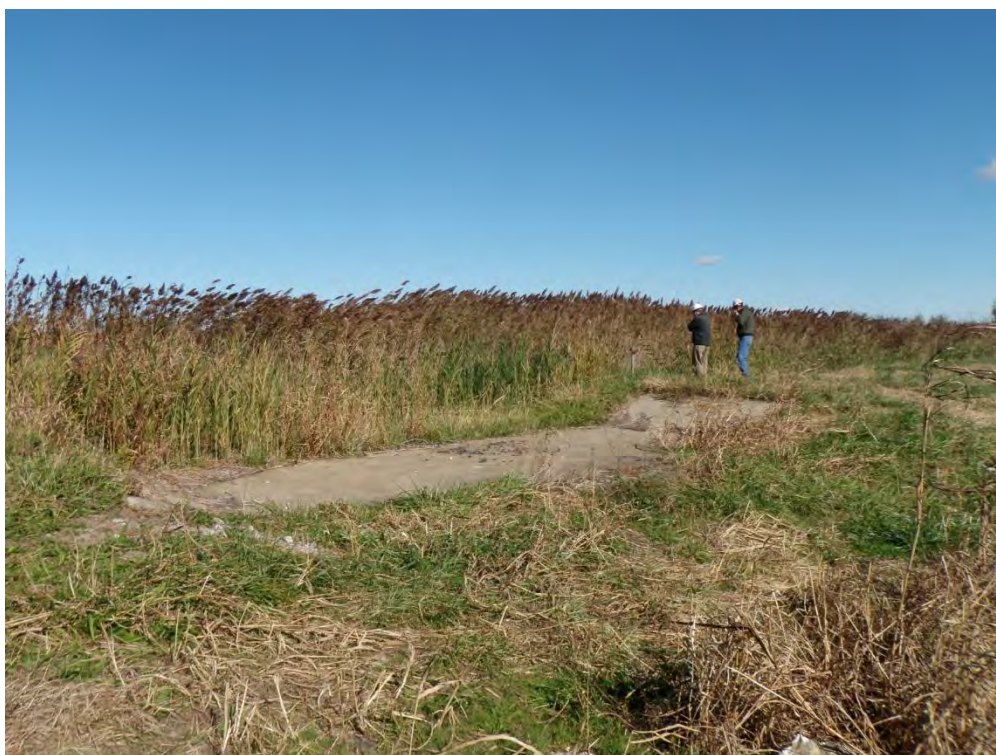
The emergency spillway near the southeast corner of the Lower Pond was covered with vegetation, but the structure appeared to be in generally good condition.

**Photo 3: Lower Pond overflow spillway near southeast corner of pond.**

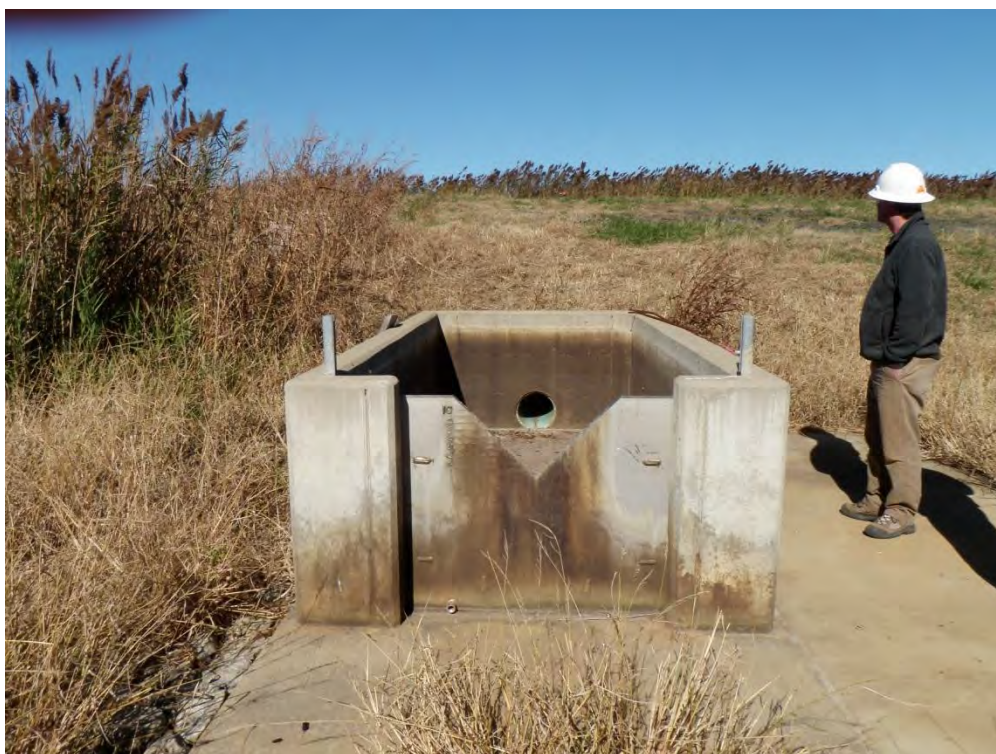
**Photo 4: Lower Pond V-notch weir next to overflow spillway.**

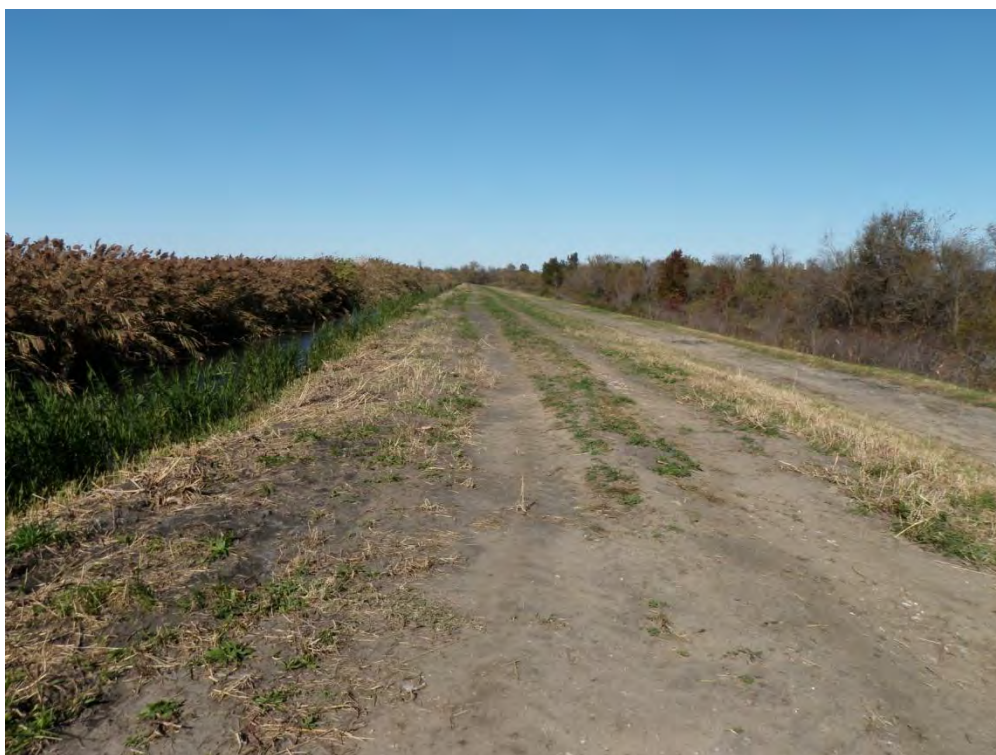
**Photo 5: Lower Pond upstream slope and crest at southeast corner looking north.**

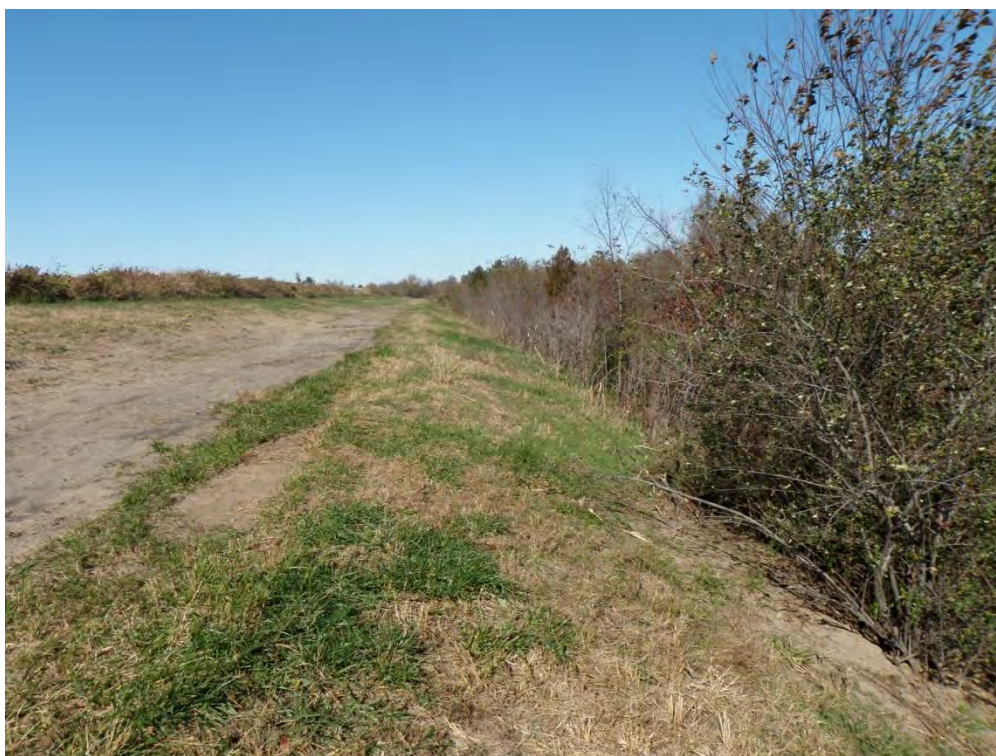
**Photo 6: Lower Pond downstream slope at southeast corner of pond looking north.  
Note heavy tree growth at the downstream toe.**

1. Continue and improve vegetation control efforts to maintain the downstream embankment slopes free of heavy vegetation and tree growth. Existing trees should be removed to prevent the root systems from creating seepage paths through the embankment slopes. A minimum of about 25 feet of clear space should be provided between the downstream toe and the tree line. Removal of root balls of large trees can cause additional damage to an embankment and removal is not recommended without appropriate engineering planning and consideration.

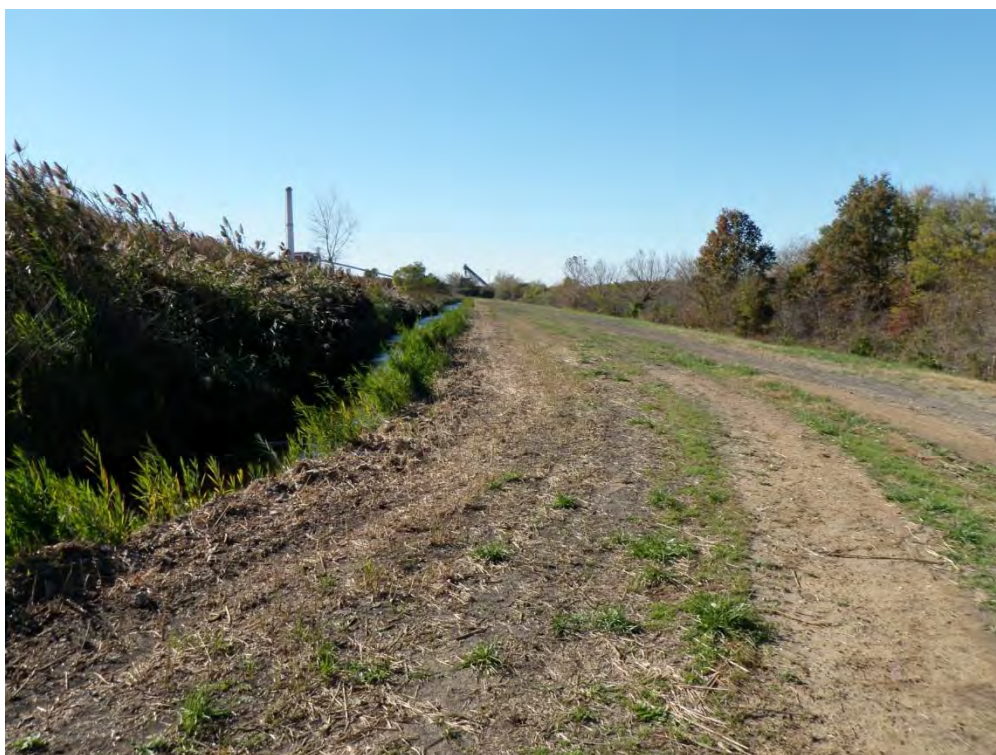
**Photo 7: Lower Pond crest and interior perimeter ditch at northeast corner looking west.**

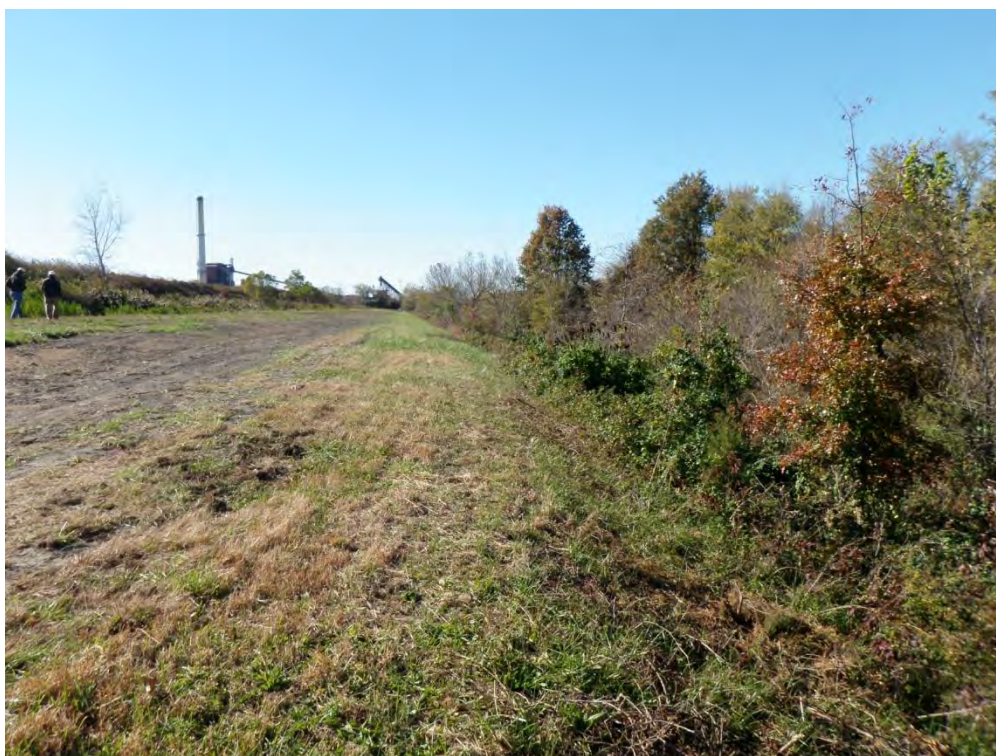
**Photo 8: Lower Pond downstream slope and exterior perimeter ditch (at right) at northeast corner looking west.**

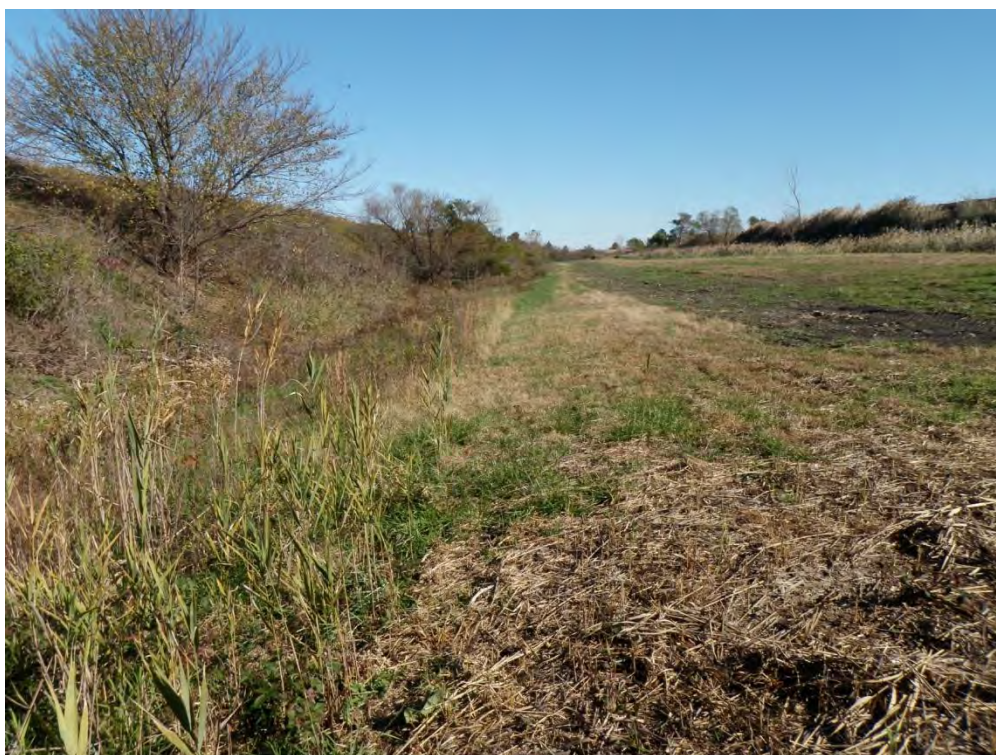
**Photo 9: Lower Pond downstream slope at northwest corner of pond looking east.**

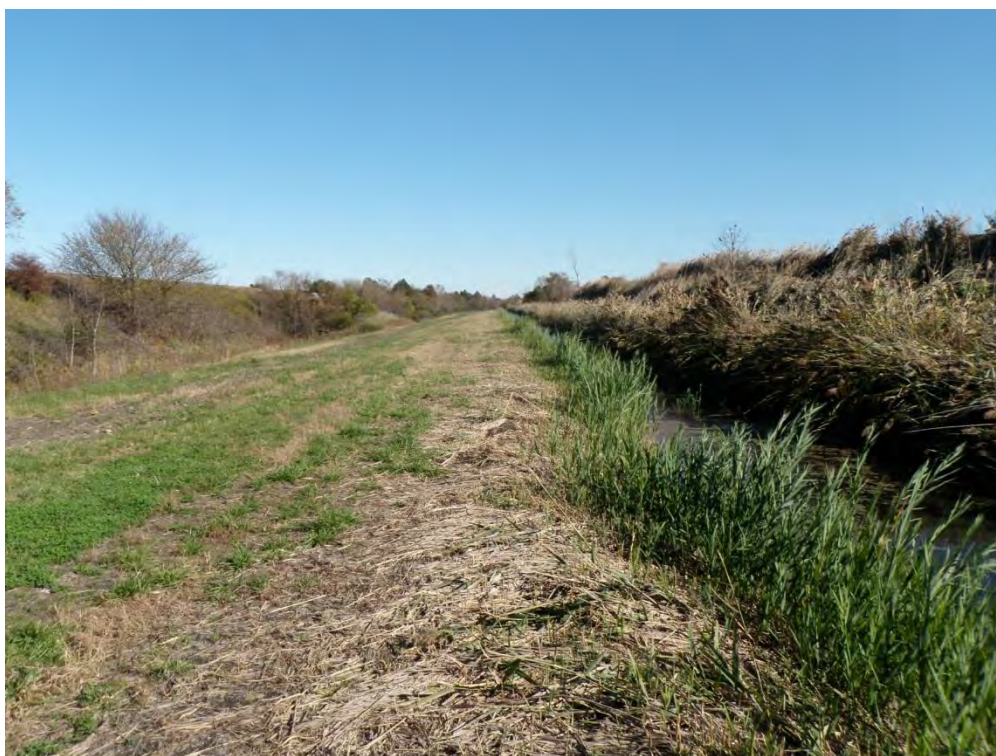
Ash stored in the Lower Pond is stored in large piles approximately 25 feet high along the north and east portions of the storage cell. These storage piles create an inner ash basin which was observed to be higher than the perimeter embankments. This ash could potentially become saturated during storm events and induce higher than anticipated loads on the perimeter embankments, most notably the east embankment.

**Photo 10: Lower Pond crest and interior perimeter ditch at northwest corner of pond looking east. Note ash pile built up to the right of the ditch.**

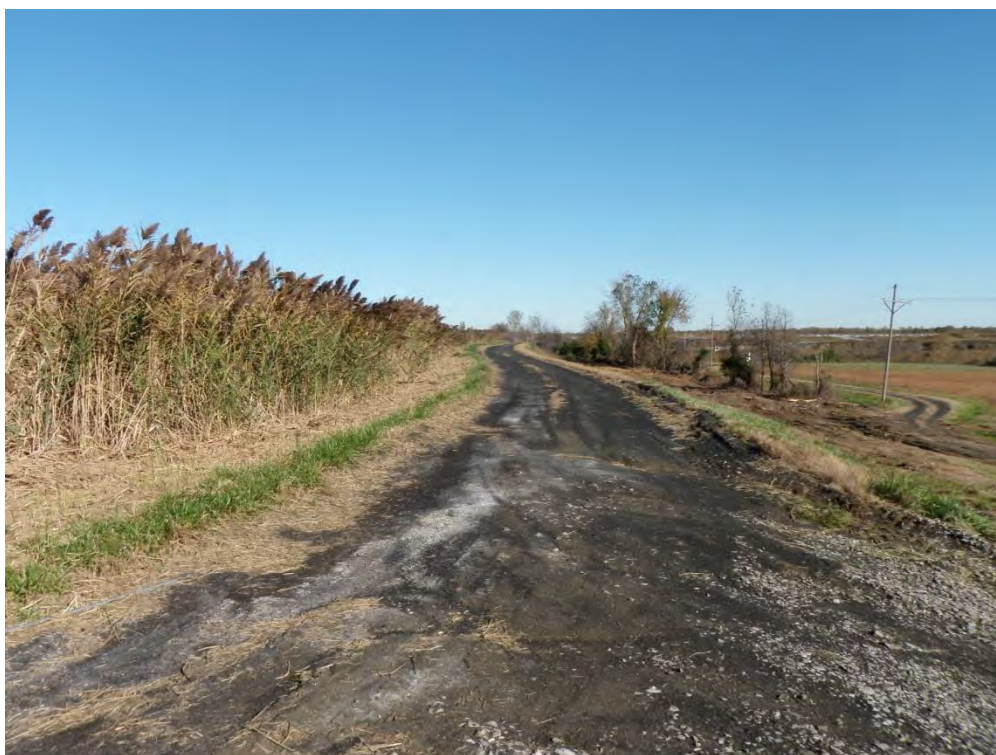
**Photo 11: Upper Pond crest and upstream vegetation at southeast corner of pond looking north.**

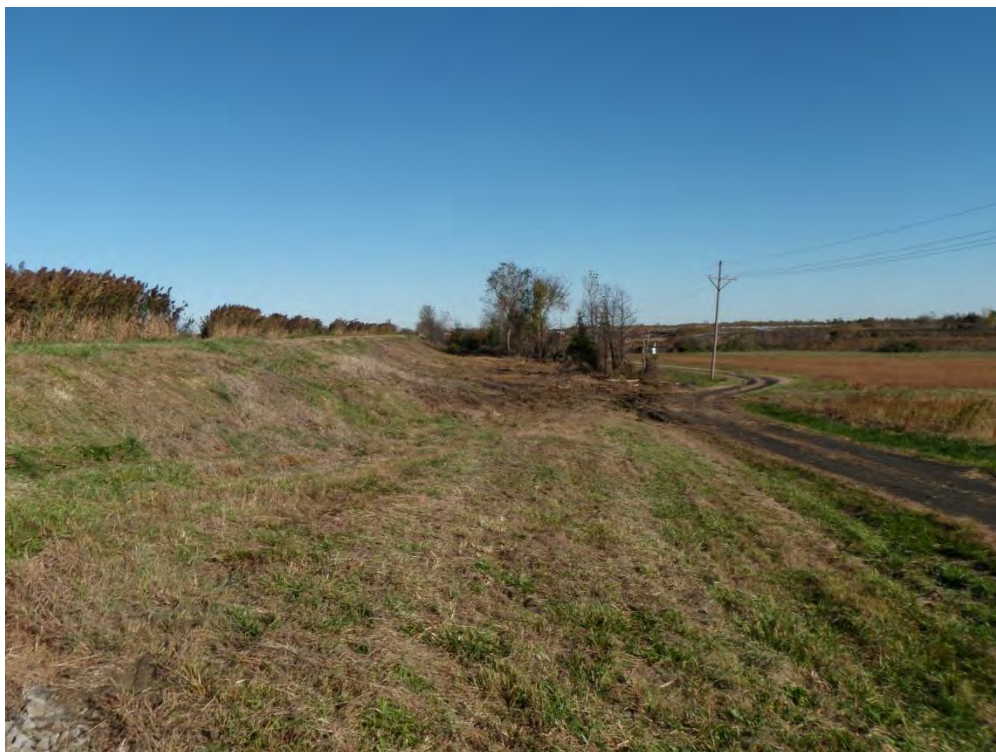
**Photo 12: Upper Pond downstream slope and tree growth at southeast corner of pond looking north.**

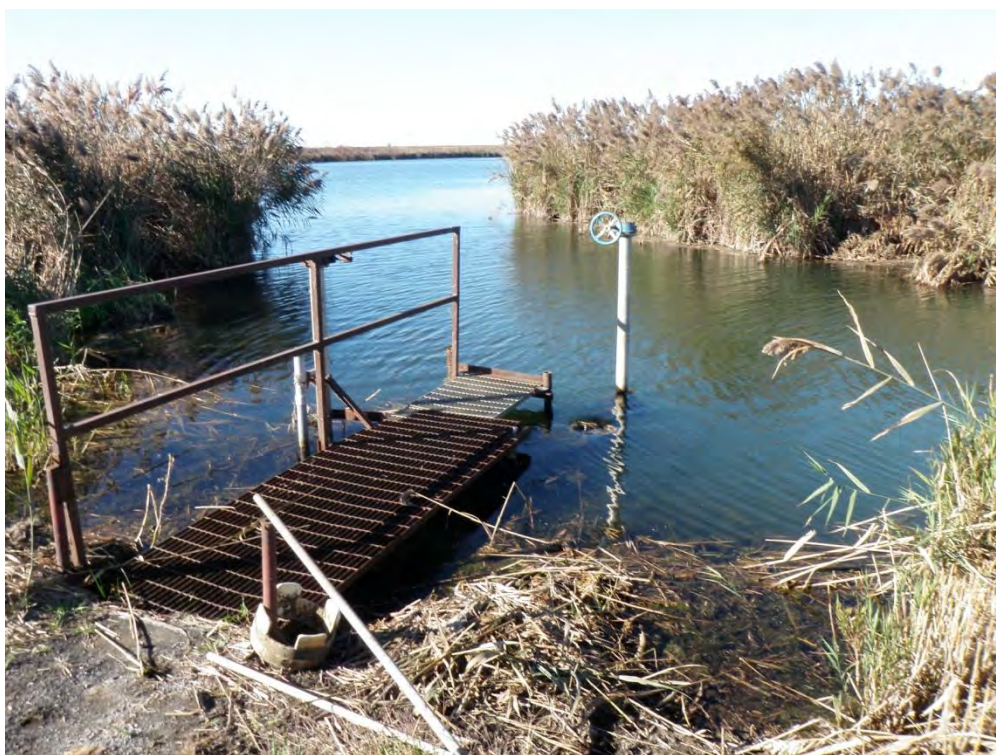
Photo 13: Upper Pond overflow drop inlet and outlet valve.

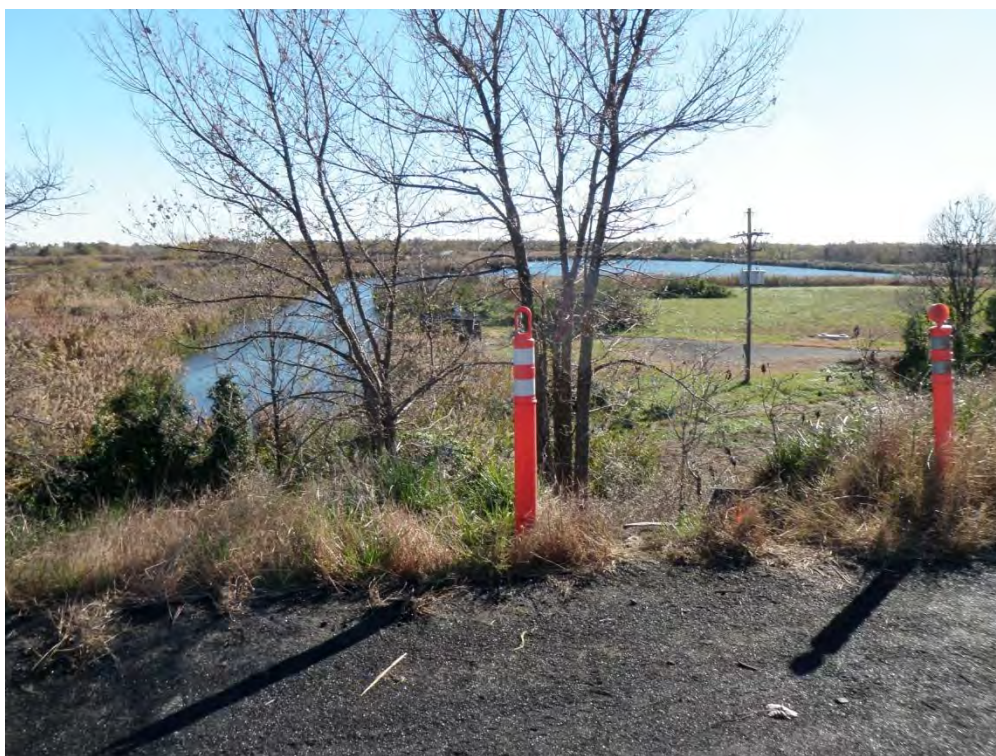
Photo 14: Upper Pond crest looking east at the Lower Pond, Upper Pond outlet discharge point (in Photo 13), and pump house (middle of photo behind trees).

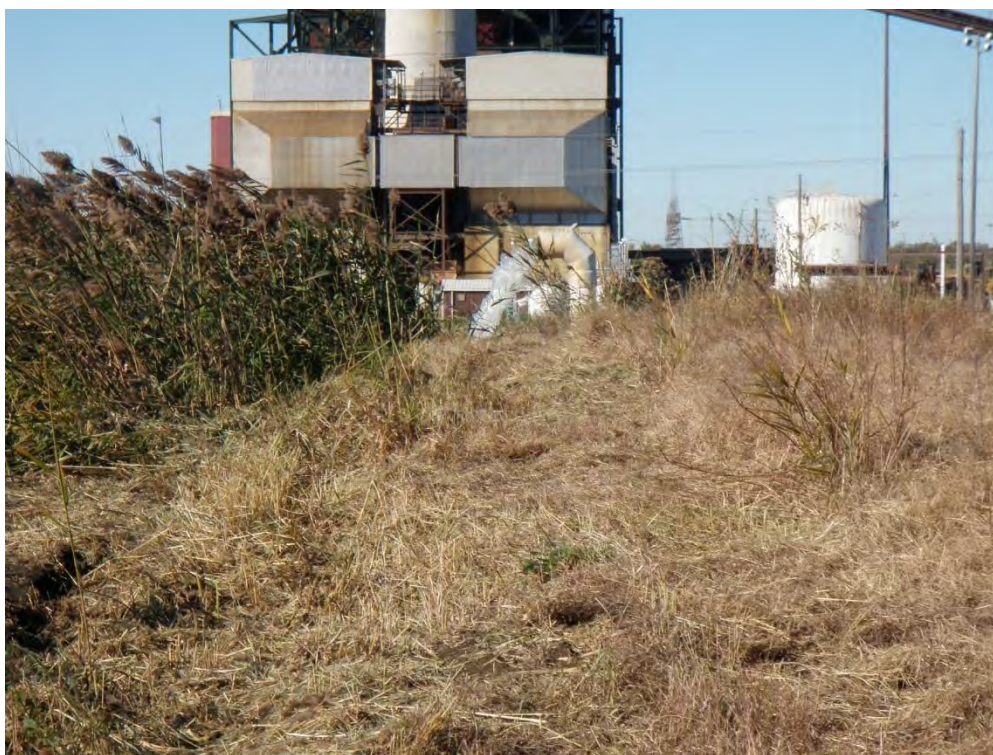
**Photo 15: Upper Pond discharge flow from Lower Pond pumphouse.**

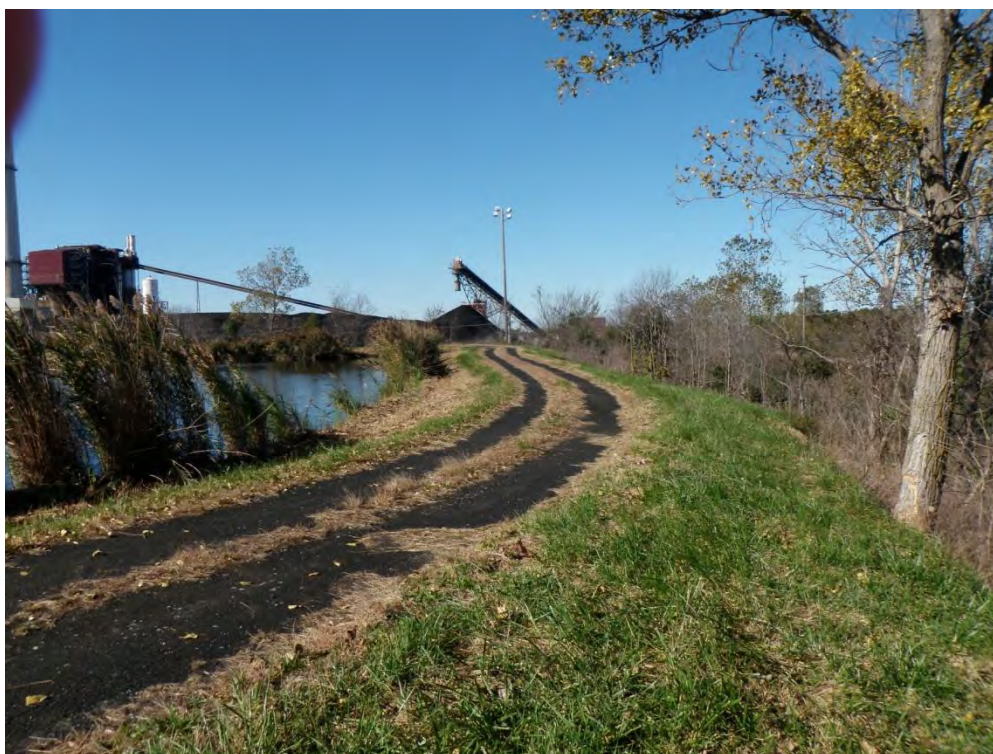
**Photo 16: Upper Pond crest and upstream slope at northeast corner of pond looking west.**

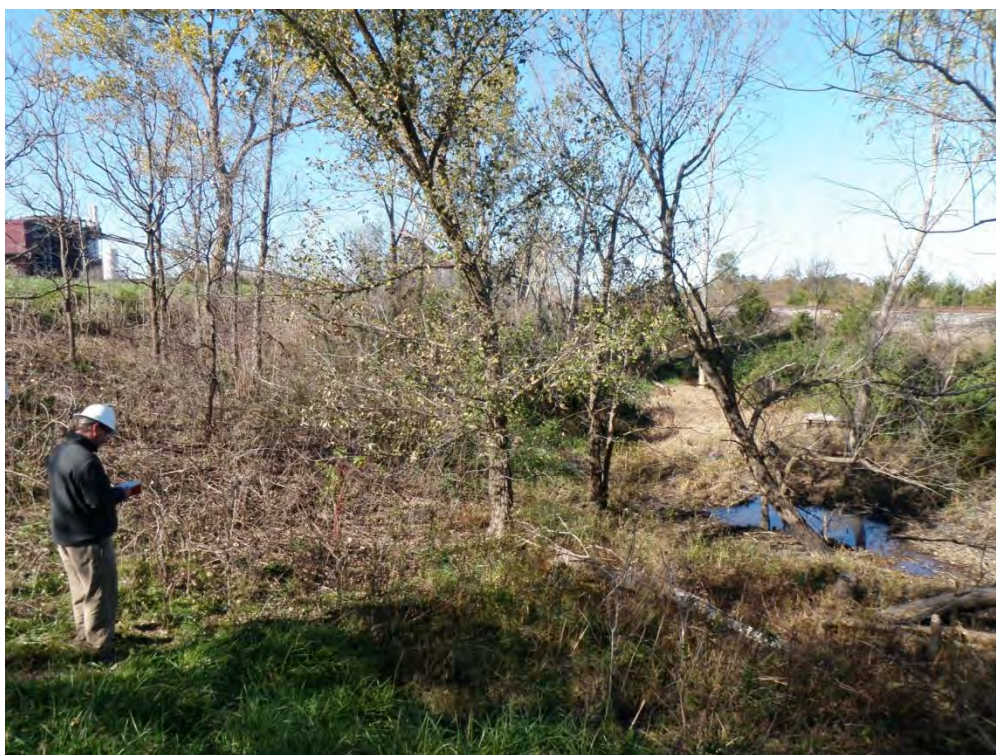
**Photo 17: Upper Pond downstream slope at northeast corner looking west.**

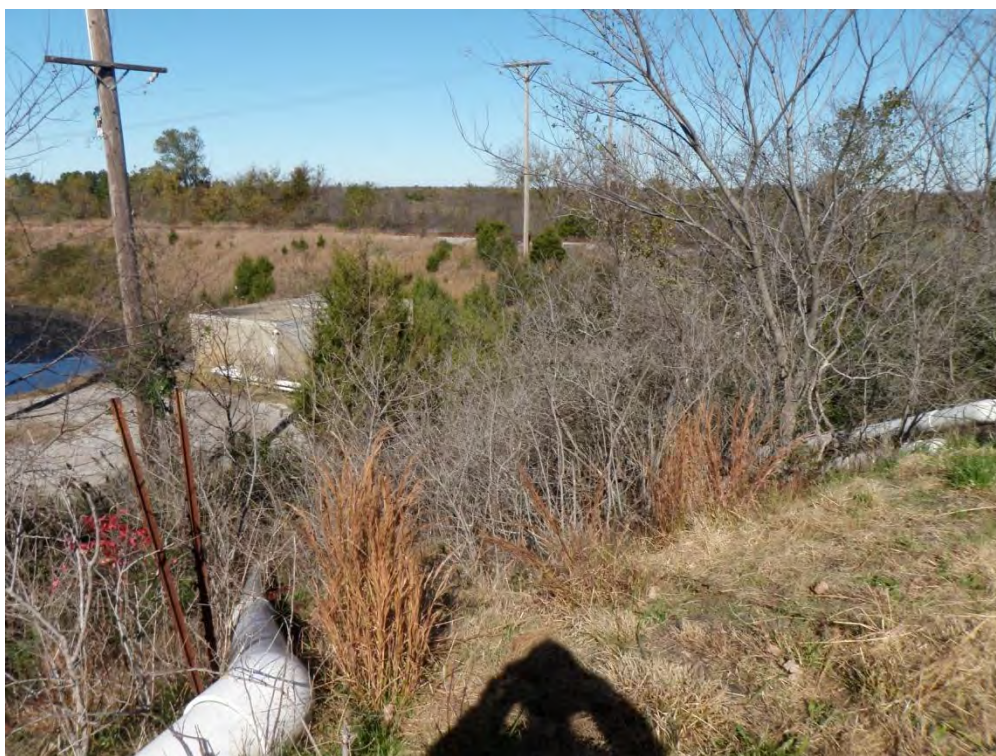
**Photo 18: Upper Pond coal pile sump at northwest corner. Note sump discharge pipes aligned into Upper Pond.**

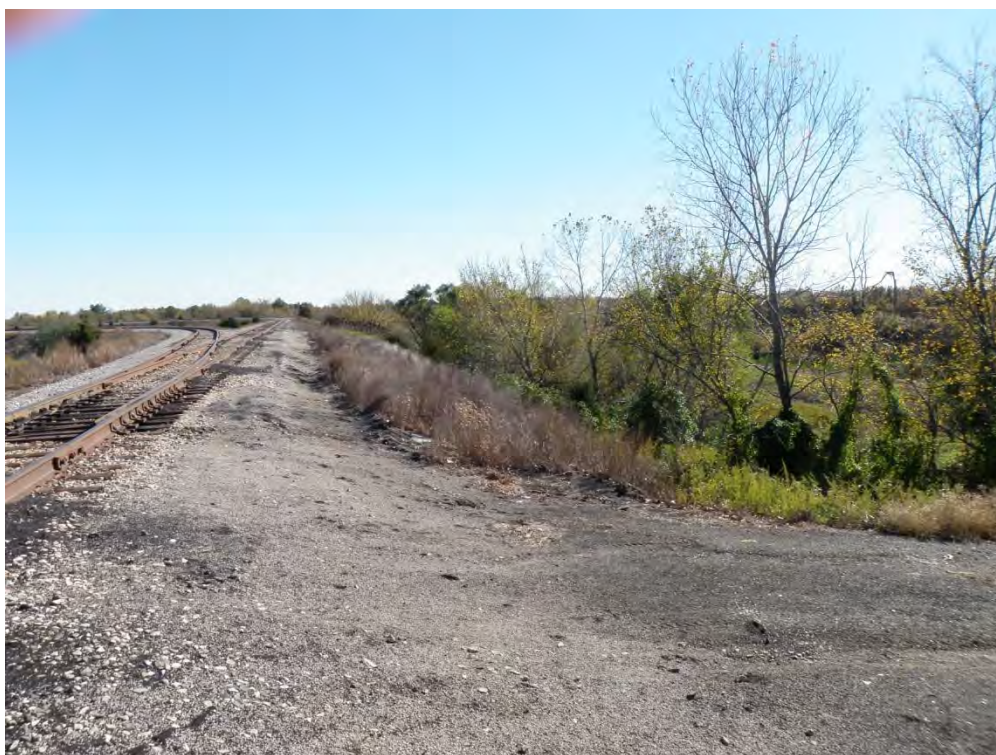
**Photo 19: Railroad grade along north side of Upper and Lower Ponds.**

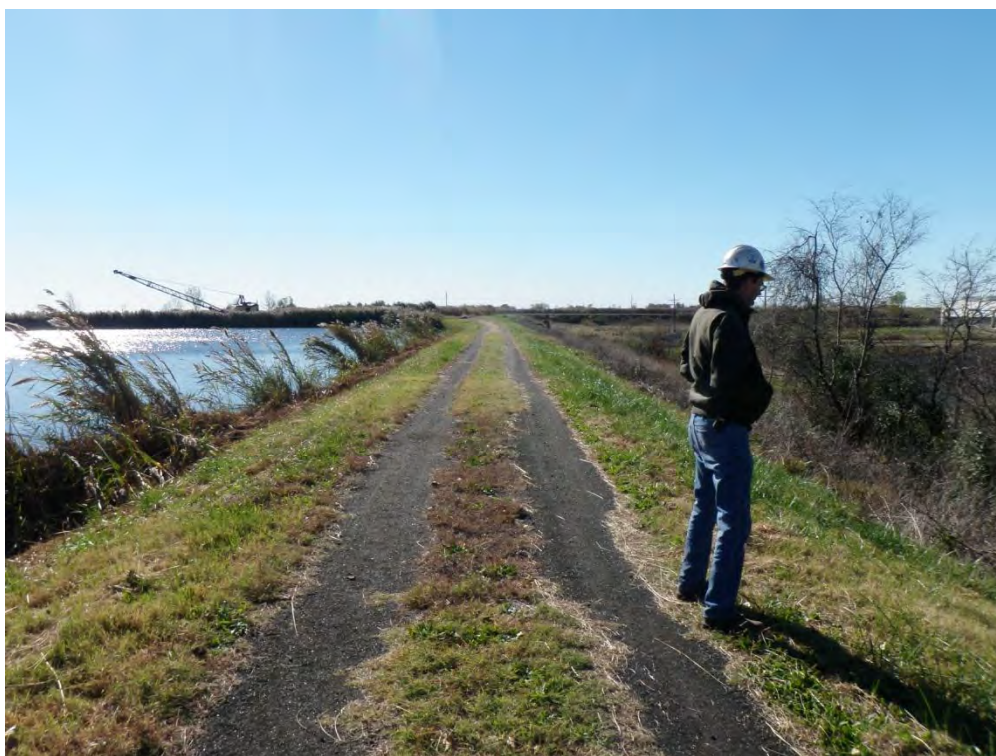
**Photo 20: Upper Pond upstream and crest at northwest corner looking south. Note tree growth on downstream slope.**

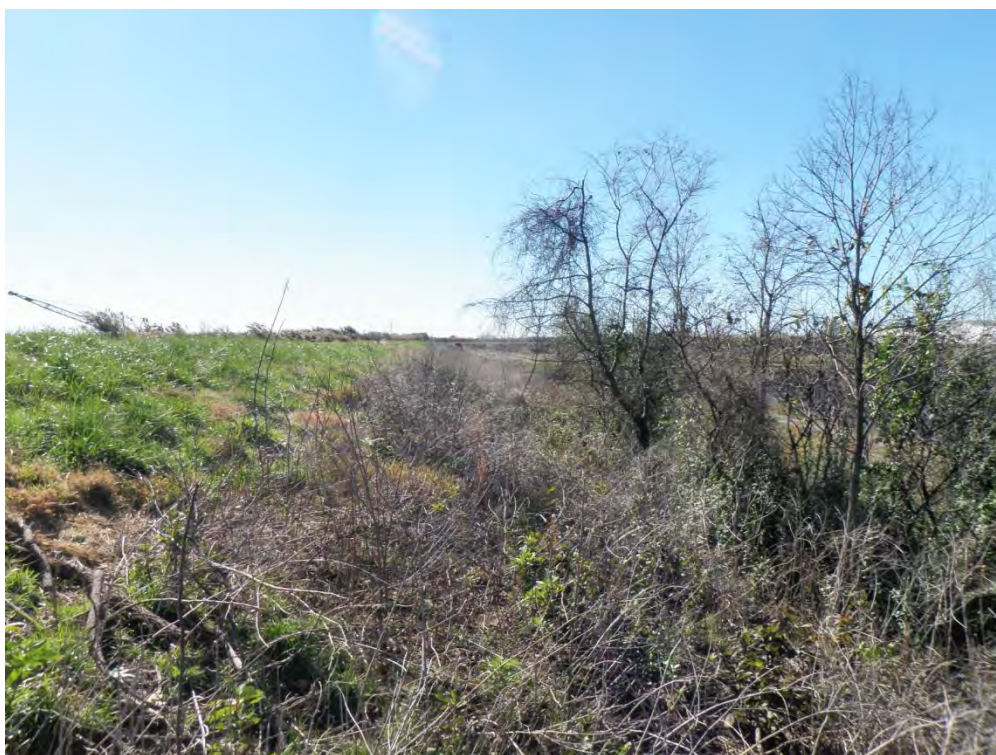
**Photo 21: Upper Pond downstream slope at northwest corner looking south.**

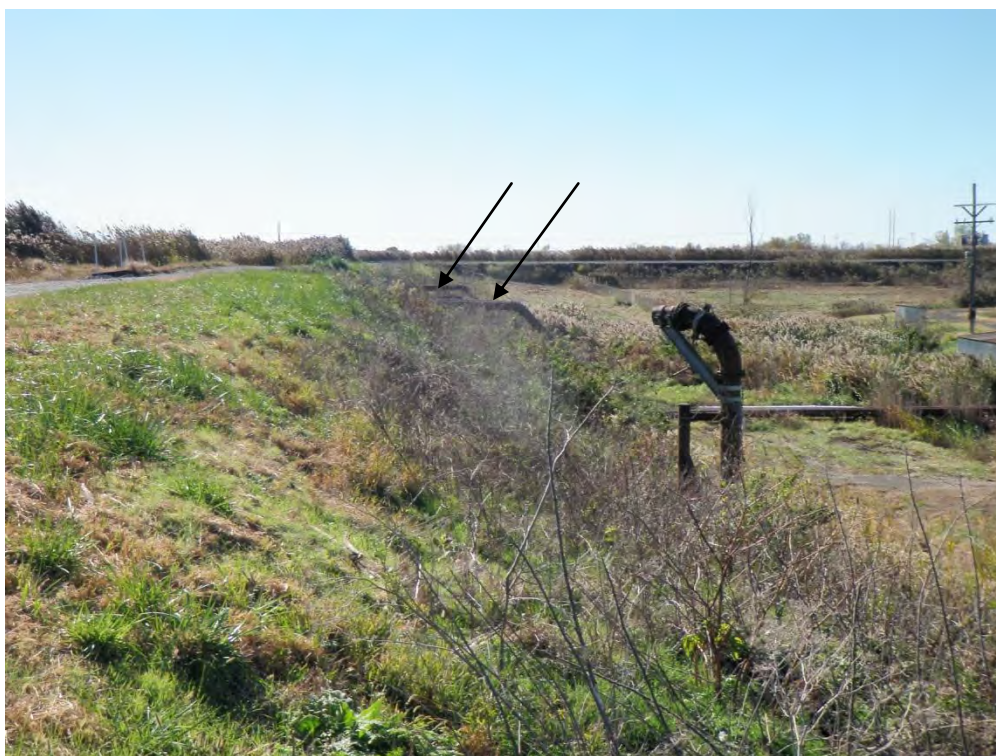
**Photo 22: Upper Pond downstream slope where CCW discharge pipes (note arrows) cross through and continue to the Lower Pond.**

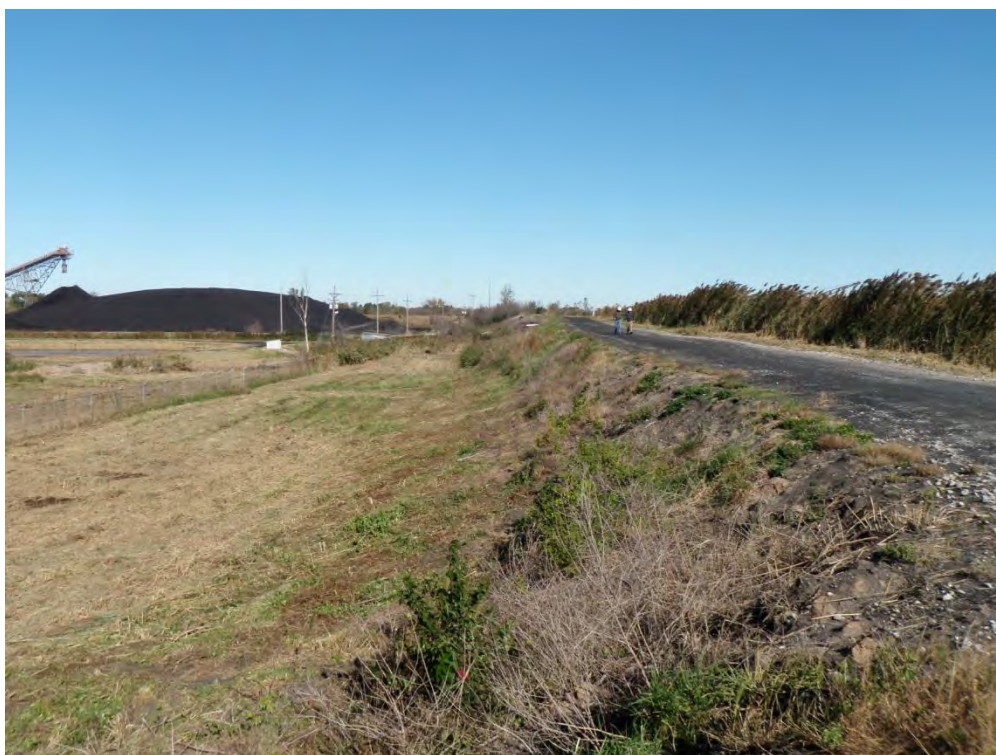
**Photo 23: Upper Pond crest and downstream slope at inside corner looking north.**

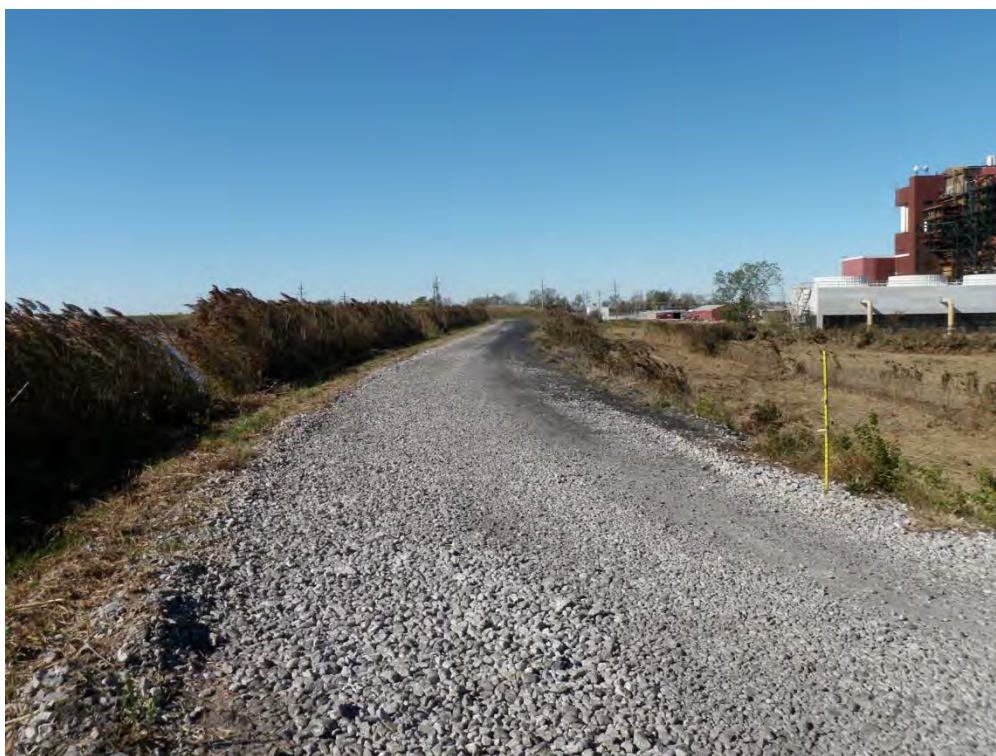
**Photo 24: Upper Pond crest and downstream slope at inside corner looking west. Note heavy vegetation on upstream slope.**

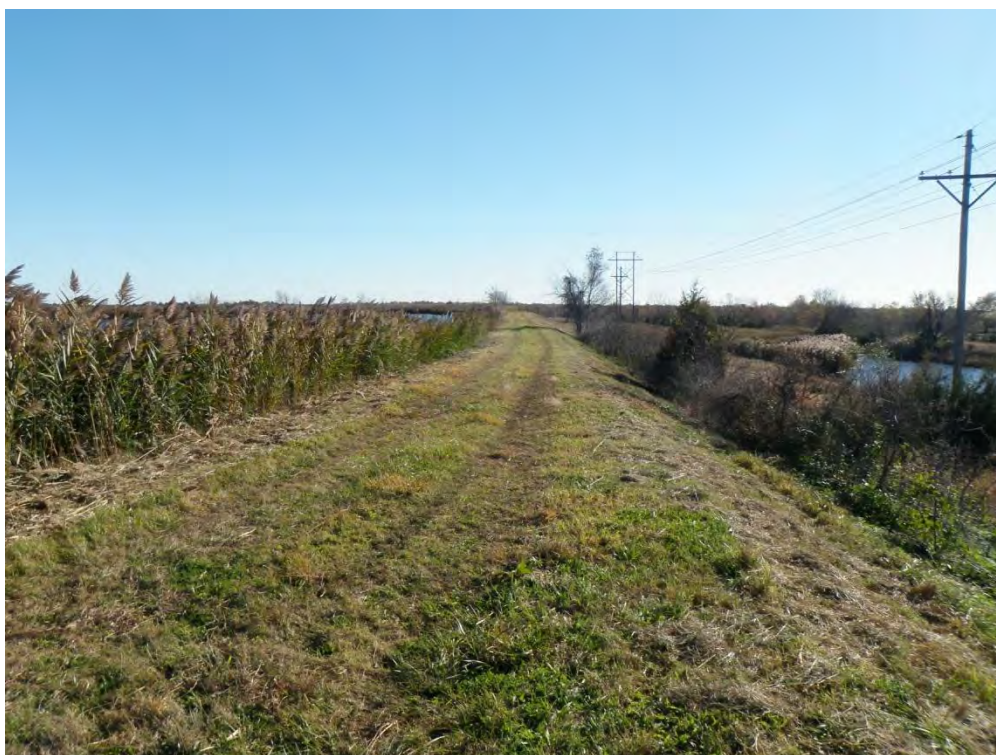
**Photo 25: South Pond upstream slope and crest at southwest corner of pond looking east.**

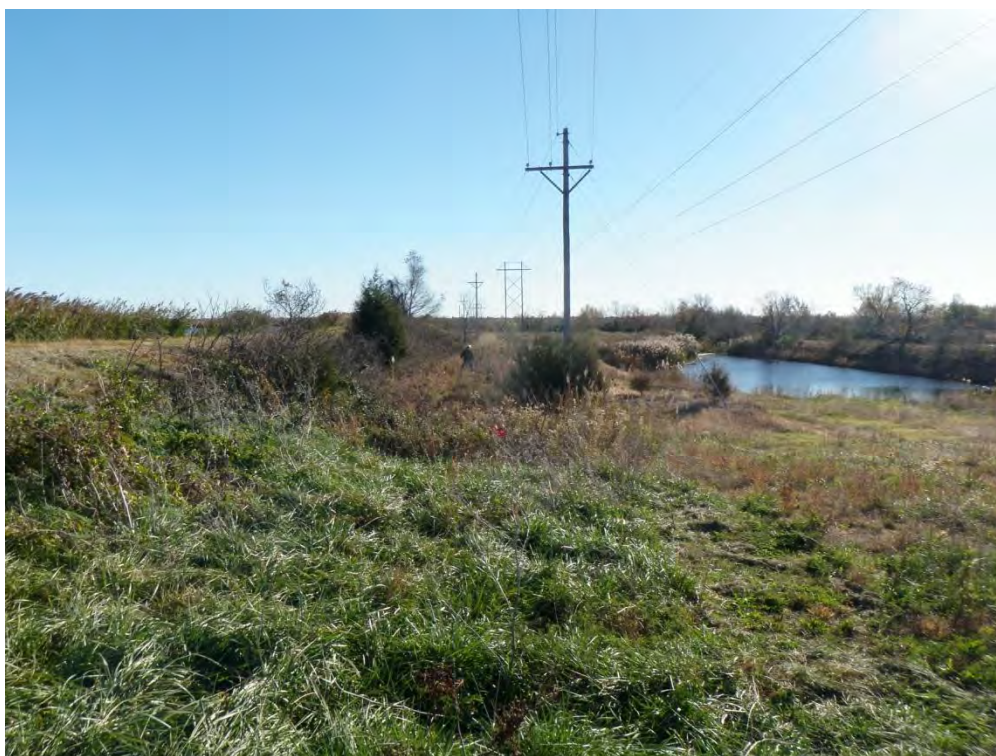
Standing water was also observed in an excavated borrow area approximately 50 feet downstream of the south embankment section. The origin of the water is unknown, but appeared to be surface runoff from adjacent areas.

**Photo 26: South Pond downstream slope at southwest corner looking east. Note heavy vegetation on downstream slope and standing water in excavated borrow area.**

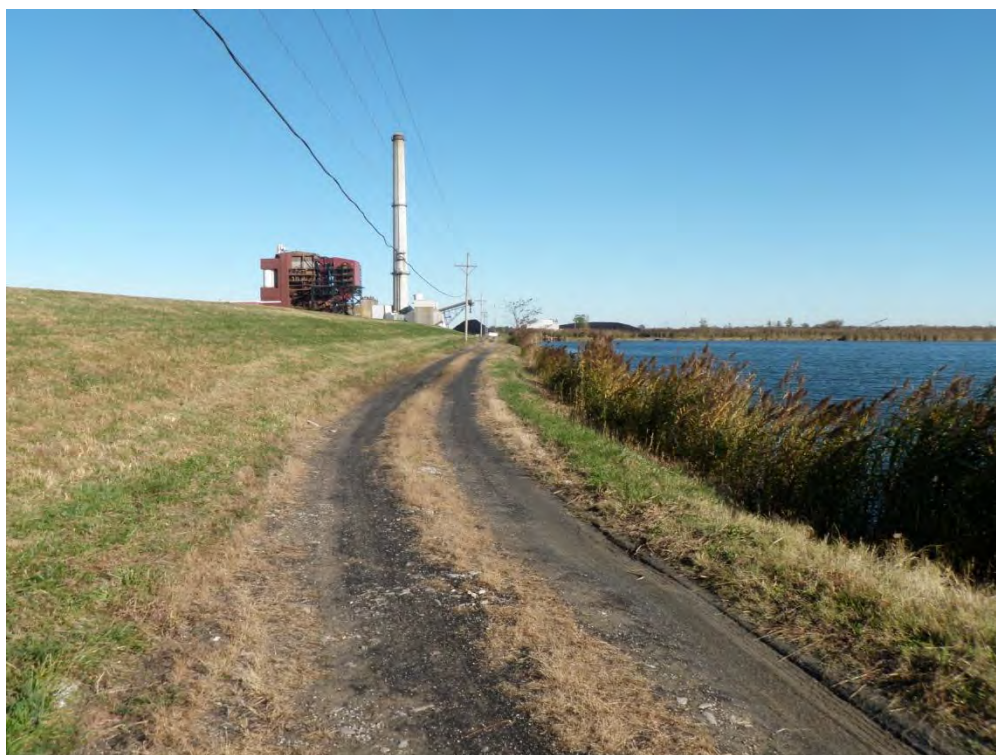
**Photo 27: South Pond west section crest adjacent to Cooling Water Reservoir (on left).**

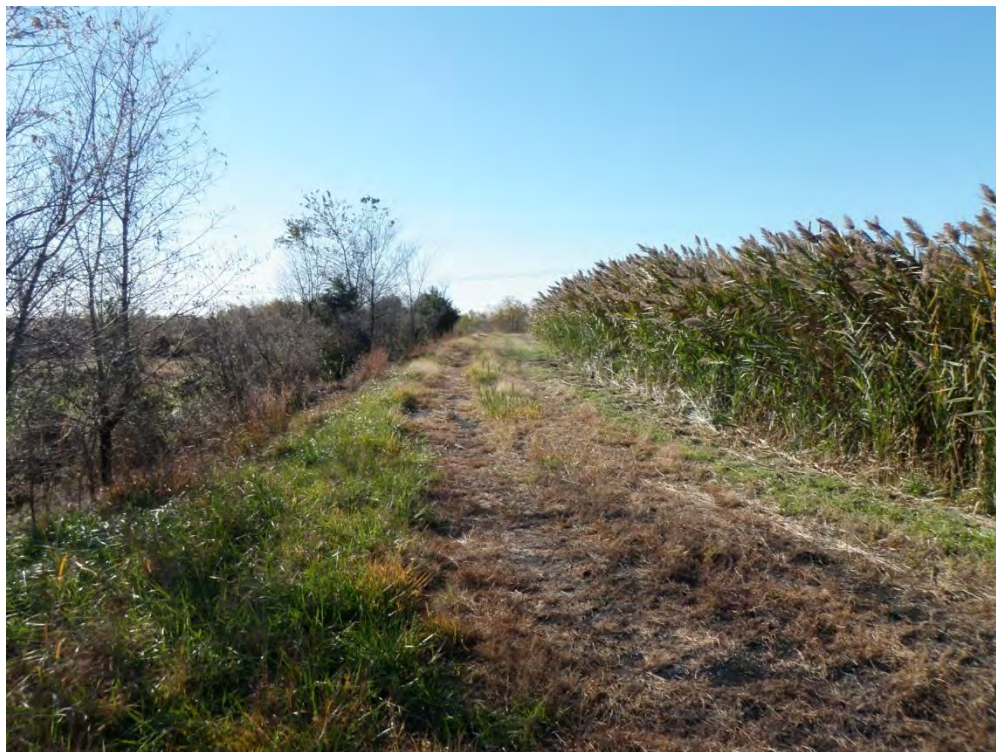
**Photo 28: South Pond crest and downstream slope at northeast corner of pond looking south. Note heavy vegetation on upstream and downstream slopes.**
