Assessment of Dam Safety Coal Combustion Surface Impoundments (Task 3) Draft Report

Louisville Gas &
Electric Company
(A subsidiary of E.ON U.S.)

Cane Run Power Station
Louisville, Kentucky

December 18, 2009

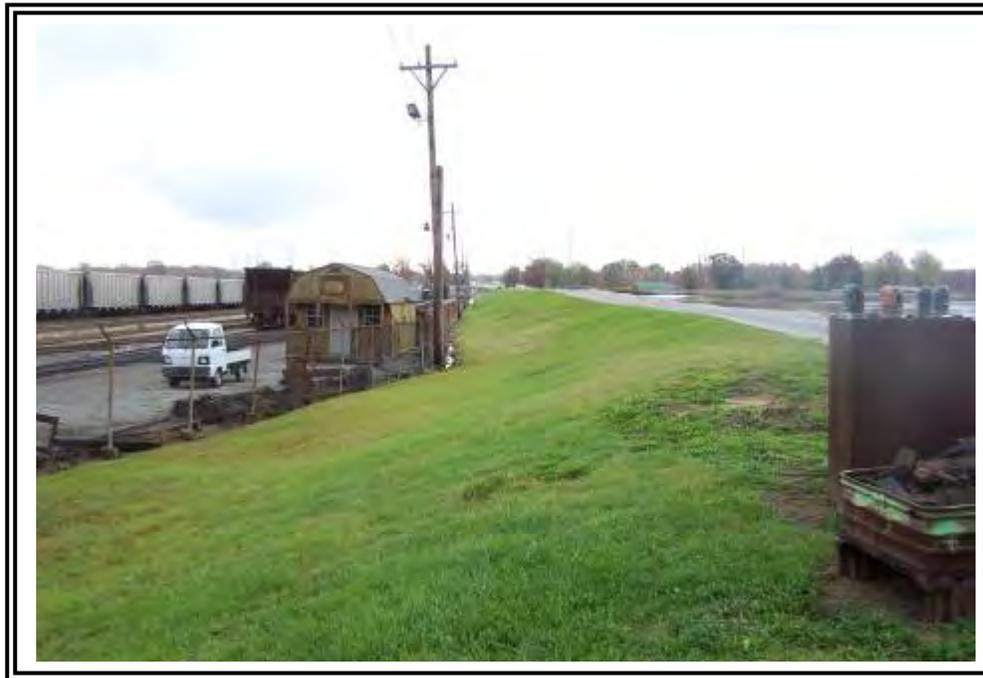
Photo 1 shows the north dike downstream slope is reasonably uniformly graded and appropriately vegetated with grass. Slope measurements indicate a variation from 2.5H :1V near the crest to 2H:1V near the toe. Occasional erosion rills have developed on the downstream slopes as shown in Photo 2. Photo 4 shows a slight irregularity in slope grading which occurs over a limited area of the downstream slope. This appears to be an overfilled repair, but could indicate soil creep. Tire ruts from mowers also exist in this area. This is common on earthen embankments, and requires observation to ensure that erosion and sloughing do not occur. Poor drainage at the toe of the slope results in ponding along much of the north dike. Photos 3, 5, and 6 show standing water and erosion at the toe likely resulting from this condition. E.ON U.S. is working with a consultant to design drainage improvements in this area. A small rodent hole, as shown in Photo 7 was seen in this area. A large area at the east end of the north dike has recently been re-graded (Summer 2009) with one to two feet of additional clay fill and sodded to address drainage problems, as shown in Photo 8. According to E.ON U.S., sod was used to avoid the difficulty of establishing grass on the slope from seed during the rainy summer season. Photos 9 through 12 show the north dike upstream embankment, which is covered with rip rap.

Downstream slope of north dike of the Ash Treatment Basin (ATB) from west intersection with county flood control dike looking east.

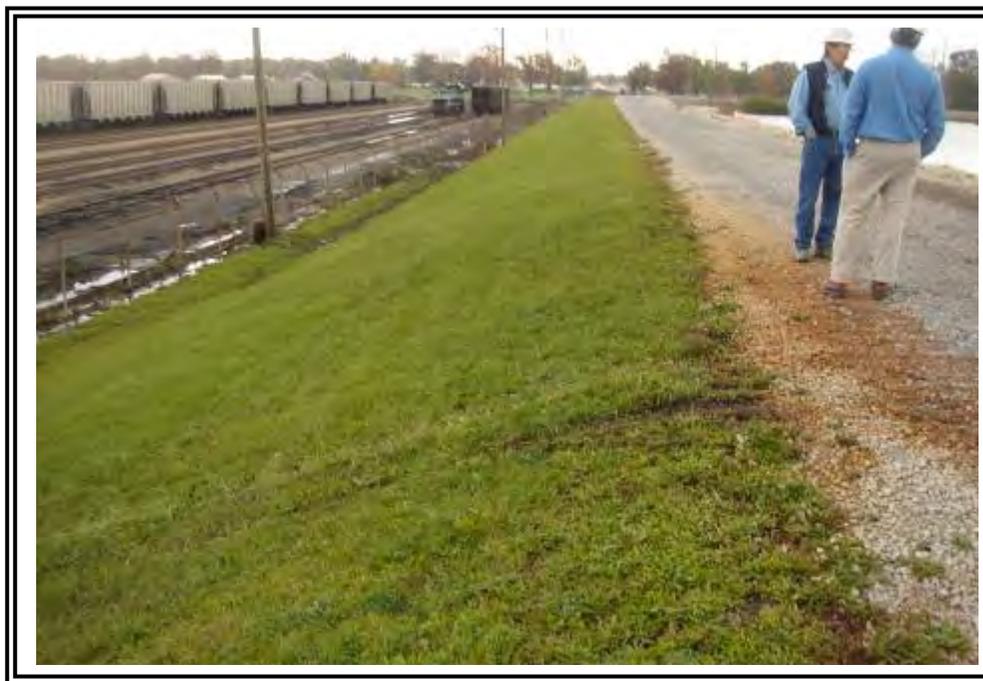
2

Slight erosion rill from crest on ATB north dike looking east.

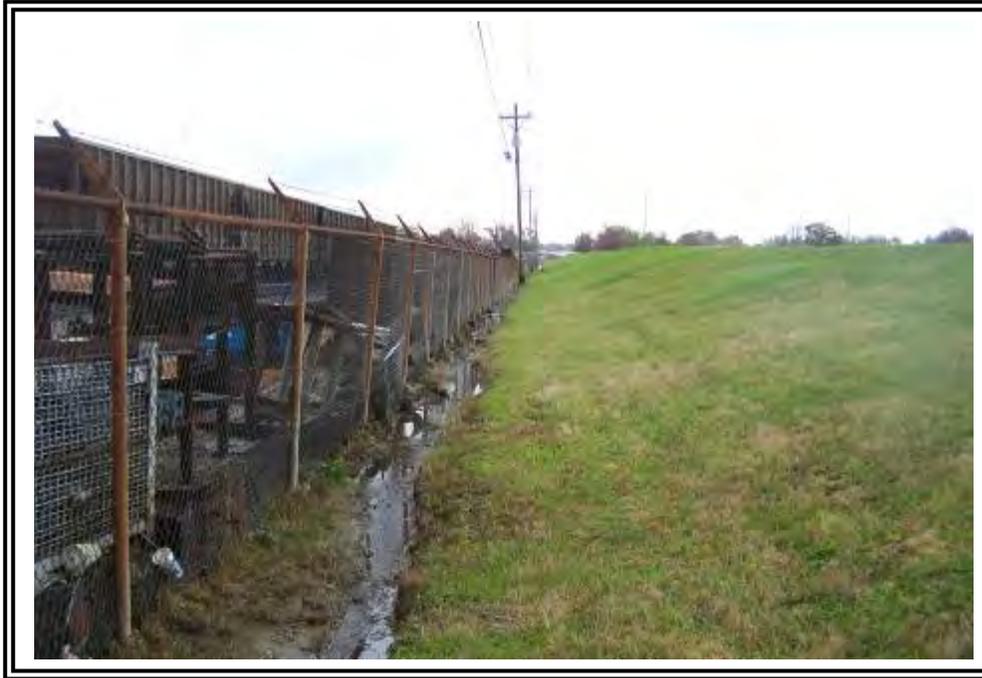
3

Downstream slope of north dike at ATB looking east. Poor drainage results in standing water at the toe of this dike. E.ON U.S. is working with a consultant to regrade this area for better drainage.

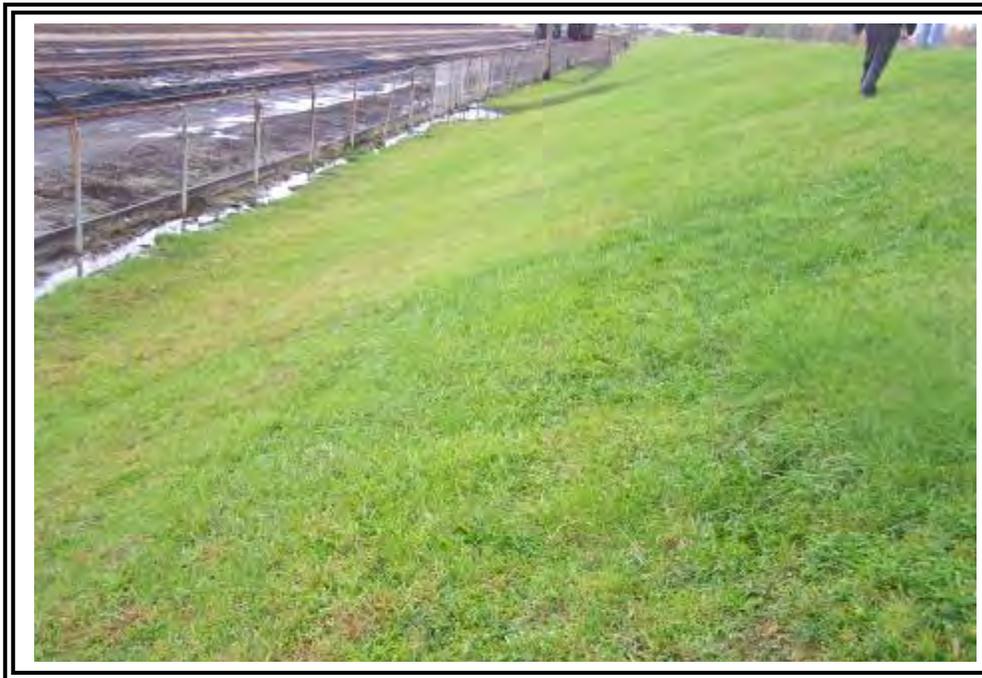
4

Downstream slope of north dike at ATB looking east. Slight irregularity in slope grading difficult to distinguish as an "as constructed" condition or soil creep.

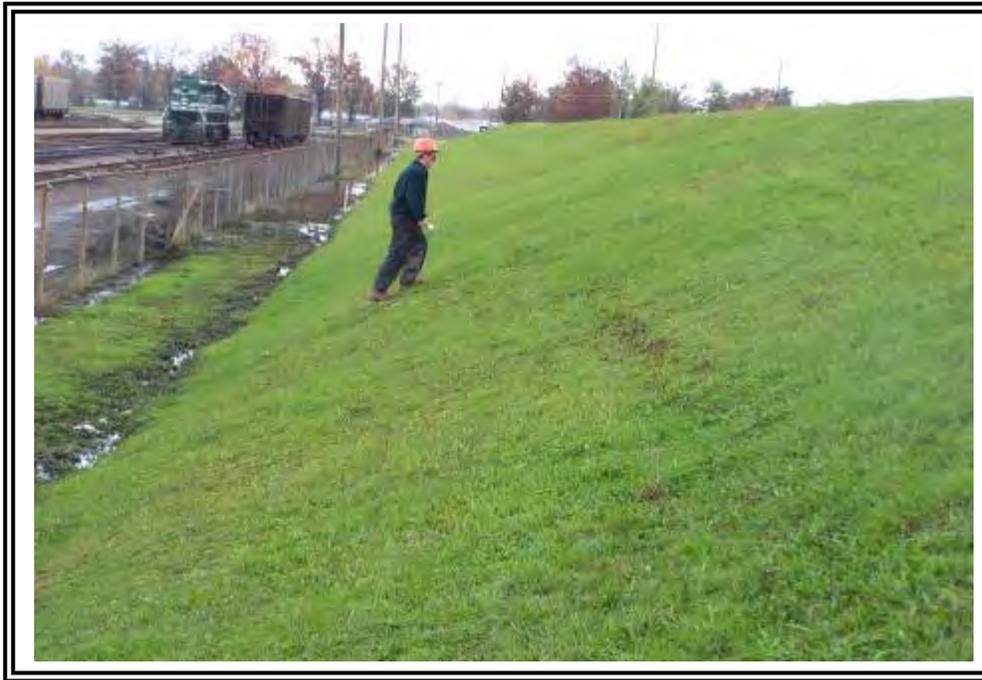
5

East end of north dike at ATB looking east. Mower ruts, and toe erosion from stormwater were observed.

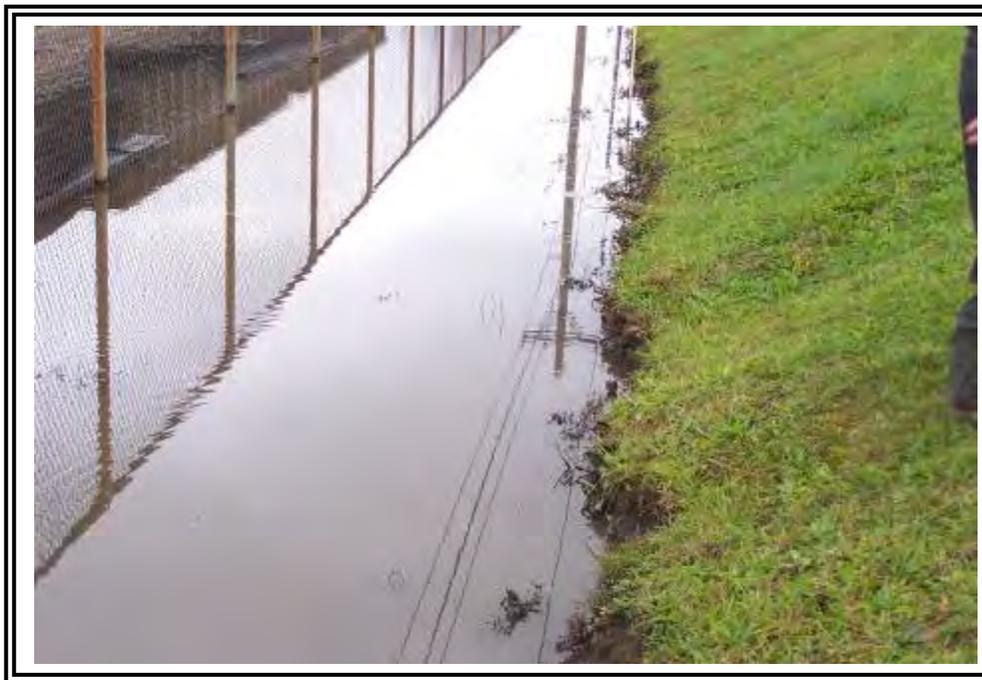
6

Close up of toe erosion on ATB north dike.

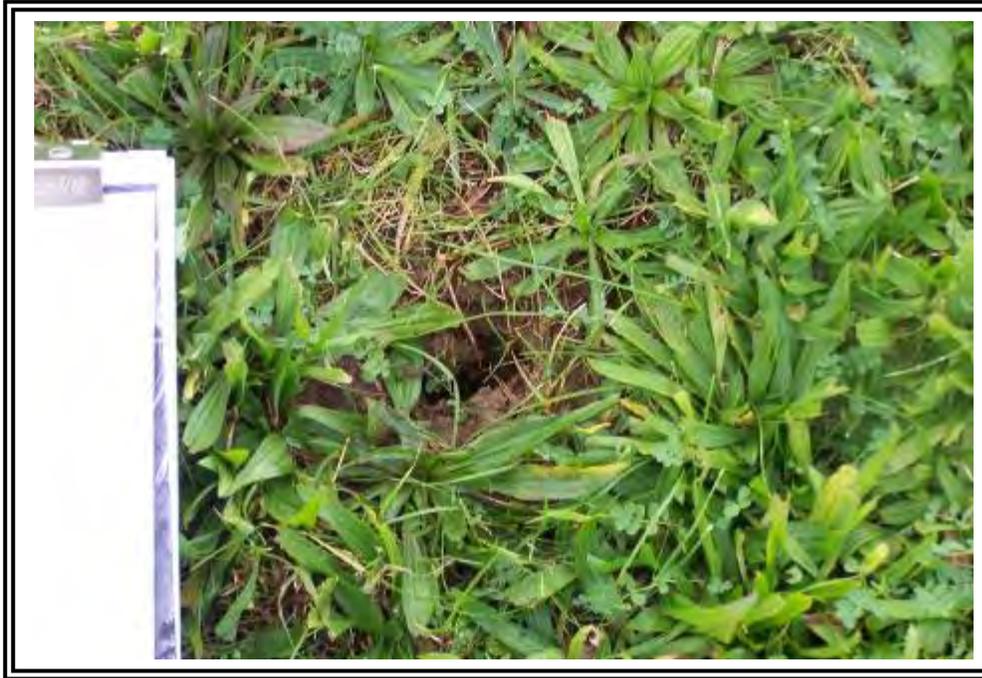
7

Small rodent hole on ATB north dike.

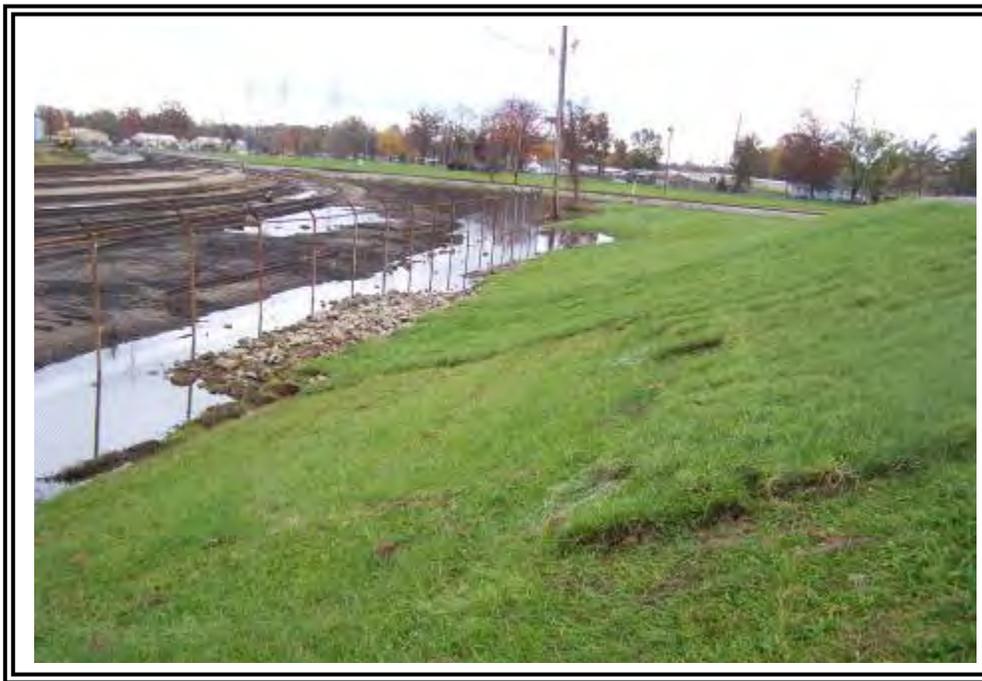
8

East end of ATB north dike has been regarded and had sod placed to address drainage problems. E.ON U.S elected to place new sod rather than seed because of this year's excessive rain.

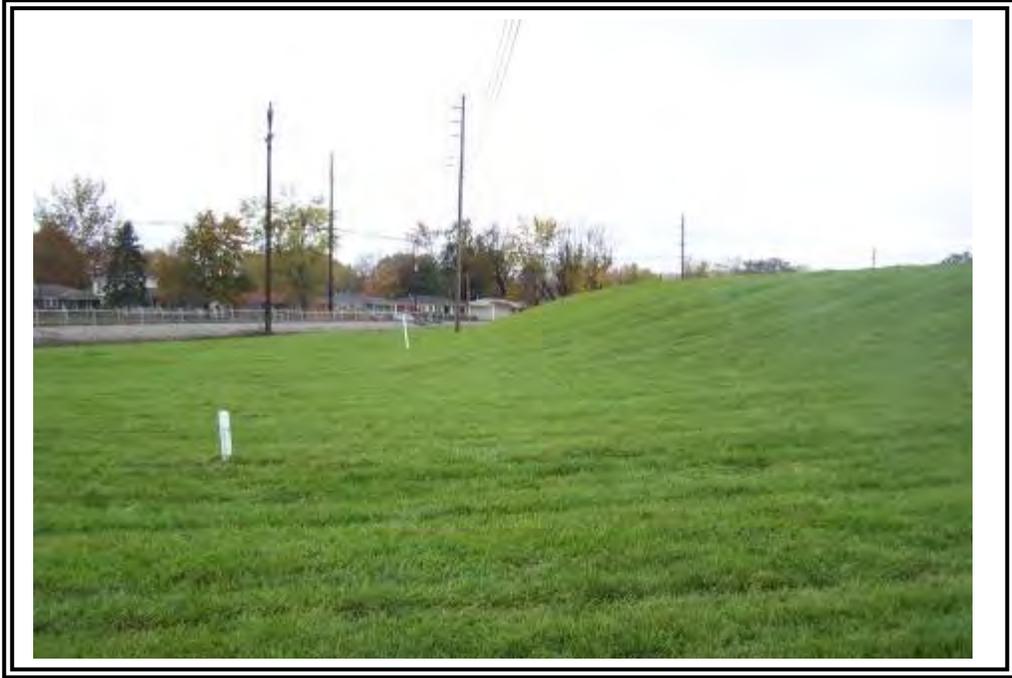
13

Downstream slope of ATB east dike looking south. The area at the toe was raised 1 to 2 feet in summer 2009 and sod placed to prevent stormwater pooling in this area. White markers indicate the location of a high pressure gas line installed in 2005.

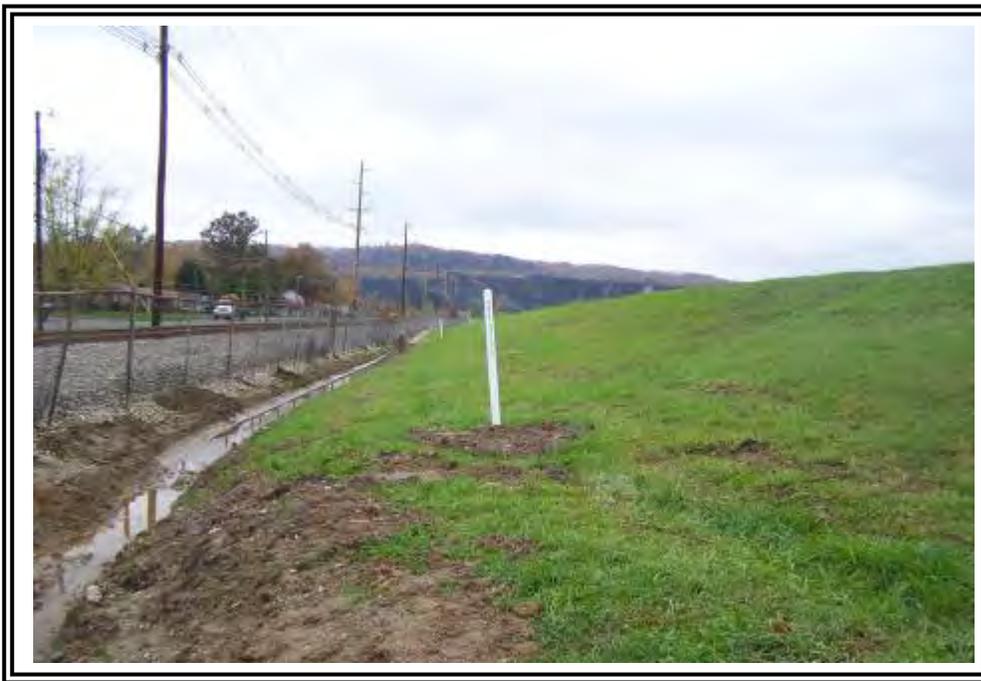
18

The gas line continues along the downstream toe of the south dike as shown in Photo 18. Photo 21 shows slight settlement which has occurred over the gas line in this area. Photo 19 shows a concrete lined swale running along the toe, which intercepts storm water and carries it to a culvert running under the adjacent railroad embankment (Photo 20). Photos 21 to 24 show the surface treatment and condition of both the upstream and downstream slopes are similar to the east dike, except for the west end, where soil material for use at the landfill has been stockpiled on the upstream side of the embankment (Photo 25).

Downstream slope of ATB south dike looking west. White markers indicate the location of a high pressure gas line installed in 2005. Drainage swale between dike and railroad tracks was cleaned out of sediment and debris in the summer of 2009.

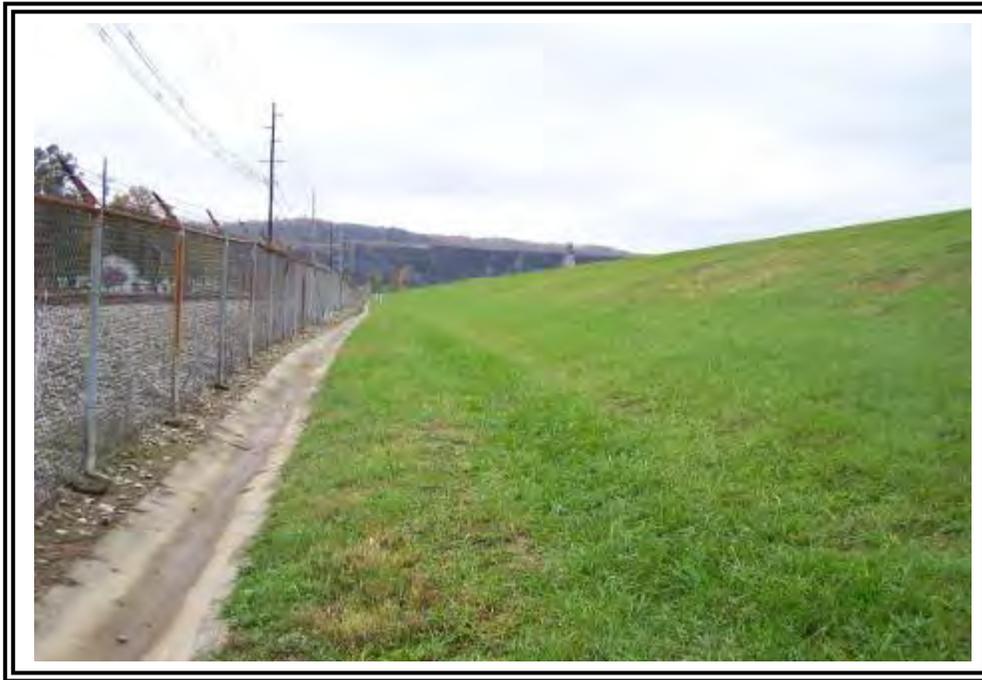
19

Downstream slope of ATB south dike looking west.

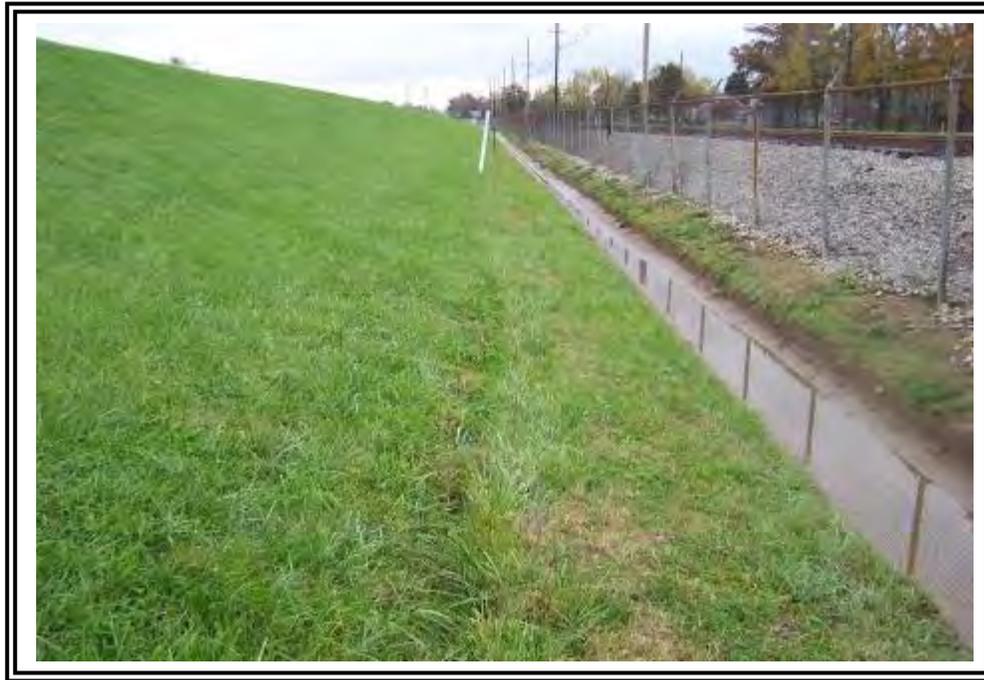
21

Downstream slope of ATB south dike looking east. White marker indicates locations of gas line. Slight depression appears to be over the pipe alignment along the south dike.

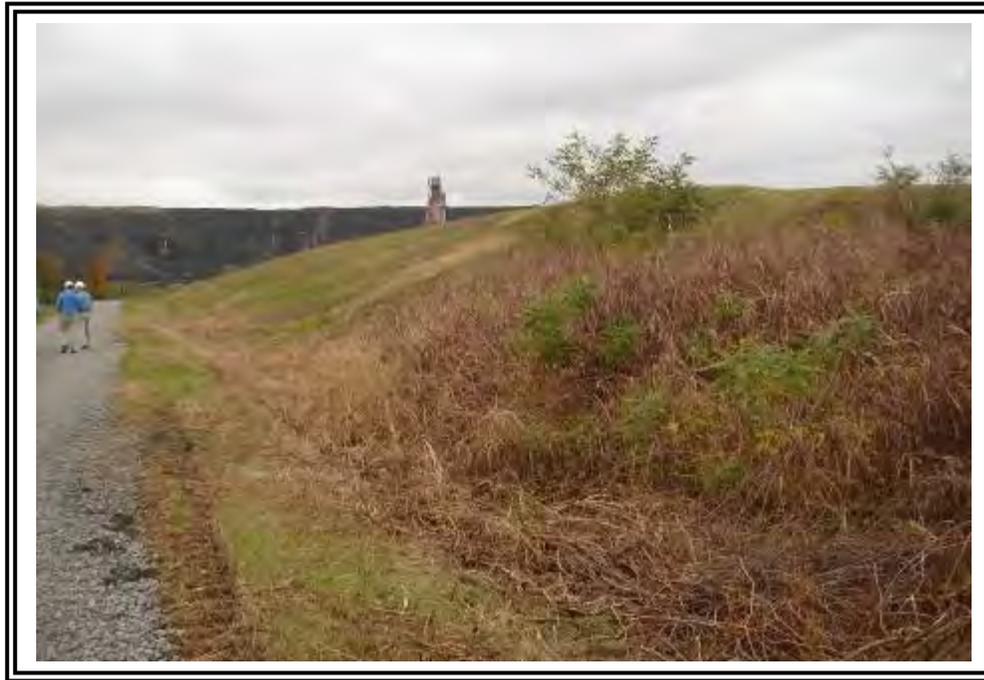
25

Stockpiled material for use at the landfill adjacent to ATB south dike looking west.

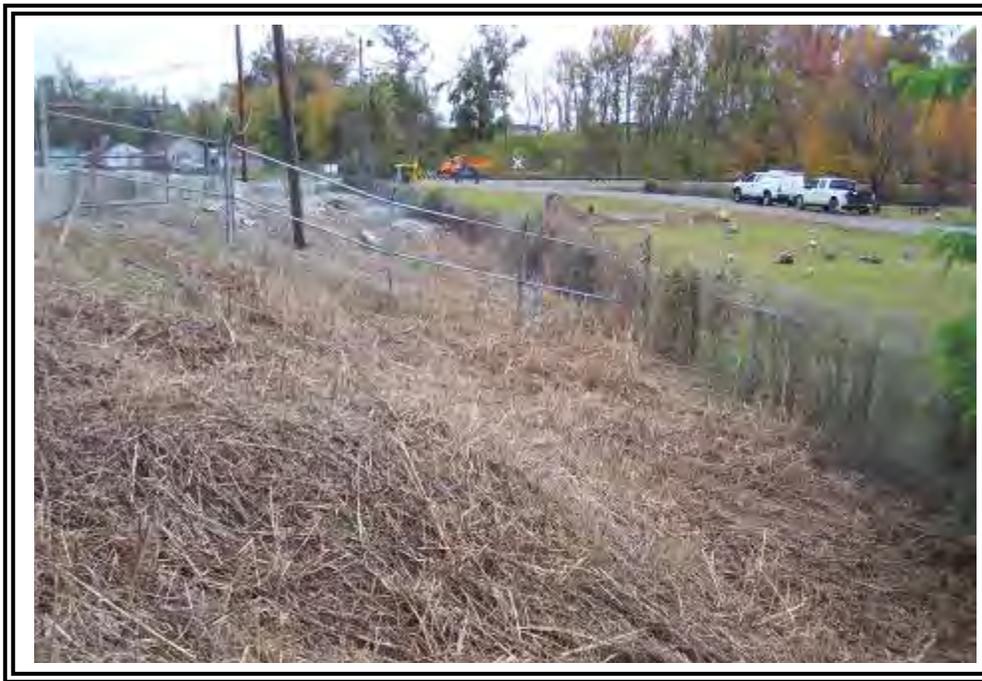
28

The ATB south dike continues along the E-Pond. The downstream embankment of the western 420 feet of the south dike, as shown in Photos 26 through 30, becomes over-steepened and irregular, and vegetation appears predominantly weedy. Surface probing indicated soft conditions, with up to 18" of penetration observed. A concrete barrier runs between the crest and the downstream face. Photo 29 shows several erosion rills which have developed under this barrier. Photo 31 shows the E-Pond which was excavated within previously deposited ash slightly to the northeast of the E-Pond location indicated on a 1972 proposed site plan. Storm water runoff from capped and uncapped areas of the landfill to the west discharge into the E-Pond via a culvert shown in Photo 32. Overflows from the E-Pond enter the ATB.

Downstream slope of west end of ATB south dike looking east. Note weedy vegetation and irregular grading.

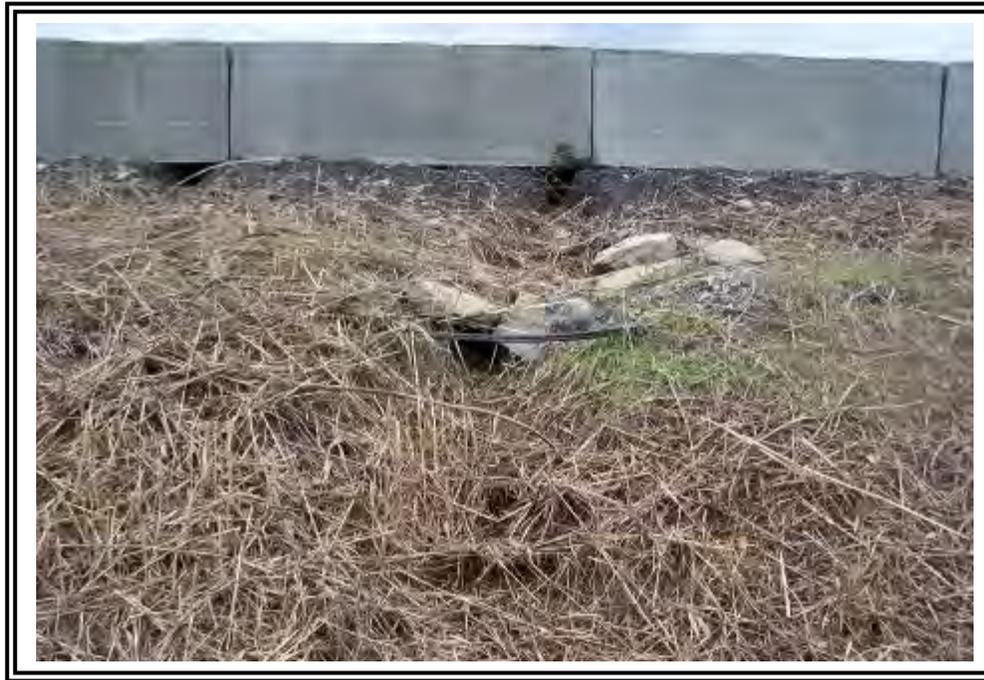
29

Erosion rills under concrete barriers at crest of south dike adjacent to the E-Pond.

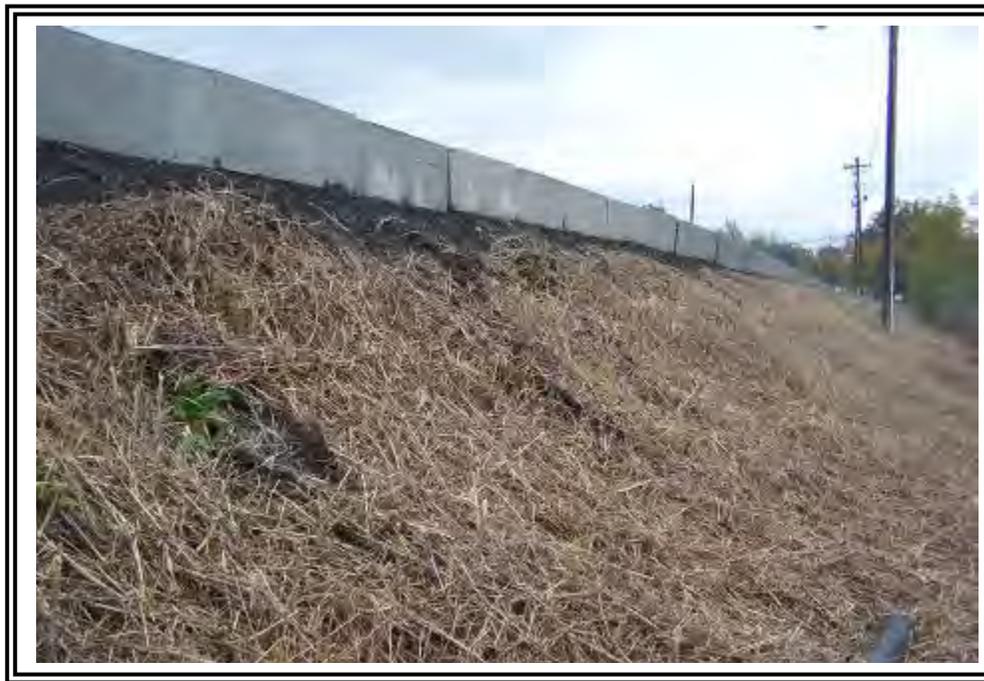
30

South dike of ATB adjacent to the E- Pond is quite steep.

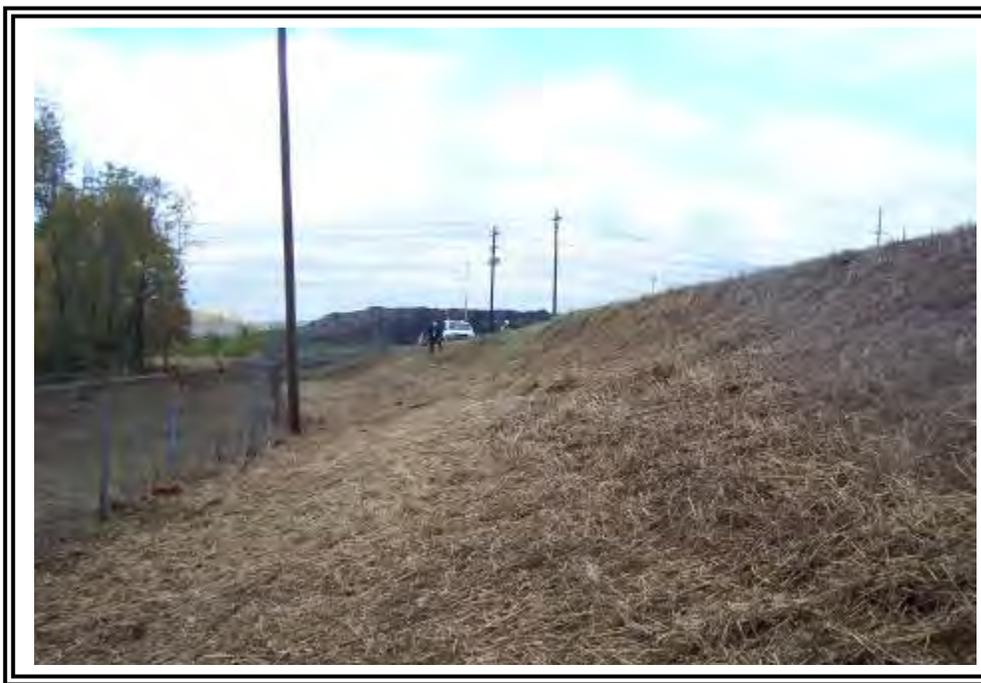
38

Vegetation is weedy and non-uniform. Photos 35 through 38, and 44 show typical slope conditions along the east dike. Photo Nos. 39 and 40 show woody brush and tree stumps on the downstream slope that have been recently cut following an inspection by E.ON U.S.'s independent consultant. Photo 41 shows an erosion rill that has developed on the east dike which is typical of the condition of the east dike. Both downstream and upstream slopes are steep and irregular as shown in Photo Nos. 42, 43, and 44. Photo 42 shows a depression that was observed near the toe at the corner between the east and north dikes. The crest road surface is crushed gravel, and water ponds in areas (Photo 45) due to wind-rowing of gravel along the edges from routine access road repair and maintenance.

Downstream slope of east dike at Basin/ Dead Storage Pond looking south.
Note steepness of the embankment and irregularity of grading.

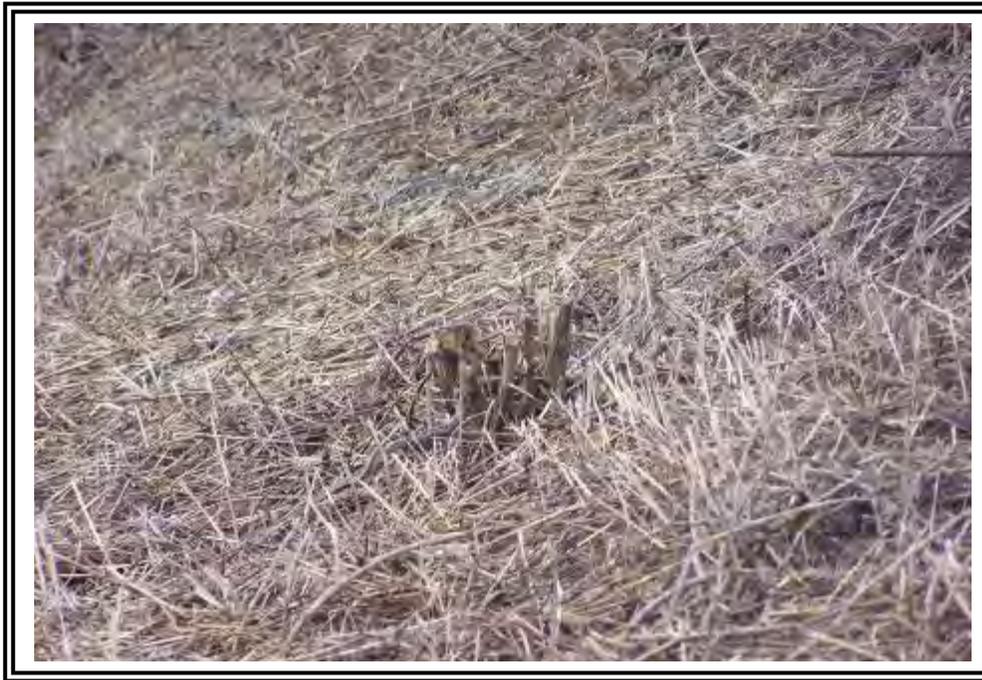
39

Example of woody brush recently cut following E.ON U.S.'s consultant's independent inspection.

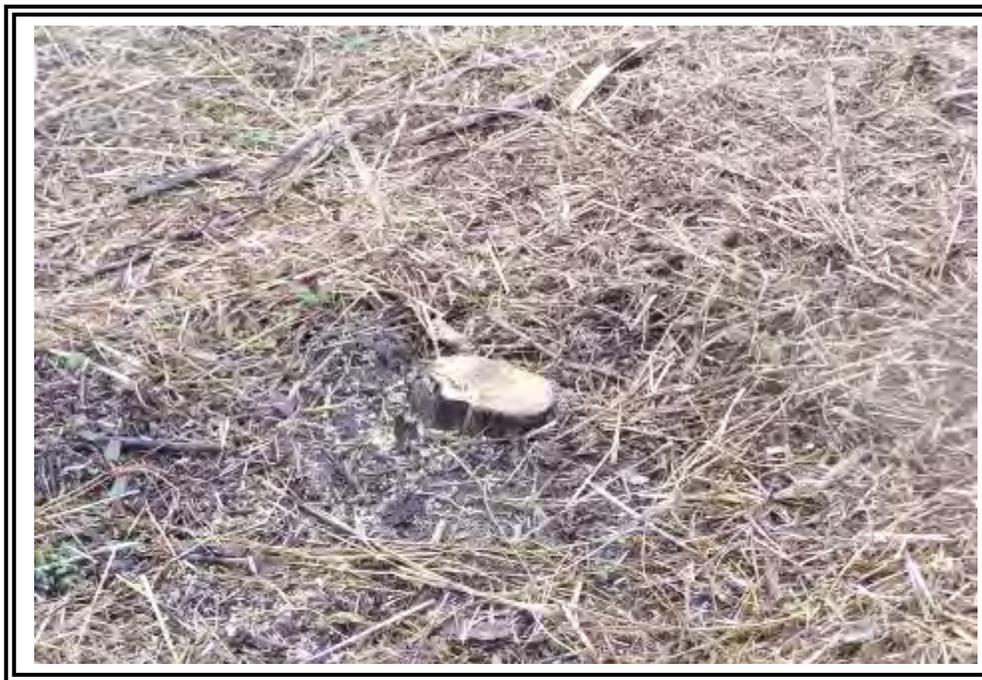
40

Example of cut, stump left in place following E.ON U.S.'s consultant's independent inspection.

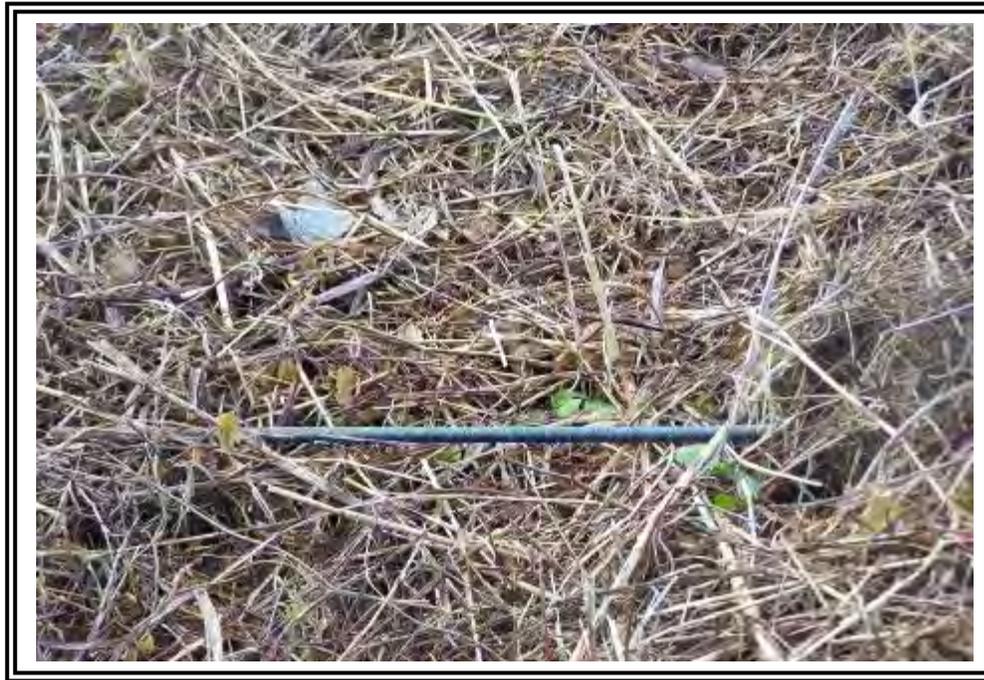
41

Erosion rill about 6 inches deep, 1.5 feet wide on east dike at Basin/ Dead Storage Pond.

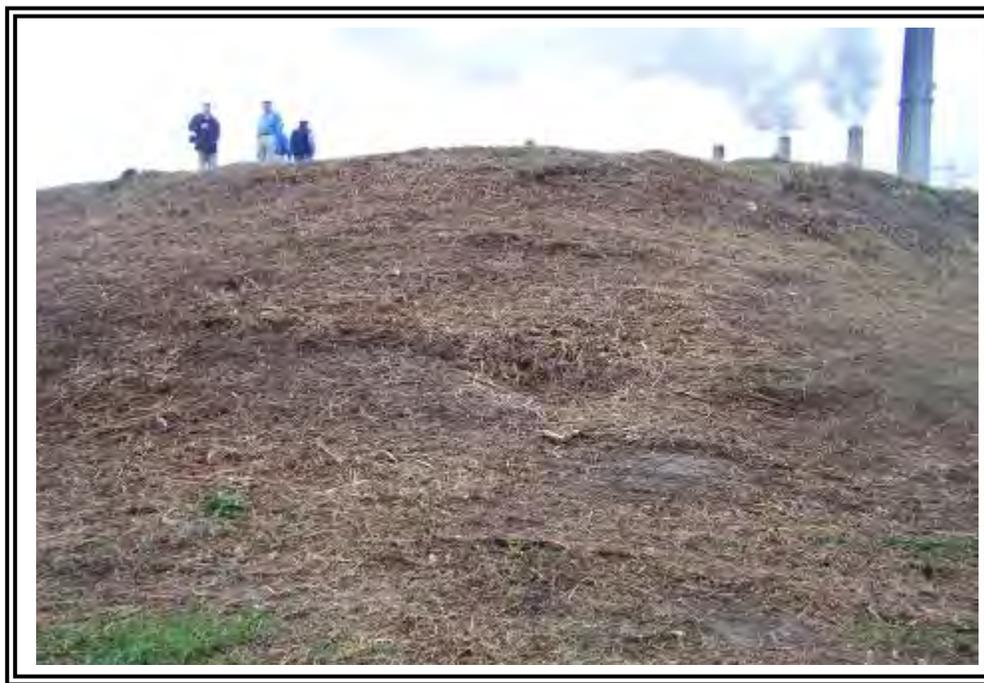
42

Depressions and irregular grading at northeast corner of Basin/ Dead storage pond dike.

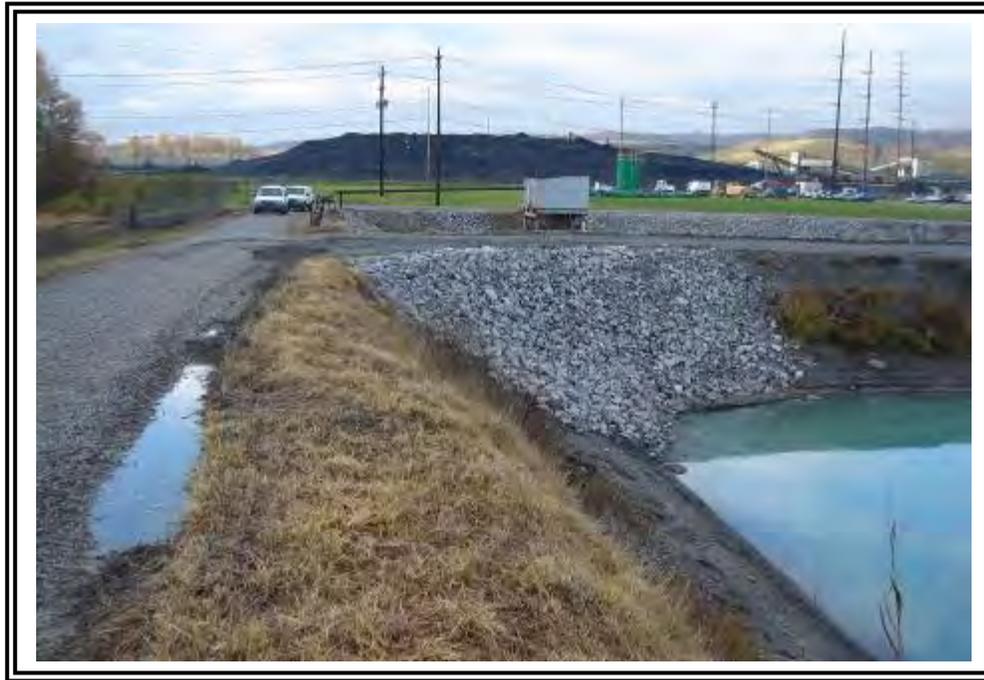
45

Standing water on east dike at Basin/ Dead storage Pond looking south.

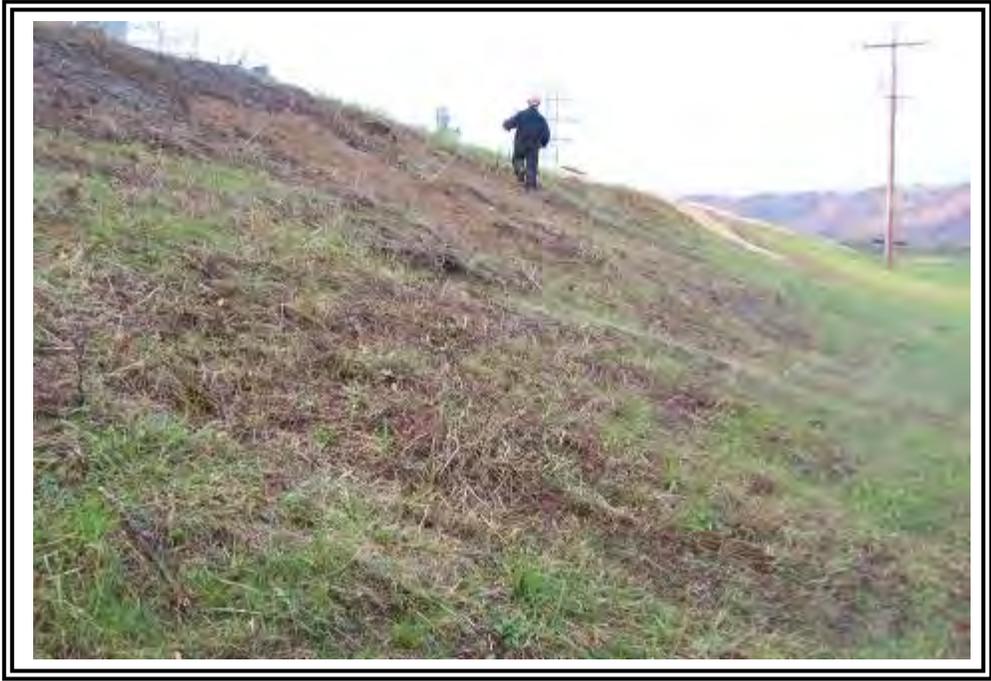
47

Surface irregularities as shown in Photos 46, 47, 50, 51 are typical along the downstream slope of the north dike, consisting of surface slumps, erosion rills and tire ruts. Surface probing indicated firm soils approximately 9 inches below the surface. Photos 48, 49, 52, 54, and 55 show recent repairs near the north dike crest which have not yet established vegetation. Surface irregularities are also apparent on the upstream slope as shown in Photo 53.

Irregularity on north dike at Basin/ Dead Storage Pond.
Combination of surface slumps, erosion rills, etc. Probes soft to about 9" then firm.

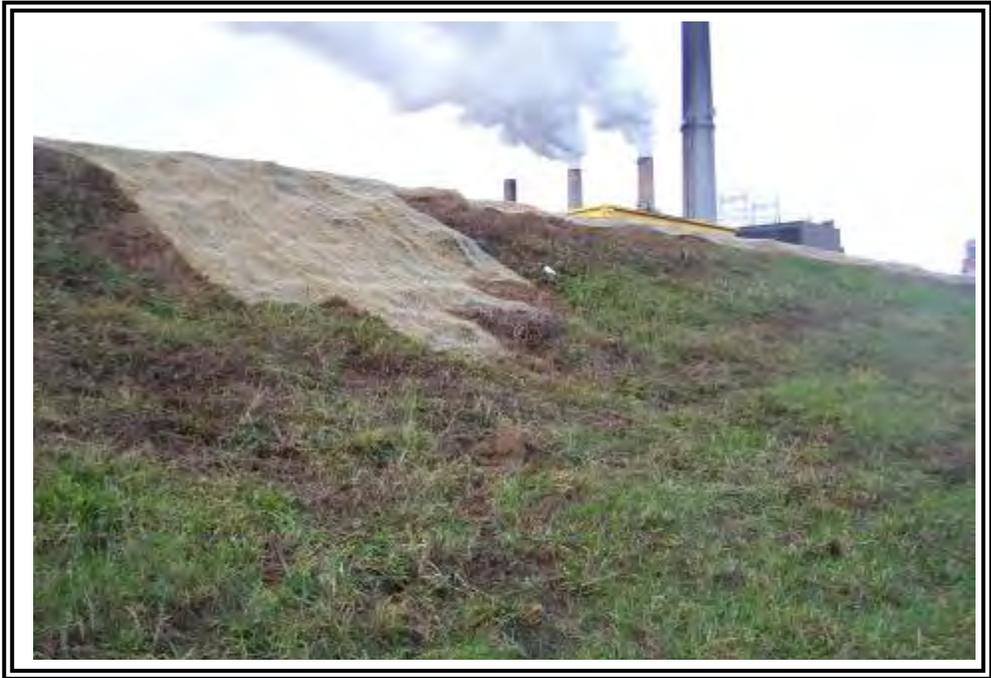
48

Recent patchwork repair along crest of north dike at Basin/ Dead storage Pond.

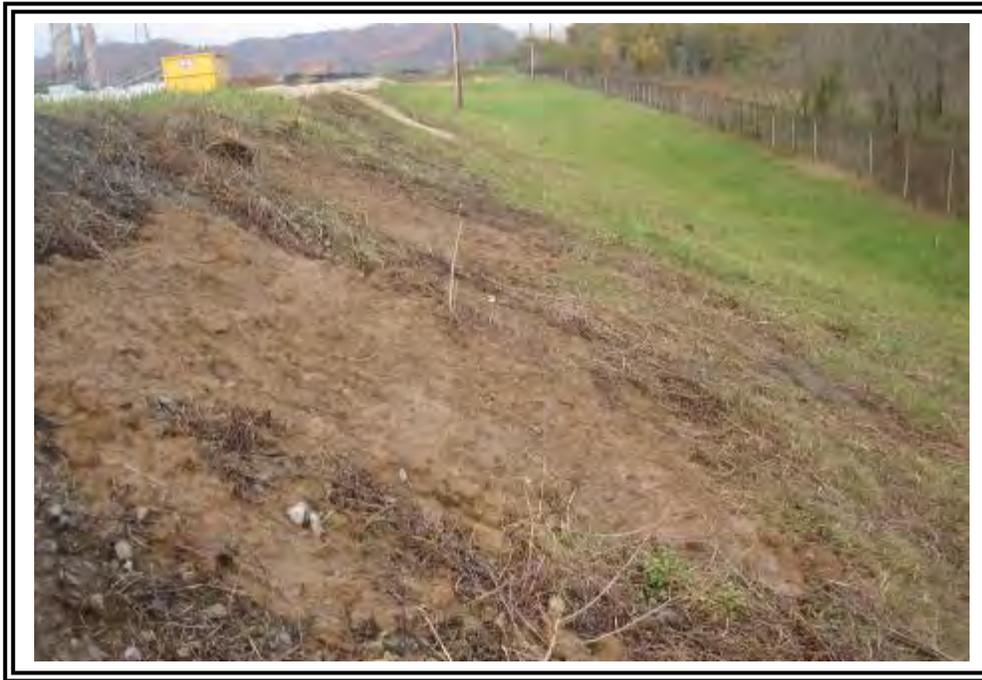
49

Repair area at north dike of Basin/ dead Storage Pond not yet reseeded.

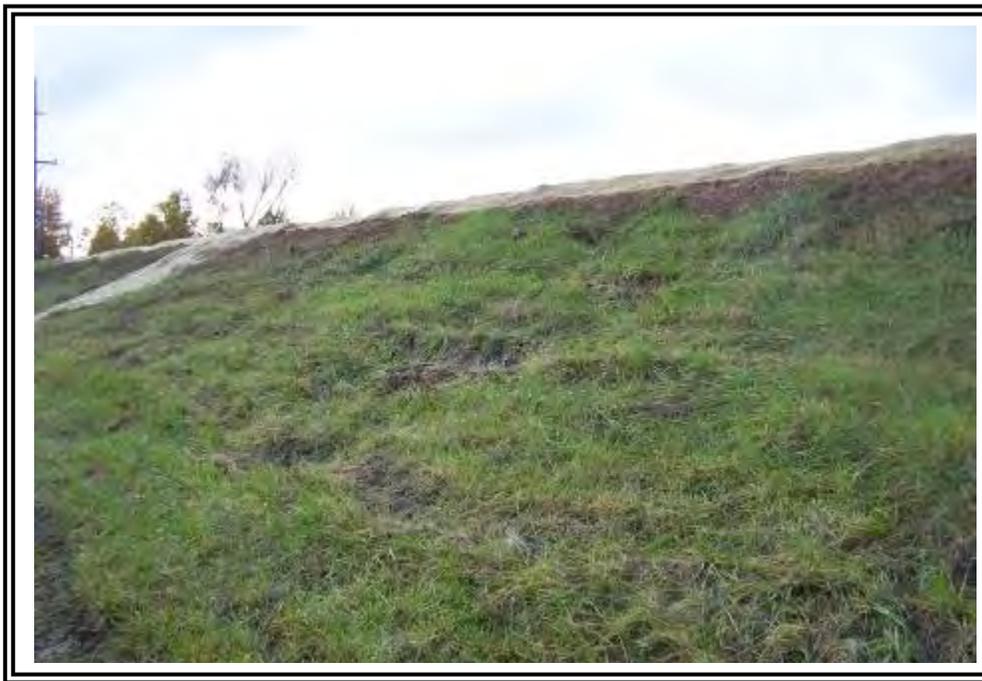
50

Tire ruts in north dike of Basin/ Dead Storage Pond.

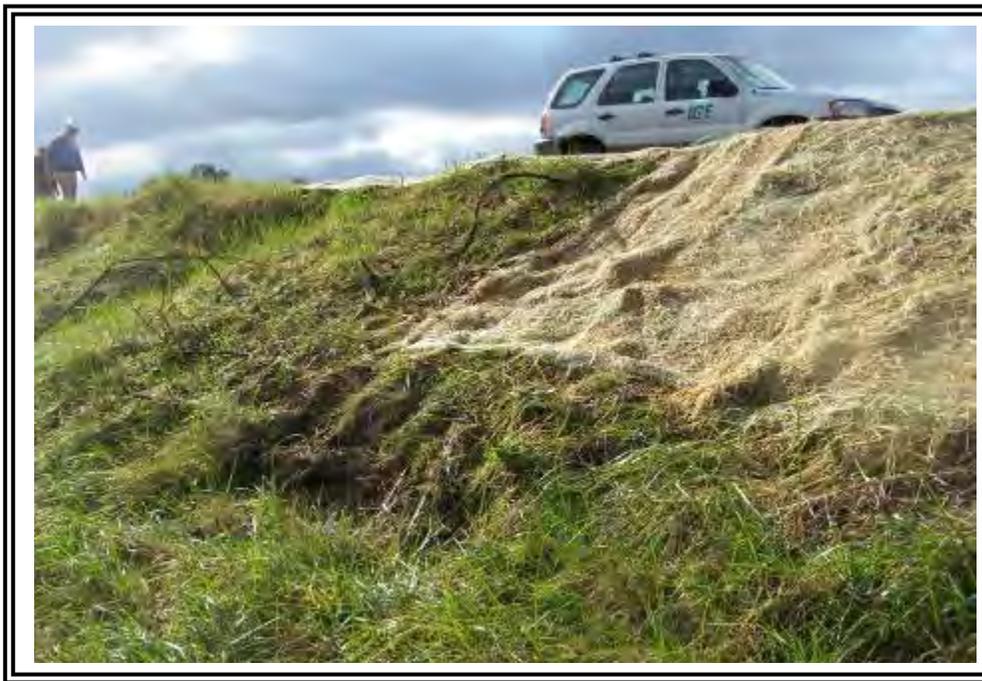
52

Irregularity on north dike at Basin/ Dead Storage Pond.
Combination of surface slumps, erosion rills, etc. Probes soft to about 9" then firm.

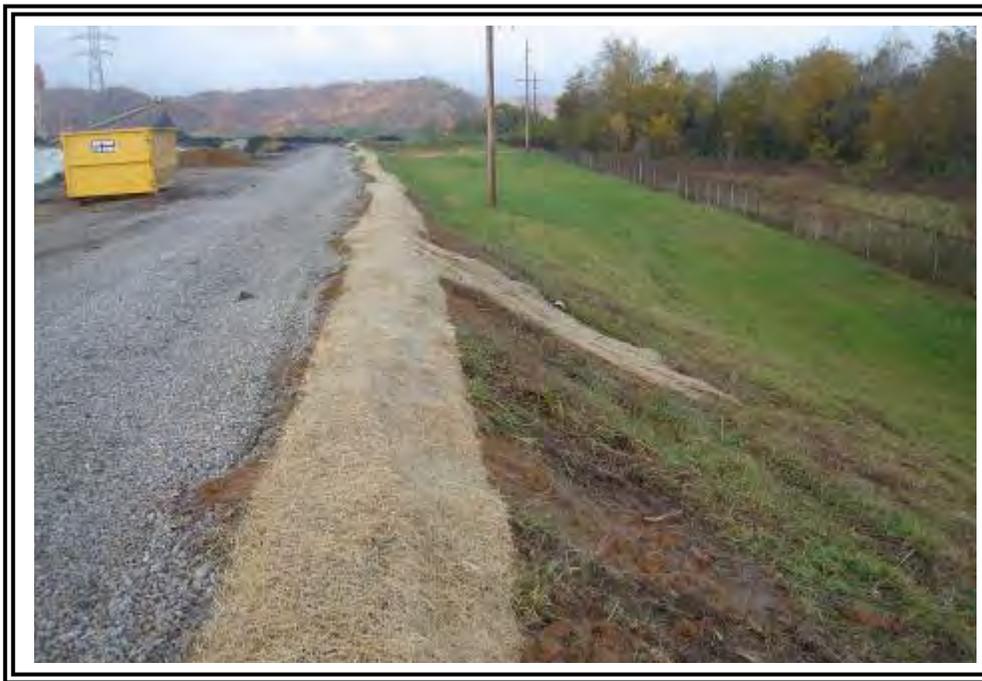
54

Recent regarding along crest of north dike of Basin/ Dead Storage Pond to improve stormwater control.
