**Coal Combustion Waste Impoundment
Task 3- Dam Assessment Report**

***E. W. Brown Plant
Auxiliary Ash Dam Complex
E.ON U.S. LLC
Harrodsburg, Kentucky***

**Project # 0-381
Assessment of Dam Safety
Coal Combustion Surface Impoundments
For the REAC Program**

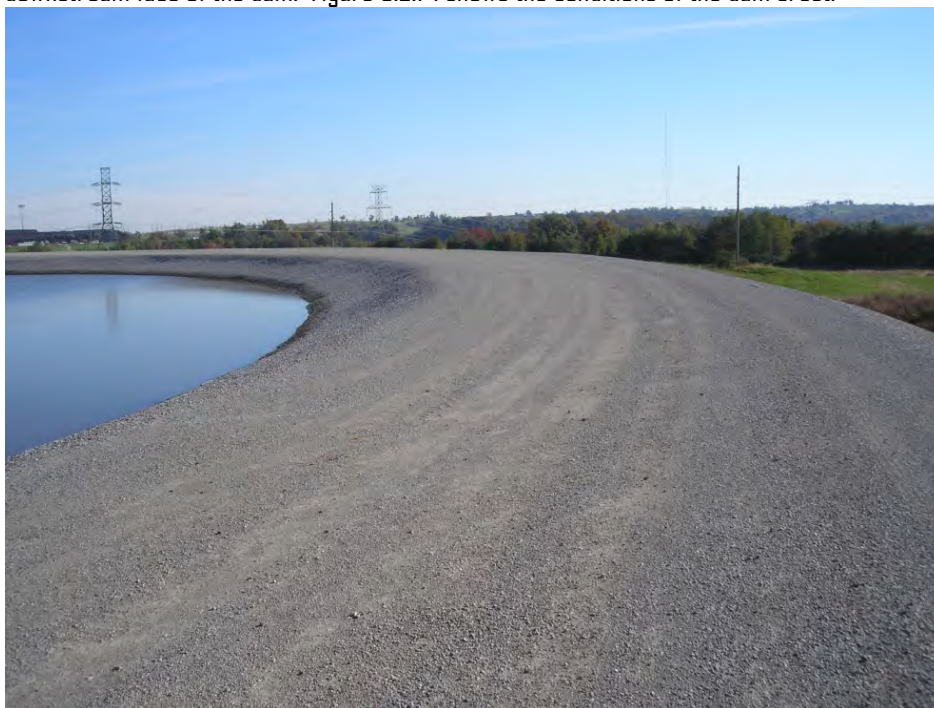
The dam crest had no signs of any depressions, tension cracks or other indications of settlement or shear failure, and appeared to be in satisfactory condition. The data did not indicate cracking along the crest or downstream face of the dam. Figure 5.2.1-1 shows the conditions of the dam crest.

Figure 5.2.1-1. Photo Showing the Dam Crest.

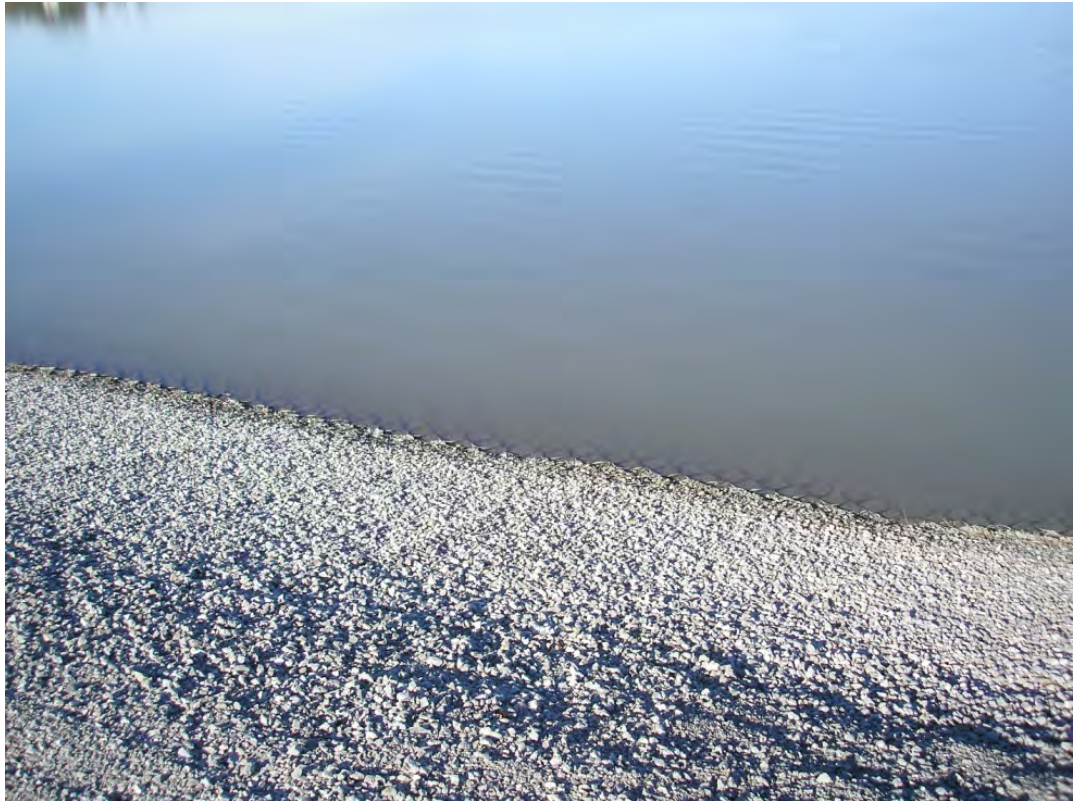
The upstream slope is protected ASTM D 448 Size 57 crushed processed stone aggregate. The cellular geosynthetic slope reinforcement is visible at the edge of the water. There were no observed scarps, sloughs, bulging, cracks or scraps or depressions or other indications of slope instability or signs of erosion. Photos 2, 44 – 45, 57, 59 – 69, 73 – 74, 78, 81, 84, 87 – 88, 93 – 94, 97, and 102 – 105 in Appendix B show the upstream slope. Figure 5.2.2-1 depicts part of the upstream slope of the dam embankment.

Figure 5.2.2-1. Photo Showing the Upstream Slope.

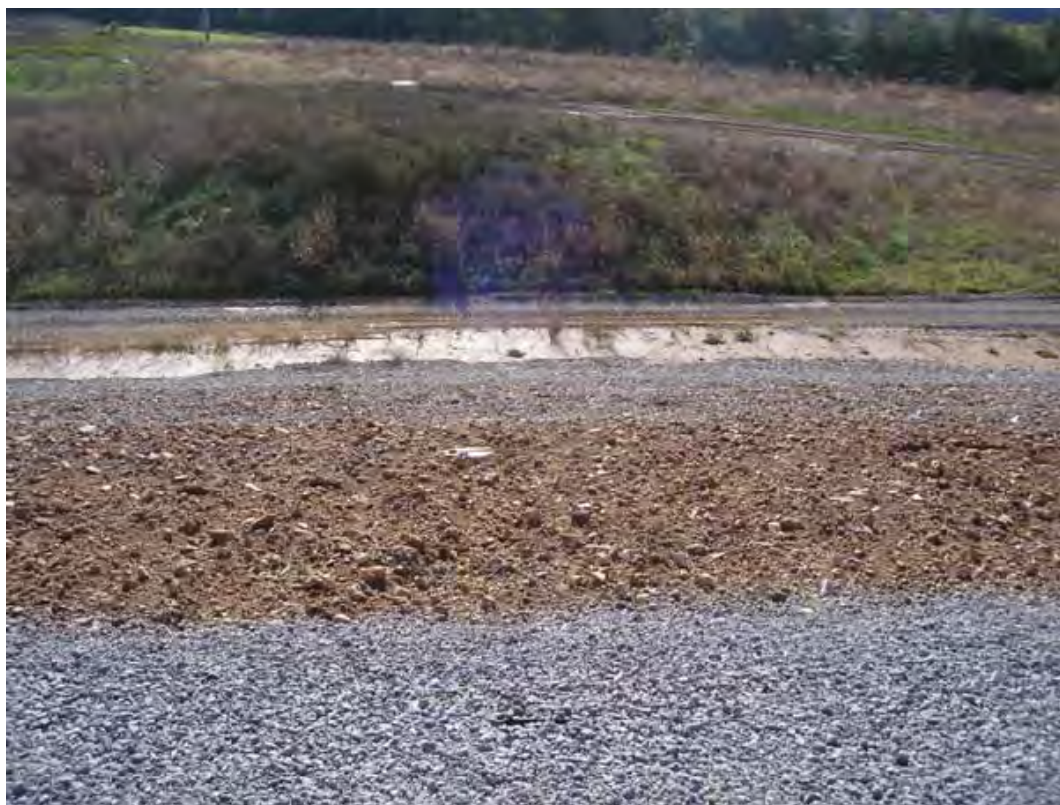
The upper portion of the downstream slope is crushed stone aggregate similar to the upstream slope. The remainder of the downstream slope is an exposed earth and rock fill face. There were no observed scarps, sloughs, depressions or other indications of slope instability or signs of significant erosion or uncontrolled seepage. A few isolated erosion gullies were observed and a single wet area of potential seepage was also observed. No seepage was observed over a widespread area or the downstream foundation area and there was no water against the downstream toe. Photos 1, 5 -41, 46, 48 - 50, 52, 54, 55, 77, 82, 83, 85, 86, 89, 90, 96, 98 - 100, and 104 in Appendix B depict various views of the downstream slope. Figure 5.2.3-1 shows the downstream slope from the North Abutment of the dam. Figure 5.2.3-2 shows the only wet area observed on the downstream slope.

Figure 5.2.3-1. Downstream Slope from South Abutment.

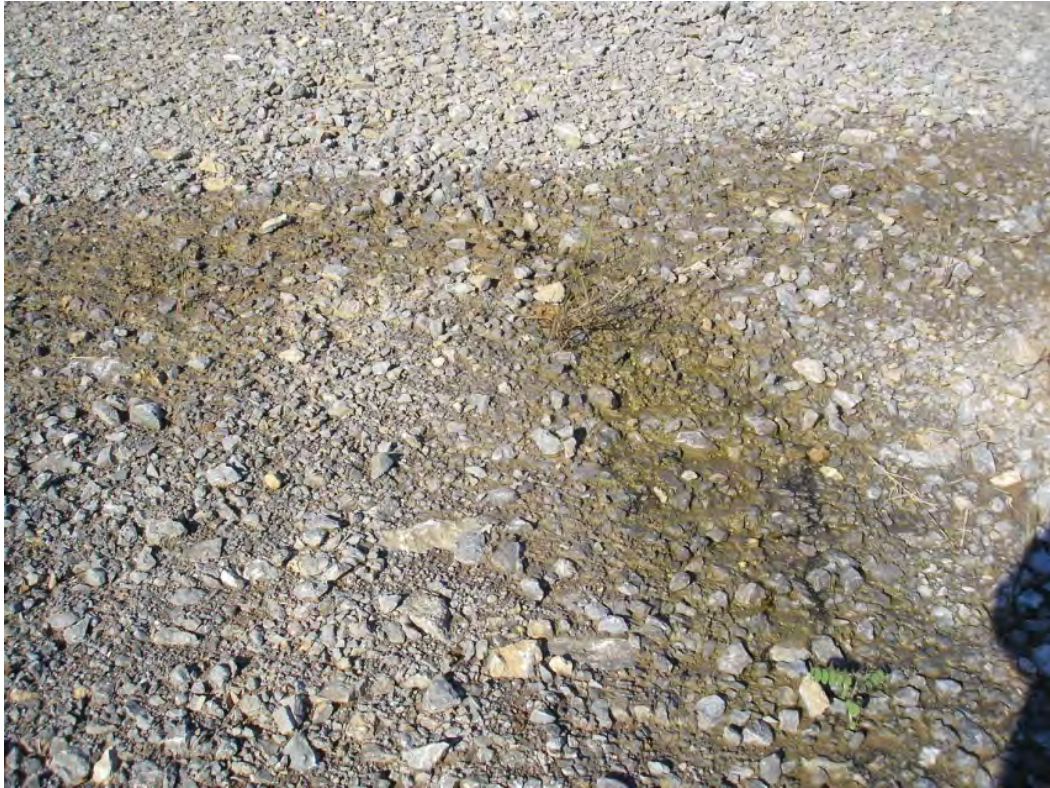
Figure 5.2.3-2. Small Seepage Area Southern Segment, Downstream Embankment.

The repairs of leaks at the principal spillway manholes have been made. The ATC-reported seep, as well as the seep identified in this evaluation, are being monitored. No changes have been reported.

- Monitor, address or otherwise repair minor erosion areas and erosion gullies, and isolated seepage spots.

Continue monitoring seepage locations

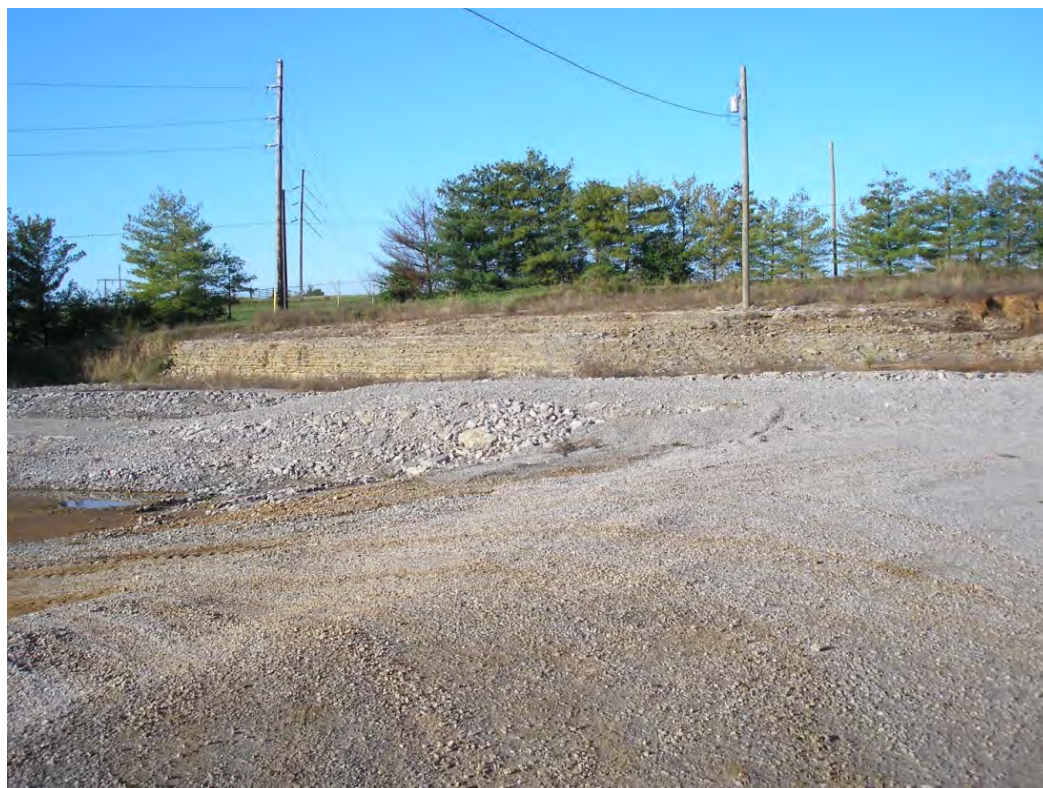
Erosion or uncontrolled seepage was not observed along either groin. The abutments and groin areas appeared to be in excellent condition. As an example, Figure 5.2.4-1 shows the eastern abutment and the southeast corner of the impoundment.

Figure 5.2.4-1. Southwest Segment Abutment

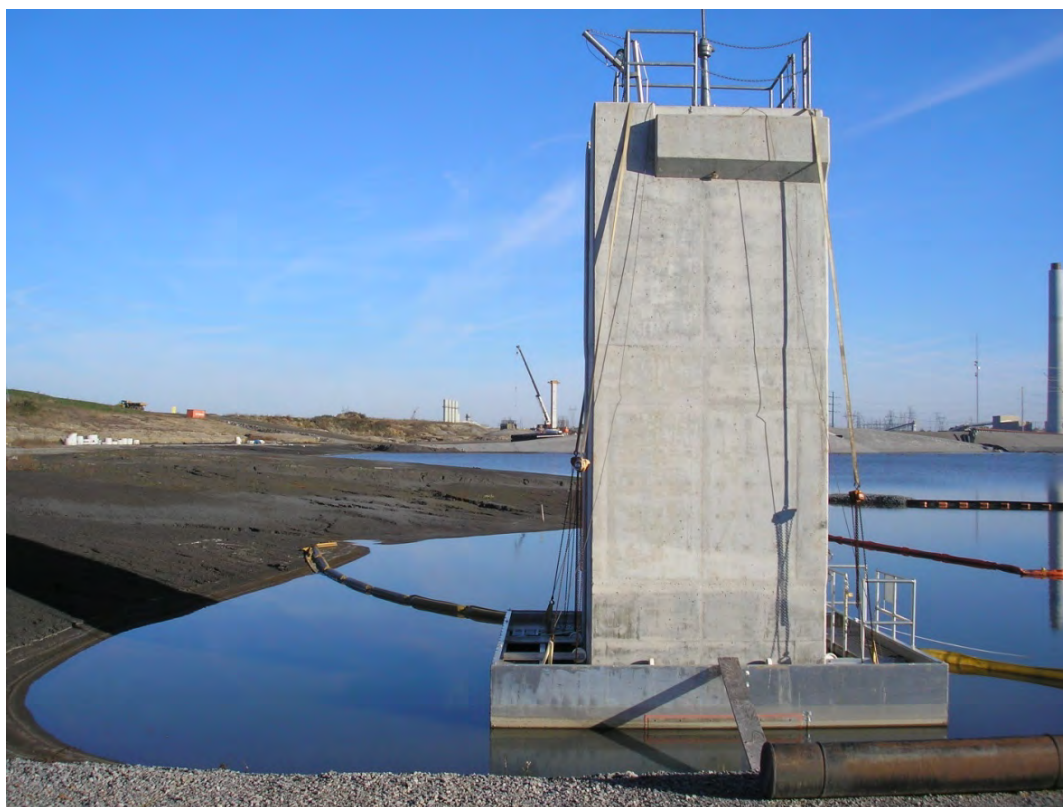
The primary overflow structure was observed to be working properly, discharging flow from the pond, and visually appeared to be in satisfactory condition. There was no sign of clogging of the spillway and the water exiting the outlet was flowing clear. Figure 5.3.1-1 shows the main outlet structure.

The January 22, 2009, ATC Associates, Inc, inspection reported leaks at the principal spillway manholes below the toe of the dam. The inspection report recommended that leak repairs be given a high priority. The leaks have been repaired (see Appendix A: doc 128).

Figure 5.3.1-1. Outlet Structure (Principal Spillway) and the Floating Pier Around it on the Northwest End of Dam.

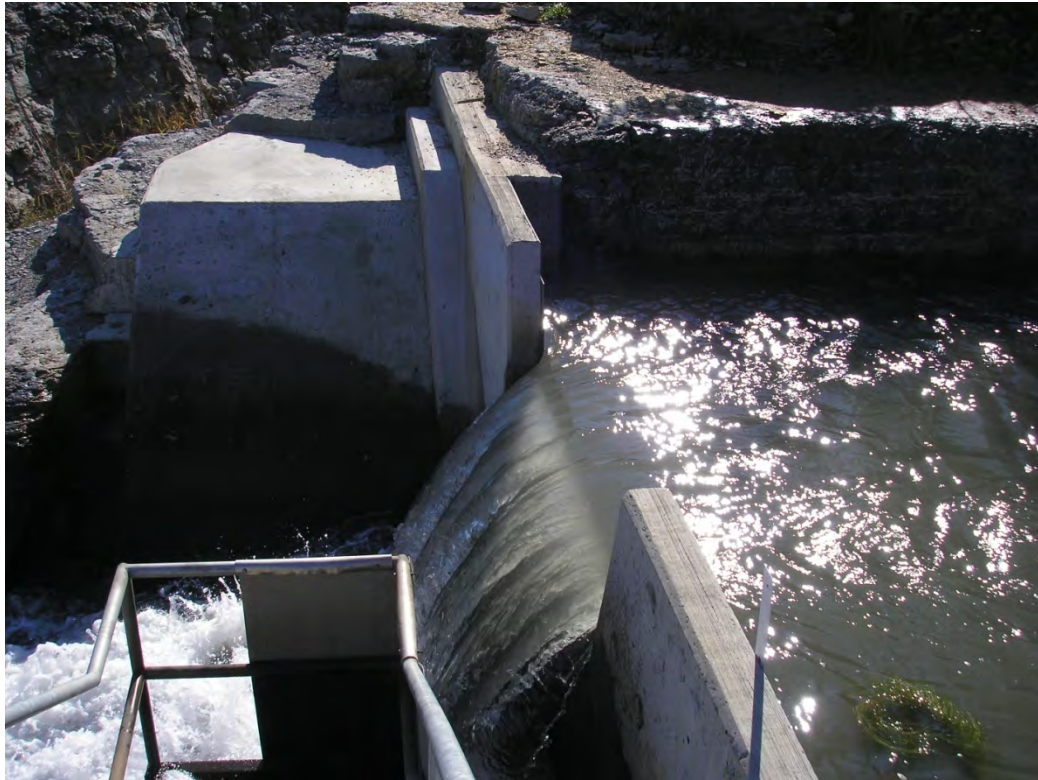
The outlet conduit appeared to be in good shape and operating normally with no sign of clogging and the water exiting the outlet was flowing clear. Figure 5.3.2-1 shows the water discharging from the main spillway tunnel outfall.

Figure 5.3.2-1. Main Spillway Tunnel Outfall.

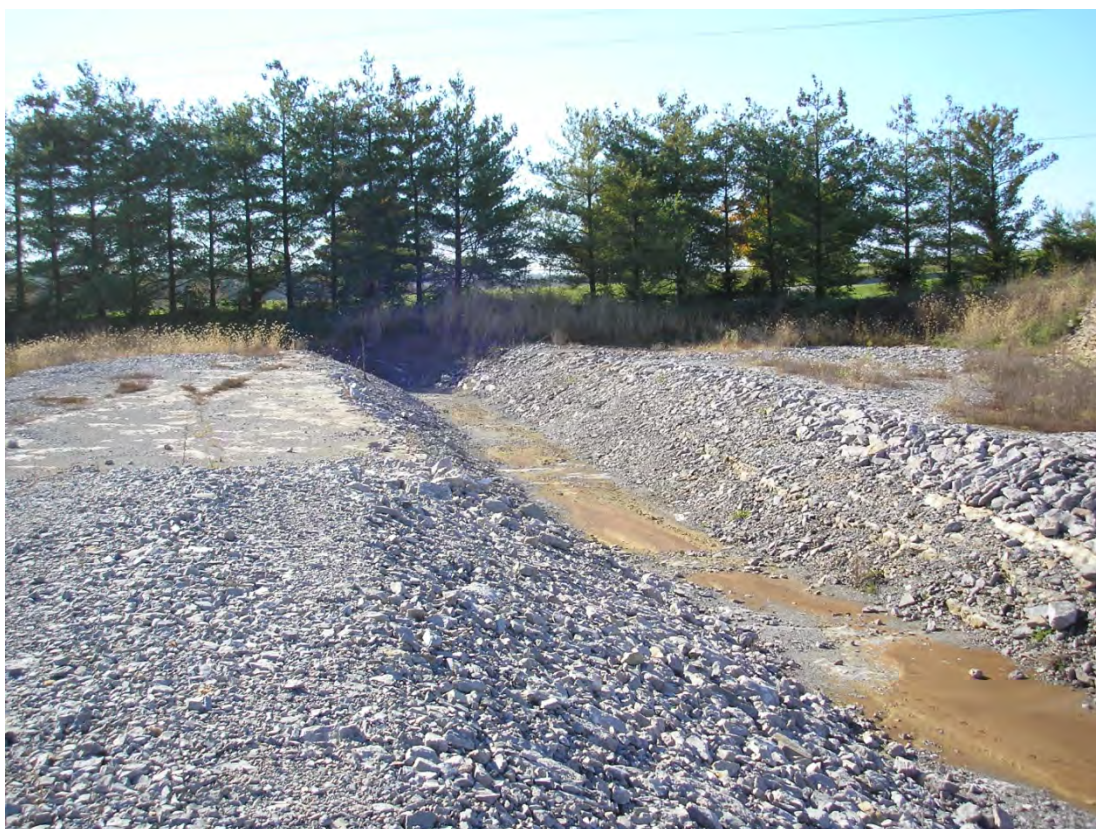
The dam has an emergency spillway in the form of an open channel that is excavated through the overburden and blasted rock at the southwest end of the dam. The emergency spillway is trapezoidal in cross section and acts as a broad crested weir. According to the available drawings (see Appendix A- Doc 79) the bottom width of the spillway is 8 ft. and side slopes are 2(H):1(V). The invert of the spillway is at 876 ft. Per the hydrologic and hydraulic review (Appendix A - Doc 02) data the emergency spillway discharge at the dam crest elevation of 880 ft is 238 cfs which when combined with 71 cfs discharge from the principal spillway results in a total discharge value of approximately 309 cfs. Photo Numbers 108 - 113 in Appendix B show the emergency spillway. Figure 5.3.3-1 shows the trapezoidal emergency spillway excavated at the southwest end of the dam.

The emergency spillway appeared to be in good condition with no sign of clogging.

Figure 5.3.3-1. Emergency Spillway at the Southwest end of Dam.
