Coal Combustion Waste Impoundment

Task 3- Dam Assessment Report

E. W. Brown Plant

Main Fly Ash Pond Dam

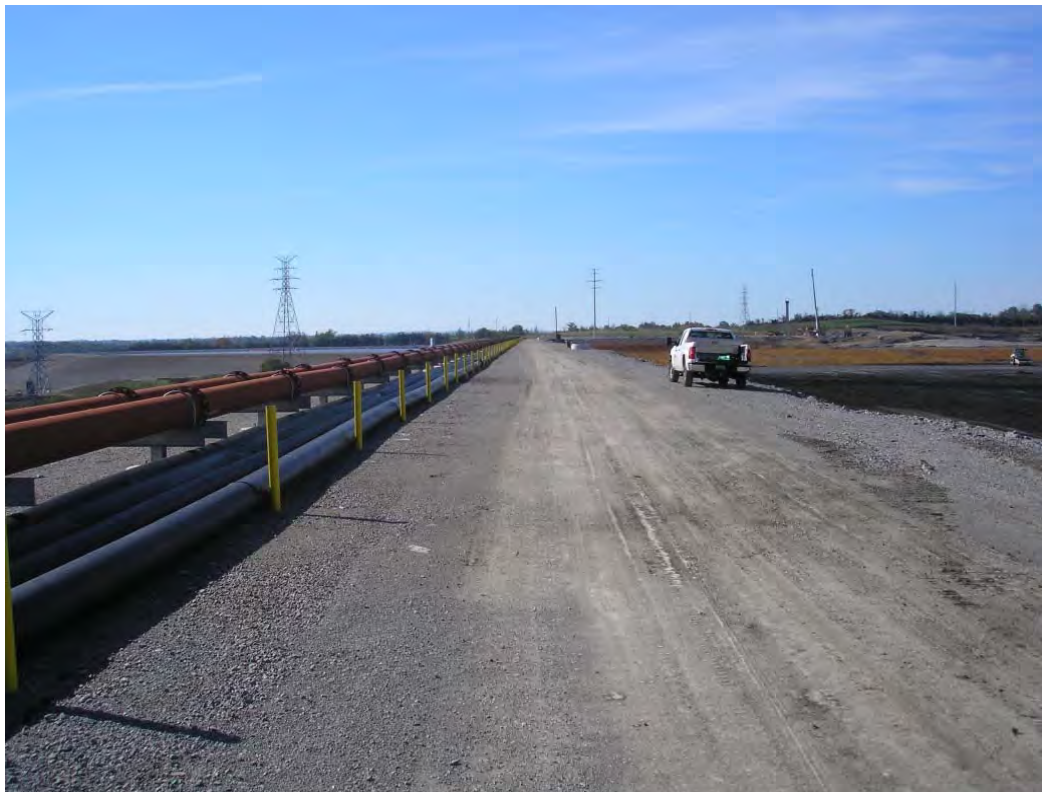
The crest of the existing dam had no signs of any depressions, tension cracks or other indications of settlement or shear failure, and appeared to be in satisfactory condition. Figure 5.2.1-1 shows the crest of the existing Main Fly Ash Pond Dam.

Figure 5.2.1-1 Crest of Main Fly Ash Pond Dam Looking Westward.

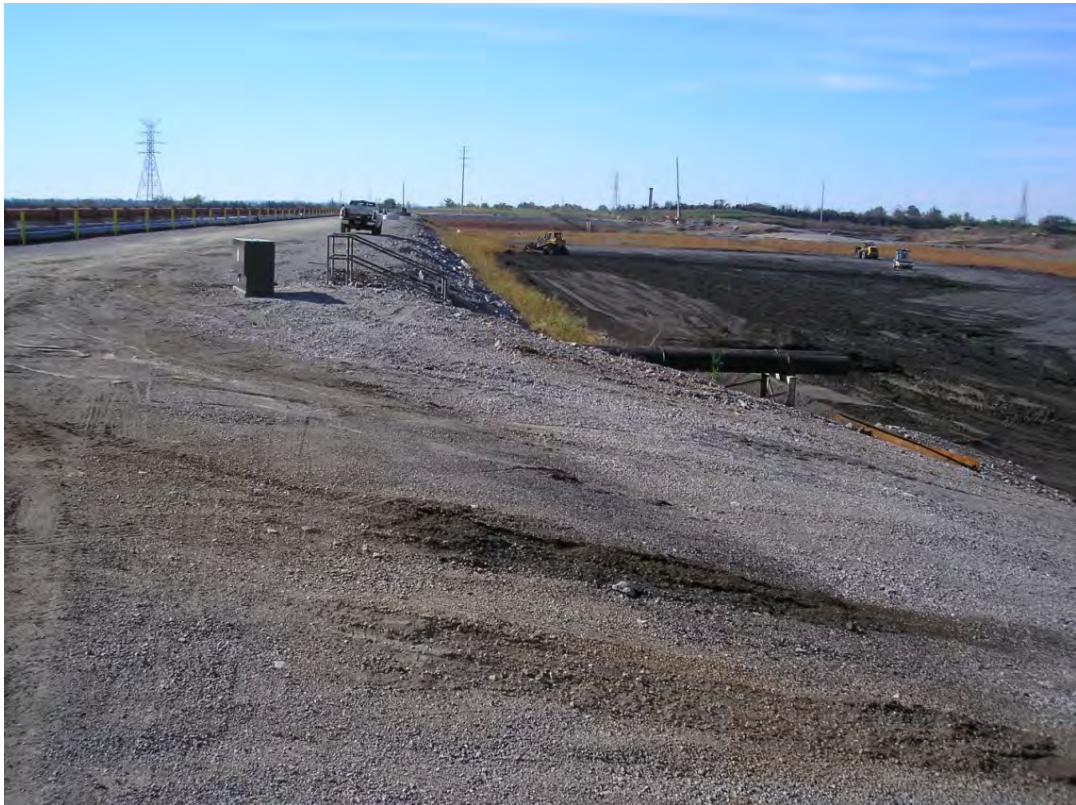
The upstream slope mostly consists of unprotected compacted soil. Figure 5.2.2-1 shows the upstream slope of the existing embankment on the south side of the impoundment. Scarps, sloughs, bulging, cracks, scarp, depressions, or other indications of slope instability or signs of erosion were not observed. The less steep slope in the foreground of the photograph is an access ramp for construction equipment working in the out-of-service impoundment.

Figure 5.2.2-1. The Upstream Slope of the Main Dam (the Embankment on the Left Side of the Picture)

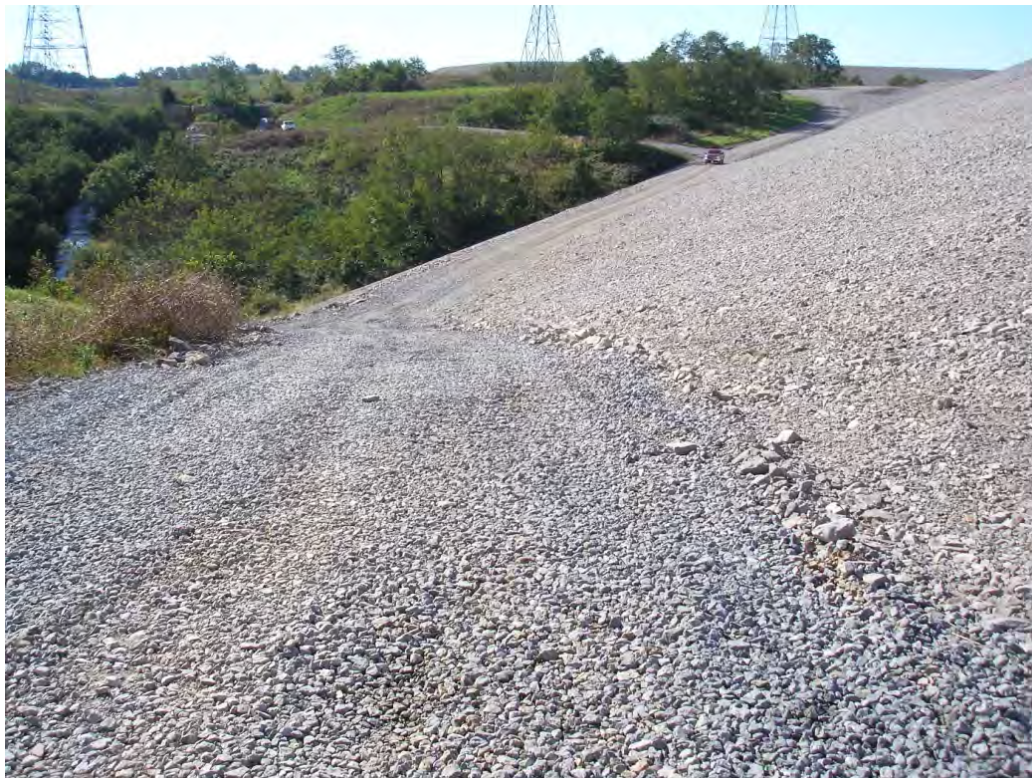
The downstream slope is protected with graded stone aggregate. Scarps, sloughs, depressions or other indications of slope instability or signs of erosion or uncontrolled seepage were not observed. Figure 5.2.3-1 shows the downstream slope at the southeastern side of the impoundment, the highest portion of the dam. Figure 5.2.3-2 shows the downstream slope along the northeastern side of the impoundment.

Figure 5.2.3-1. Downstream Slope at the Southeast Side of Impoundment

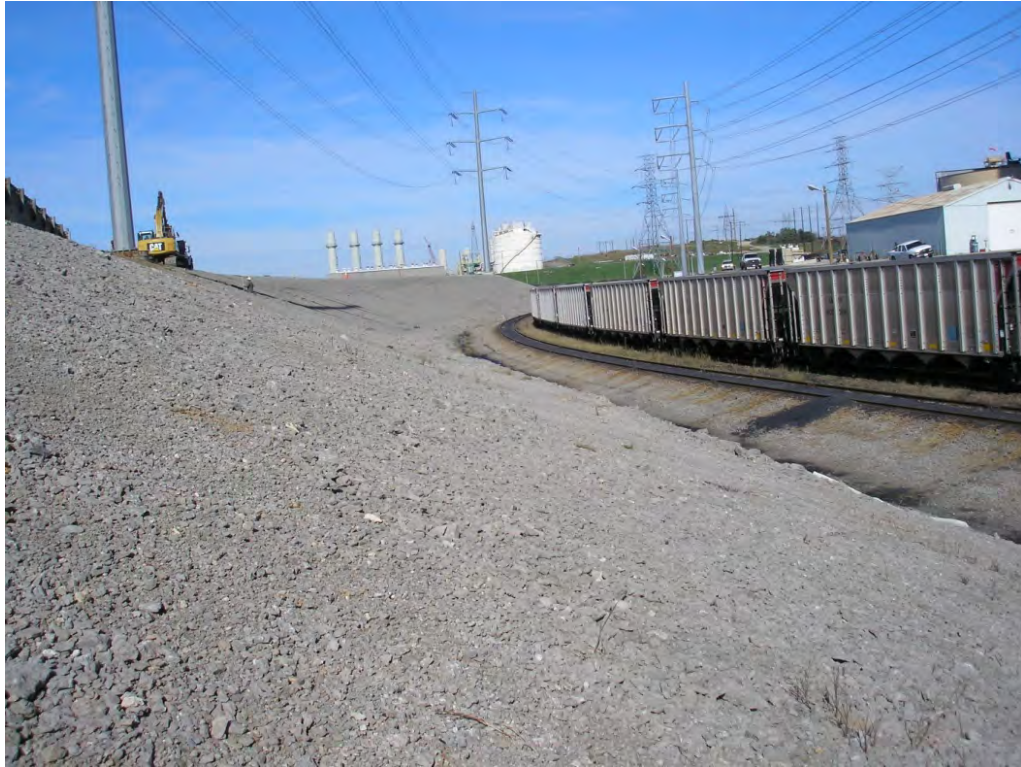
Figure 5.2.3-2. Downstream Slope at the Northeast Side of Impoundment

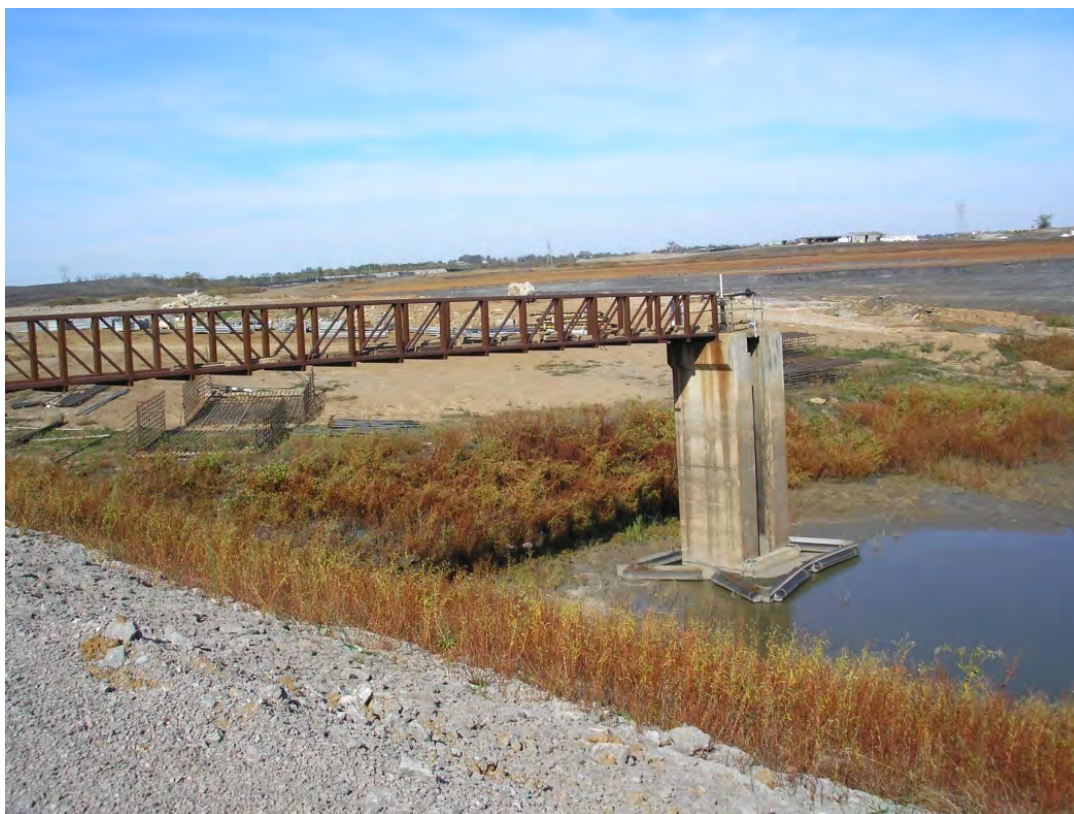
The existing primary spillway consists of a vertical decant riser and a 24-inch diameter corrugated metal discharge pipe (Figure 5.3.1-1). As the pond is currently out of service no water was flowing through the primary spillway at the time of Dewberry's inspection. The primary riser is scheduled to be grouted and abandoned as part of the current expansion and reconfiguration construction.

Figure 5.3.1-1. Existing Primary Spillway Structure.

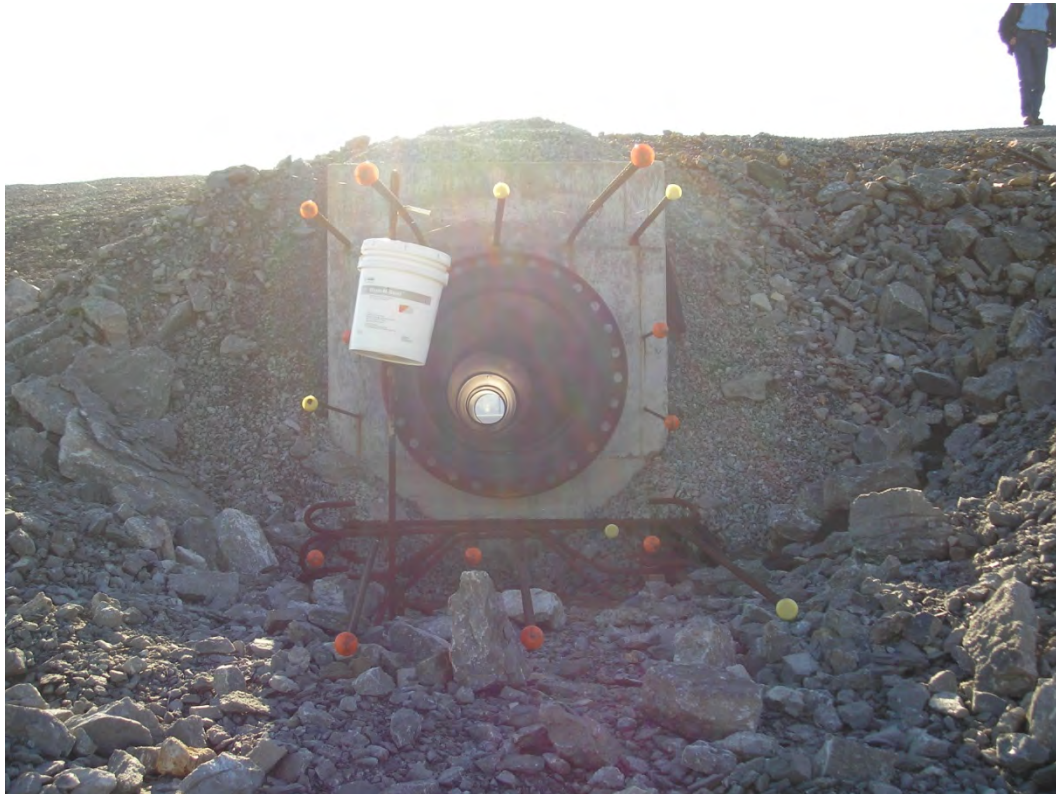
The existing emergency spillway has been abandoned. The new emergency spillway for the reconfigured Main Fly Ash Pond is a piped spillway into the adjacent Auxiliary Fly Ash Pond. Figure 5.3.2-1 shows the new emergency spillway discharge end at the Auxiliary Fly Ash Pond.

Figure 5.3.2-1. New Emergency Spillway from Reconfigured Main Fly Ash Pond to Auxiliary Fly Ash Pond (Discharge End Shown)
