# Assessment of Dam Safety Coal Combustion Surface Impoundments (Task 3) Draft Report

**Kentucky Utilities**

**Ghent Generating Station**

December 8, 2009

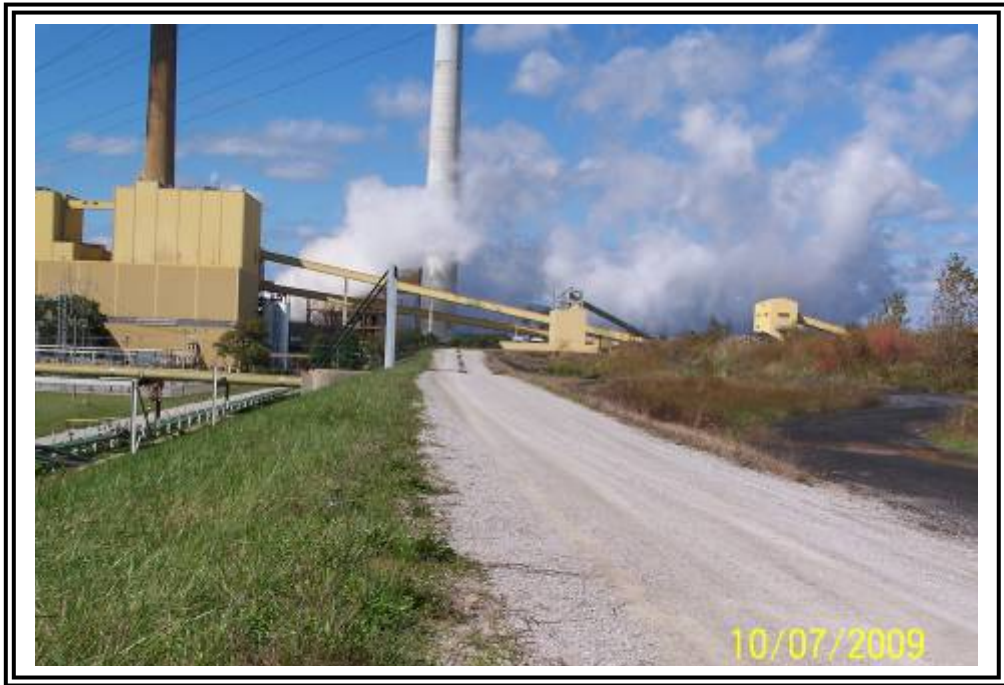
1

Crest of west dike ATB #1 looking north, "bumpiness" from buried sluice pipe crossing.

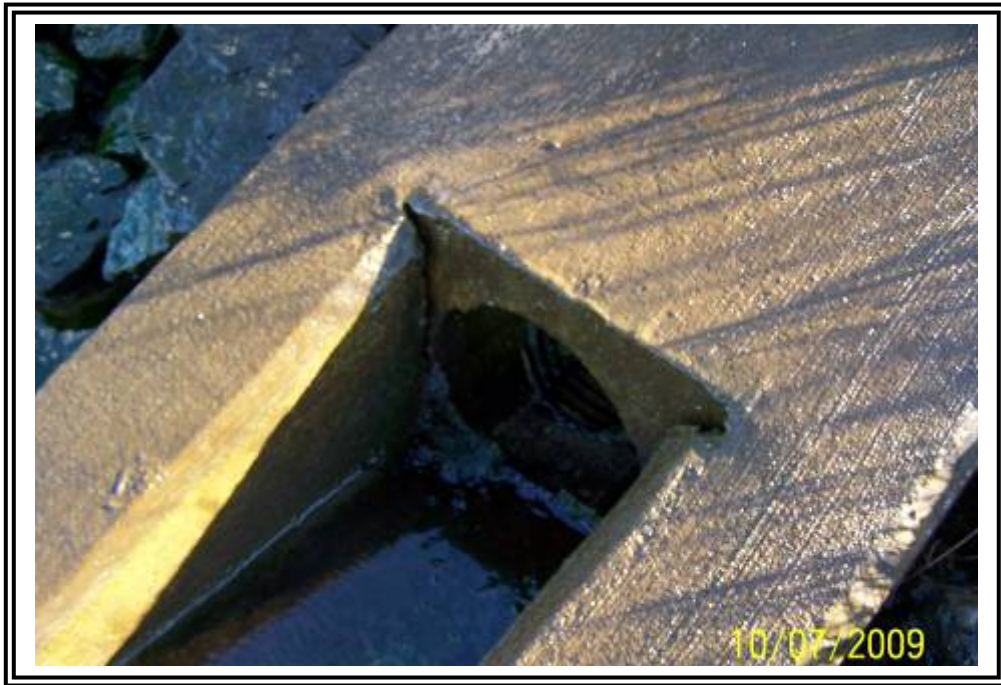
23

Toe drain at northeast corner of ATB #1. No apparent flow, concrete is wet from splash from outlet pipe.

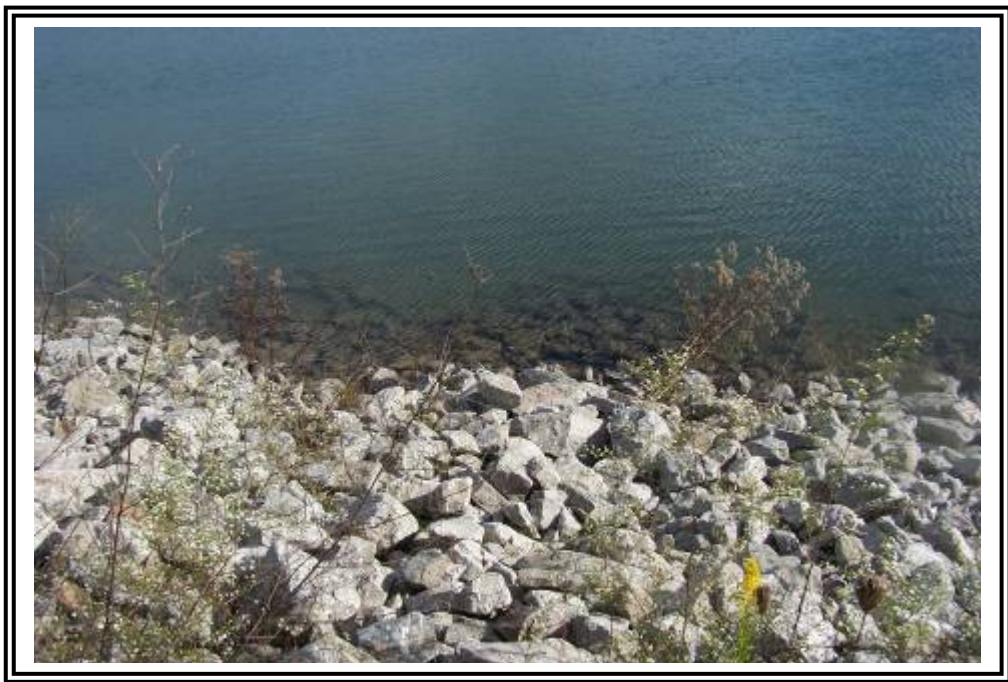
28

Rip rap protection on upstream slope of ATB #2 extends below the normal pool elevation.

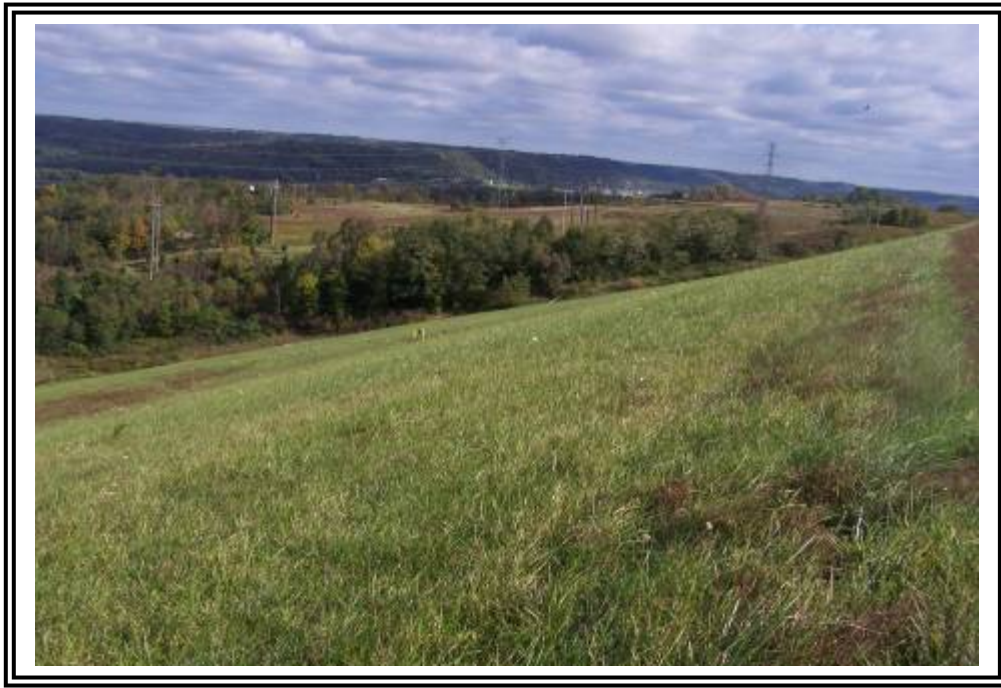
47

Upper portion of downstream slope of ATB #2 looking northeast. Instrumentation marked with yellow bollards, horizontal benched in main section of Dike at 50 vertical foot increments. .

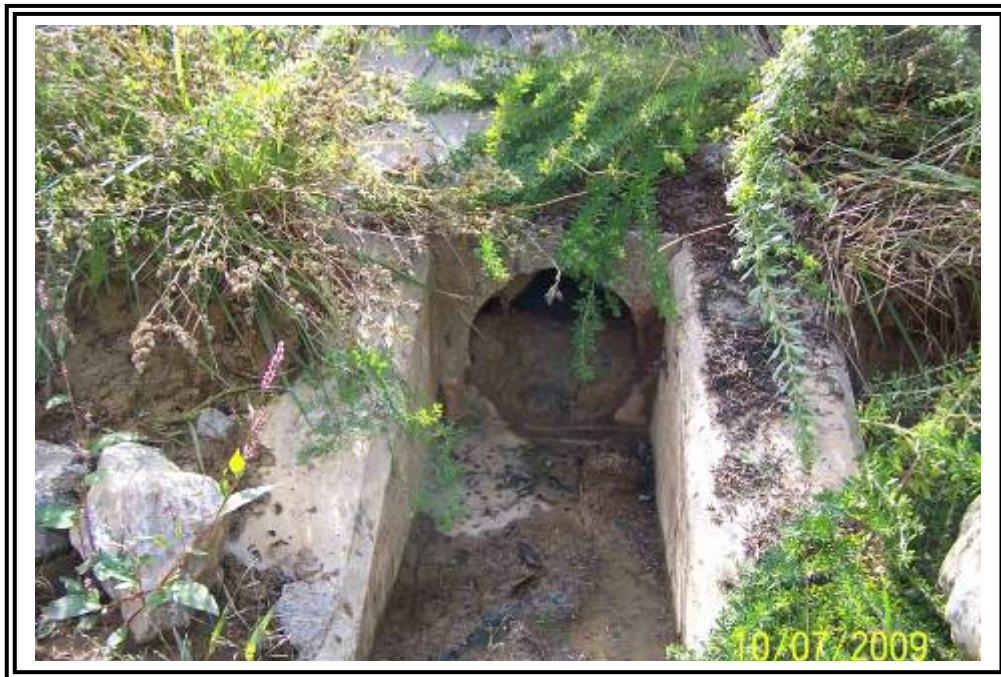
60

Toe drain on east side of secondary drainage fill about ¾ clogged at outlet. Signs of erosion on slopes around outlet so unclear if sediment is from pipe or other causes.

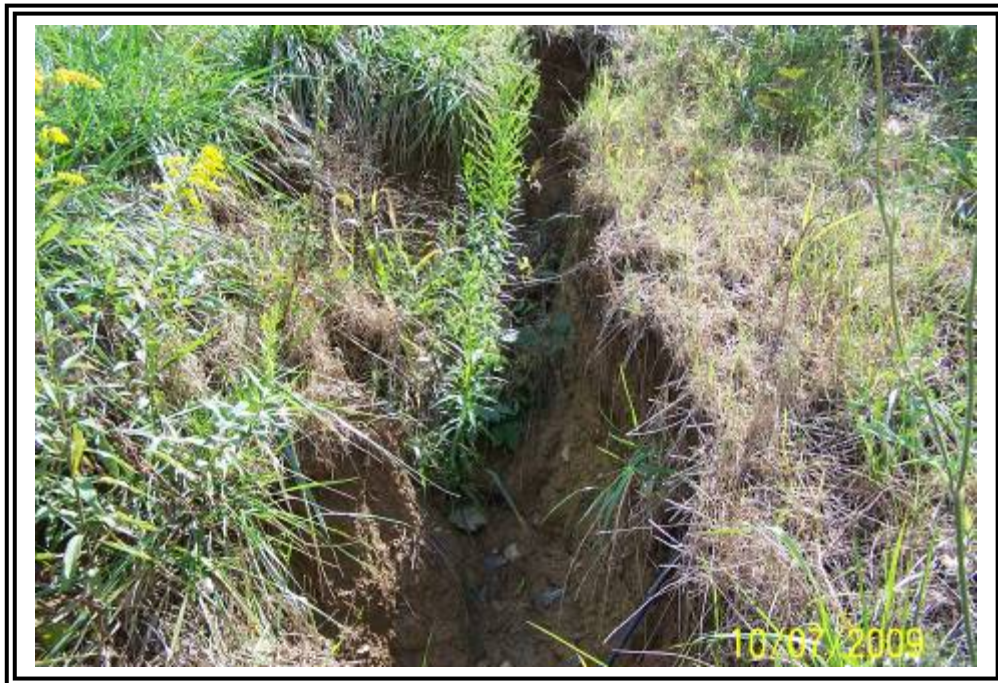
70

Erosion cut gully in west side of main fill about midway up slope from the base. About 2 feet deep.

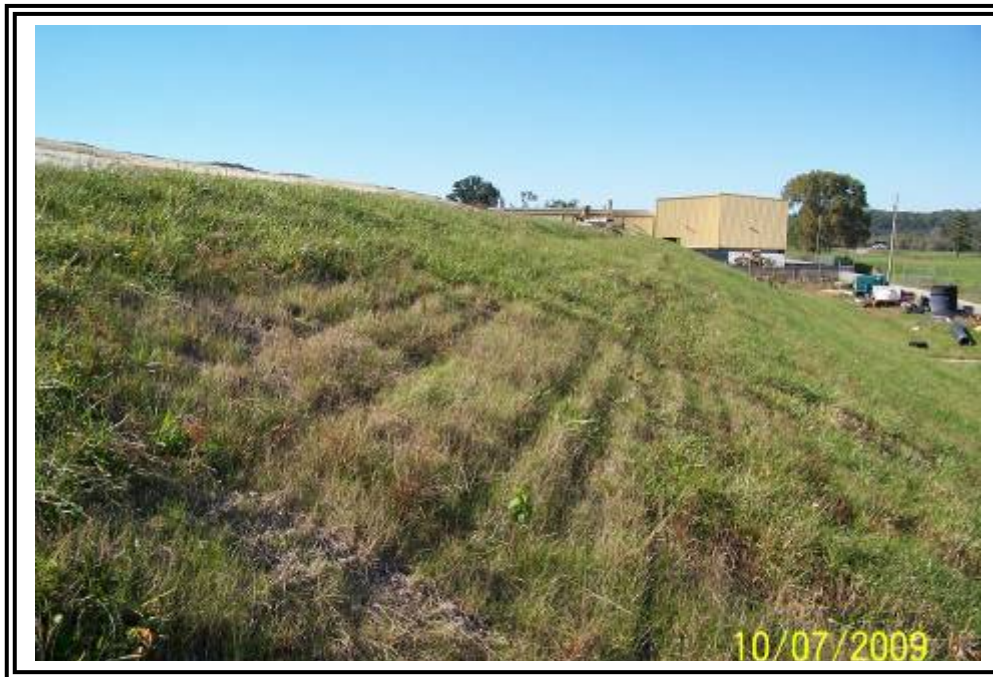
102

Area of repaired surficial slough on the east side of the gypsum stacking facility starter dike. Slough occurred and was repaired in Spring 2009.
