**Pennsylvania Department of Environmental Protection's Comments On:
Draft Report – Little Blue Run Dam Inspection Report
Bruce Mansfield Power Plant
Beaver County, Pennsylvania**

The Draft Report has been prepared for the U.S. Environmental Protection Agency, Washington, D.C., by CHA.

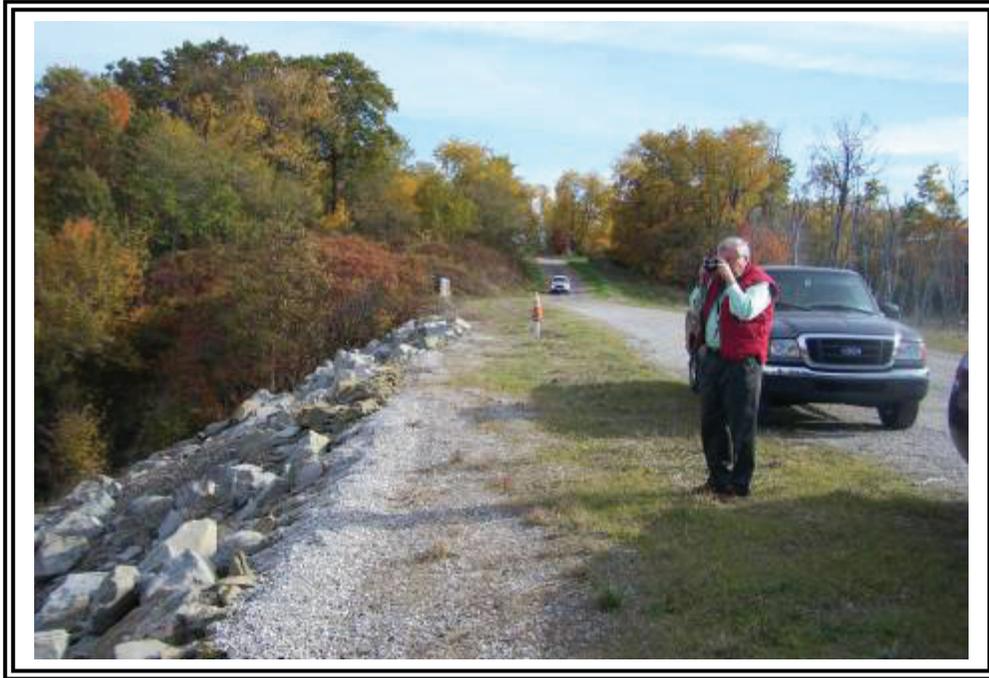
1

East abutment, looking east.

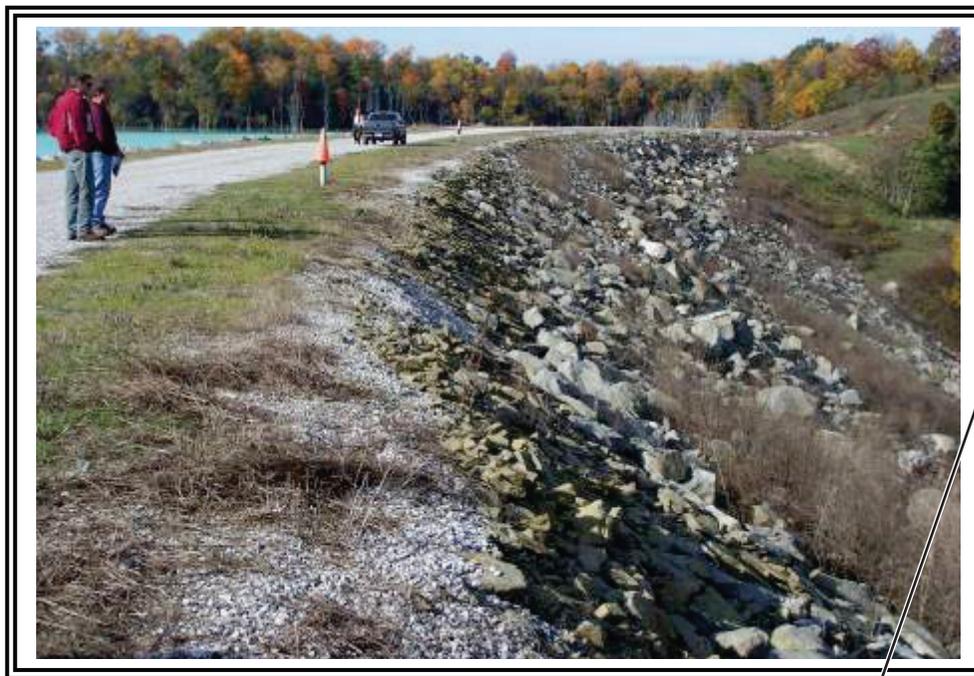
8

Crest elevation re-establishment made with darker stone and gravel.

The crest elevation and 2-foot camber was made by adding 0-3.5 feet of rock fill to the top of the dam and rip rap slope protection to the upstream and downstream slope.

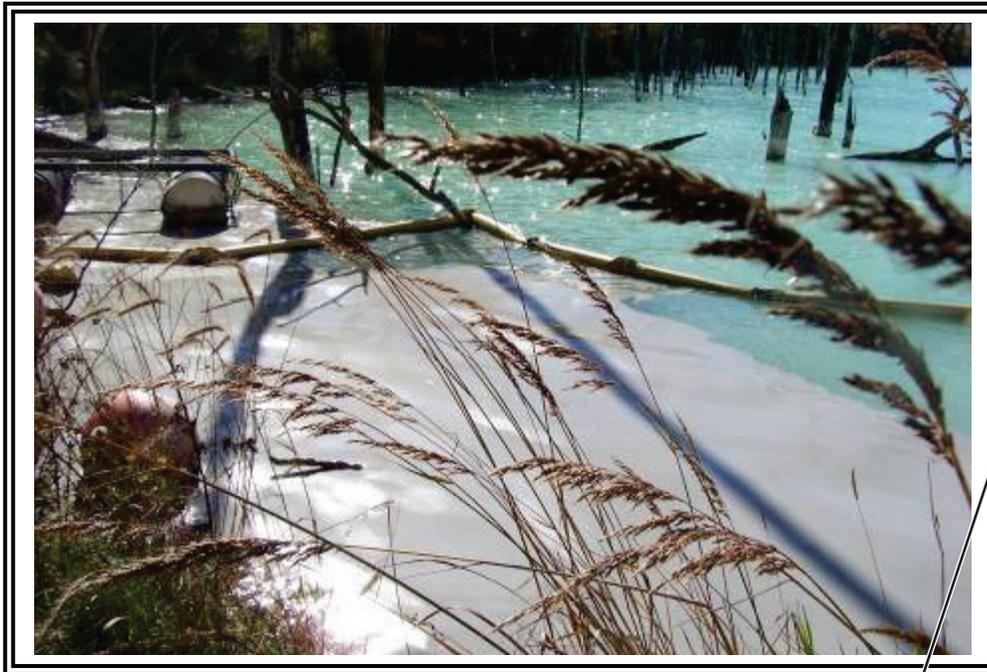
22

Area of secondary spillway intake. Pipe was submerged during our sit visit.

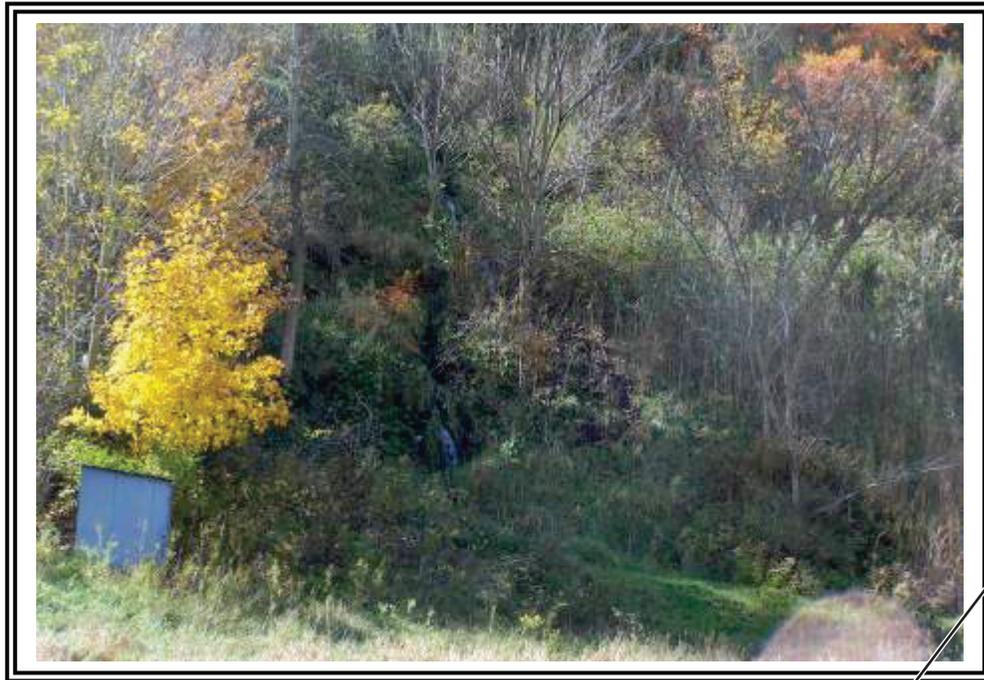
During the site visit, First Energy and GAI representatives pointed out areas previously repaired on the west ~~embankment-abutment contact~~ where surface sloughing and sliding of surficial soils had occurred in the location of an access road some years ago (Photos 6, 12 and 13). Seepage that is directed to weirs for monitoring was observed on the west abutment (Photos No. 27 and 33). The east abutment was also observed (Photo Nos. 1, 10, and 11).

West abutment seepage.

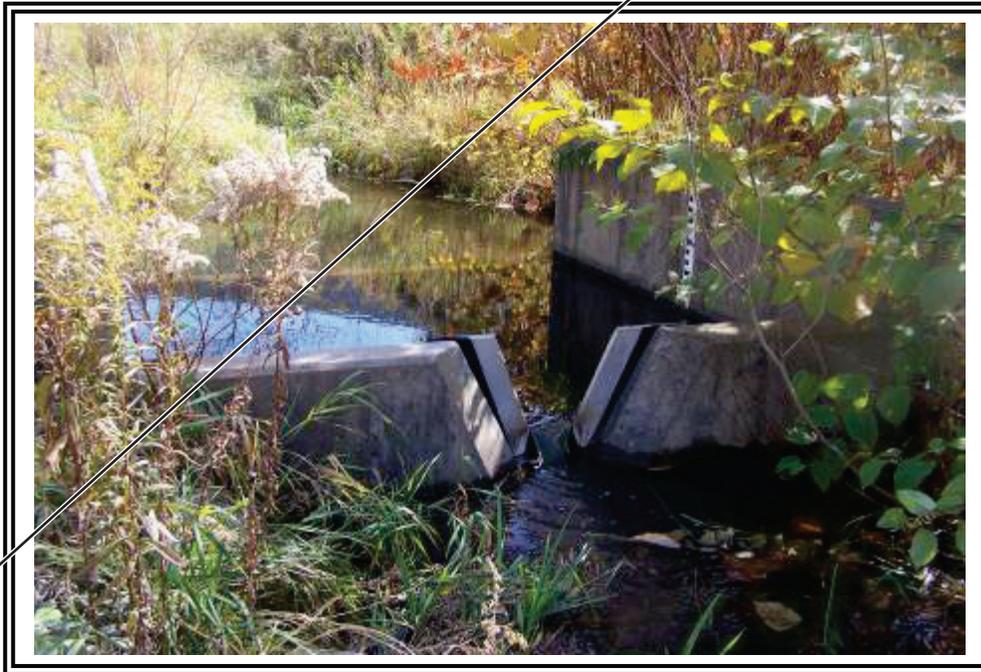
30

weir (ULA) was clogged causing back-flow in to the weir structure (Photo No. 30). The Parshall Flume toe drain (TD) which is a monitoring point for blanket drain seepage was also observed (Photo Nos. 28 and 29).

V-notch monitoring weir for west abutment seepage monitoring. Clogged culvert was causing back flow during our site visit.

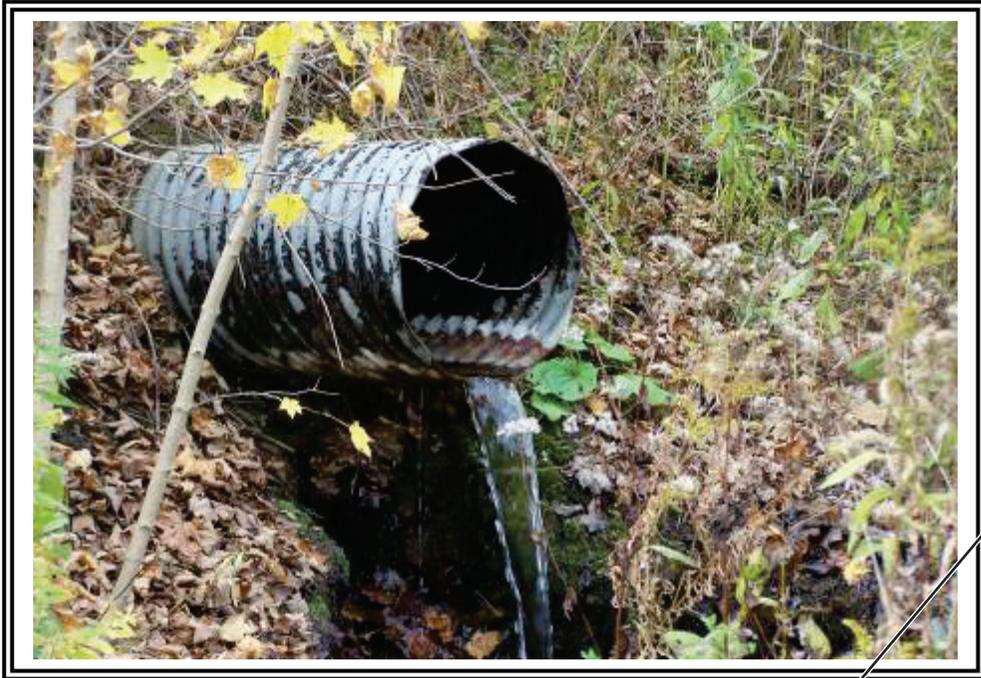
33

Lower left (west) abutment seepage. This natural seepage maintains flow in Little Blue Run per permit conditions.

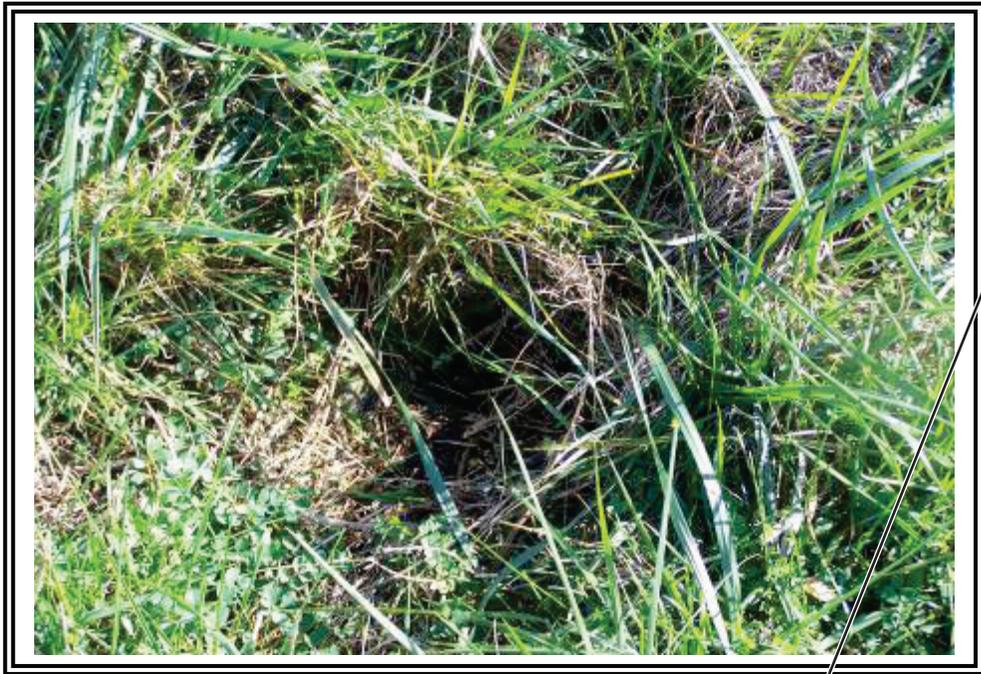
38

At the time of the site visit the Little Blue Run Dam was not impounding water. A gravel access road runs the length of the crest of the Little Blue Run Saddle Dam (Photo No. 36). The upstream and downstream embankment slopes are grass covered (Photo Nos. 37 and 39). A small rodent hole was observed on the upstream slope (Photo No. 38).

Small rodent hole on upstream slope of Little Blue Run Saddle Dam.

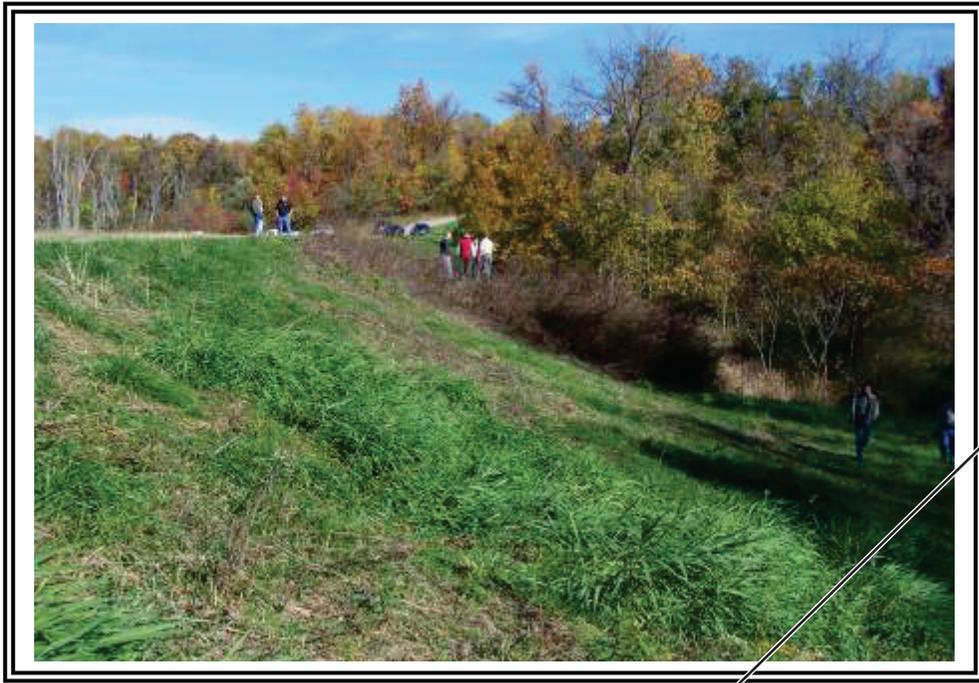
39

Downstream slope of Little Blue Run Saddle Dike, looking north.
Vegetation near group of people on slope consists of material that the mower cannot traverse.

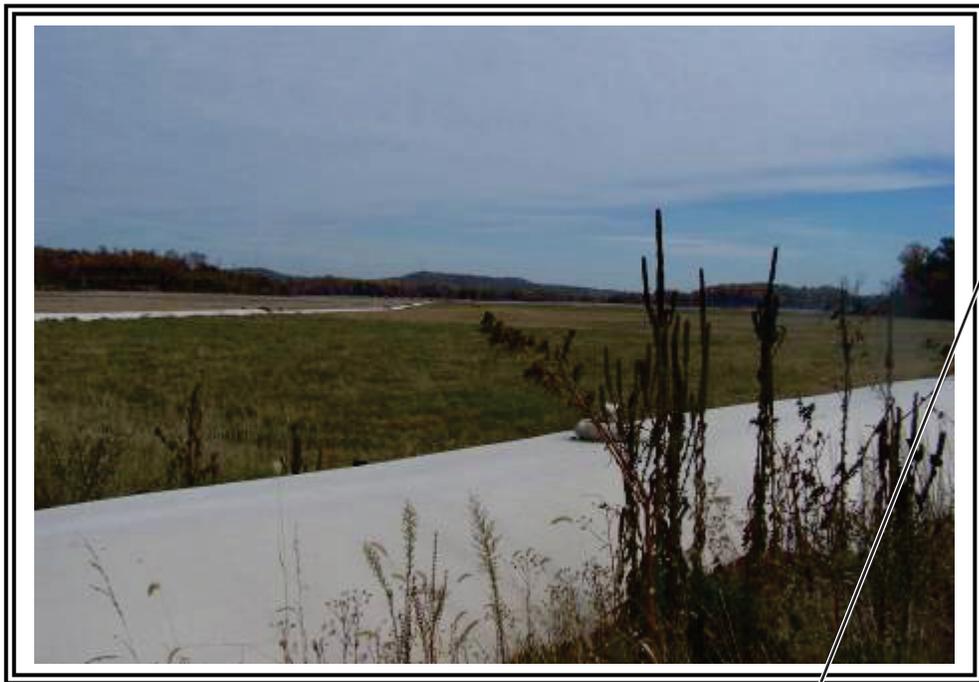
40

The Geotubes which were installed for vertical expansion of ~~the impoundment~~ without raising the elevation of the existing dam embankment were observed during the site visit (Photo No. 40).

Arrow points to state line. The photo is not at this location but does represent what a geotube looks like. 2

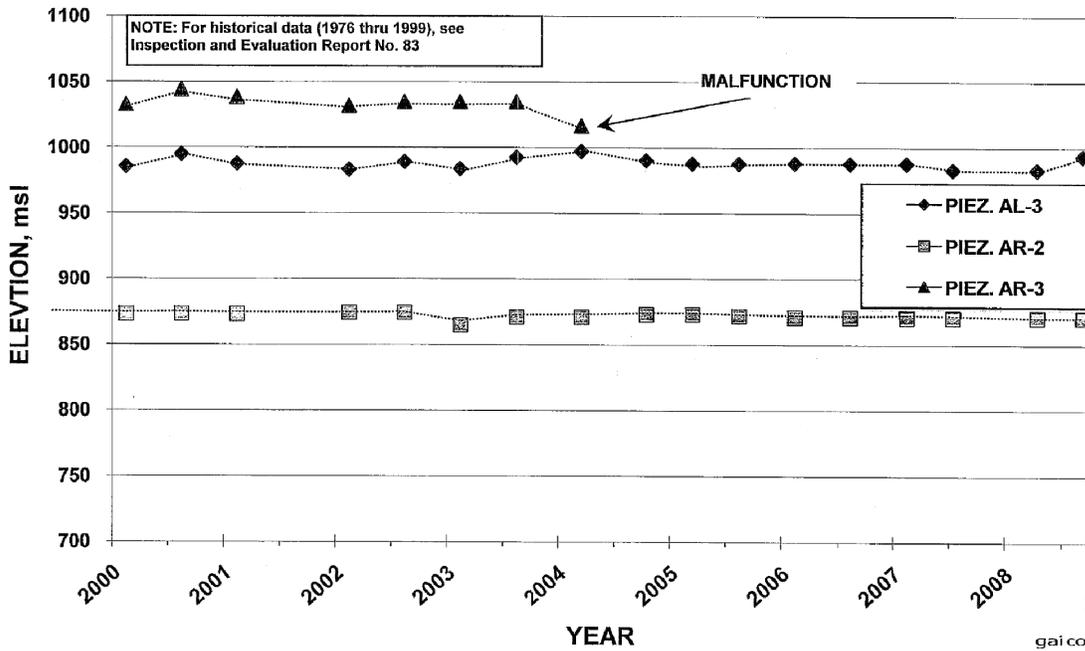
PROJECT NO. 20085.8000
DATE: 12/2009
FIGURE 11B

- Piezometers AL-3 and AR-2 monitor pore pressures near claystone interfaces, which is considered to be relatively weak zones within the abutment foundation. Piezometer AL-3 showed a sharp increase in pore pressure from the previous reading. Piezometer AR-2 showed no change in pore pressure from the previous readings. It was noted that both piezometers yield data below their specified limits but the piezometers continue to be suspect.
