Assessment of Dam Safety Coal Combustion Surface Impoundments (Task 3) Draft Report

FirstEnergy Generation
Corporation

Bruce Mansfield
Power Plant
Little Blue Run Dam
Shippingport, Pennsylvania

December 3, 2009

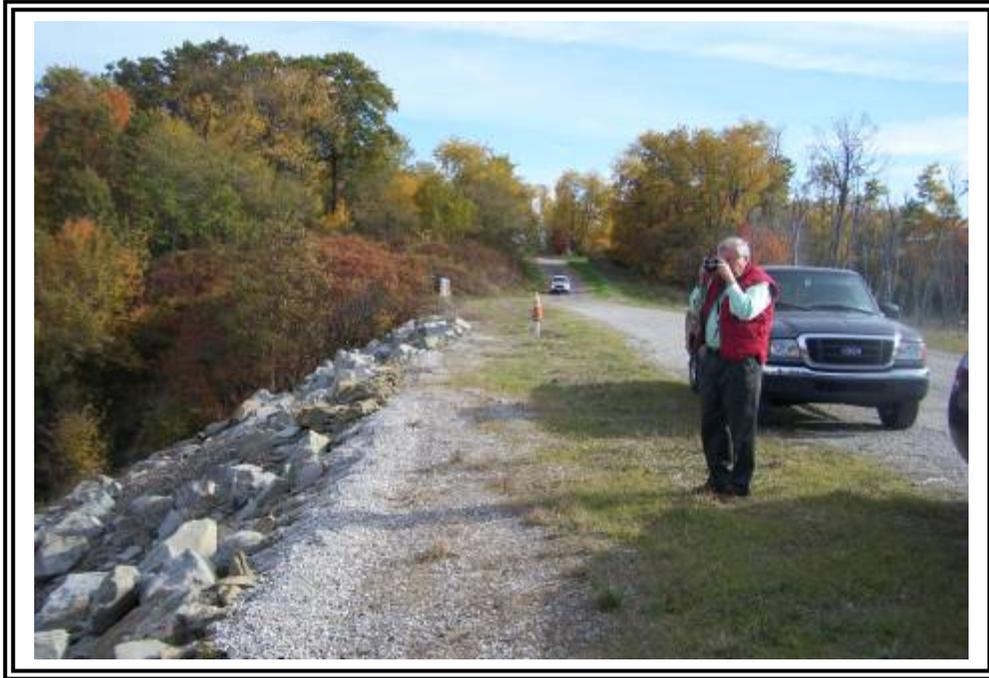
1

East abutment, looking east.

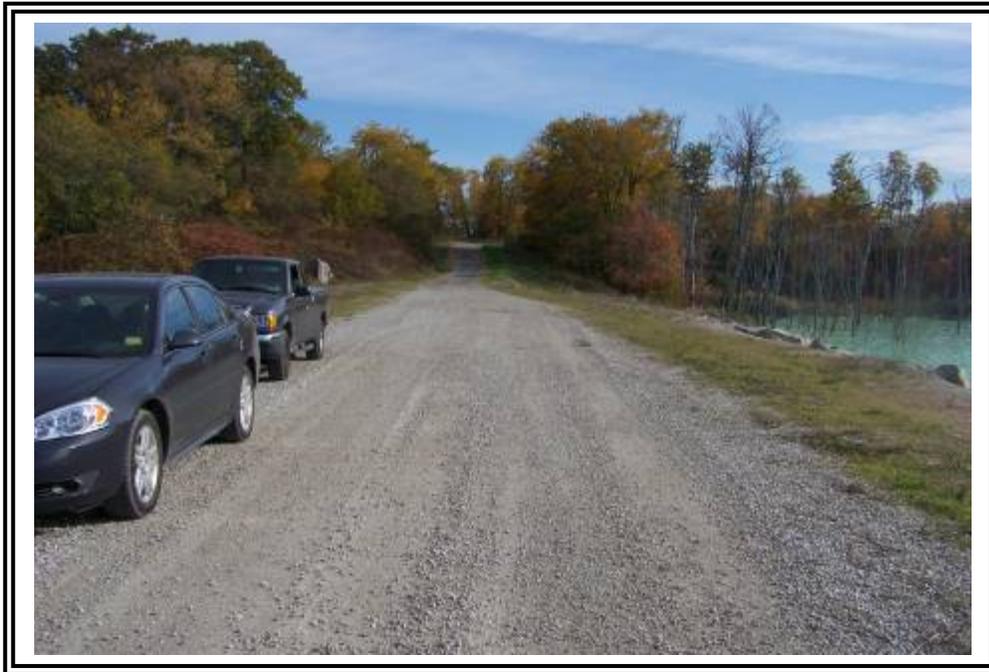
2

Crest and east abutment, looking east.

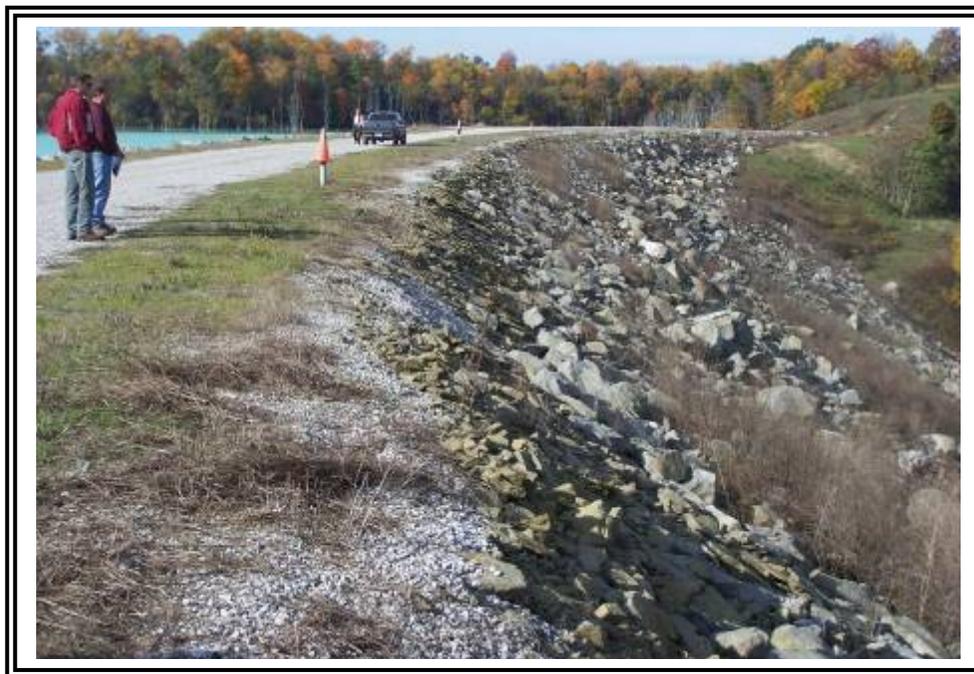
8

Crest elevation re-establishment made with darker stone and gravel.

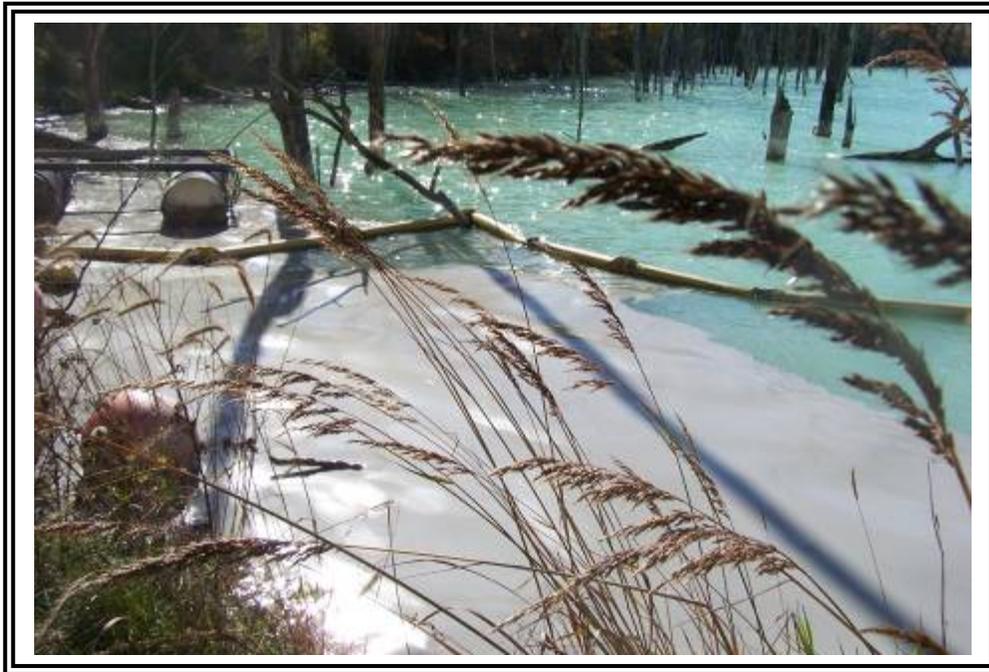
22

Area of secondary spillway intake. Pipe was submerged during our sit visit.

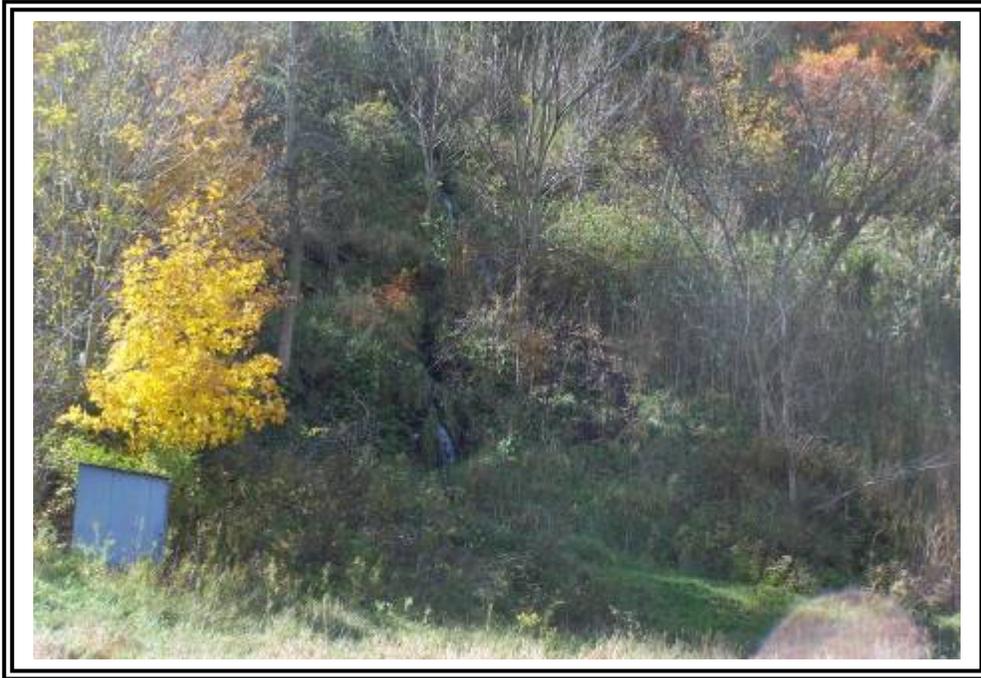
During the site visit, First Energy and GAI representatives pointed out areas previously repaired on the west embankment-abutment contact where surface sloughing and sliding of surficial soils had occurred in the location of an access road some years ago (Photos 6, 12 and 13). Seepage that is directed to weirs for monitoring was observed on the west abutment (Photos No. 27 and 33). The east abutment was also observed (Photo Nos. 1, 10, and 11).

West abutment seepage.

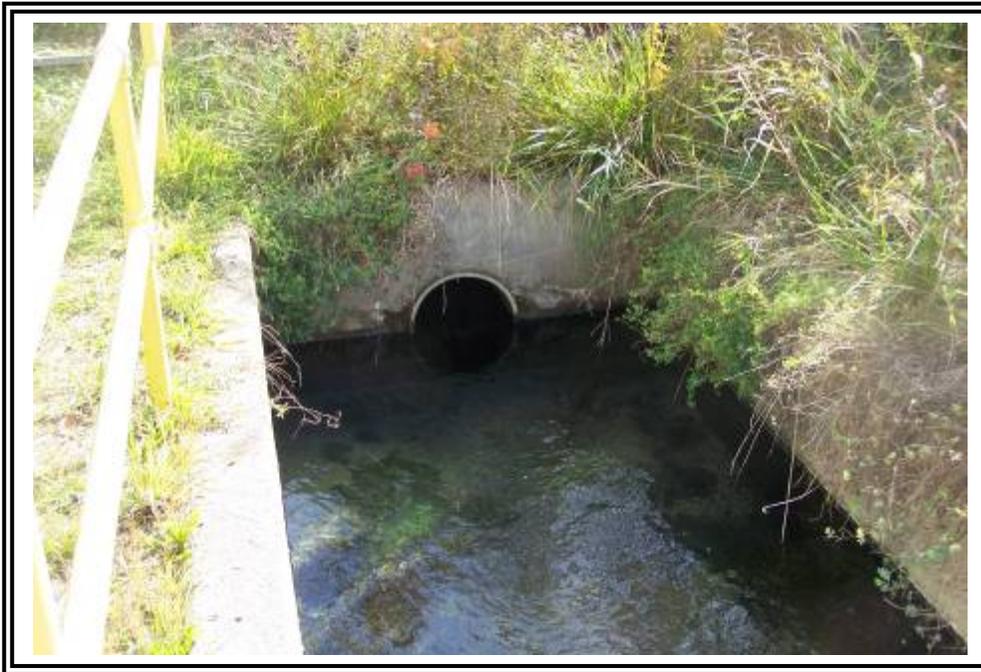
28

Toe drain collection pipe terminating in Parshall Flume.

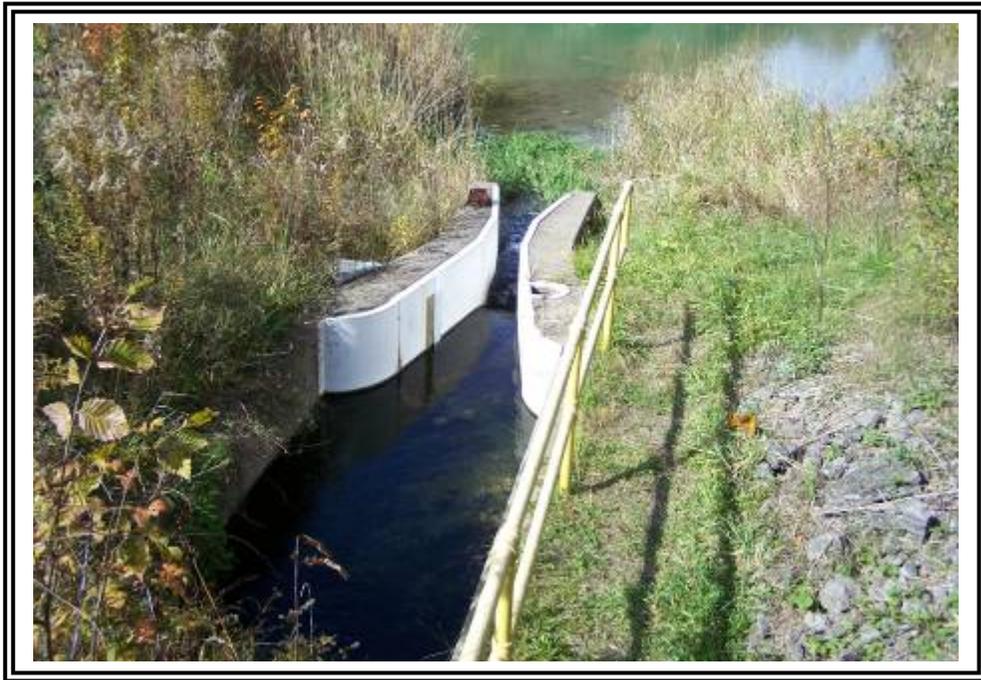
29

weir (ULA) was clogged causing back-flow in to the weir structure (Photo No. 30). The Parshall Flume toe drain (TD) which is a monitoring point for blanket drain seepage was also observed (Photo Nos. 28 and 29).

Parshall flume monitoring point for blanket drain seepage.

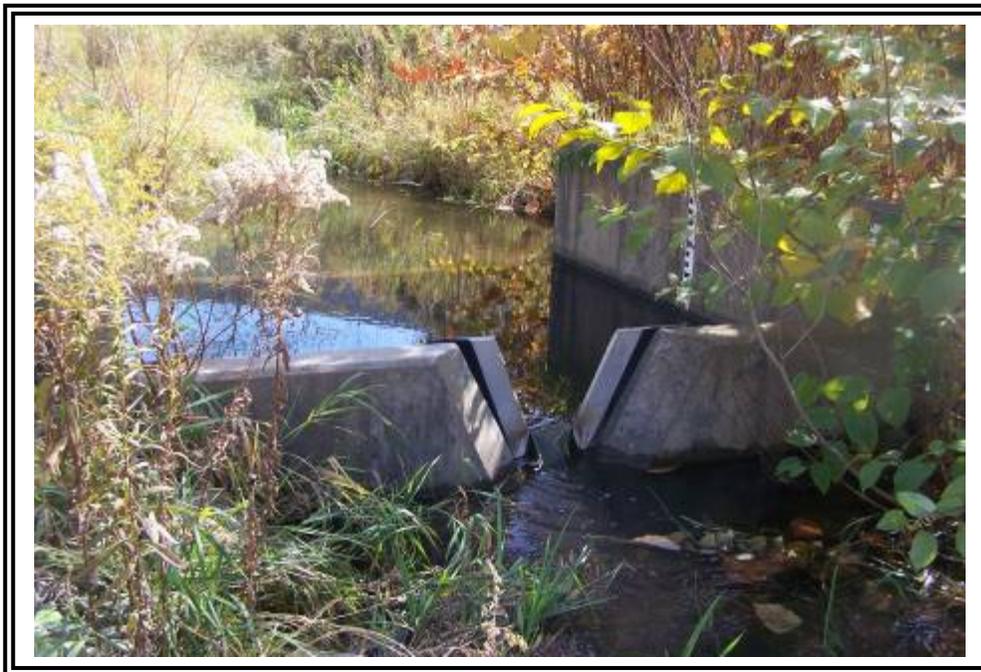
30

The weirs located on the left and right abutments to collect and monitor seepage discharges were observed. On the west abutment there are two weirs; the upper weir (ULA, Photo No. 30) and the lower weir (LLA, Photo No. 34) and on the right abutment there is one weir (RA, Photo No. 25). During the site visit it was observed that the culvert downstream of the west abutment upper

V-notch monitoring weir for west abutment seepage monitoring. Clogged culvert was causing back flow during our site visit.

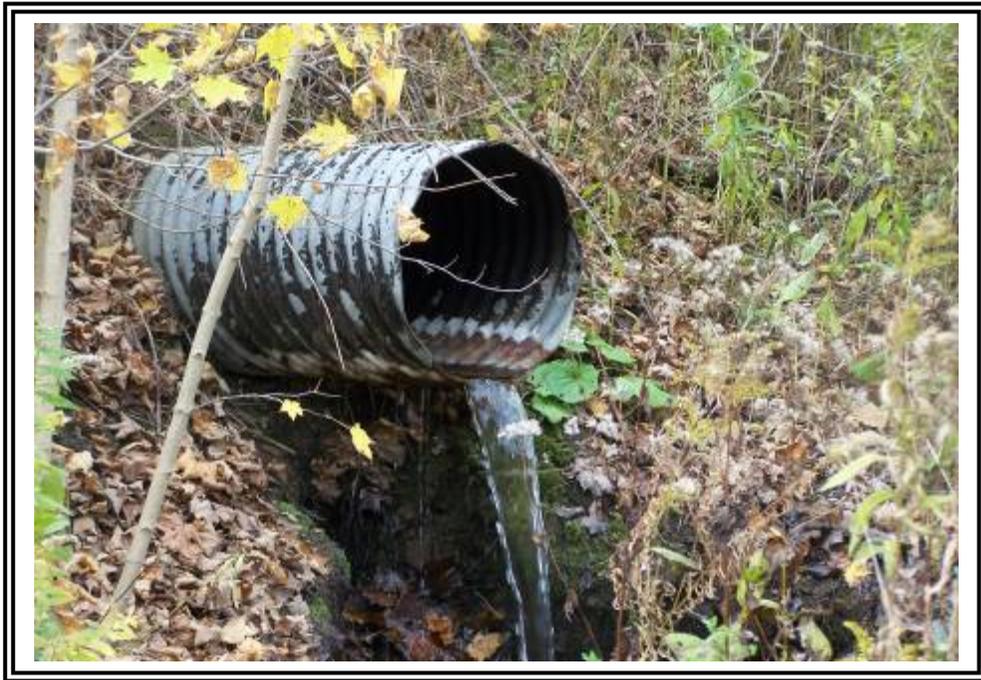
33

Lower left (west) abutment seepage. This natural seepage maintains flow in Little Blue Run per permit conditions.

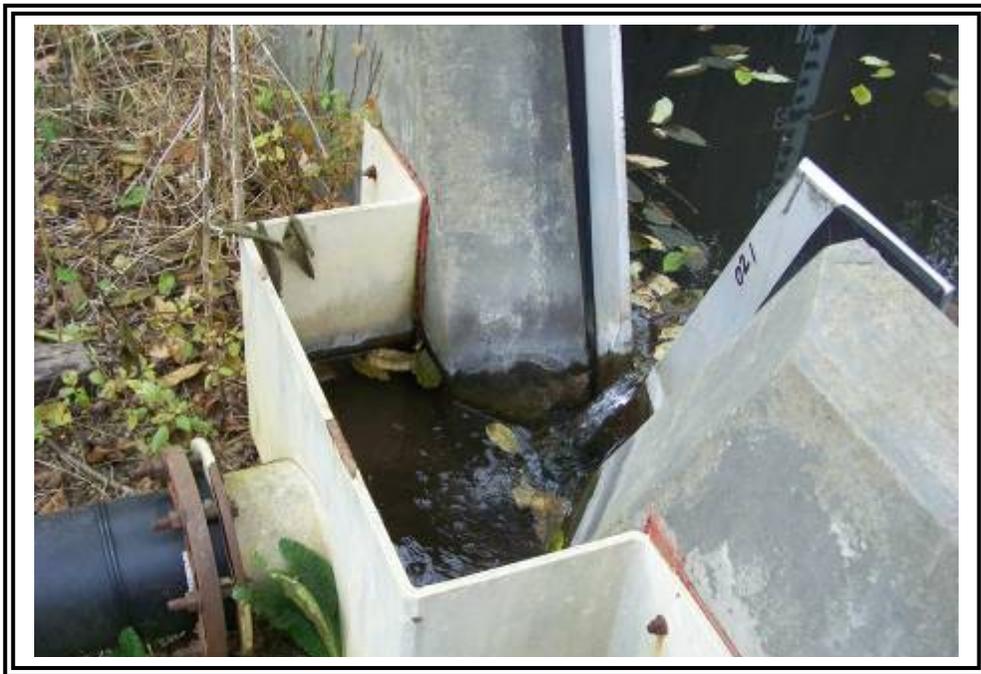
34

V-notch monitoring weir for lower left abutment seepage.

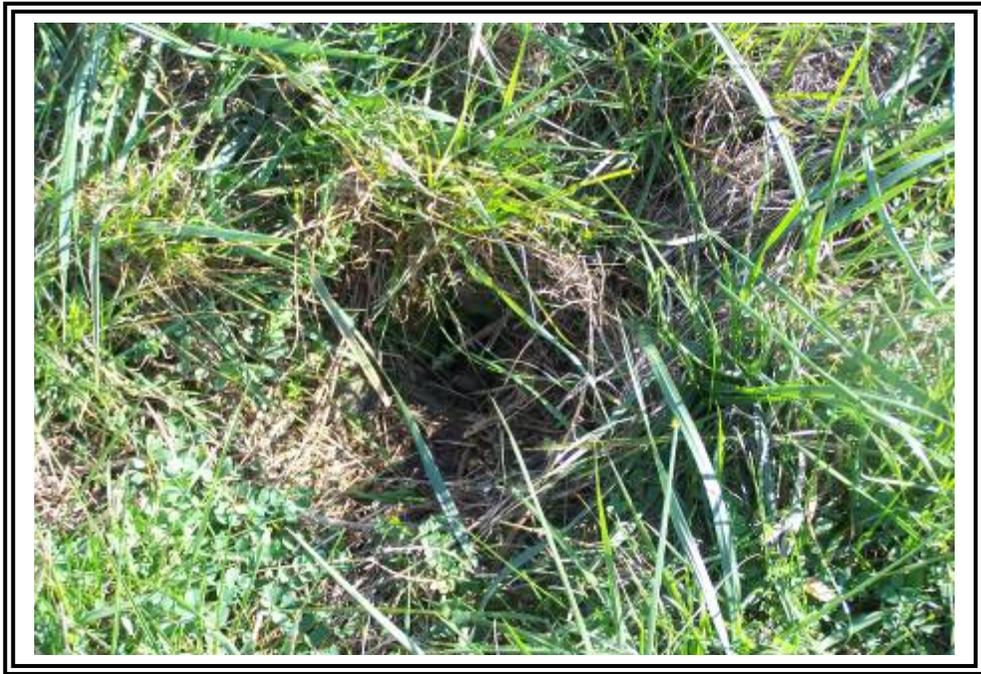
38

At the time of the site visit the Little Blue Run Dam was not impounding water. A gravel access road runs the length of the crest of the Little Blue Run Saddle Dam (Photo No. 36). The upstream and downstream embankment slopes are grass covered (Photo Nos. 37 and 39). A small rodent hole was observed on the upstream slope (Photo No. 38).

Small rodent hole on upstream slope of Little Blue Run Saddle Dike.

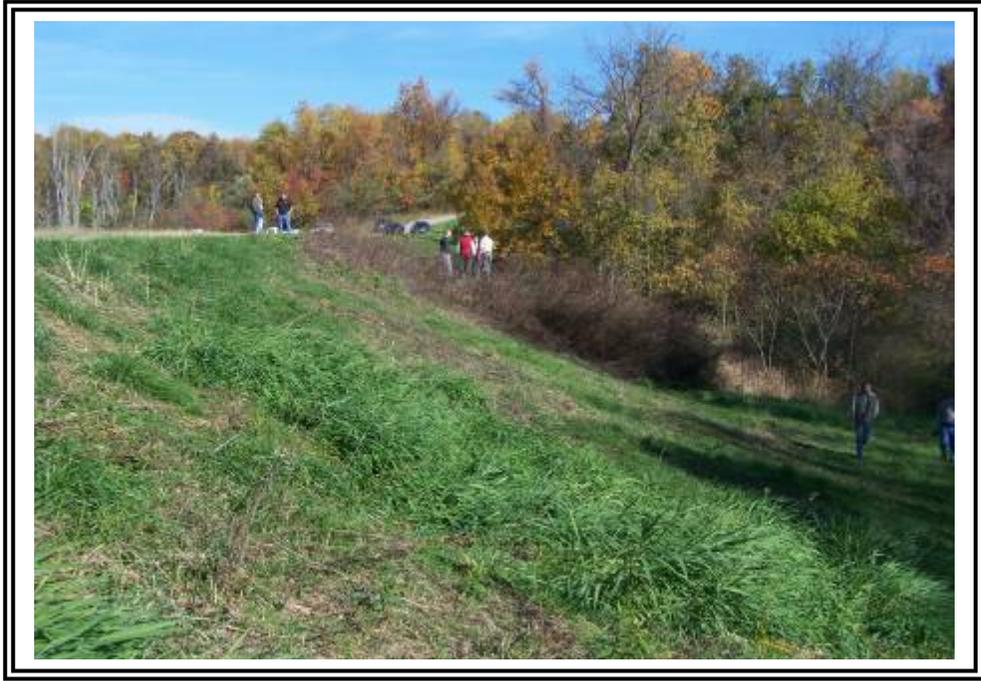
39

Downstream slope of Little Blue Run Saddle Dike, looking north.
Vegetation near group of people on slope consists of material that the mower cannot traverse.

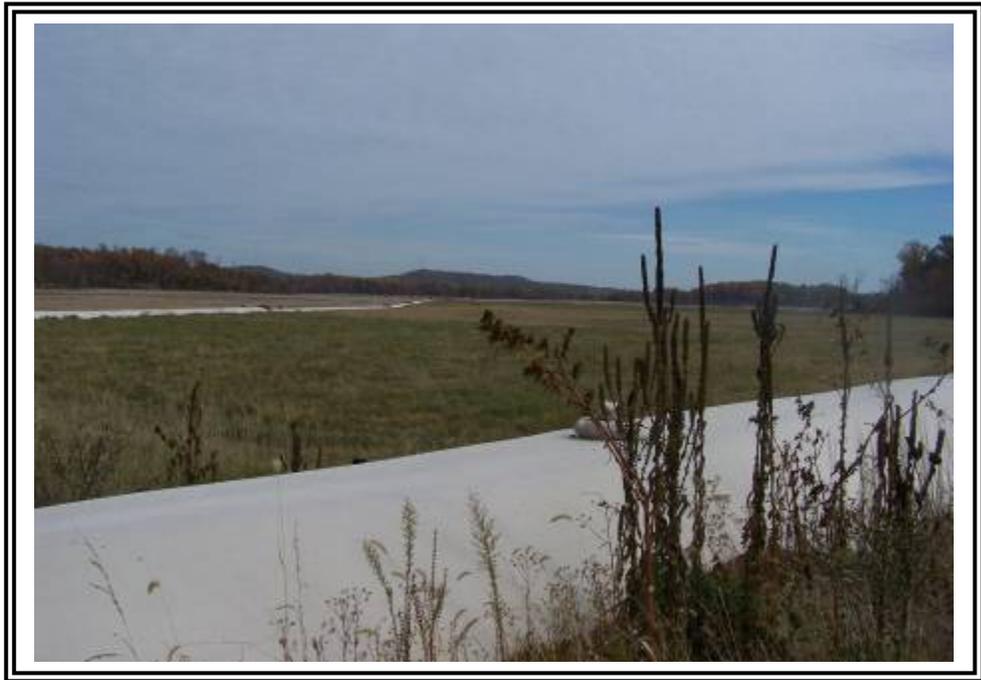
40

The Geotubes which were installed for vertical expansion of the impoundment without raising the elevation of the existing dam embankment were observed during the site visit (Photo No. 40).

Geotubes and dry ash placement at south end of reservoir.
