Assessment of Dam Safety

Coal Combustion Surface Impoundments (Task 3)

FirstEnergy Generation
Corporation

Bruce Mansfield
Power Plant
Little Blue Run Dam
Shippingport, Pennsylvania

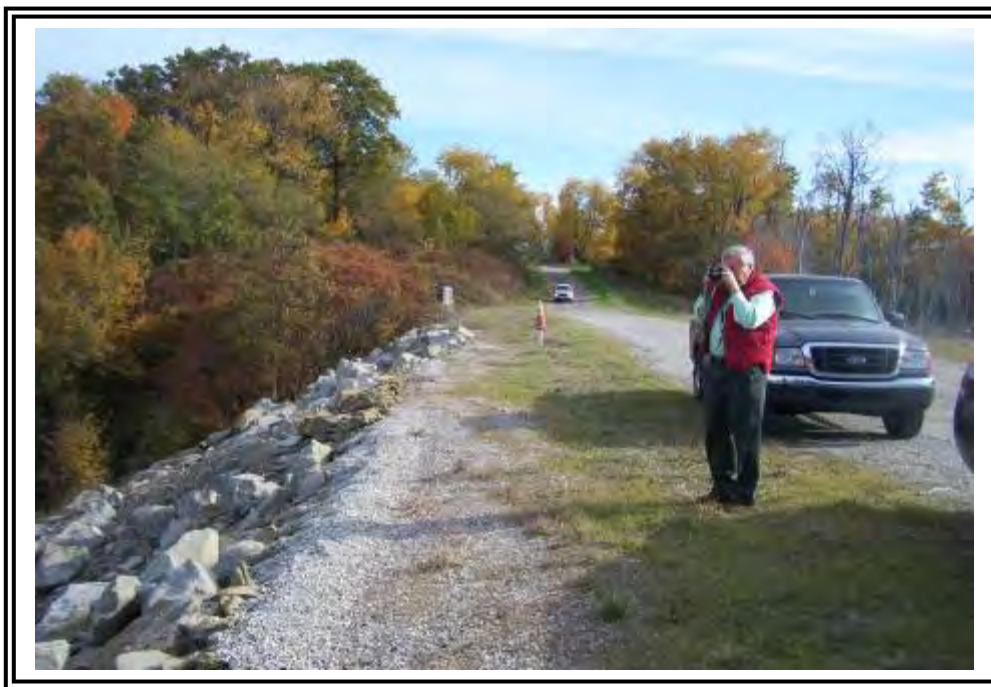
1

East abutment, looking east.

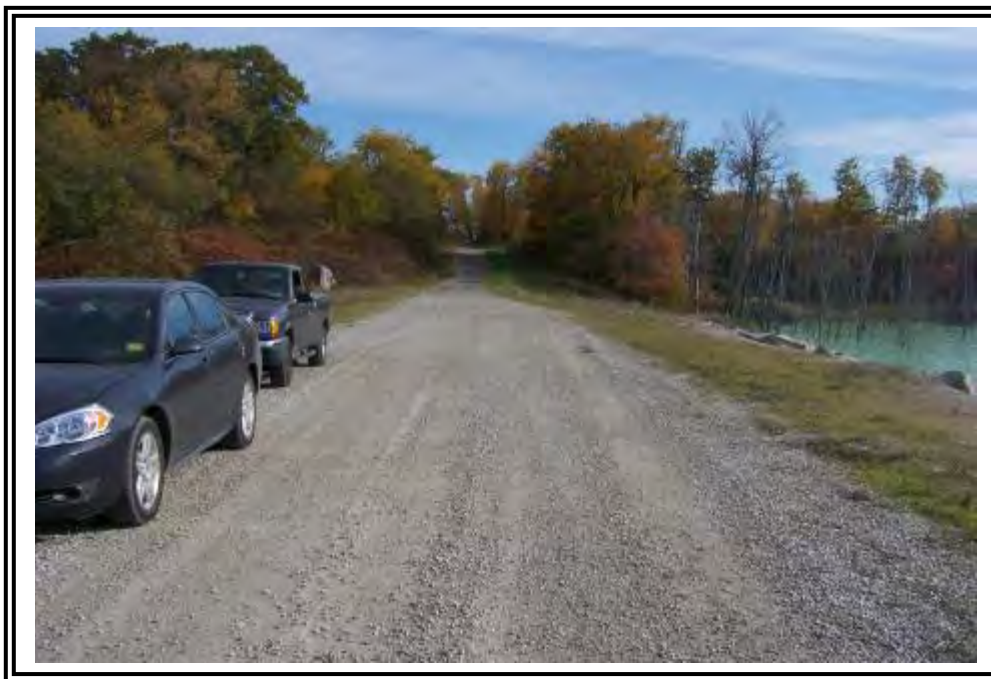
2

Crest and east abutment, looking east.

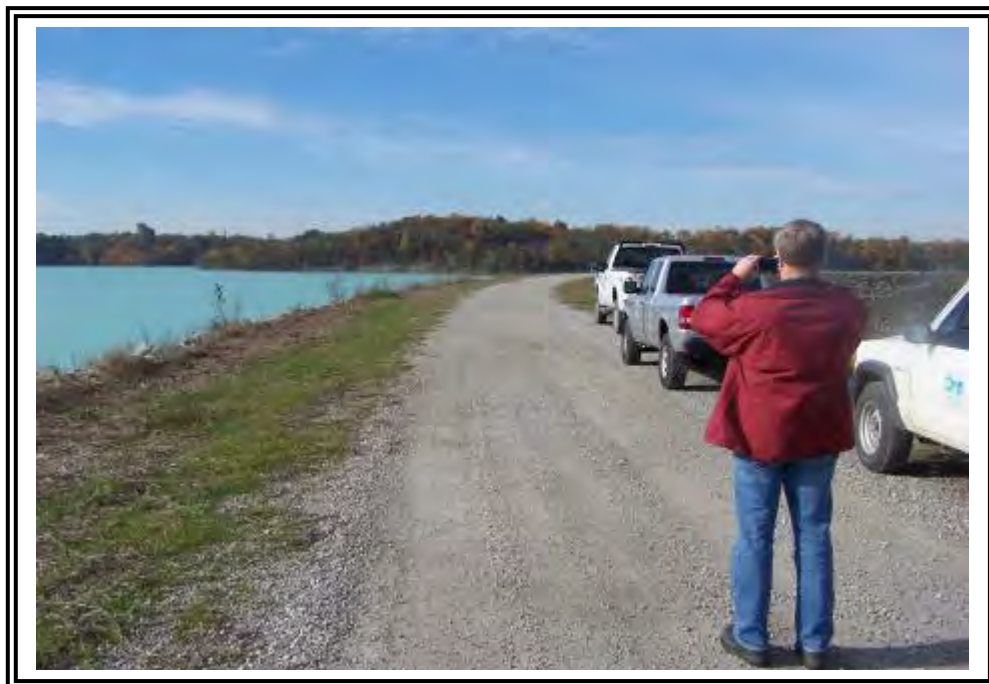
3

Dam crest, looking southwest.

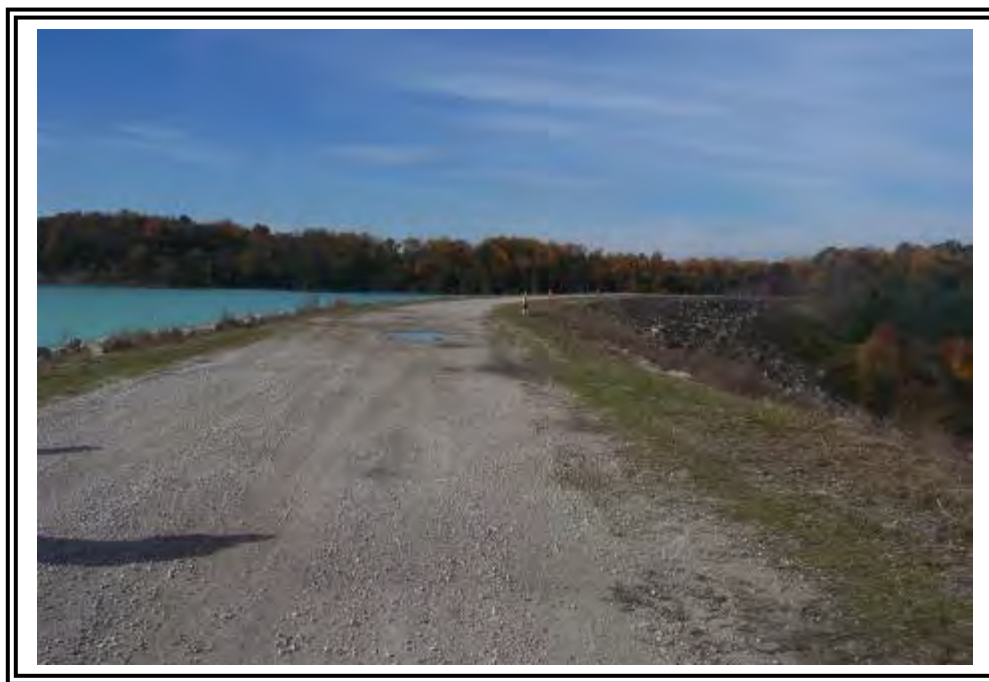
4

Dam crest, looking west.

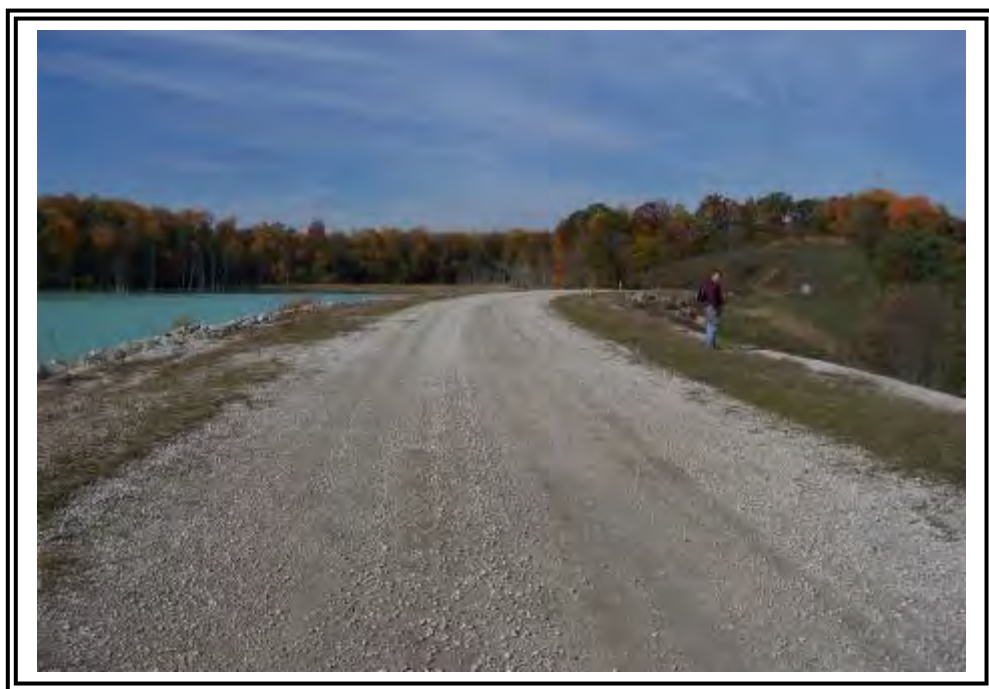
5

Dam crest, looking west.

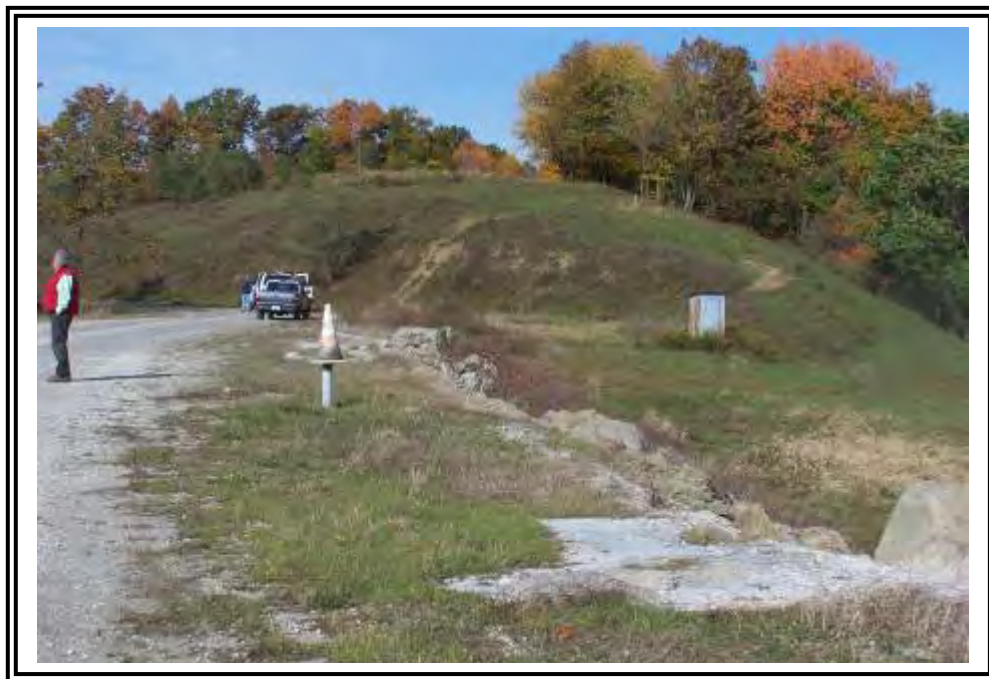
6

West abutment, looking west.

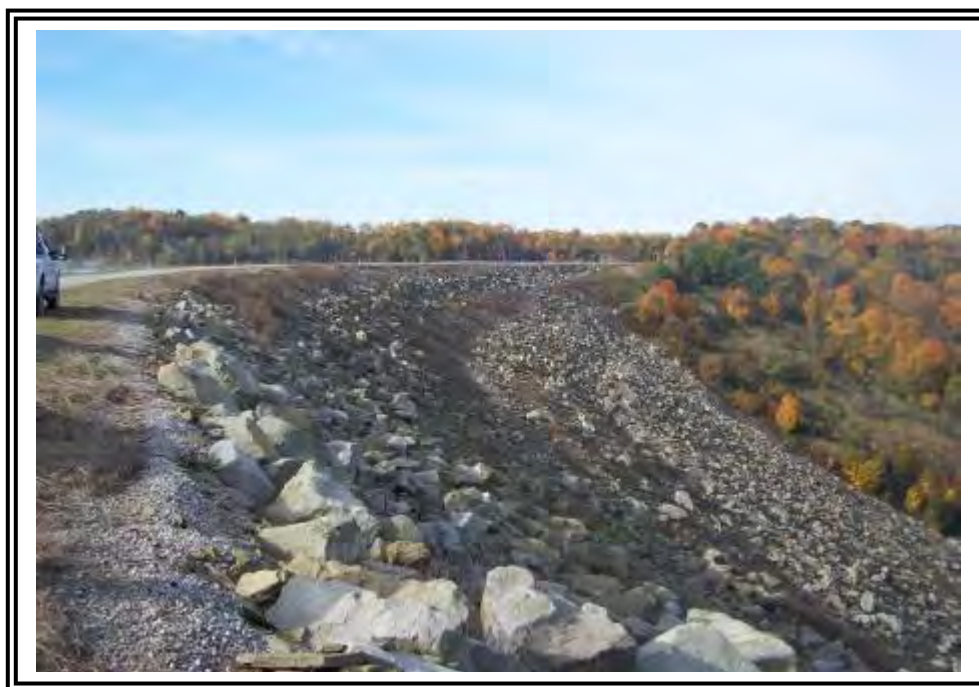
7

Downstream slope, looking west.

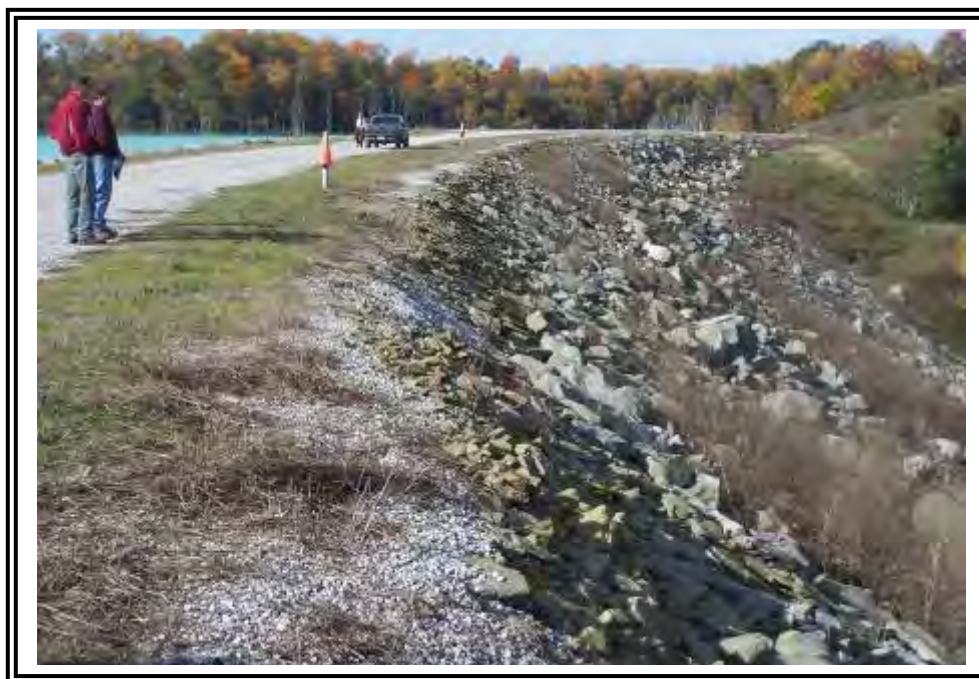
8

The crest elevation and 2-foot camber was made by adding 0 to 3.5 feet of rock fill to the top of the dam and rip rap slope protection to the upstream and downstream slope.

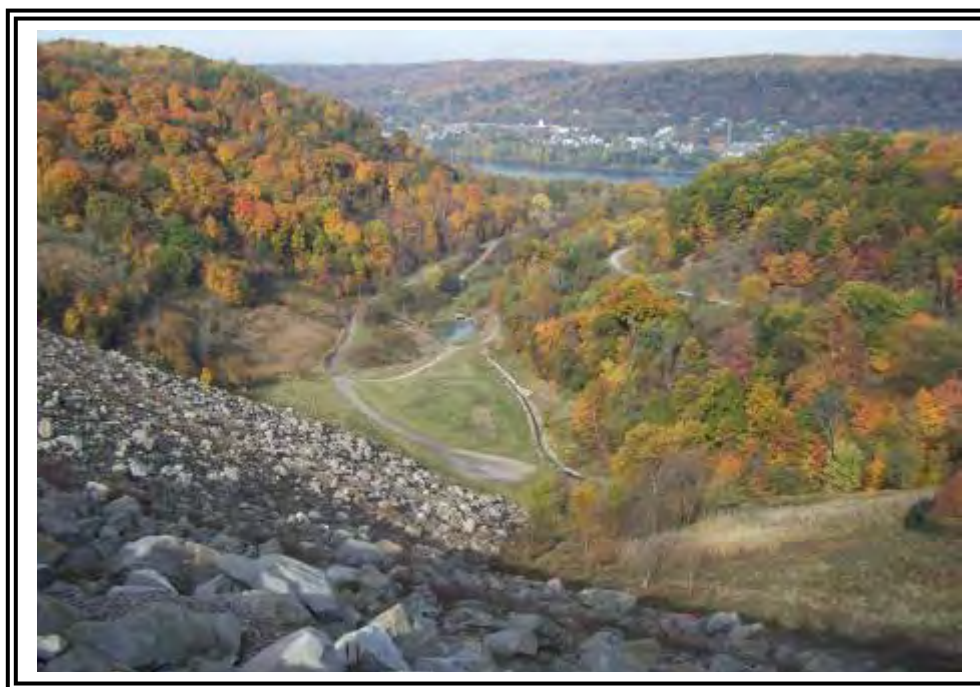
9

Downstream slope looking north at toe and stilling basin.

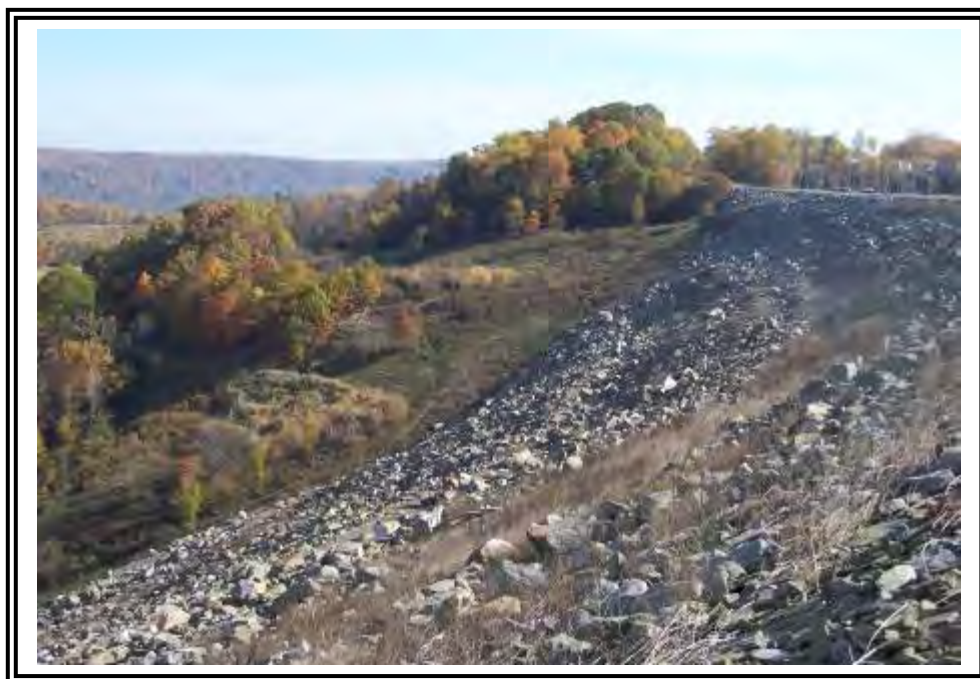
10

East abutment contact with downstream slope, looking east.

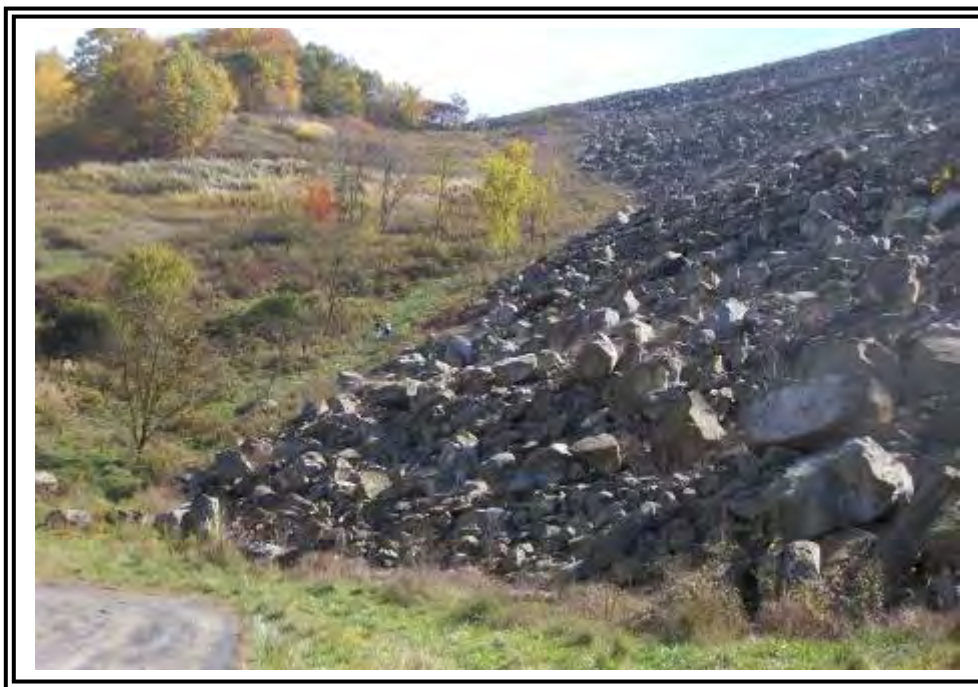
11

East abutment contact with downstream slope, looking up from the toe.

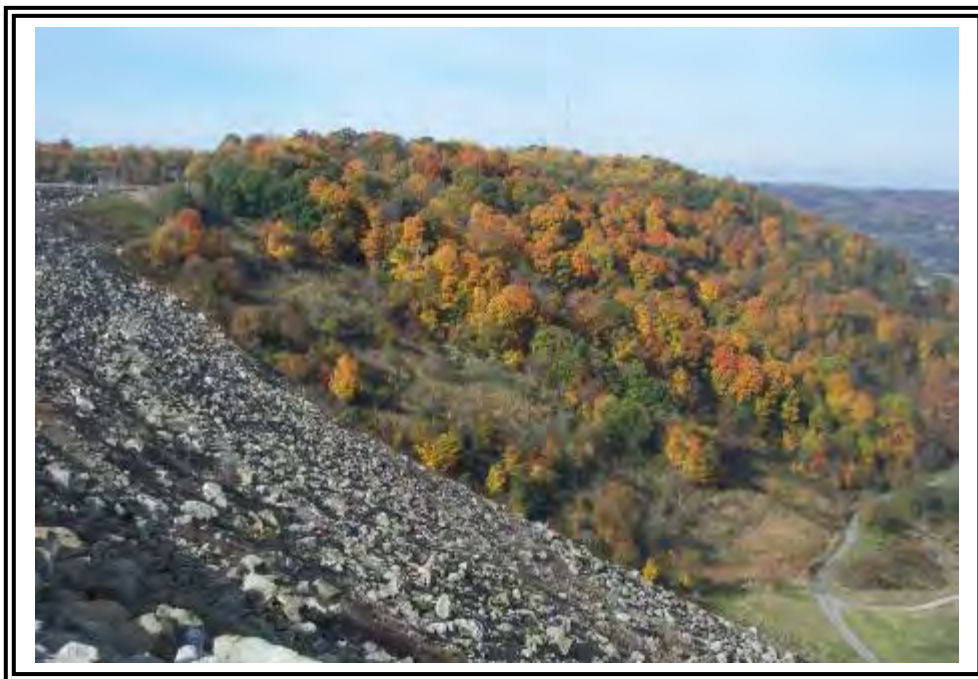
12

West abutment contact with downstream slope, looking west.

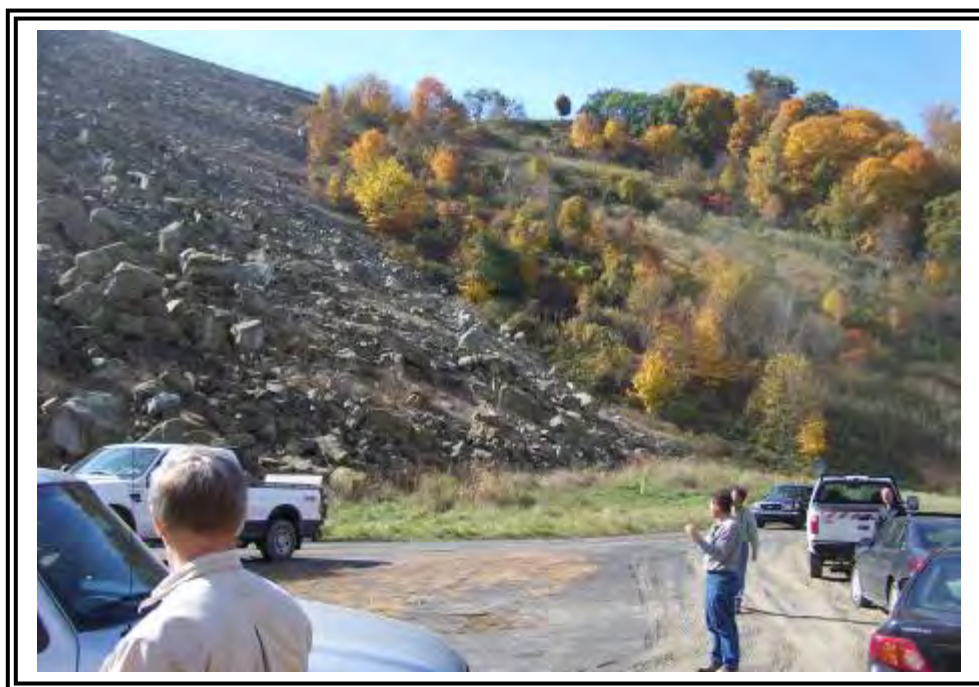
13

West abutment contact with downstream slope, looking up from the toe.

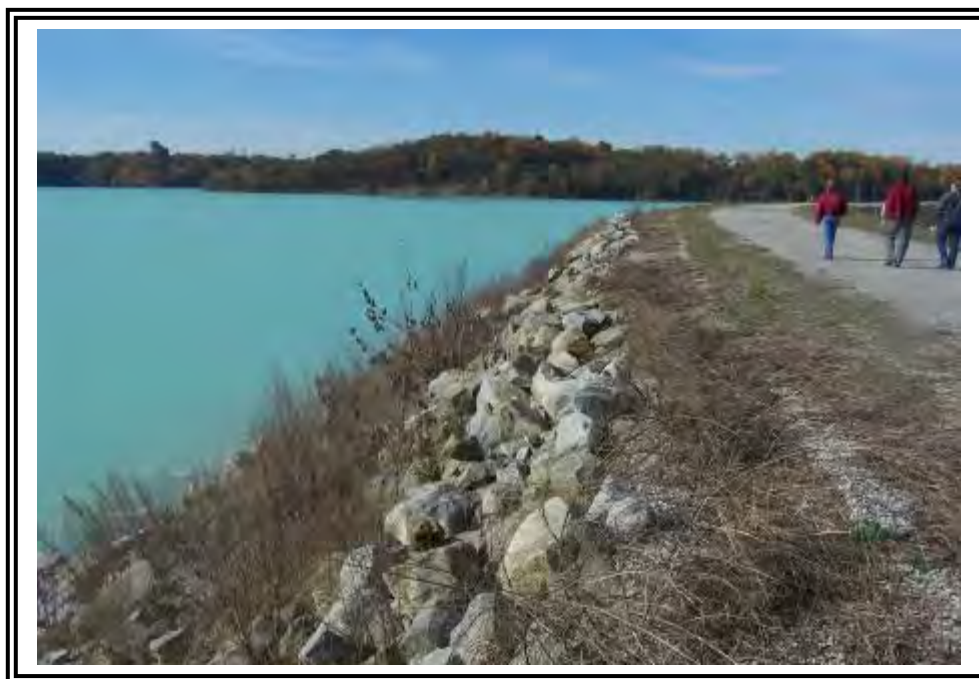
14

Upstream slope, looking southwest.

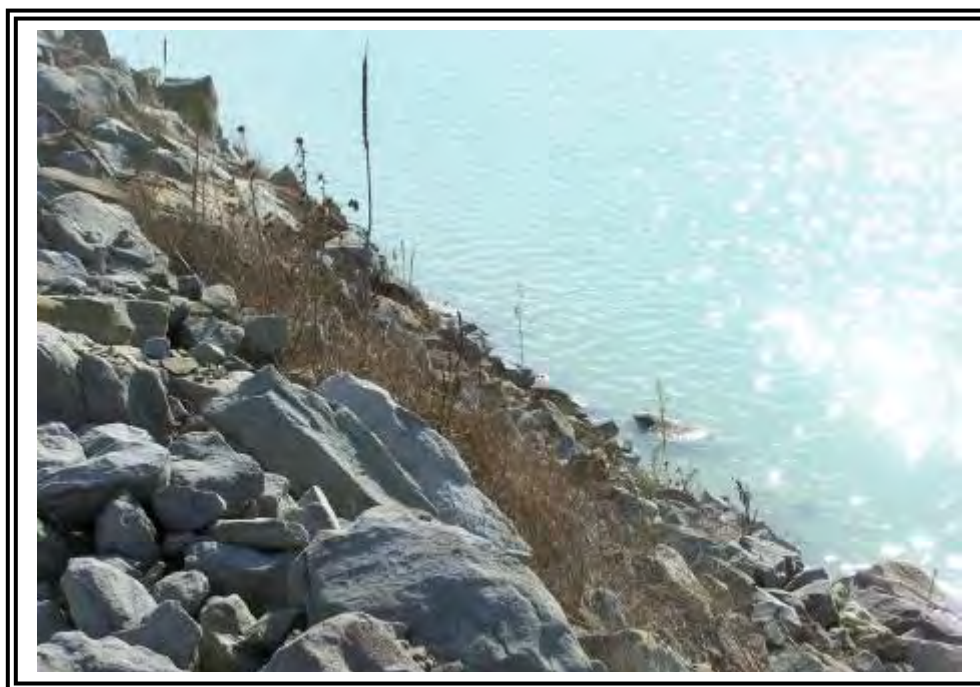
15

Upstream slope, looking southeast.

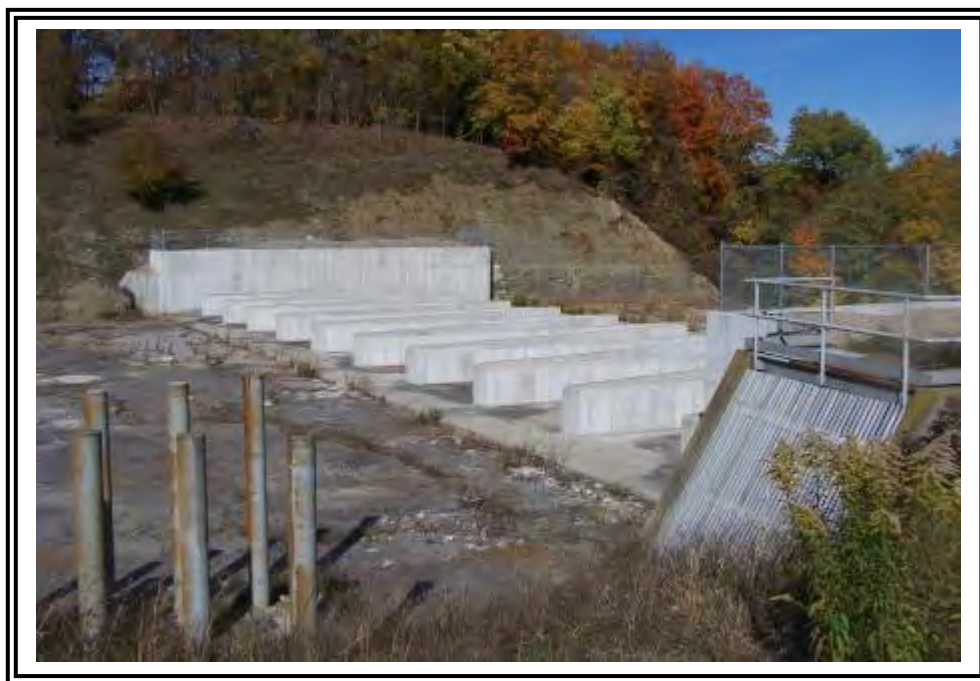
16

The three outlet structures at the Little Blue Run Dam were observed during the site visit. The service spillway is located on the left side of the dam and has an invert at elevation 1,090.3 feet (Photo No. 16). The spillway discharges to a 48-inch concrete pipe 1,000 feet long that discharges to the stilling basin (Photo 17).

Concrete labyrinth (left-center) and Service Spillway inlet with trash rack and bollards (right).

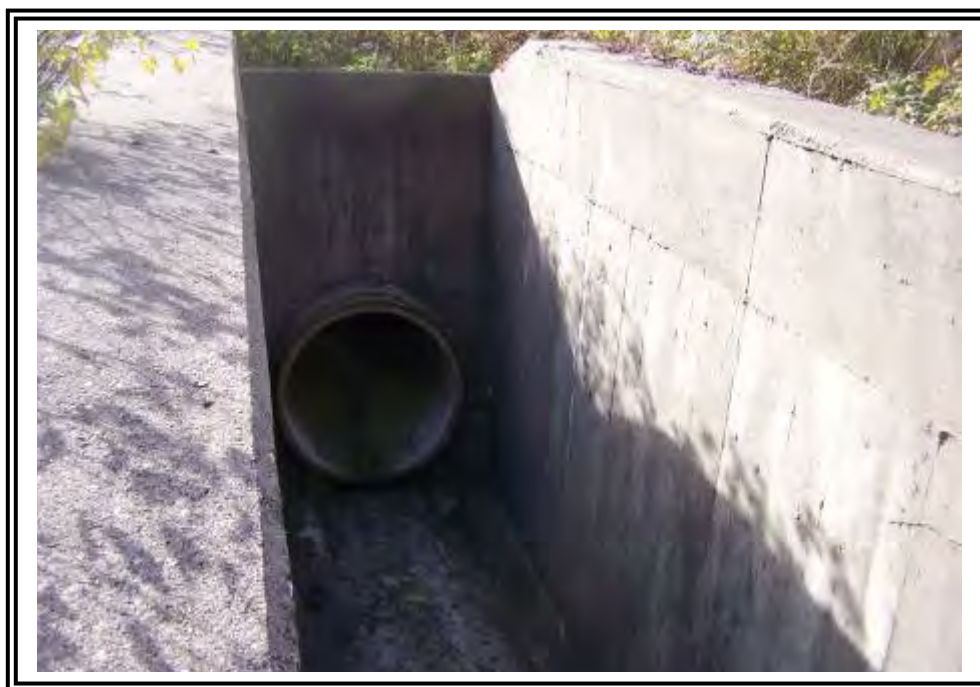
17

Terminus of service spillway at stilling basin.

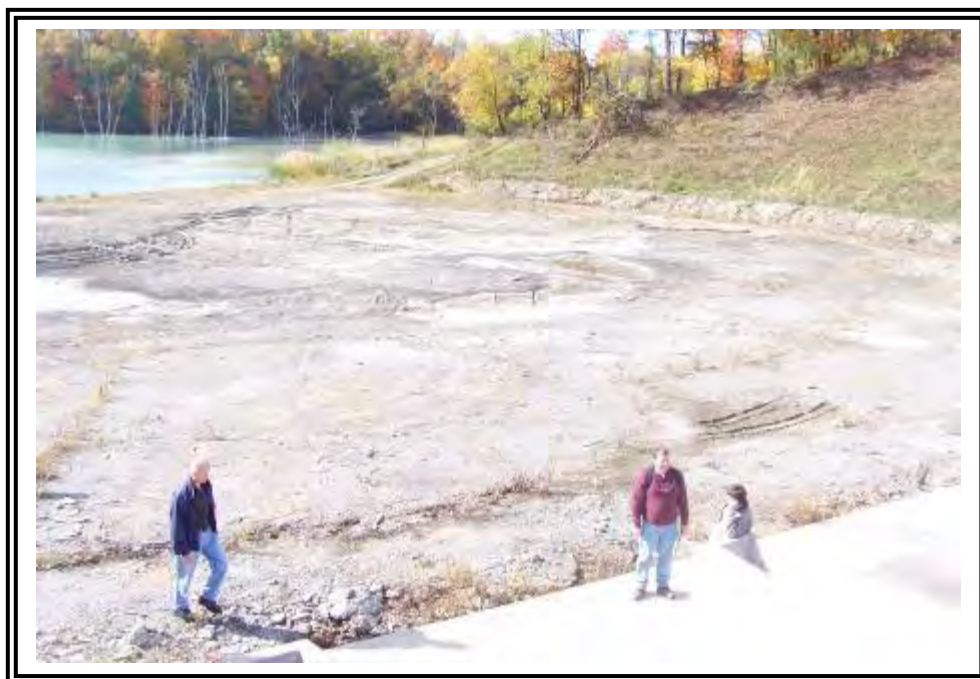
18

Approach to emergency spillway in bedrock.

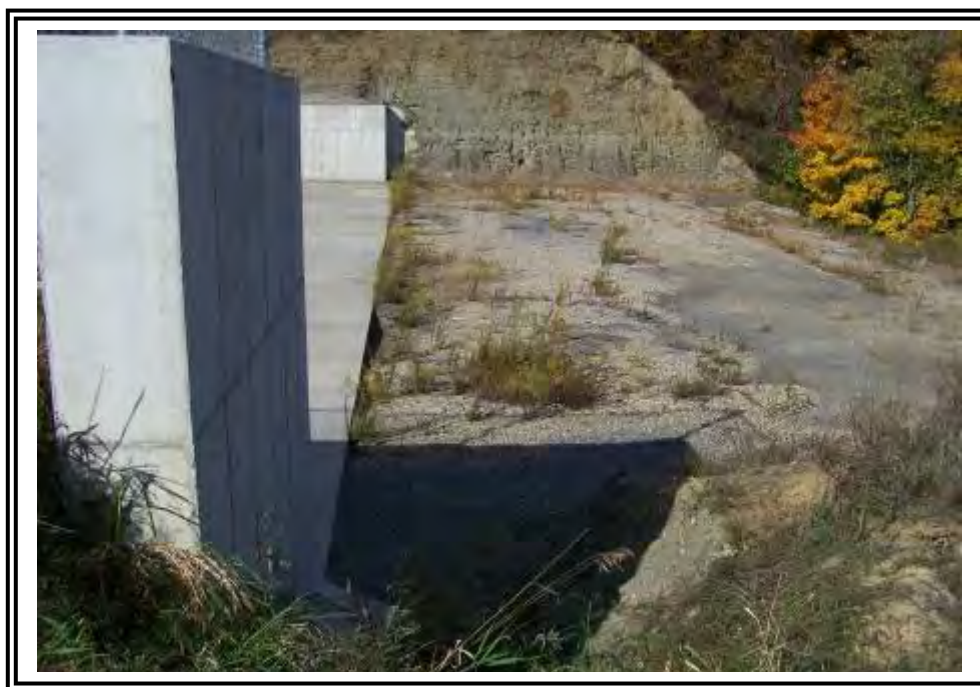
19

Downstream channel of emergency spillway.

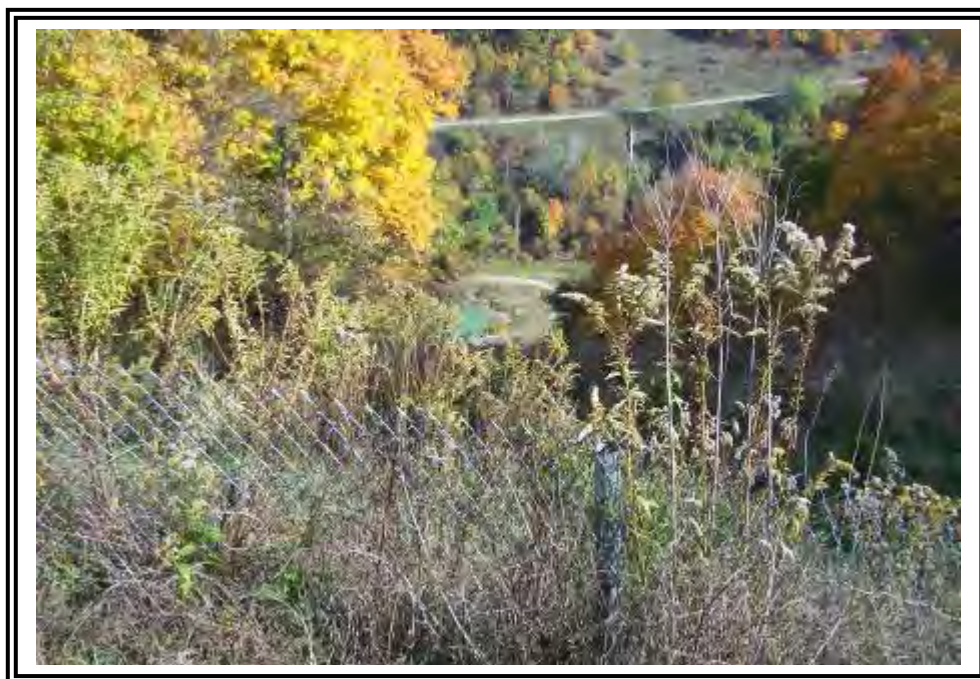
20

Service spillway right-of-way looking down the slope to the stilling basin (center).

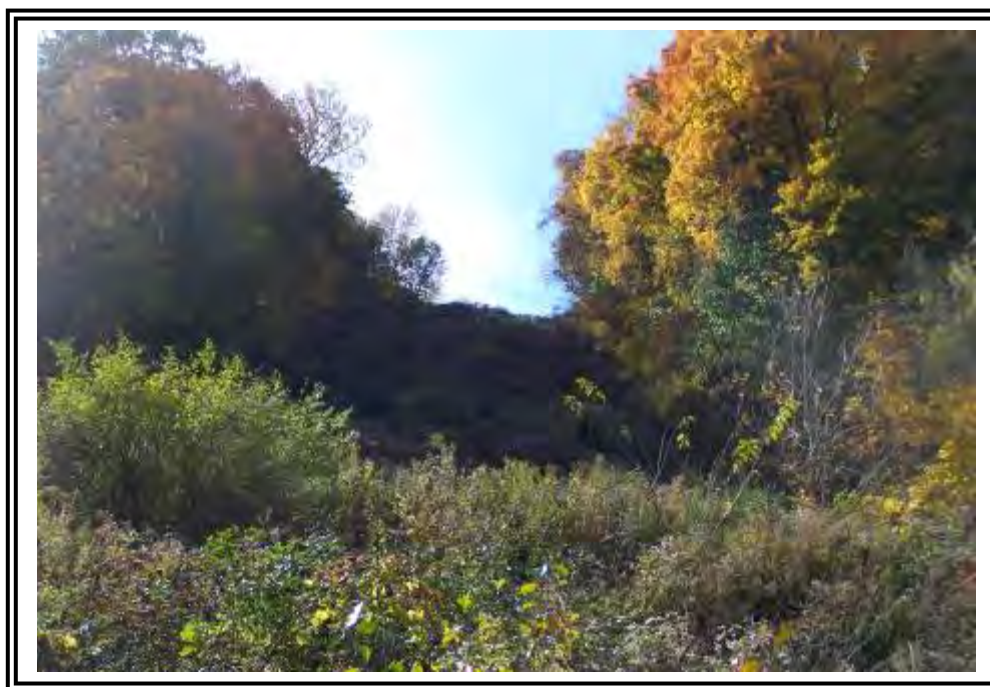
21

Service spillway right-of-way looking upstream from the stilling basin.

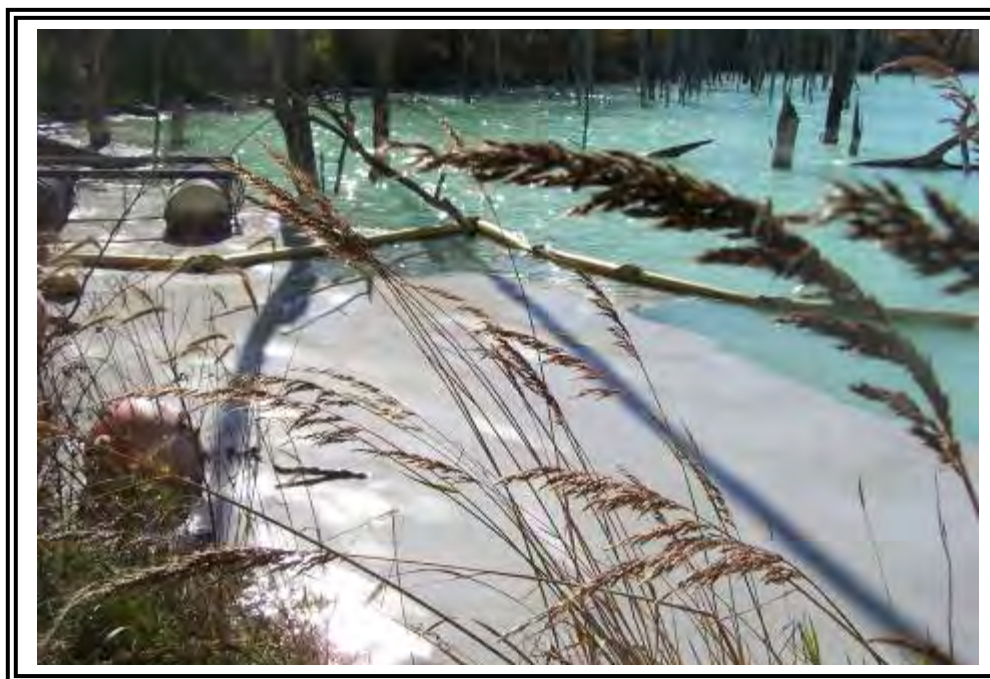
22

Impoundment side of Secondary Spillway approach channel. Pipe was submerged during our site visit.

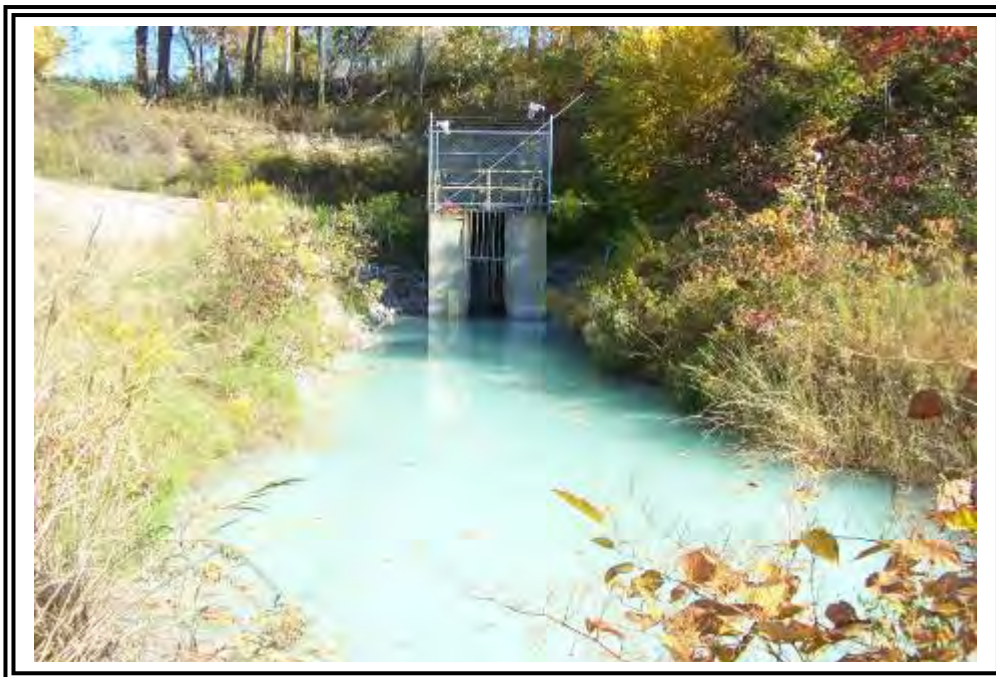
23

Secondary spillway approach channel and inlet.

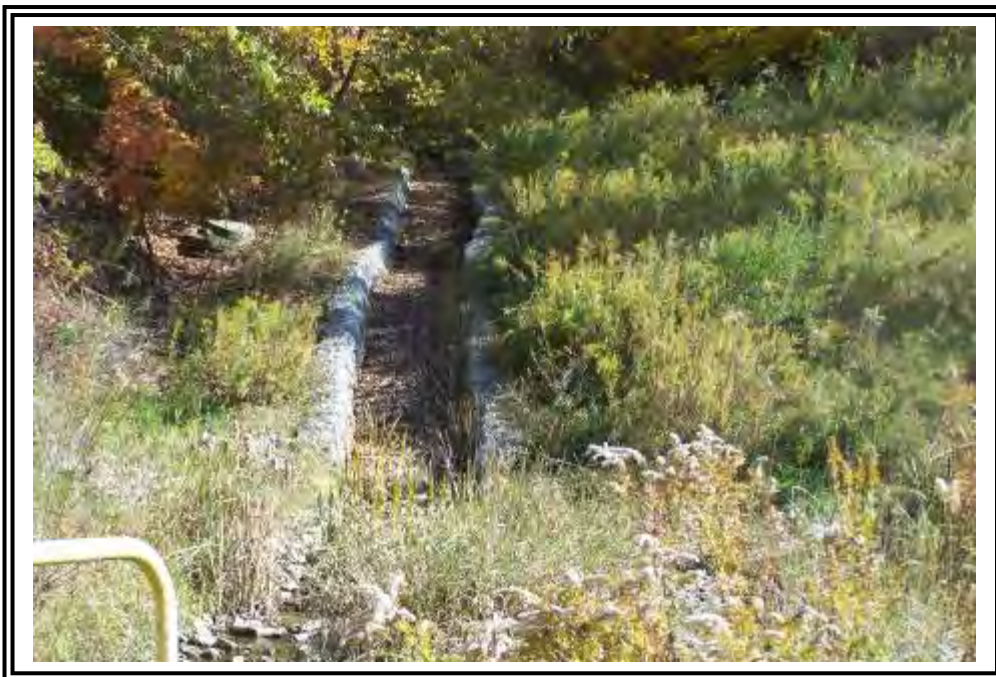
24

Gabion channel from secondary spillway.

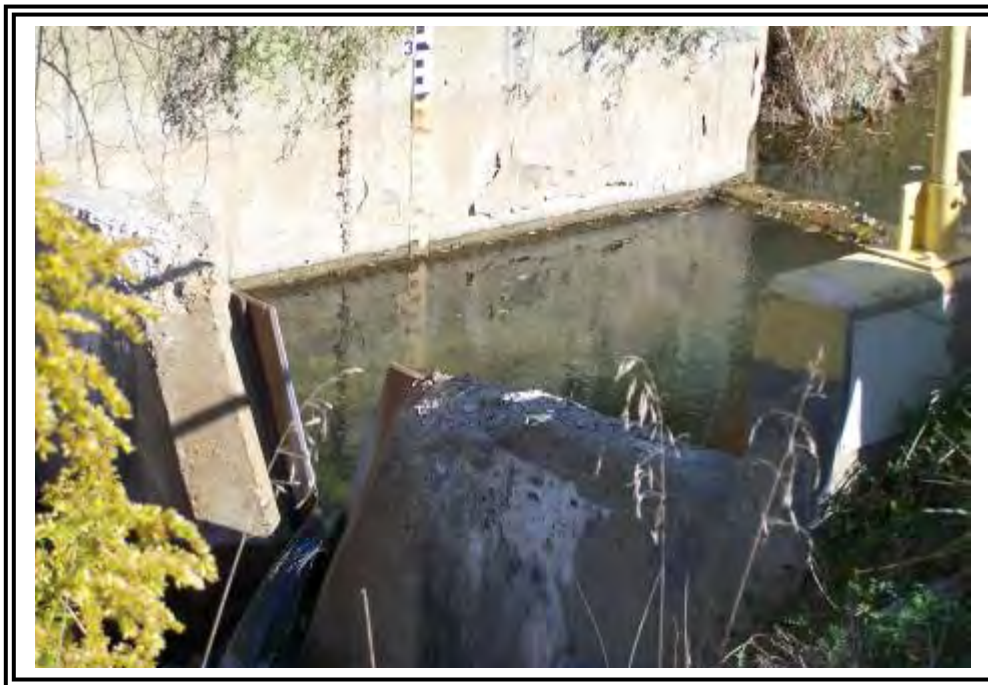
25

Right Abutment (RA) v-notch monitoring weir containing secondary spillway and east abutment seepage flow.

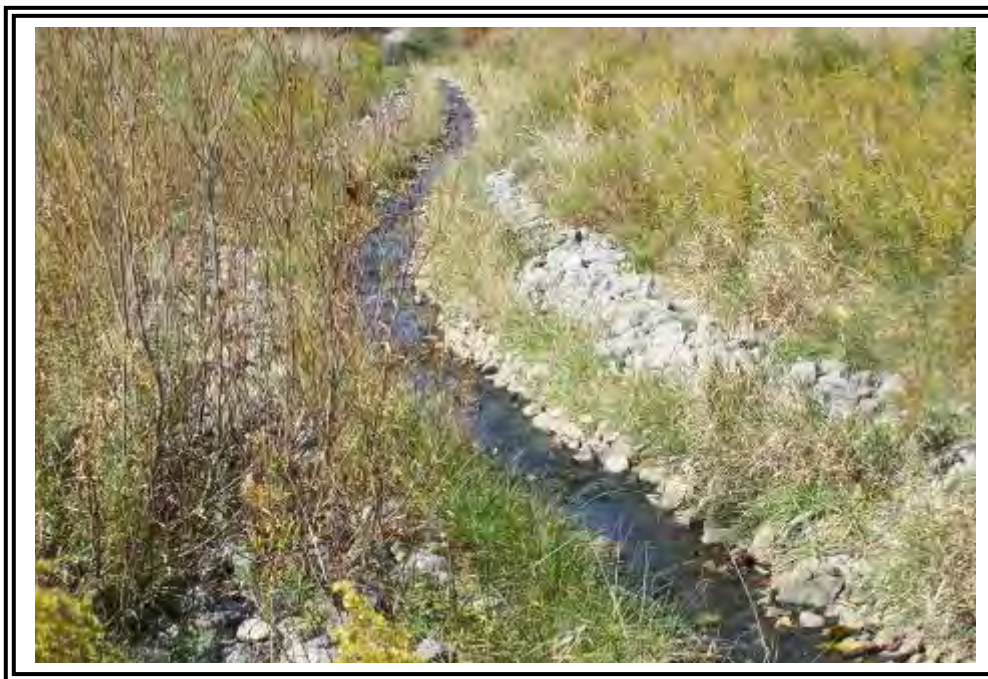
26

Channel downstream of the right abutment (RA) v-notch weir to stilling basin.

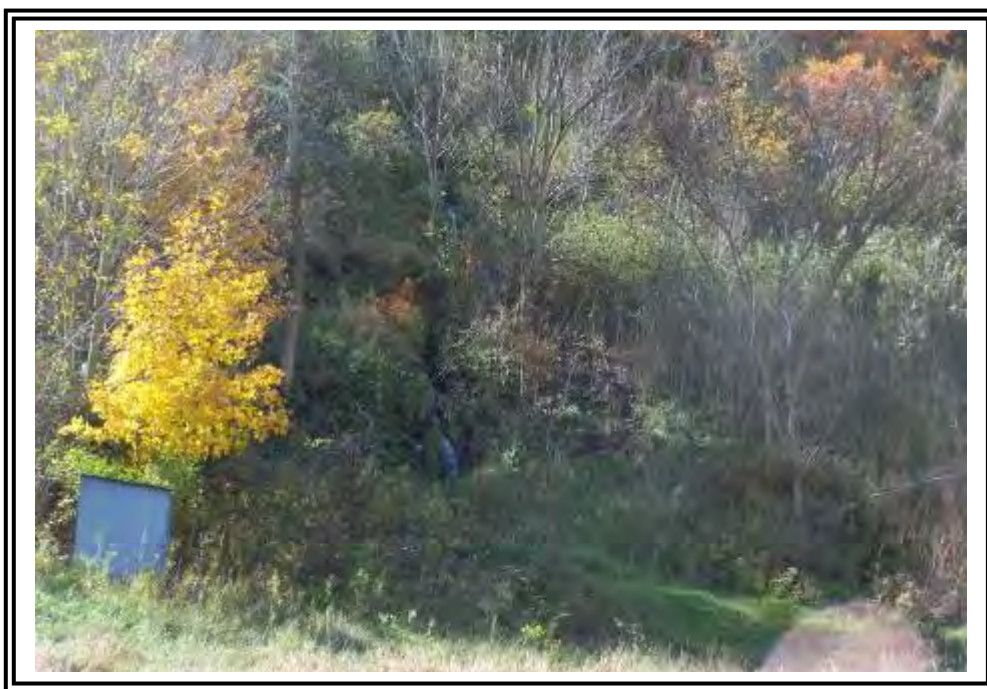
During the site visit, FirstEnergy and GAI representatives pointed out areas previously repaired on the west abutment where surface sloughing and sliding of surficial soils had occurred in the location of a temporary construction access road some years ago (Photos 12 and 13). Seepage that is directed to weirs for monitoring was observed on the west abutment (Photos No. 27 and 33). The east abutment was also observed (Photo Nos. 1, 10, and 11).

West abutment seepage.

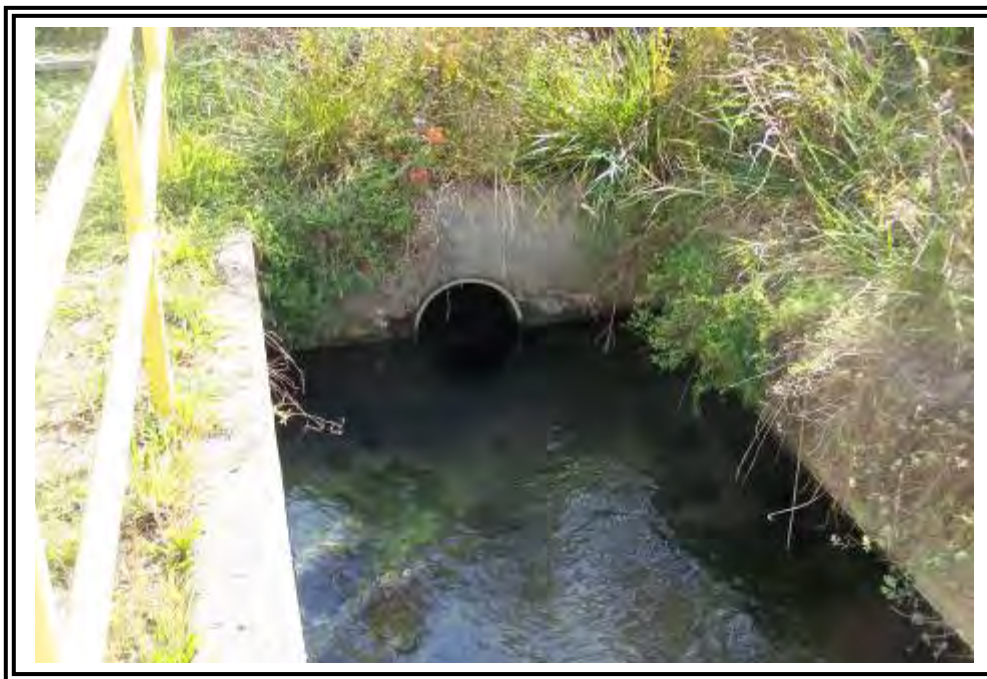
28

Toe drain (TD) collection pipe terminating in Parshall Flume.

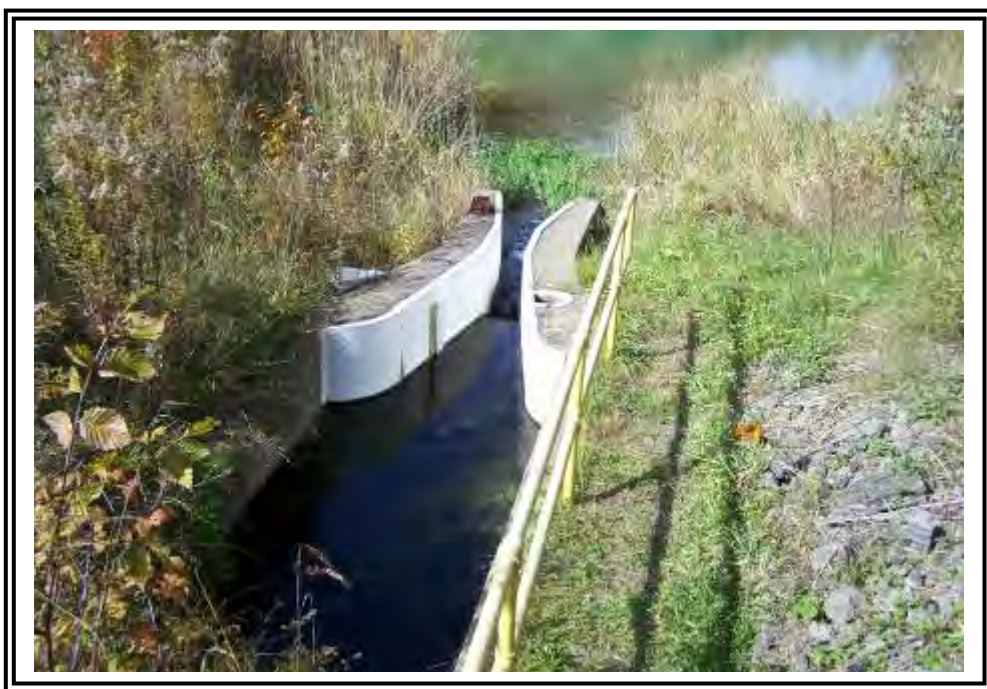
29

weir (ULA) was clogged causing back-flow in to the weir structure (Photo No. 30). The Parshall Flume toe drain (TD) which is a monitoring point for blanket drain seepage was also observed (Photo Nos. 28 and 29).

TD Parshall flume monitoring point for blanket drain seepage.

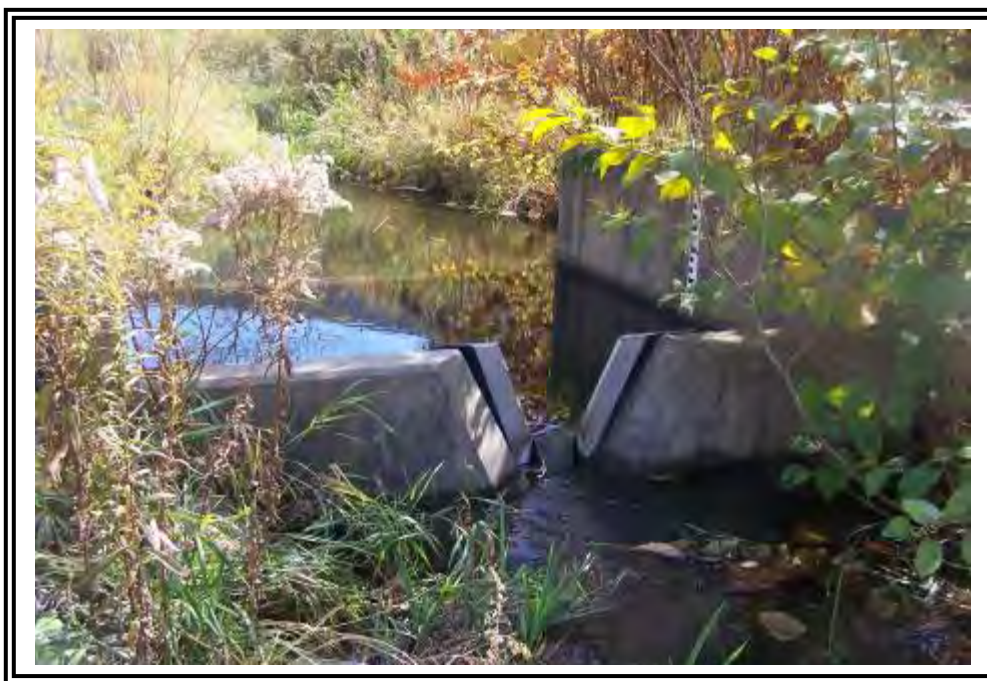
30

The weirs located on the left and right abutments to collect and monitor seepage discharges were observed. On the west abutment there are two weirs; the upper weir (ULA, Photo No. 30) and the lower weir (LLA, Photo No. 34) and on the right abutment there is one weir (RA, Photo No. 25). During the site visit it was observed that the culvert downstream of the west abutment upper

ULA v-notch monitoring weir for west abutment seepage monitoring. Clogged culvert was causing back flow during our site visit.

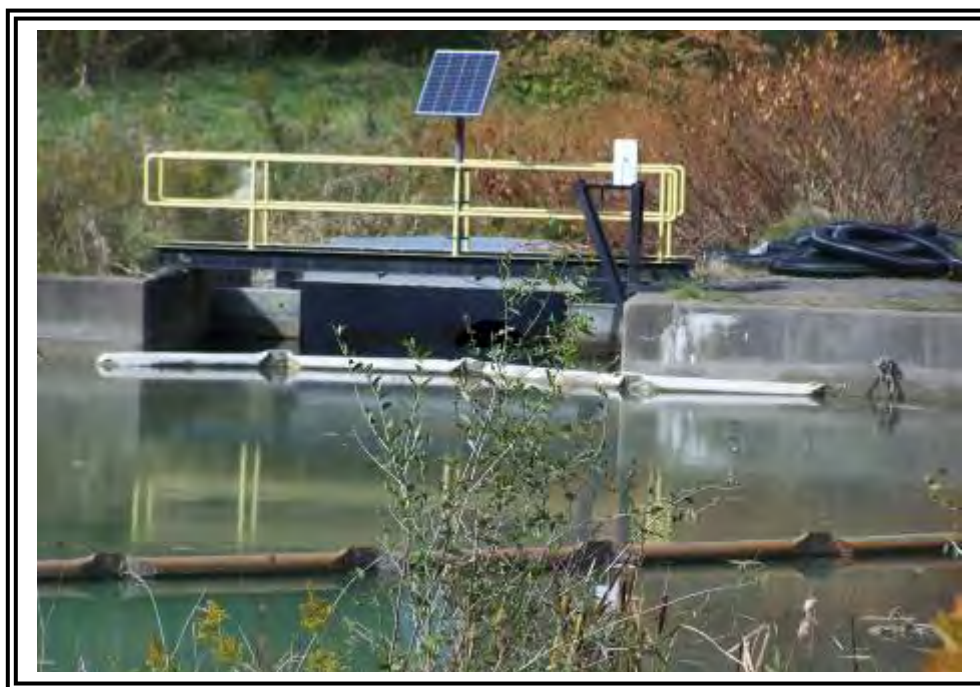
31

Stilling basin with floating debris barriers.

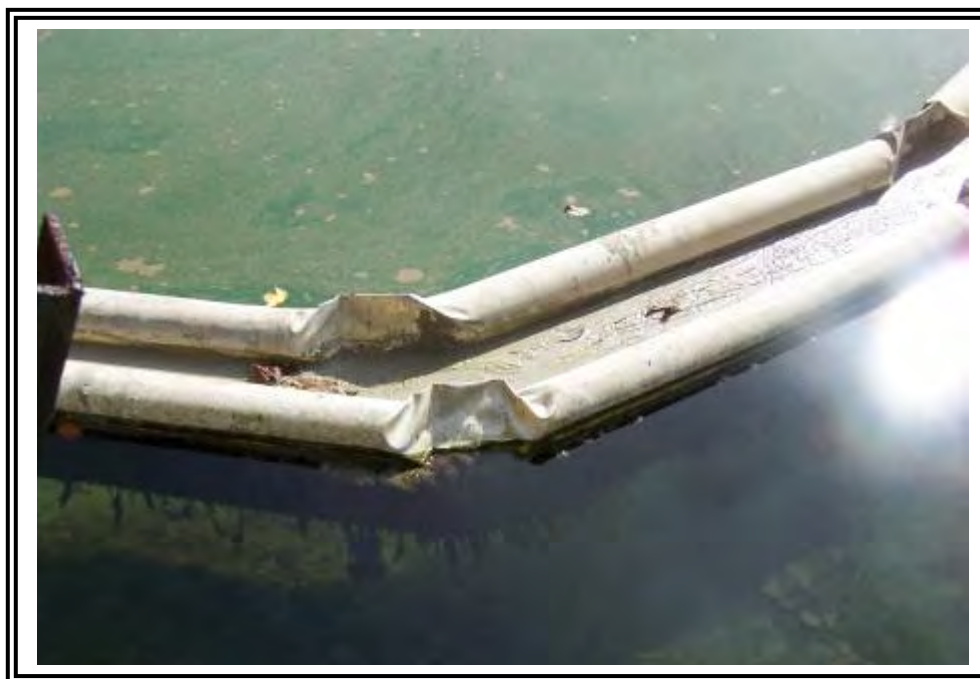
32

Water in stilling basin was clear at the time of our site visit.

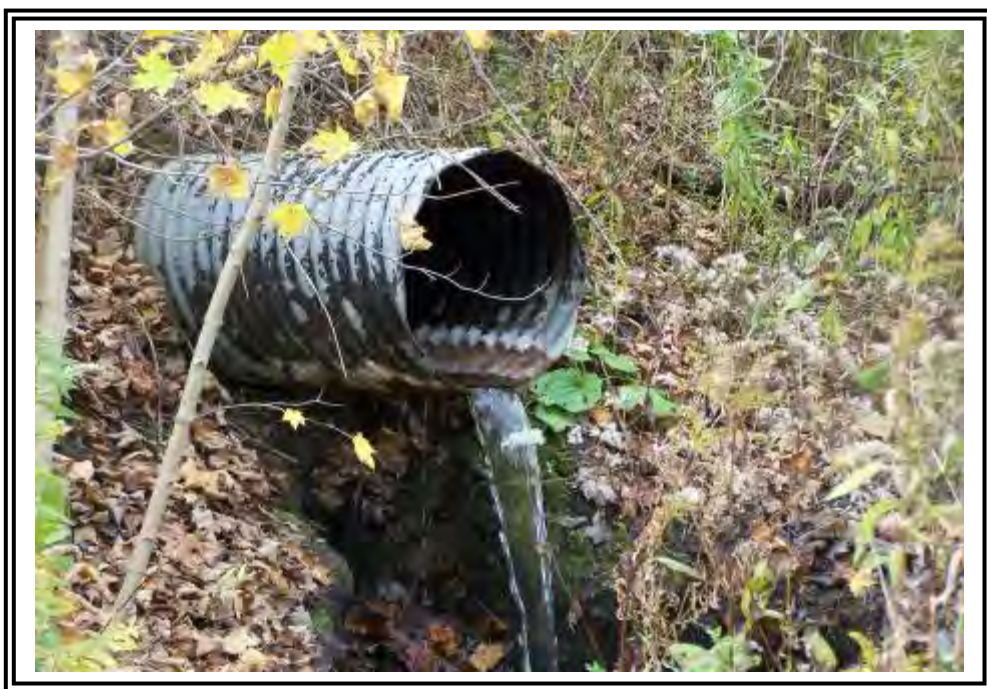
33

Lower left (west) abutment seepage. This natural seepage maintains flow in Little Blue Run per permit conditions.
