Assessment of Dam Safety

Coal Combustion Surface Impoundments (Task 3)

FirstEnergy Generation
Corporation

Bruce Mansfield
Power Plant
Little Blue Run Dam
Shippingport, Pennsylvania

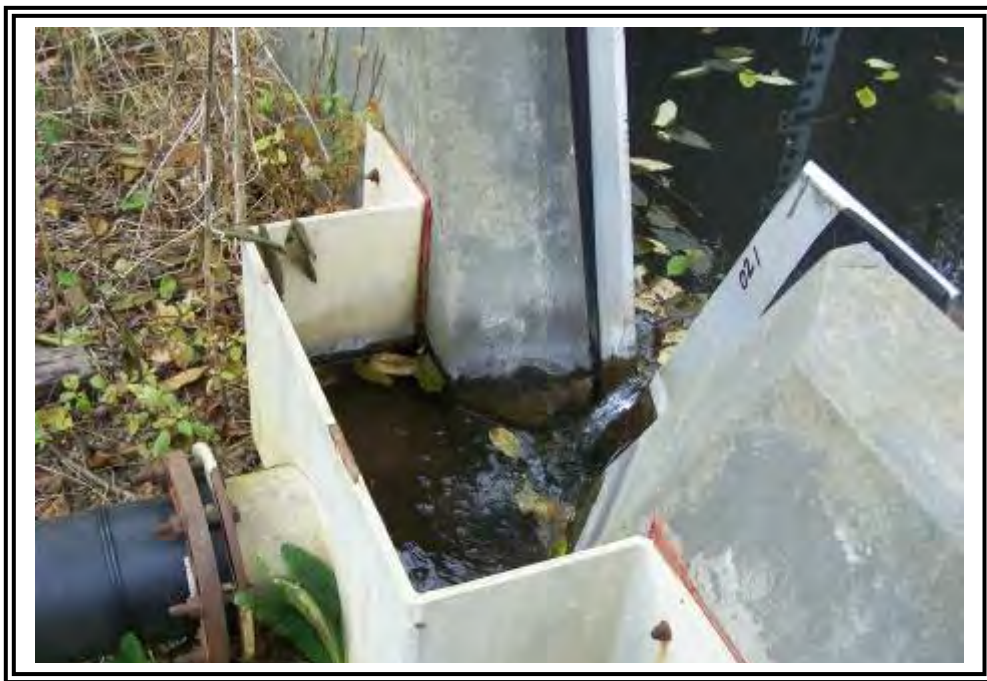
34

LLA v-notch monitoring weir for lower left abutment seepage.

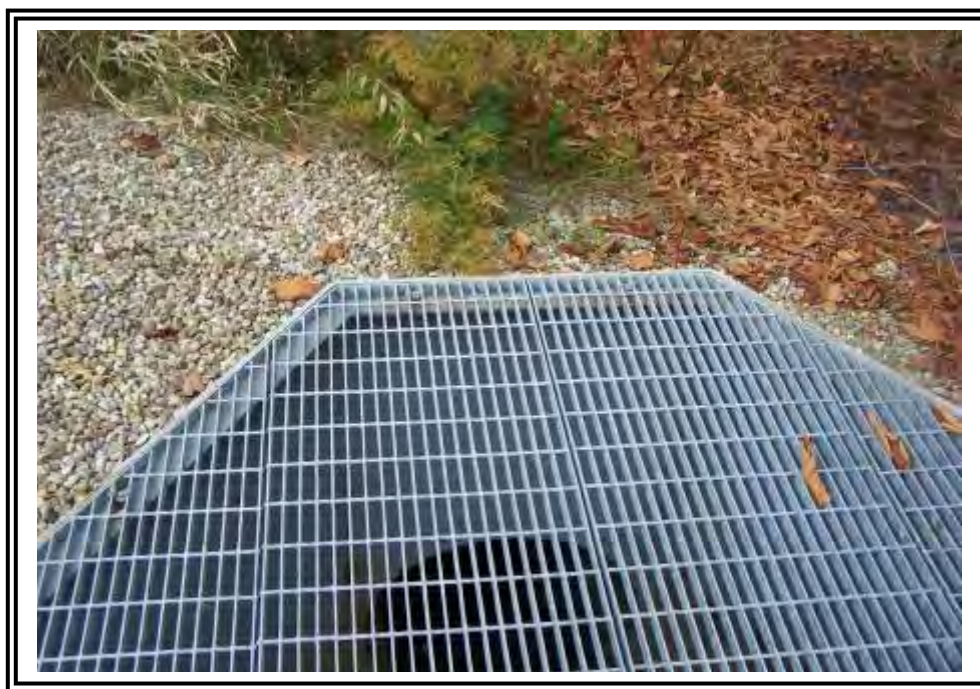
35

Outfall from stilling basin conveyed by buried HDPE pipe to the Ohio River.

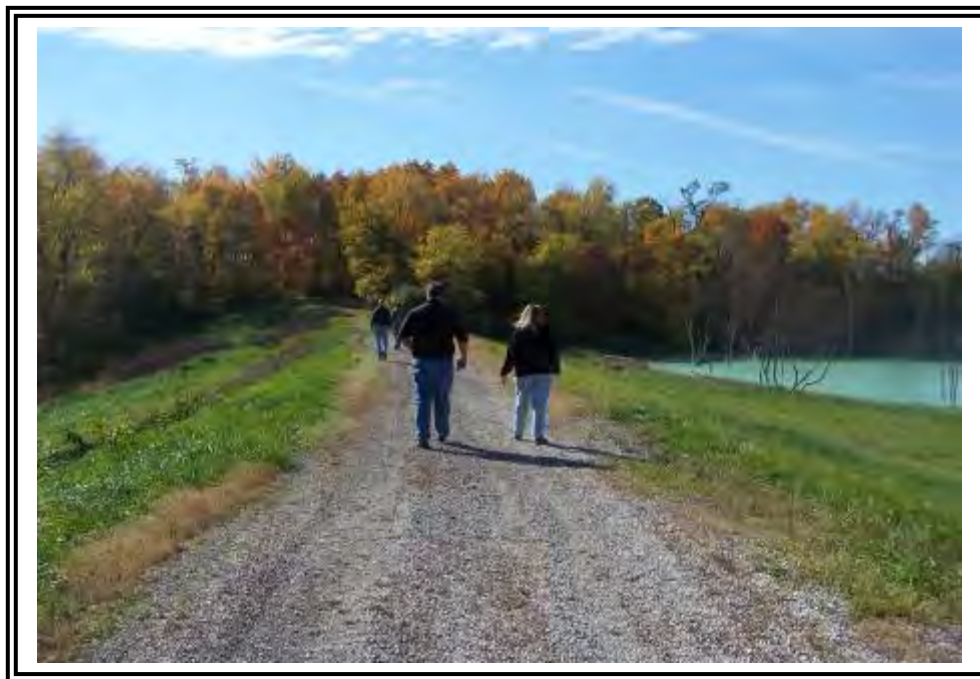
36

Crest of Little Blue Run Saddle Dam, looking south.

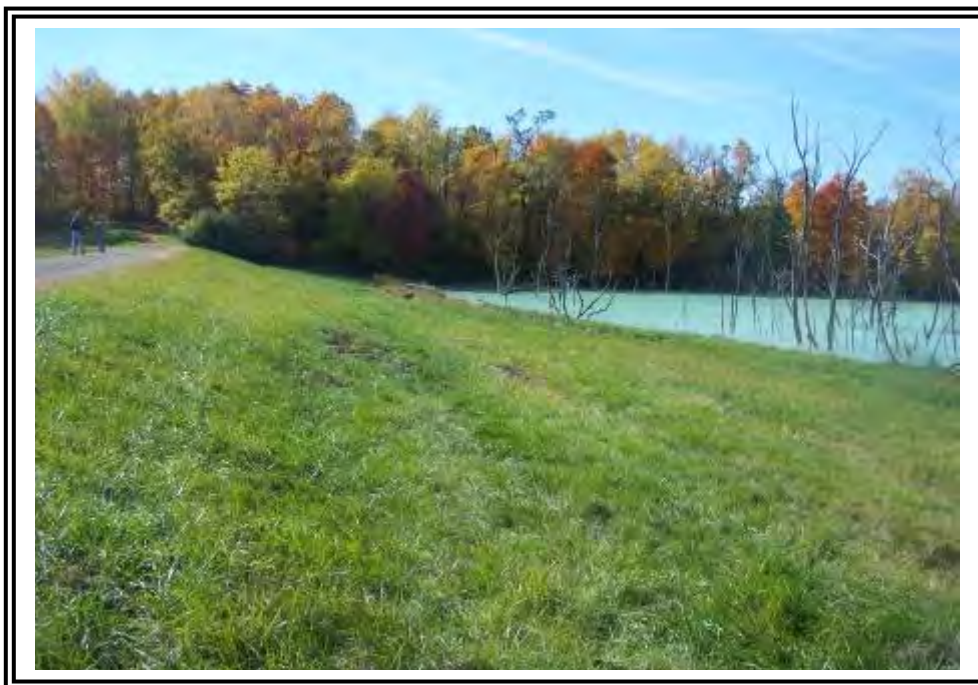
37

Upstream slope of Little Blue Run Saddle Dam, looking south.

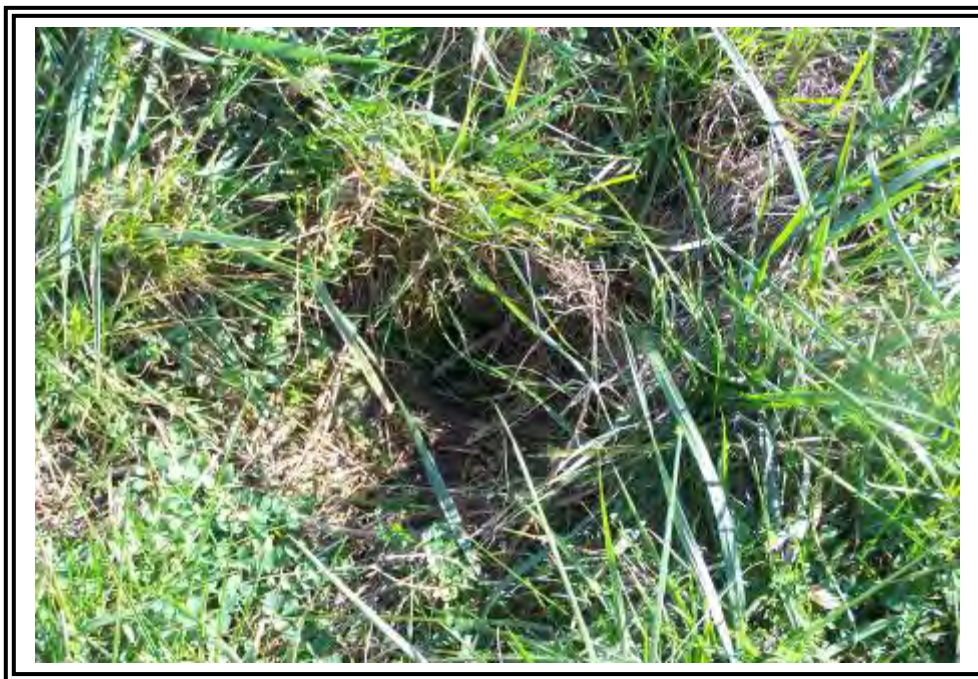
38

At the time of the site visit the Little Blue Run Saddle Dam was not impounding water. A gravel access road runs the length of the crest of the Little Blue Run Saddle Dam (Photo No. 36). The upstream and downstream embankment slopes are grass covered (Photo Nos. 37 and 39). A small rodent hole was observed on the upstream slope (Photo No. 38).

Small rodent hole on upstream slope of Little Blue Run Saddle Dam.

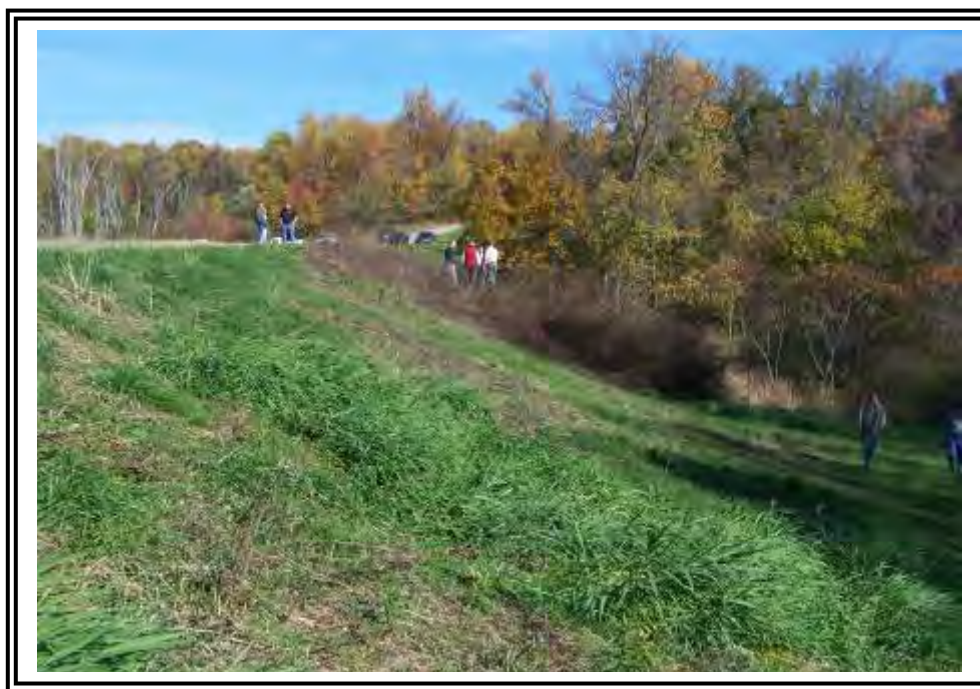
39

Downstream slope of Little Blue Run Saddle Dam, looking north.
Vegetation near group of people on slope consists of material that the mower cannot traverse.

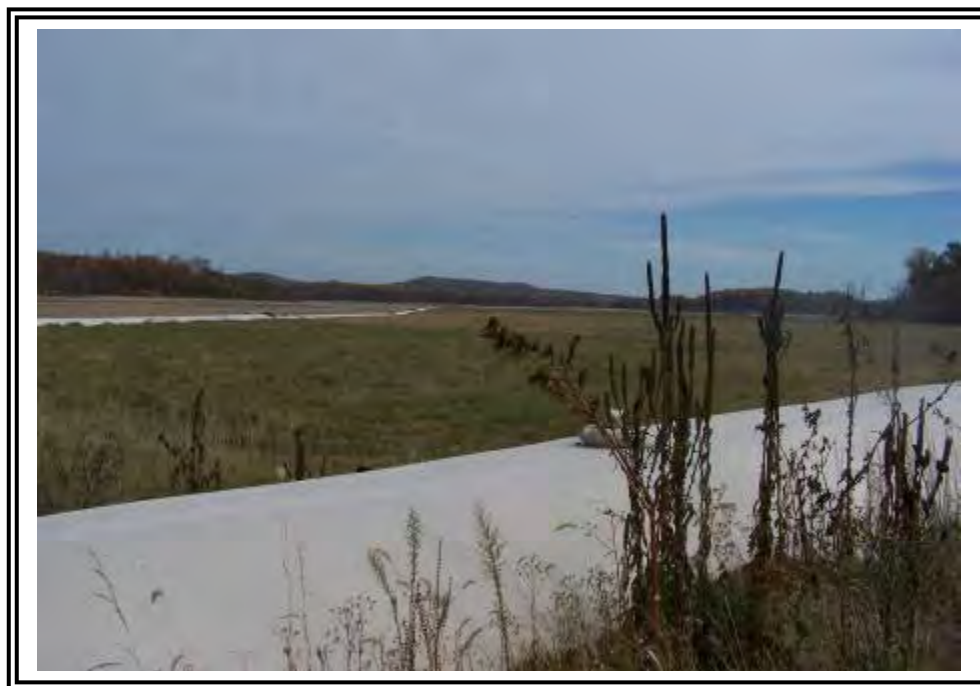
40

The Geotubes which were installed for vertical expansion of CCW waste disposal without raising the elevation of the existing dam embankment were observed during the site visit (Photo No. 40).

Geotubes and CCW waste placement at the south end of the impoundment.
