CCW IMPOUNDMENTS INSPECTION REPORT

**BRUCE MANSFIELD POWER
PLANT
BEAVER COUNTY,
PENNSYLVANIA**

**PROJECT NO. 09-4157
DECEMBER 2009**

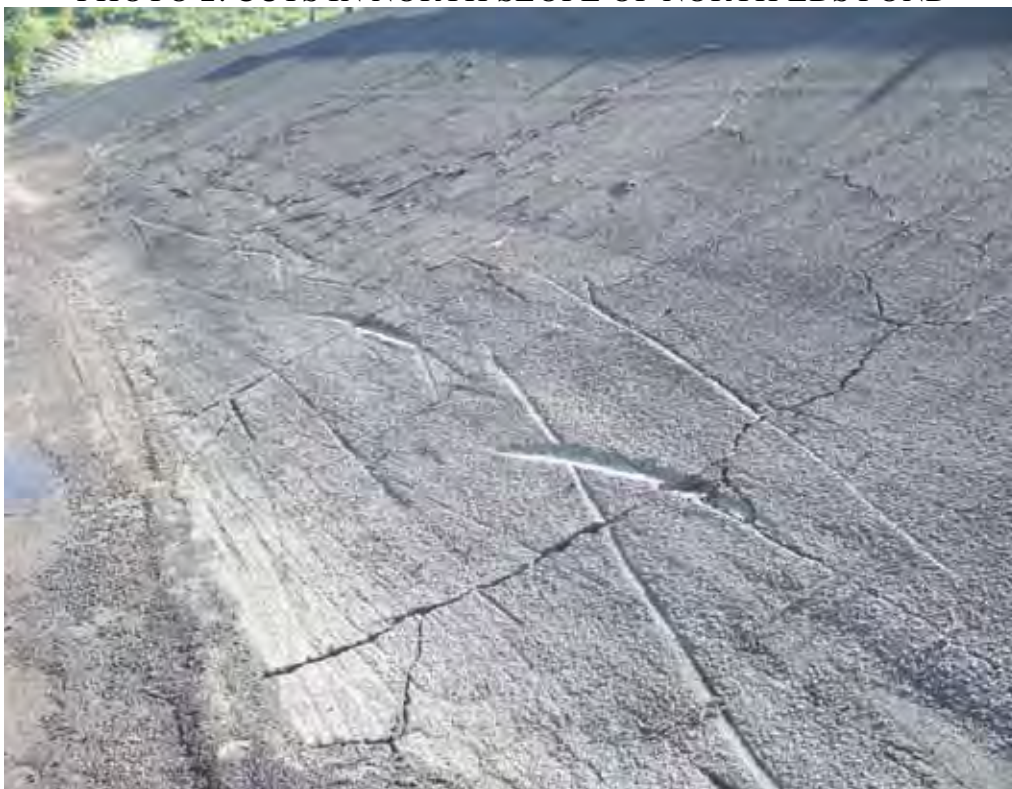
PHOTO 2: CUTS IN NORTH SLOPE OF NORTH LDS POND

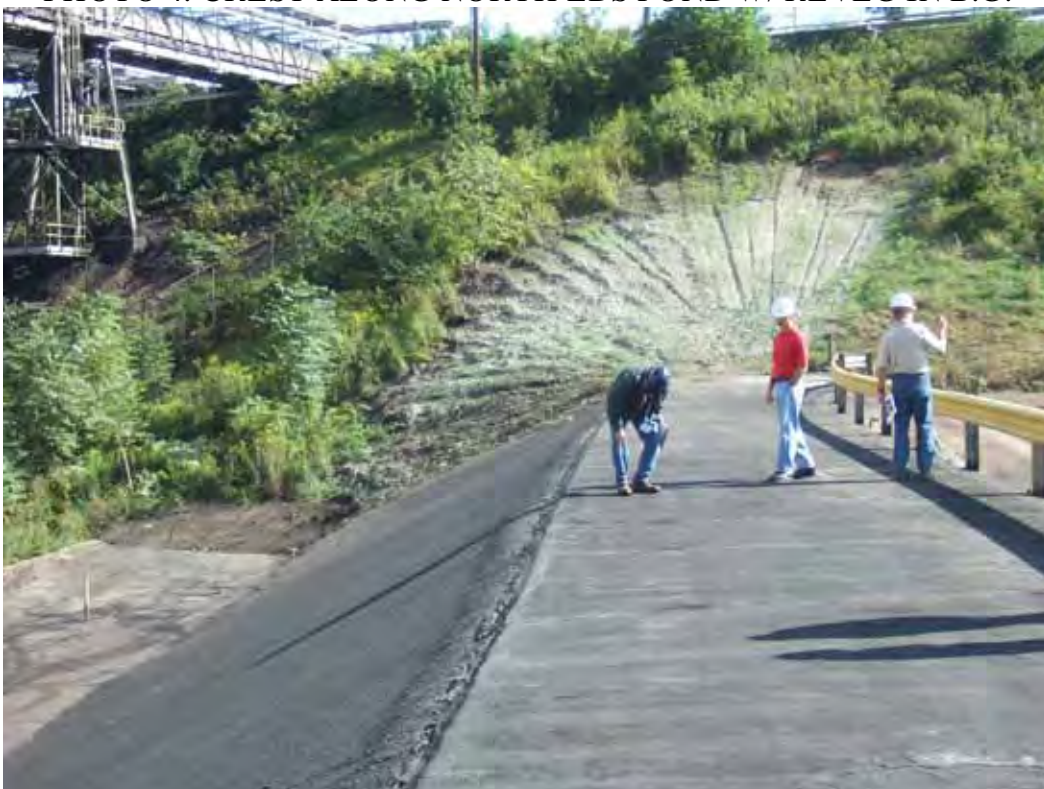
PHOTO 4: CREST ALONG NORTH LDS POND W/ REVEG IN B.G.

The rebuild and revegetation of the earthen embankment at the northeast corner of the impoundment due to a prior manhole overflow appeared to be in good condition. The rebuild was well-graded, and the vegetation was taking hold nicely (*Photograph 4*).

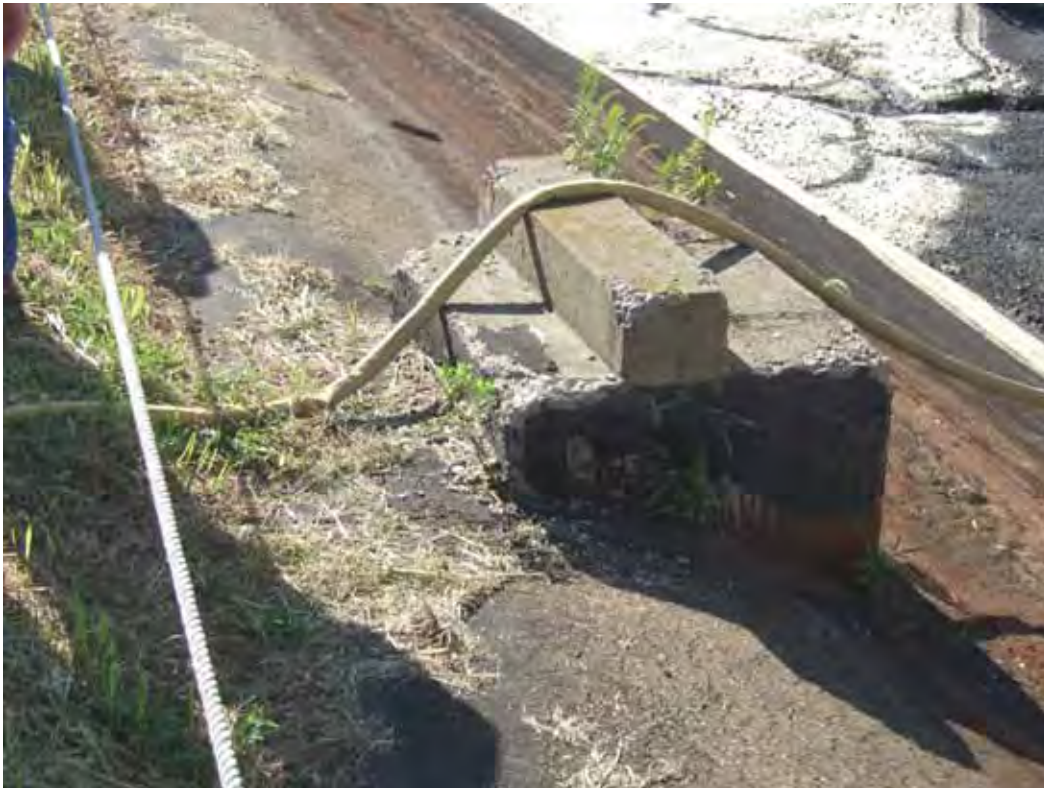
PHOTO 5: VEGETATION AT N.E. CORNER OF NORTH LDS POND

Along the eastern embankment, the vegetation is well-maintained and trimmed back approximately 10 feet from the edge of the asphalt liner. Some minor vegetation creep was observed along the end of the asphalt line along the slope of the eastern embankment (*Photograph 5*).

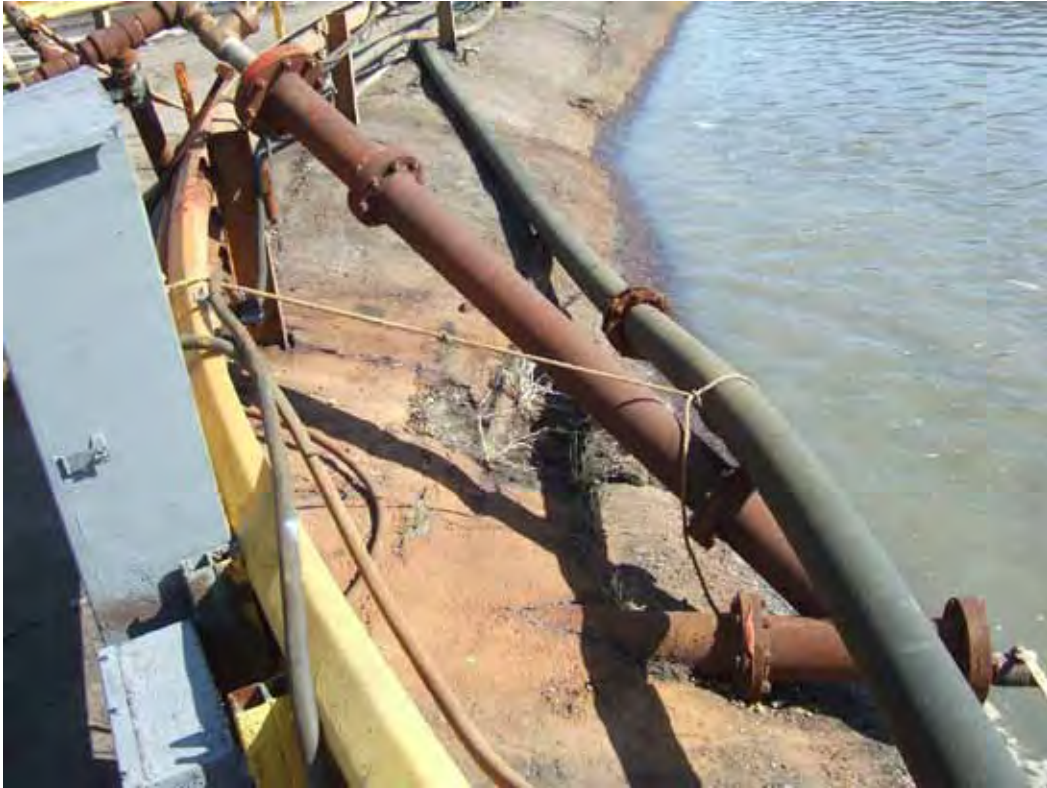
PHOTO 9: VEGITATION AT N.W. CORNER OF SOUTH LDS POND

There was about 2 feet of freeboard along the upstream slope of the South LDS Pond at the time of inspection. No major cracks were observed in the visible portion of the upstream liner, which is constructed of the more impervious asphalt material. Some minor damage and vegetation was observed at the northwest corner of the upstream slope, near the fire hose system and bubbler

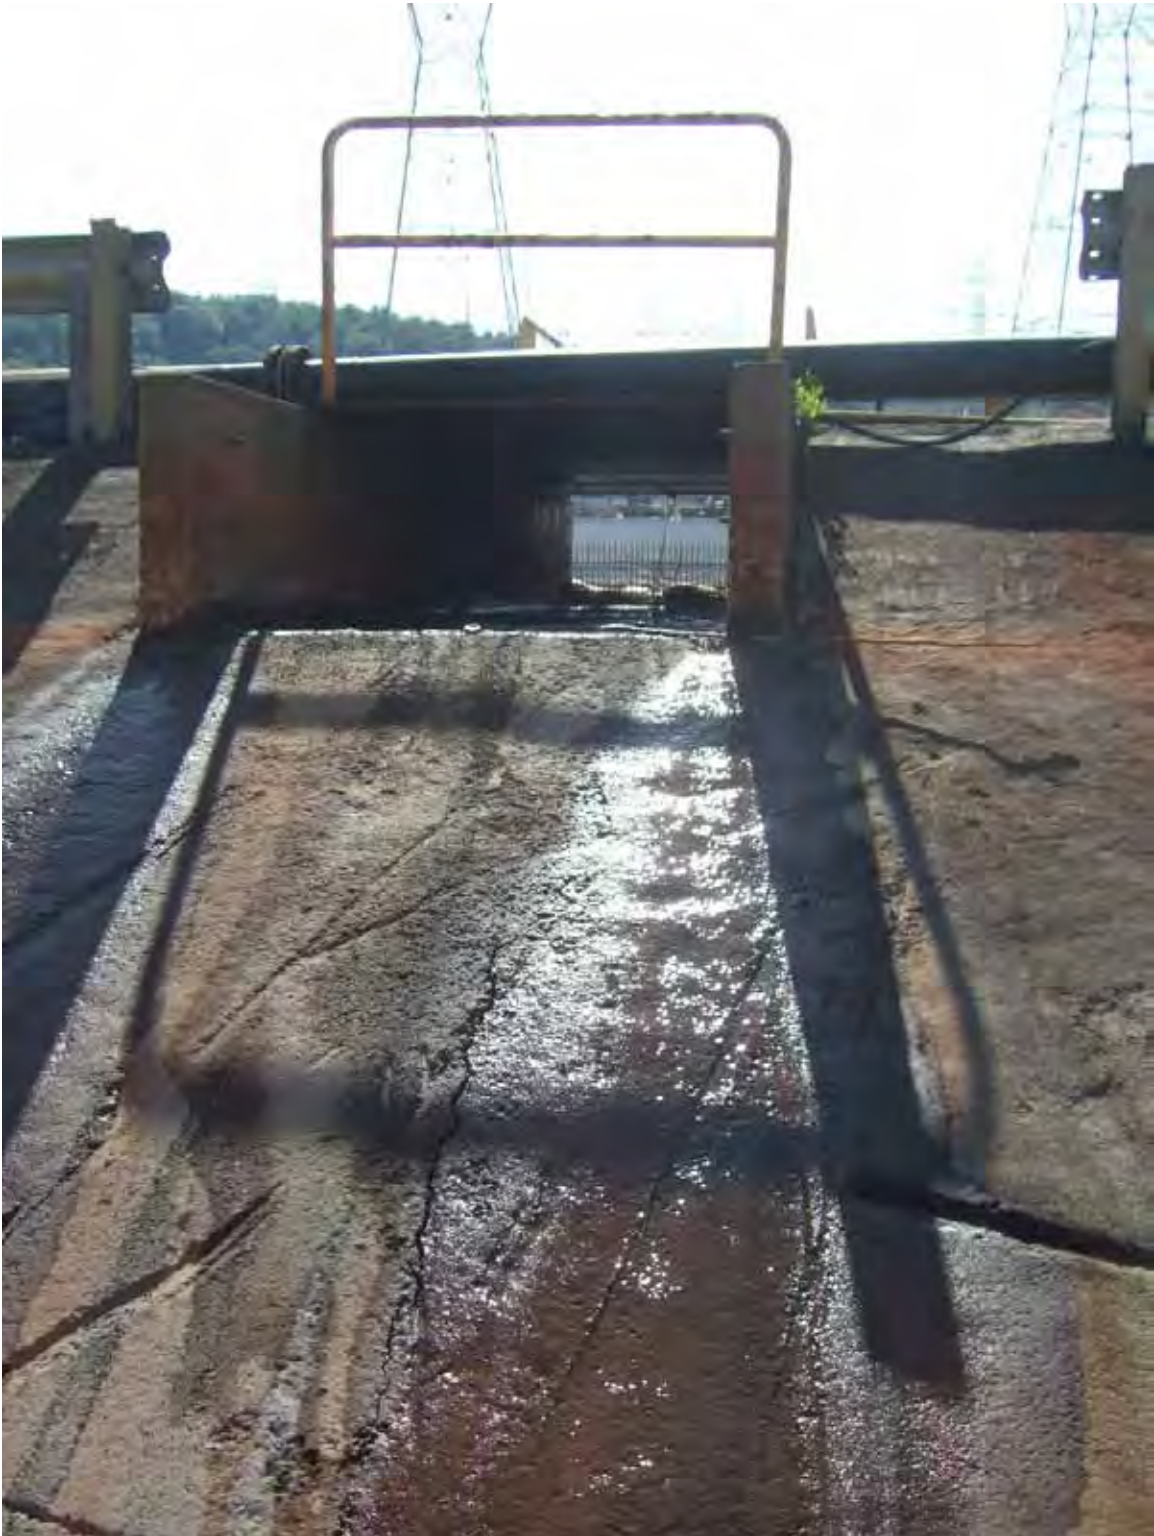
PHOTO 10: SPILLWAY BETWEEN NORTH AND SOUTH LDS PONDS

The small spillway between the North and South LDS Ponds was in good condition at the time of inspection (*Photograph 10*). The concrete was in good condition, while the weir and trashrack were observed to be free of obstructions or debris.

The small spillway between the North and South LDS Ponds was in good condition at the time of inspection *(Photograph 10)*. The concrete was in good condition, while the weir and trashrack were observed to be free of obstructions or debris.

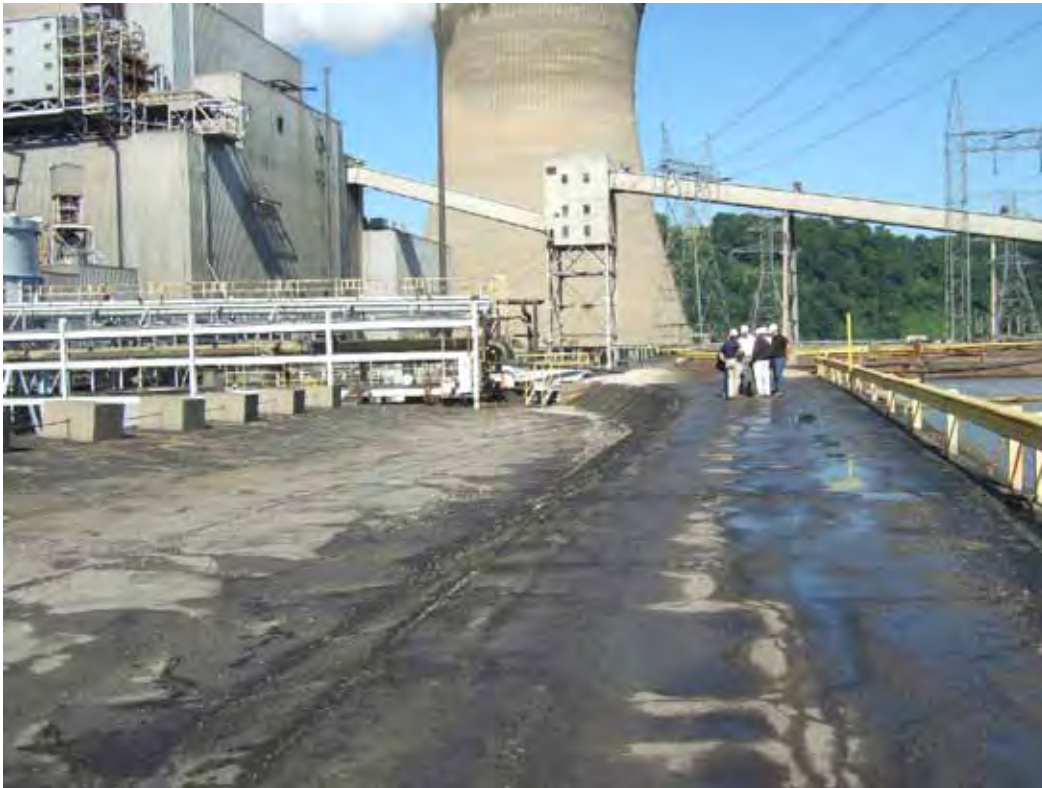
PHOTO 11: WEST EMBANKMENT CREST FOR SOUTH LDS POND

(Photograph 9). The crest of embankment and downstream slope showed cracks and spalling throughout the top layer (about 3 inches) asphalt, due to sun exposure and weathering *(Photograph 11)*. These cracks are cosmetic, do not extend to the underlying soil, and do not pose any risk to the stability and integrity of the embankments. Nonetheless, they should be sealed periodically to reduce vegetation growth. Along the eastern embankment, the vegetation is well-maintained and trimmed back approximately 10 feet from the edge of the asphalt liner. The western downstream slope is vegetated and was well maintained and trimmed at the time of inspection. No seepage was observed by RIZZO along the downstream toe of the South LDS Pond. Several minor wet spots were observed at the toe of the western downstream embankment by the PADEP and RIZZO at the time of the inspection. According to the owner, this area is subject to rain, periodic dust control watering, and is periodically hosed down for general cleaning.

We recommend that the surface asphalt along the crest and downstream slopes of all embankments continue to be maintained as part of the plant facility's regular maintenance activities. Clearing of vegetation, sealing of cracks, and repair of larger defects should be performed on a regular basis. The hydrologic study for the site states that SDF will overtop the impoundments by approximately 0.3 foot. Passage of the SDF without erosion of the embankments is dependent on the asphalt layer, and it should not be allowed to degrade to a point where an overtopping could cause a failure.

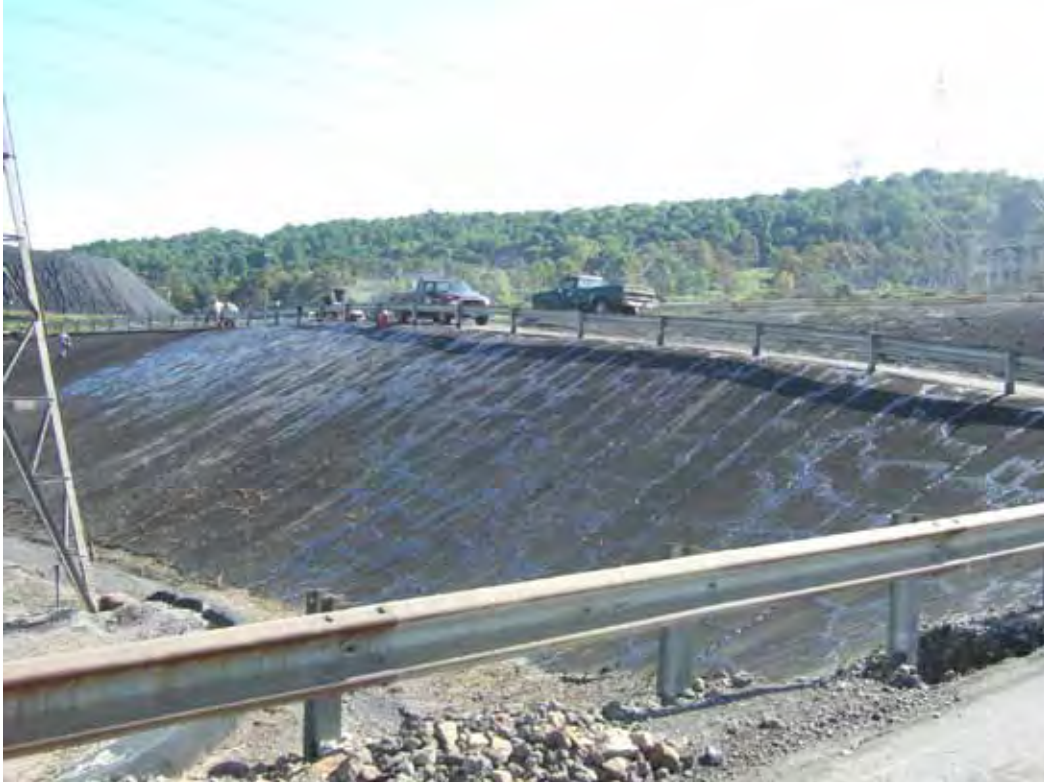
PHOTO 13: REPAIR OF ASPHALT ON WEST HDS POND NORTH SLOPE

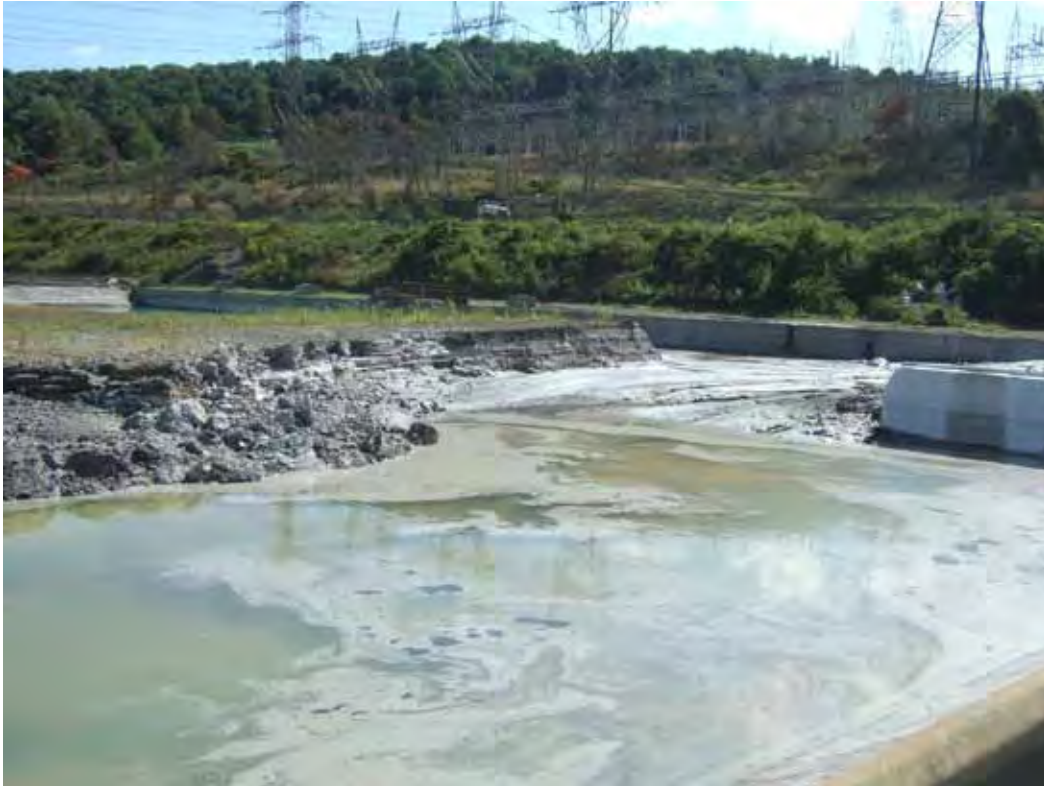
PHOTO 15: WASTE BUILDUP IN WEST HDS POND

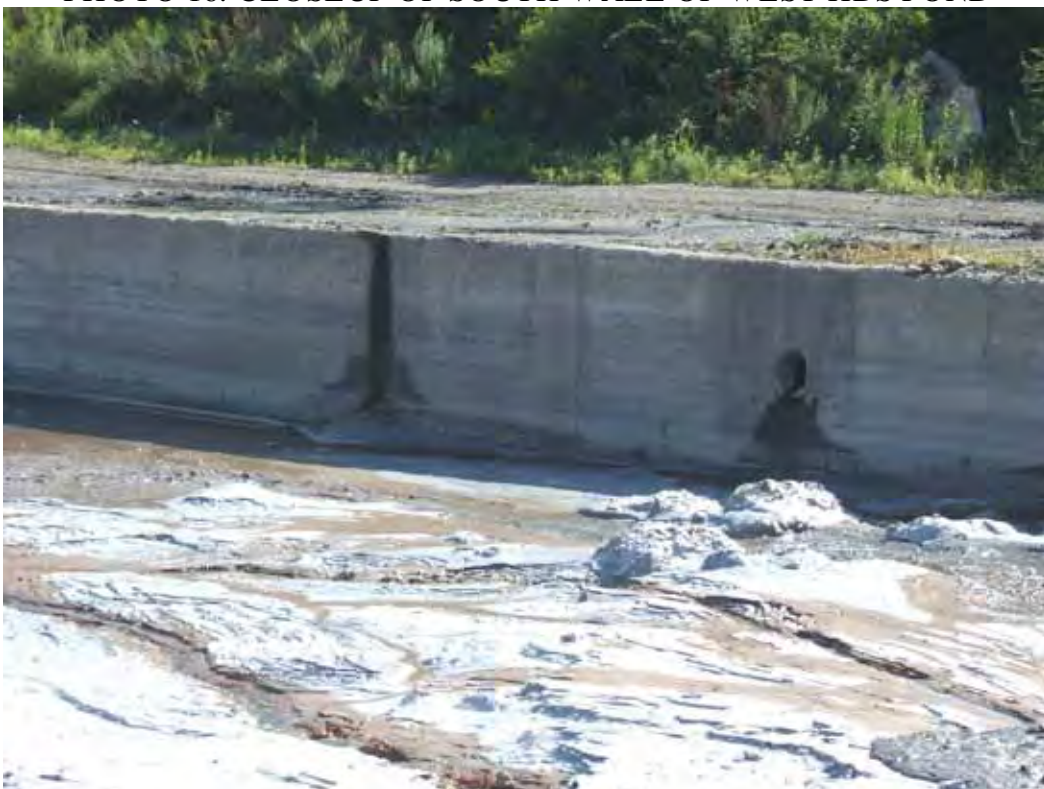
PHOTO 16: CLOSEUP OF SOUTH WALL OF WEST HDS POND

There was about 4 feet of freeboard along the upstream slope of the West HDS Pond at the time of inspection. The water was clear, and no major cracks were observed in the visible portion of the upstream liner, which is constructed of the more impervious asphalt material. The crest of embankment and downstream slope showed minor cracks and spalling throughout the top layer (about 3 inches) asphalt due to sun exposure and weathering *(Photographs 14 and 17)*. These cracks are cosmetic, do not extend to the underlying soil, and do not pose any risk to the stability and integrity of the embankments. Nonetheless, they should be sealed periodically to reduce vegetation growth. At the time of inspection, maintenance crews were clearing away vegetation along the northern downstream slope and sealing the cracks with tar *(Photograph 13)*. The southern reinforced concrete wall was in good condition *(Photograph 16)*. No seepage was observed along the downstream toe of the West HDS Pond.

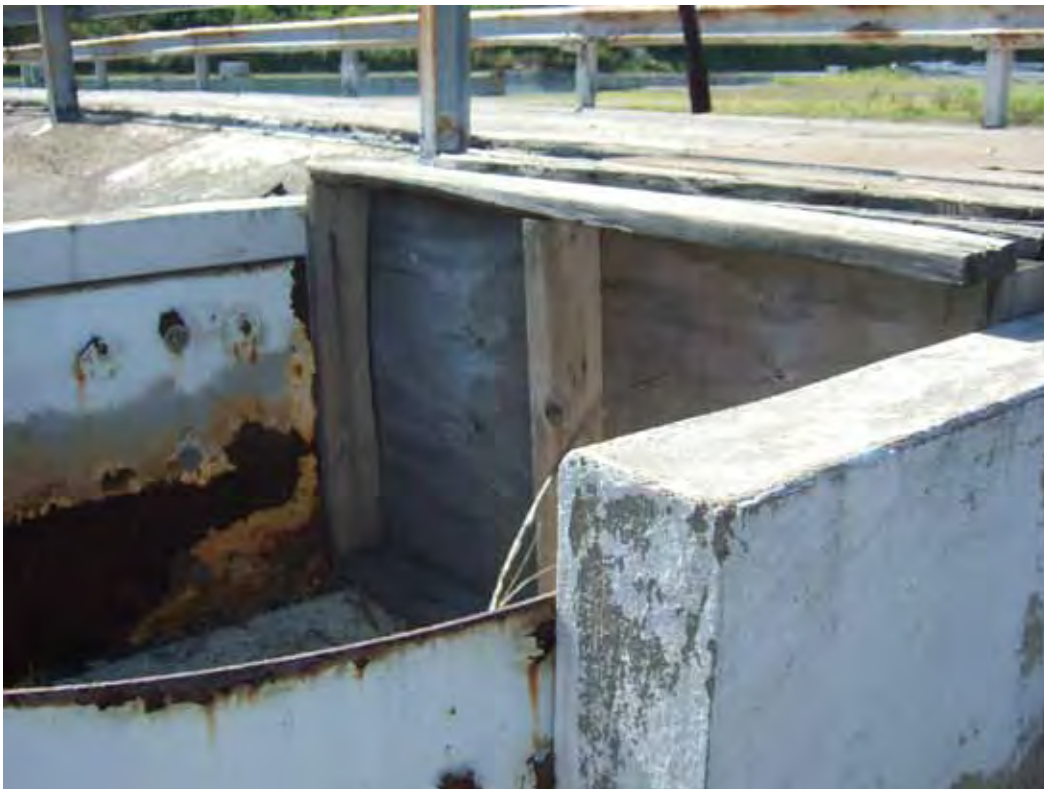
PHOTO 21: SPILLWAY BETWEEN WEST AND EAST HDS POND

The small spillway between the East and West HDS Ponds has been decommissioned, but the concrete still appeared in good condition at the time of inspection (*Photograph 21*).

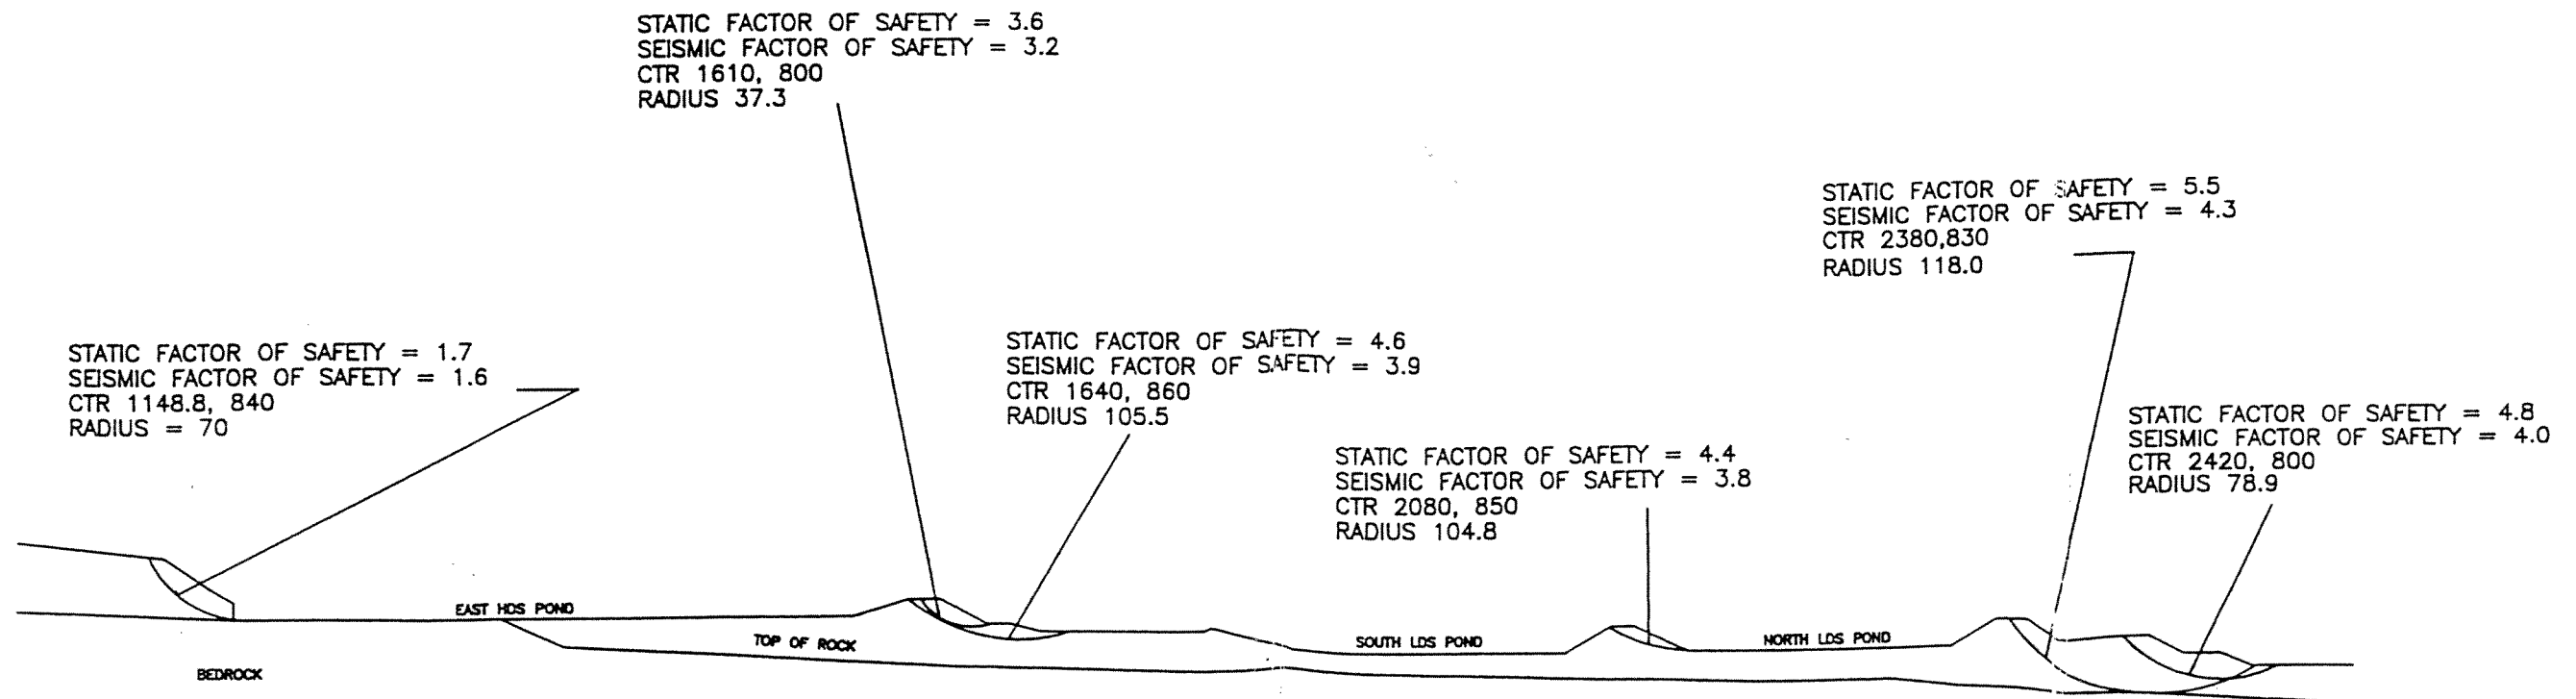
SOIL PARAMETERS:	MINIMUM FACTOR OF SAFETY:
UNIT WEIGHT = 120 pcf	STATIC = 1.7
COHESION = 500 psf	SEISMIC = 1.6
FRICTION ANGLE = 30 degrees	●CTR 1148.75, 840
	RADIUS = 70

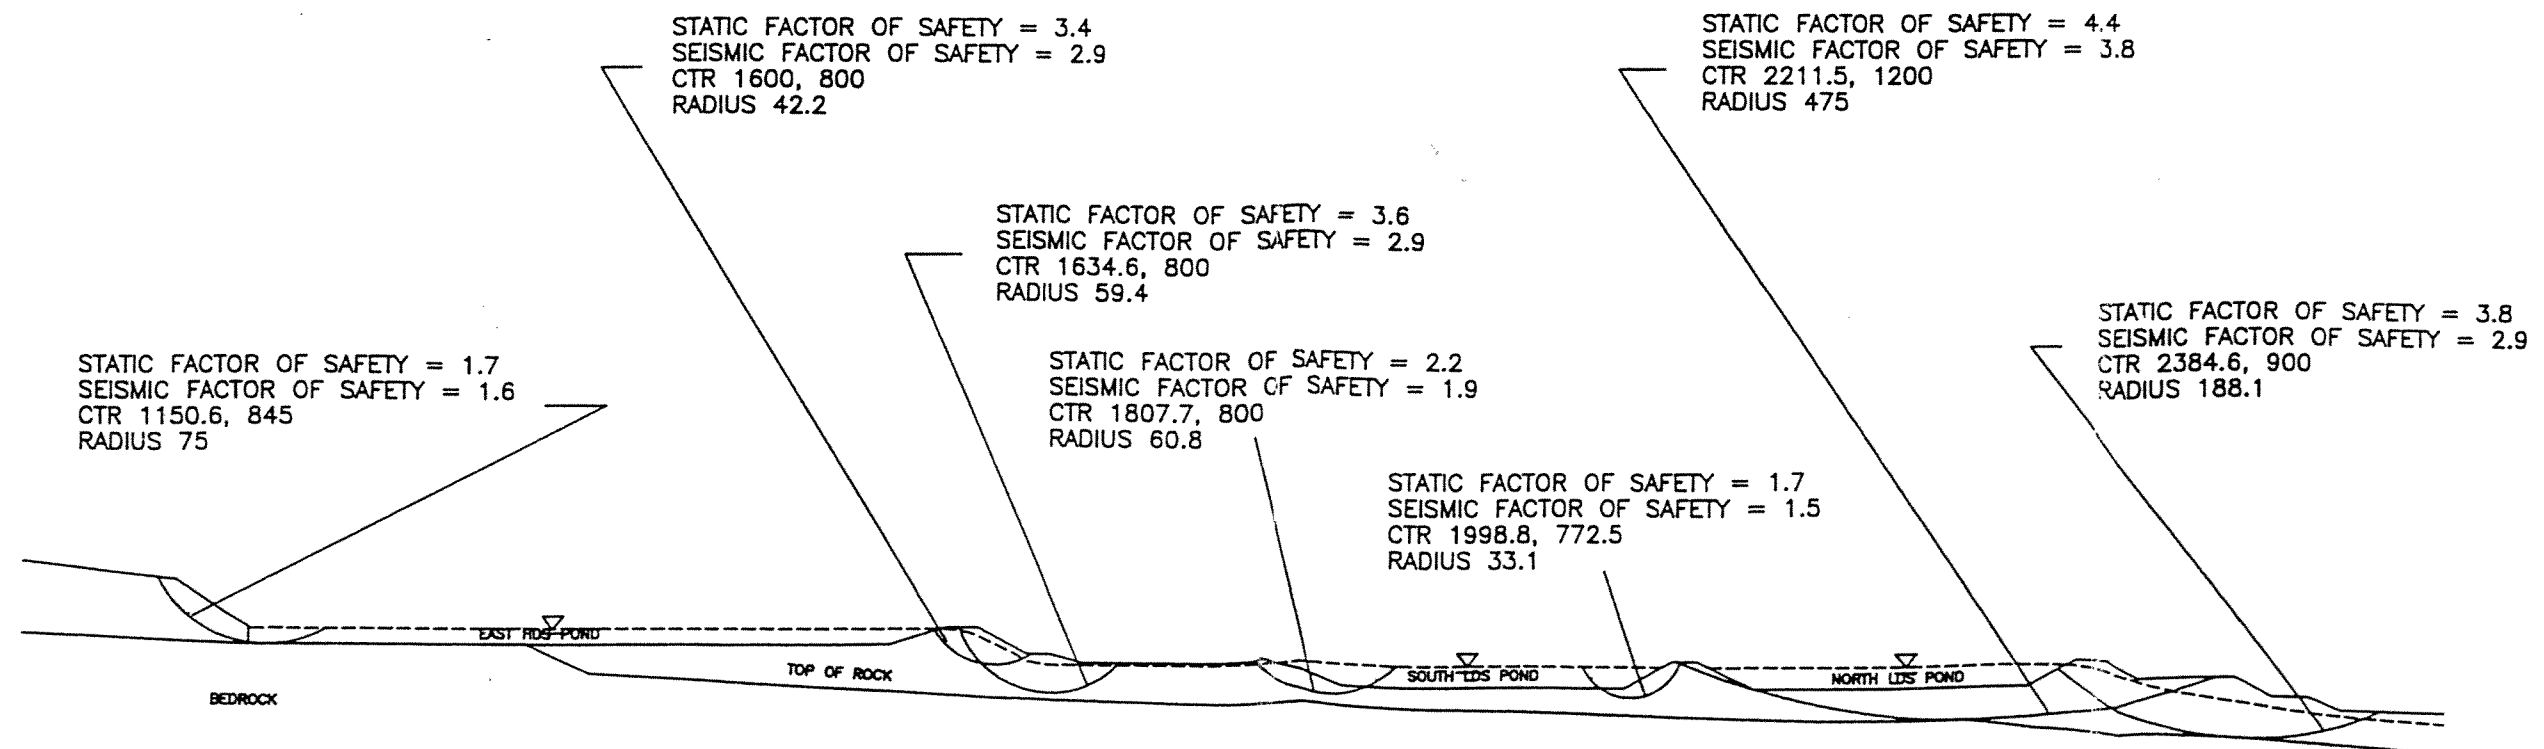
PENNSYLVANIA POWER COMPANY
 BRUCE MANSFIELD PLANT HDS and LDS PONDS
 DIKE STABILITY – SATURATED CASE

SOIL PARAMETERS:	MINIMUM FACTOR OF SAFETY:
UNIT WEIGHT = 120 pcf	STATIC = 1.7
COHESION = 500 psf	SEISMIC = 1.5
FRICTION ANGLE = 30 degrees	⊙ CTR 1998.7, 772.5
	RADIUS = 33.1
