**TRANSMITTAL  
ASSESSMENT OF DAM SAFETY OF  
COAL COMBUSTION SURFACE IMPOUNDMENTS  
DRAFT INSPECTION REPORT  
SITE 30 (BRUCE MANSFIELD)**

**DAM SAFETY INSPECTION NOTICE**

DEP Office	SWRO- PITTSBURGH Phone 4124424000	Dam Permit or ID. #	D04-049
Address	400 WATERFRONT DR BH PA 15222	Dam or Project Name	LITTLE BLUE RUN
Owner or Permittee	FIRST ENERGY GENERATION CORPORATION	County	BEAVER
Complete Mailing Address	BRUCE MANFIELD PLANT PO Box 128 SHIPPINGPORT PA 15077-0128	Municipality	GREENE TOWNSHIP
		Take GPS readings at the center of the crest of the dam.	
		Latitude:	40° 37' 40.14" N
		Longitude:	80° 30' 47.79" W

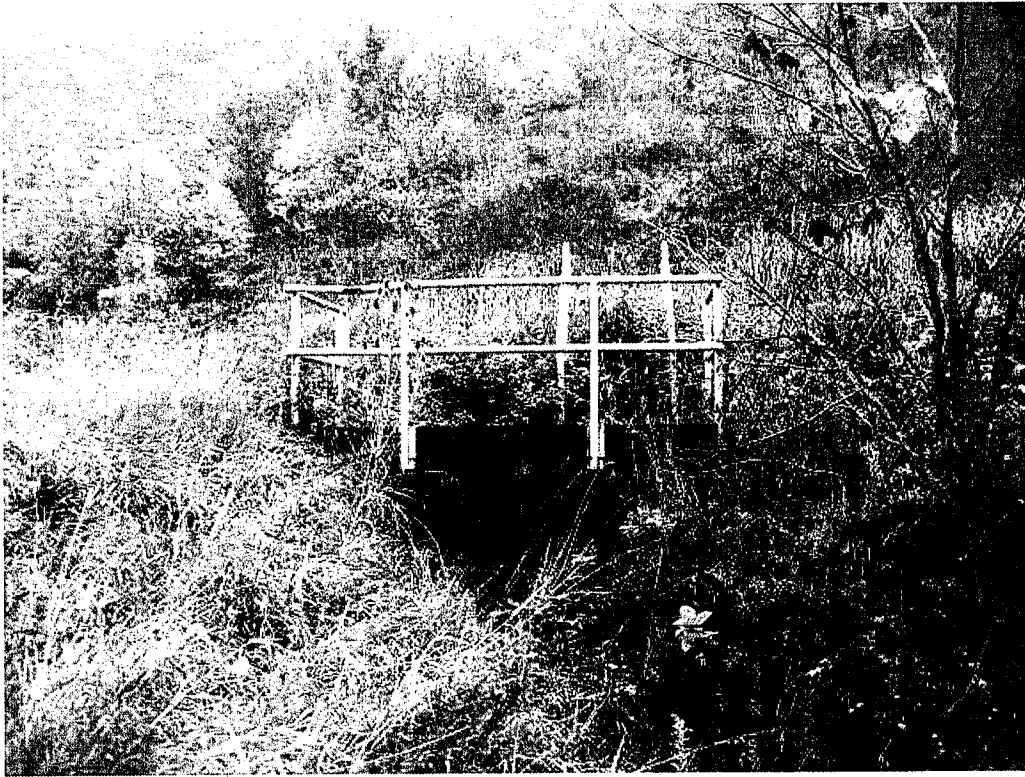
d04-049 10/23/07 discharge from left abutment

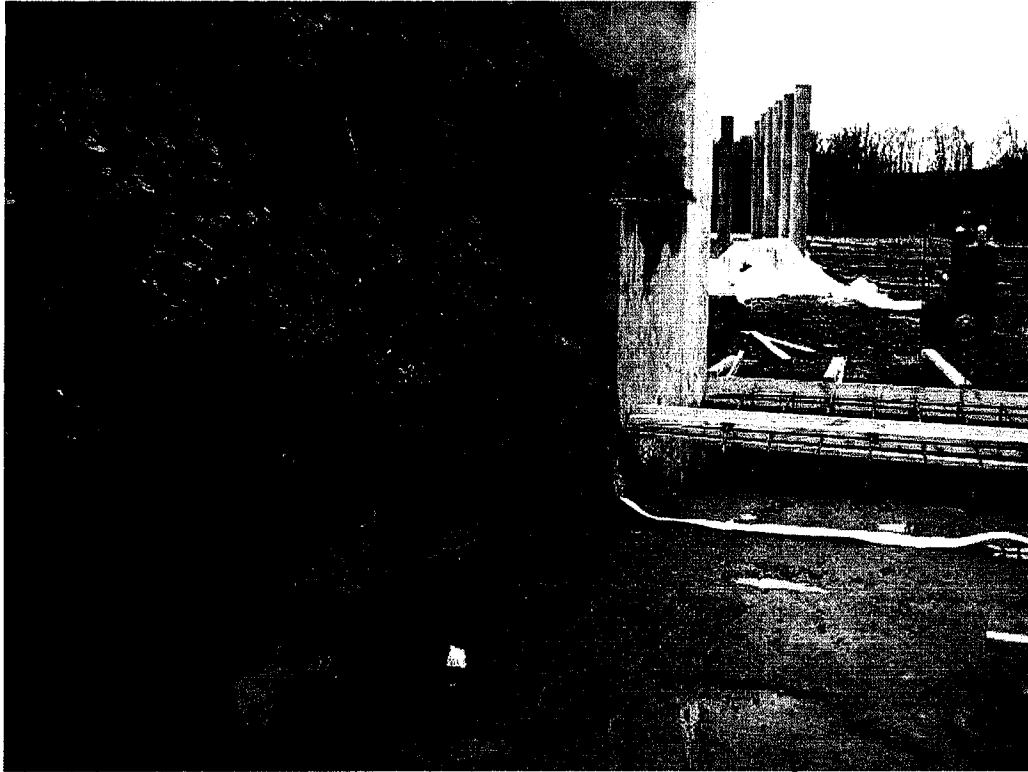
d04-049 11/20/06 forming at right wall – note waterstop

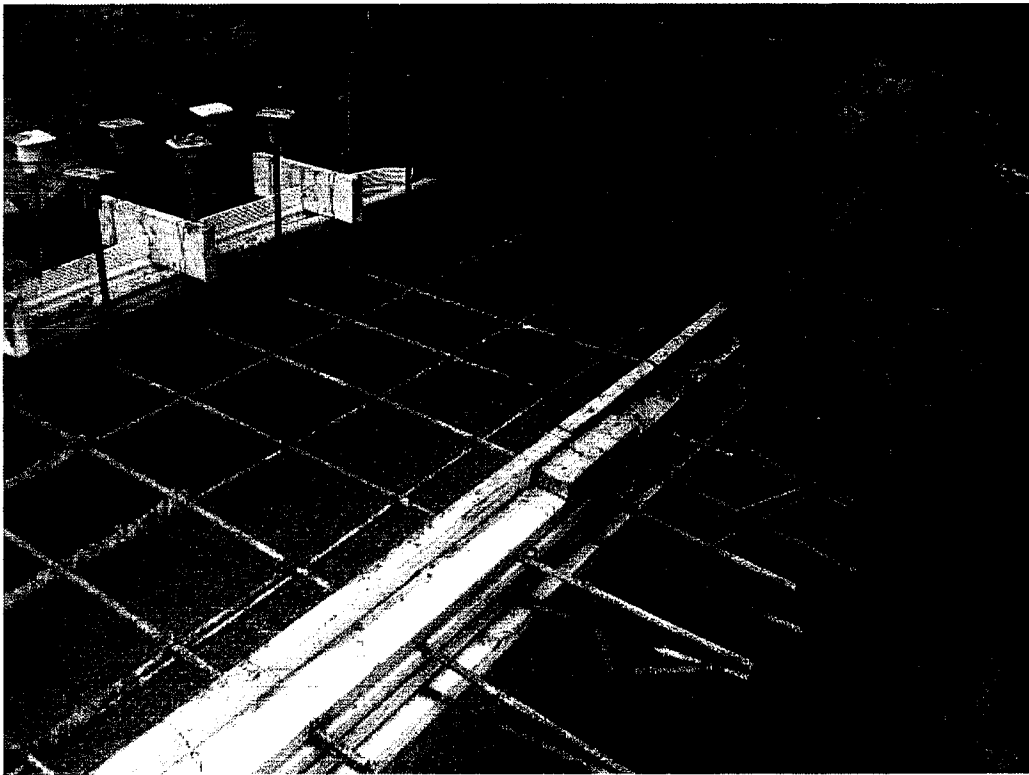
d04-049 11/20/06 lower portion of left US notch is 1/2 filled with concrete

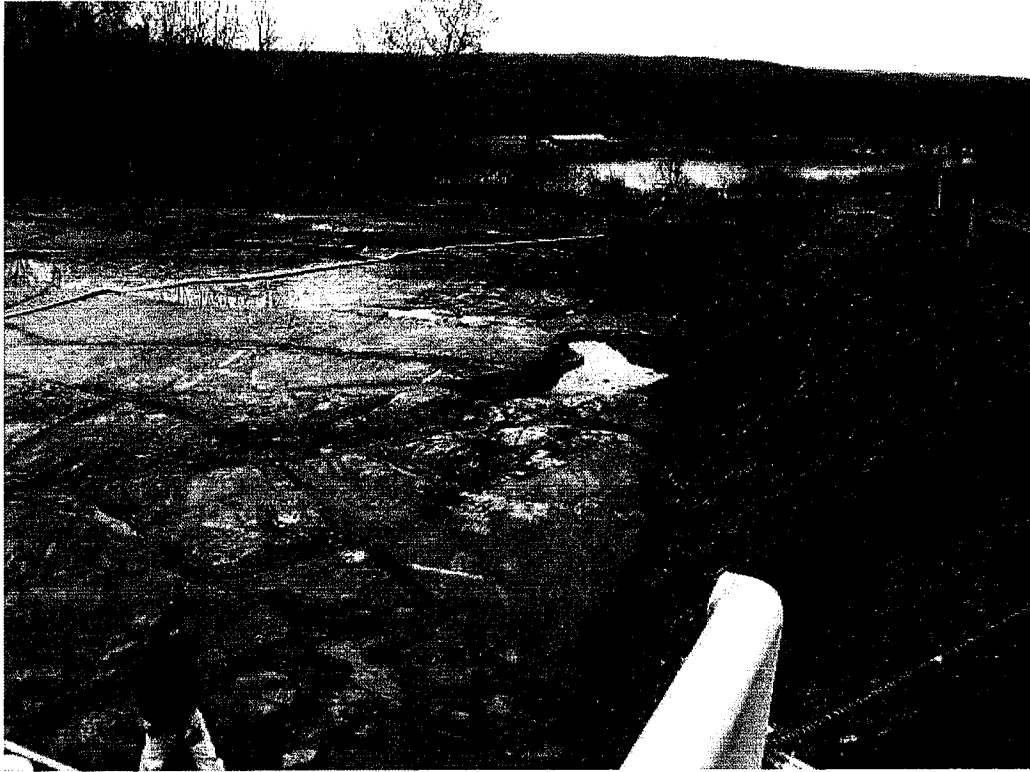
d04-049      11/20/06      DS of weir from right – showing joints in the abutment

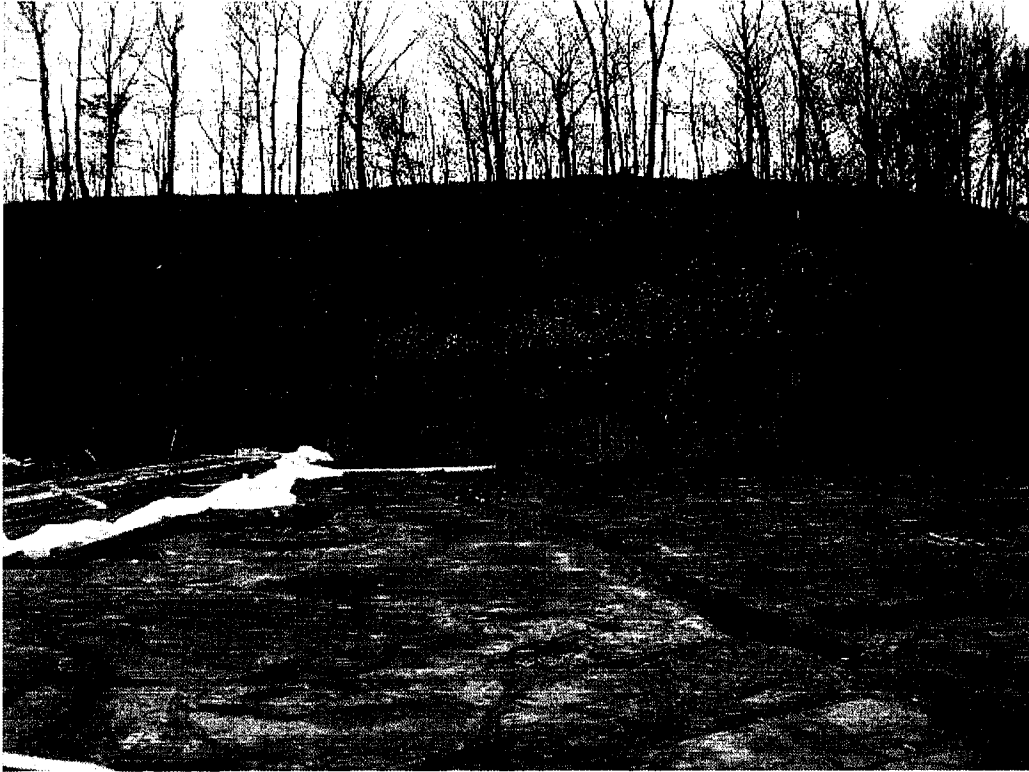
d04-049 11/20/06 rock floor joints & left abutment joints

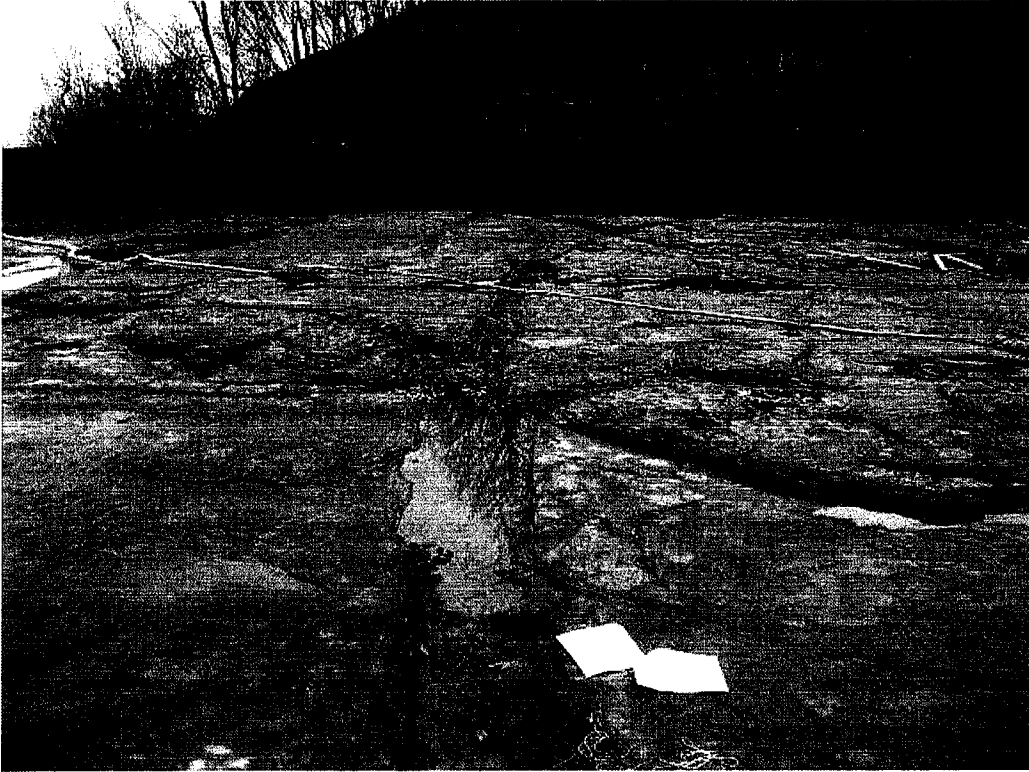
d04-049 11/20/06 rock joint structure looking right – 8.5 x 11 inch paper for scale

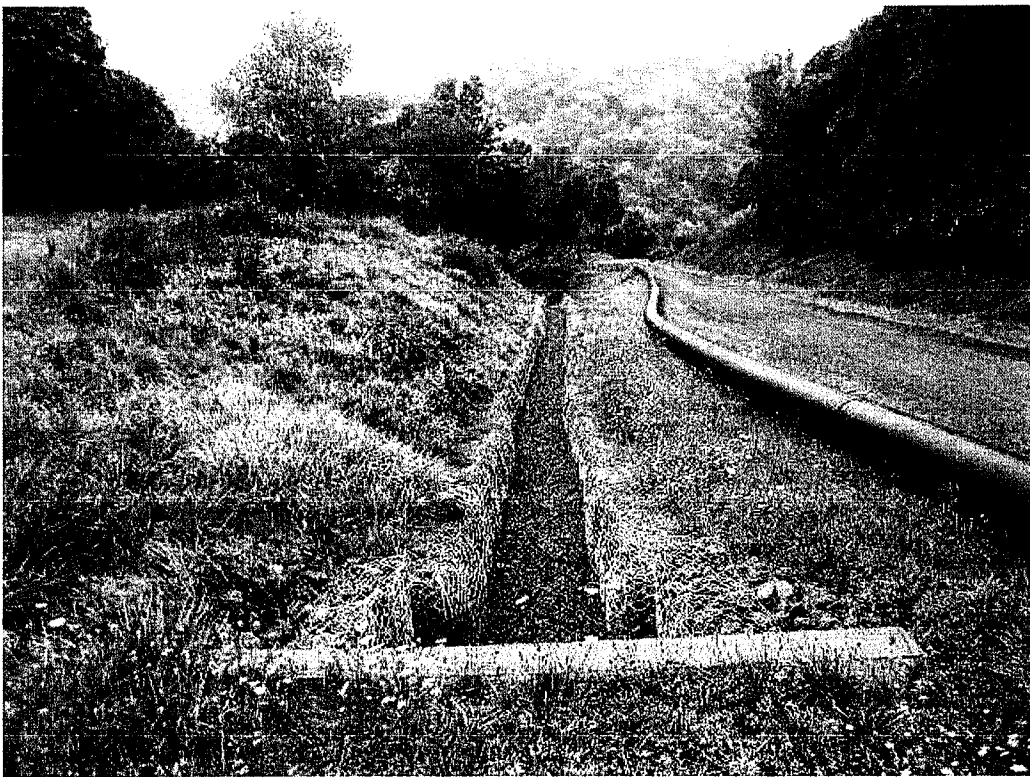
d04-049      8/29/05      gabion channel for right abutment seepage

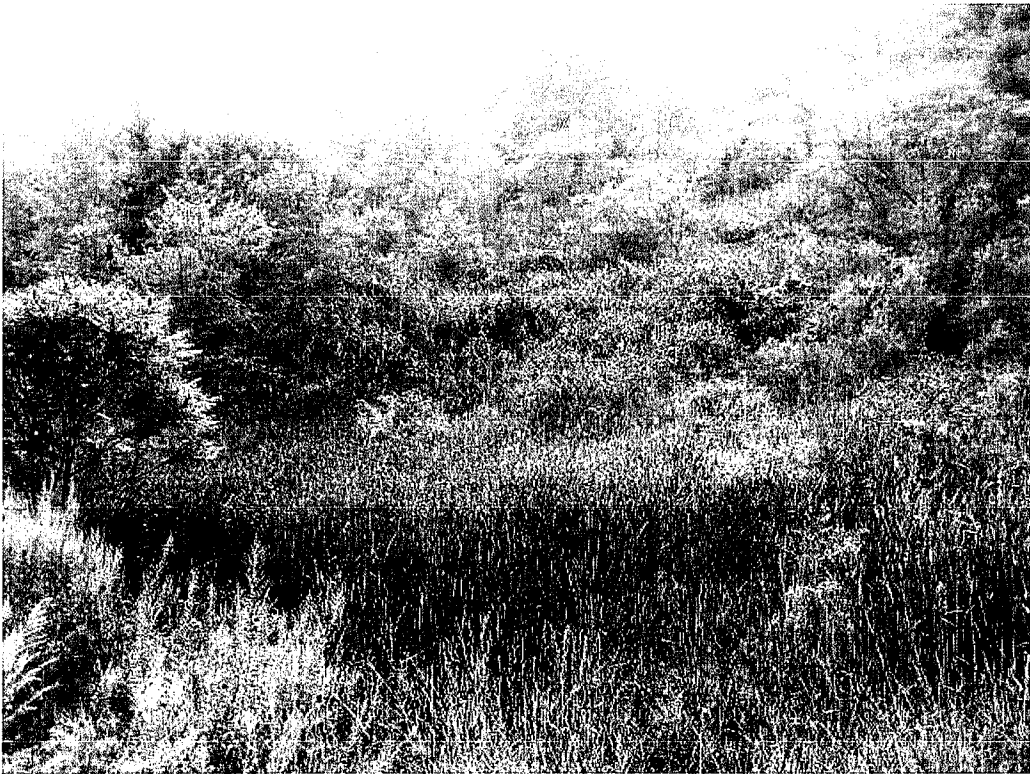
d04-049 8/29/05 wetland growth on left abutment

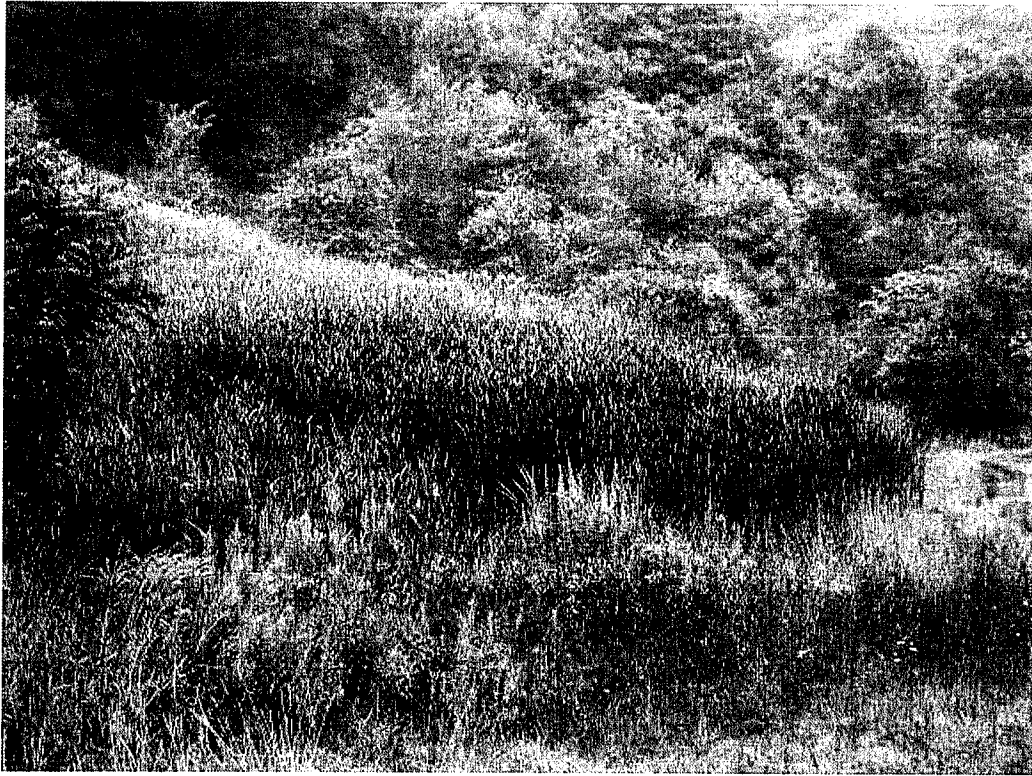
wetland growth on left abutment

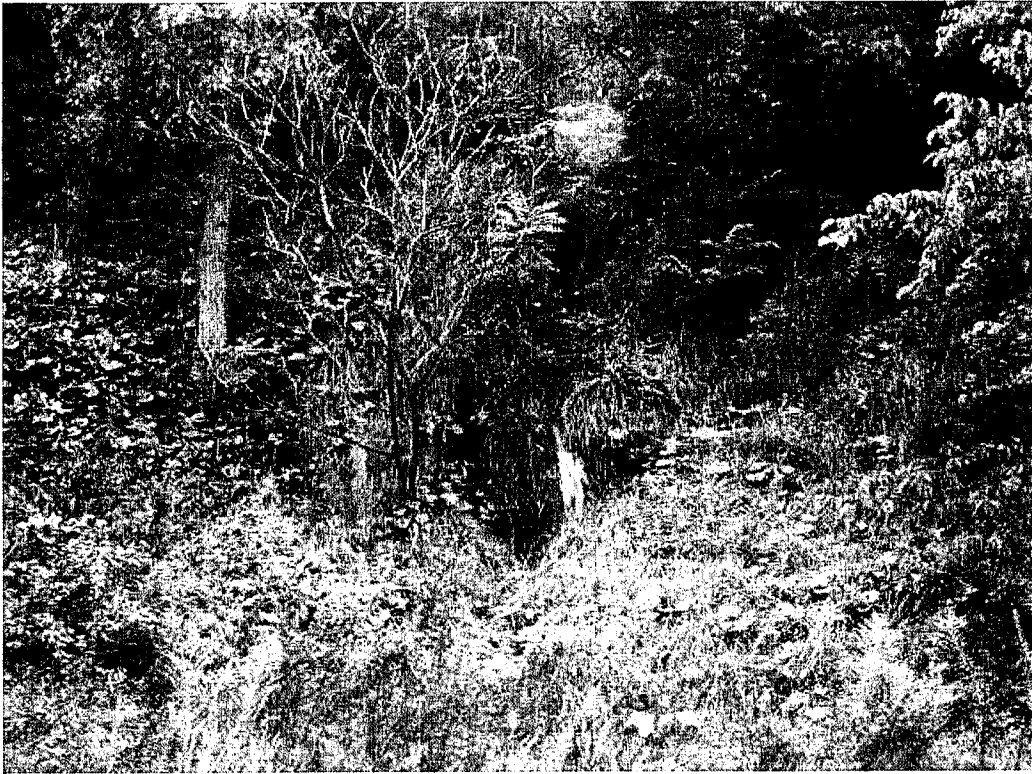
close-up of left abutment discharge

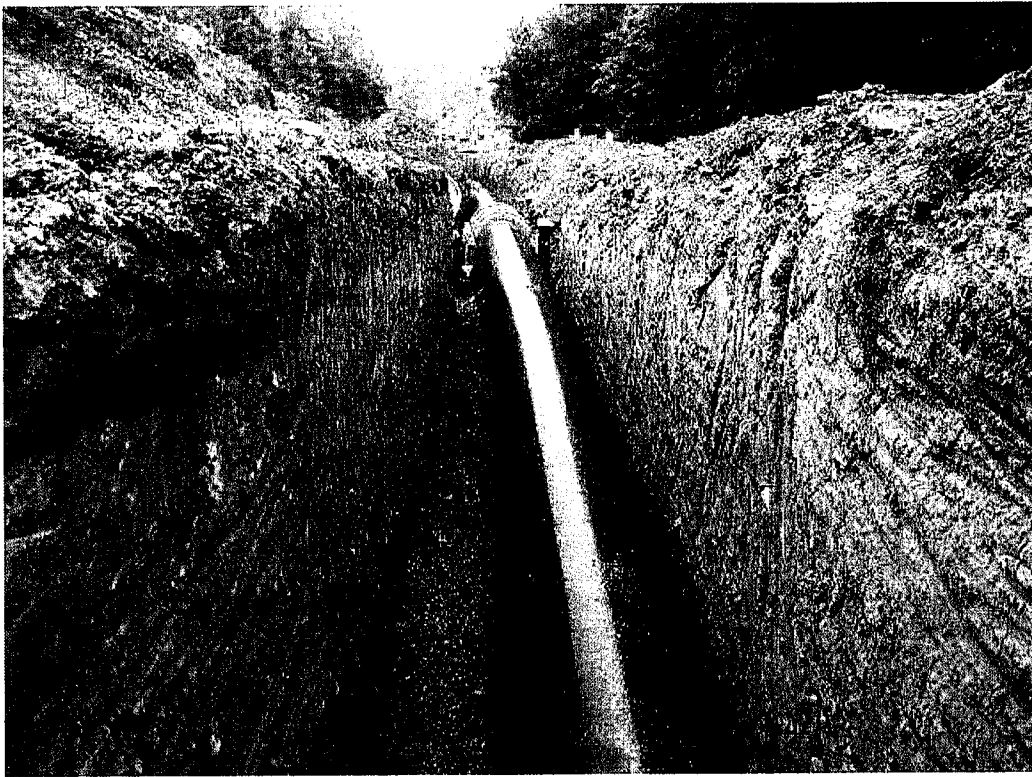
d04-049      8/29/05      soil cut on right side of abutment
