**DRAFT REPORT  
ROUND 10 DAM ASSESSMENT – MAY 23, 2011  
FIRSTLIGHT POWER RESOURCES, INC.  
MT. TOM GENERATING STATION  
BOTTOM ASH BASIN A, EQUALIZATION TANK, AND SPECIAL BASIN  
HOLYOKE, MASSACHUSETTS**

March 9, 2012  
GZA File No. 170142.30

Re: CCW Impoundment Inspection Report  
Bottom Ash Basin A, Special Basin, and Equalization Tank  
Mt. Tom Generating Station  
Holyoke, Massachusetts

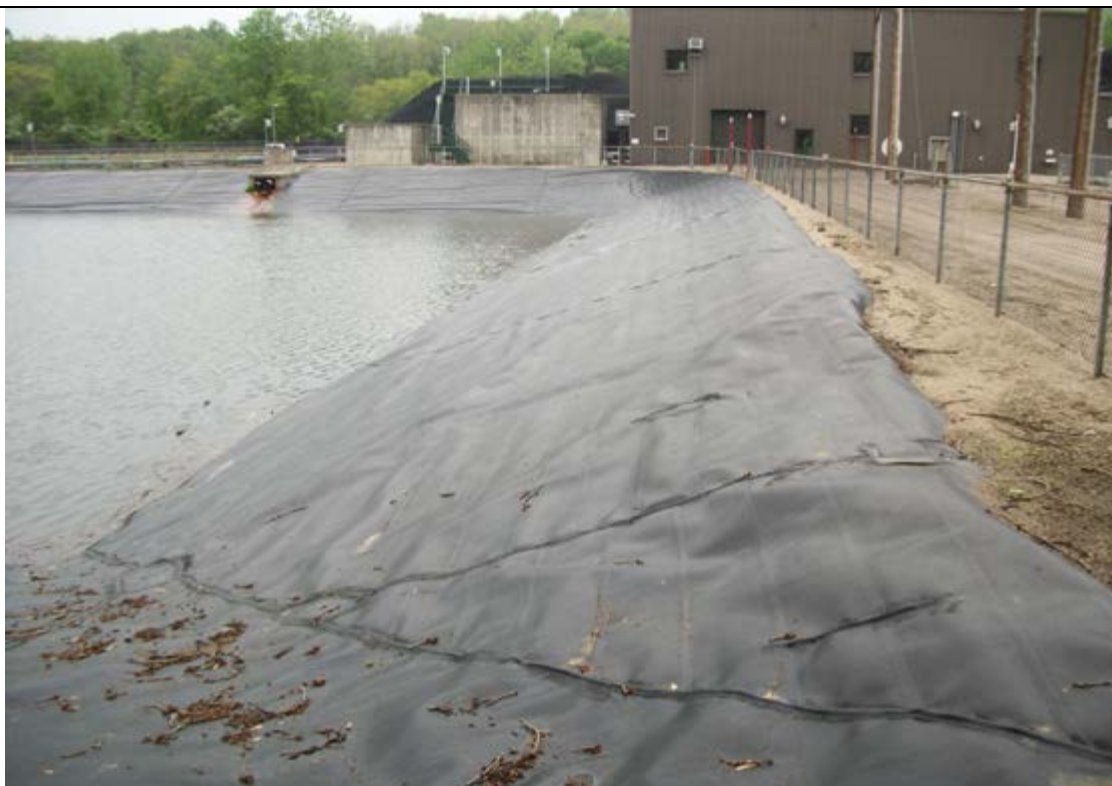
**8**

View along north slope of Special Basin. Note minor surficial erosion at top of liner in foreground. Equalization Tank and wastewater treatment plant located in background.

1. Fill low/rutted areas on access roads around the Bottom Ash Basin A and Special Basin with appropriately sized and compacted stone;
2. Repair/fill areas of erosion on the surface of the berms and embankment slopes. New material should be appropriately sized to prevent erosion from surficial runoff;

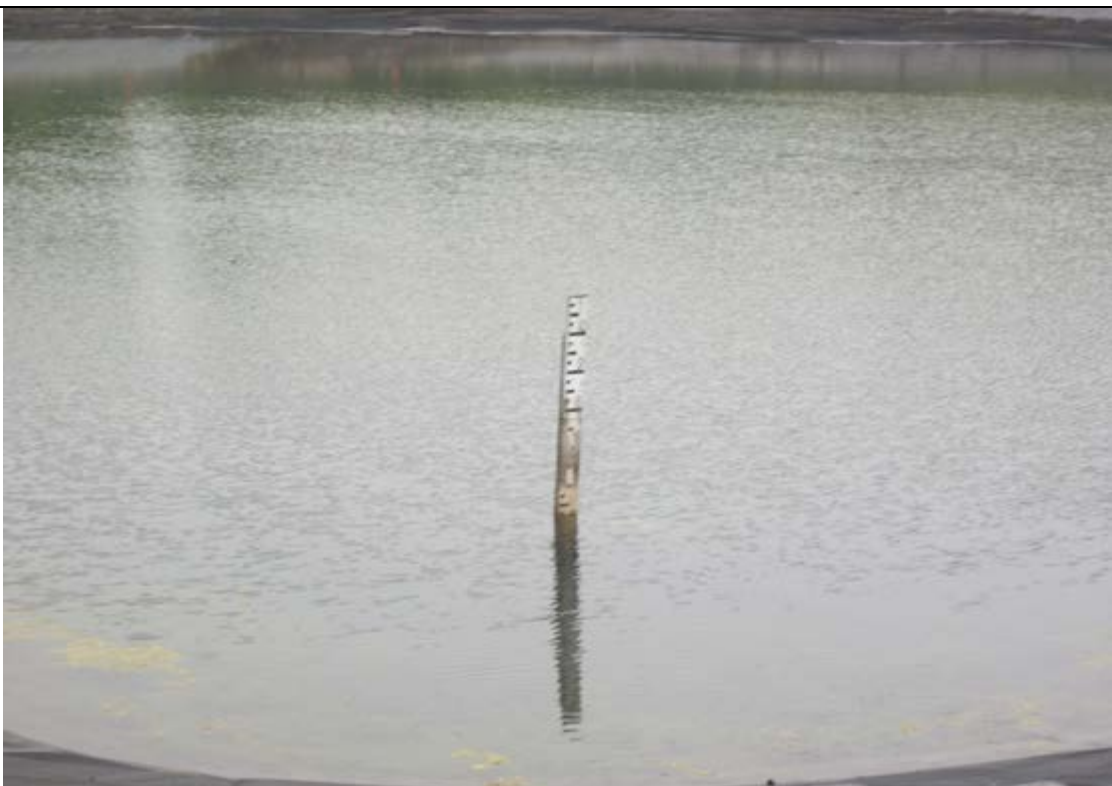
**Photo No.**  
20

View of minor surficial erosion along top of slope at access road along east side of Bottom Ash Basin A.

1. Staff gage numbers are worn and difficult to read near the water line.

View off staff gage in Bottom Ash Basin A. Note marks/numbers difficult to read due to worn paint.

5. Repair/replace Bottom Ash Basin A and Equalization Tank staff gages, and provide distinct marking for the maximum operating level.

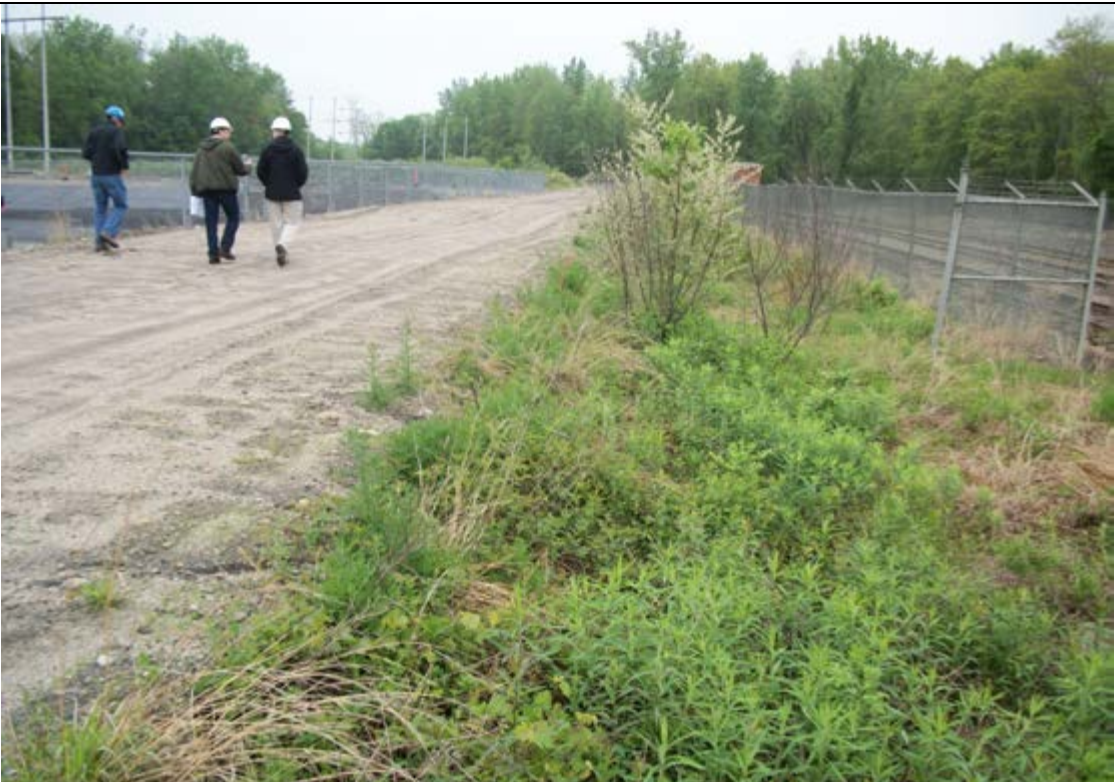
| <b>Description:</b><br>View of minor embankment and slope between Bottom Ash Basin A and plant rail lines. Note woody brush on slope. | | |

4. Based on the results of the embankment fill delineation recommended above, clear vegetation including trees (and associated roots/ root balls) from embankment fill slopes. Fill any voids resulting from root removal with compacted granular material. Establish healthy grass cover on slopes after vegetation removal is complete;

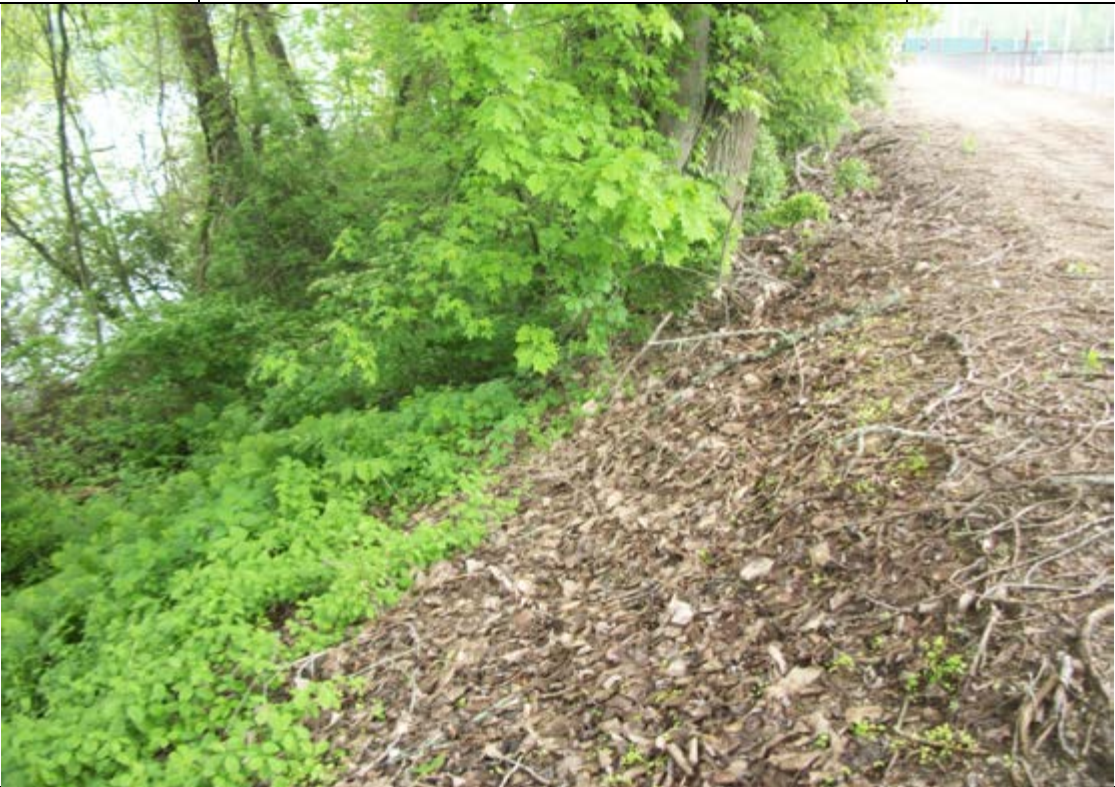
| <b>Description:</b><br>View along downstream slope of Special Basin. Note tree and brush growth. Transition between embankment slope and river bank is unclear. | | | |

1. Investigate and delineate the extent of embankment fill along the eastern (Connecticut River) side of the Bottom Ash Basin A and Special Basin, and evaluate the presence of trees and woody vegetation on the surface of the filled embankment slopes.
2. Perform a geotechnical stability analysis of the embankments and/or management units under all applicable loading conditions, including earthquake-induced loading.

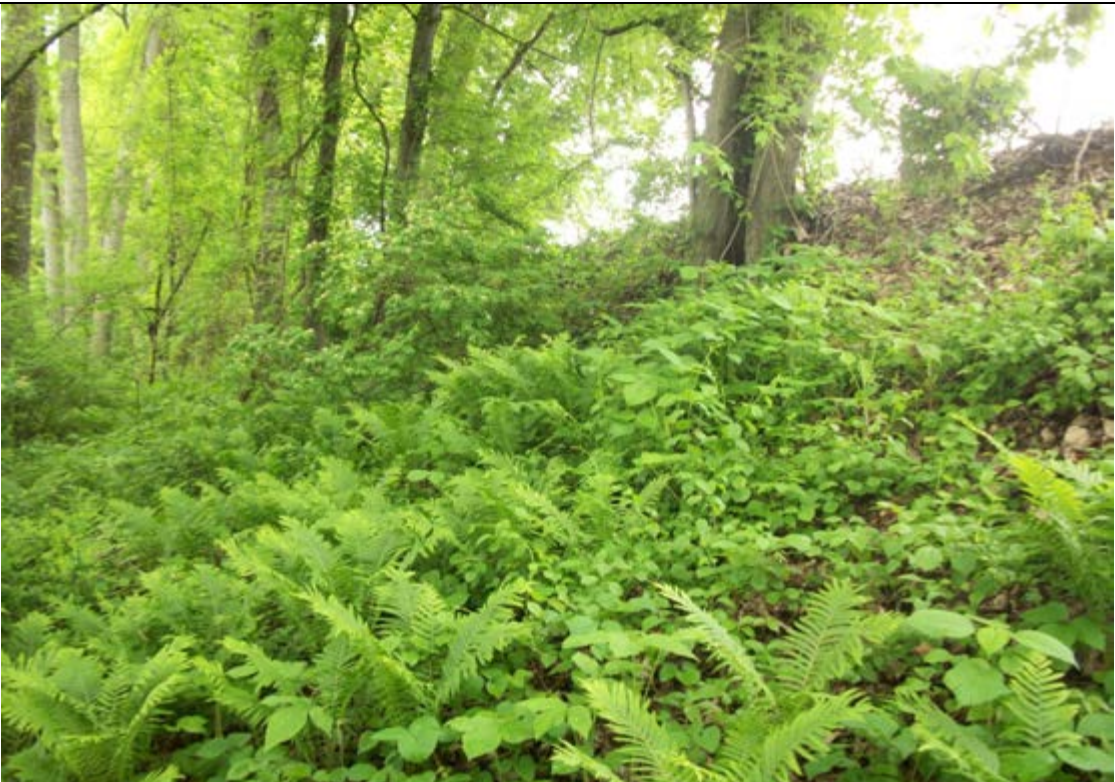
| <b>Description:</b><br>View along downstream slope of Special Basin. Note tree and brush growth. Transition between embankment slope and river bank is unclear. | | |
