# Assessment of Dam Safety

## Coal Combustion Surface Impoundments (Task 3)

Georgia Power  
Company

Plant Branch

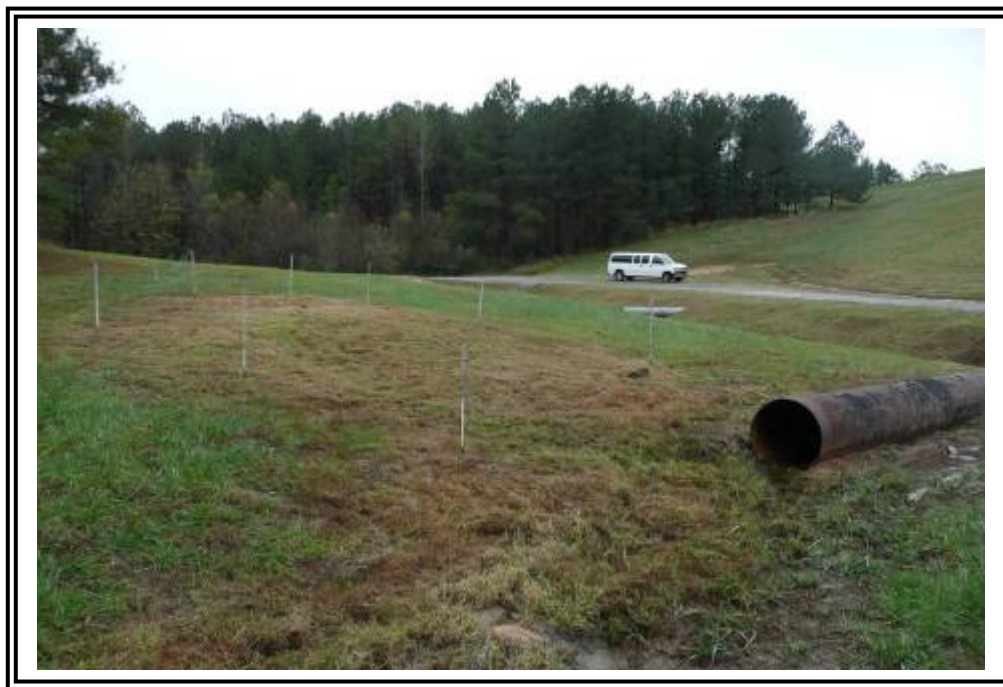
However, three “soft” areas of saturated soils were observed east of the lower concrete lined drainage channel. These areas have been previously recognized by members of Georgia Power and they have been delineated using wooden stakes (Photos 5 and 10). These areas are regularly reviewed for any changes during inspections. As indicated by Georgia Power personnel, these areas have remained as originally recognized over at least the last 9 years, based upon specific references to these areas in quarterly reports dating to the latter part of 2000. It is also possible that some of these areas may actually be older, based upon non specific references to downstream seeps dating back to the time the impoundment was initially filled in 1985.

Ash Pond E, "soft spot" located south of emergency overflow drain (1 of 3 observed near Ash Pond E). This area has been monitored for 9 years by Georgia Power with no additional expansion observed. Perimeter stakes have been placed to aid in monitoring.

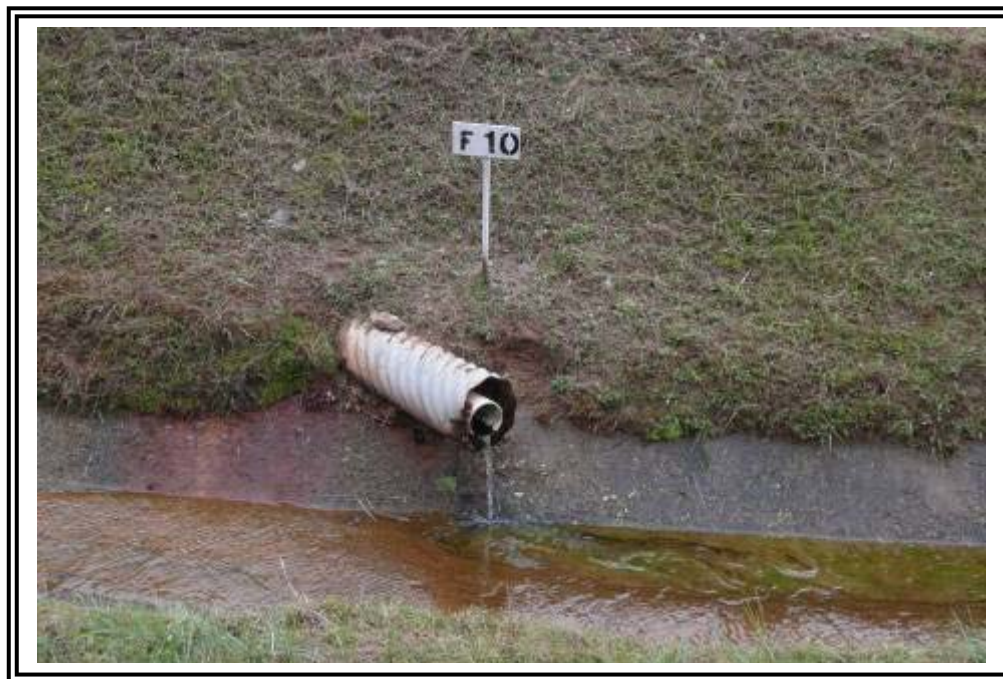
6

The finger drains observed along the toe of the dike appeared to produce clear water and discharged directly in the concrete lined drainage channel as shown in Photo 6. The channel also collects surface run-off.

Ash Pond E finger drain #10. Drainage from finger drains observed to be clear.

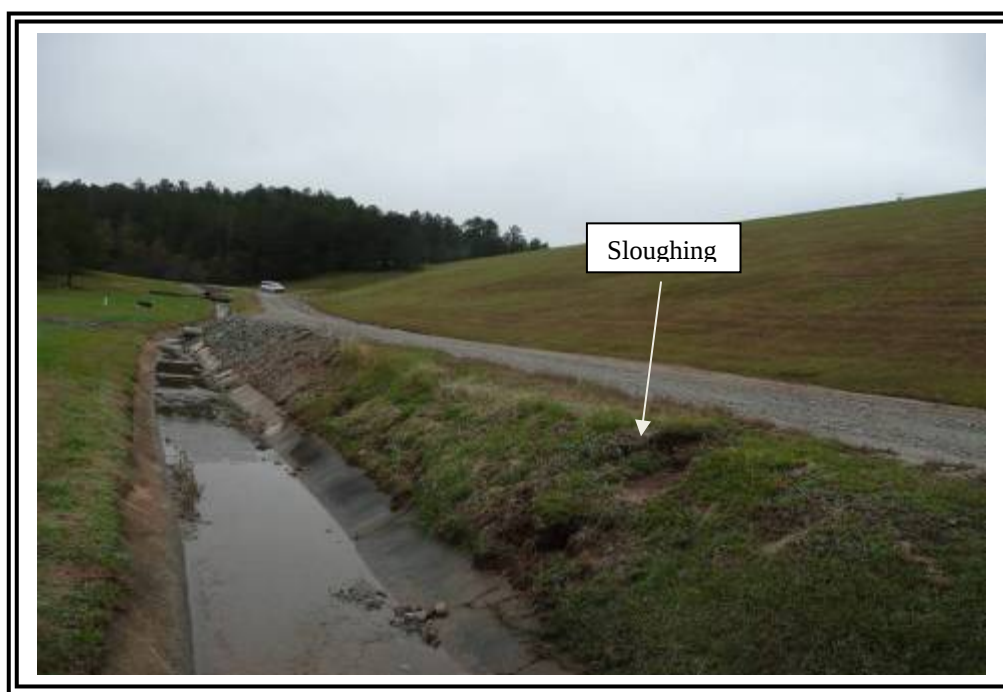
8

A small area of sloughing was noted along the south central portion of the dike adjacent west of the lower concrete channel along the toe as shown in Photo 8. The area determined to be sloughing appeared to be due to recent rainfall activity.

Ash Pond E, sloughing observed along west edge concrete line channel at the base of the toe, central portion of the dike.

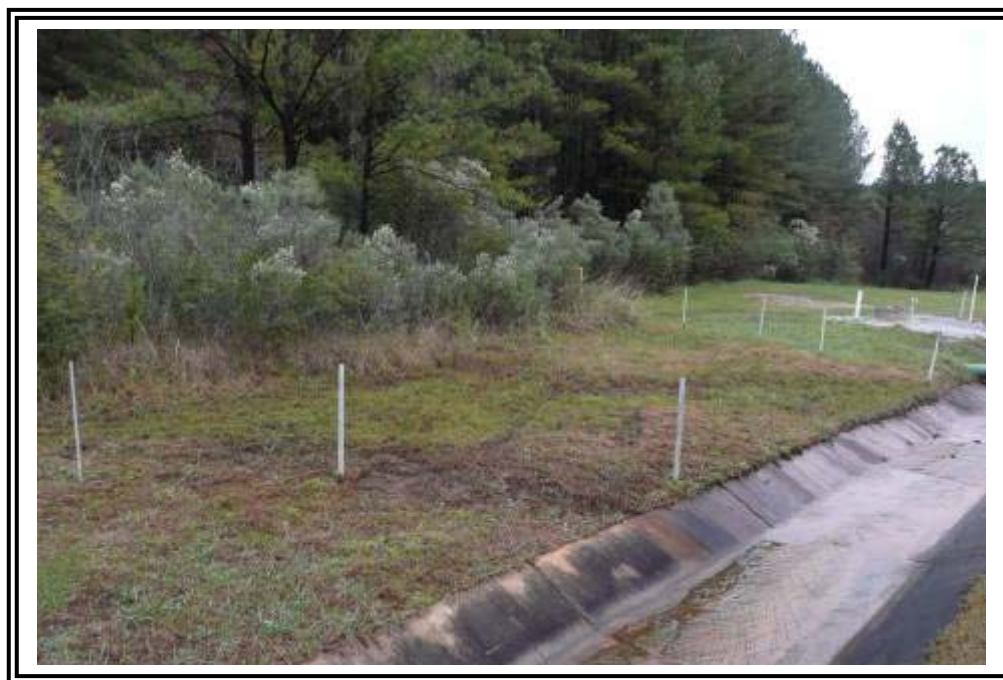
10

Ash Pond E, 3<sup>rd</sup> observed "soft spot" located east of finger drain #5. Perimeter stakes installed for all soft spots in effort to monitor expansion. No observed expansion for any of the 3 soft spots in at least 9 years, as indicated by Georgia Power.

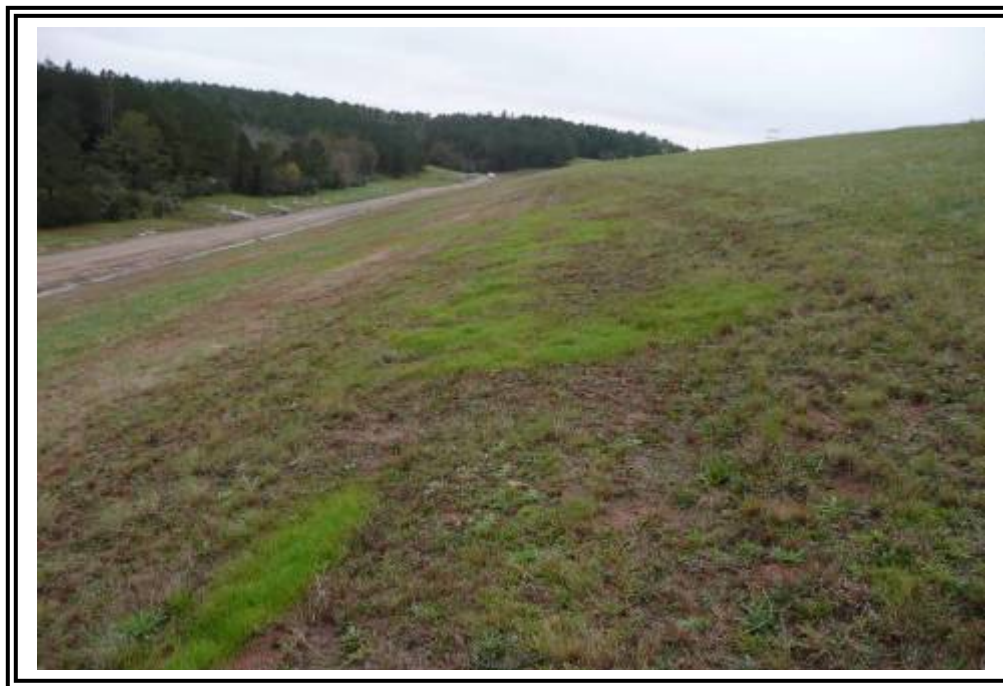
A few areas along the downstream face and crest of the dike were observed to have sparse vegetation. The majority of these areas appeared to be due to slippage along the face of the dike by mowers as shown in Photos 13 and 14. Several areas were also noted as having a variation in the existing grass on the dike face. Based upon information provided by Georgia Power personnel, these areas were seeded with "rye grass" to provide vegetative cover during the winter months, which would be reseeded with the appropriate grass cover in the spring. With this exception, the remainder of the grass cover appeared to be uniform. Some very minor rutting or tracking was also observed along the face of the dike which also appeared to be due to current mowing practices.

Ash Pond E, mid-height of dike, northern end of dam facing south. Mower-rutting observed throughout portions of the dike. Rye grass patching observed and indicated to be seasonal grass cover in effort to minimize sparse vegetation.

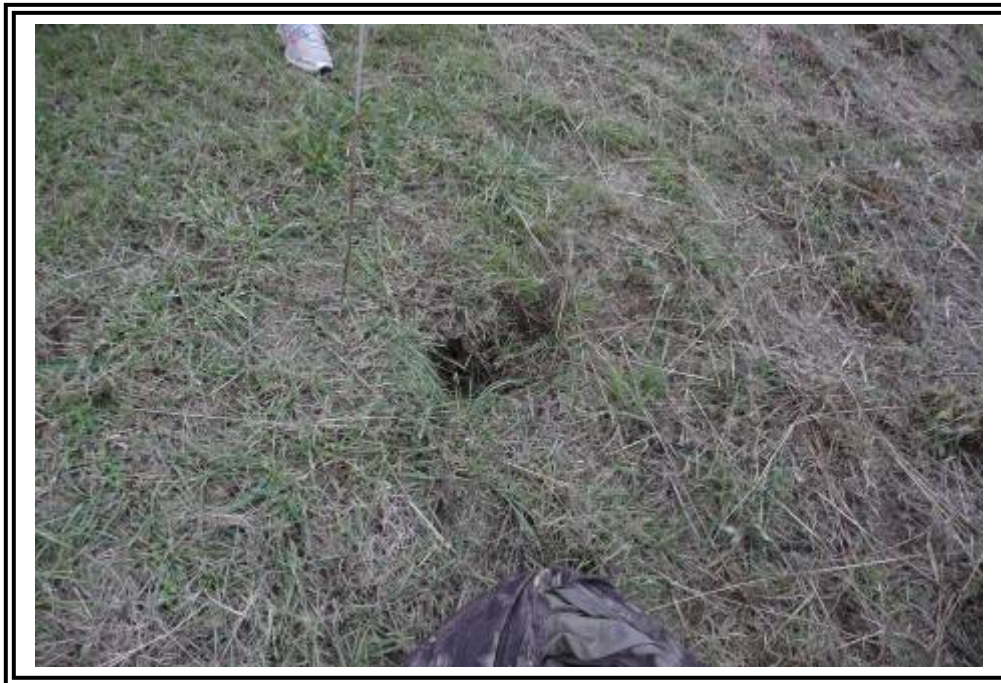
19

Upon inspection of the dike from the crest, a widening of the dike was noted along the northern end as shown in Photo 22. Georgia Power personnel indicated that this is due to the buildup of fly ash along the interior edge of the dike which has slowly filled the pond as shown in Figure 2D. Based upon aerial photo mapping and available site plans, roughly 1,400 feet of the Pond D dike structure has silted in and no longer actively impounds water as measured from the northern end of the dike. Only about 600 feet of the dike now retains open water and this section of the dike has developed a stand of aquatic vegetation at the pond dike interface over time. Additionally, several rodent borrows (Photo 19) were located along the upstream edge of the dike.

Ash Pond D, animal burrow located along central portion of the dike along the interior edge.  
One of several found throughout the length of the dike.

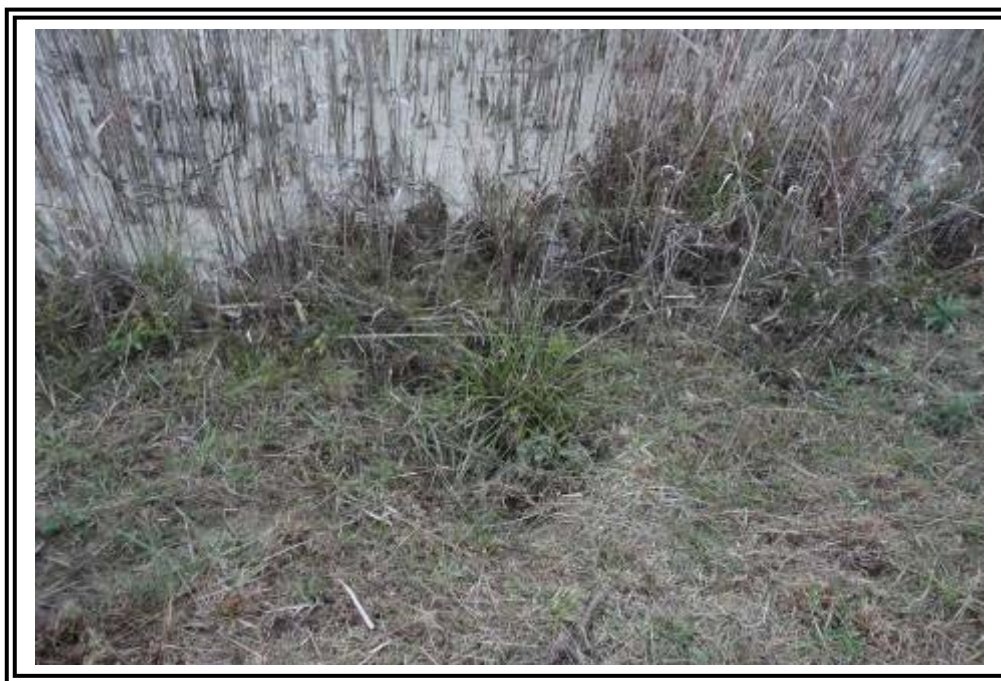
20

Ash Pond D, central portion of the dike facing east.  
Interior edge of the dike (pond side) shown with possible ash build up.

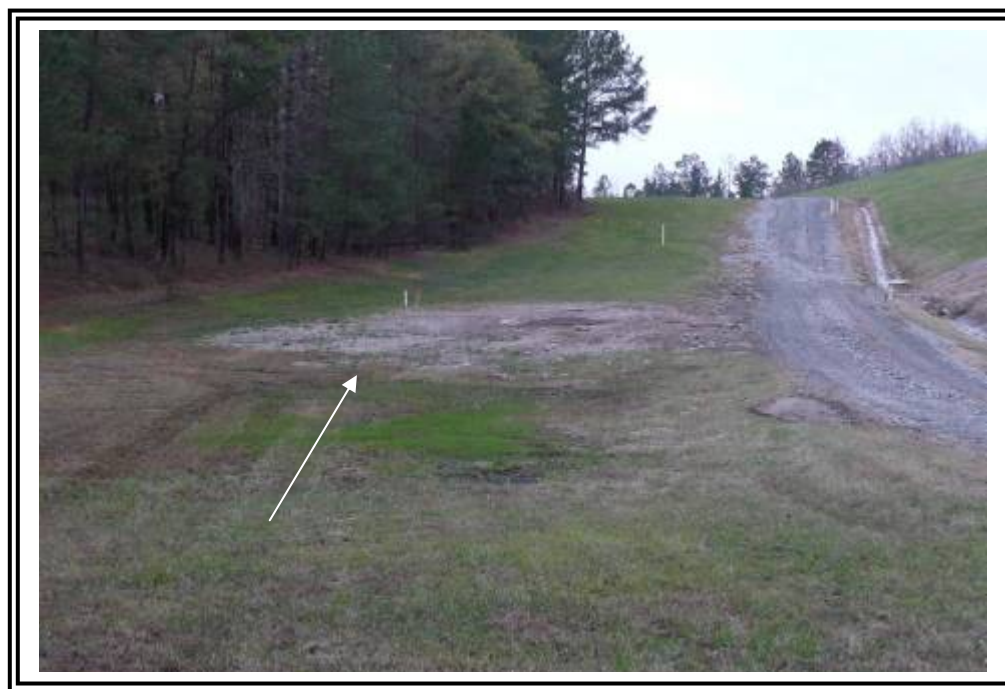
27

Ash Pond D, central portion of dike, west of toe facing north west. "Soft area" covered with rock indicated by arrow.

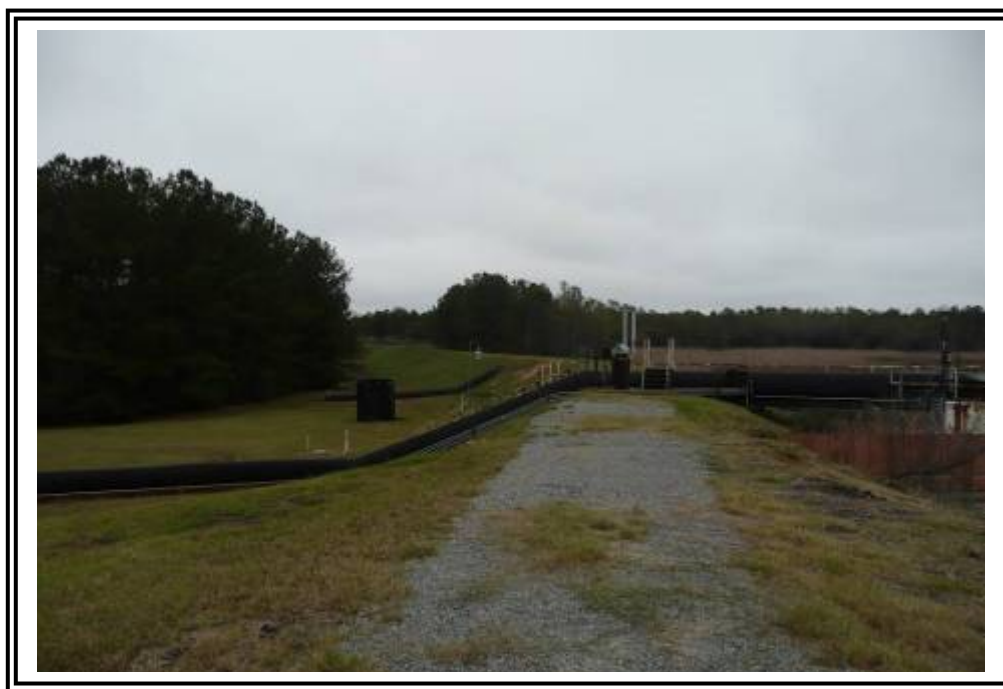
During the site reconnaissance of the west dike, a historic discharge system was observed at the south end (Photos 31 and 32). This was originally constructed as the primary outfall via a gravity feed to a treatment facility before the water was recycled or discharged to the lake. It was later replaced with a siphon at this location to provide an emergency outlet should the need arise. This was done around the same time the primary siphon system conveying water to the Pond B was installed. Georgia Power indicated that the historic discharge system facility has been decommissioned; however the plant maintains an NPDES discharge permit at this location.

Southwest edge of Ash Pond C along west dike crest, facing north. Historic discharge facility shown frame right is no longer in use per Georgia Power personnel.

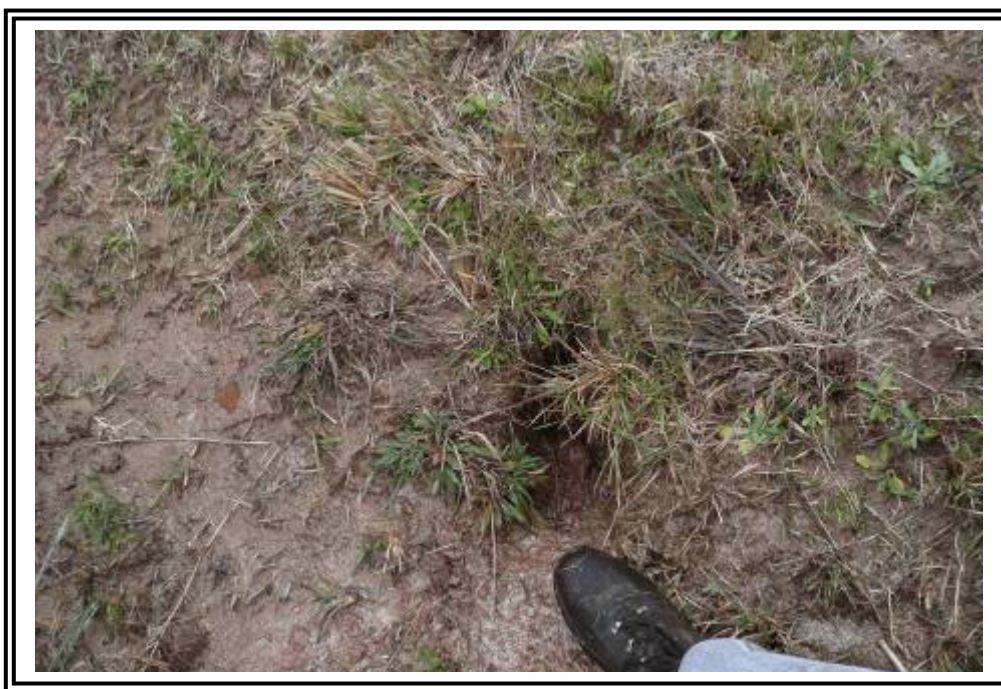
37

Several apparent areas of sparse vegetation were noted along the central and northern exterior portion of the west dike (Photo 35). These areas appeared to be caused by mowers slipping down the exterior face of the dike. Additionally, few rodent burrows were observed along the length of the dike (Photo 37).

Ash Pond C, north portion of west dike, rodent burrow observed on upstream side of dike.

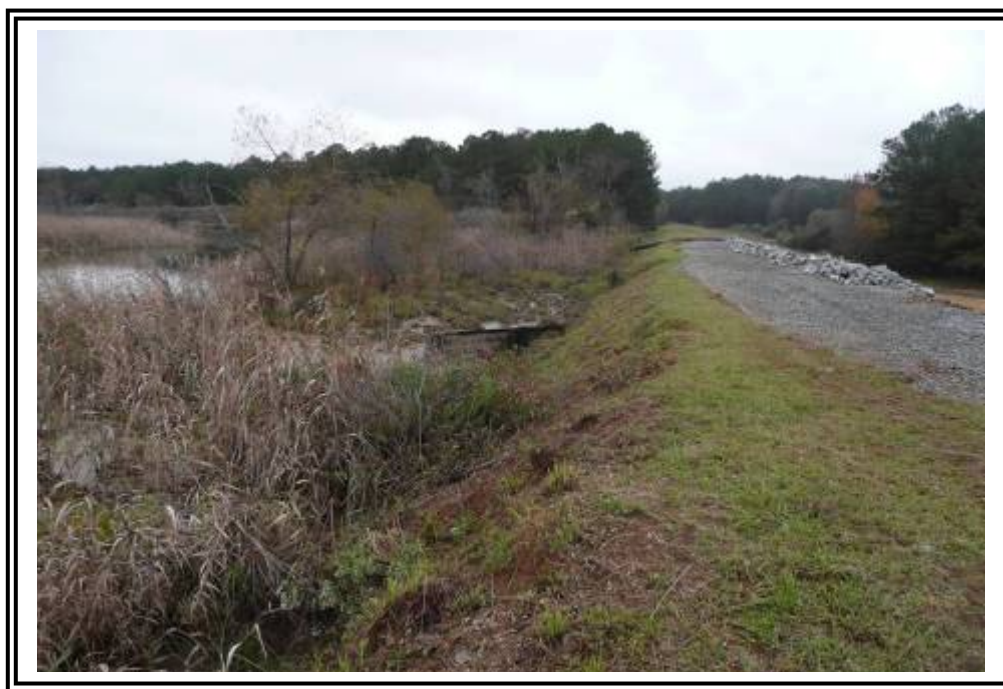
49

Central portion of Ash Pond C east dike facing north. Interior pond edge shown with thick and tall vegetative growth.

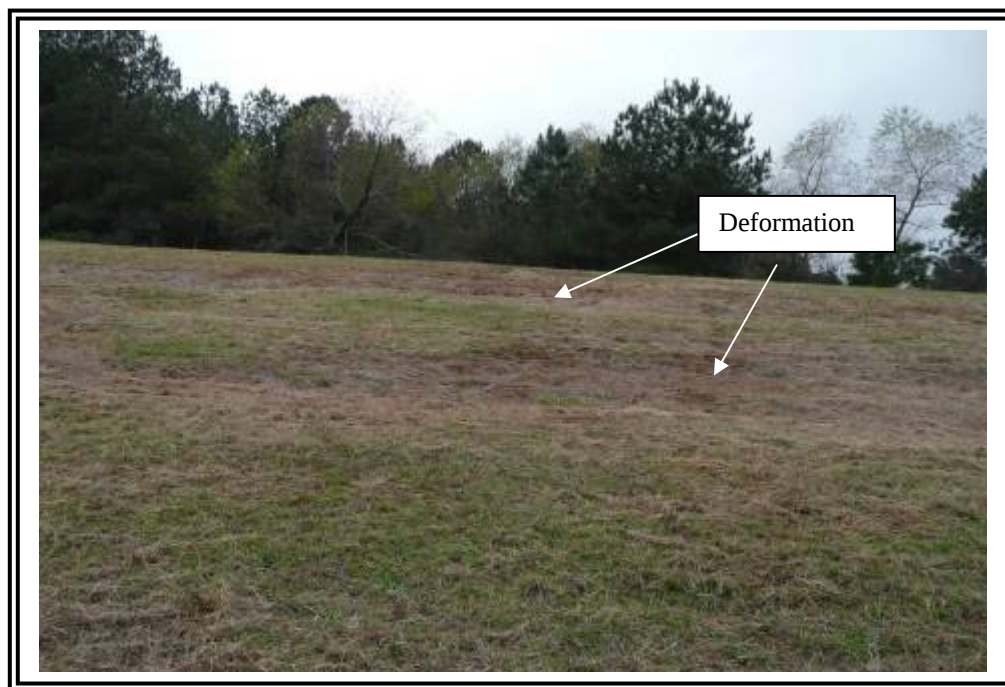
53

Ash Pond C, north end of east dike along dike toe, facing west. Dike scarping indicated.

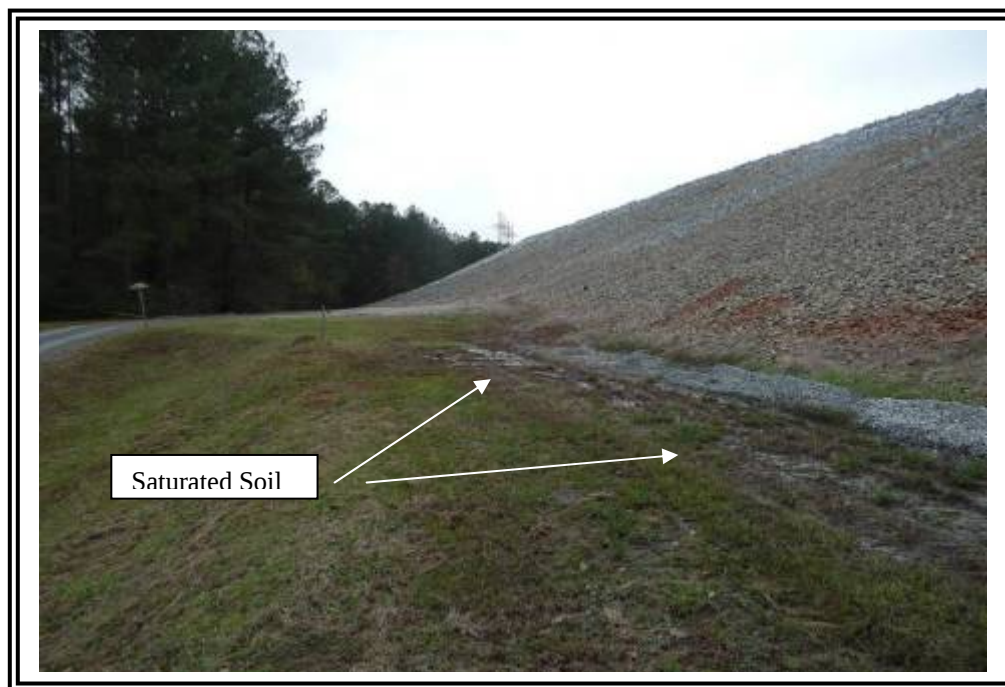
59

Ash Pond C, western central portion of south dike facing west. Saturated soil shown.

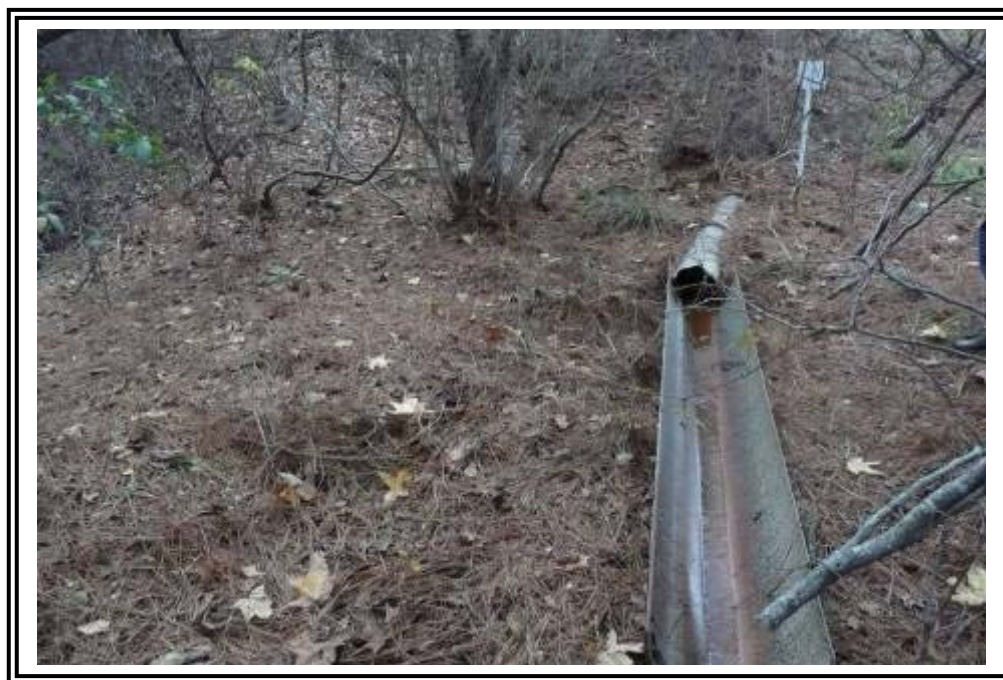
62

Ash Pond C seepage drain No. 3 shown. Draining water was observed to be clear.

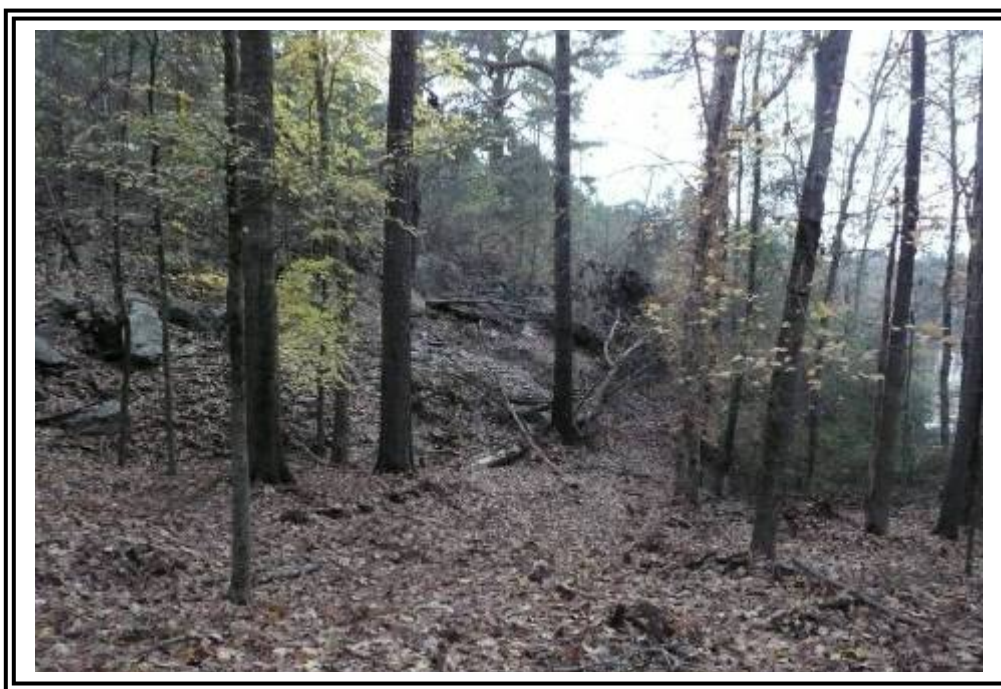
67

During the site visit, heavy vegetative cover including large trees and large boulders were noted as being present along the downstream edge of the dike and along the toe as shown in Photos 66 through 68. Heavy tree cover was also observed along the east end of the upstream edge of the dike and on top of the filled in area of the pond. Representatives of Georgia Power stated that it was their opinion that due to an “over” constructed dike and the southern portion of the pond being filled with bottom ash and capped, the trees along the edge of the crest would not pose any impact to the stability of the existing dike.

Ash Pond B, central portion of dike along the toe facing east. Heavy vegetative growth present and large boulders present throughout. Lake Sinclair shown frame right.

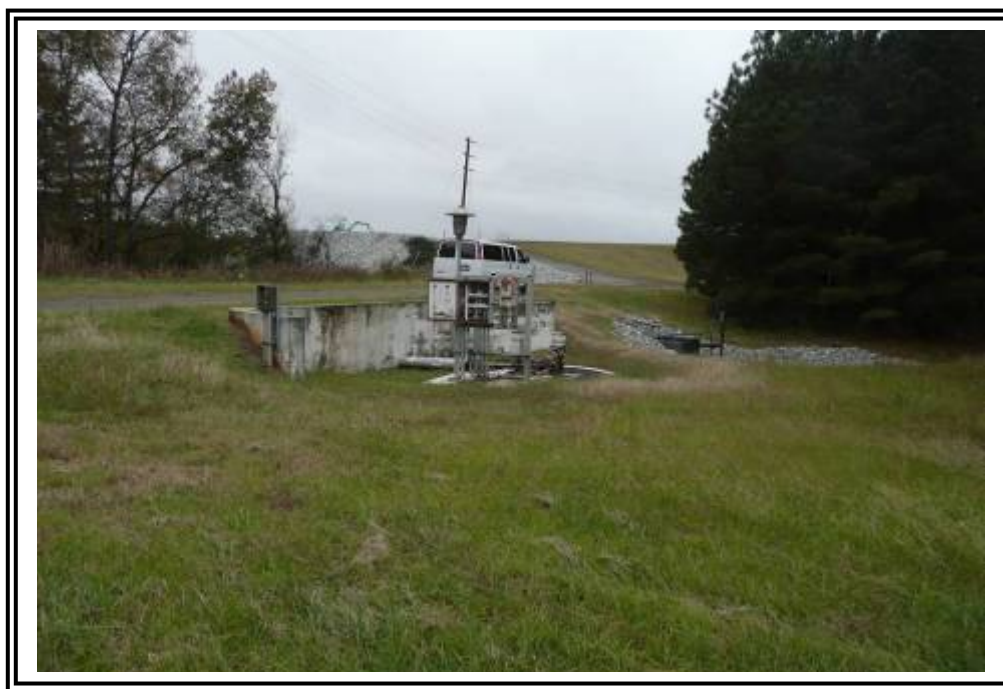
69

Ash Pond B, west end of dike. Emergency spillway (black pipe in background) and abandoned primary discharge facility shown.
