US EPA ARCHIVE DOCUMENT

Assessment of Dam Safety Coal Combustion Surface Impoundments (Task 3) Final Report

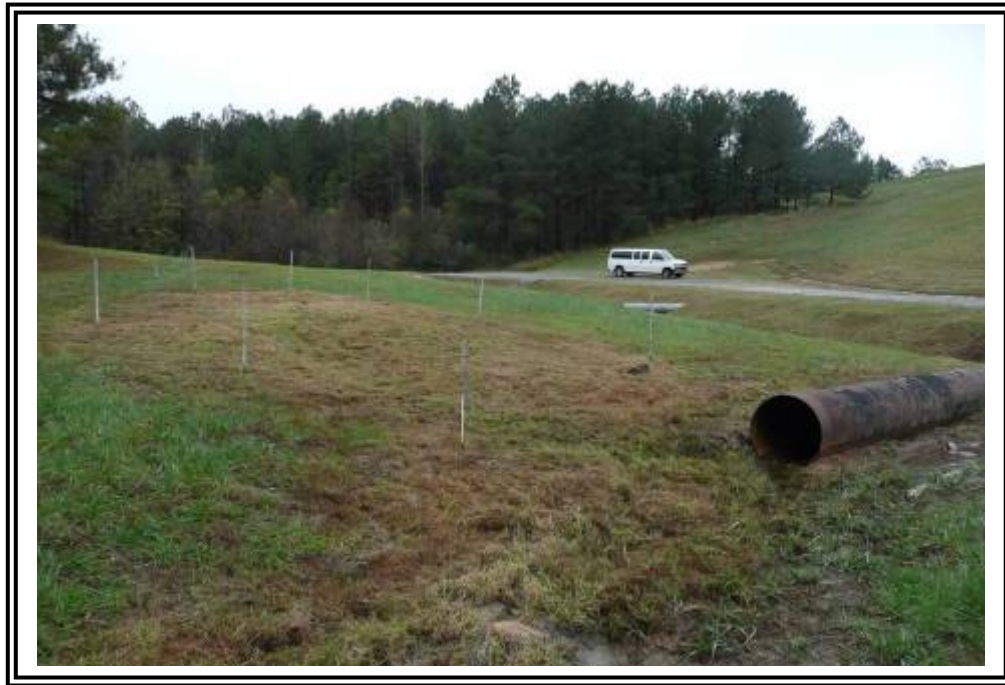
Ash Pond E, “soft spot” located south of emergency overflow drain (1 of 3 observed near Ash Pond E). This area has been monitored for nine years by Georgia Power with no additional expansion observed. Perimeter stakes have been placed to aid in monitoring.

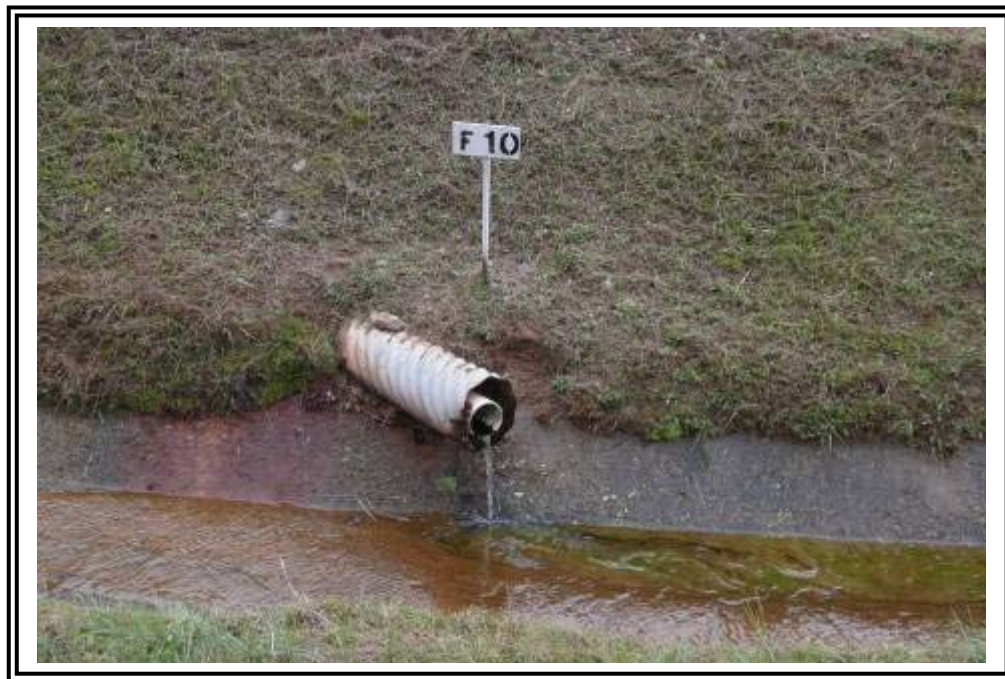
Ash Pond E finger drain #10. Drainage from finger drains observed to be clear.

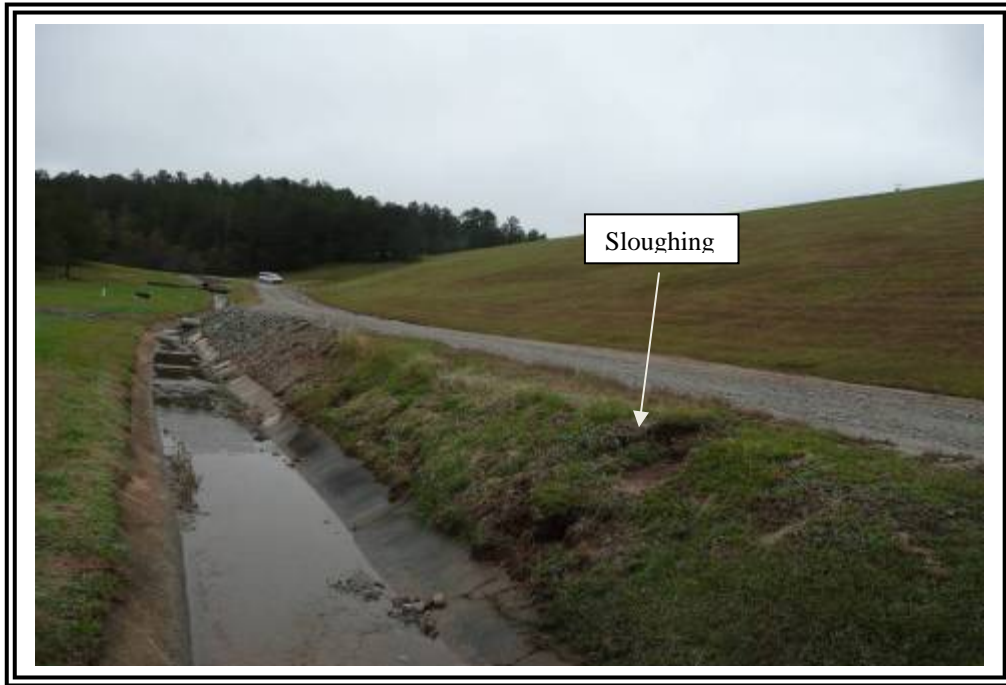
Ash Pond E, sloughing observed along west edge concrete line channel at the base of the toe, central portion of the dike.

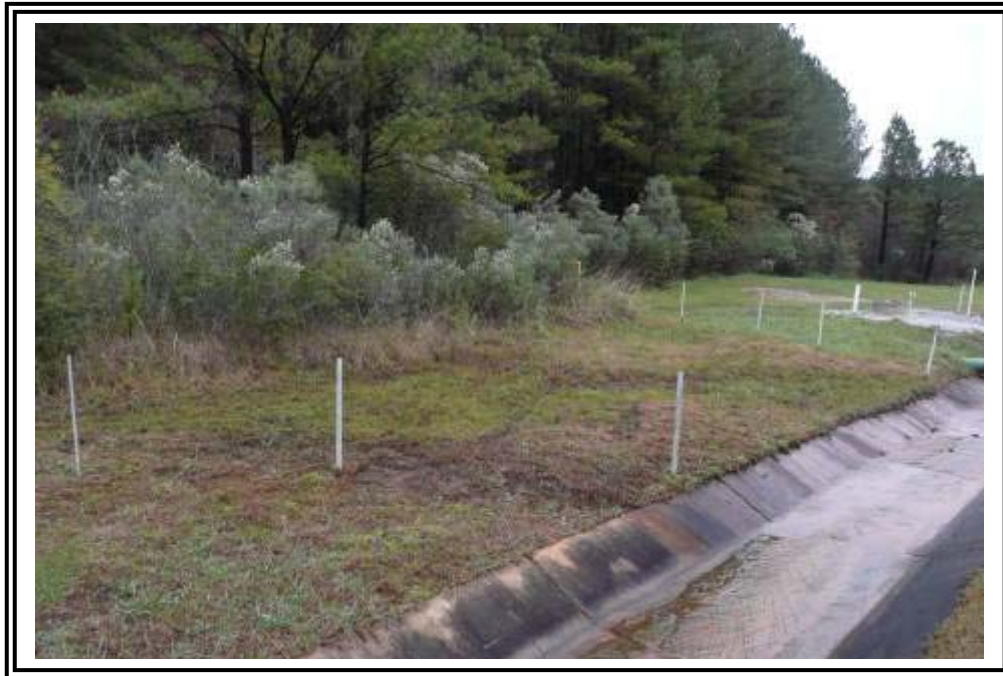
Ash Pond E, 3rd observed “soft spot” located east of finger drain #5. Perimeter stakes installed for all soft spots in effort to monitor expansion. No observed expansion for any of the three soft spots in at least nine years, as indicated by Georgia Power.

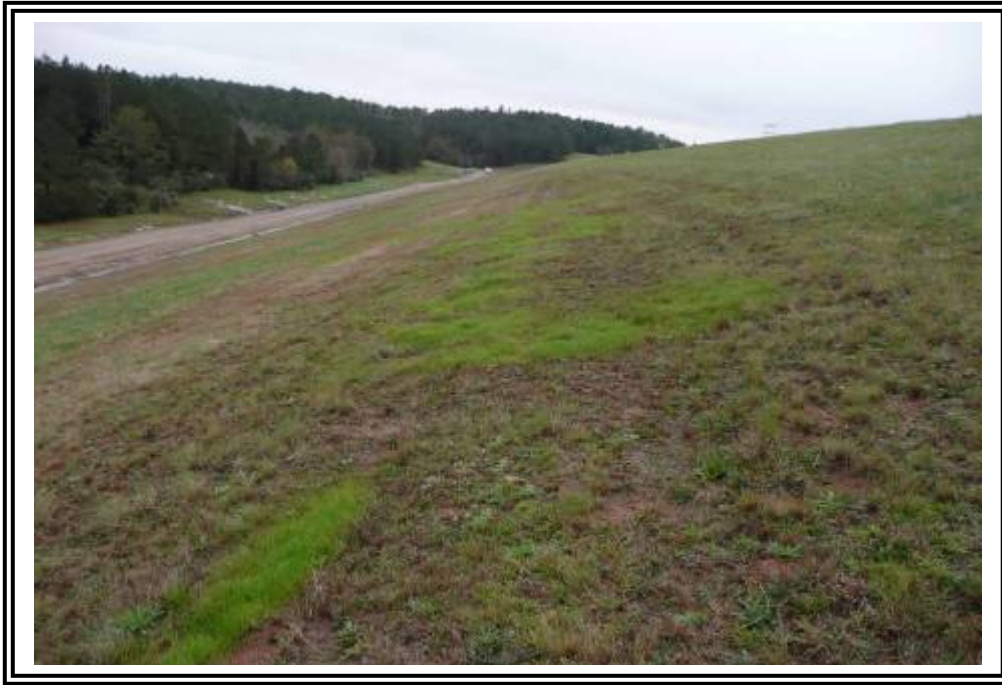
Ash Pond E, mid-height of dike, northern end of dam facing south. Mower-rutting observed throughout portions of the dike. Rye grass patching observed and indicated to be seasonal grass cover in effort to minimize sparse vegetation.

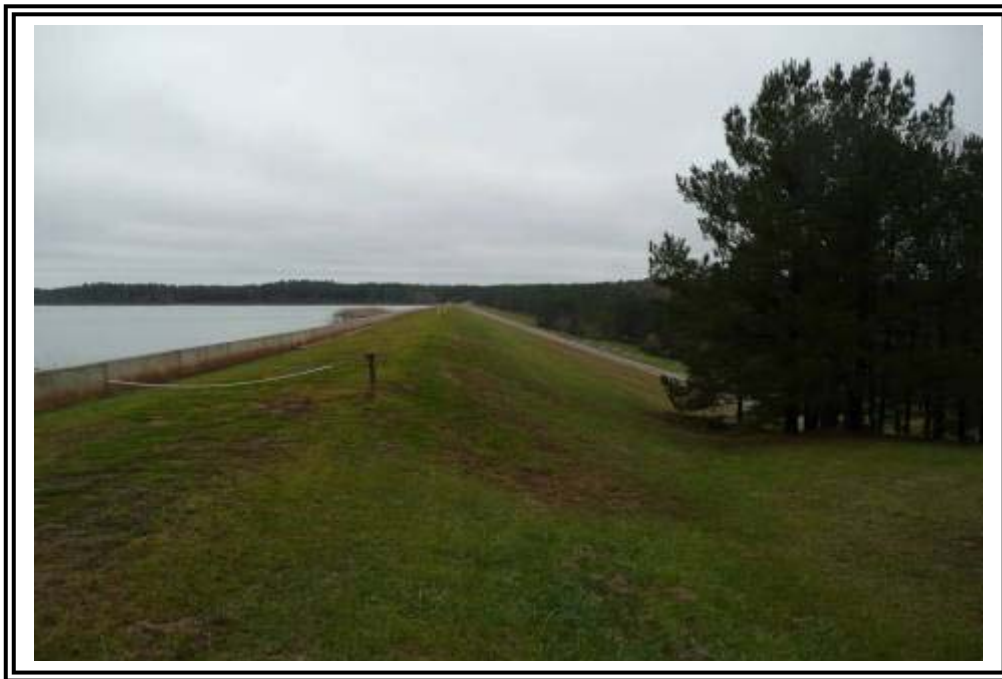
Ash Pond E, south end of dike, facing north.

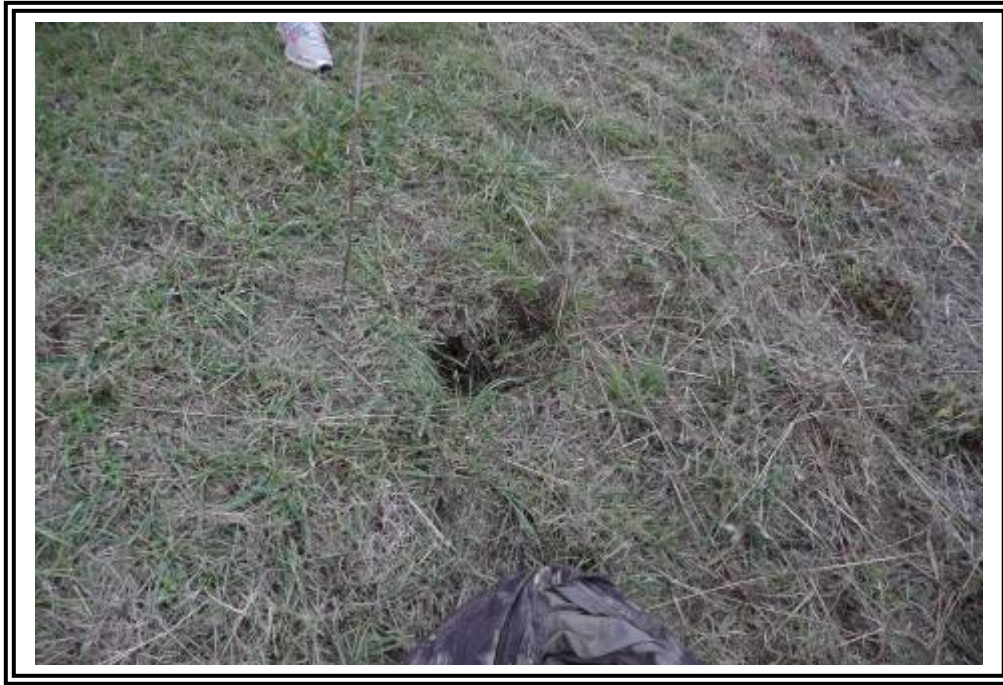
Ash Pond D, animal burrow located along central portion of the dike along the interior edge.
One of several found throughout the length of the dike.

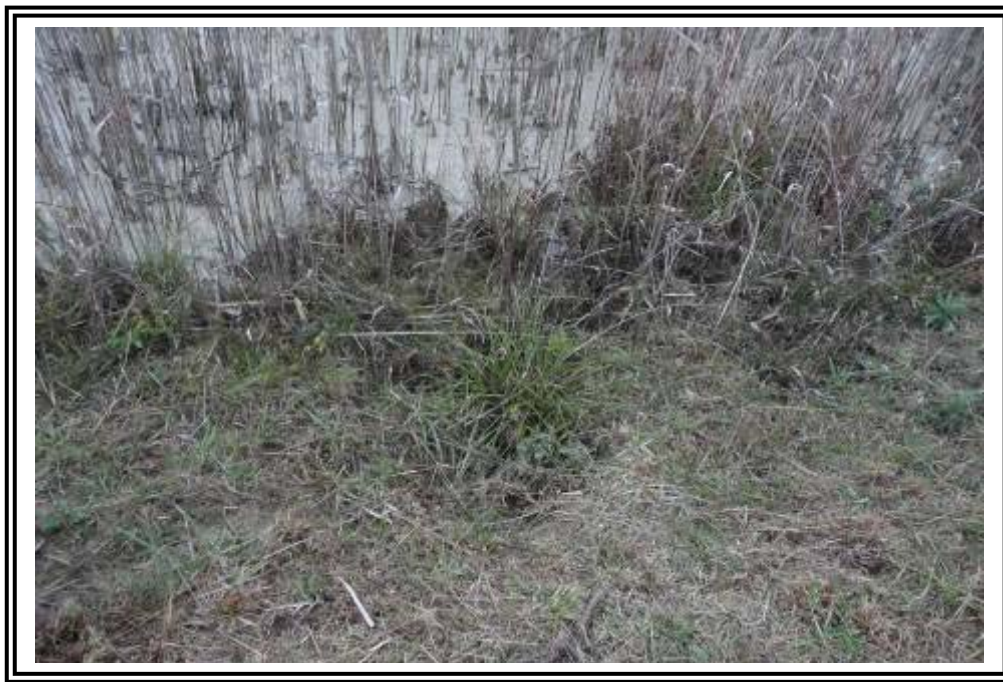
Ash Pond D, central portion of the dike facing east.
Interior edge of the dike (pond side).

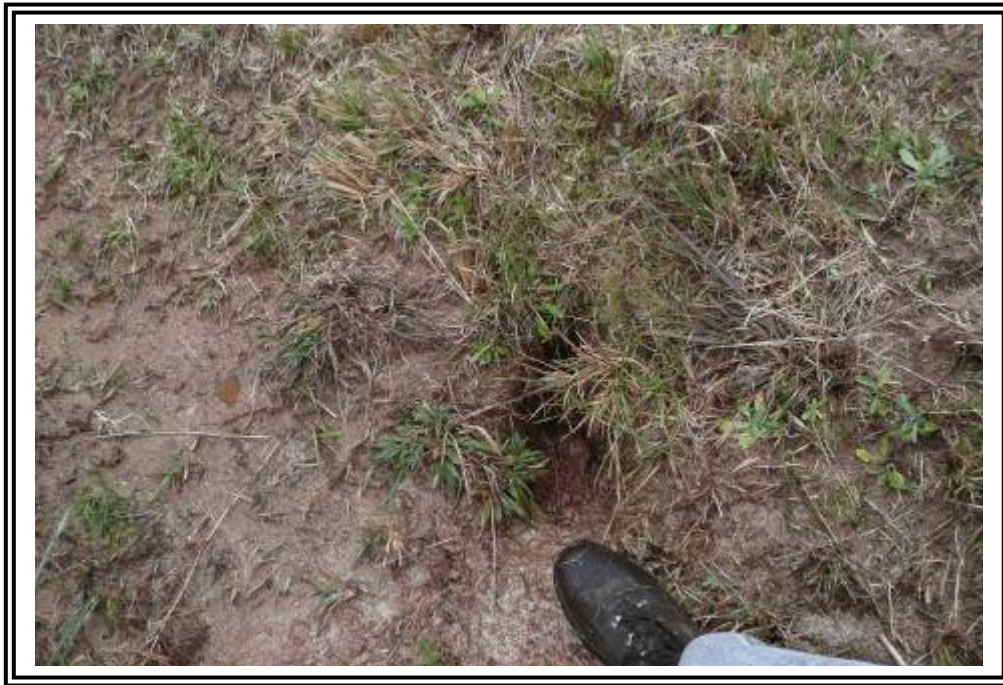
Ash Pond C, north portion of west dike, rodent burrow observed on upstream side of dike.

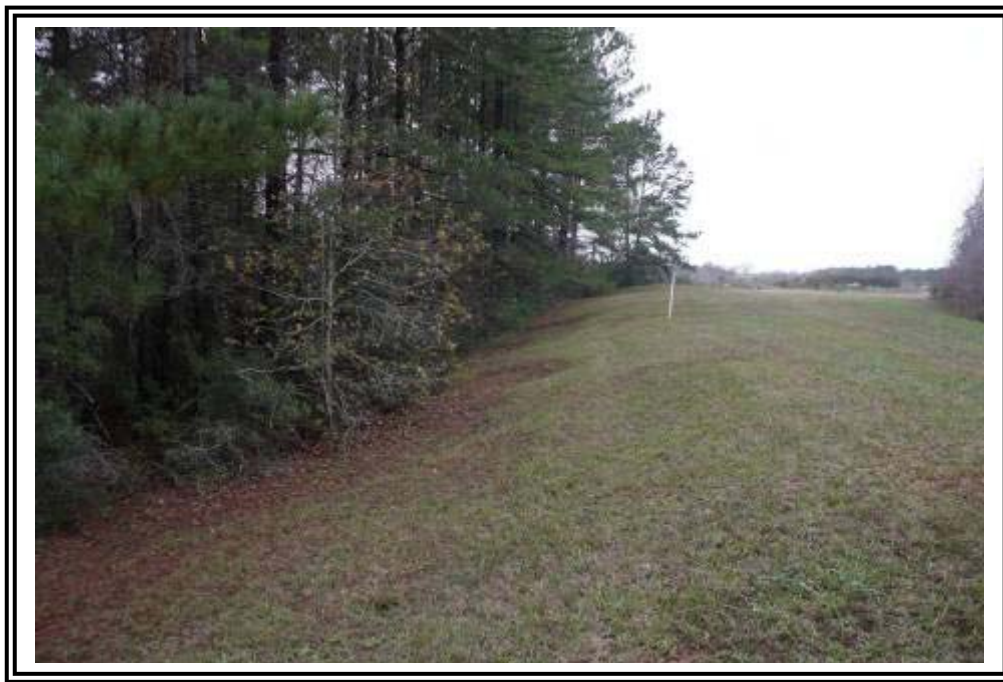
Ash Pond C, downstream edge of west dike at north end of dike, facing north.

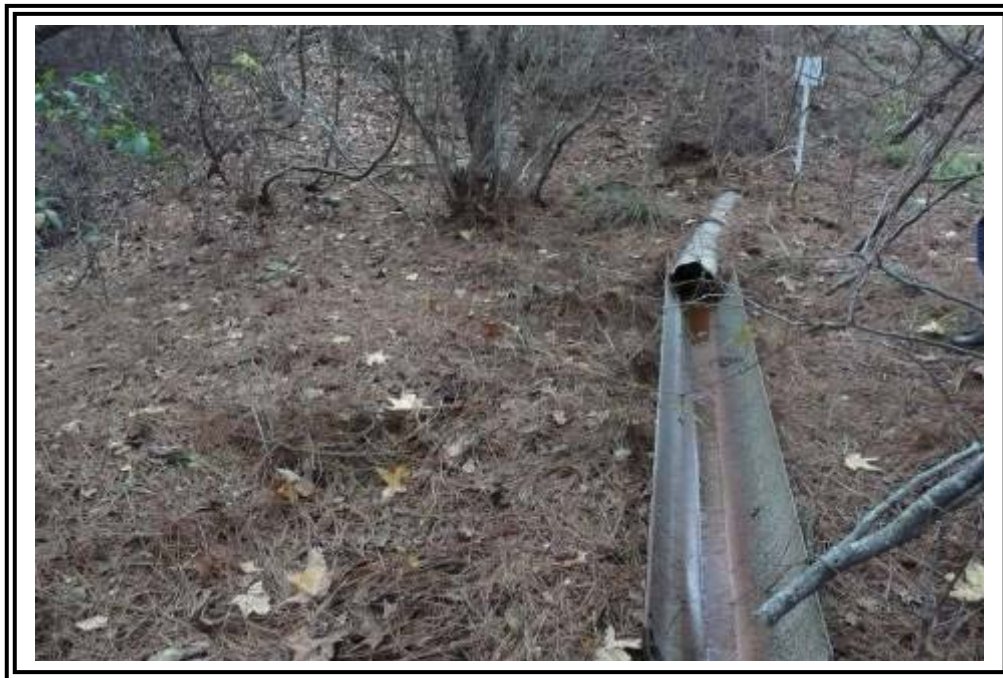
Ash Pond C seepage drain No. 3 shown. Draining water was observed to be clear.

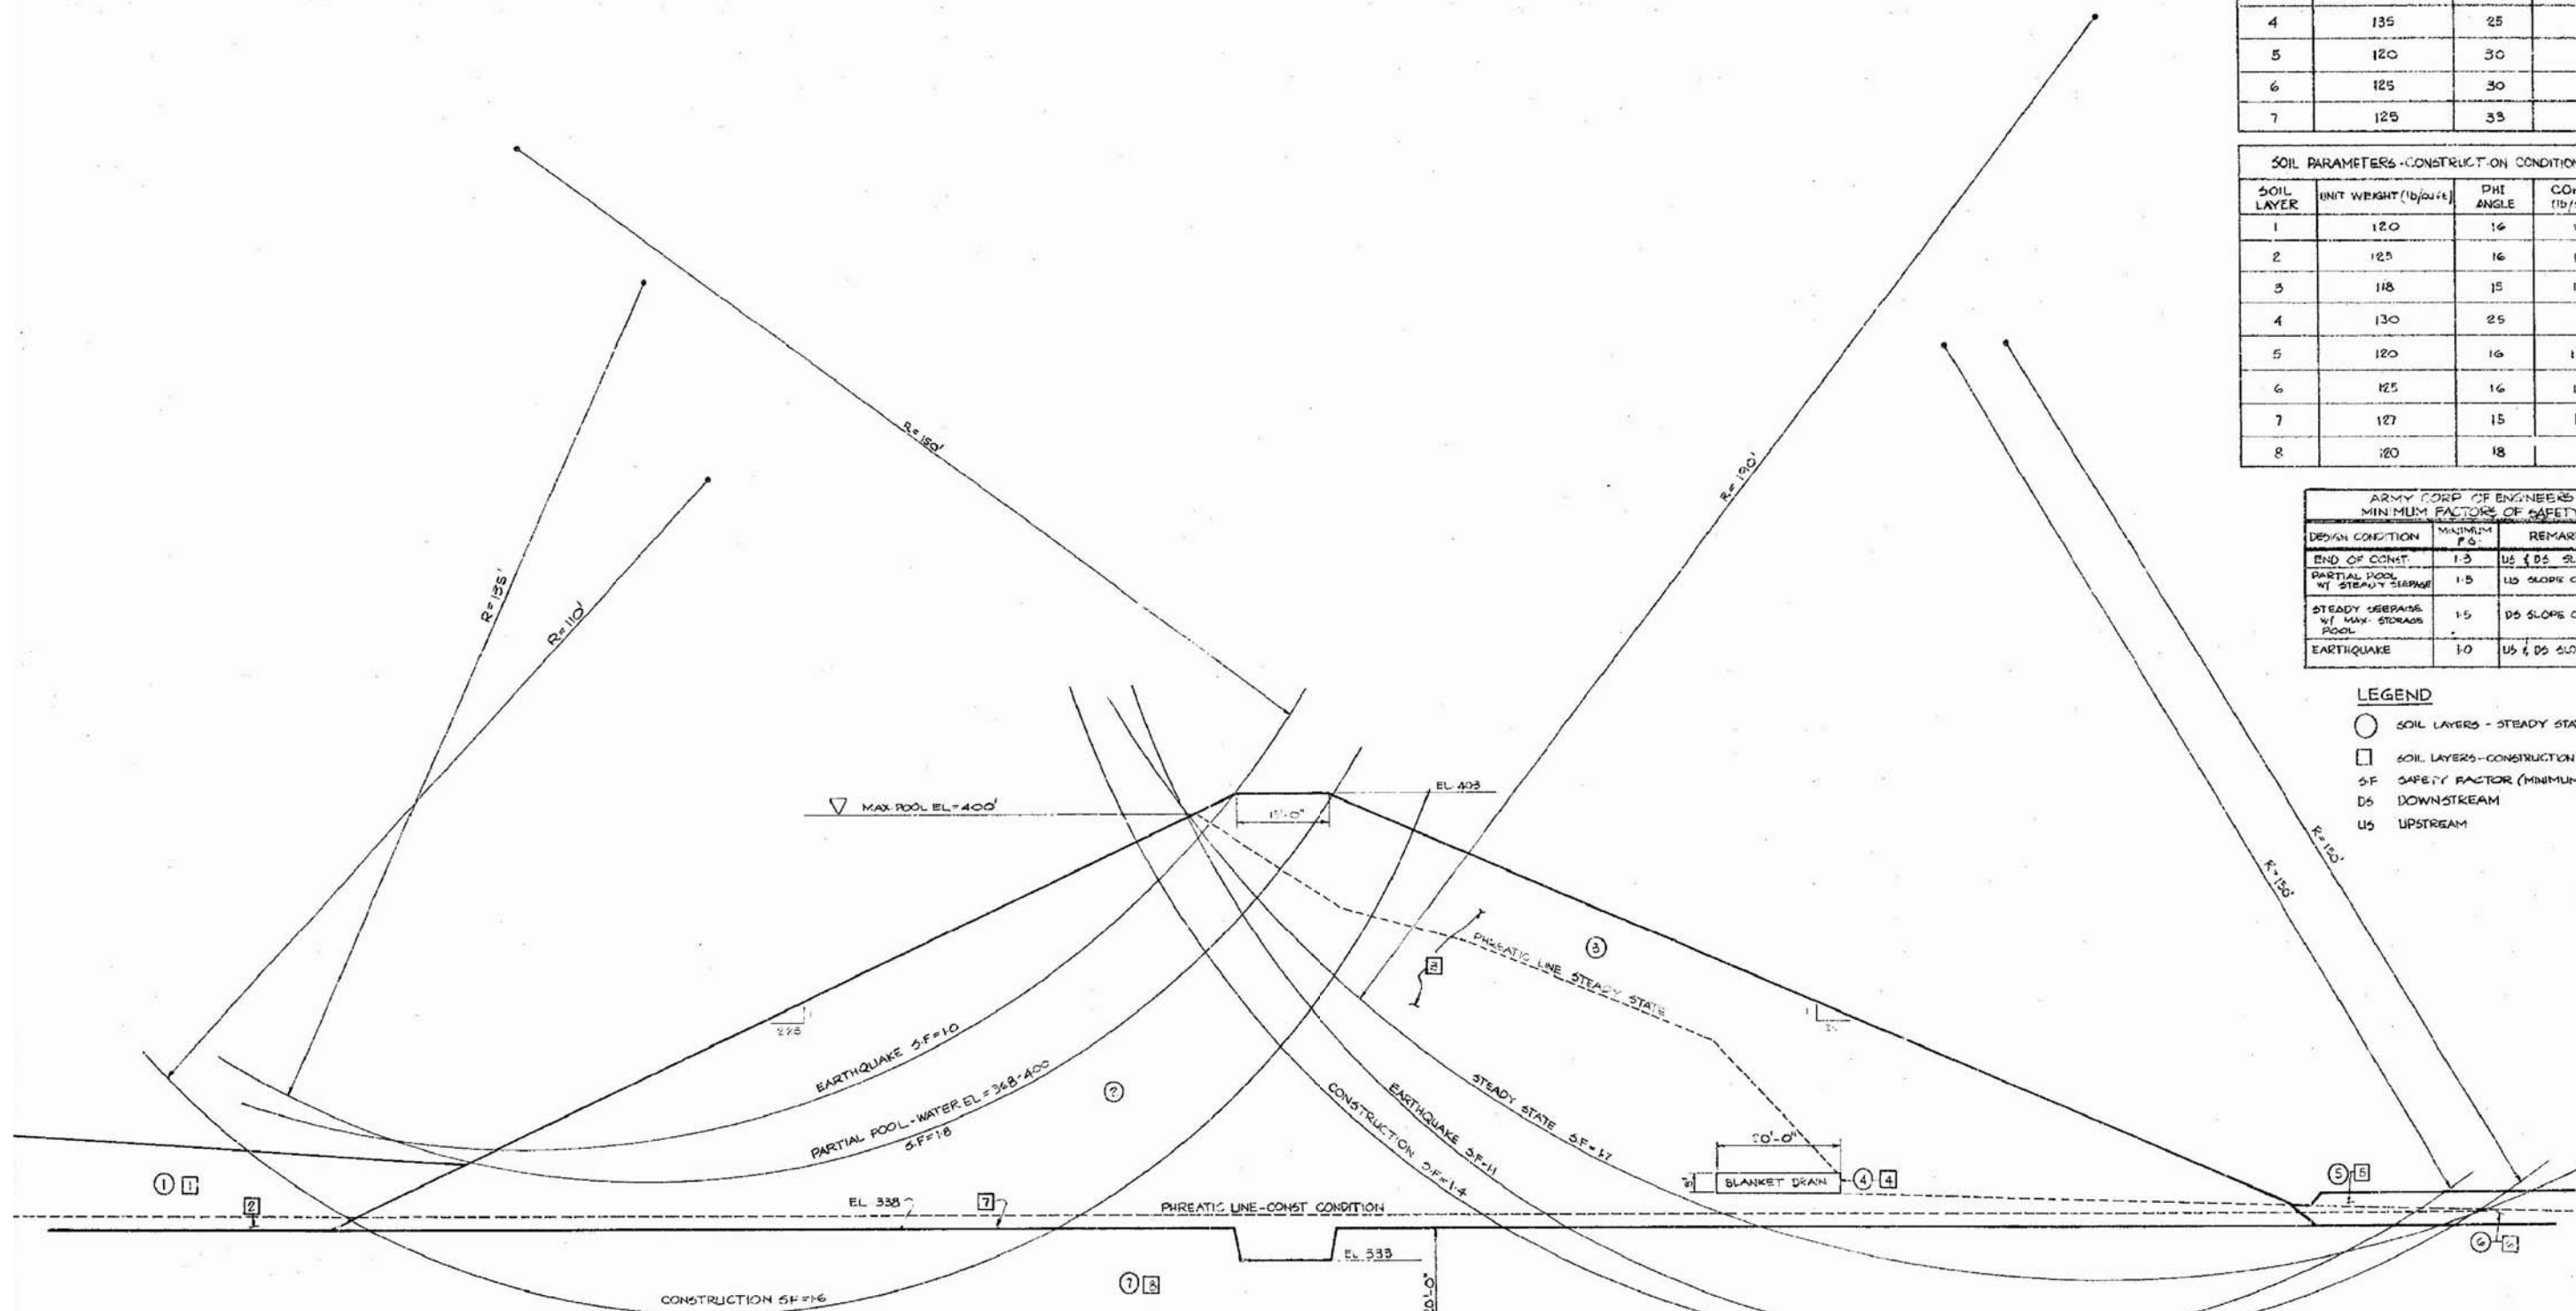
SOIL PARAMETERS - STEADY STATE AND EARTHQUAKE CONDITION - (1)			
SOIL LAYER	UNIT WEIGHT (lb/cu ft.)	PHI ANGLE	COHESION (lb/sq ft.)
1	125	30	0
2	127	32	0
3	118	32	0
4	135	25	0
5	120	30	0
6	125	30	0
7	125	33	0

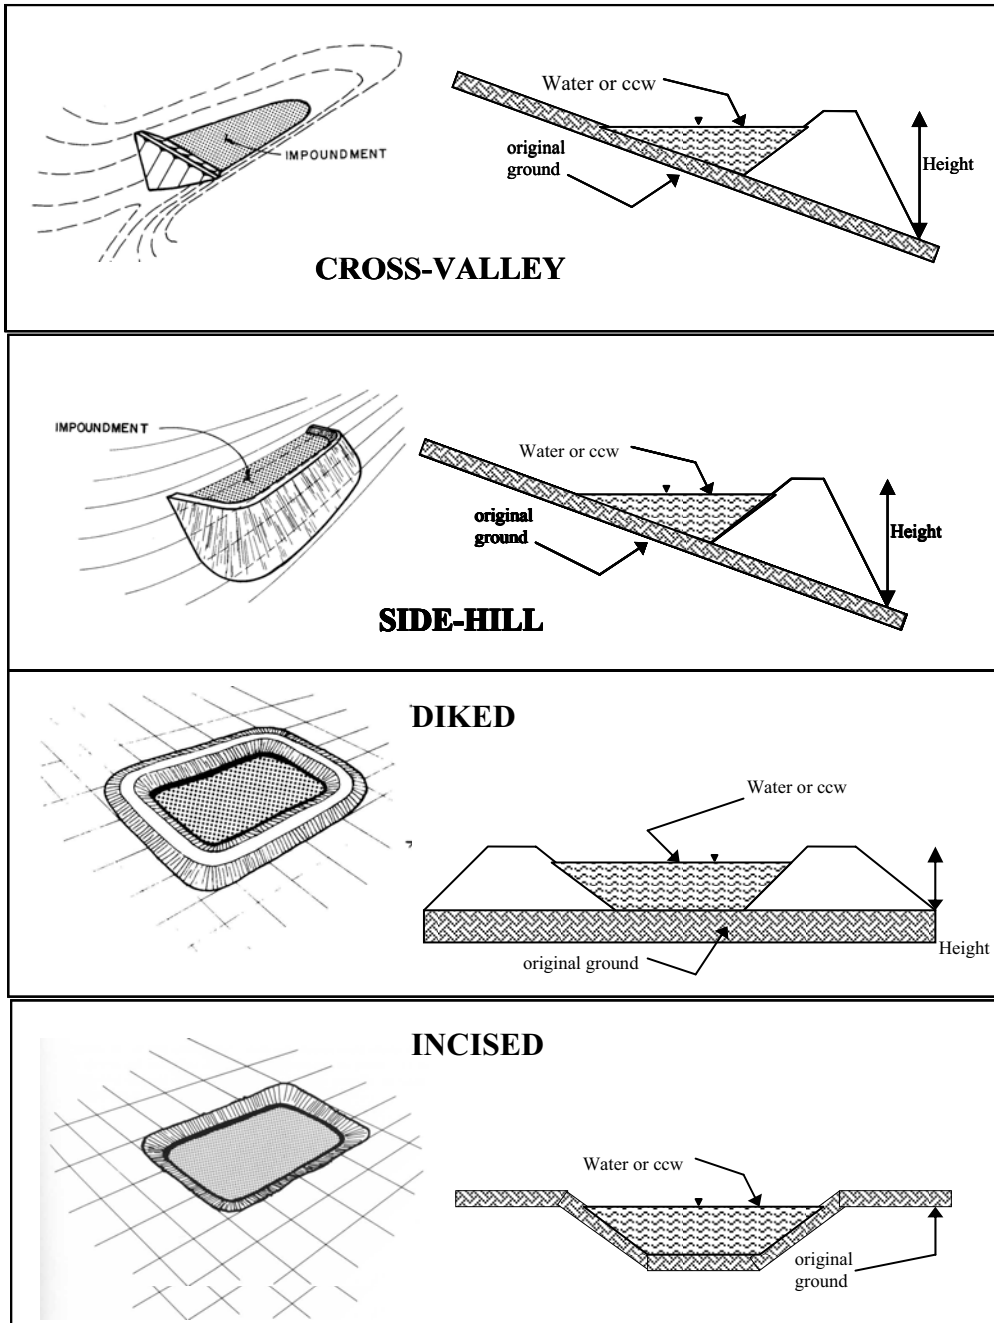
Cross-Valley
 Side-Hill
 Diked
 Incised (form completion optional)
 Combination Incised/Diked

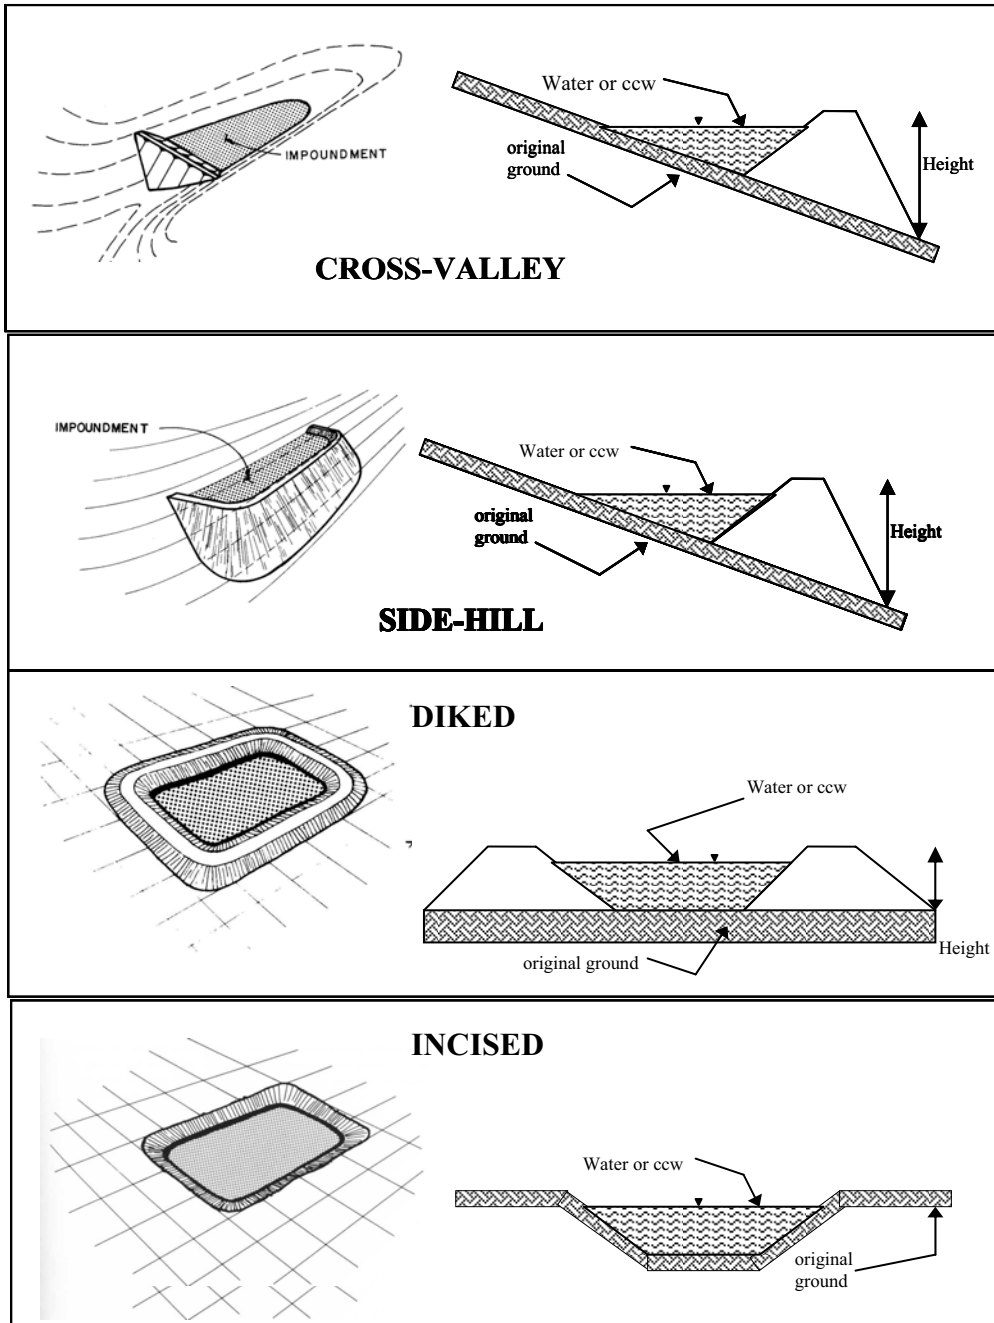
- Cross-Valley
- Side-Hill
- Diked
- Incised (form completion optional)
- Combination Incised/Diked

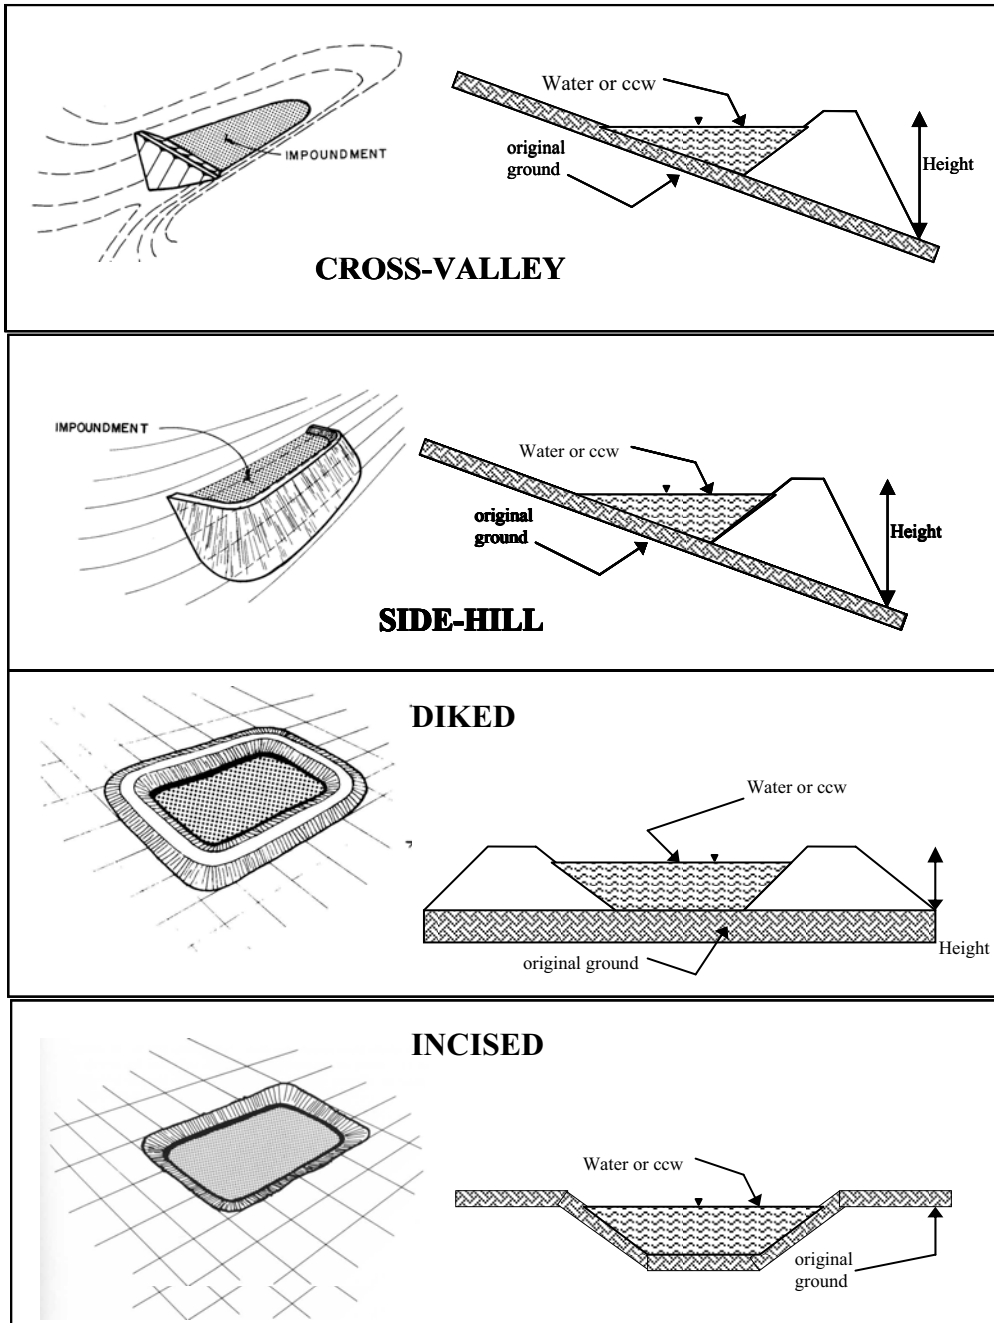
- Cross-Valley
- Side-Hill
- Diked
- Incised (form completion optional)
- Combination Incised/Diked

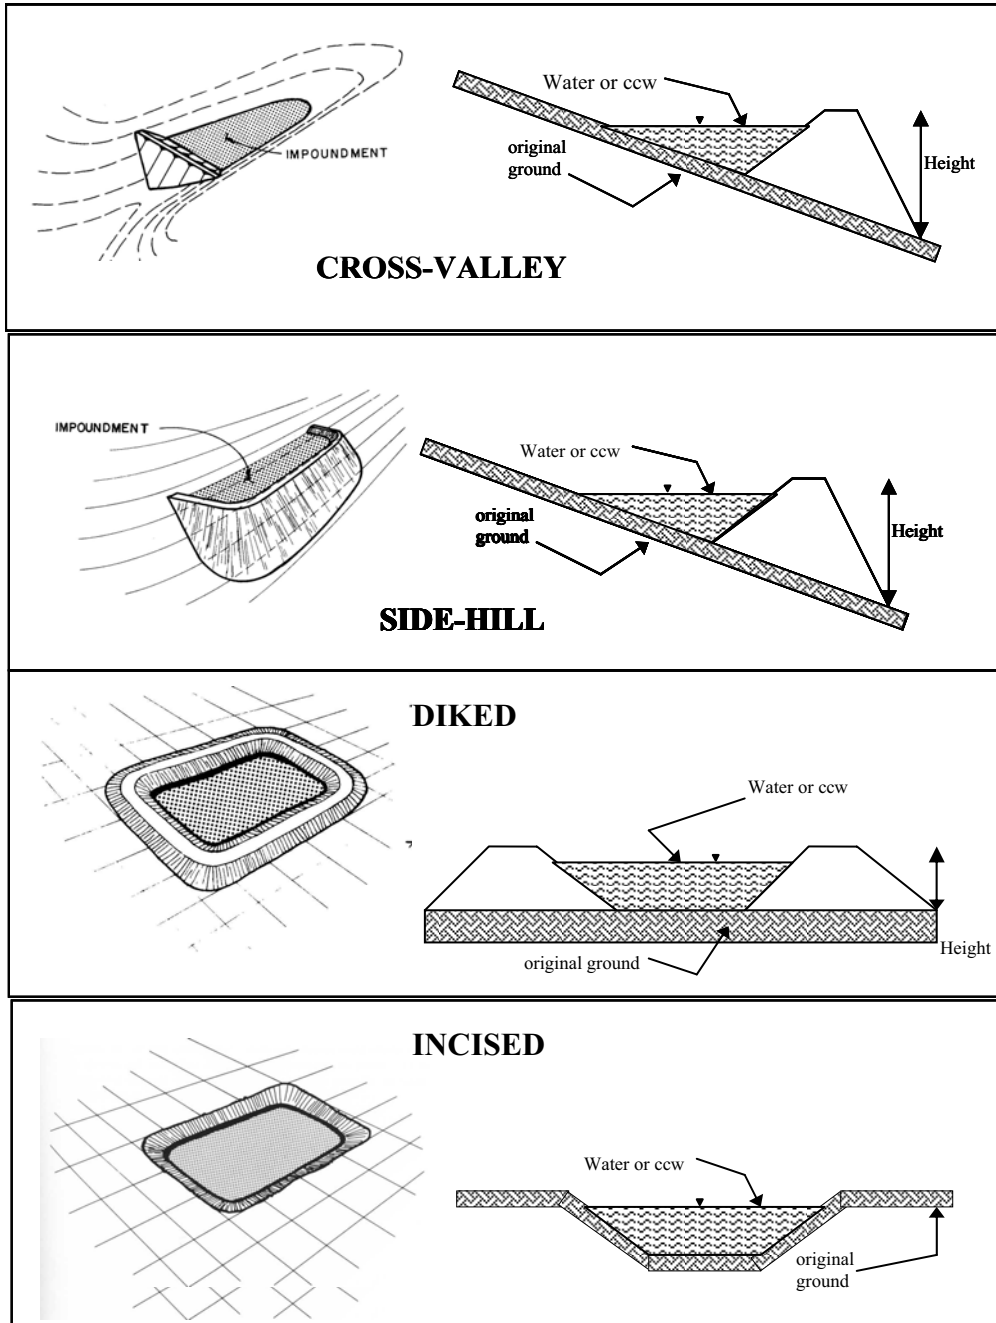
- Cross-Valley
- Side-Hill
- Diked
- Incised (form completion optional)
- Combination Incised/Diked
