Assessment of Dam Safety Coal Combustion Surface Impoundments Draft Report

Georgia Power
Company

Plant Bowen

July 6, 2009

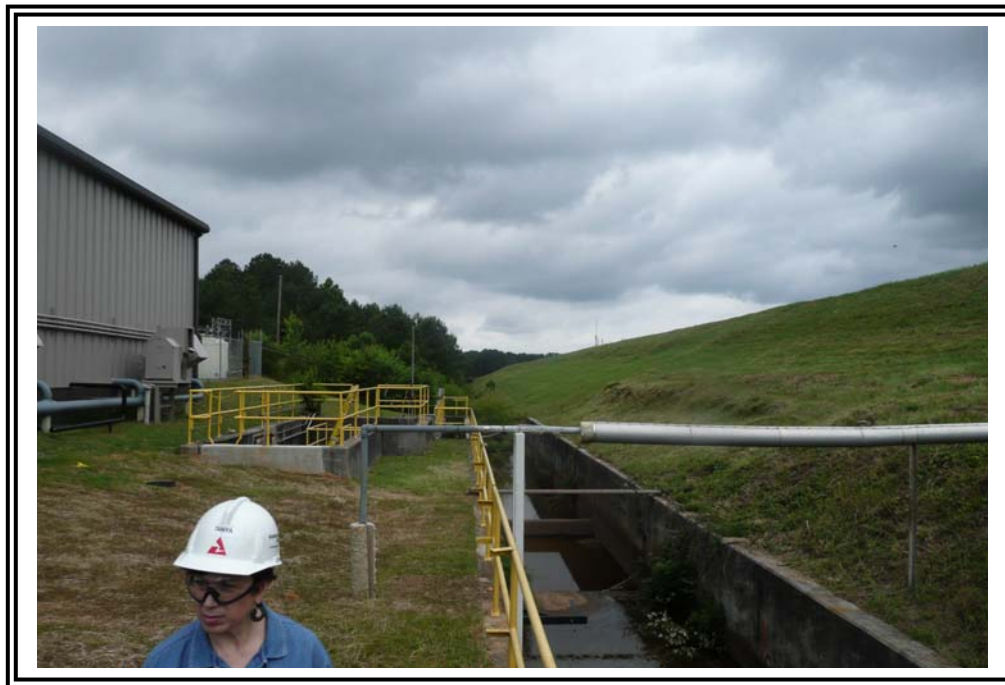
1

South end of main dike at NPDES Sampling flume, looking west. The majority of the slope shown is a natural cut slope, 5 to 10 foot high embankment constructed to blend into slope in this area.

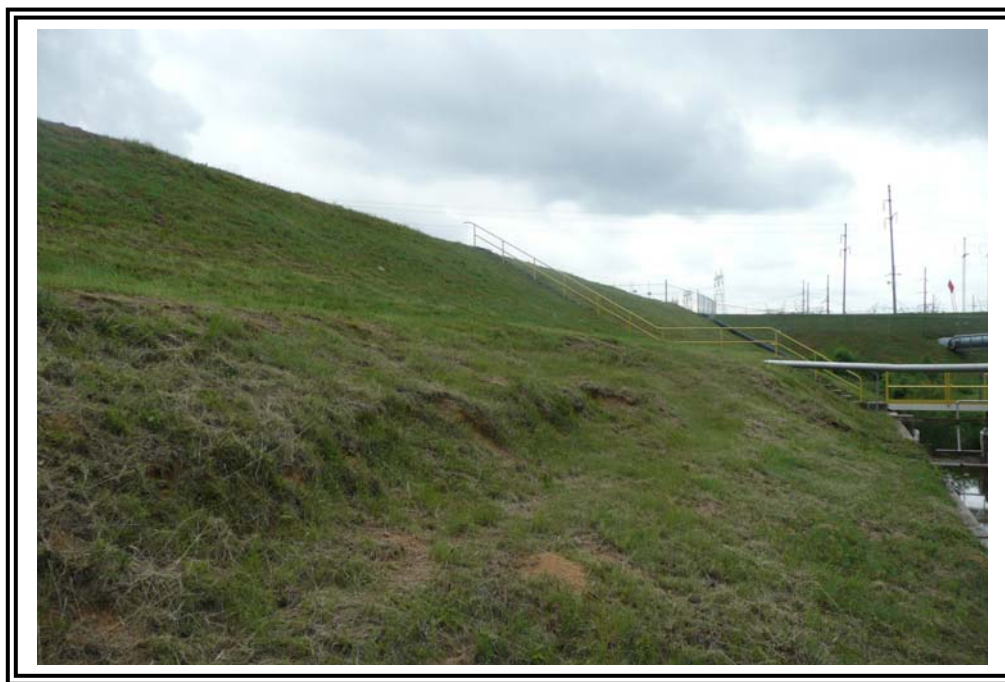
2

South end of main dike at NPDES sampling flume, looking east. Scarp in natural cut slope, reportedly unchanged in 6 to 10 years per Georgia Power Engineer responsible for inspections.

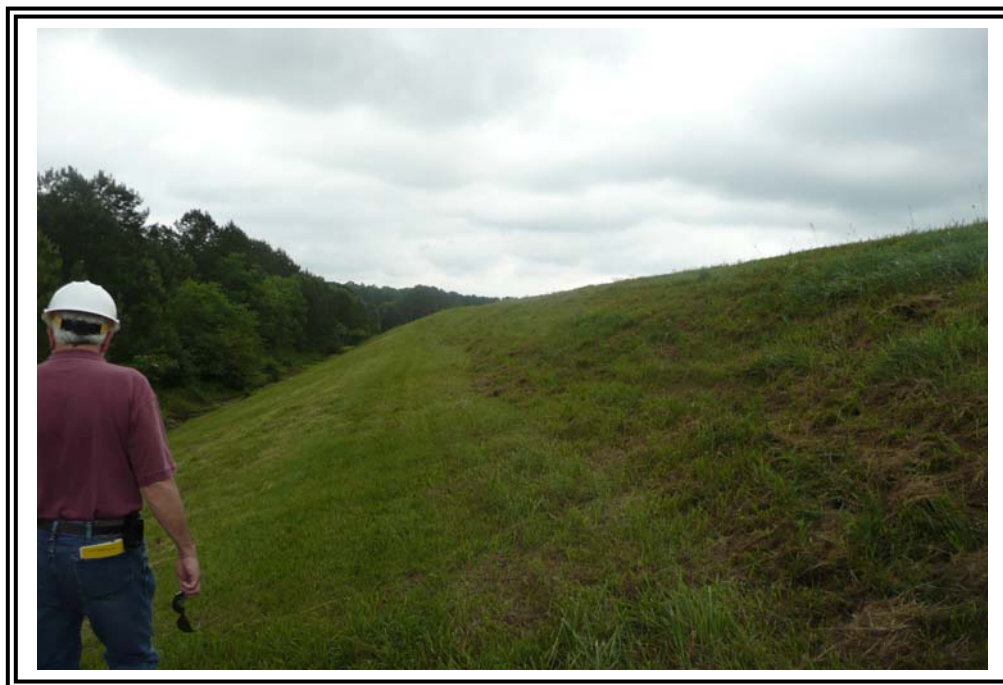
3

South end of the main dike, looking west. Note transition between natural cut slope and raised dike.

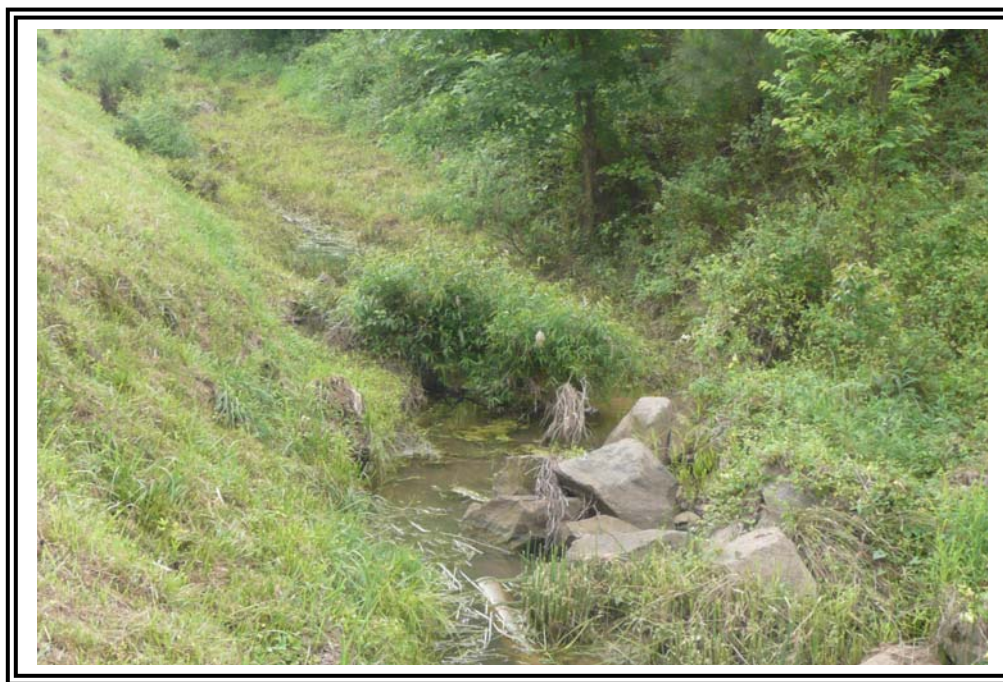
4

Perimeter ditch at south end of main dike, looking east. Another area of slough in natural cut slope has choked the channel and has reportedly remained unchanged in 6 to 10 years per Georgia Power Engineer responsible for inspections.

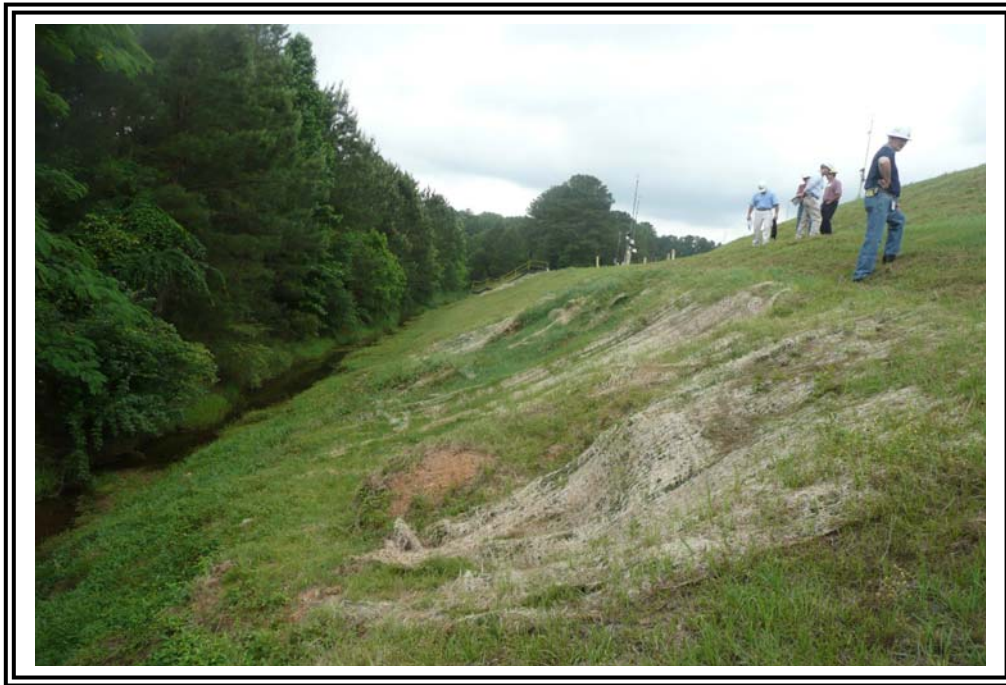
7

Continuing west on south end of main dike, another slough area in the natural slope reportedly unchanged in 6 to 10 years per Georgia Power engineer responsible for inspections. This area reportedly has had a difficult time re-establishing grass growth so more recent efforts included placing erosion matting.

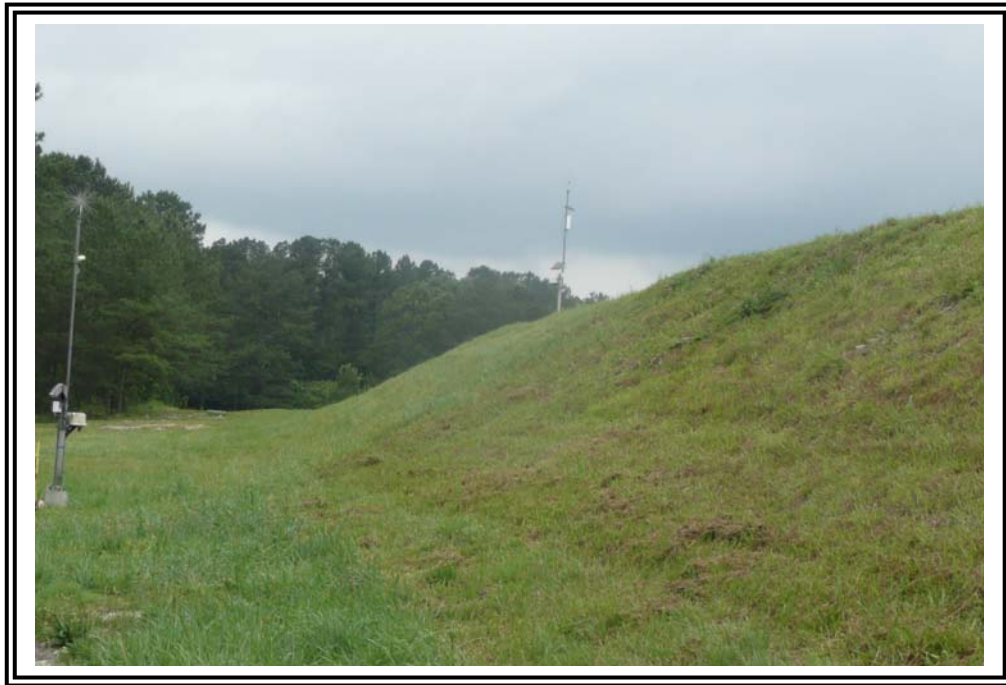
8

South portion of the embankment near the end of the reclaimed water portion of the impoundment (looking west). Reclaim Pond is lined. Note set up for remote monitoring of piezometers (not operational as of our visit).

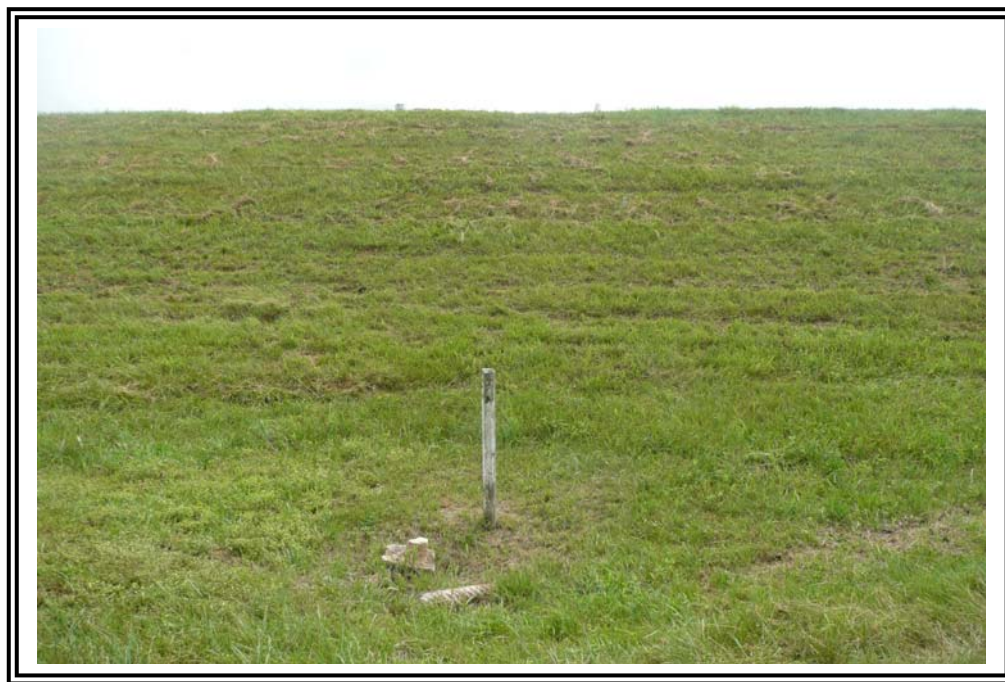
10

South end of the west portion of the Dike. Toe drain outlets are marked with concrete posts. Toe drain outlets located about every 200 feet. No flow noticed, and Georgia Power indicates they have not seen water flowing in the toe drain.

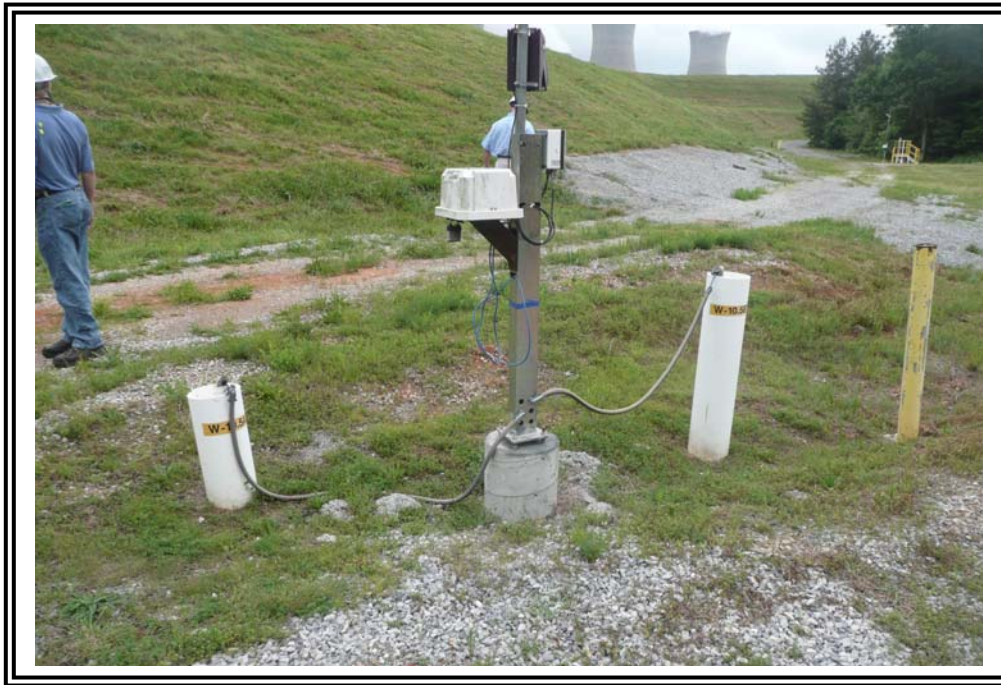
11

Embankment at the “Horseshoe” (looking south). Note the gravel at the toe which was placed during the grouting program to seal karst features below the embankment.

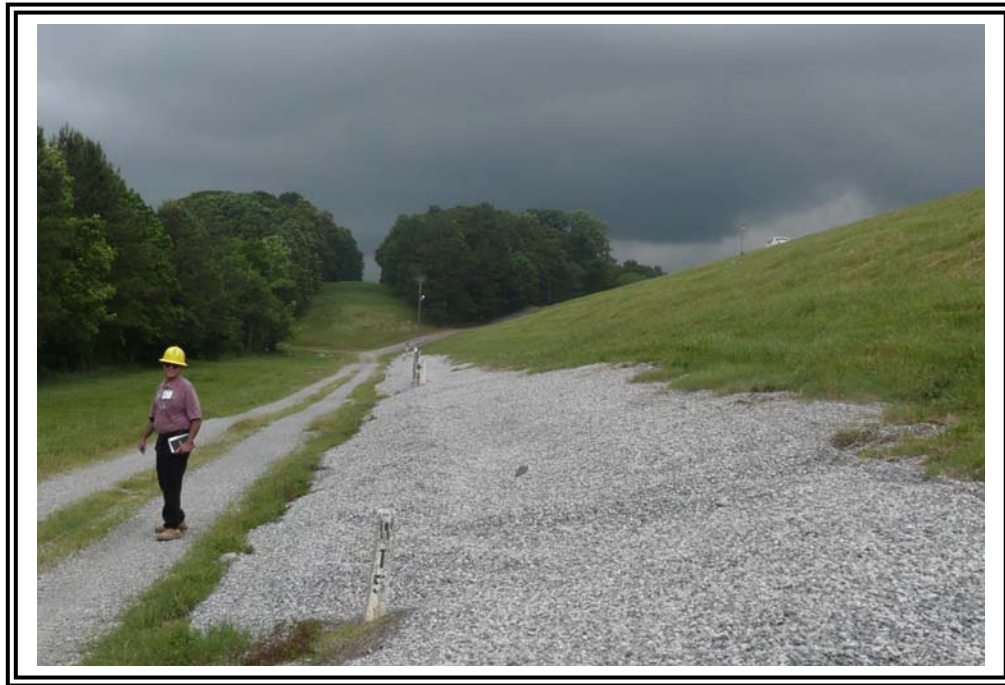
13

Stone cover at North end of main embankment placed during the grouting program to seal karst features below the embankment. The white numbered concrete posts mark toe drain locations.

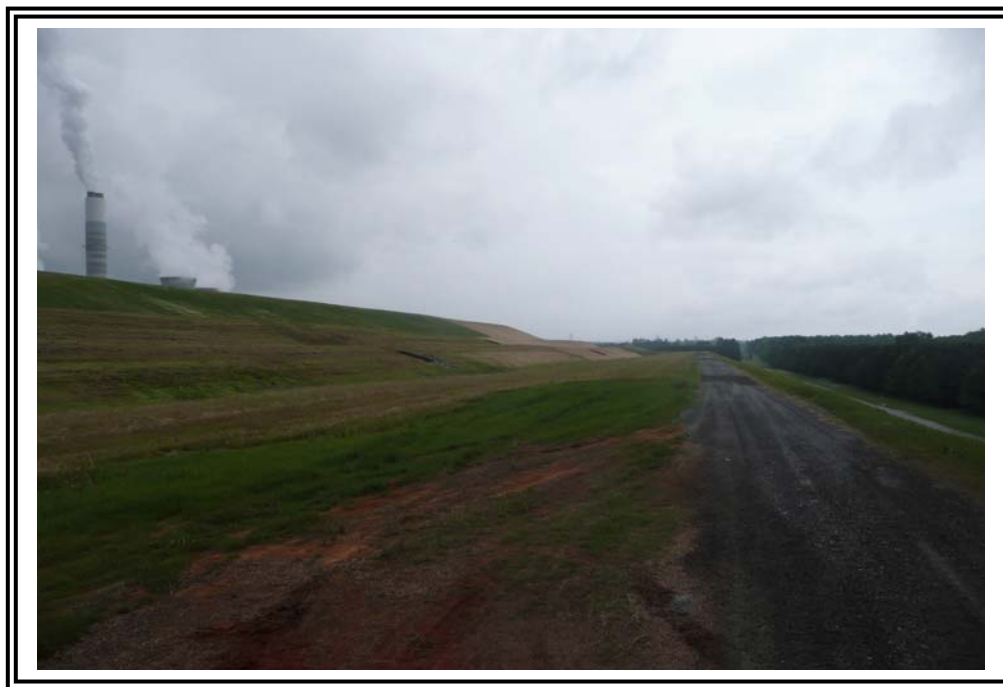
In the area where the recycle pond ends and the main dike curves to the north, formerly sluiced or placed ash is level with the crest of the dam as shown in Photos 15, 16, 18, and 20. The design width of the crest was 15 feet. This condition continues along the entire length of the main dike from the southwest curve to the north abutment. Although obscuring the upstream slope of the constructed dike and the upstream edge of the main dike crest, CHA did not observe conditions of concern along the crest of the main dike.

Main Embankment Crest looking south. Note dry ash stack area in the left of the photo, original embankment crest width 15 feet. Drainage swale is located between the dam and the dry stacked ash pile.

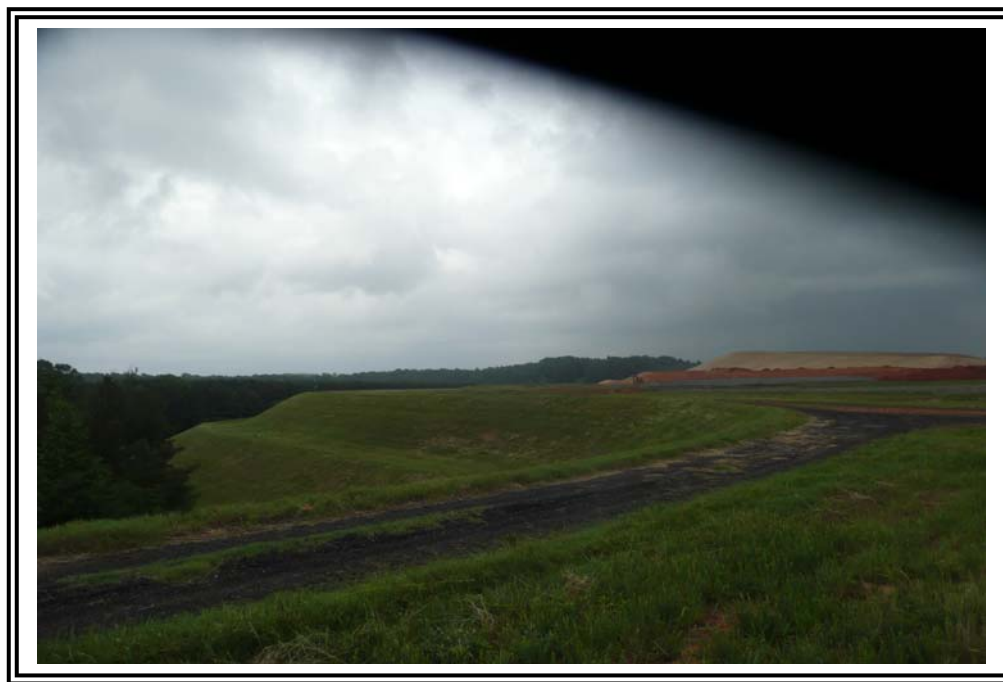
18

Embankment at the "Horseshoe" looking north. Note original embankment crest width was 15 feet. Dry stacked ash placed uniform to dam crest.

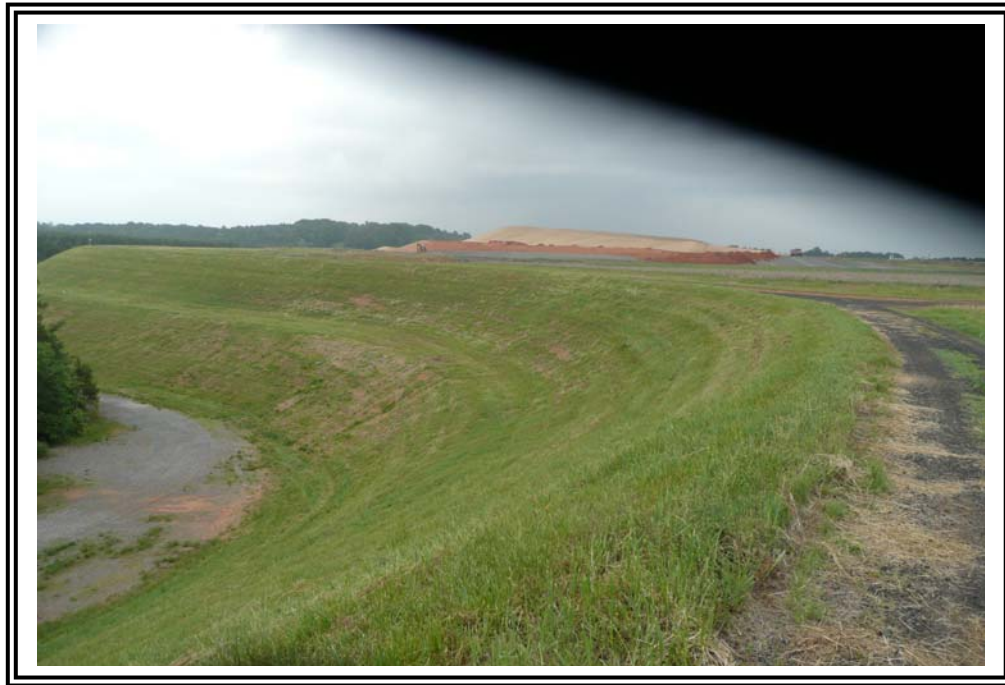
19

Embankment at the "Horseshoe" looking north. Gray coloring at toe of embankment is gravel placed during the grouting program to seal karst features below the embankment.

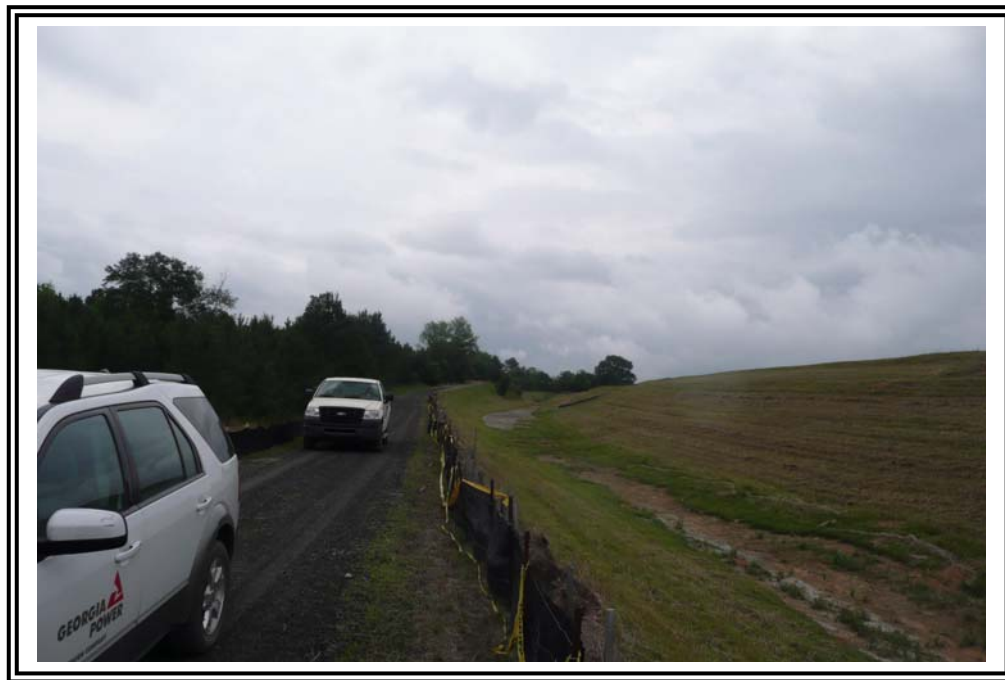
24

Upstream side of North Dike looking east. Dry Stack ash piles in the right of the photo. Drainage swale in this area is unlined, but lining is planned for the 2009 construction season.

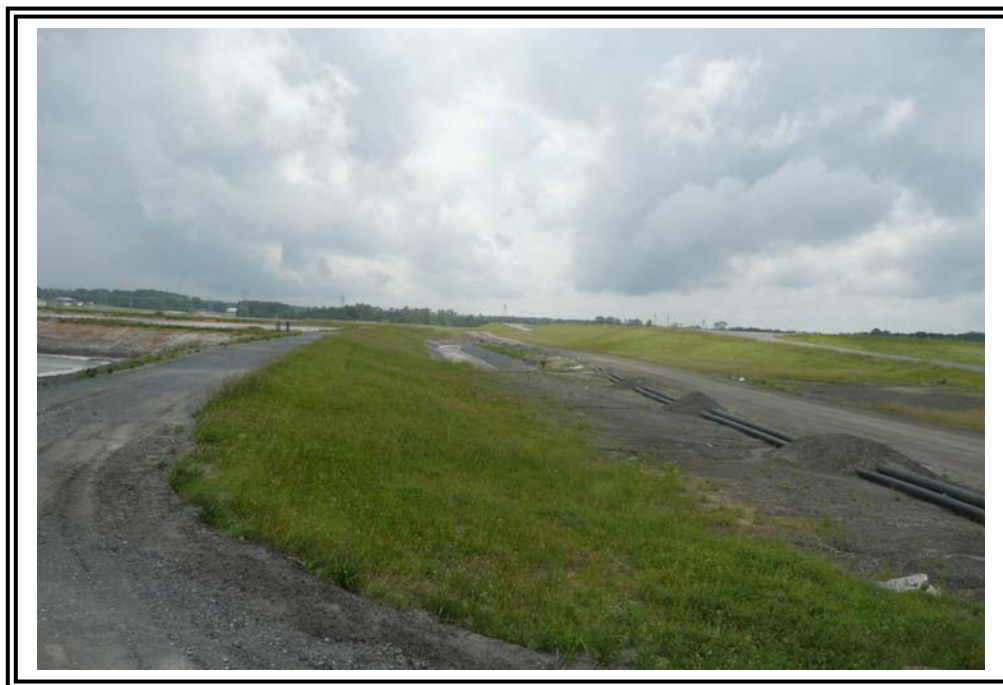
29

The west embankment of the wet ash ponds. Note short height and 3H:1V slope.

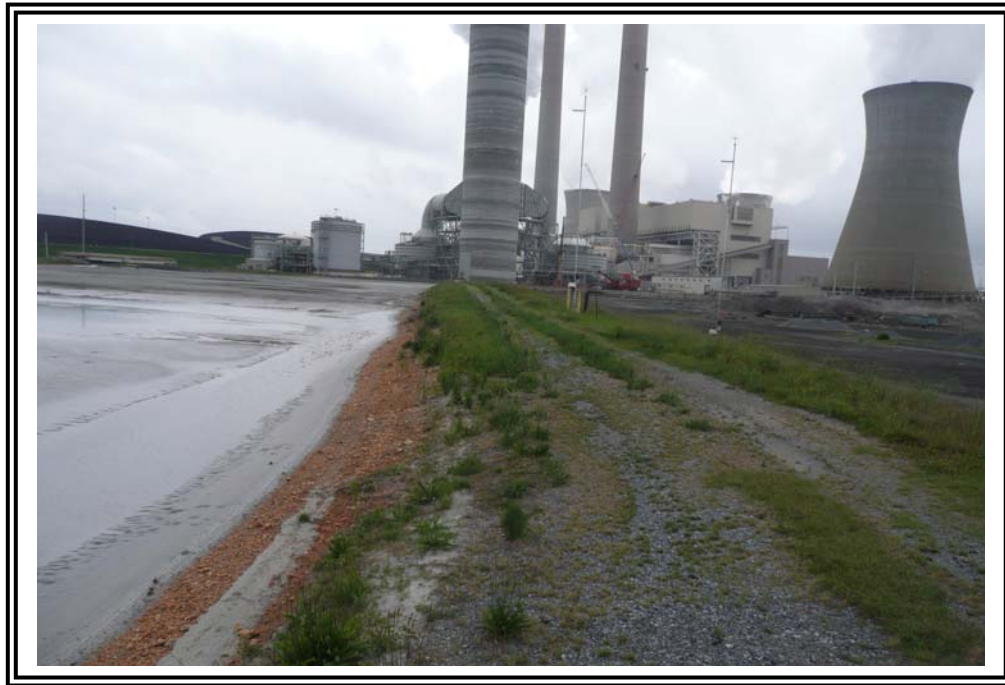
37

Upstream slope of south embankment of wet ash ponds, looking east. Note the red clay liner which overlays a liner.
