# Assessment of Dam Safety Coal Combustion Surface Impoundments (Task 3) Draft Report

Georgia Power  
Company

Plant Branch

December 23, 2009

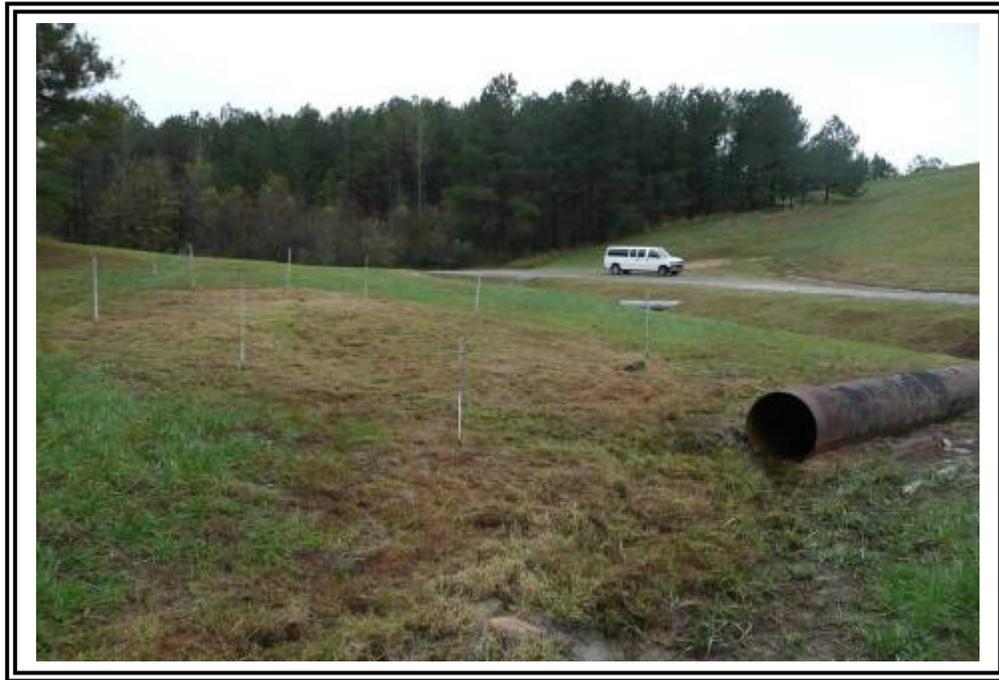
5

Ash Pond E, "soft spot" located south of emergency overflow drain (1 of 3 observed near Ash Pond E). This area has been monitored for 9 years by Georgia Power with no additional expansion observed. Perimeter stakes have been placed to aid in monitoring.

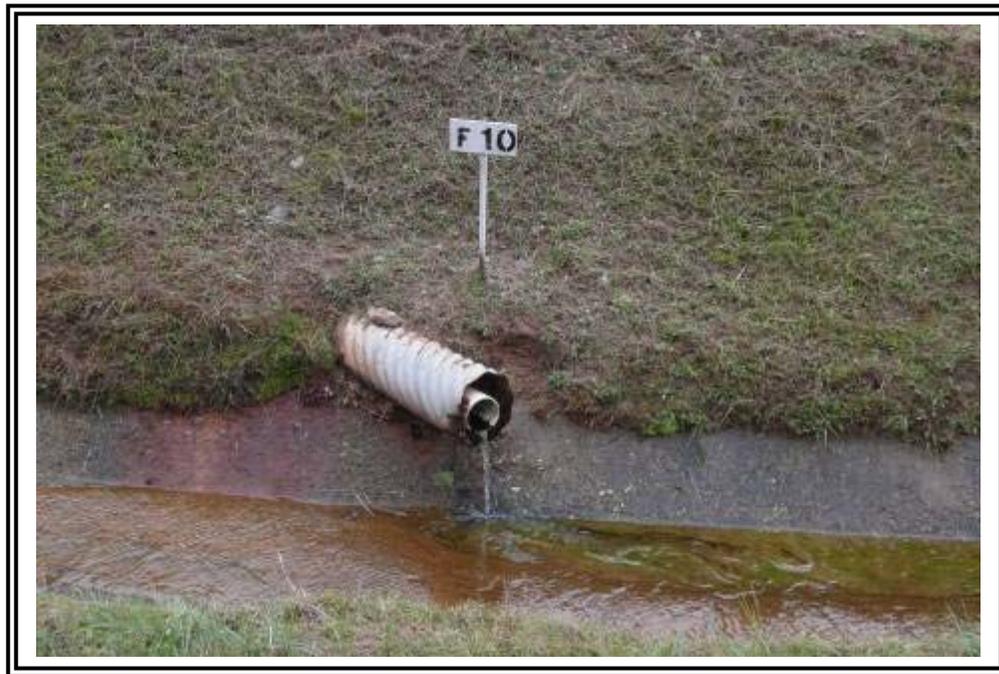
6

Ash Pond E finger drain #10. Drainage from finger drains observed to be clear.

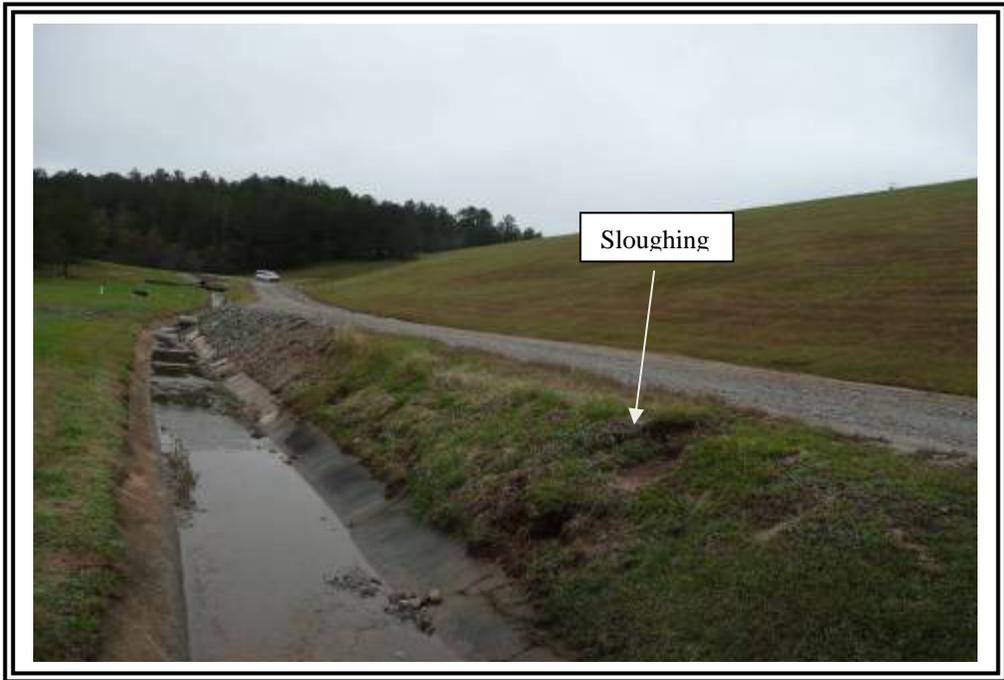
8

Ash Pond E, sloughing observed along west edge concrete line channel at the base of the toe, central portion of the dike.

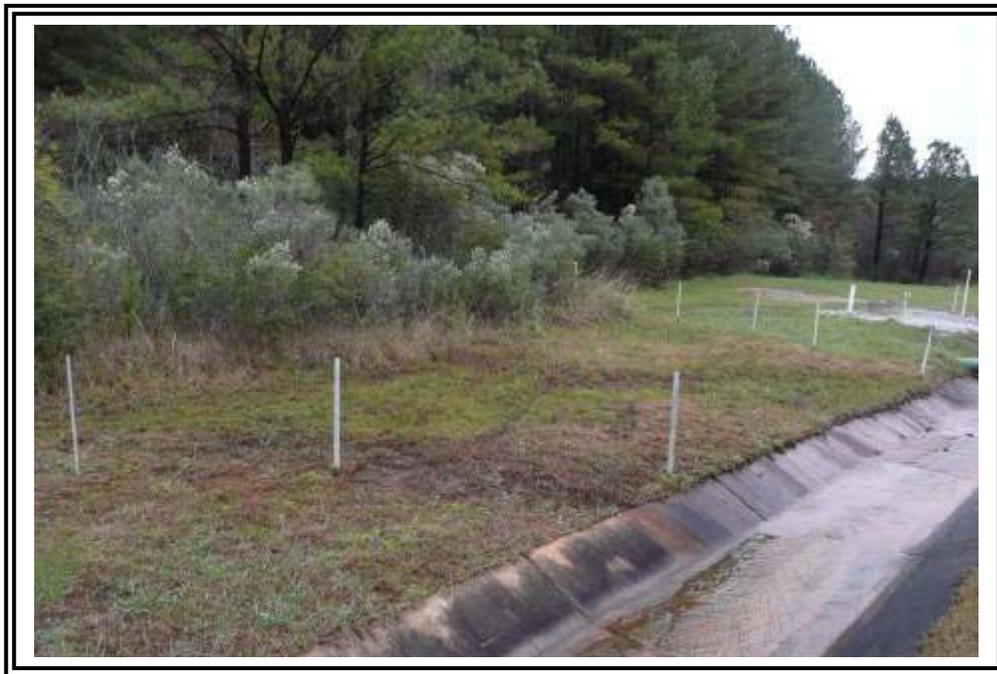
10

Ash Pond E, 3<sup>rd</sup> observed “soft spot” located east of finger drain #5. Perimeter stakes installed for all soft spots in effort to monitor expansion. No observed expansion for any of the 3 soft spots in at least 9 years, as indicated by Georgia Power.

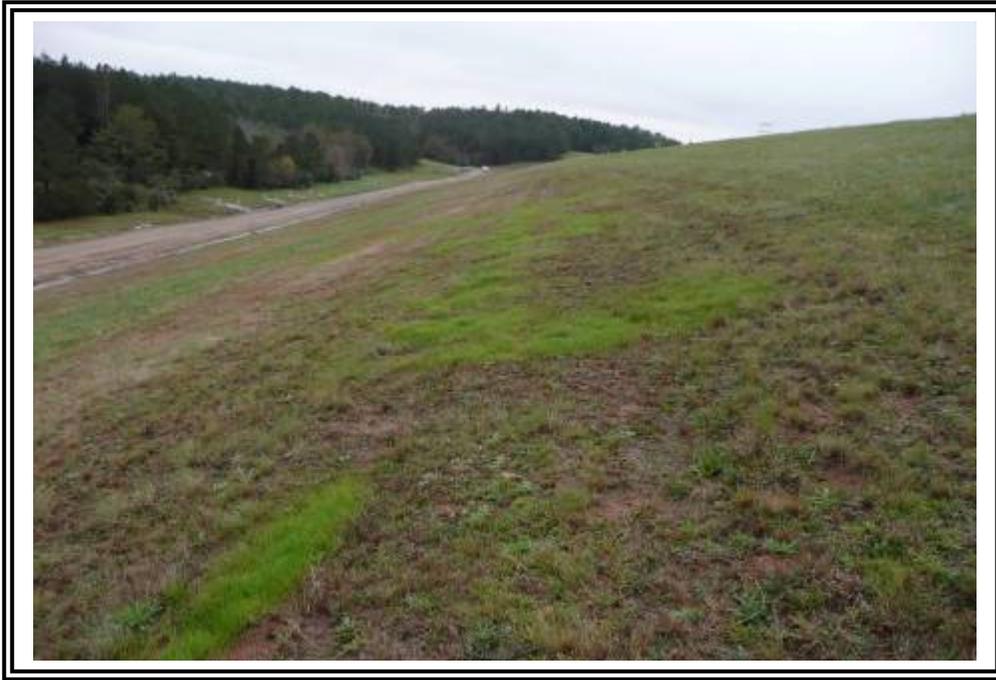
13

Ash Pond E, mid-height of dike, northern end of dam facing south. Mower-rutting observed throughout portions of the dike. Rye grass patching observed and indicated to be seasonal grass cover in effort to minimize sparse vegetation.

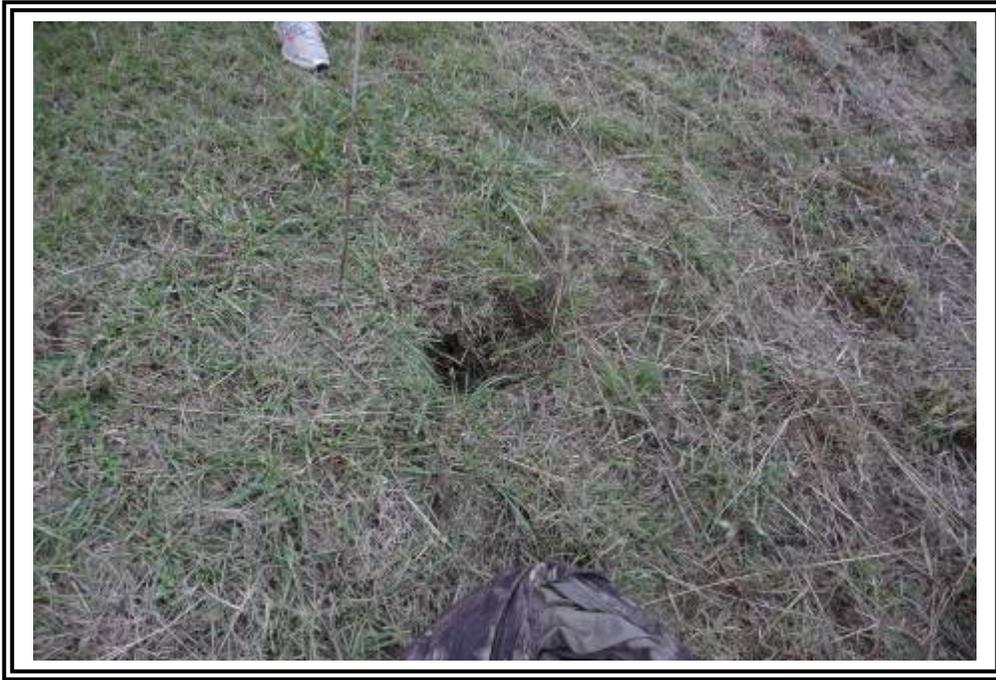
19

Upon inspection of the dike from the crest, a widening of the dike was noted along the northern end as shown in Photo 22. Georgia Power personnel indicated that this is due to the buildup of fly ash along the interior edge of the dike which has slowly filled the pond as shown in Figure 2D. Based upon aerial photo mapping and available site plans, roughly 1,400 feet of the Pond D dike structure has silted in and no longer actively impounds water as measured from the northern end of the dike. Only about 600 feet of the dike now retains open water and this section of the dike has developed a stand of aquatic vegetation at the pond dike interface over time. Additionally, several rodent borrows (Photo 19) were located along the upstream edge of the dike.

Ash Pond D, animal burrow located along central portion of the dike along the interior edge. One of several found throughout the length of the dike.

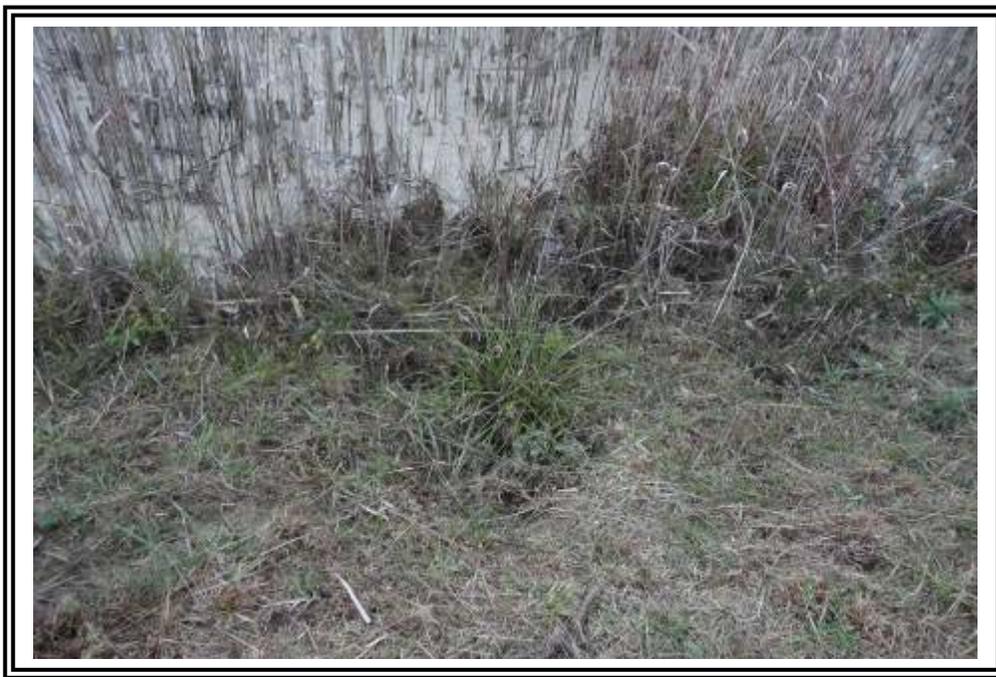
20

Ash Pond D, central portion of the dike facing east. Interior edge of the dike (pond side) shown with possible ash build up.

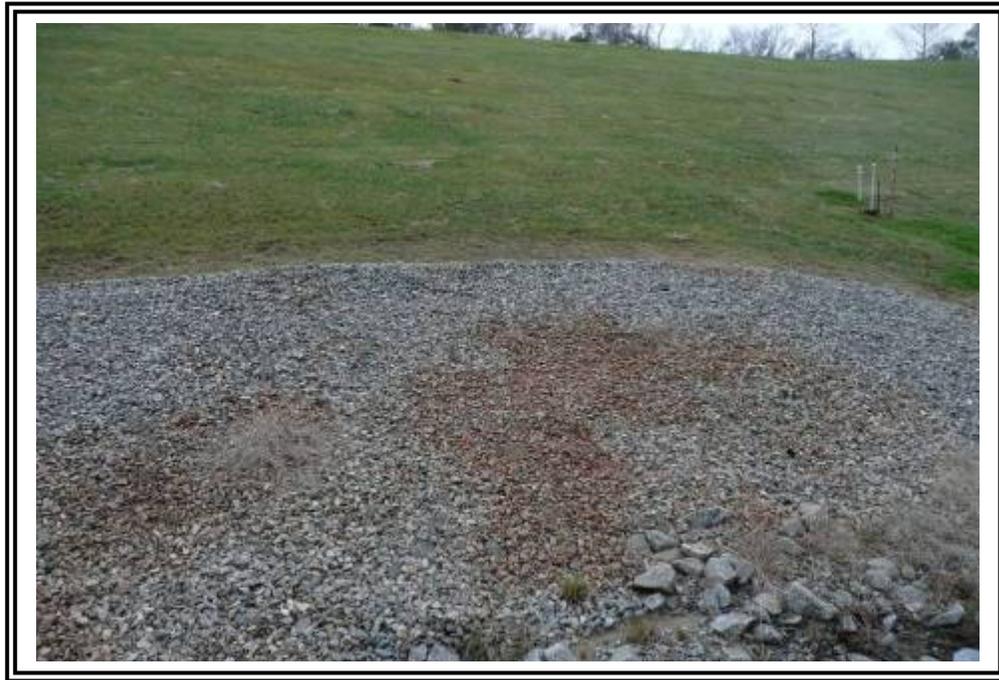
25

Ash Pond D, central portion of dike at edge of toe. Seepage remediation area shown.

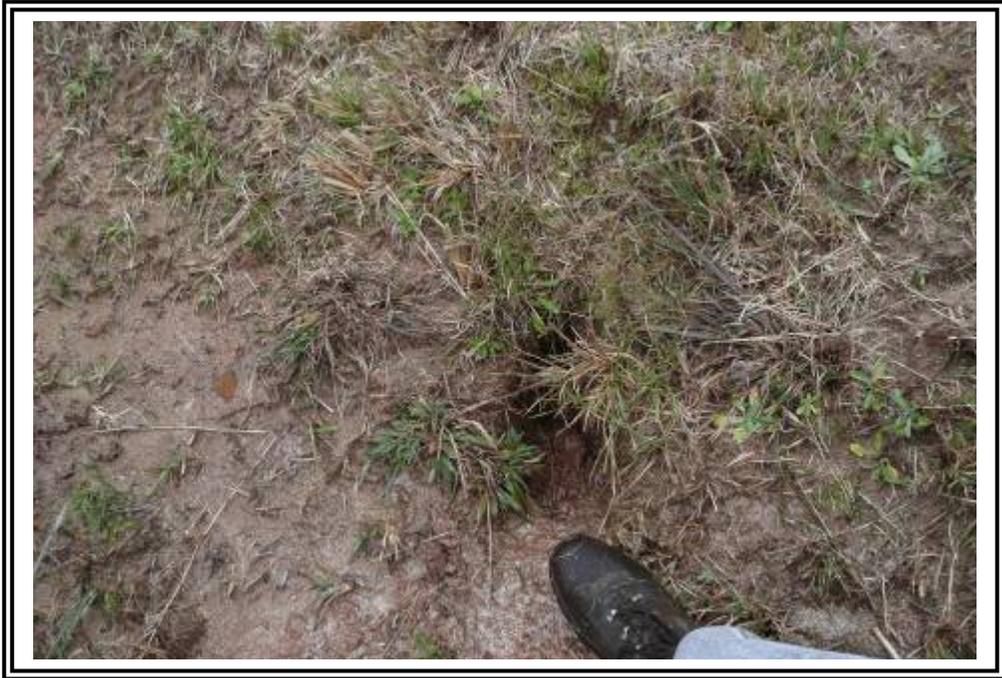
37

Several apparent areas of sparse vegetation were noted along the central and northern exterior portion of the west dike (Photo 35). These areas appeared to be caused by mowers slipping down the exterior face of the dike. Additionally, few rodent burrows were observed along the length of the dike (Photo 37).

Ash Pond C, north portion of west dike, rodent burrow observed on upstream side of dike.

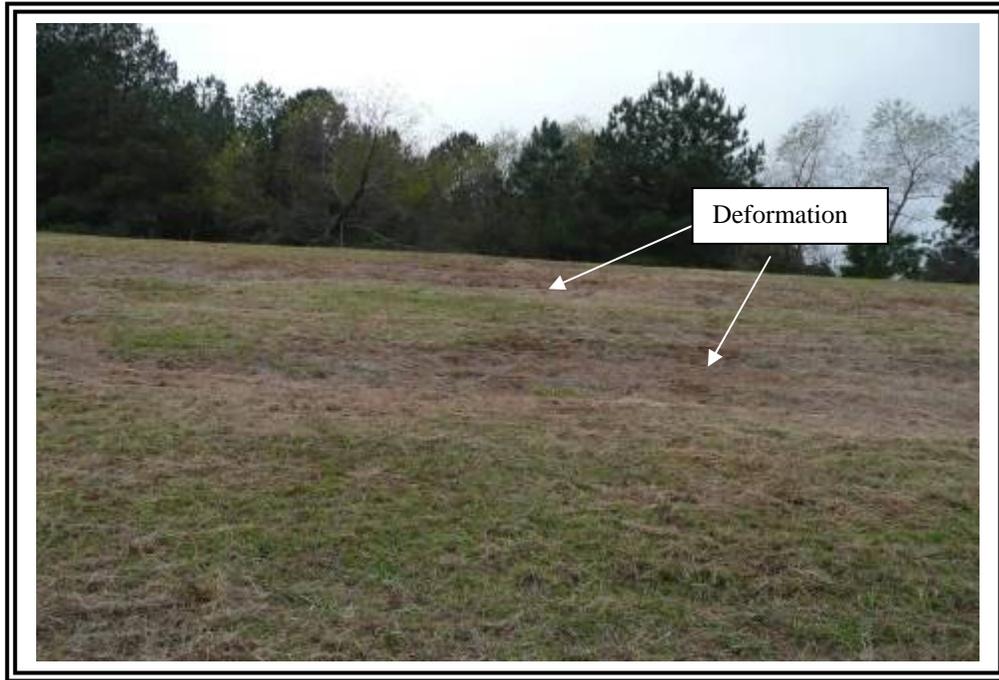
53

Ash Pond C, north end of east dike along dike toe, facing west. Dike scarping indicated.

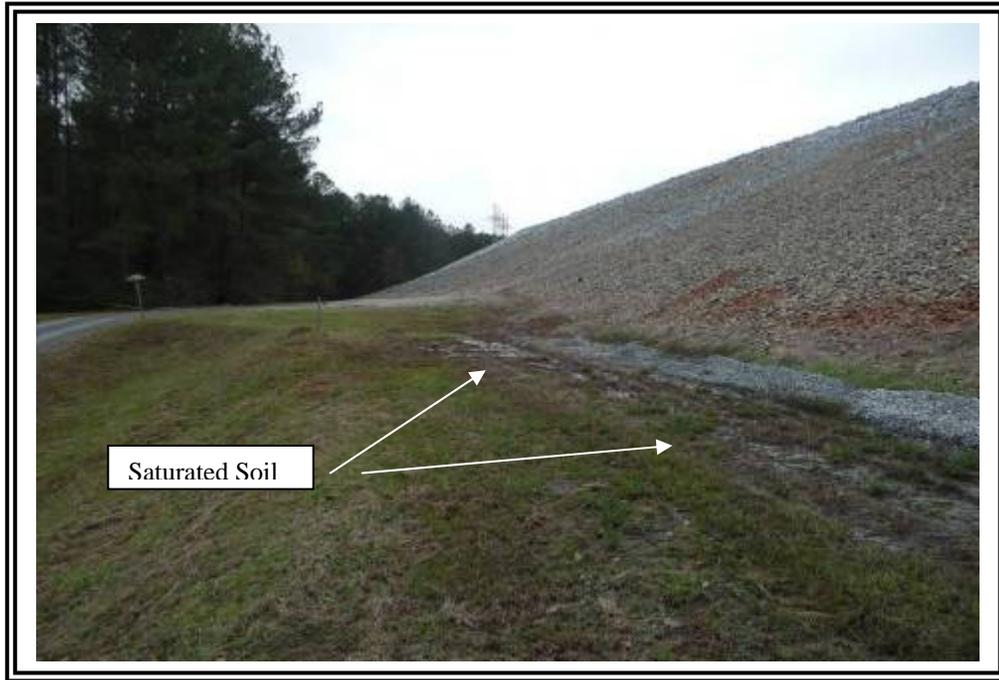
59

Ash Pond C, western central portion of south dike facing west. Saturated soil shown.

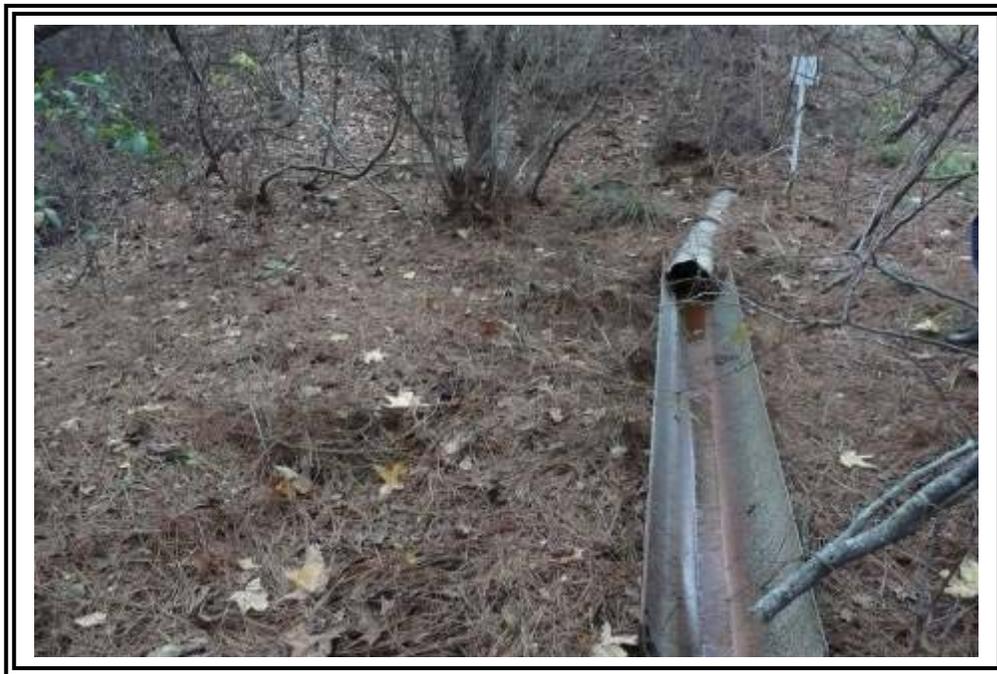
62

Ash Pond C seepage drain No. 3 shown. Draining water was observed to be clear.
