# Assessment of Dam Safety Coal Combustion Surface Impoundments (Task 3) Final Report

Georgia Power  
Company

Plant Branch

Milledgeville, GA

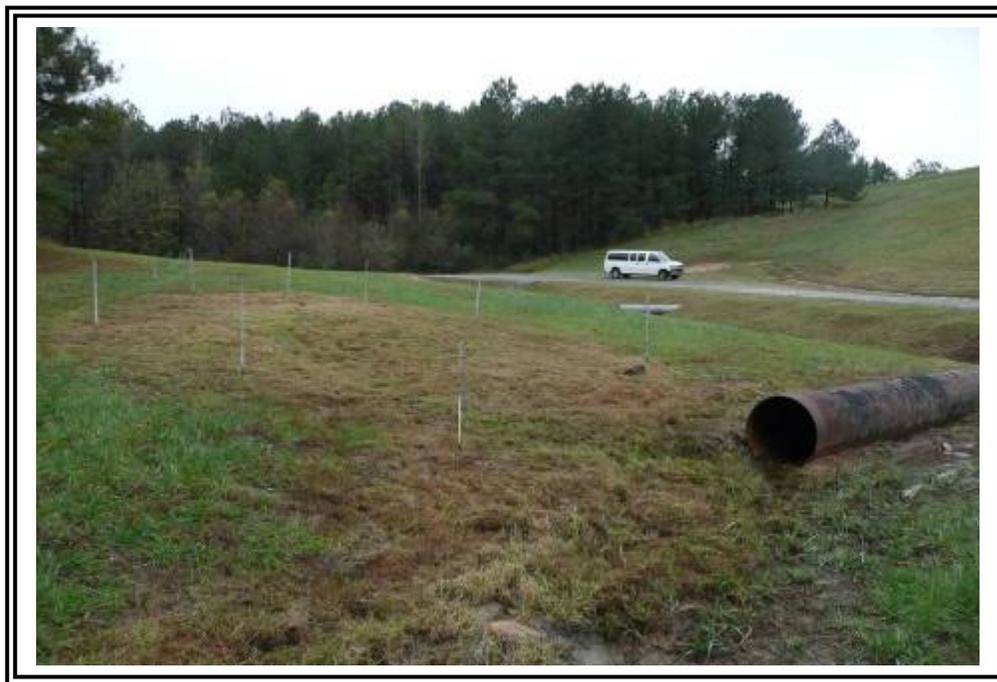
5

Ash Pond E, "soft spot" located south of emergency overflow drain (1 of 3 observed near Ash Pond E). This area has been monitored for nine years by Georgia Power with no additional expansion observed. Perimeter stakes have been placed to aid in monitoring.

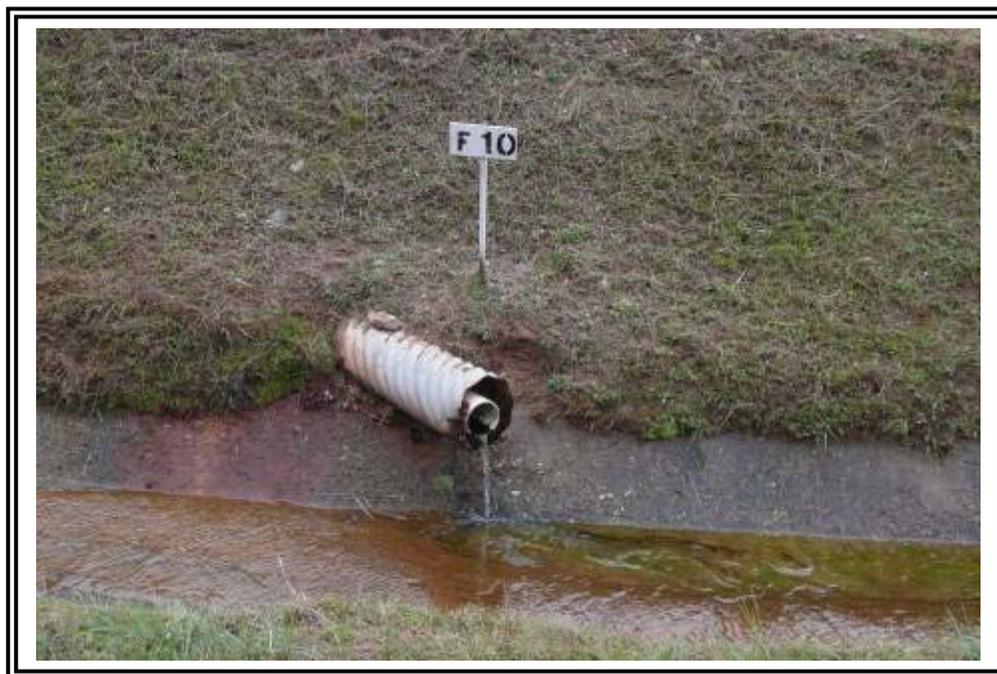
6

Ash Pond E finger drain #10. Drainage from finger drains observed to be clear.

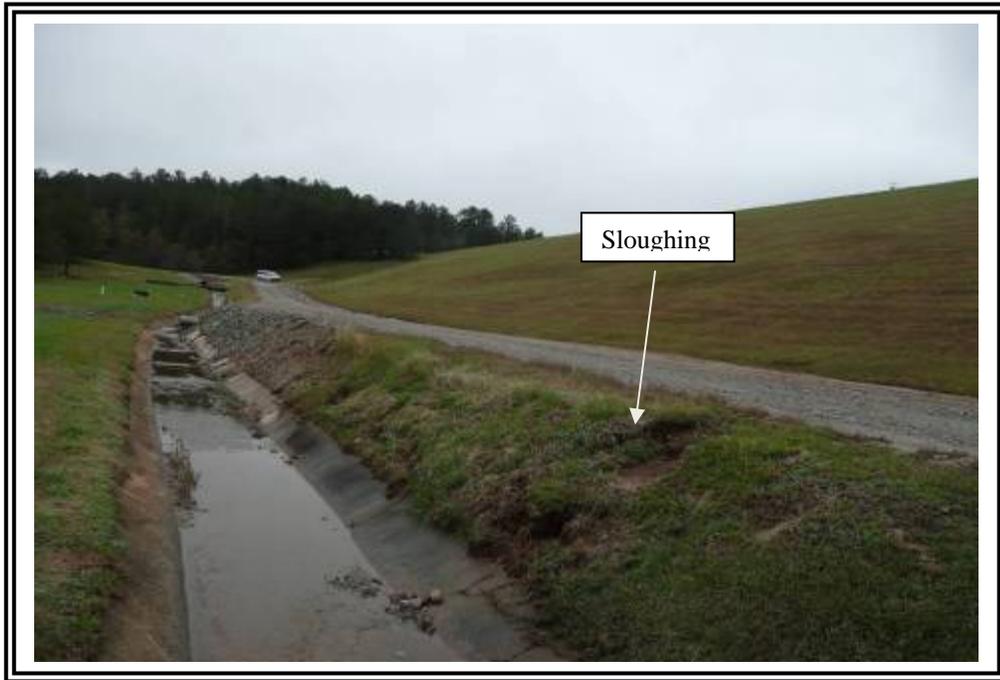
8

Ash Pond E, sloughing observed along west edge concrete line channel at the base of the toe, central portion of the dike.

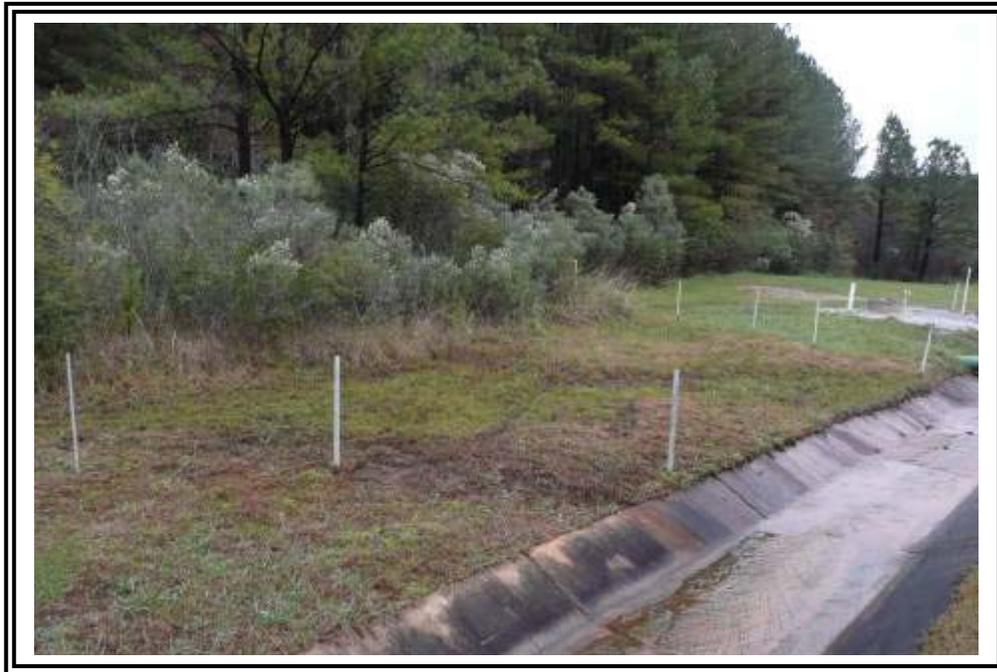
10

Ash Pond E, 3<sup>rd</sup> observed “soft spot” located east of finger drain #5. Perimeter stakes installed for all soft spots in effort to monitor expansion. No observed expansion for any of the three soft spots in at least nine years, as indicated by Georgia Power.

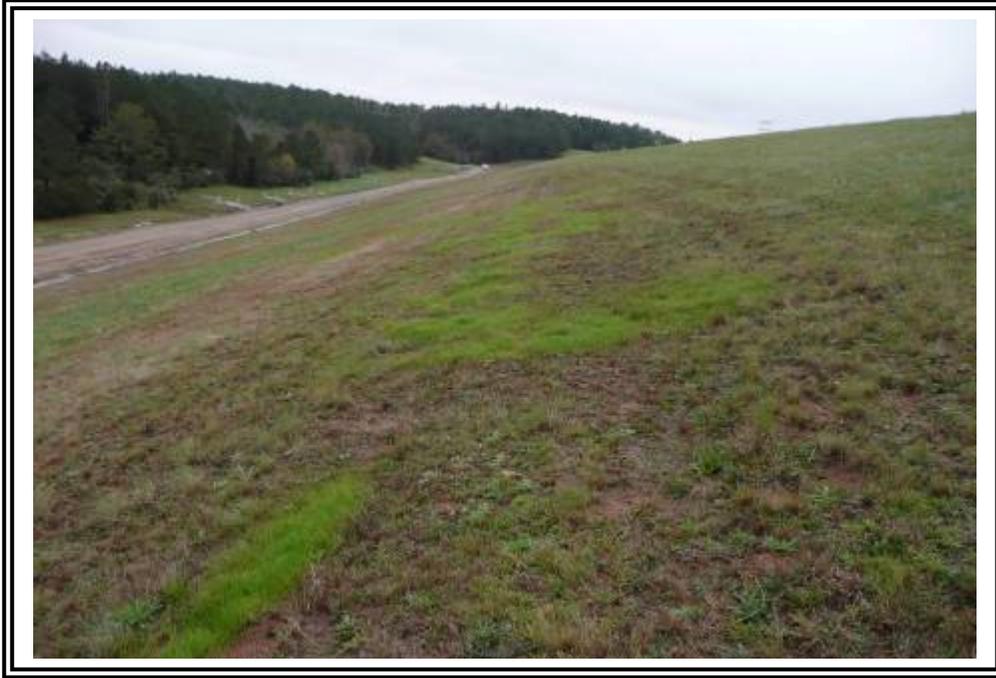
13

Ash Pond E, mid-height of dike, northern end of dam facing south. Mower-rutting observed throughout portions of the dike. Rye grass patching observed and indicated to be seasonal grass cover in effort to minimize sparse vegetation.

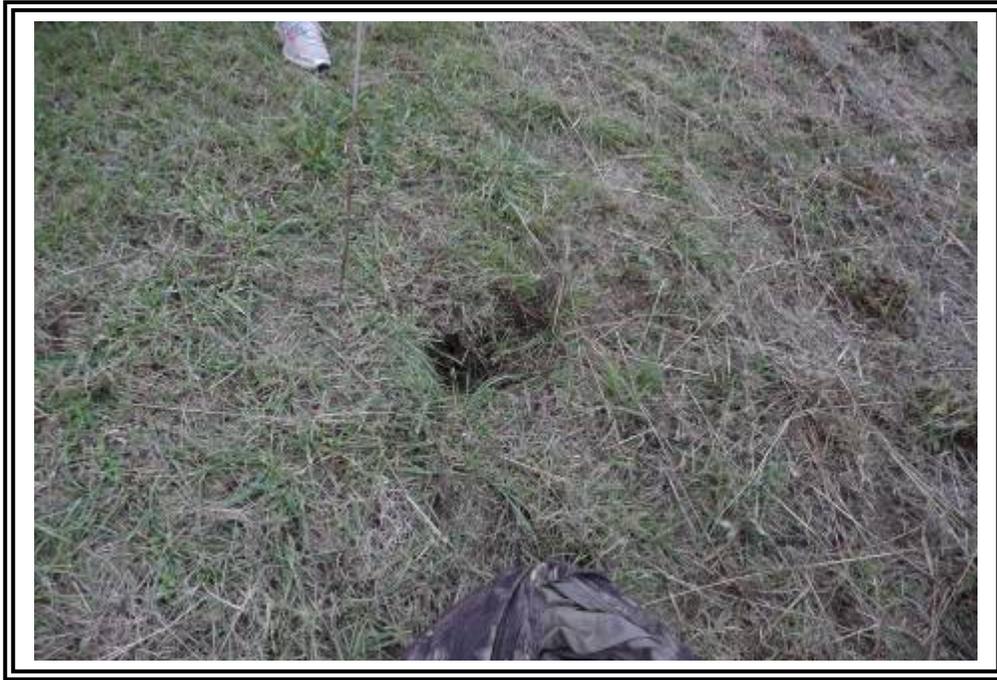
19

Ash Pond D, animal burrow located along central portion of the dike along the interior edge. One of several found throughout the length of the dike.

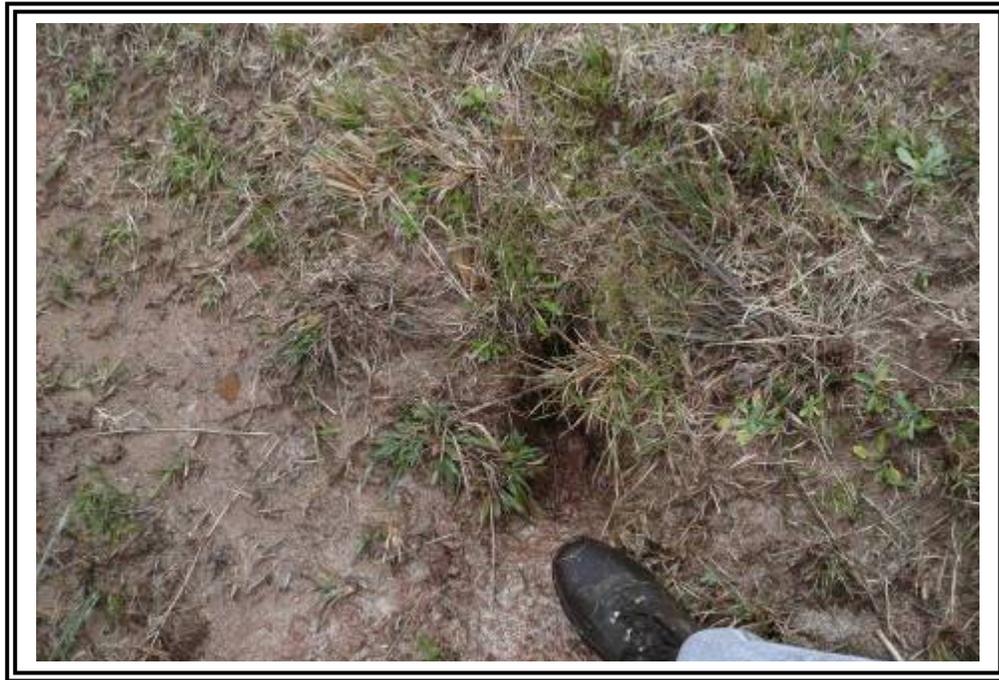
37

Ash Pond C, north portion of west dike, rodent burrow observed on upstream side of dike.
