Re: "Assessment of Dam Safety Coal Combustion Surface Impoundments (Task 3) Final Report" for Georgia Power Plant Branch, Milledgeville, Georgia

**Re: Additional Information in Response to “Assessment of Dam Safety Coal
Combustion Surface Impoundments (Task 3) Final Report” for Georgia Power
Plant Branch, Milledgeville, Georgia**

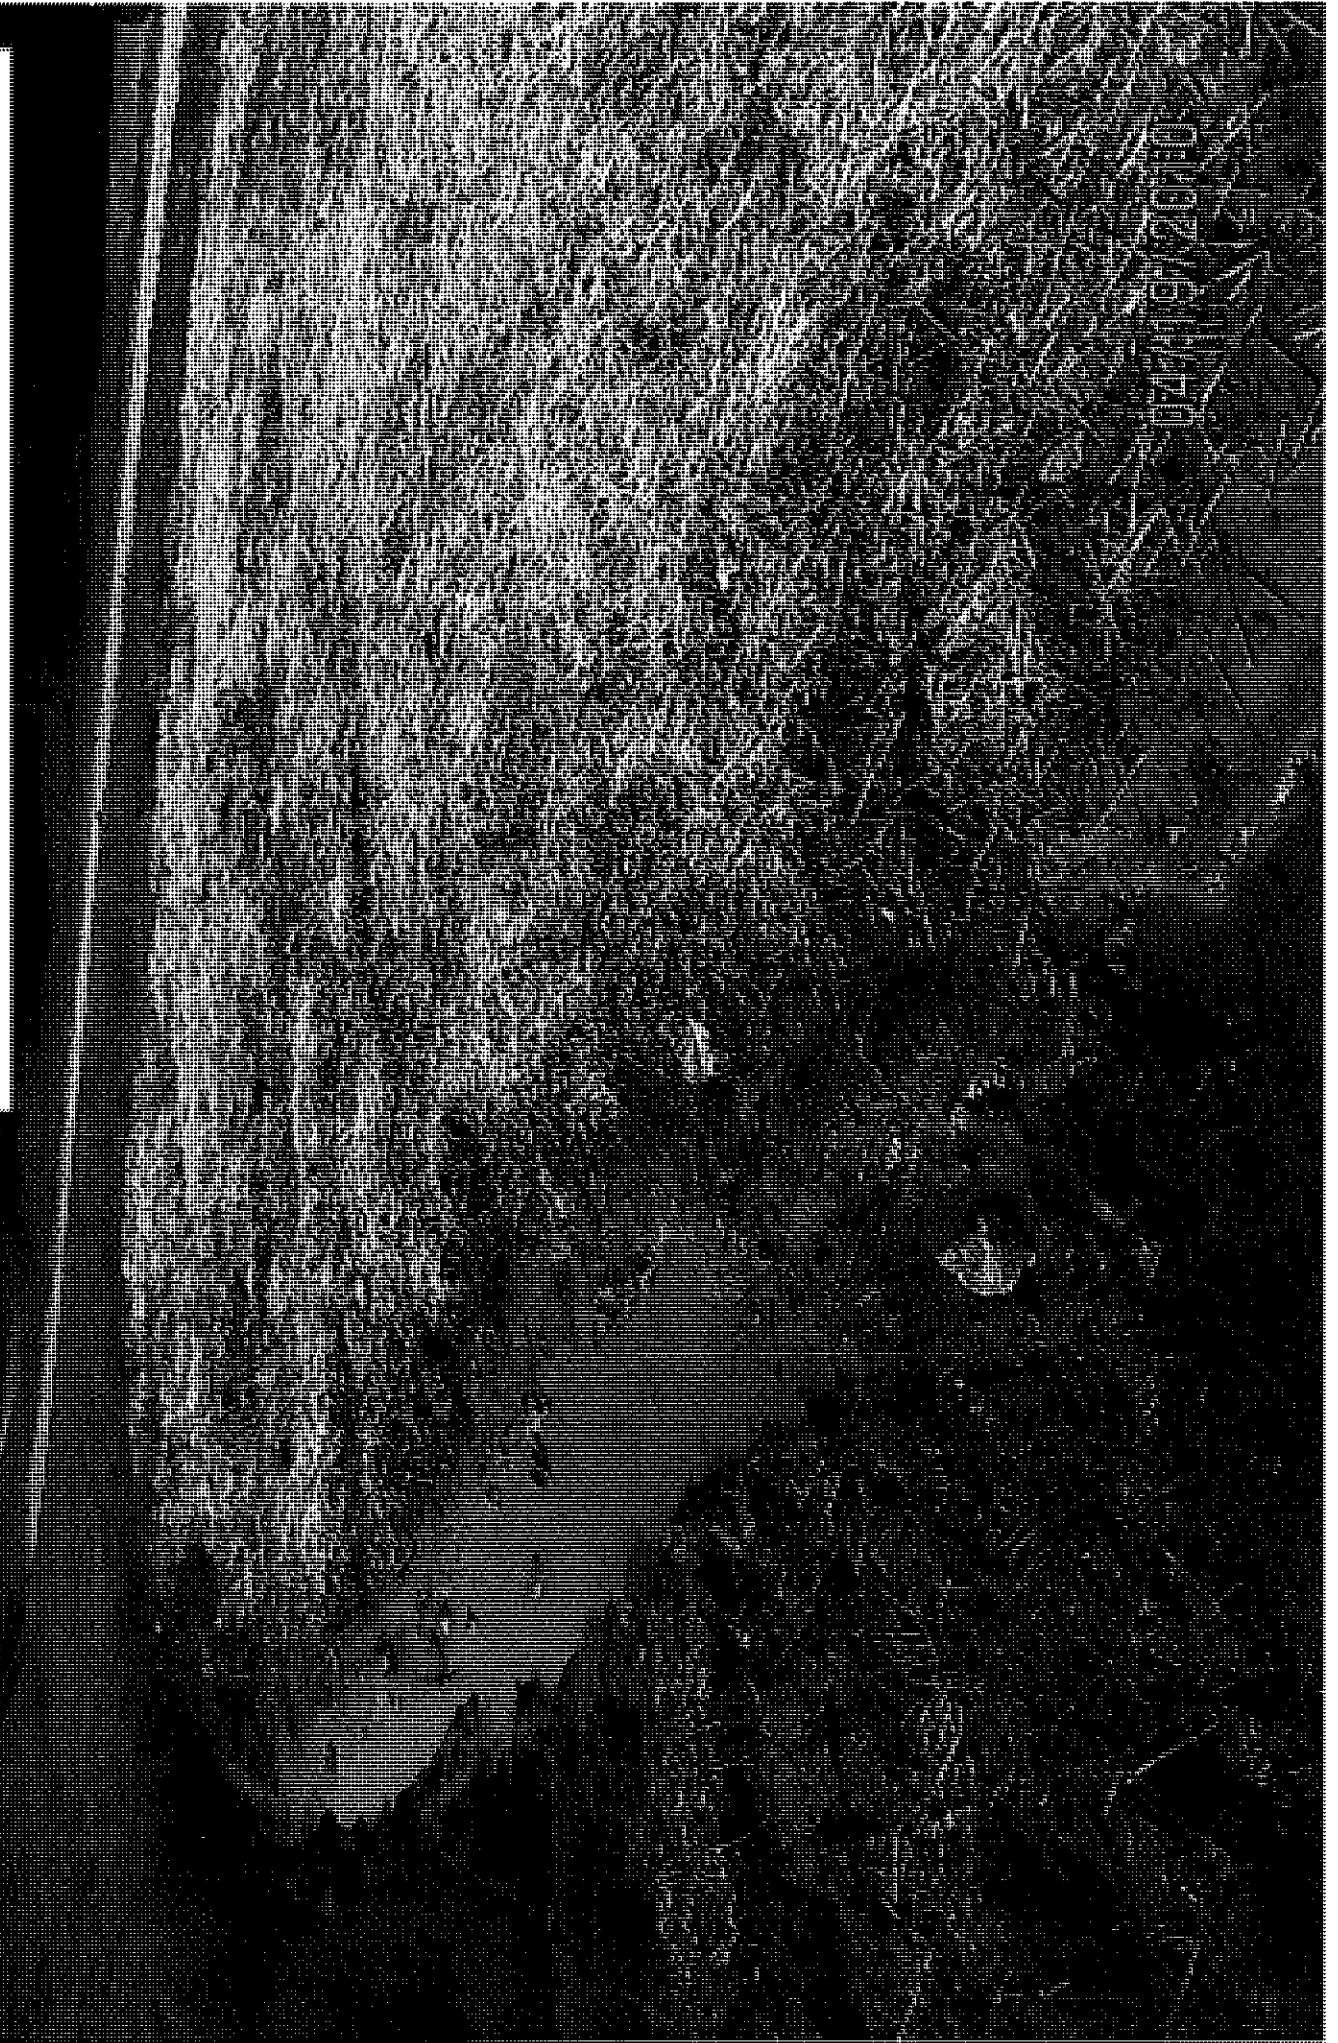
- *Saturated soil conditions were also noted north of the recycle water pump station. We understand that Georgia Power has placed rock in this area previously and the wet conditions have continued. CHA recommends that Georgia Power consult with a geotechnical engineer to develop recommendations for this area.*

Plant Branch Ash Pond C, East Dike (Photo 1) Shows area regraded and water rerouted away from dike

Georgia Power has completed grading in this area to route water to Ash Pond B. Photo documentation is attached (Photo #1). This should close out this issue.

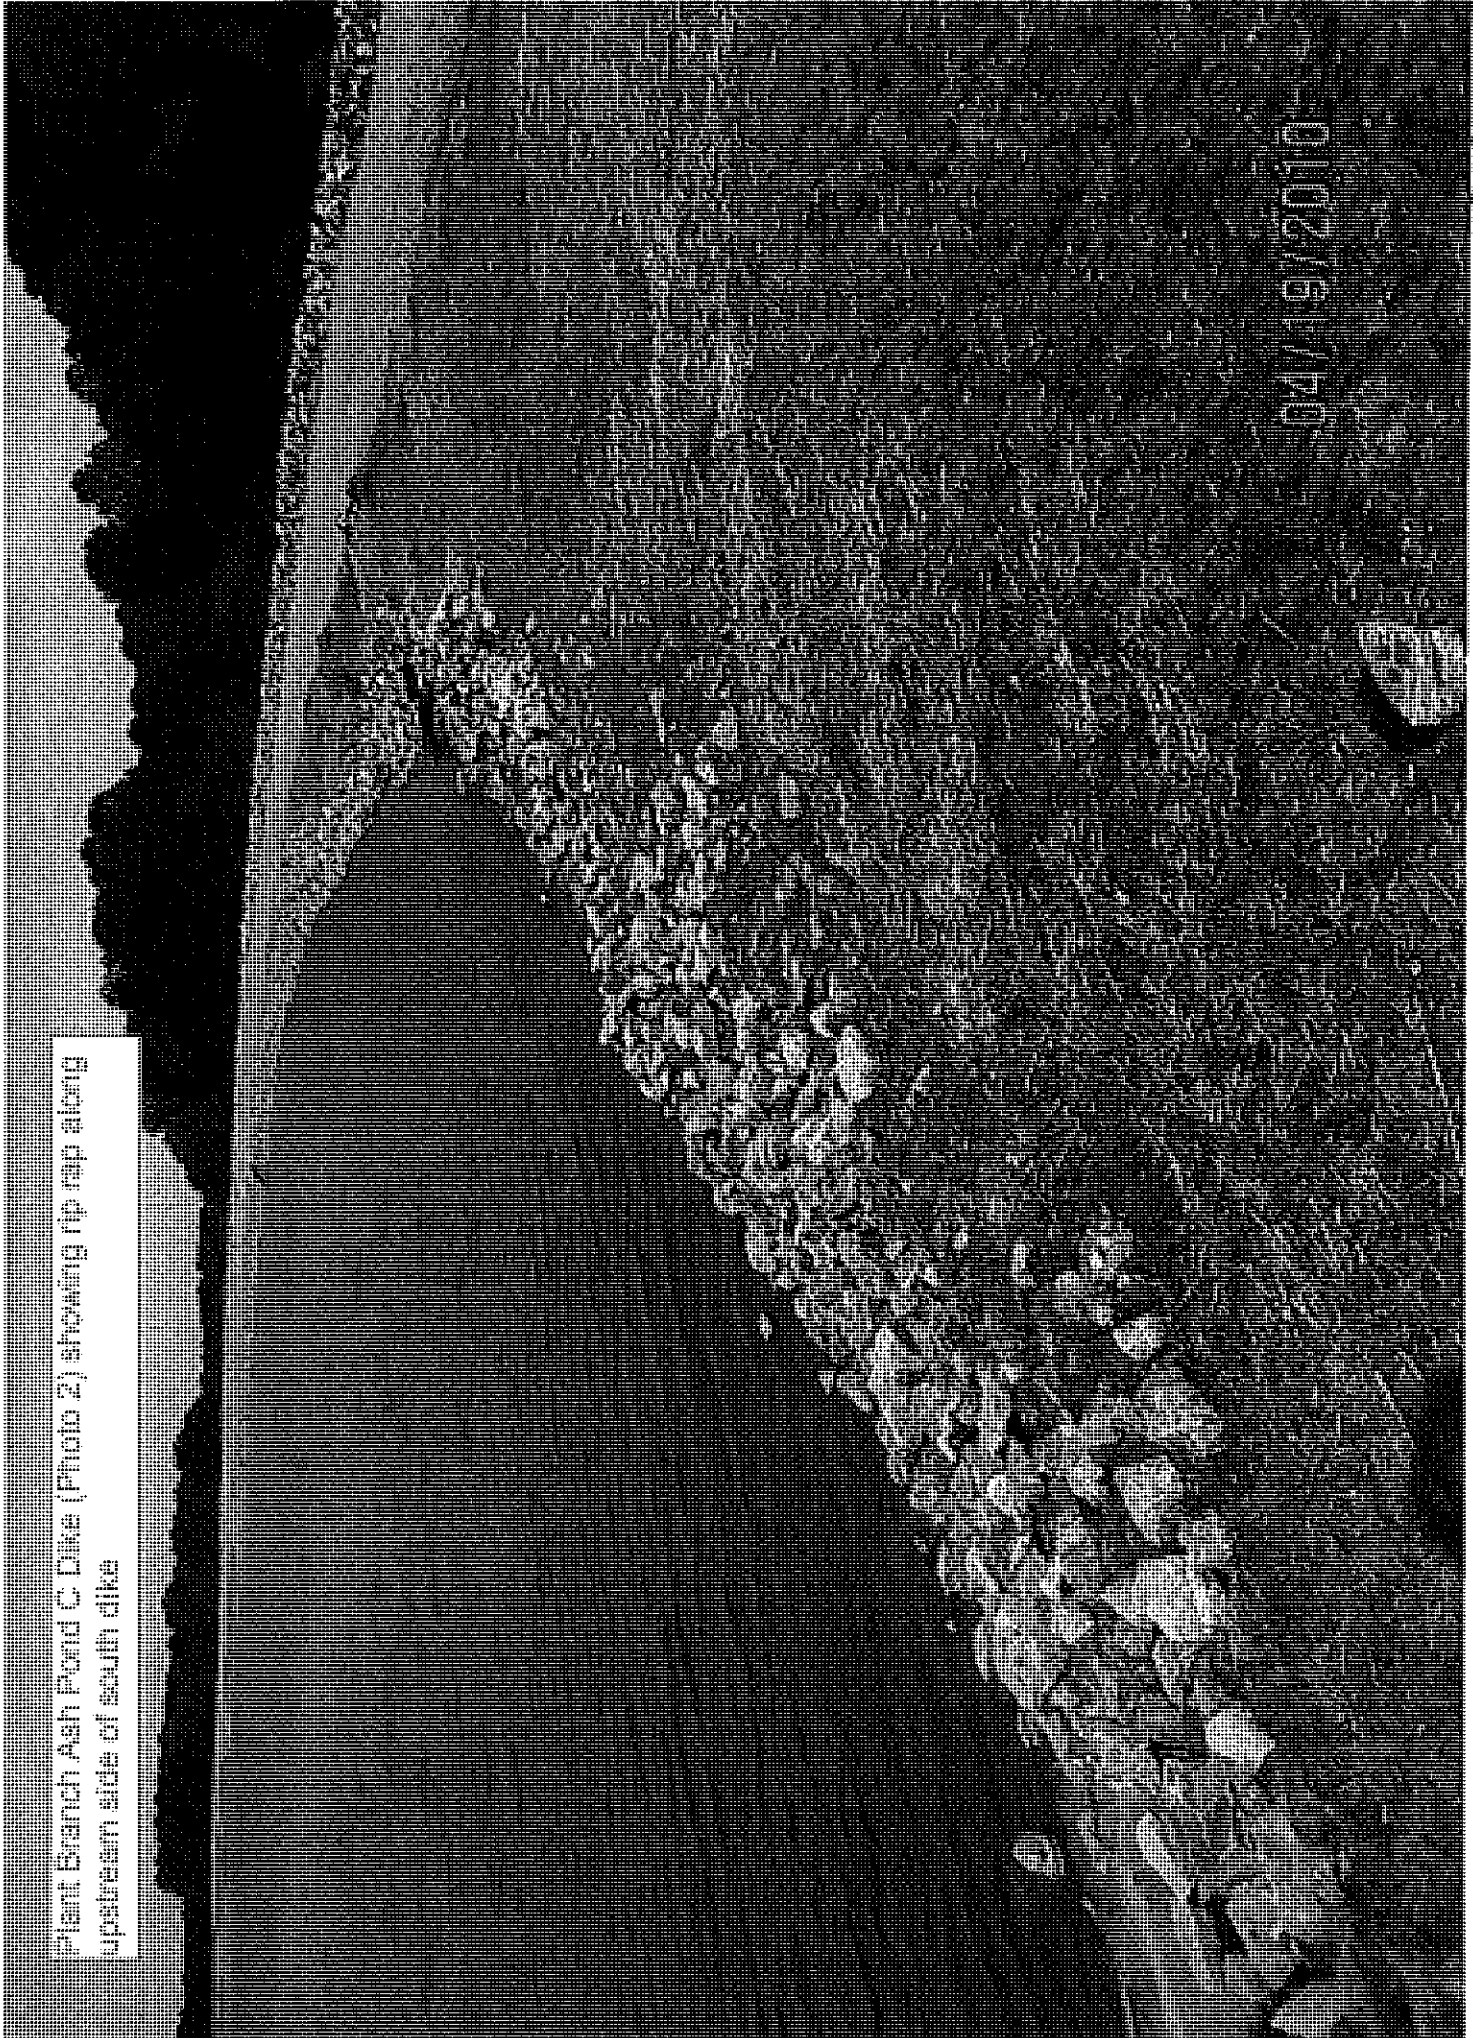
- *Erosion due to water "lapping" the surface was observed on the upstream side of the south dike. CHA recommends improvements to the erosion protection along the water's edge. Georgia Power has indicated that this has been completed since CHA's site visit.*

Plant Branch Ash Pond C Dike (Photo 2) showing rip rap along
upstream side of south dike

Rip rap has been placed on the upstream side of the south dike for erosion protection. Please reference attached the photo documentation (Photo #2).

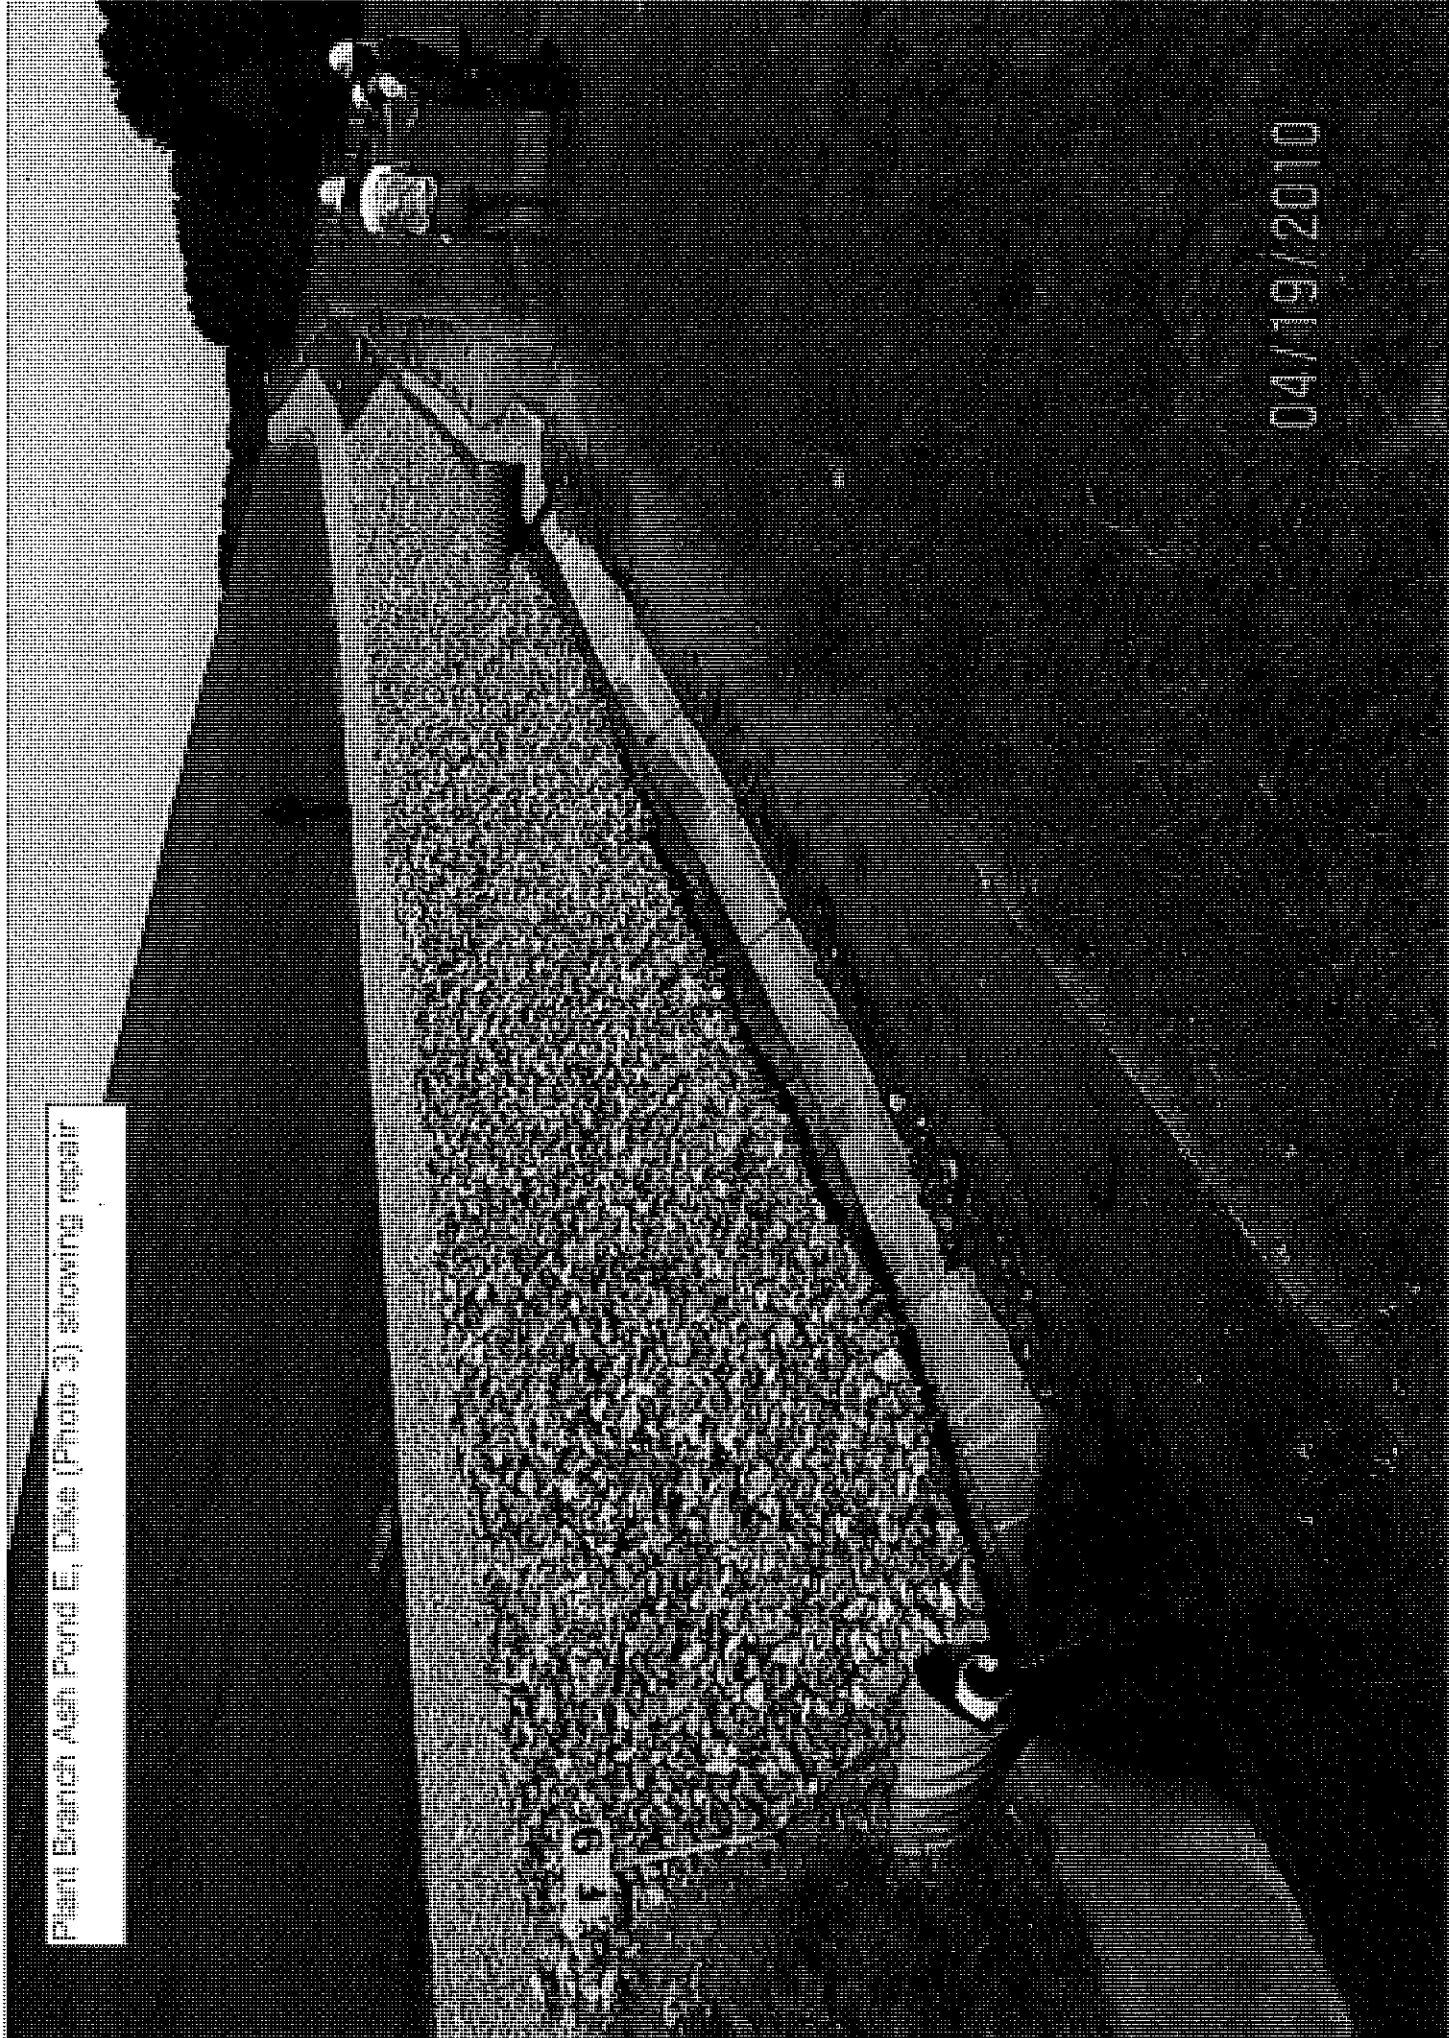
•Sloughing and surface irregularity due to recent rain was noted along the southern end of the downstream slope and sparse vegetation due to mowing activities was also observed. Measures should be implemented to reduce the potential for progressive erosion in these areas.

Plant Branch Ash Pond E, Dike (Photo 3) showing repair

The sloughed area has been repaired (Photo #3). Also, future mowing activities will be limited to periods where the slope is sufficiently dry to prevent rutting. In addition, affected areas of the dike have been re-seeded and Georgia Power will continue to monitor for sparse vegetation and take appropriate actions as necessary.
