Report of Safety Assessment
Coal Combustion Surface Impoundments
Georgia Power
Plant Hammond, Rome, Georgia

AMEC Project No. 3-2106-0174.0500

December 2010

Southern Company, Georgia Power, Plant Hammond: Ash Pond 1, Ash Pond 2, Ash Pond 3, Ash Pond 4

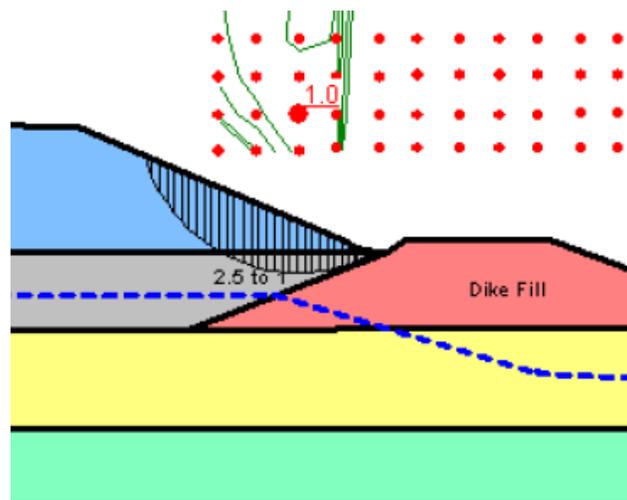
The sketch below (taken from page 143 of the Georgia Power analysis) shows the calculated failure surface during a seismic event of Section D-D'.

The concern with a factor of safety of 1.0 is that a failure during a seismic event could result in deposition of ash into the environment. The Georgia Power stability analysis notes that, "This number is below the required current minimum criteria, but is at the minimum criteria at the time of the design of the ash stack in the 1990s according to the criteria set in the US Corps of Engineers Manual EM 1110-2-1902, April 1970" (HAM-API 077, p. 6 of 196). However, the revised report states that closure of the stack under Georgia Solid Waste Management Rules will require the slopes to be flattened to at least 3H:1V. The revised Stability Analysis submitted for review subsequent to publication of the draft report, indicates that the 3H:1V slopes will provide an acceptable factor of safety of 1.1.

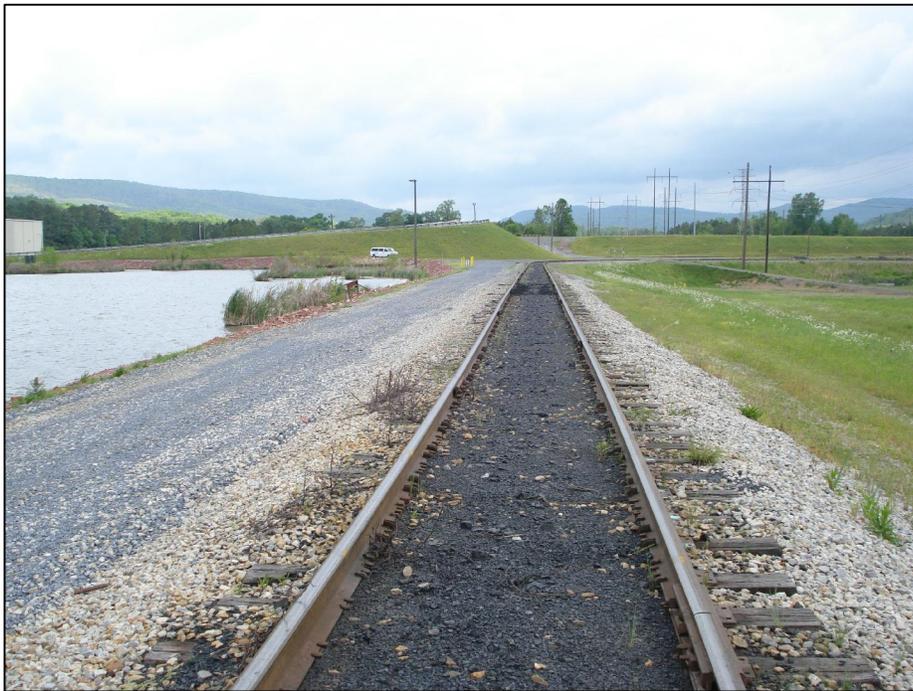
1-14

Ash Pond 1, commissioned in 1952, is a co-treatment facility and receives only low volume wastes. At the time of the site visit, railroad tracks were noted located along the eastern and southern dikes (photos 1-9 and 1-14).

RAILROAD TRACKS ALONG CREST OF EASTERN DIKE

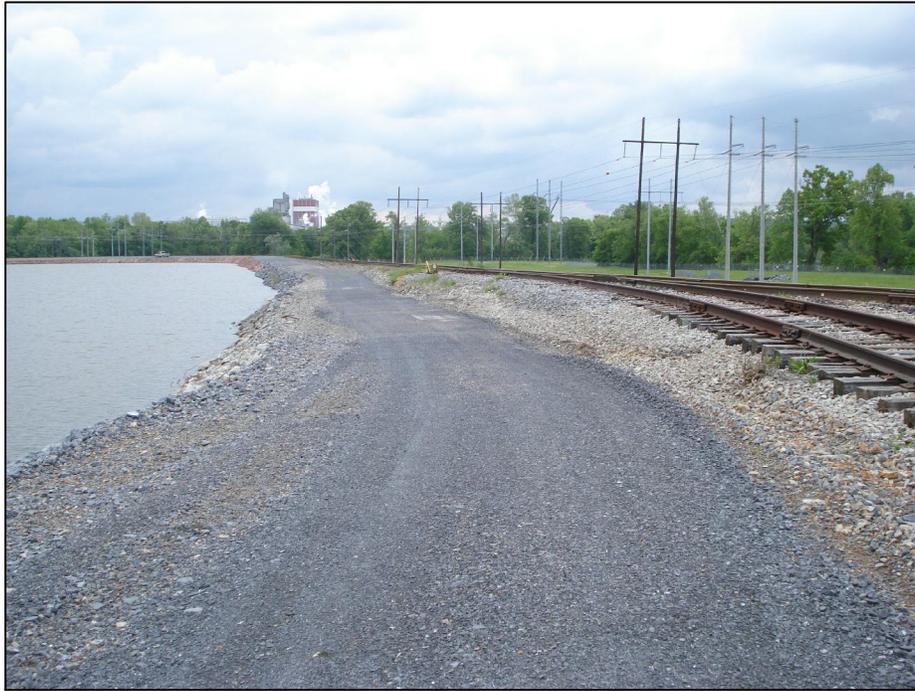
1-25

SLIGHT SURFACE DEPRESSION ALONG SOUTHERN DIKE

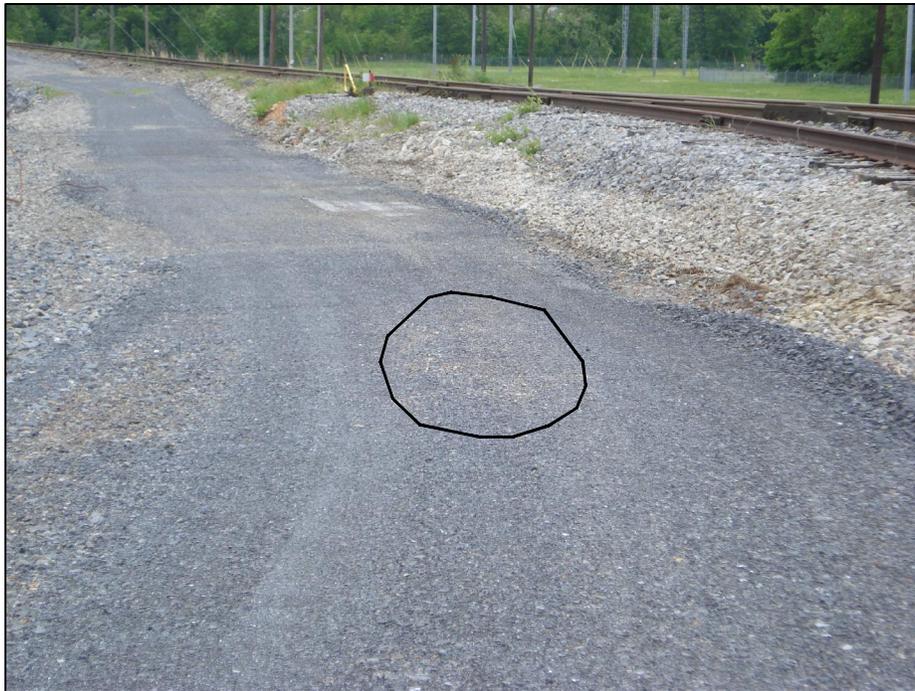
Surficial depressions that appeared to be the result of rutting from vehicles were noted along the crest of the southern dike (photos 1-16 and 1-26 through 1-30). Additional wet areas, also apparently the result of rutting from maintenance trucks, were noted at the southern and eastern downstream toe (photos 1-31, 1-35, and 1-36).

SLIGHT SURFACE DEPRESSION LIKELY DUE TO VEHICLE TRAFFIC ALONG CREST OF SOUTHERN DIKE

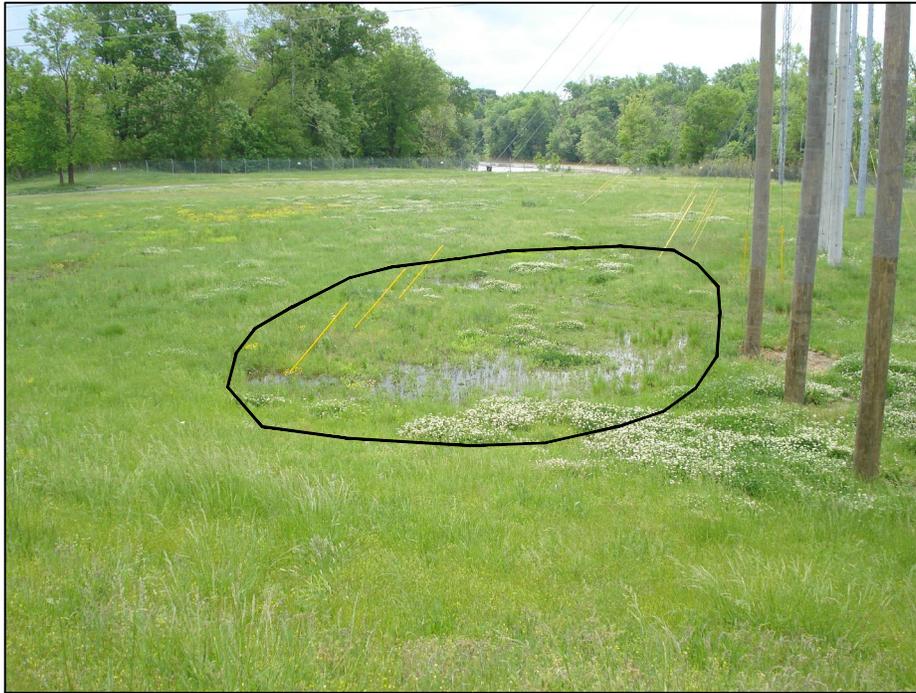
1-31

WATER ALONG SOUTHERN DIKE OF DOWNSTREAM TOE

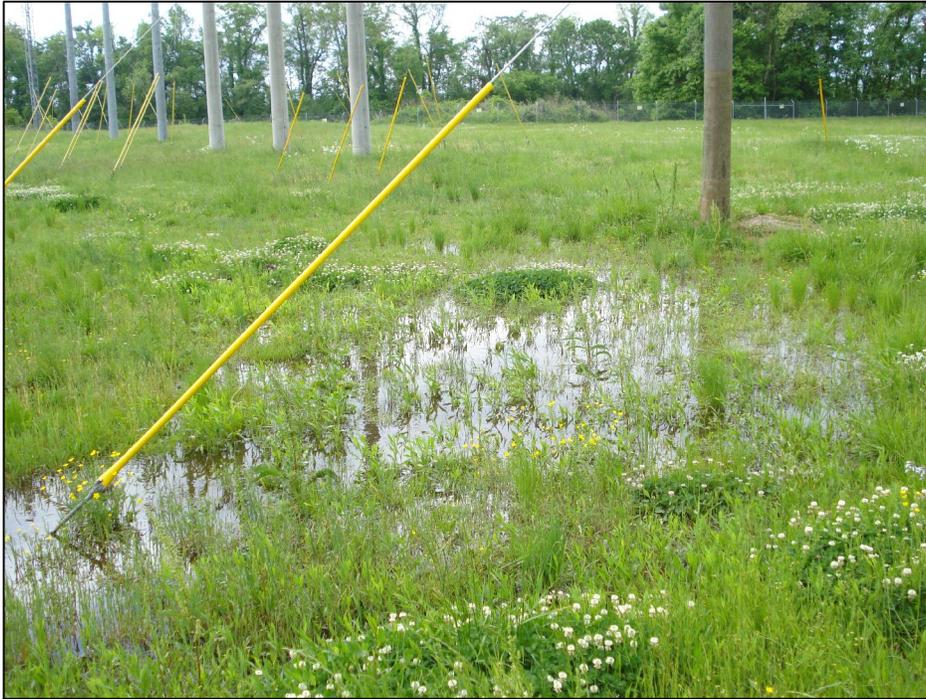
1-35

WATER ALONG SOUTHERN DIKE OF DOWNSTREAM TOE

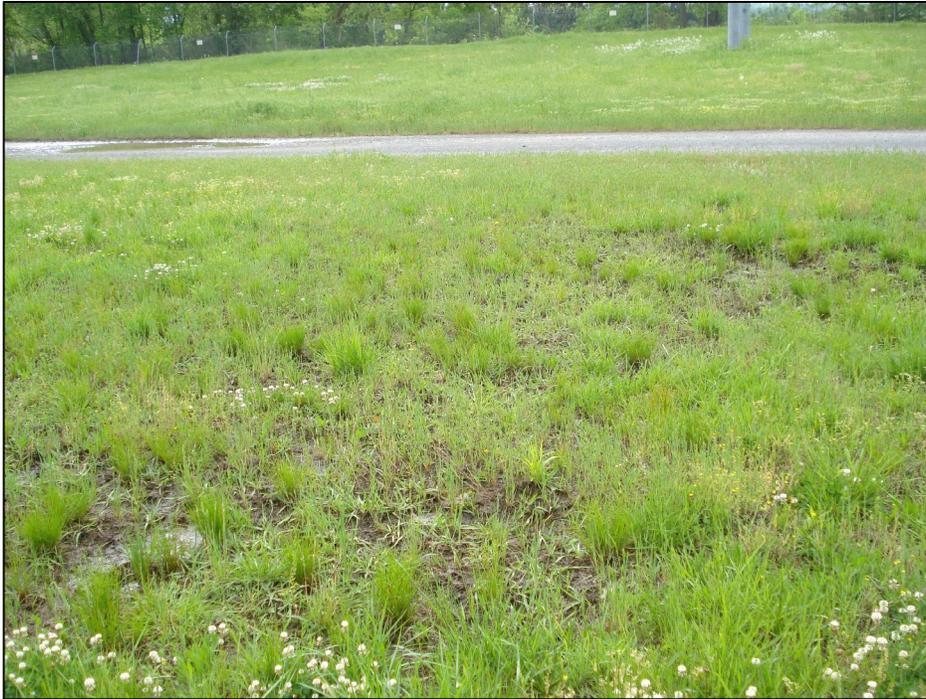
1-36

WET AREA ALONG SOUTHERN DOWNSTREAM TOE

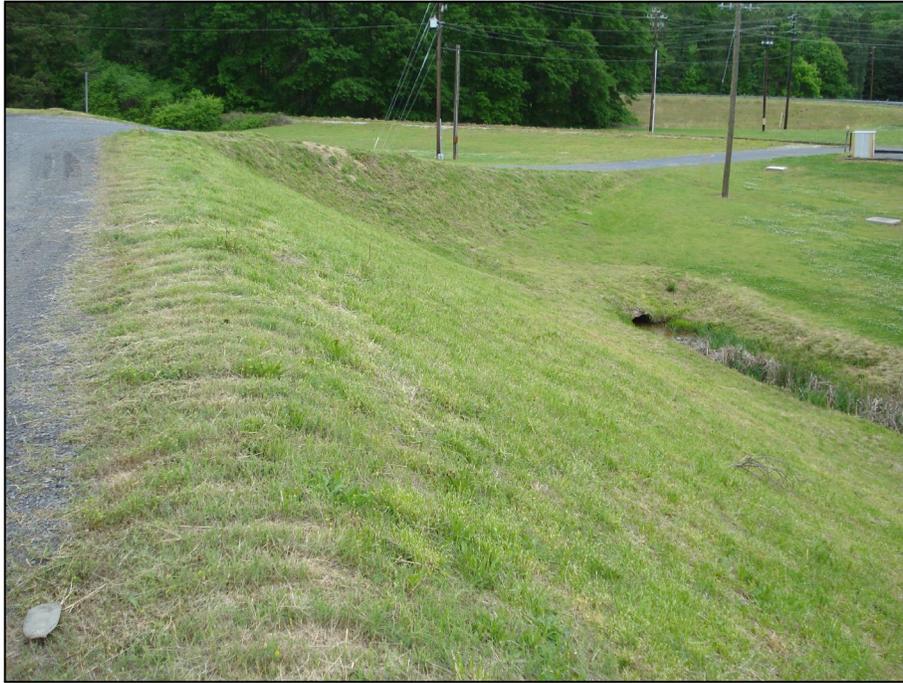
A drainage ditch was noted along the northern downstream toe (photos 2-7 and 2-48). Additionally, a ditch-like area referred to by Georgia Power personnel as an “unnamed creek” was located along the northern downstream toe in the vicinity of the drainage ditch (photos 2-9, 2-10, 2-12, 2-46, and 2-47).

DRAINAGE DITCH ALONG NORTHERN DOWNSTREAM FACE

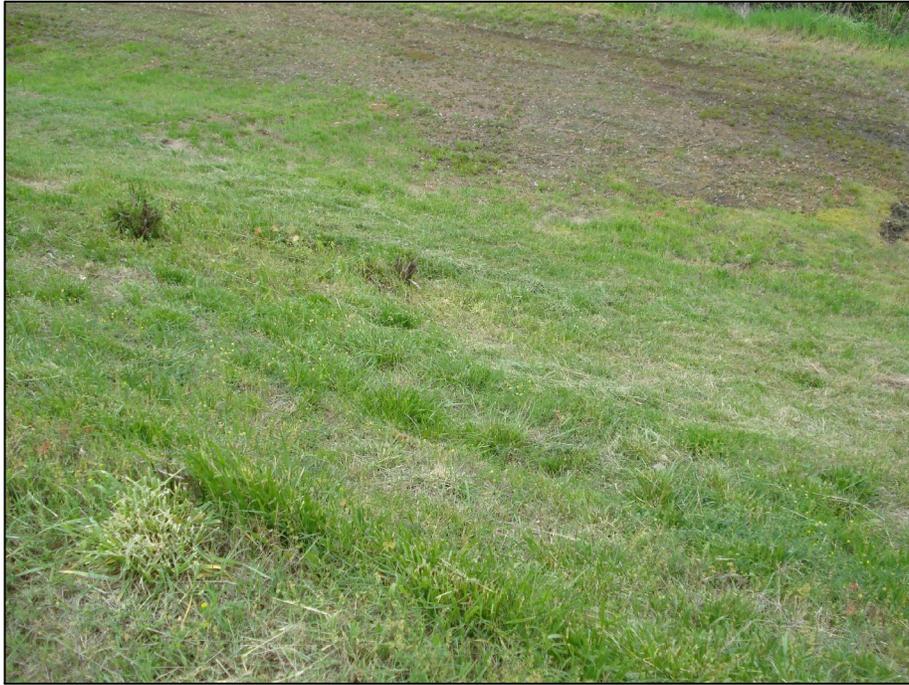
2-23

An uneven ground surface, which consisted of bulges and depressions, was noted along the northern and western downstream slope (photos 2-11, 2-21, 2-22, and 2-23). Steep slopes and sloughing were observed along the southern downstream slope (photos 2-30 through 2-35). Gravel had been placed along the downstream toe at some of these locations (photos 2-27 and 2-29). Cracks were visible in the haul road that runs parallel to the southern dike and functions as the access road to Ash Pond 4 (photos 2-36 and 2-37).

UNEVEN GROUND SURFACE AREAS ALONG WESTERN DOWNSTREAM SLOPE

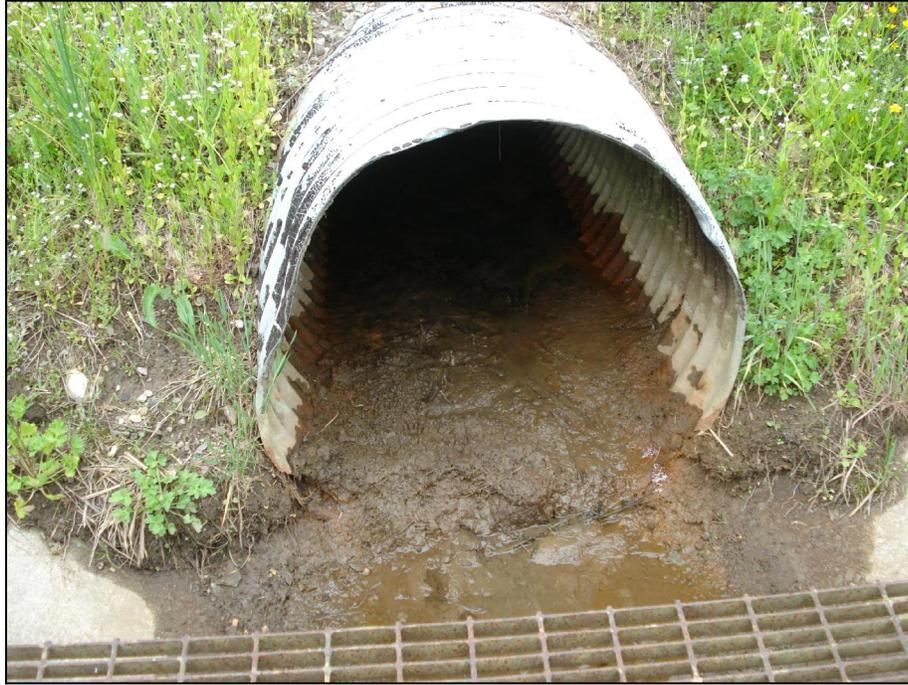
The inactive primary outlet (photos 3-9 and 3-10) and emergency outlet (photos 3-23, 3-25 and 3-29) were observed along the western and northeastern sides of the pond, respectively.

3-29
EMERGENCY OVERFLOW OUTLET

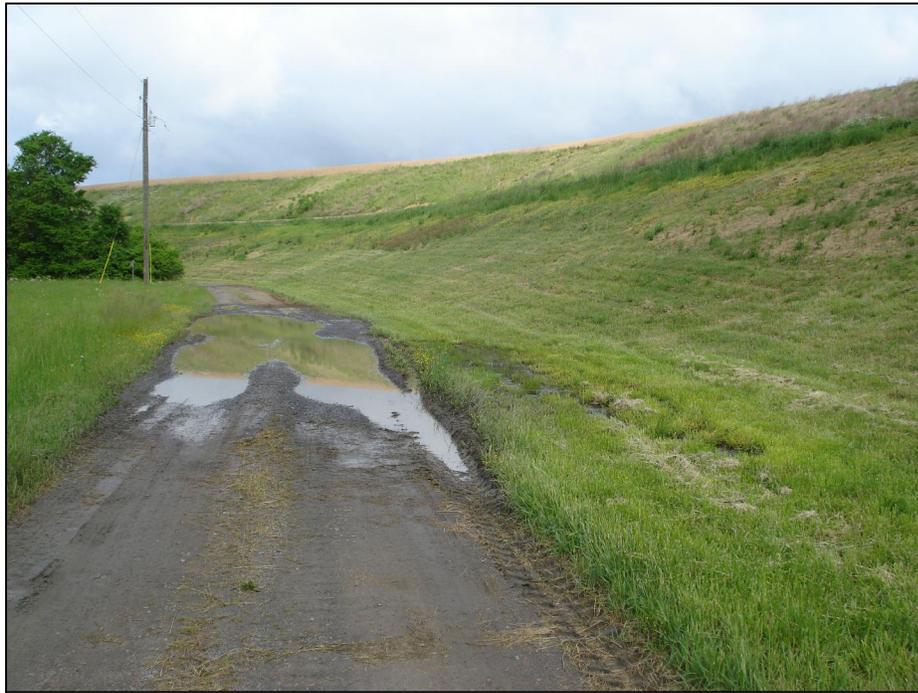
4-5

WATER AT BASE OF SOUTHERN DOWNSTREAM TOE

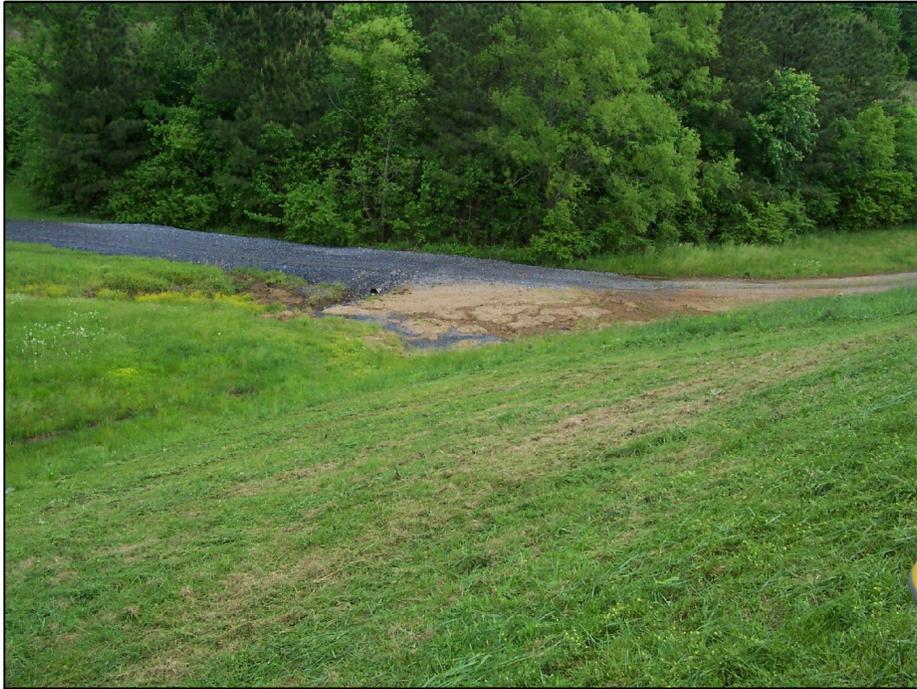
4-37

UNEVEN GROUND SURFACE AREA ALONG WESTERN DOWNSTREAM SLOPE
