**Coal Combustion Residue Impoundment
Round 9 - Dam Assessment Report**

Plant Kraft

Ash Dikes

Georgia Power Company
Port Wentworth, Georgia

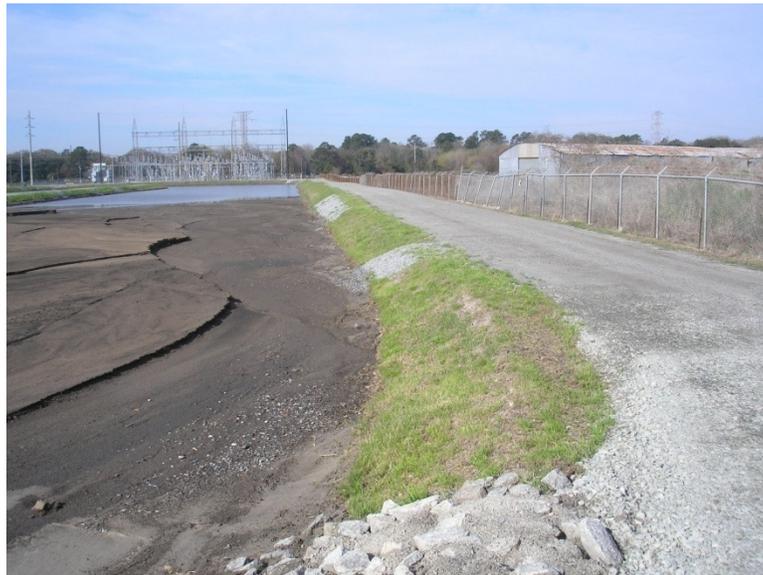
Figure 5.2-1: Embankment Crest on North Side of CCR Impoundment

The crest of the CCR impoundment embankment had no signs of depressions, tension cracks, or other indications of failure. Previous inspection reports reviewed by Dewberry did not indicate issues concerning the crest. Figure 5.2 – 1 shows the condition of the embankment crest.

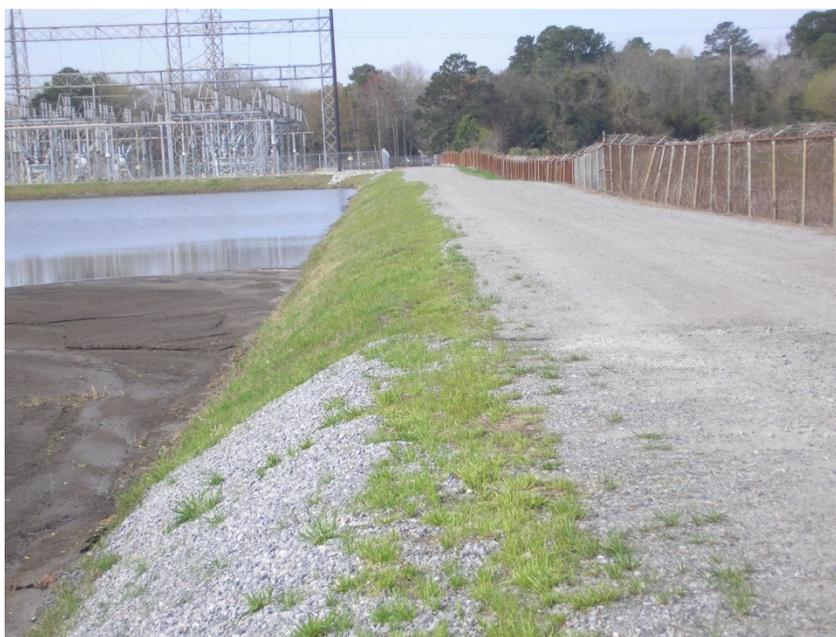
Figure 5.3-1: Inside Slope of Embankment on North Side of Impoundment

The inside slope of the embankment is covered with grass vegetation. There were no observed scarps, sloughs, bulging, cracks, depression, or other indications of slope instability or signs of erosion. Areas of the inside slope impacted by surface runoff across the crest have been armored by the addition of small riprap. Figure 5.3-1 shows the general condition of the slope and an area to which riprap protection has been added.

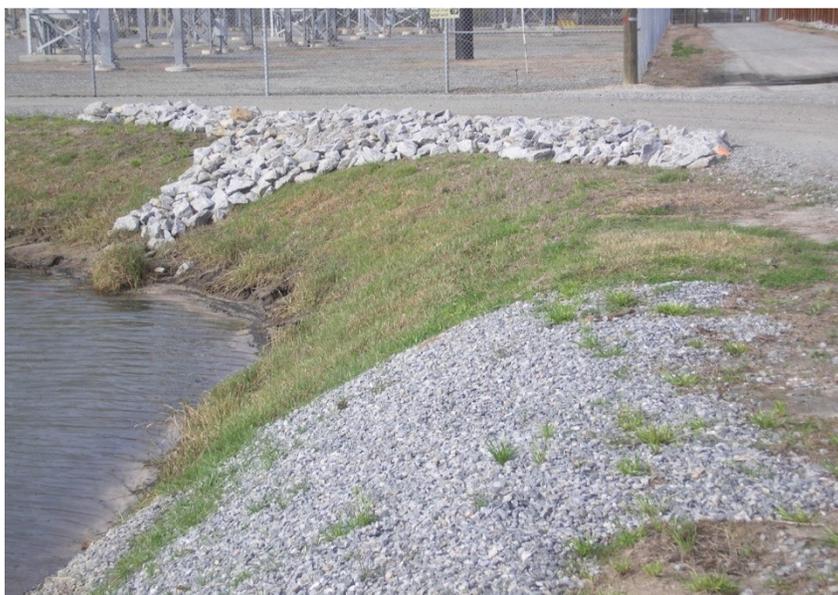
Figure 5.5-1: Groin Area in Northwest Corner of Embankment

Erosion or uncontrolled seepage was not observed along embankment groins. Embankment groins on the north side of the CCR impoundment have had riprap added to protect against erosion caused by surface runoff across the embankment crest.

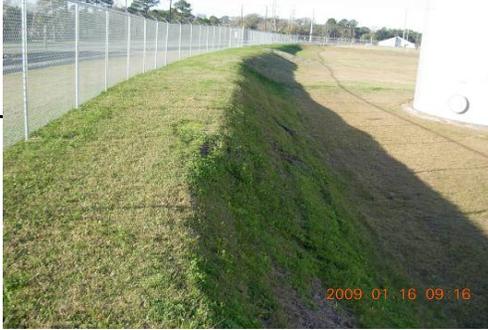
Location No. Photo No.	Description	Photo
289 2839	Oil tank containment dike (looking west) Inside slope. There is some damage to the grass from mowers.

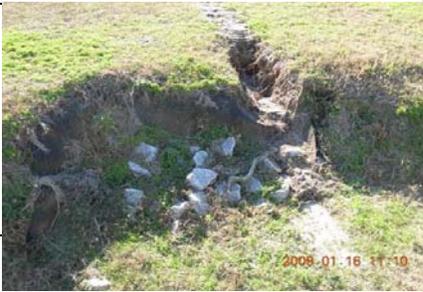
Location No. Photo No.	Description	Photo
301 2862	Eroded area at termination of plastic down drain. The pipe should be put back in place. These oversteep slopes should be laid back to a reasonable slope, then grassed, fertilized and mulched. A splash pad for the down drain outlet should be constructed. This could be made of sand-cement bags or of riprap on a bed of gravel.

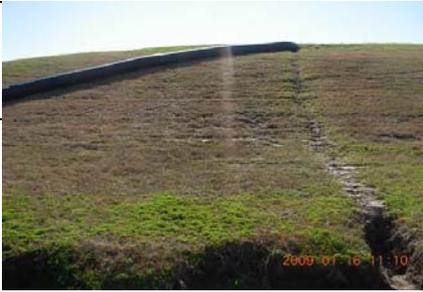
301 2863	The large black plastic down drain has been moved, probably to facilitate mowing, and has not been replaced. This could lead to erosion in the event of rain.

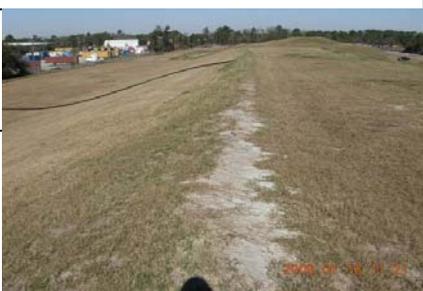
304 2867	Damage to berm on top of landfill due to mower scalping. This could lead to serious erosion problems if not corrected.

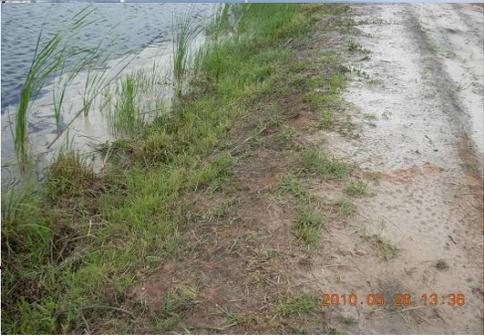
Photo No.	Description	Photo
3904	The mower has scalped the edge of the crest here, while leaving vegetation high near the water. There is a high potential for mowers to do more harm than good. This area will need to be reseeded, fertilized and mulched. Improper mowing does more harm than good.

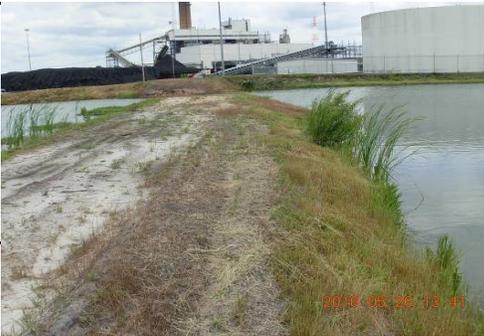
2010.05.26 13:36
3905	As in the photo above, the mower has scalped the edge of the crest while leaving tall vegetation near the water. The tall vegetation, in this case willows, should be cut down and the stumps poisoned. Woody vegetation will degrade earth structures.

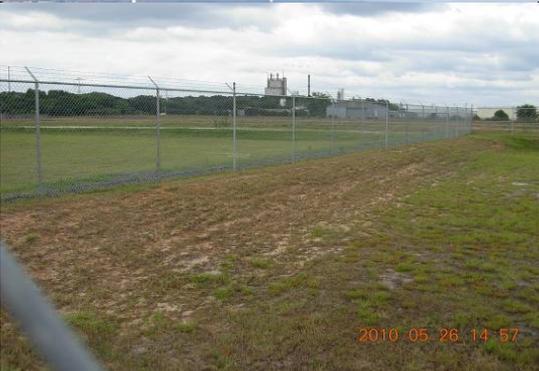
Photo No.	Description	Photo
3915	This slope needs grass seed, fertilizer and gentle mowing in order to develop a good stand of grass.
