Report of Geotechnical Assessment  
Dam Safety of Coal Combustion Surface  
Impoundments  
Plant McDonough, Smyrna, GA

AMEC Project No. 3-2106-0174.0100

June 2010

The management unit referenced herein: Southern Company, Georgia Power, Plant McDonough: Ash Pond 1, Ash Pond 2, Ash Pond 3, Ash Pond 4; was assessed on April 28<sup>th</sup>, 2010.

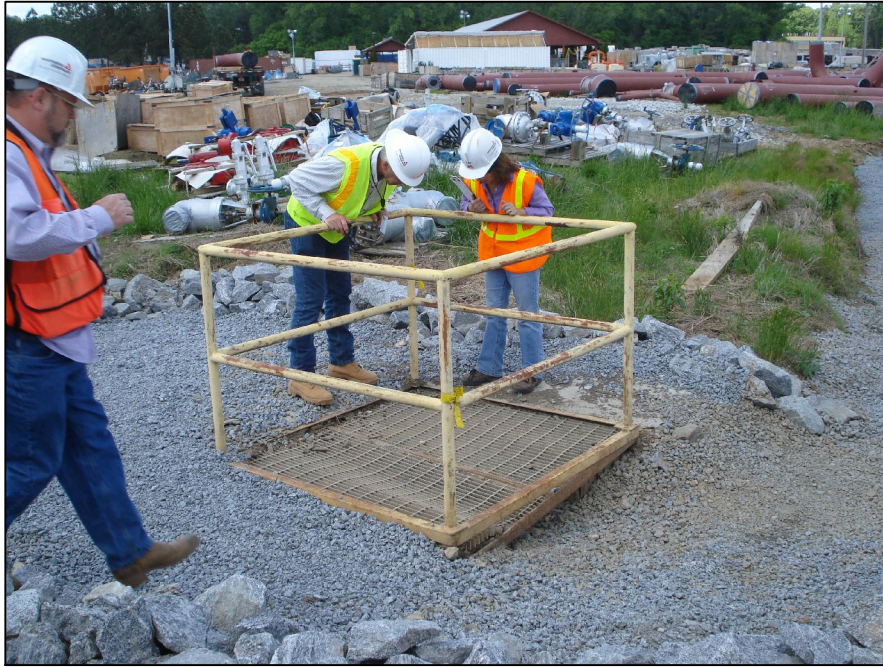
**1-1**  
**PRIMARY SPILLWAY INLET**

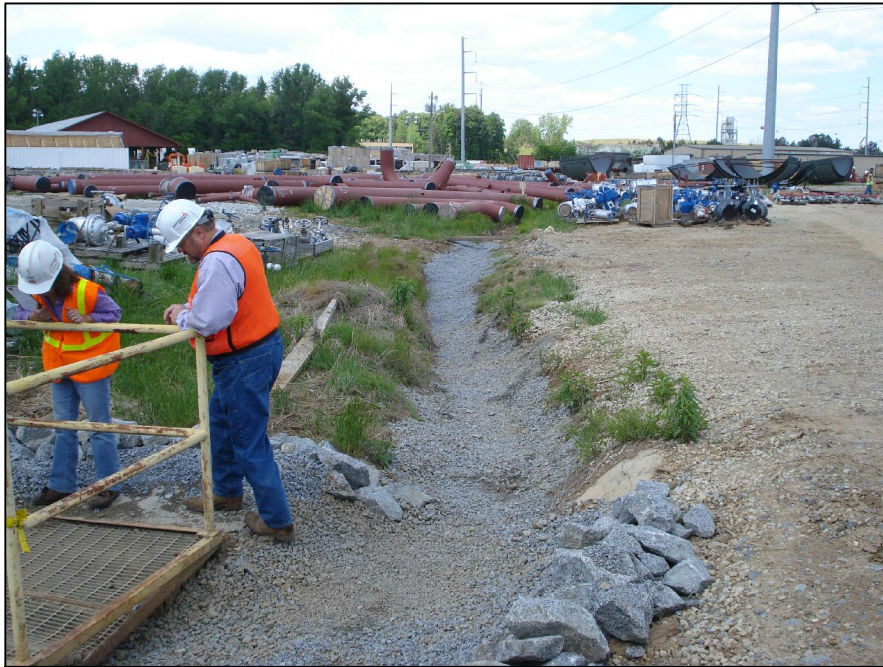
**1-2**  
**PRIMARY SPILLWAY INLET**

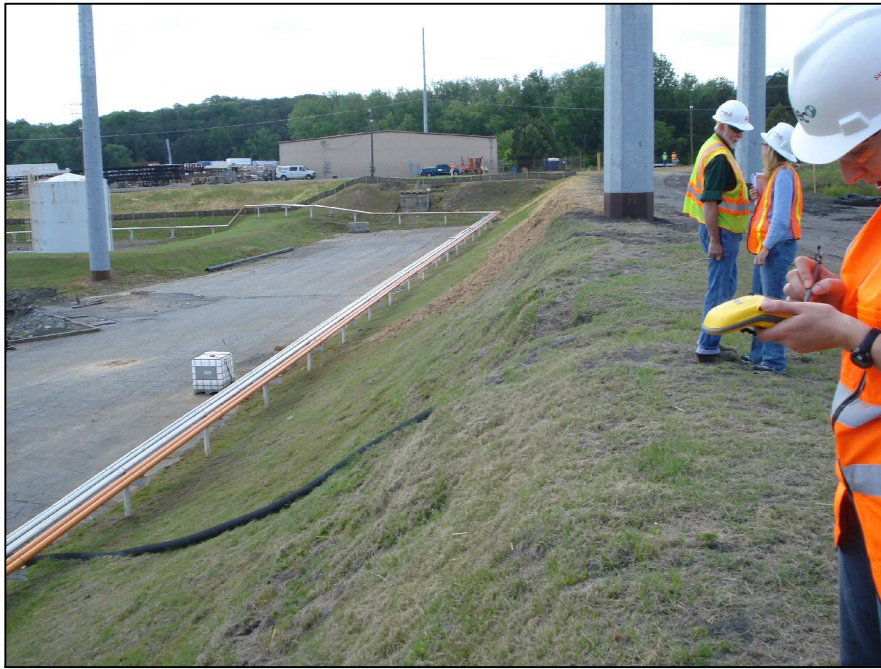
**2-1**

Ash Pond 2 has a side-hill configuration along the southern and eastern dikes, but is incised along the remainder of the structure. Ash Pond 2 has a 16-foot high embankment with a pool area of 6.5 acres. At the time of the site visit, the freeboard was approximately 2 feet. Currently, the pond is primarily dry and is partially used as a dewatering and processing area. Steep slopes and an uneven ground surface, which consisted of minor bulges and depressions, were noted along the southern slope (photo 2-1). The dikes appeared to be maintained and mowed at the time of the site visit.

**STEEP SLOPE/UNEVEN GROUND SURFACE ALONG EASTERN DIKE**

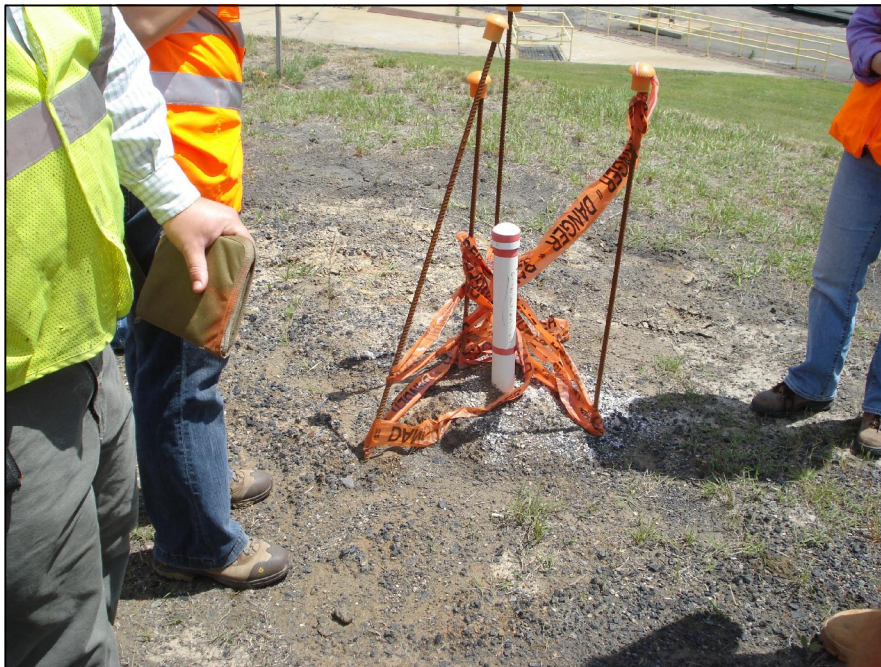
**2-2**

**TEMPORARY PIEZOMETERS AP2-2**

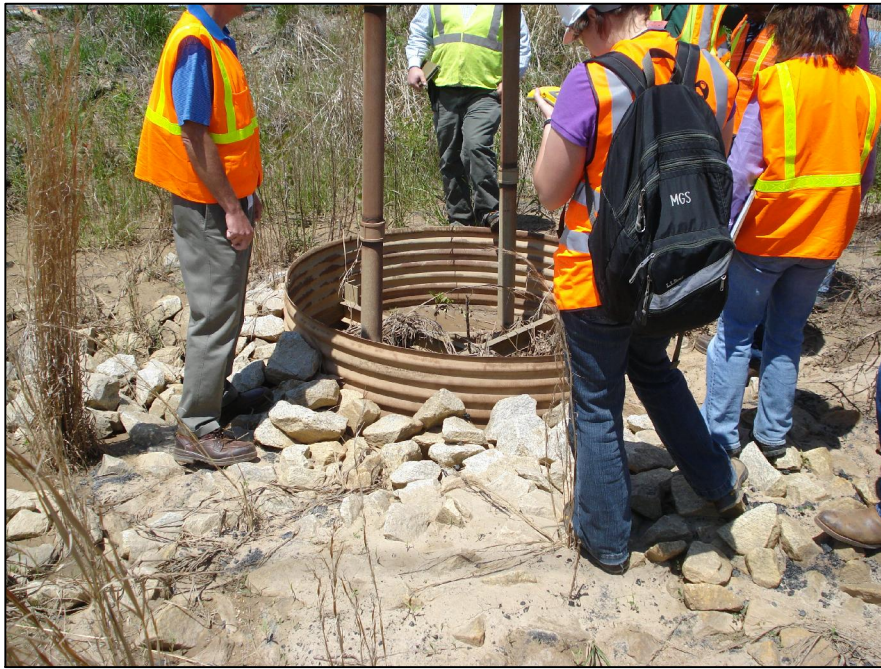
The original primary discharge structure does not currently discharge decant flow for Ash Pond 3. The structure, a 36-inch vertical CMP riser connected to a 24-inch diameter CMP, was observed along the southeastern portion of the pond (photo 3-1) and discharges to an incised sediment basin (Figure 2) for newly constructed plant facilities. The outlet pipe was observed to be unobstructed, however it appeared to have been recently damaged by construction equipment (photo 3-5). The original design of Ash Pond 3 included an open channel spillway at the northeast corner of the impoundment. That structure has subsequently been changed to a culvert at the end of the "S" channel, which discharges into Ash Pond 4. The current primary flow outlet from Ash Pond 3 is the serpentine channel that discharges directly into Ash Pond 4. This channel forms a direct hydraulic connection between the two ponds. There is at least one roadway, with an associated flow through culvert, at about the midway point of the channel's flow path. Neither the channel nor the culvert capacities are known. Although the NPDES Process Flow Diagram does not indicate that Ash Pond 3 has an emergency overflow discharge, the site visit and historical construction drawings indicate that a trapezoidal channel located between Ash Ponds 3 and 4 (and indicated as the emergency discharge for Ash Pond 4) may function as some type of emergency discharge for Ash Pond 3 as well.

**3-1**  
**PRIMARY OUTLET**

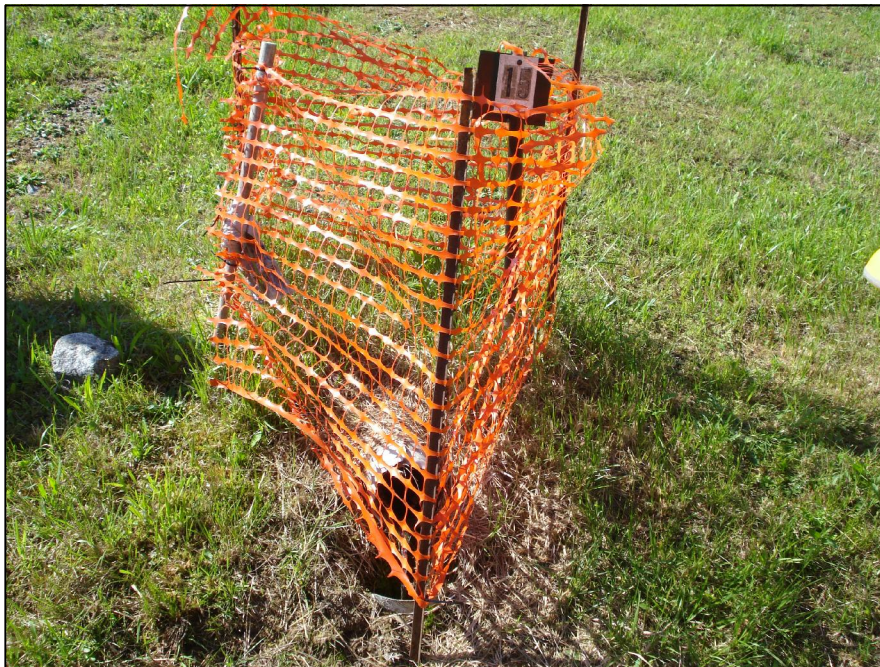
A total of 19 lateral drains are located along the embankment of Ash Pond 4, see Figure 5 for drain locations. During the site inspection Drain 15 was noted to be flowing, which according to on-site personnel, is typical. Additionally, two weirs (east and west weir) are located at the downstream toe of the north end of the embankment. The most current quarterly report provided (dated January 8, 2010) stated that flows for the two weirs has remained close to or slightly below their historical range. In regards to the drains, flow for Drain No. 1 increased significantly during and following slope modifications and road reconstruction along the south dike in June 2009. Drain 1 was rebuilt to capture the additional seepage that resulted from the work on the south dike. Flow for Drain 15 increased close to historic levels, which is expected to be a result of heavy rainfall during the fall months.

**4-2**  
**DRAIN NUMBER 15 (FLOWING) ALONG WESTERN DOWNSTREAM TOE**

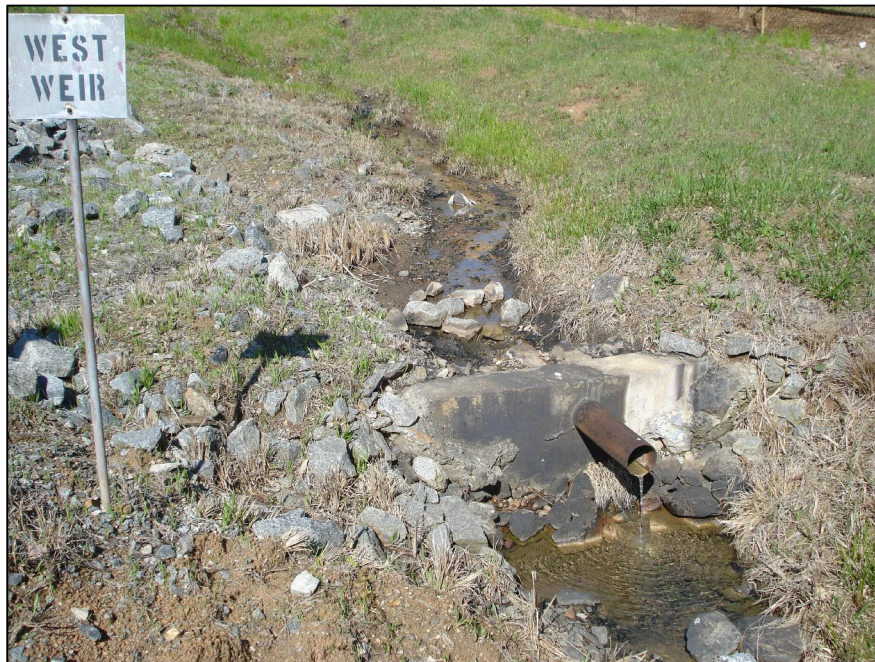
**4-3**

Ash Pond 4 is a 68 foot high, earthen embankment, with a 41 acre pool area. A freeboard of approximately 10 feet was noted during AMEC's site visit (photo 4-10). The dikes appeared to be maintained and mowed. The dam was designed with an internal drainage system and the outlets were observed to be working; sediment free water was noted to flow out of several of the drains. A total of 19 lateral drains are located along the embankment of Ash Pond 4. During the site inspection Drain 15 was noted to be flowing (photo 4-2), which according to on-site personnel, is typical. Additionally, two weirs (east and west weir) are located at the downstream toe of the north end of the embankment (photo 4-3).

**WEST WEIR ALONG WESTERN DOWNSTREAM TOE**

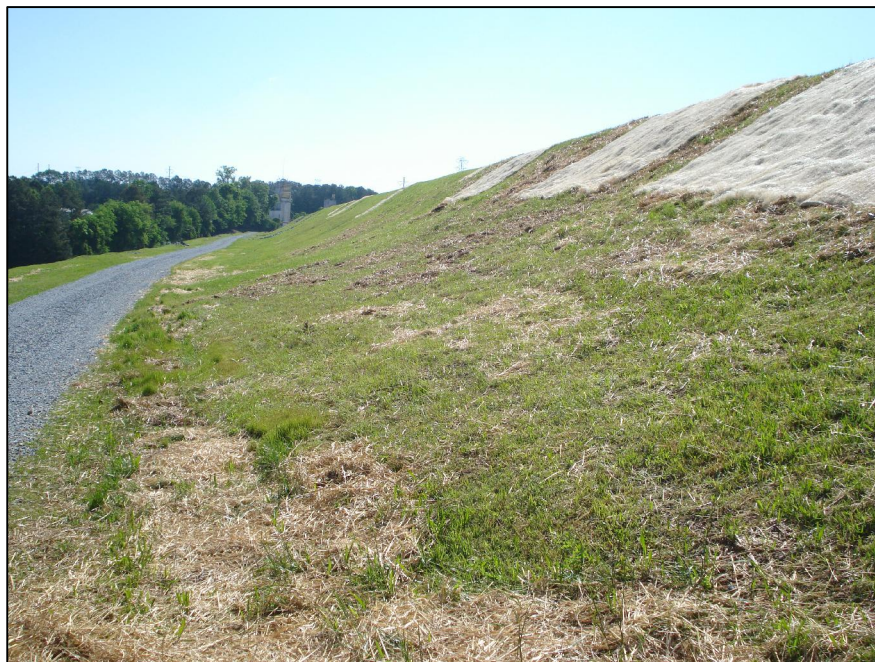
**4-4**

Several locations along the eastern downstream face lacked vegetation; however, reseeding efforts were in progress during the site visit (photos 4-4). Additionally, a bulge was noted along the eastern downstream crest. Site personnel explained that the bulge had been noted previously and had not changed for several years.

**RESEEDED AREA ALONG WESTERN DOWNSTREAM TOE**

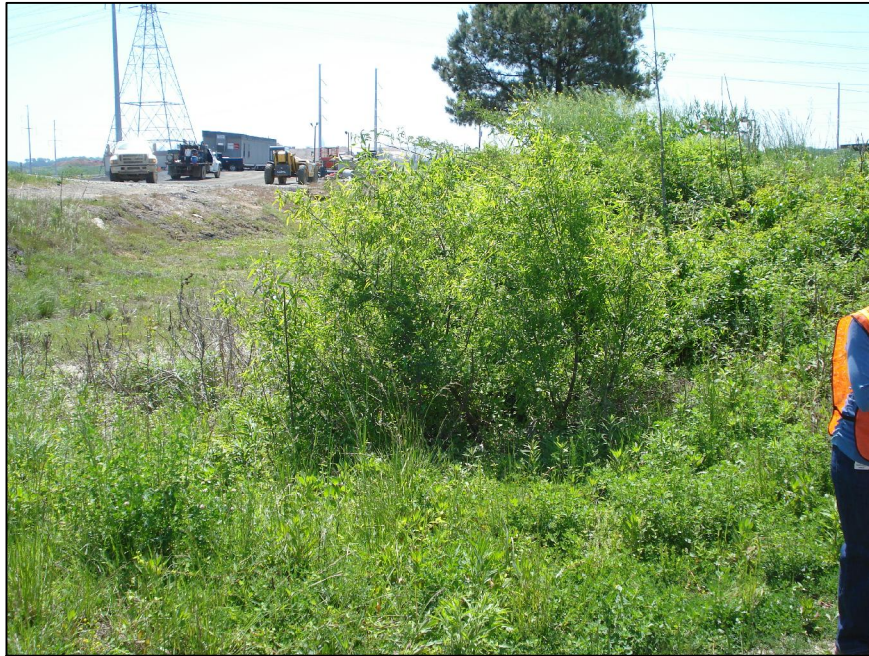
**4-9**

A trapezoidal, open channel emergency spillway is located along the northwestern corner of the pond and was dry at the time of the site visit. The spillway was measured and found to be approximately 4 feet deep, with approximate top and bottom widths of 47 feet and 15 feet, respectively. The earthen trapezoidal channel carries flow to a 48-inch vertical inlet with a 36-inch diameter CMP outlet pipe. There were no connective elevations, flows, or hydraulic calculations in the provided documentation to identify the controlling hydraulic structure at this location, but it would appear to be the control section of the emergency spillway. According to the NPDES Process Flow Diagram, the emergency discharge from Ash Pond 4 is tributary to the Coal Pile Runoff Pond, located south of Ash Pond 2. The spillway was noted to have some overgrown vegetation (photo 4-9).

**OVERGROWN EMERGENCY OVERFLOW**

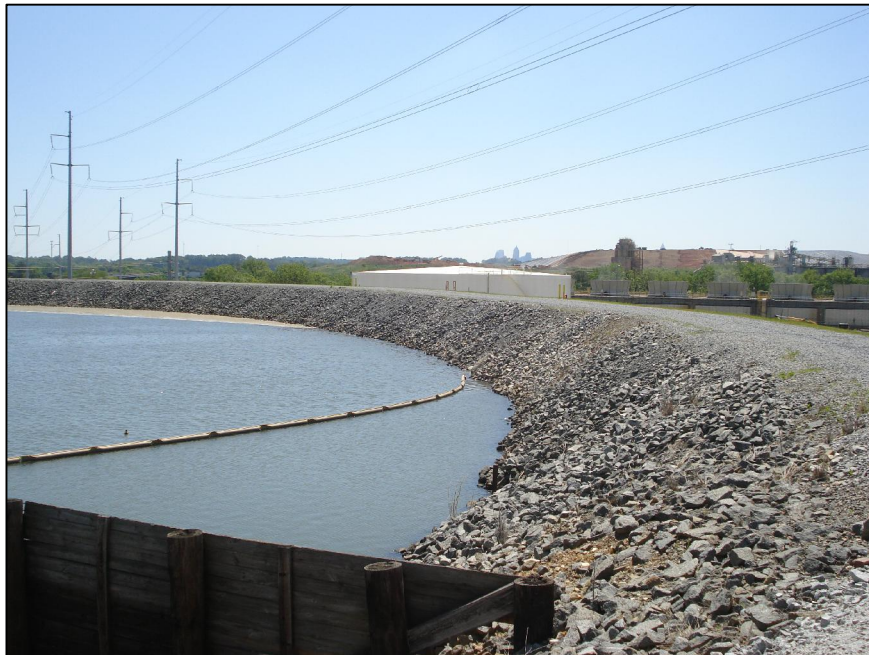
**4-10**

**CURRENT FREEBOARD**
