Report of
Dam Safety Assessment of Coal Combustion
Surface Impoundments
Plant McDonough, Smyrna, GA

AMEC Project No. 3-2106-0174.0100

December 2010

The management units referenced herein: Southern Company, Georgia Power, Plant McDonough: Ash Pond 1, Ash Pond 2, Ash Pond 3, and Ash Pond 4; were assessed on April 28th, 2010.

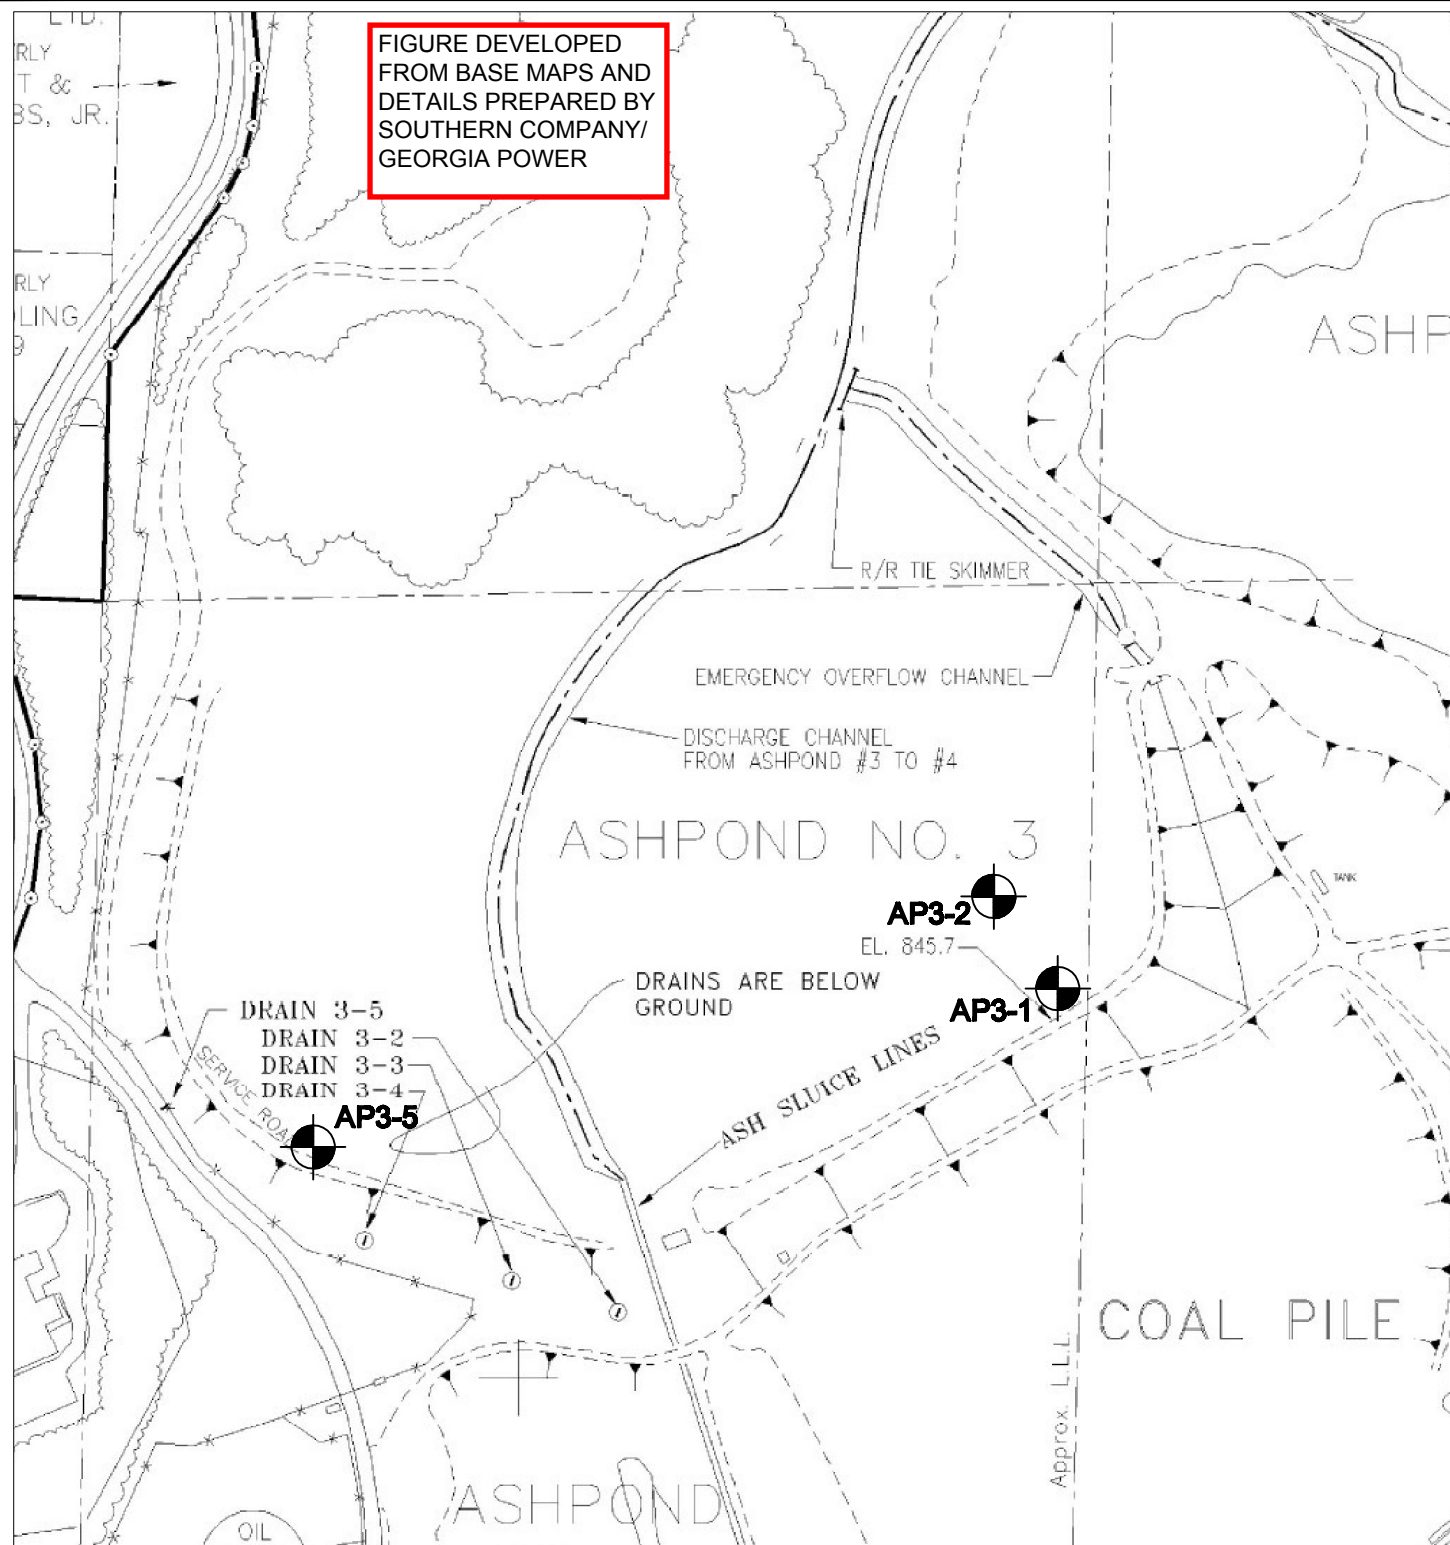
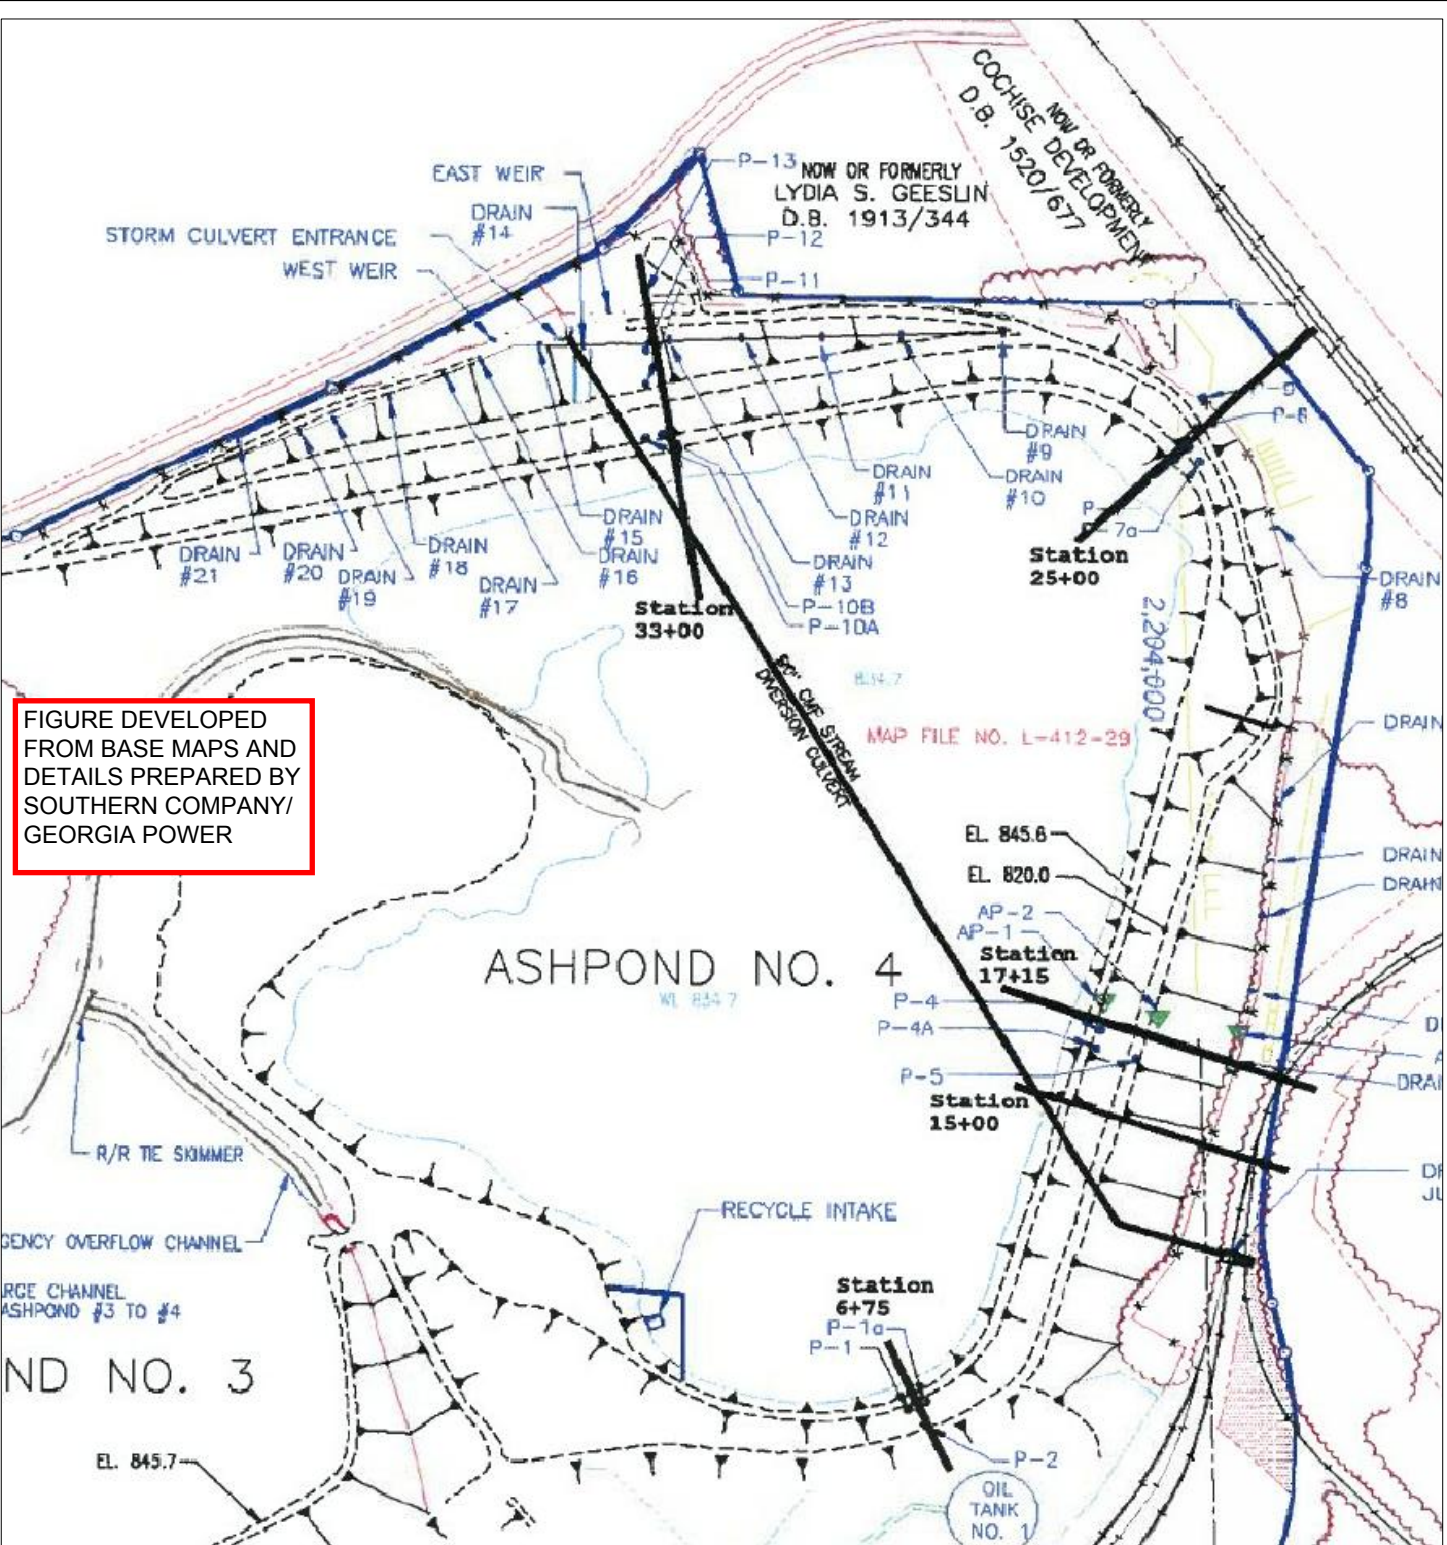
DATE: 6/2/10
 PROJECT NO: 3-2106-0174.0100
 REV. NO:
 FIGURE No: 5

Axial and lateral drains are present in Ash Pond 3; see Figure 5 for drain locations. As illustrated by “Plant McDonough-Atkinson Site Surveillance Map” dated January 4, 1996, four lateral drains (drains 3-2, 3-3, 3-4, and 3-5) are present along the southern and southwestern downstream toe. Station numbers for these drains were not provided. During the site visit, lateral drain 3-3 was noted to be flowing, which was typical according to on-site personnel. It was observed that on drawing “Plant Jack McDonough/Atkinson Ash Pond Details of Underground Drainage” dated May 12, 1969, additional 6 to 8-inch CMP lateral drains are indicated to be present at stations 14+85, 15+85, and 16+85 along the southwestern toe, however these drains do not appear on the later 1996 drawing.

A total of 19 lateral drains are located along the embankment of Ash Pond 4, see Figure 5 for drain locations. During the site inspection Drain 15 was noted to be flowing, which according to on-site personnel, is typical. Additionally, two weirs (east and west weir) are located at the downstream toe of the north end of the embankment. The most current quarterly report provided (dated January 8, 2010) stated that flows for the two weirs has remained close to or slightly below their historical range. In regards to the drains, flow for Drain No. 1 increased significantly during and following slope modifications and road reconstruction along the south dike in June 2009. Drain 1 was rebuilt to capture the additional seepage that resulted from the work on the south dike. Flow for Drain 15 increased close to historic levels, which is expected to be a result of heavy rainfall during the fall months.

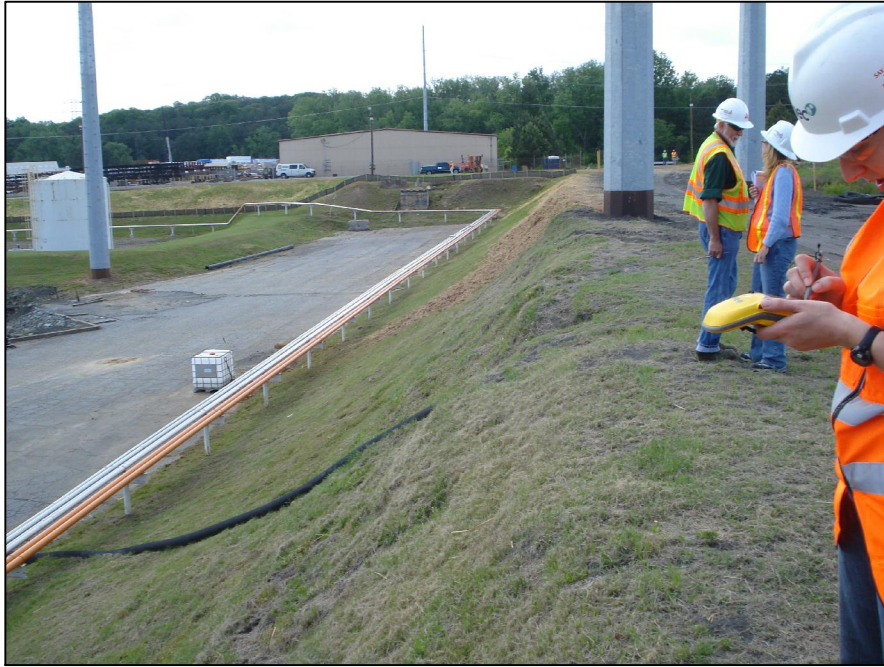
2-1

STEEP SLOPE/UNEVEN GROUND SURFACE ALONG SOUTH DIKE

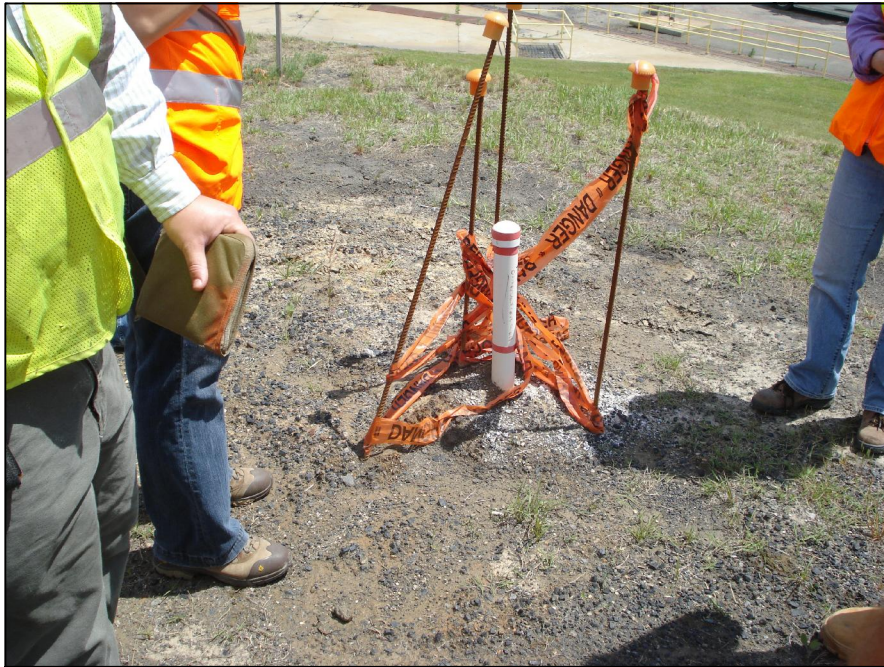
2-2

TEMPORARY PIEZOMETERS AP2-2

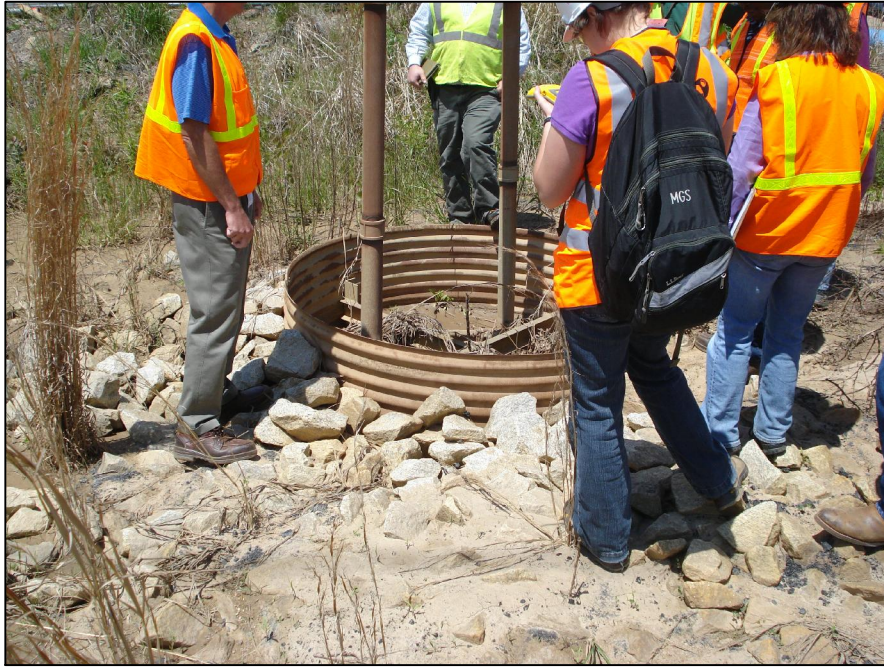
3-1

The original primary discharge structure does not currently discharge decant flow for Ash Pond 3. The structure, a 36-inch vertical CMP riser connected to a 24-inch diameter CMP, was observed along the southeastern portion of the pond (photo 3-1) and discharges to an incised sediment basin (Figure 2) for newly constructed plant facilities. The outlet pipe was observed to be unobstructed, however it appeared to have been recently damaged by construction equipment (photo 3-5). Georgia Power reports that use of this pipe was discontinued in 2009 and the flow redirected to a nearby sedimentation basin; the damaged pipe was removed after the AMEC site visit in 2010.

SECONDARY OULET (FORMERLY PRIMARY DISCHARGE STRUCTURE)

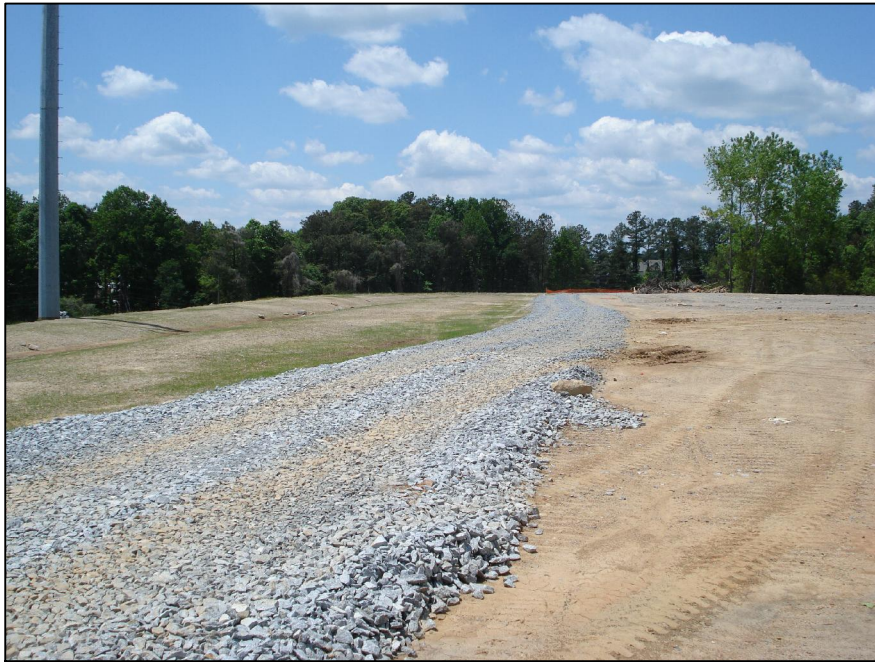
3-3
GRASSY AREAS RESEEDED ON DIKE

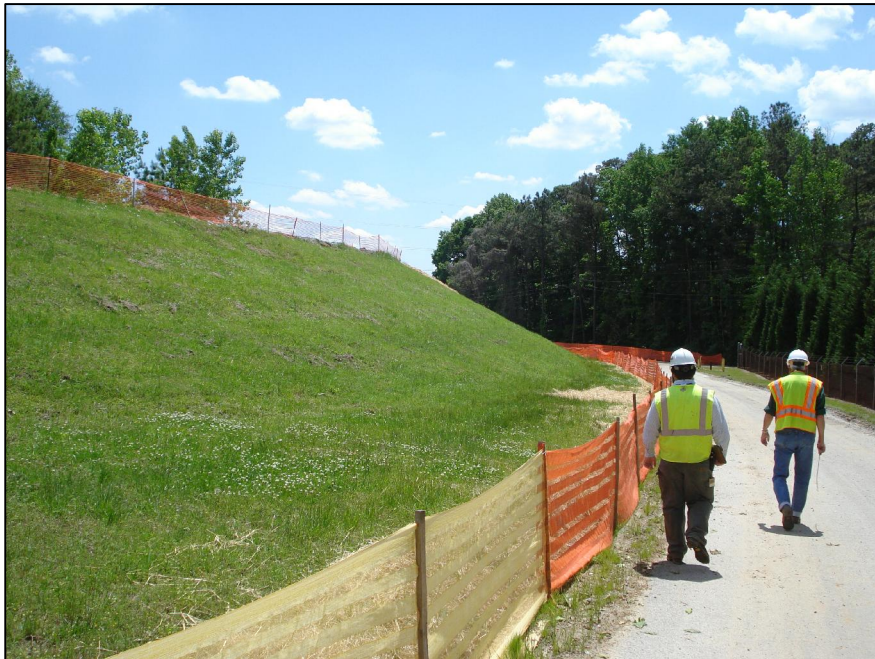
Ash Pond 3 has a side-hill embankment 39 feet high and an original pond area of 23 acres. The dikes appeared to be maintained and mowed (photo 3-4). Axial and lateral drains are present in Ash Pond 3. Four lateral drains are present along the southern and south-western downstream toe. Station numbers for these drains were not provided. During the site visit, lateral drain 3-3 was noted to be flowing, which was typical according to on-site personnel. Drawings indicate axial drains are present along the southern and south-western downstream toe. Ash Pond 3 has a functional drop inlet decant. The western side of the pond embankment faces Maner Rd SE; residential and business neighborhoods are present west of the dam.

3-4
GENERAL SITE PHOTO

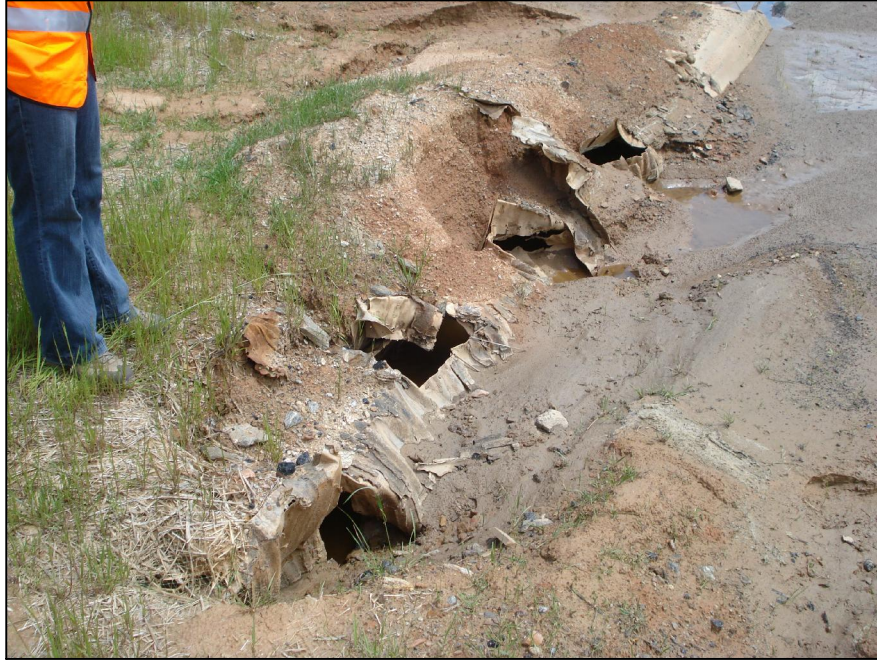
3-5

FORMER OUTLET FROM PRIMARY SPILLWAY

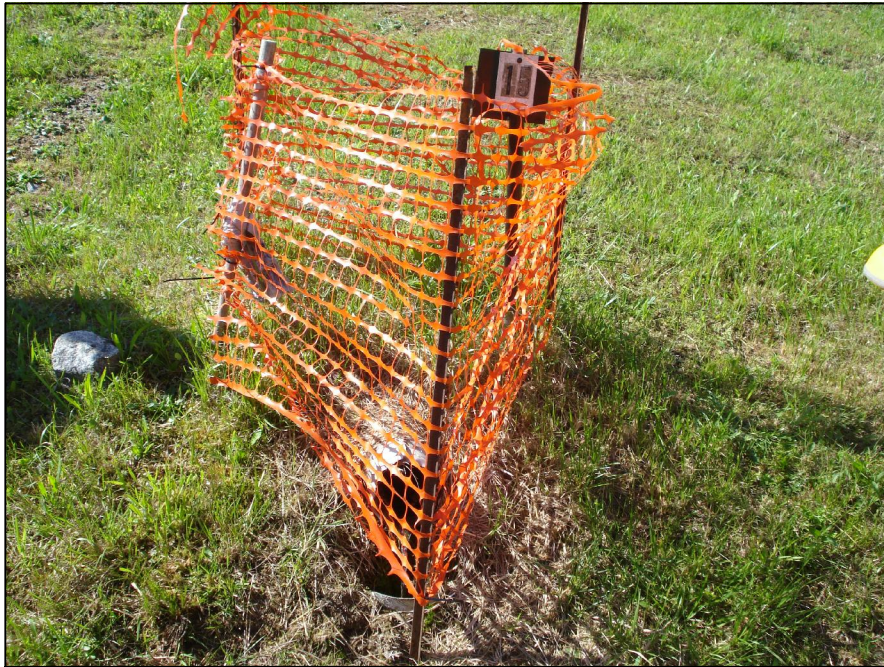
Pond 4. During the site inspection Drain 15 was noted to be flowing (photo 4-2), which according to on-site personnel, is typical. Additionally, two weirs (east and west weir) are located at the downstream toe of the north end of the embankment (photo 4-3).

4-2
DRAIN NUMBER 15 (FLOWING) ALONG WESTERN DOWNSTREAM TOE

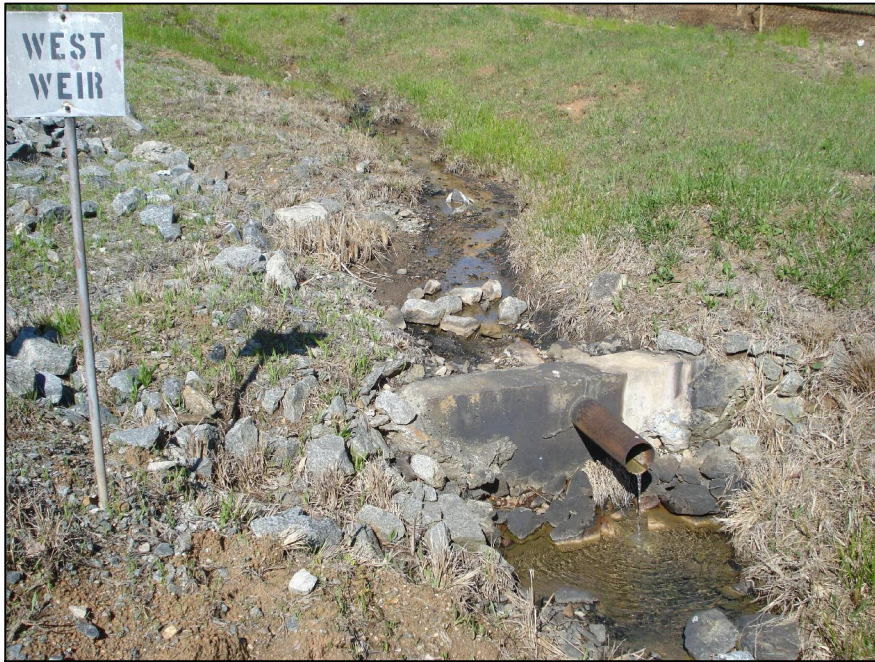
4-3

WEST WEIR ALONG WESTERN DOWNSTREAM TOE

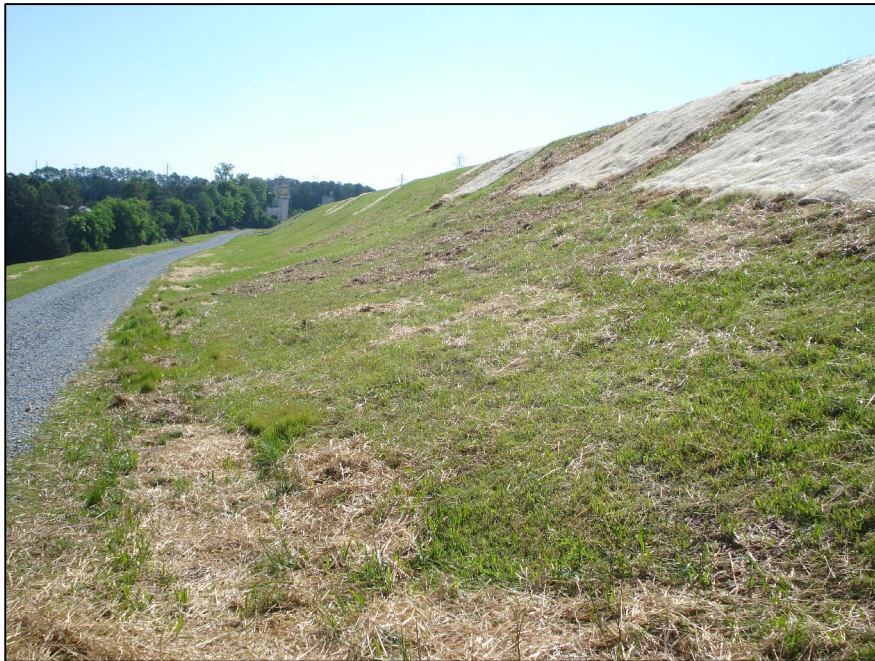
4-4

Several locations along the eastern downstream face lacked vegetation; however, reseeding efforts were in progress during the site visit (photos 4-4). Additionally, a bulge was noted along the eastern downstream crest. Site personnel explained that the bulge had been noted previously and had not changed for several years.

RESEEDED AREA ALONG WESTERN DOWNSTREAM TOE

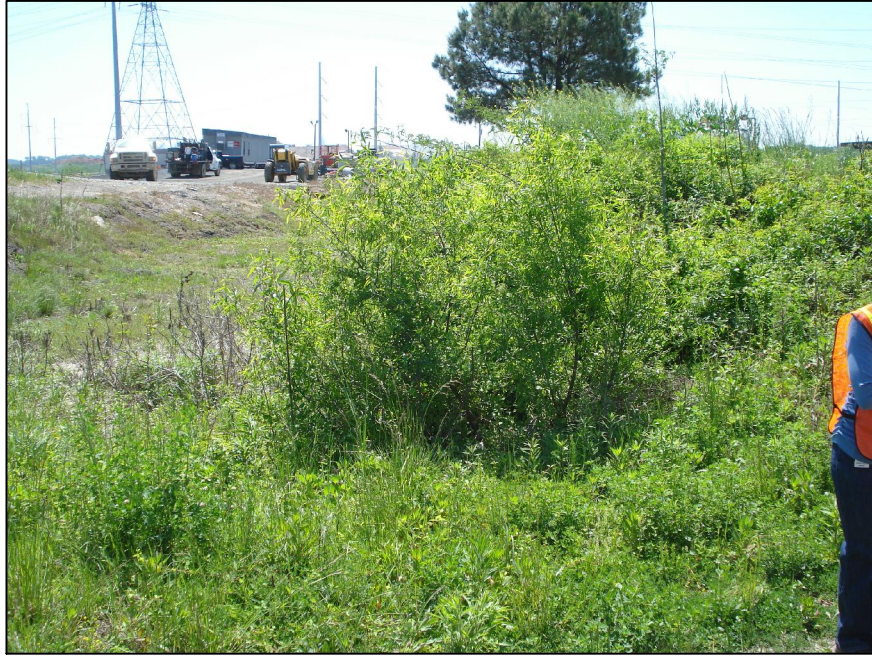
A trapezoidal, open channel emergency spillway is located along the northwestern corner of the pond and was dry at the time of the site visit. The spillway was measured and found to be approximately 4 feet deep, with approximate top and bottom widths of 47 feet and 15 feet, respectively. The earthen trapezoidal channel carries flow to a 48-inch vertical inlet with a 36-inch diameter CMP outlet pipe. There were no connective elevations, flows, or hydraulic calculations in the provided documentation to identify the controlling hydraulic structure at this location, but it would appear to be the control section of the emergency spillway. According to the NPDES Process Flow Diagram, the emergency discharge from Ash Pond 4 is tributary to the Coal Pile Runoff Pond, located south of Ash Pond 2. The spillway was noted to have some overgrown vegetation (photo 4-9) at the time of AMEC's inspection. Georgia Power reports that the vegetation was subsequently removed.

4-9
OVERGROWN EMERGENCY OVERFLOW

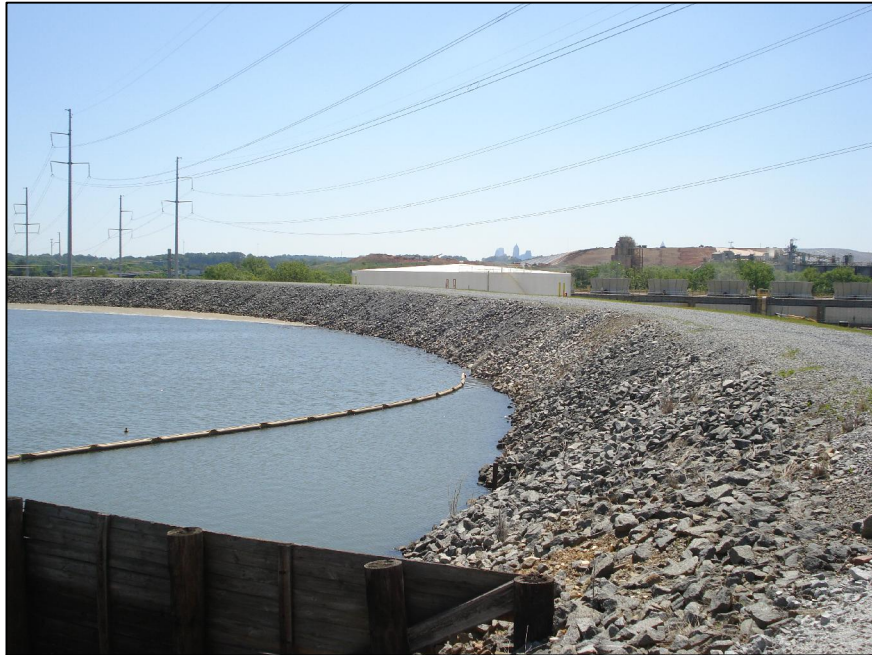
Ash Pond 4 has a 68-foot high earthen embankment, with an original pond area of 41 acres. A freeboard of approximately 10 feet was noted during AMEC's site visit (photo 4-10). The dikes appeared to be maintained and mowed. The dam was designed with an internal drainage system and the outlets were observed to be working; sediment free water was noted to flow out of several of the drains. A total of 19 lateral drains are located along the embankment of Ash

4-10
CURRENT FREEBOARD
