Report of Geotechnical Investigation  
Dam Safety Assessment of Coal Combustion  
Surface Impoundments  
Georgia Power  
Plant Mitchell, Albany, GA

AMEC Project No. 3-2106-0174.0600

June 2010

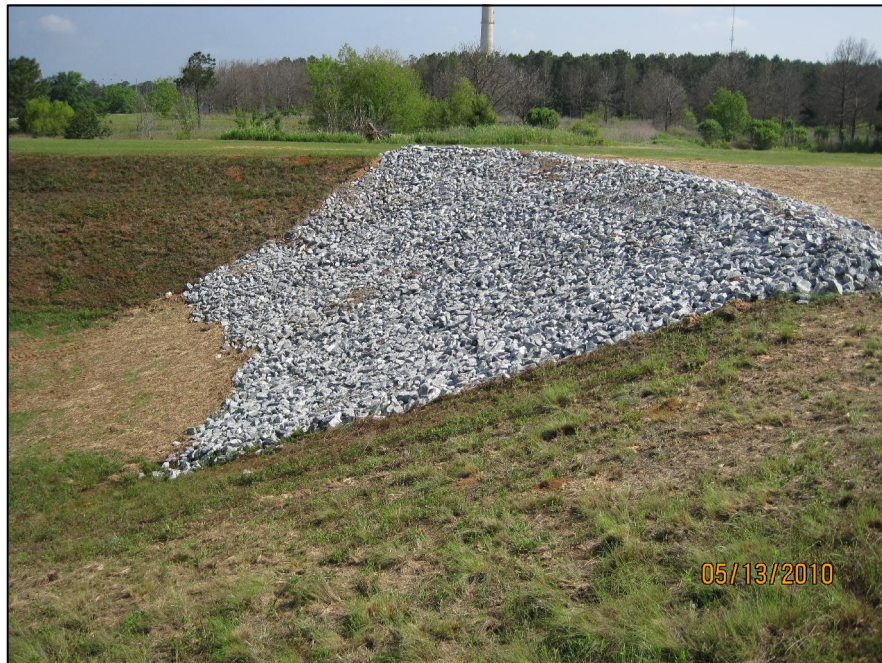
**1-4**

Although Ash Pond 1 was originally constructed as a separate unit, its southern dike was incorporated into the northern dike of Ash Pond 2, upon the construction of Ash Pond 2 in 1979. The common dike is grass covered on the upstream embankment and gravel on the crest (photos 1-1 and 1-2). The surface of the crest for Ash Pond 1 transitions to grass at the west end of the common dike (photo 1-3). The embankment at the west end of the common dike has been repaired from toe to crest with rip-rap (photo 1-4 and 1-5). At this groin location between Ash Pond 1 and 2, a 3-foot wide chimney drain, consisting of washed river sand, was installed to elevation 182 feet along the existing dike of Ash Pond 1. Seepage from the chimney drain flows into a 6-inch polyethylene (PE) pipe which is located two feet below natural ground surface and directs seepage to Drain Outlet 1 (photos 1-4, 1-5). The drain does not appear to run the length of the common dike.

**REPAIRED (RIP-RAP) EROSION RILLS AT WEST END COMMON DIKE (DRAIN OUTLET D1 TO LEFT)**

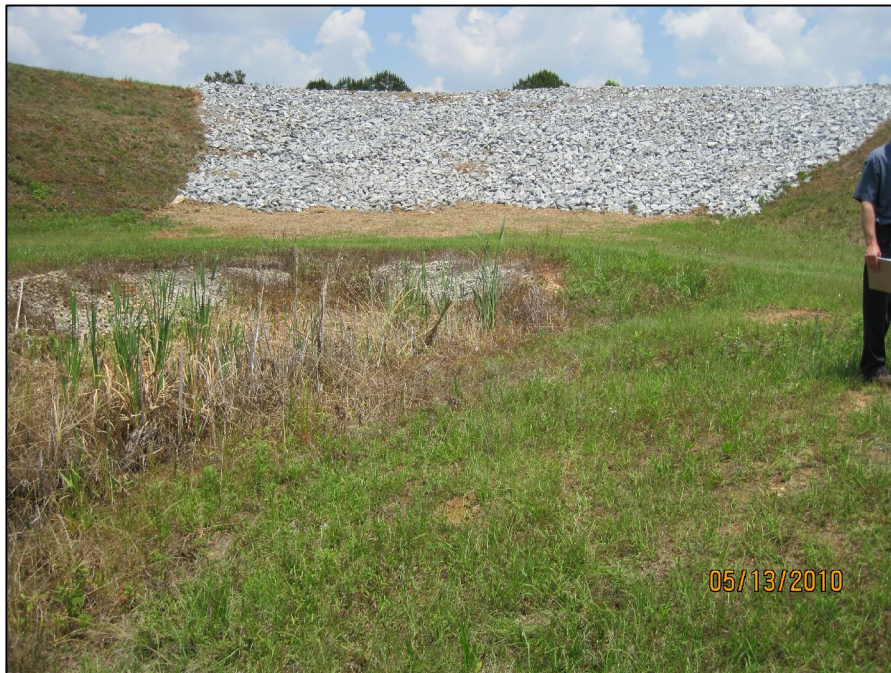
**1-5**

**WEST END OF COMMON DIKE, LOOKING NORTHEAST AT BLANKET DRAIN OUTLET #1 AND RIP-RAP EMBANKMENT**

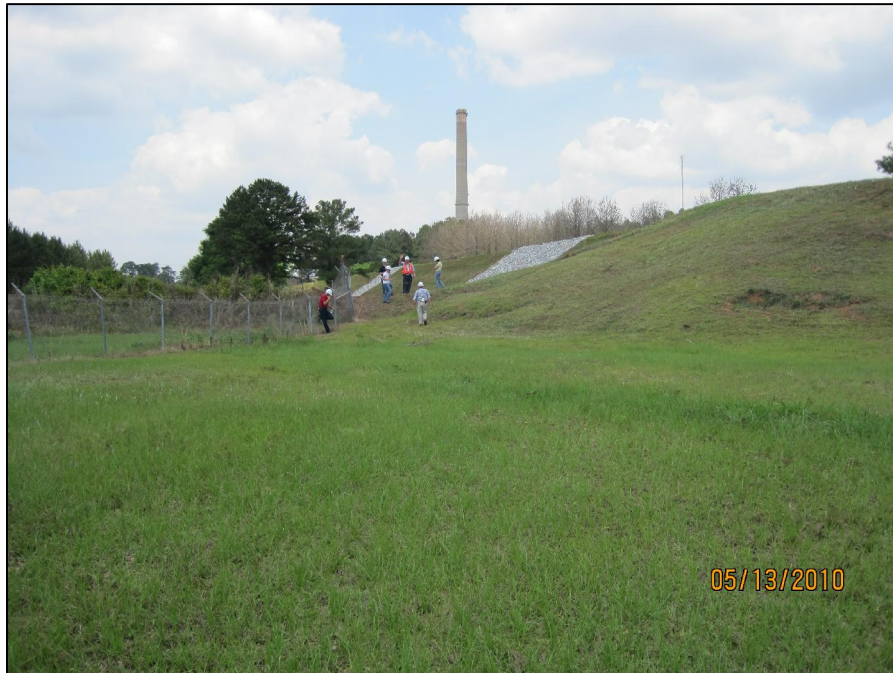
**1-7**

The surface of the west dike embankments and crest is primarily grass. During the site visit, a depression was noted in the downstream embankment in this area and was reported as being caused by work crews (photo 1-7). Two slope repairs consisting of rip-rap were noted, approximately 200 feet apart along the downstream slope of the western dike (photos 1-7, 1-8 and 1-9). Although station numbers are not provided to confirm repair locations, they appear to coincide with areas marked "slough" in drawing H 5329 issued in 1995 (MIT-API 0005). A toe berm, constructed in 1973, was observed along the downstream toe of the western dike (photos 1-10 and 1-11). Details regarding the berm were provided previously in Section 1.4.3. Due to a 1994 flood event, a levee was constructed at the northwest corner of Ash Pond 1 (photo 1-12).

**SOUTHWEST END OF ASH POND 1, LOOKING NORTH AT TOE AND DOWNSTREAM SLOPES, ASH POND 1 RECYCLE LINE (HUMP), DEPRESSION IN DOWNSTREAM SLOPE ON RIGHT**

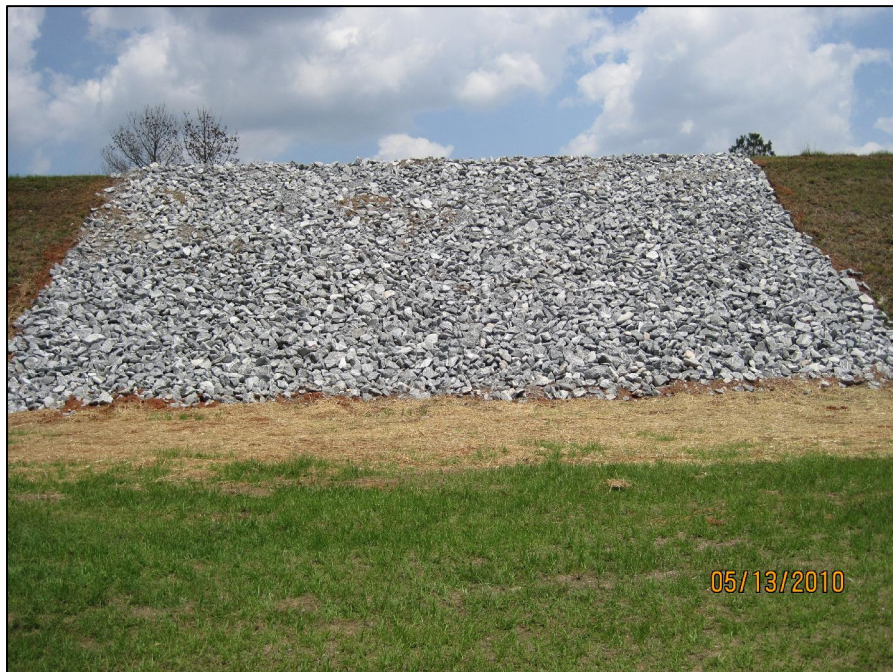
**1-8**

During the site visit, steep slopes were noted along Ash Pond 1. Design drawings indicate a maximum embankment height of 23 feet with embankment slopes constructed at 1.5 feet horizontal to 1 foot vertical. Previous repairs along the western and northern downstream face appear to be a result of sloughing caused by the over-steep slopes.

**SOUTHWEST END OF ASH POND 1, LOOKING EAST AT DOWNSTREAM SLOPE REPAIR**

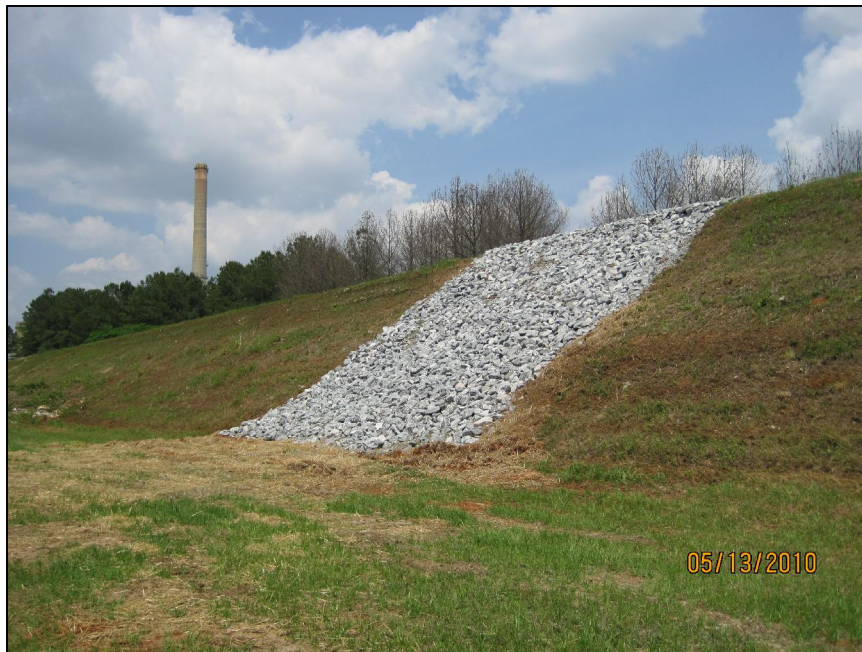
**1-9**

**SOUTHWEST SIDE OF ASH POND 1, DOWNSTREAM SLOPE REPAIR 200 FEET NORTH OF PHOTO 1-7**

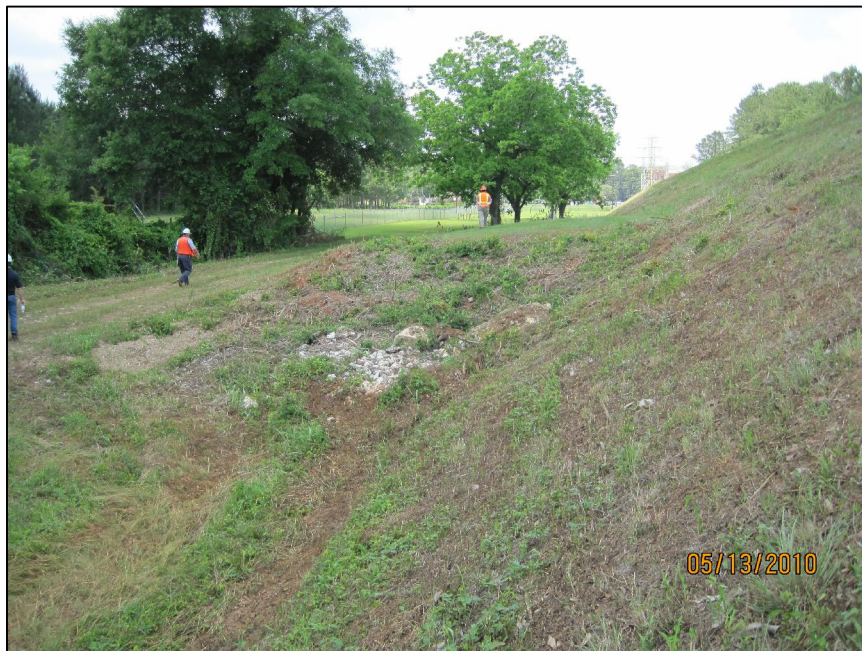
**1-10**

**WEST SIDE OF ASH POND 1, LOOKING NORTH AT DOWNSTREAM SLOPE AND 1973 REPAIR, LARGE ROCK/IRREGULAR SURFACE/DUMP AT SOUTH END OF REPAIR**

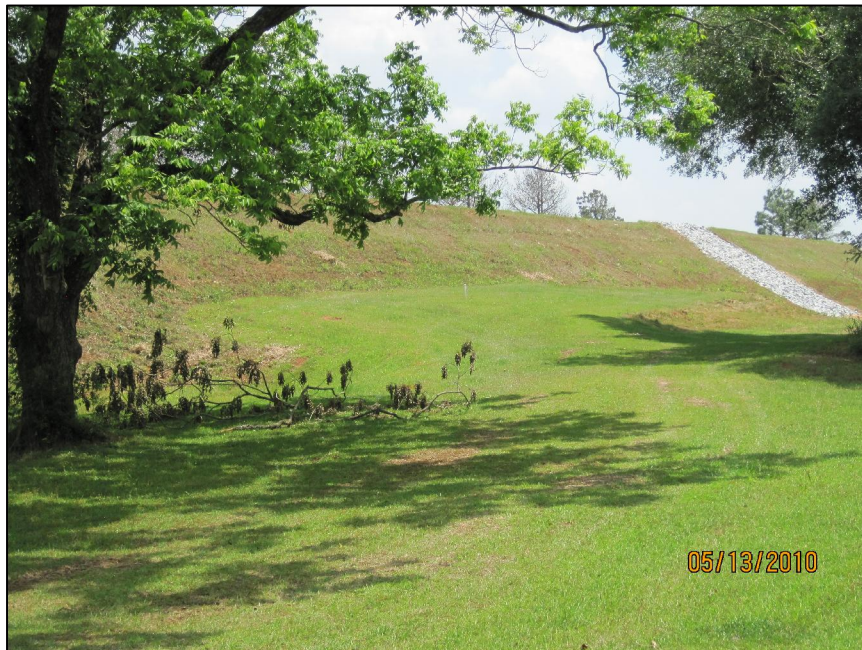
**1-11**

**WEST SIDE OF ASH POND 1, LOOKING SOUTHEAST AT DOWNSTREAM SLOPE AND 1973 REPAIR, PZ IN REPAIR AREA**

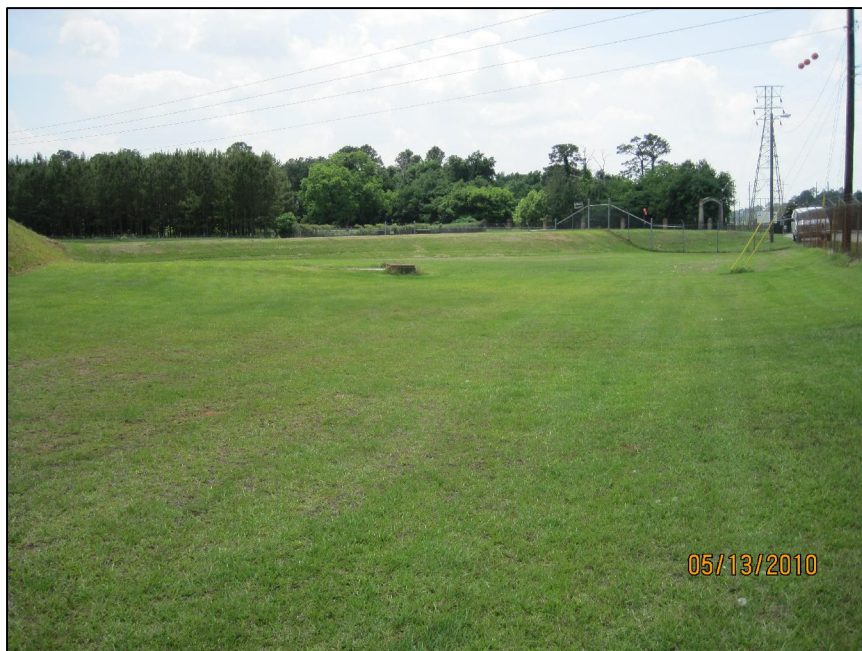
**1-12**

**NORTHWEST CORNER OF ASH POND 1, LOOKING WEST, BACKGROUND: LEVEE BERM INITIATED FROM 1994 FLOOD (T. S. ALBERTO), PIPE AND CATCH BASIN: EMERGENCY OUTLET ASH POND 1 AND SURFACE WATER CATCH BASIN (FLOWS TO PERMIT OUTFALL 01E)**

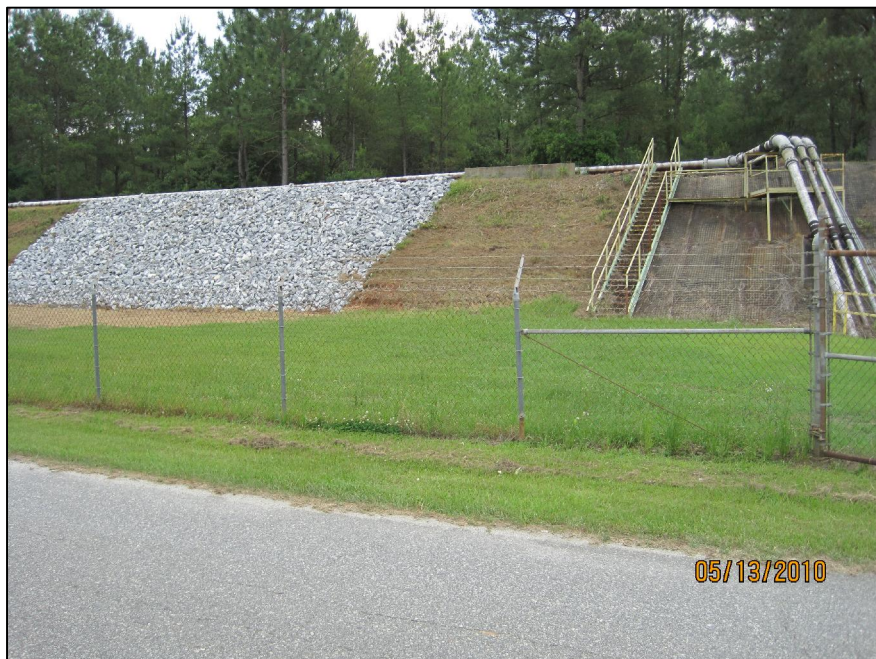
**1-14**

**NORTHWEST END OF ASH POND 1, LOOKING SOUTH AT ASH SLUICE DISCHARGE LINES FOR UNITS 1, 2 AND 3 AND DOWNSTREAM SLOPE REPAIR**

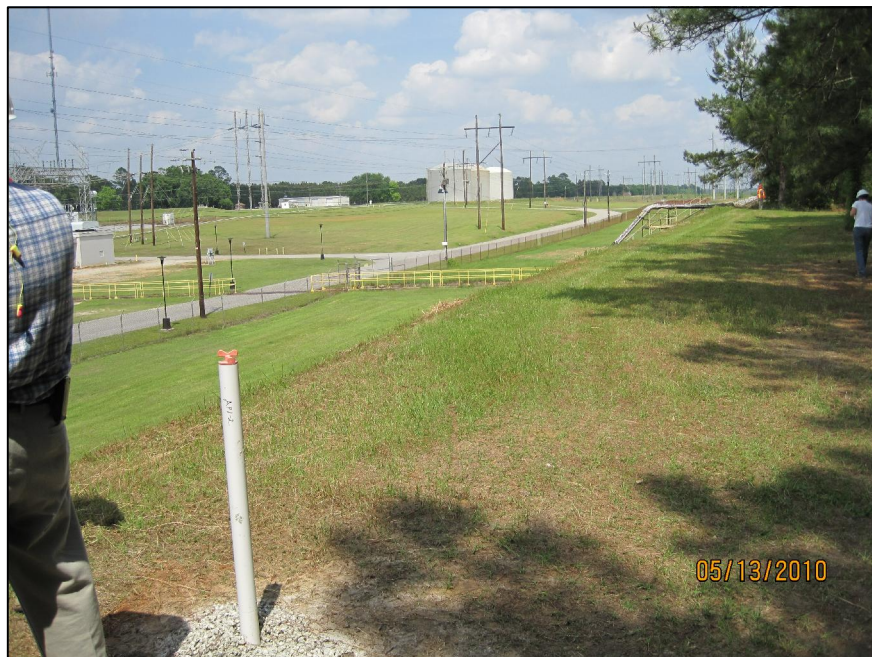
**1-18**

The north dike faces the plant and the surface cover of the embankment and crest is generally grass (photo 1-23). A newly installed piezometer, AP1-2, is located on the crest at the west end of the north dike (photo 1-18). A slope repair, consisting of rip-rap and located along the northern embankment adjacent to sluiced ash discharge pipes from Unit 3, appears to coincide with areas marked "slough" on drawing H5329, dated 1995 (photos 1-13 and 1-14). The sluiced ash discharge pipes from Unit 3 are located along the northern and eastern crest of Ash Pond 1 (photos 1-12 and 1-13), and continue to the southeast corner of Ash Pond 2. An inactive Low Volume Sump is located within the embankment (photo 1-16) along the northern section of the eastern dike. At the time of the site visit, the pond was filled to design capacity and was covered with vegetation including grass and pine trees (photo 1-15).

**NORTHWEST CORNER OF ASH POND 1, LOOKING NORTHEAST TOWARD ASH POND A, NEW PZ AP1-2**

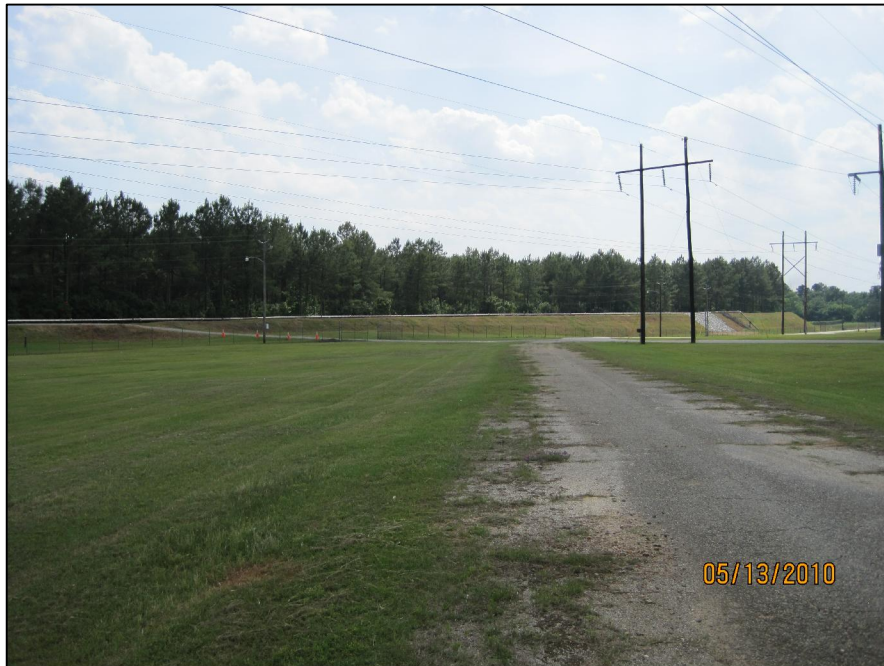
**1-23**

**LOOKING SOUTHWEST FROM APPROXIMATELY NORTH END OF ASH POND A TOWARD WEST END OF ASH POND 1**

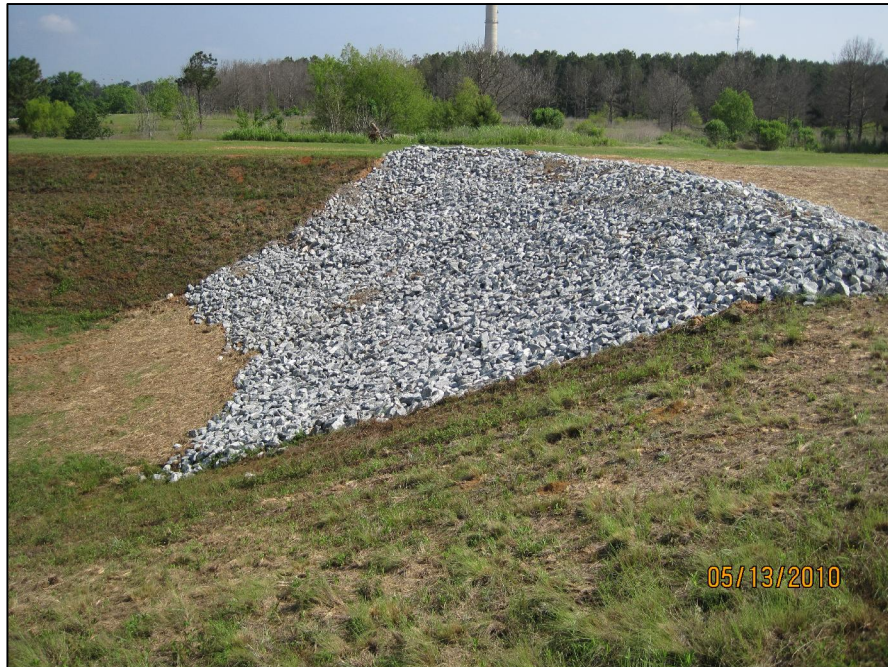
**2-4**

**REPAIRED (RIP-RAP) EROSION RILLS AT WEST END COMMON DIKE (DRAIN OUTLET D1 TO LEFT)**

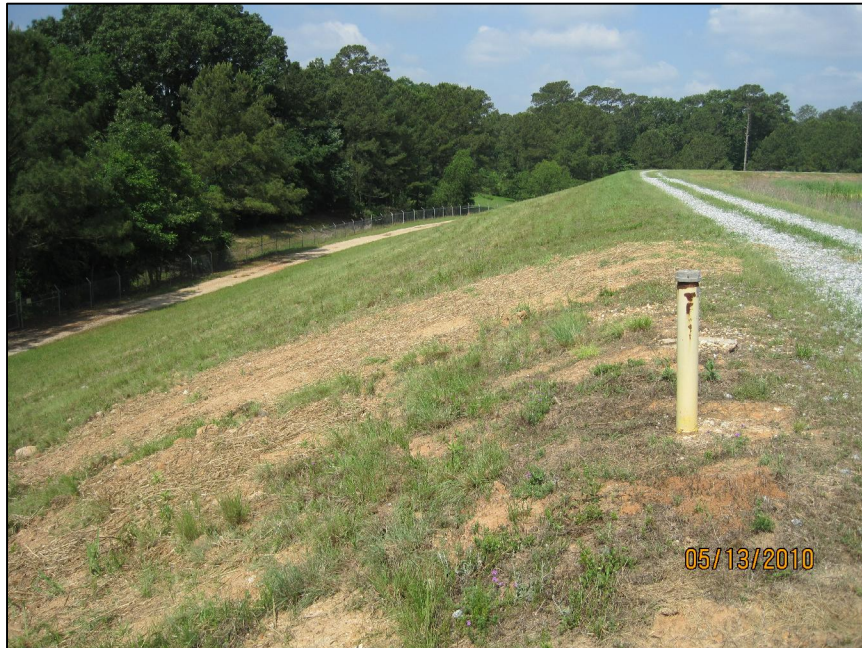
**2-15**

The south dike of Ash Pond 2 is covered with grass on the embankments and gravel on the crest (photo 2-15, 2-16, and 2-18). Fire-ant hills are shown in these photos. Bare and/or irregular surface areas, shown in these photos, were more prevalent toward the south end of Ash Pond 2. A wet area along the downstream toe was observed from the fence line below the toe of the south embankment and extended approximately 500 feet to the west (photo 2-22).

**SOUTHWEST END OF ASH POND 2 FROM PZ-168 CREST AND DOWNSTREAM SLOPES,  
ANTHILL IN FRONT OF PIEZOMETER, LACK OF VEGETATION ON DOWNSTREAM SLOPE**

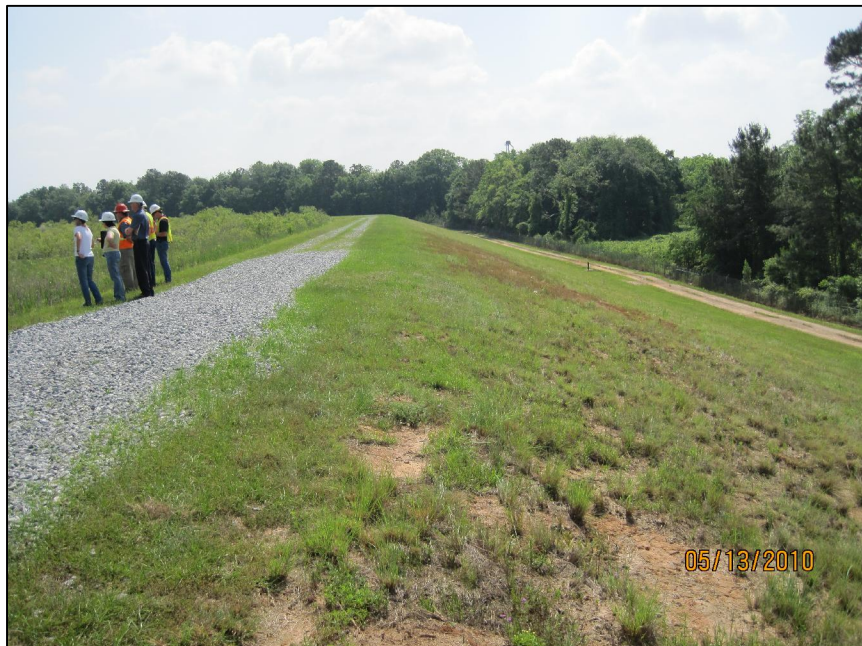
**2-16**

**SOUTHEAST END OF ASH POND 2 FROM PZ-168 CREST AND DOWNSTREAM SLOPES,  
WOODY VEGETATION IN INTERIOR, PZ AT TOE OF SLOPE .**

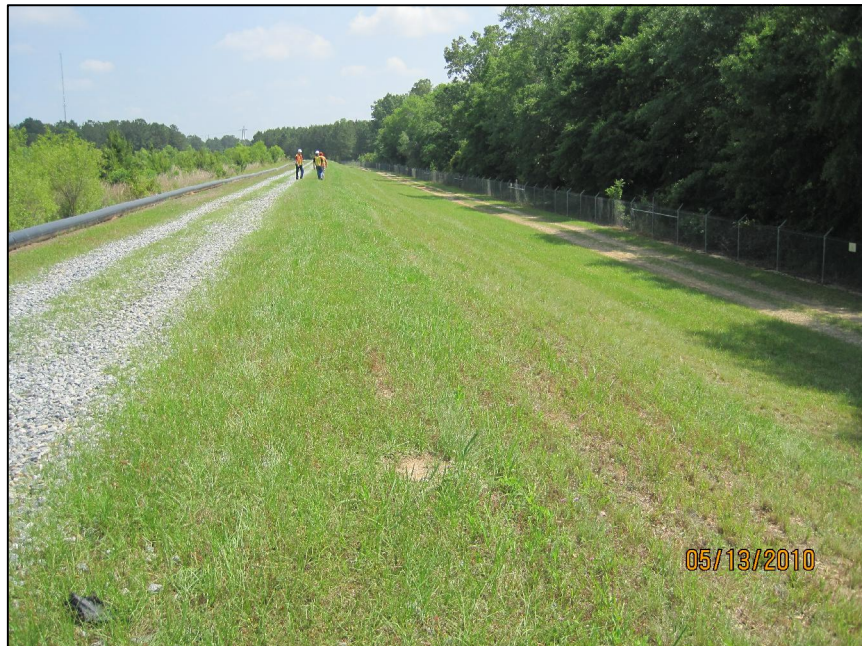
**2-20**

The ash sluice pipe from Facility Unit 3 is located on the crest of the east dike and discharges into Ash Pond 2 near its southeast corner (photo 2-19). The east dike has a gravel crest and grass covered embankment surfaces with downstream slopes that are in good to fair condition with isolated bare areas (photos 2-20 and 2-21).

**EAST SIDE OF ASH POND 2 CREST AND DOWNSTREAM SLOPE**

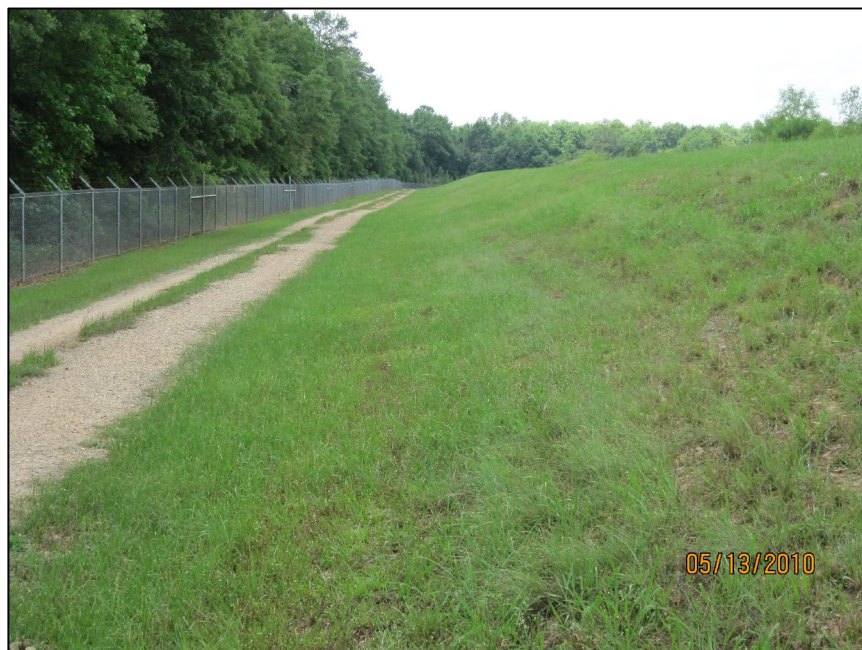
**2-21**

**EAST SIDE OF ASH POND 2 LOOKING SOUTH AT DOWNSTREAM SLOPE AND TOE**

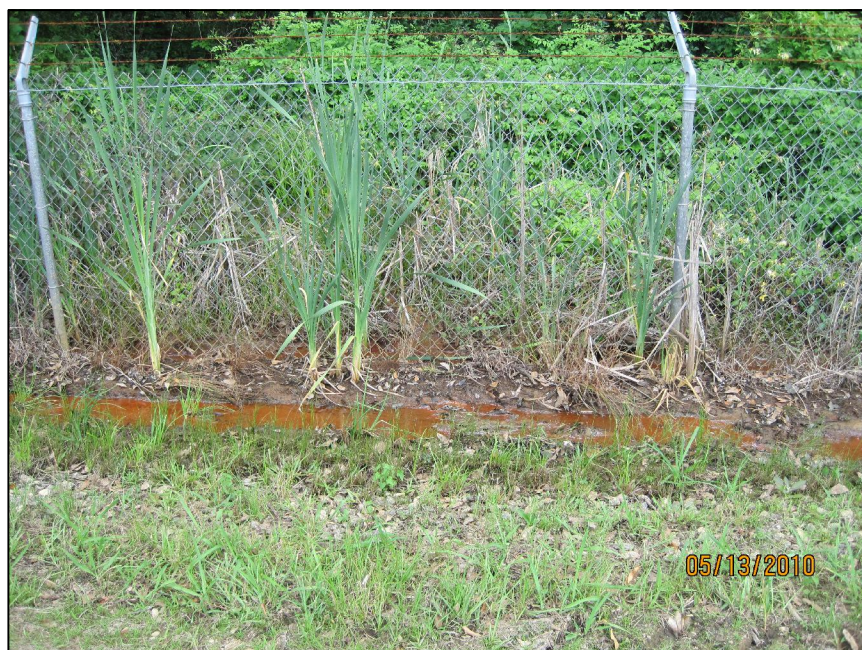
**2-22**

**EAST SIDE OF ASH POND 2, LOOKING EAST AT WET AREA AT FENCE BEYOND TOE OF SLOPE**

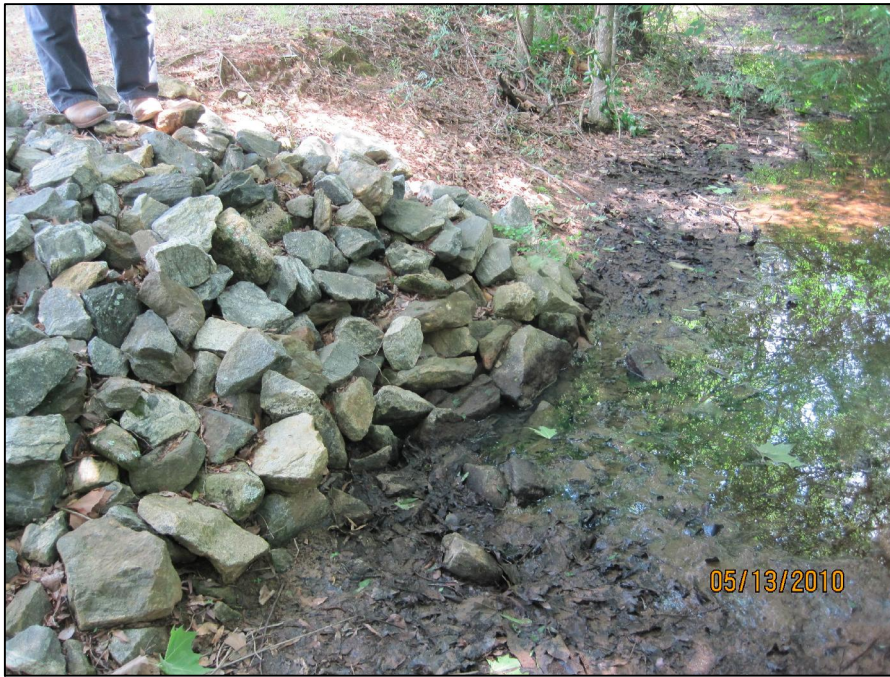
**2-23**

**SOUTH SIDE OF ASH POND 2, EAST OF FENCE BEYOND TOE OF SLOPE, LAST (NORTH)  
TOE BLANKET DRAIN OUTLET (NOT FLOWING)**

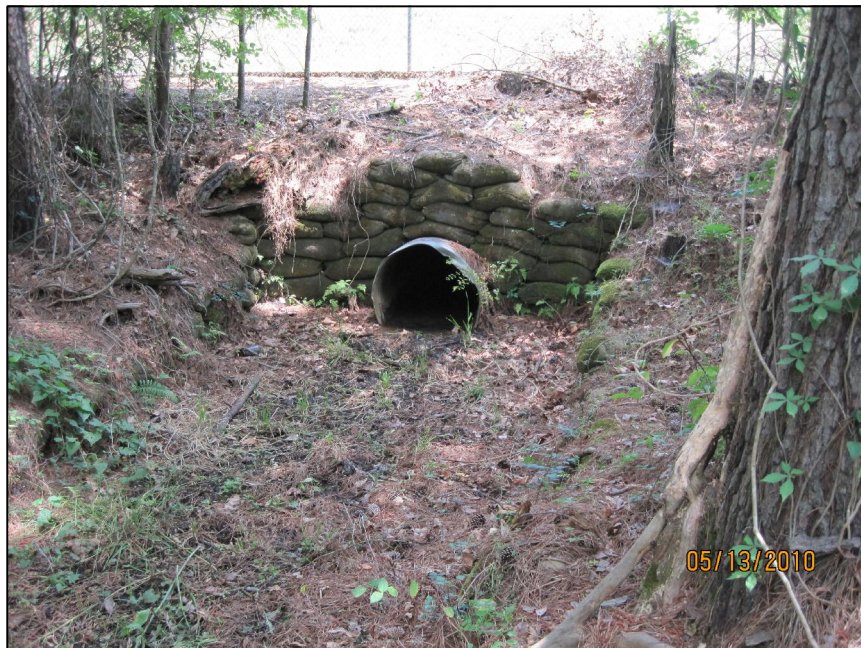
**2-26**

**OUTLET OF EMERGENCY SPILLWAY OUTLET PIPE (AP2), NOTED TRICKLE OUTFLOW**

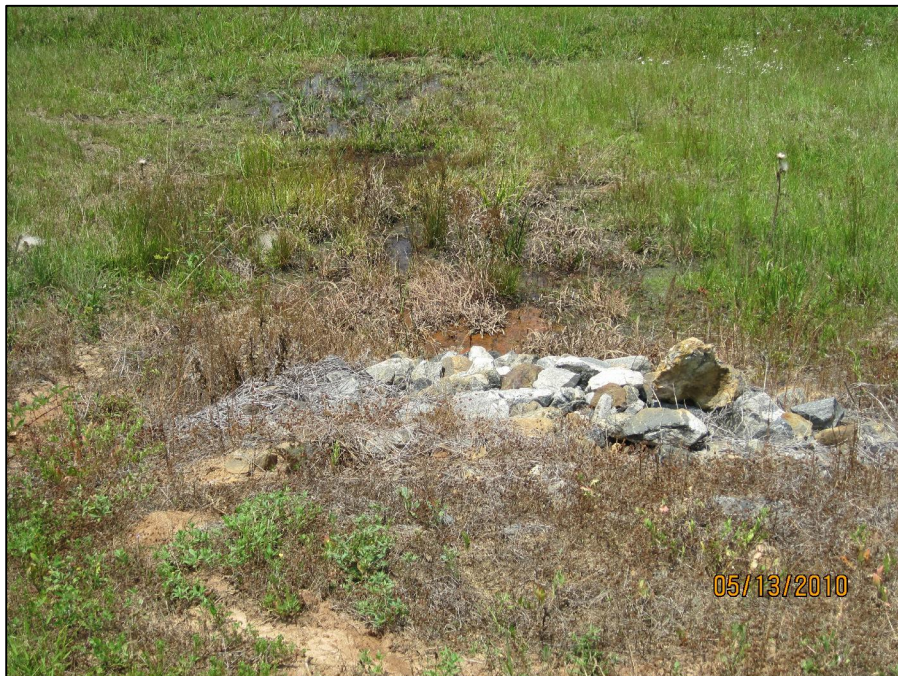
**2-28**

**NORTHWEST SIDE OF ASH POND 2, LOOKING WEST AT BLANKET DRAIN OUTLET #2, SLIGHT FLOW**
