Report of Dam Safety Assessment
Coal Combustion Surface Impoundments
Georgia Power
Plant Mitchell, Albany, GA

AMEC Project No. 3-2106-0174.0600

December 2010

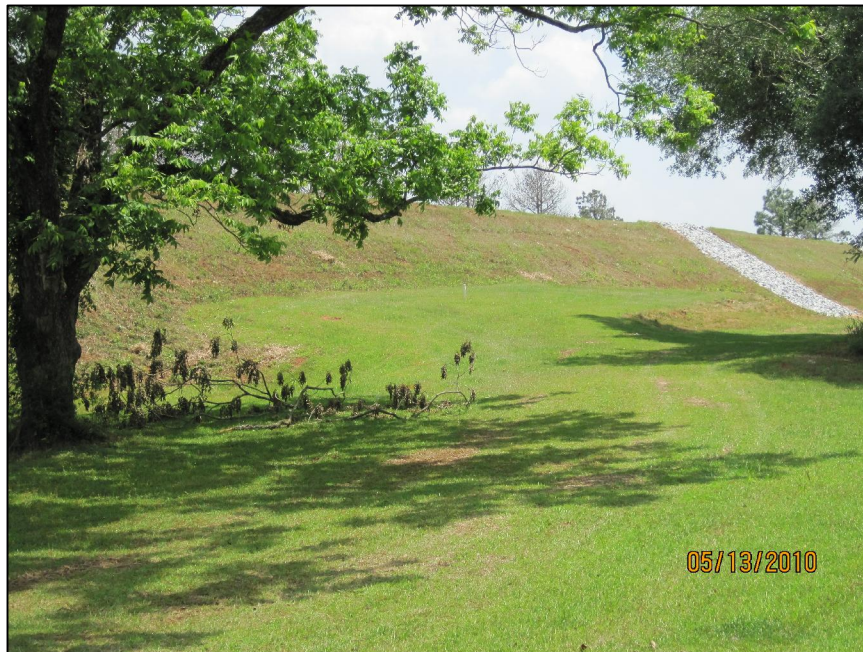
1-11

WEST SIDE OF ASH POND 1, LOOKING SOUTHEAST AT DOWNSTREAM SLOPE AND 1973 REPAIR, PZ IN REPAIR AREA

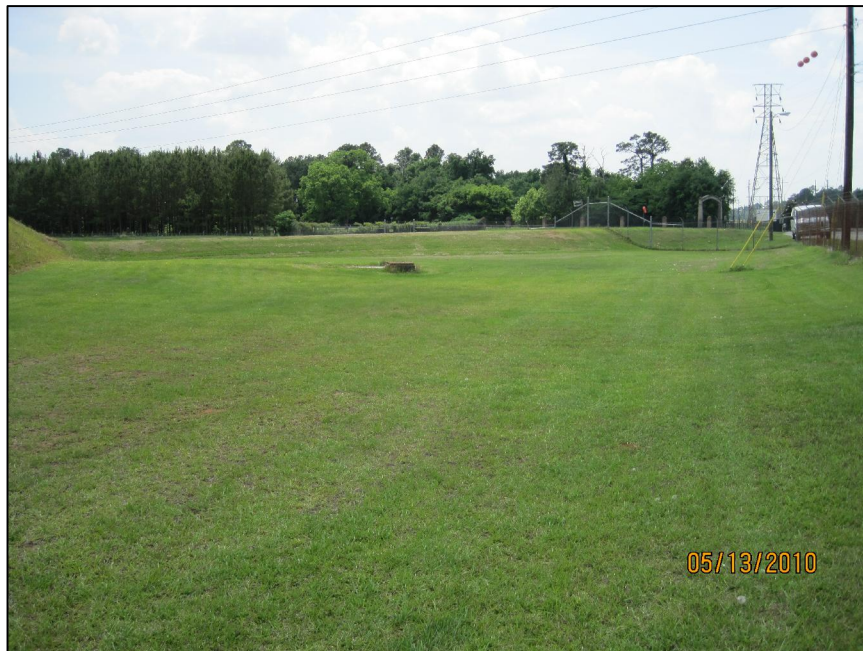
1-12

The surface of the west dike embankments and crest is primarily grass. During the site visit, a depression was noted in the downstream embankment in this area and was reported as being caused by work crews (photo 1-7). Two slope repairs consisting of rip-rap were noted, approximately 200 feet apart along the downstream slope of the western dike (photos 1-7, 1-8, and 1-9). Although station numbers are not provided to confirm repair locations, they appear to coincide with areas marked "slough" in drawing H 5329 issued in 1995 (MIT-API 0005). A toe berm, constructed in 1973, was observed along the downstream toe of the western dike (photos 1-10 and 1-11). Details regarding the berm were provided previously in Section 1.4.3. Due to a 1994 flood event, a levee was constructed at the northwest corner of Ash Pond 1 (photo 1-12).

NORTHWEST CORNER OF ASH POND 1, LOOKING WEST, BACKGROUND: LEVEE BERM INITIATED FROM 1998 FLOOD (UNNAMED), PIPE AND CATCH BASIN: EMERGENCY OUTLET ASH POND 1 AND SURFACE WATER CATCH BASIN (FLOWS TO PERMIT OUTFALL 01E)

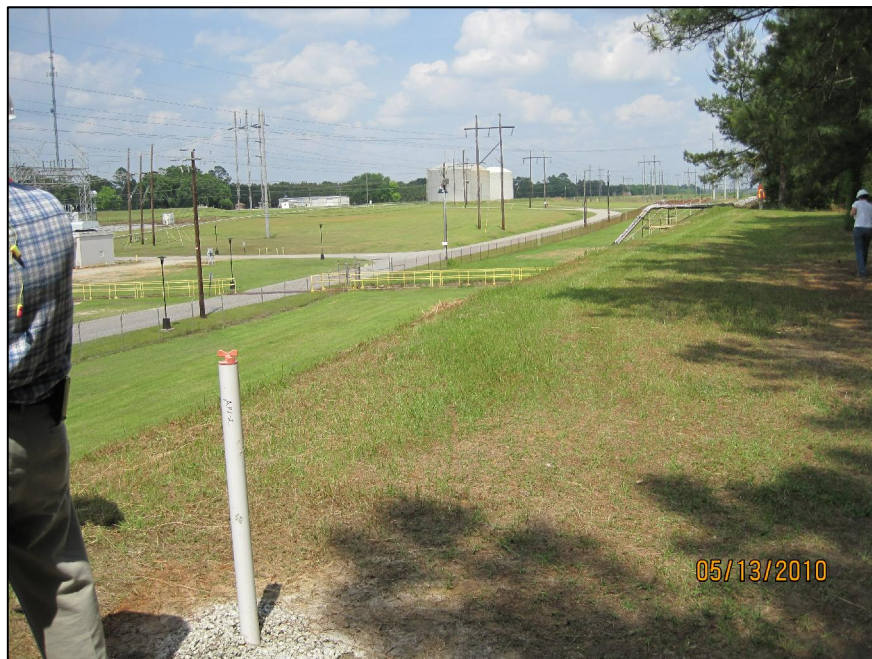
1-18

The north dike faces the plant and the surface cover of the embankment and crest is generally grass (photo 1-23). A newly installed piezometer, AP1-2, is located on the crest at the west end of the north dike (photo 1-18). A slope repair, consisting of rip-rap and located along the northern embankment adjacent to sluiced ash discharge pipes from Unit 3, appears to coincide with areas marked "slough" on drawing H5329, dated 1995 (photos 1-13 and 1-14). The sluiced ash discharge pipes from Unit 3 are located along the northern and eastern crest of Ash Pond 1 (photos 1-12 and 1-13), and continue to the southeast corner of Ash Pond 2. An inactive Low Volume Sump discharge line is located within the embankment (photo 1-16) along the northern section of the eastern dike. At the time of the site visit, the pond was filled to design capacity and was covered with vegetation including grass and pine trees (photo 1-15).

NORTHWEST CORNER OF ASH POND 1, LOOKING NORTHEAST TOWARD ASH POND A, NEW PZ AP1-2

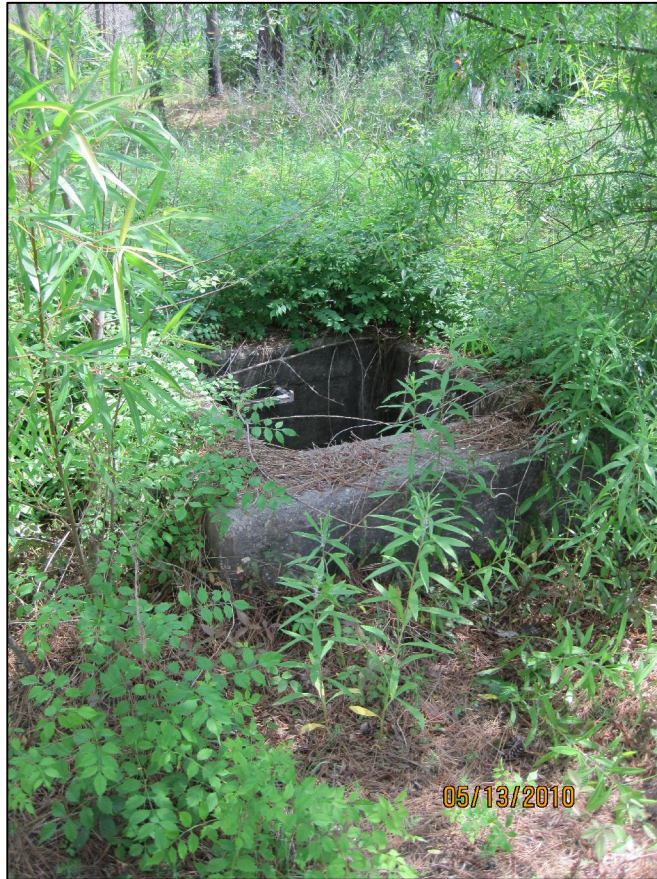
1-19

NORTHWEST CORNER OF ASH POND 1, INTERIOR: EMERGENCY OVERFLOW INLET, TOP IS 12 TO 14-INCHES ABOVE GROUND

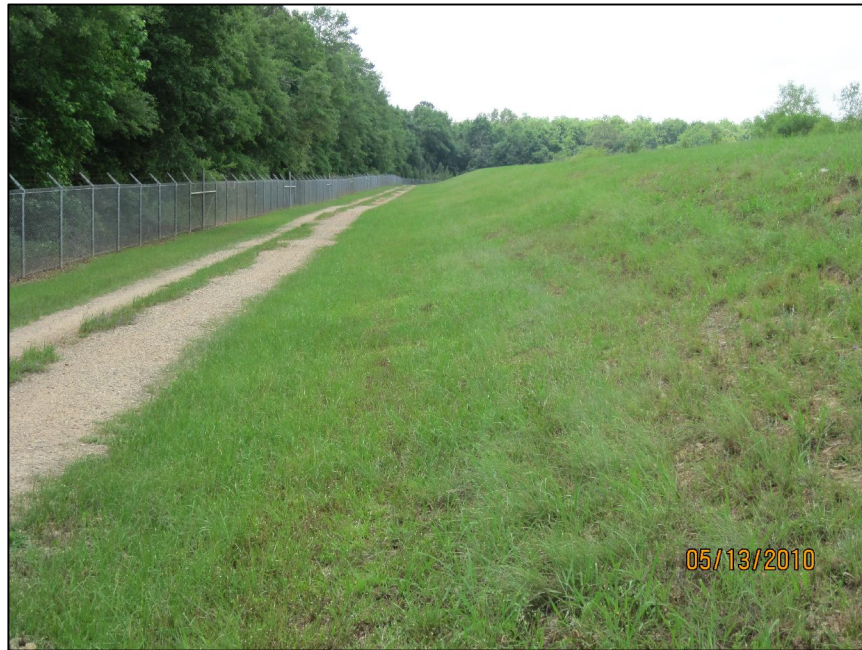
2-21

The ash sluice pipe from Facility Unit 3 is located on the crest of the east dike and discharges into Ash Pond 2 near its southeast corner (photo 2-19). The east dike has a gravel crest and grass covered embankment surfaces with downstream slopes that are in good to fair condition with isolated bare areas (photos 2-20 and 2-21).

EAST SIDE OF ASH POND 2 LOOKING SOUTH AT DOWNSTREAM SLOPE AND TOE

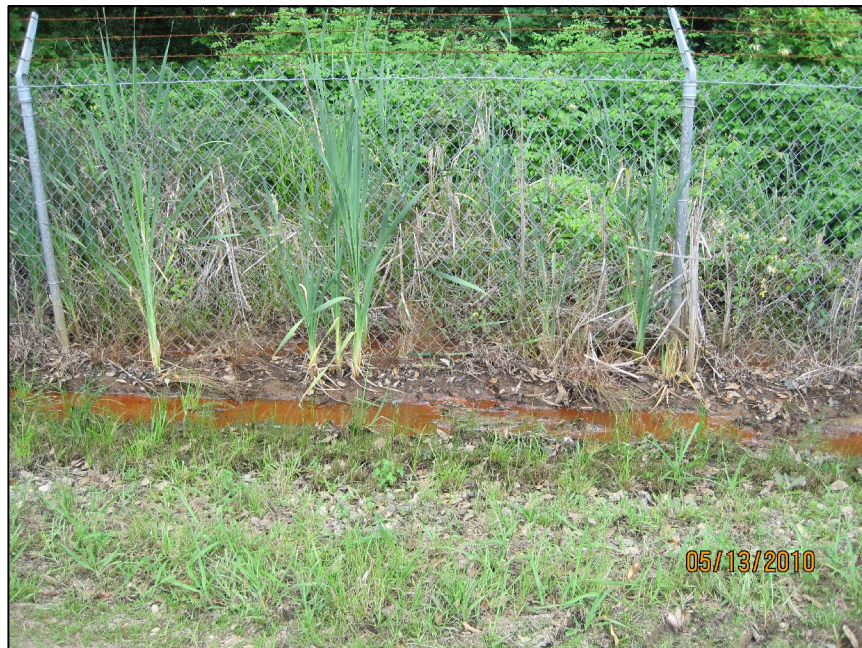
2-22

The south dike of Ash Pond 2 is covered with grass on the embankments and gravel on the crest (photo 2-15, 2-16, and 2-18). Fire-ant hills are shown in these photos. Bare and/or irregular surface areas, shown in these photos, were more prevalent toward the south end of Ash Pond 2. A wet area along the downstream toe was observed from the fence line below the toe of the south embankment and extended approximately 500 feet to the west (photo 2-22).

SOUTH SIDE OF ASH POND 2, LOOKING SOUTH AT WET AREA AT FENCE BEYOND TOE OF SLOPE

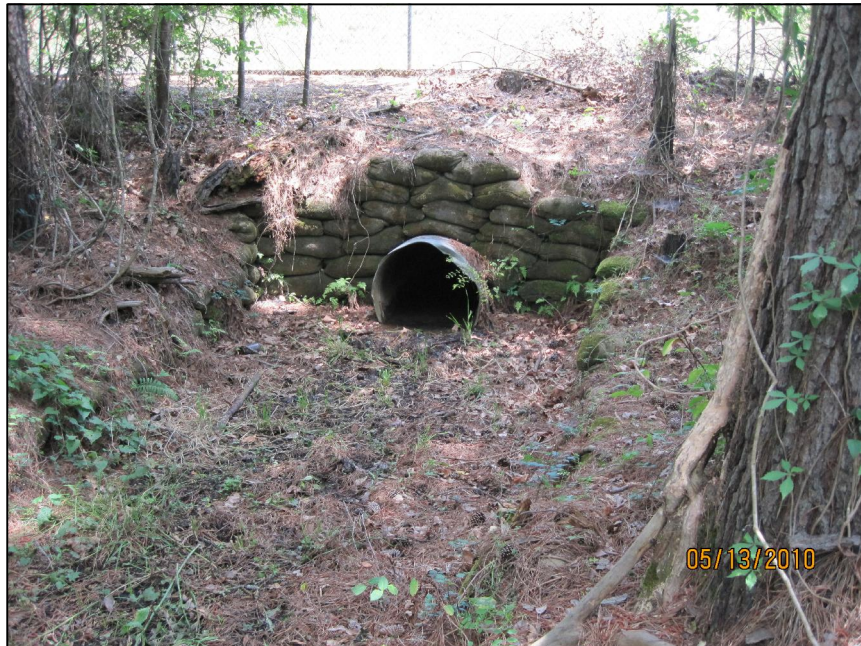
2-26

OUTLET OF EMERGENCY SPILLWAY OUTLET PIPE (AP2), NOTED TRICKLE OUTFLOW
