**Coal Combustion Waste Impoundment
Round 5 - Dam Assessment Report**

Plant Wansley

Ash Pond Separation Dike

*Georgia Power
Carrolton, Georgia*

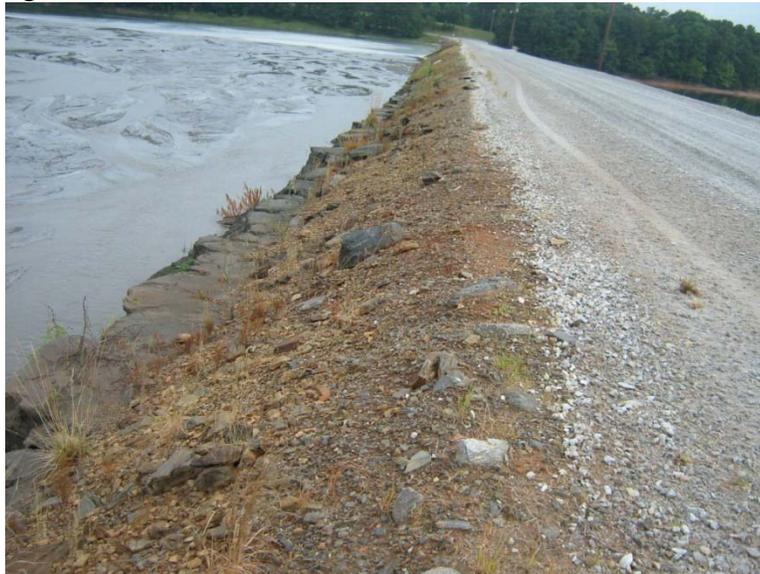
The crest was covered by graded aggregate base material and had no signs of any rutting, depressions, tension cracks or other indications of settlement or shear failure, and appeared to be in satisfactory condition.

The upstream slope of the separation dike is mostly lined with rip rap and stone. Scarps, sloughs, depressions, bulging or other indications of slope instability or signs of erosion were not observed.

Figure 5.2.2a: Crest and Upstream Slope of ash pond's separation dike.

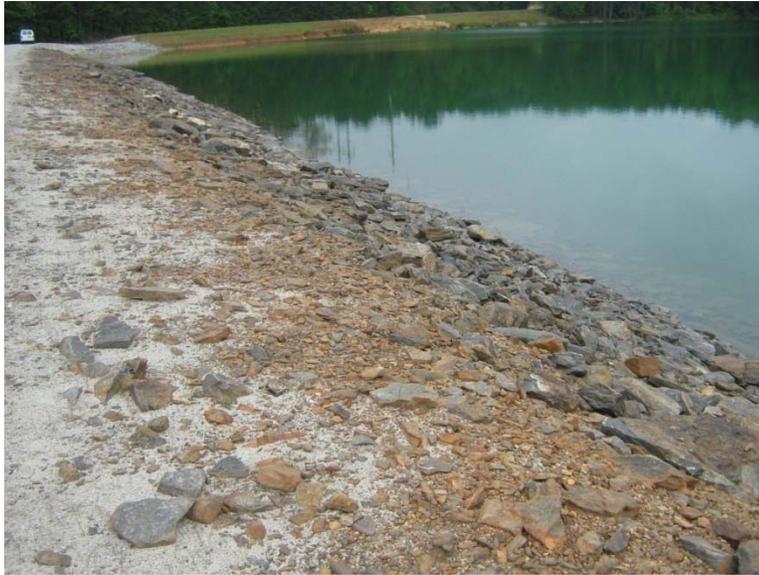
The upstream slope of the western dike is mostly lined with rip rap and stone. Scarps, sloughs, depressions, bulging or other indications of slope instability or signs of erosion were not observed.

Figure 5.2.2b: Upstream side of western dike

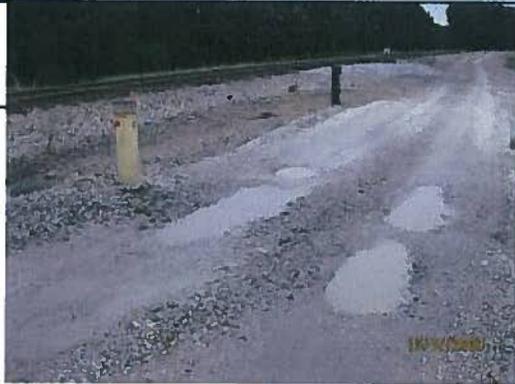
Photo No.	Description	
1	Storage Pond - East Dike - Crest - Localized depressions at crest should be filled with Graded Aggregate Base (GAB).

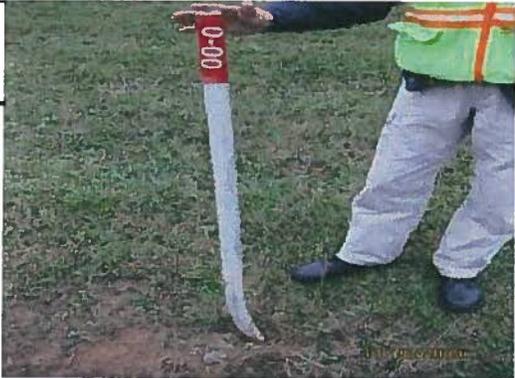
2	Storage Pond - East Dike - Marker pole at Sta 0-00 needs to be re-installed. Has been broken off at ground level

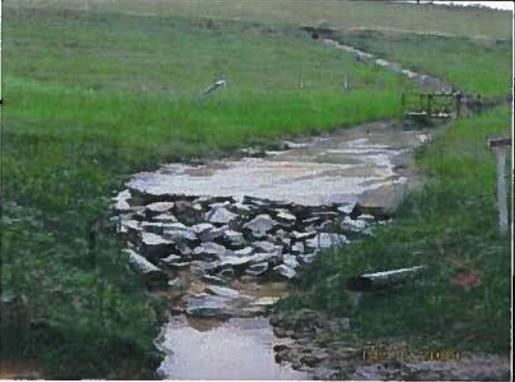
10	Storage Pond - Southeast Dike - Lower Slope - Sta 37+00 - Undermined area at end of concrete lined ditch fixed satisfactorily.

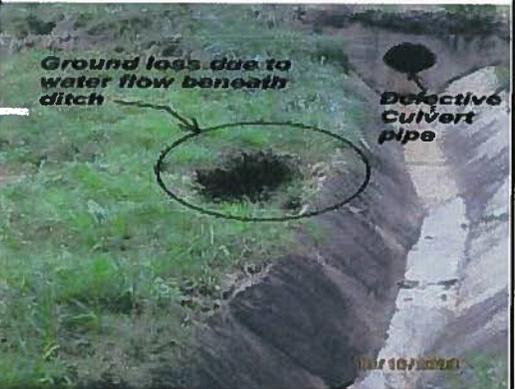
11	Storage Pond - Southeast Dike-Downstream-Lower Slope -Sta 37+50 - Ground loss resulting from defective/leaking (corroded) culvert allowing water to flow beneath and beside concrete ditch. Both items have been repaired since inspection on 10-16-09.

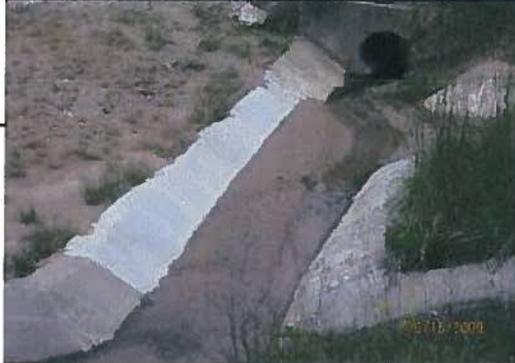
Photo No.	Description	
13	Storage Pond- Southeast Dike - Lower Slope - Toe Ditch - Mud needs to be removed from ditches.

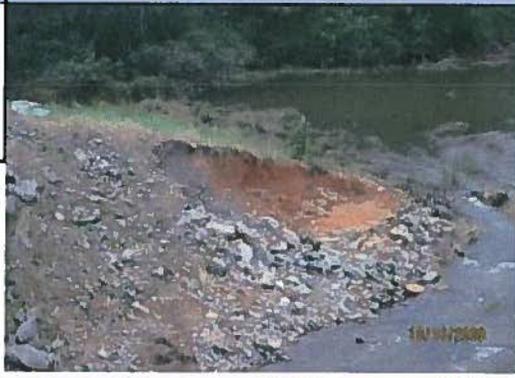
Photo No.	Description	
17	Potable Water Pond- Spillway - Upstream - Left, upstream spillway approach embankment needs to be repaired. Hydro Services has provided plant personnel with repair procedure.

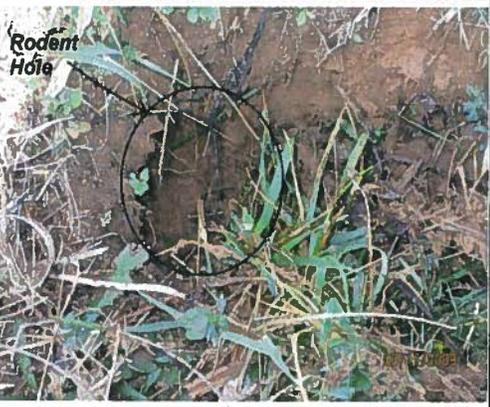
3	Storage Pond - East Dike - Localized rodent holes observed on slope need to be filled in.

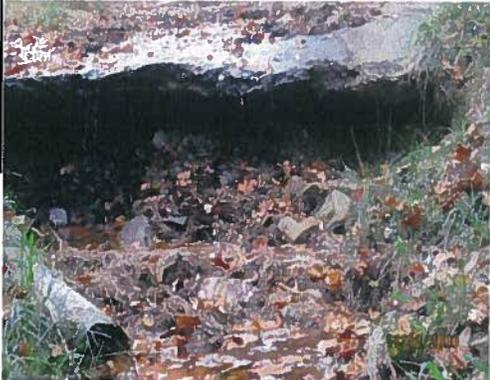
15	Storage Pond - Southeast Dike - Downstream-Lower Slope at Sta 37+ 50 - Undermining at end of concrete drainage ditch requires repair. (See repair procedure in letter of May 28, 2008)

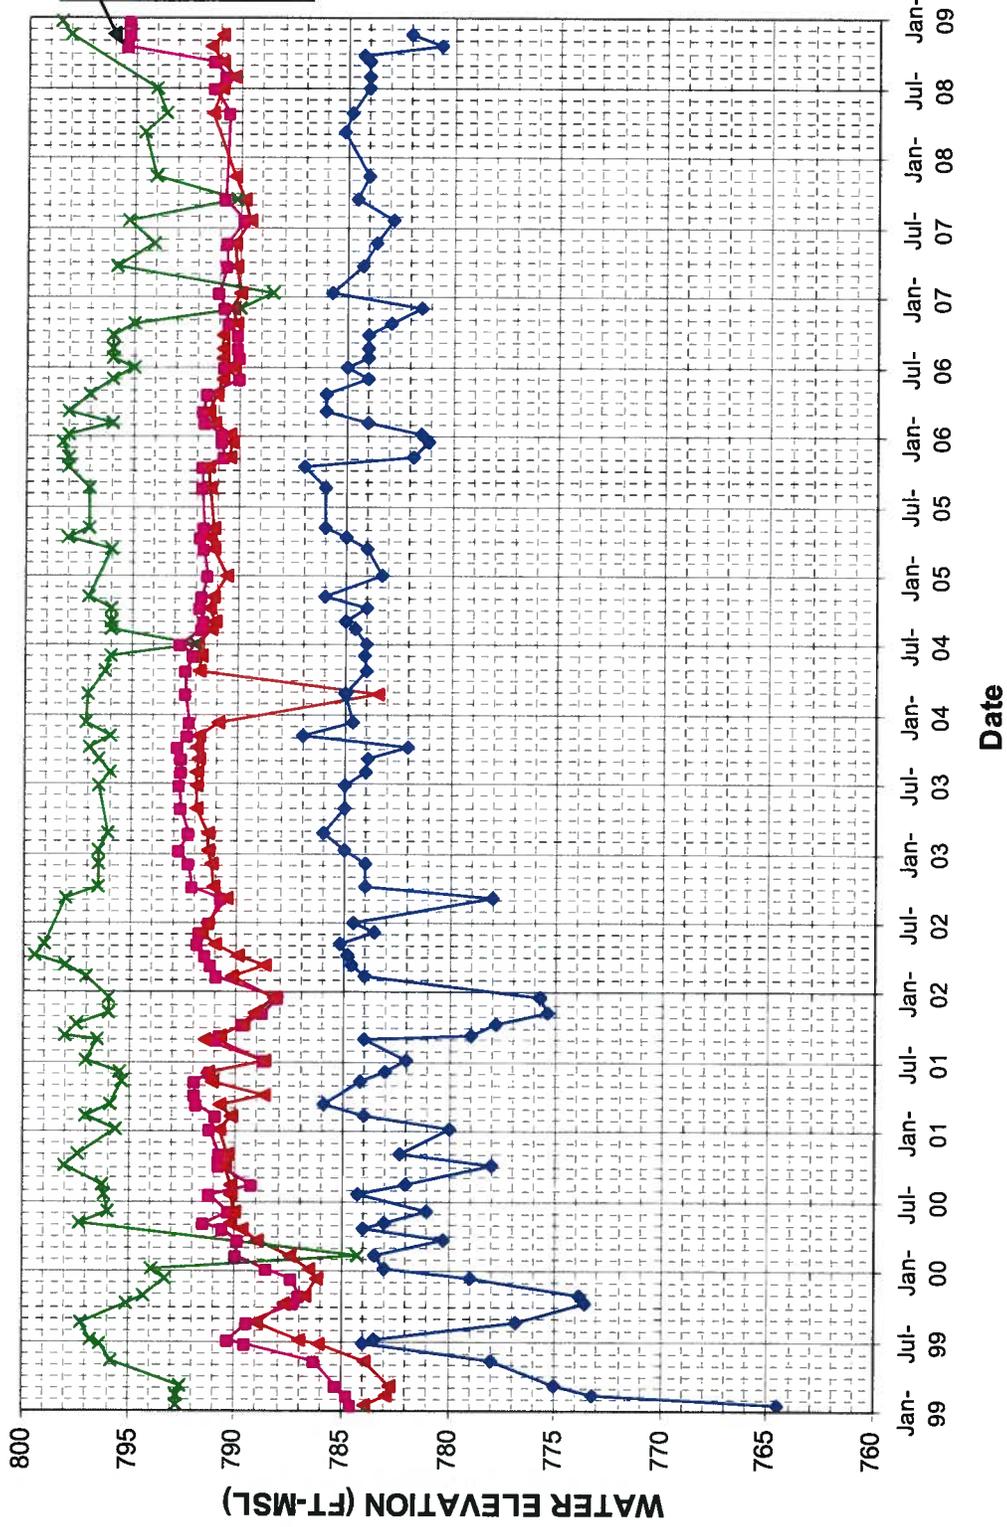
Wansley Separation Dike Pz's BB and DD

Top of piezometer elevation to be checked by site. Could have changed due to damage following gypsum pond construction. - Pending confirmation 1/6/09

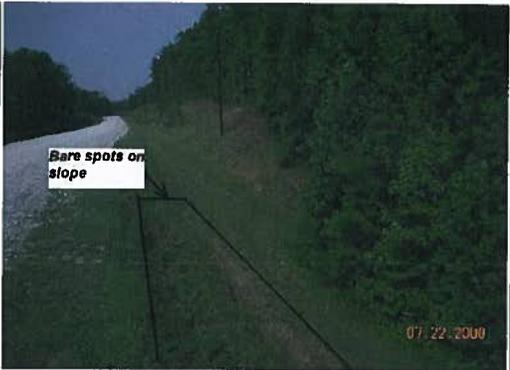
2	Storage Pond - N. Dike - Localized bare spots in grass cover. Re-establish grass to prevent erosion.

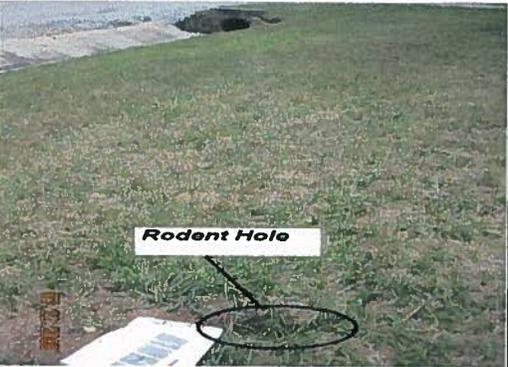
14	Storage Pond - Southeast Dike D/S - Rodent Holes on lower slope at approx. Sta 67+60 (near headwall) and Sta 68+40 need to be filled

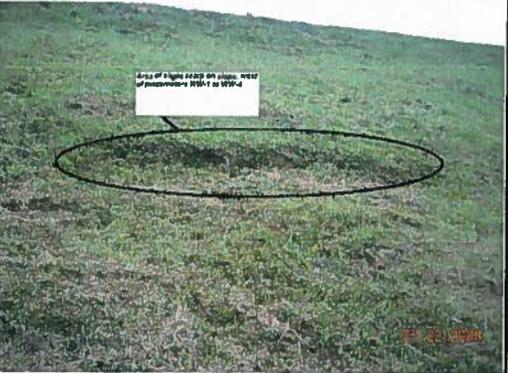
15	Storage Pond - Southeast Dike D/S - Sta. 37+50 - Ground surface was damp/wet. A localized area was observed where minor scarp indicating surface movement may have occurred. This area to be monitored routinely by plant for evident of on-going movement.

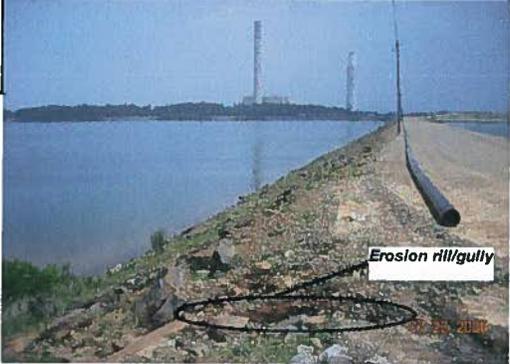
Photo No.	Description	
17	Storage/Ash Pond - Separator Dike - Upstream Slope. No evidence of instability or distress. Minor erosion rills/gullies need to be filled in.

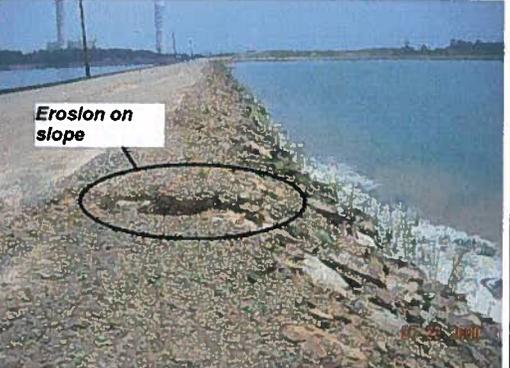
18	Storage/Ash Pond - Separator Dike - Downstream Slope - Localized erosion rills/gullies need to be repaired to prevent further erosion.

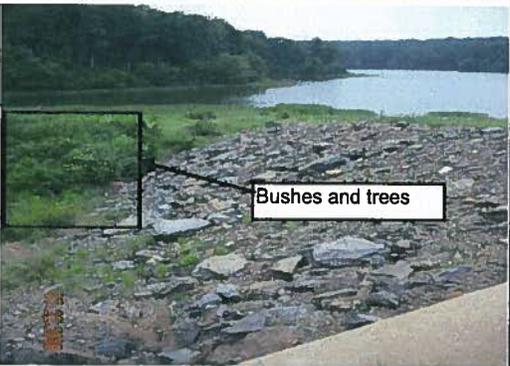
22	Potable Water Pond-Spillway Approach Channel- Remove small trees/bushes within channel.

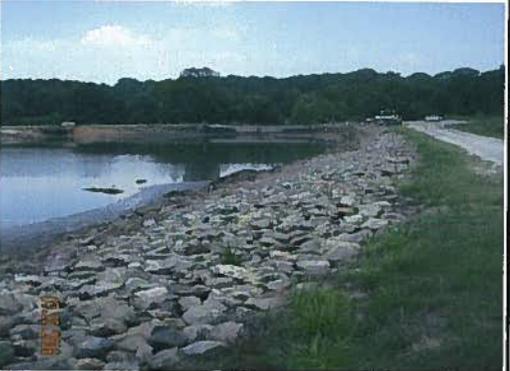
23	Detention Pond - Upstream Slope - Rip-rap in good condition, no visible evidence of instability.

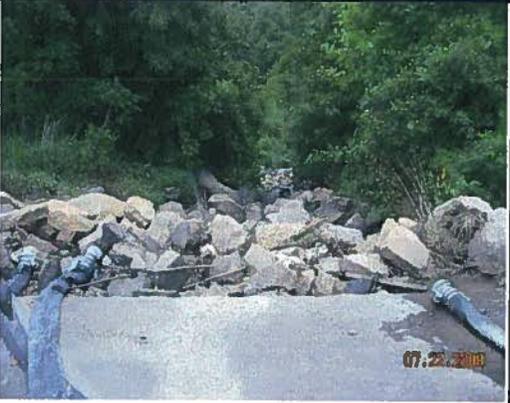
Photo No.	Description	
25	Detention Pond - Outfall Channel - Rip-rap and channel are in good condition. No erosion or instability observed.

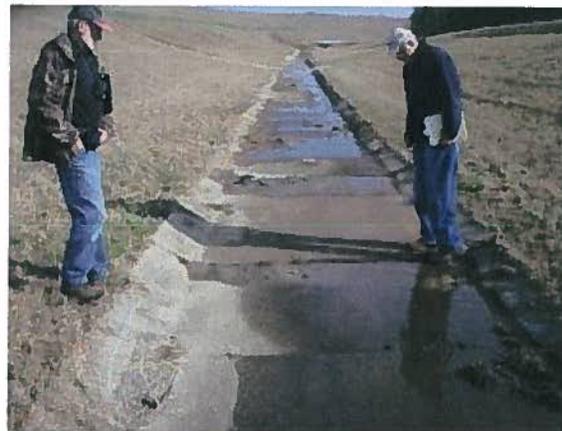
General Comment – Remove all accumulated vegetation within concrete lined channels

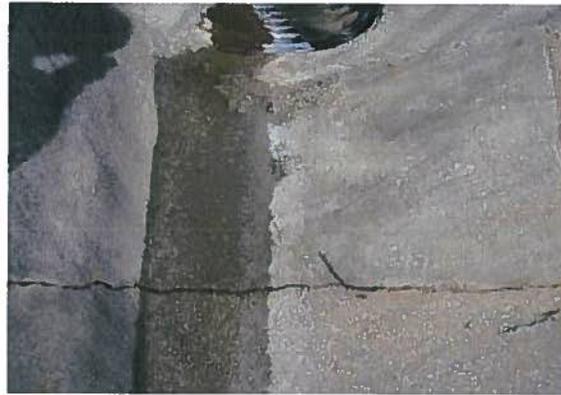
Pt. 130 – Cracks in concrete lined channel. **Cracks like this should be cleaned out of dirt and caulked (using an appropriate caulking material).** This will prevent water infiltration and progressive undermining beneath the concrete,

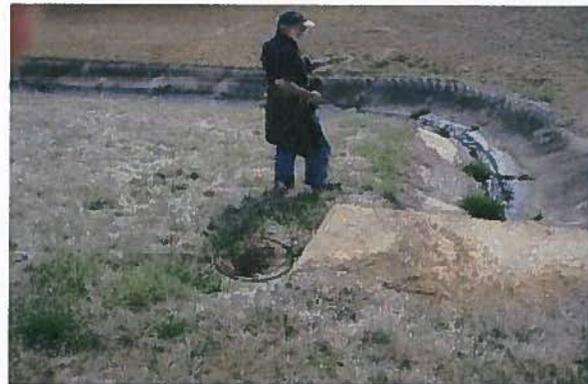
Animal burrows need to be filled in.

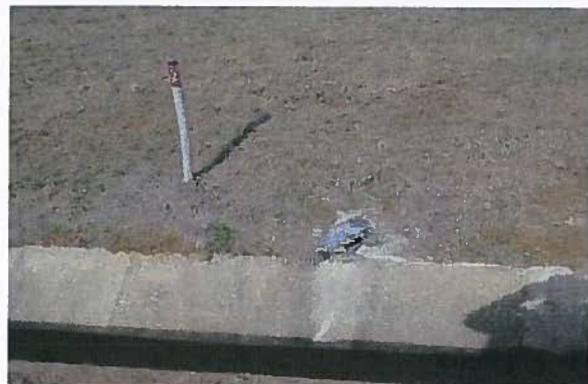
Sta. 72+50 and 70+00 (pictured) and 66+00 – End of toe and finger drains damaged by mowers. **Repair ends of drains (i.e. add new section of pipe or beat back into shape). Provide markers to prevent re-occurrence**

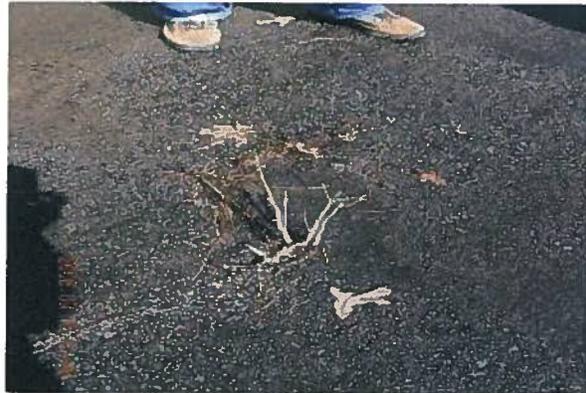
Pt. 151 – Localized minor vegetation observed at floor of spillway. **Remove vegetation from weep hole and other various locations in the spillway floor.**

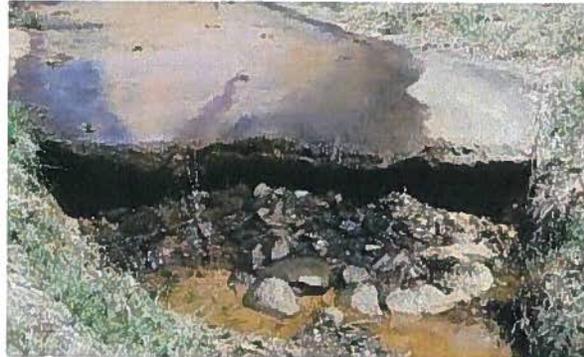
Sta. 37+50 – Progressive undermining of concrete paving. **Requires repair to mitigate further ground loss and future damage to pavement. (See attached Sketch No. 1 below for proposed repair option)**

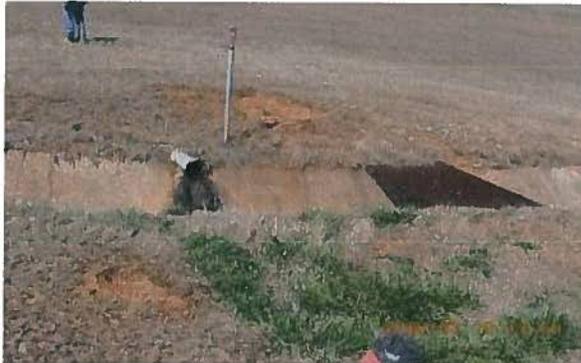
Pt 152 (Sta. 68+00) –Bare spots in slope
Localized re-seeding to re-establish grass cover.

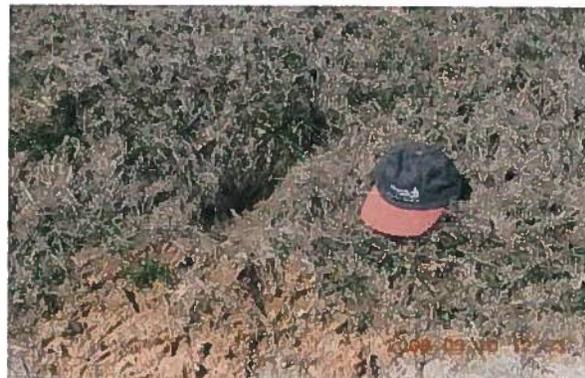
Pt 153 – Animal burrow just upslope from concrete drainage channel (approx Sta. 68+00). **Requires repair/filled in.**

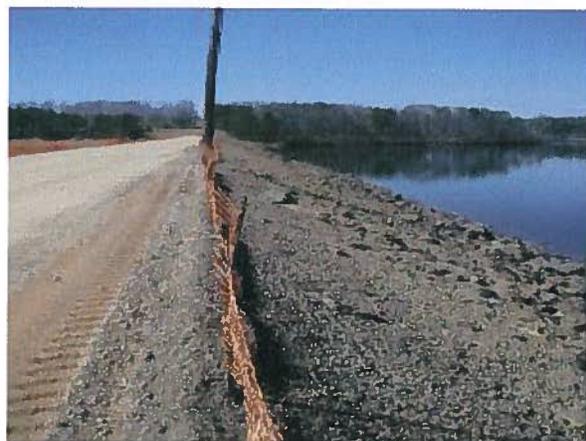
Localized re-grading required to flatten over steepened upper portion of slope and to provide positive drainage to minimize over-slope flows (which will result in progressive erosion along slope)

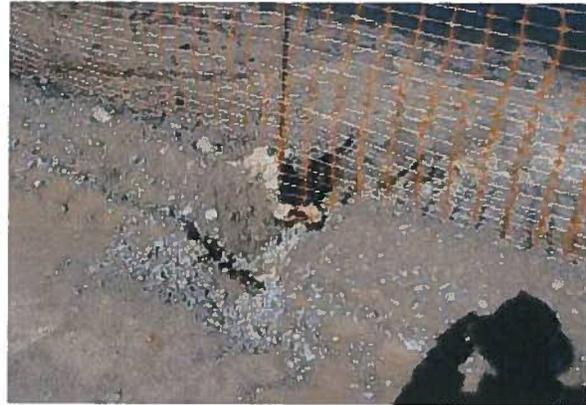
Crest of Upstream Slope - Localized erosion rill needs to be repaired with #57 stone.

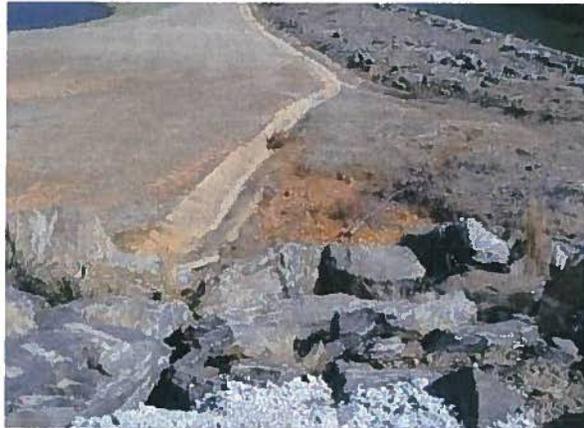
(See Updated Status from Third Quarter Report –Location 092, for items to be completed)

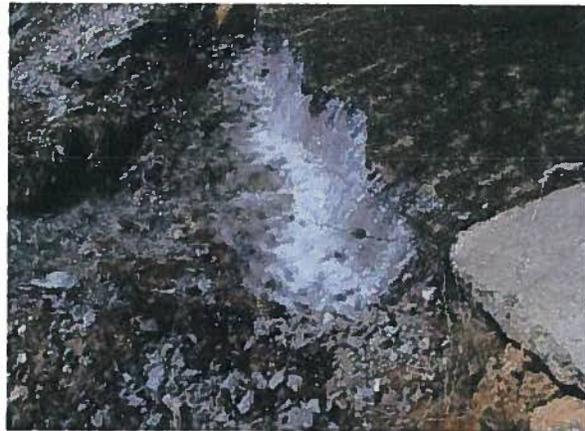
Rip-rap on upstream and downstream slopes overall looks good. No evidence of recent erosion or instability. Brush has been cleared since 3rd Quarter 2007.

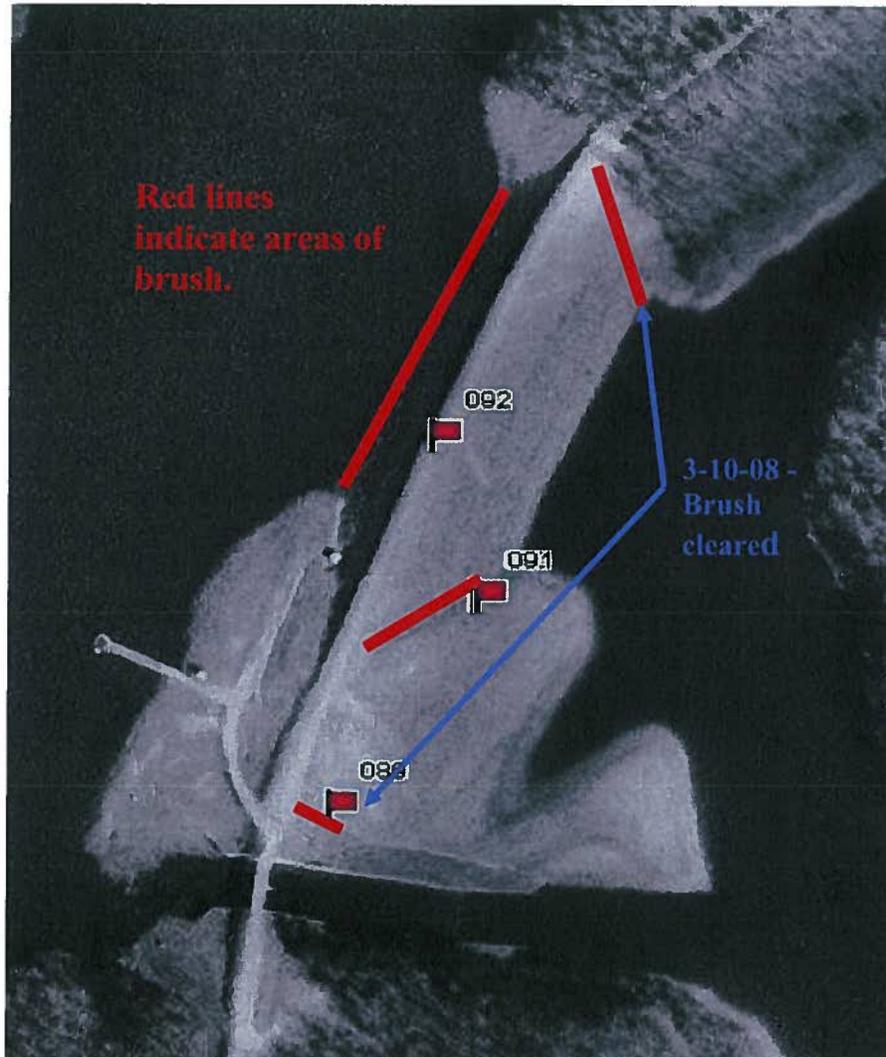
089 An eroded area was noted on the downstream slope just east of the spillway. This appears to be the result of runoff from the roadway passing through the riprap and running down this area instead of into the adjacent paved ditch. It would be a good idea to add some rock to the eroded area to protect it from further erosion and to add some rock to the riprap at the top of the slope to try to direct the runoff into the existing paved ditch. There are also some small trees growing in this area. These should be cut or poisoned.

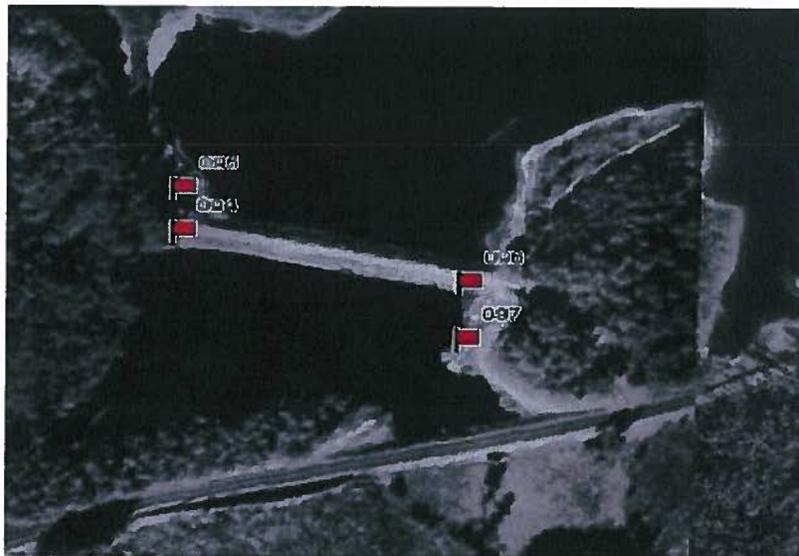
Ash Pond Emergency Overflow

094 The downstream outfall for the paved ditch has been undermined. Storm flows from the ditch undermine the ditch liner and will eventually remove the soil supporting the end of the ditch liner causing the liner to fail. **This area should be reinforced by placing Type I riprap in the pond at the outfall and choking that with Type III riprap. See sketch below.**

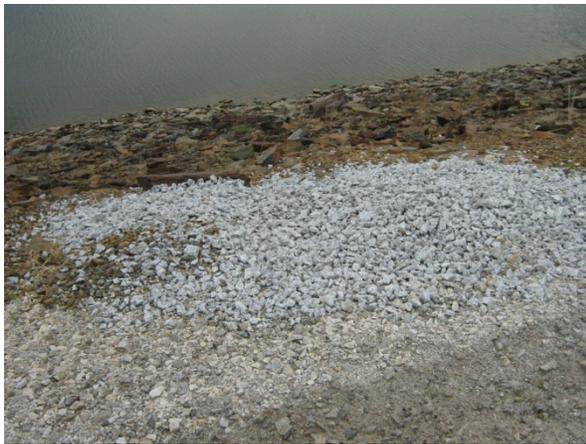
Photo 24: Downstream slope erosion repair

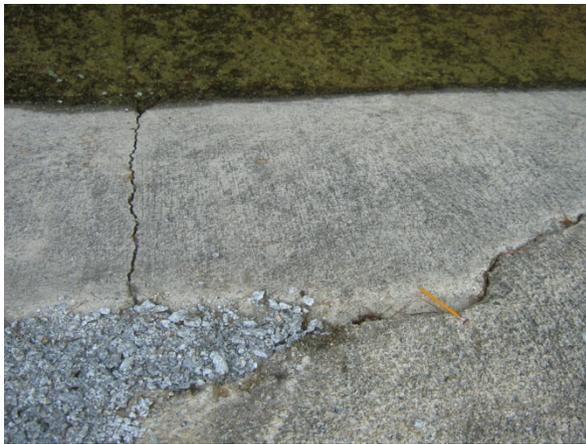
The emergency overflow concrete channel was cracking and showed a potential to be undermined in future rain events. This is not a safety issue at this time, but needs to be monitored.

Photo 56: Cracking along overflow channel

Continue current program. Begin monitoring erosion at concrete channel to avoid channel being undermined. Monitor cracking along the concrete channel.
